THE REPAIRS ON THE JOINT HEAD DAM ON THE SALT  
RIVER IN ARIZONA.

LUTHER R. TILLOTSON, -- 1916.

United States Reclamation Service  
F. Williams, Superv. Eng. C.H. Fitch, Project Mgr.  
**DETAILS AND PLANS FOR EXTENSIONS TO JOINT HEAD DAM**  
Scale as noted

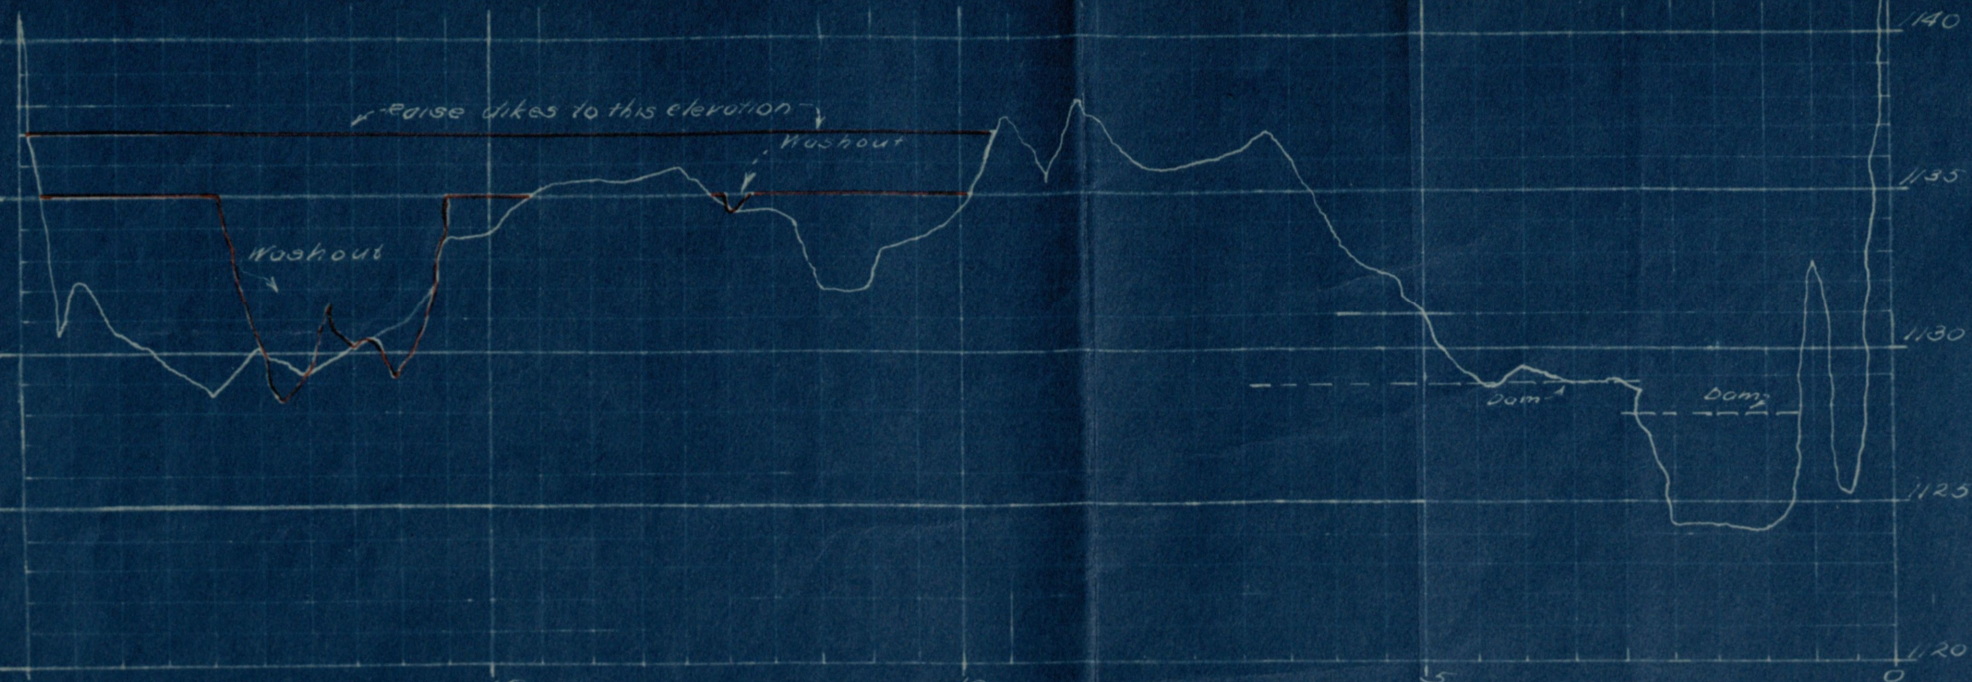
PROFILE FOR RAISING, REPAIRING AND STRENGTHENING DIKES

to have active charge of the work north of the Salt River and the Joint Head Dam repair work was part of my assignment. In February of 1914, the Joint Head structure had been compelled to withstand a flood estimated by the hydrographer of the project as 22000 sec. ft. The earth dykes south of the river had not withstood the flood and washouts had occurred, as shown on the accompanying plans. The dam was badly washed out downstream.

A work order had been issued to the previous construction engineer, authorizing him to proceed with the work; but his plans were so poorly prepared, due to an insufficient engineering office, and apparently based on such poor information, due probably to the economy on the part of the government in not hiring a sufficient engineering department, it was thought best to secure more accurate data before attempting to proceed with construction. It was thought best to secure soundings below the structure and to obtain a line of levels over the dykes, to enable the showing of washouts on a profile of the dykes and also to permit of computation

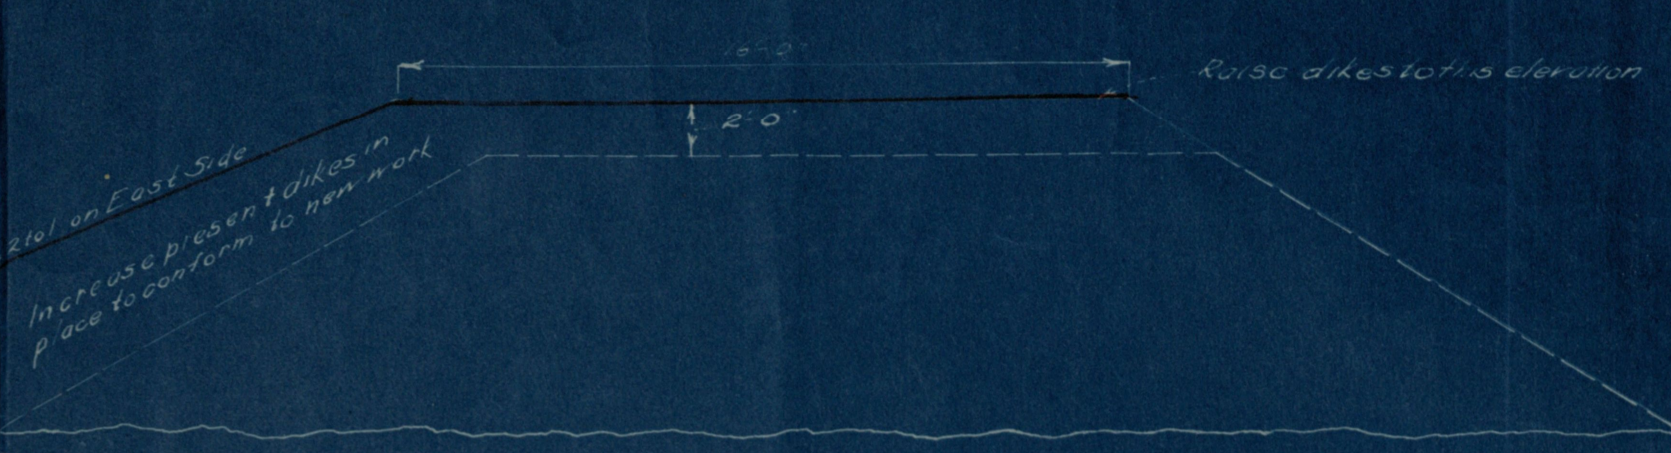
EXTENSIONS TO JOINT HEAD DAM  
Scale 1/20" = 1'

of quantities. A great pool was caused by the flood below the dam and it was this hole which threatened the structure. Soundings were obtained by sending a man with a level rod out on a rope stretched across the pool below the dam. The water level being known, the rod could be let down and by reading the rod at the surface when it rested on the bottom the data on depth could be obtained. Readings were taken every five feet up and down stream and every fifteen feet length-wise of the dam apron. The readings were taken out for 105 feet from the face of the apron downstream where the pool ended. The soundings indicated that the hole at the deepest point was about at the foot of the downstream drop wall.

It was thought best to pump the water out below the dam, driving a cofferdam for the downstream drop wall of the new apron and place the toe of the wall well into the sand and gravel which composed the stream bed. The new apron was only made 20' X 120' which was as long as the washout. The balance of the hole was filled with granite boulders hauled from the Tempe Powerhouse waste excavation about three miles away. The cement came from the Phoenix Warehouse and was the Cowboy brand of El Paso manufacture. The local cement plant was not running. The sand and rock came from the river bed and was really obtained by screening gravel from the dam site. The pump was a ten inch centrifugal run by alternating motor obtaining its current from the Salt River Valley high tension line from Arizona Falls to Phoenix. This necessitated a transformer installation, to step the current down from eleven thousand to two thousand, two hundred volts. The pump was run by electricity in a rather peculiar fashion. The outlet pipe was placed over the dam and the water pumped upstream. The waste gates of the Salt Canal
