**CRACK SURVEYS OF LOW-CRACKING HIGH-PERFORMANCE CONCRETE
BRIDGE DECKS IN KANSAS
2014-2015**

**Structural Engineering and Engineering Materials
SL Report 15-3**

**THE UNIVERSITY OF KANSAS CENTER FOR RESEARCH, INC.
LAWRENCE, KANSAS
September 2015**

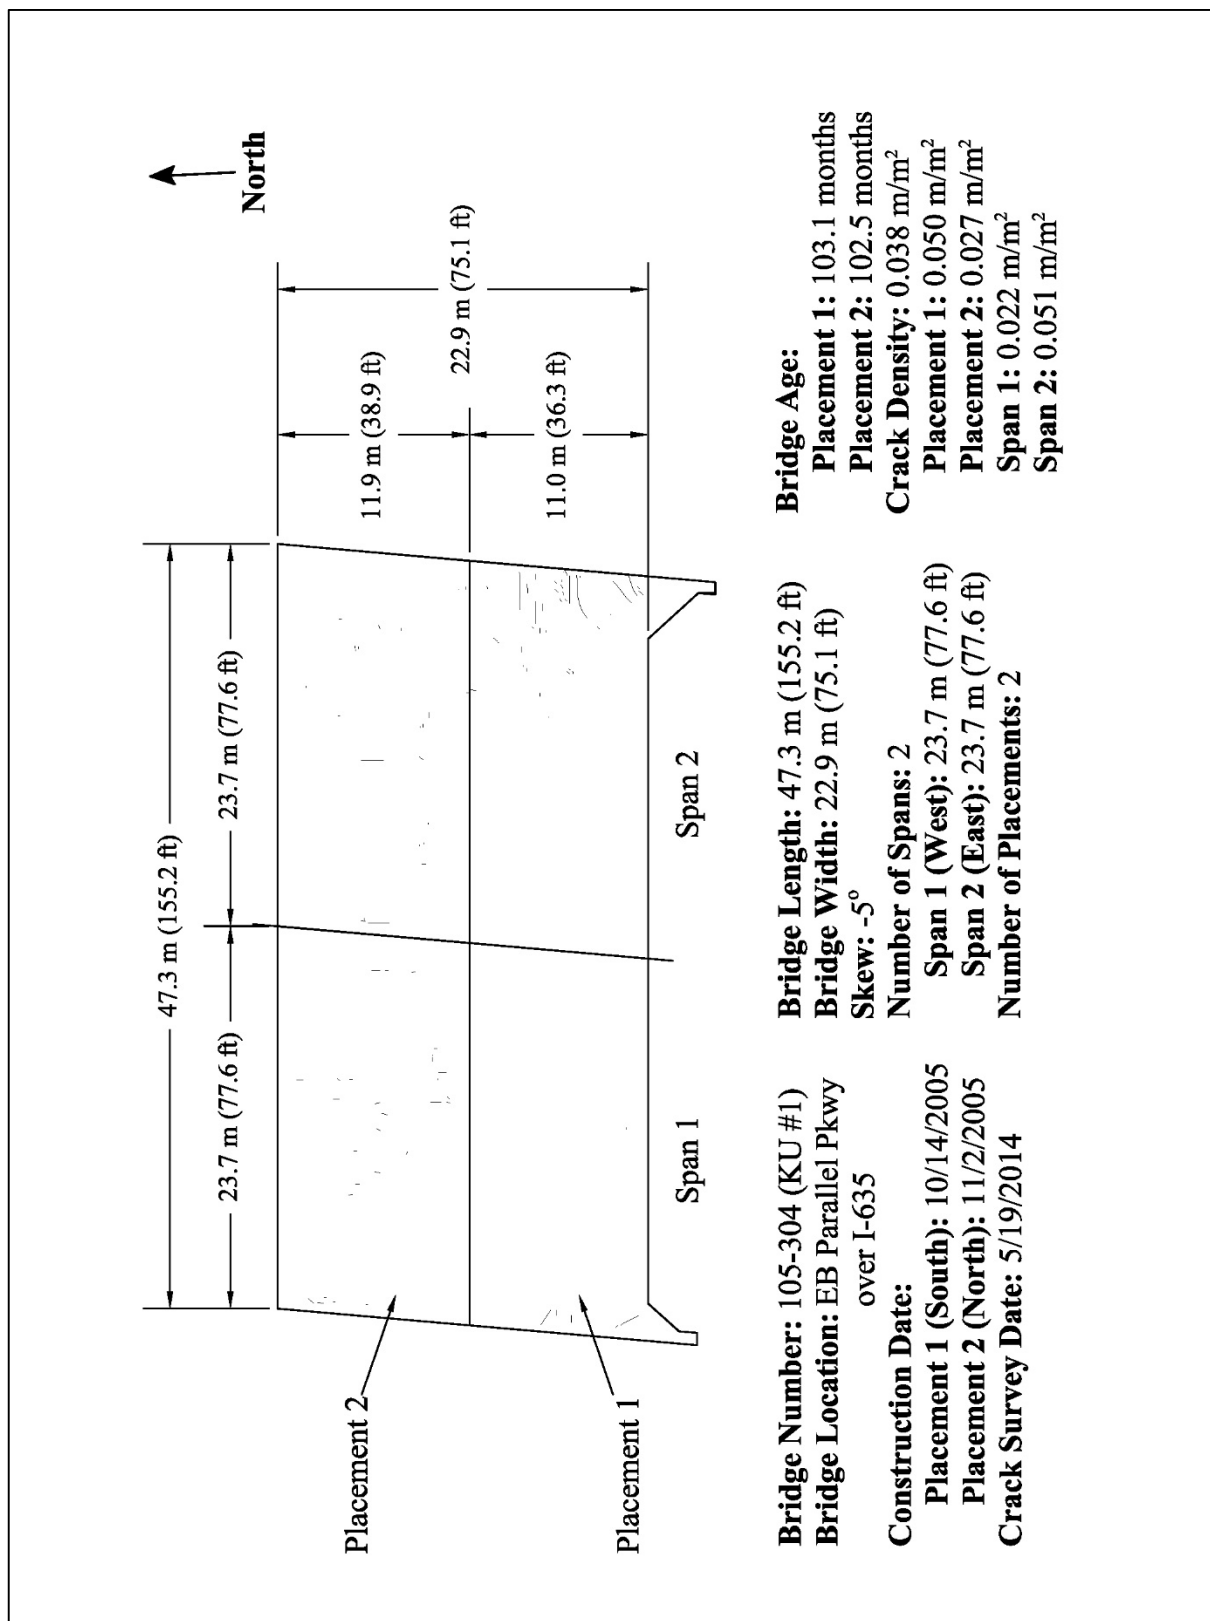
Figure 3: LC-HPC-1 (Survey 9)

The bridge deck of LC-HPC-1 was constructed in two placements; Placement 1 was placed on 10/14/2005 and Placement 2 was placed on 11/2/2005. This bridge has been surveyed ten times; the results of Surveys 9 and 10 of LC-HPC-1 are included in this report. Survey 9 was performed at a deck age of 103.1 months for Placement 1 and 102.5 months for Placement 2; the crack map from this survey is shown in Figure 3. Survey 10 was performed at a deck age of 115.1 months for Placement 1 and 114.5 months for Placement 2; the crack map from this survey is shown in Figure 4. Crack densities of 0.050 and 0.027 m/m² were observed in Survey 9 (Figure 3) for Placements 1 and 2, respectively. These values are similar to the crack densities from Survey 8, reported by Bohaty et al. (2013). Crack densities of 0.037 and 0.055 m/m² were observed in Survey 10 (Figure 4) for Placements 1 and 2, respectively. Survey 10 for Placement 1 showed that the bridge deck had a slightly lower crack density compared to Survey 9. The surveys showed that the deck has experienced some scaling, making it harder to identify cracks during the survey. As shown in Figures 3 and 4, most of the cracks that were marked for both placements are relatively small transverse cracks, parallel to the deck's top reinforcement, with longitudinal cracks near the abutments.

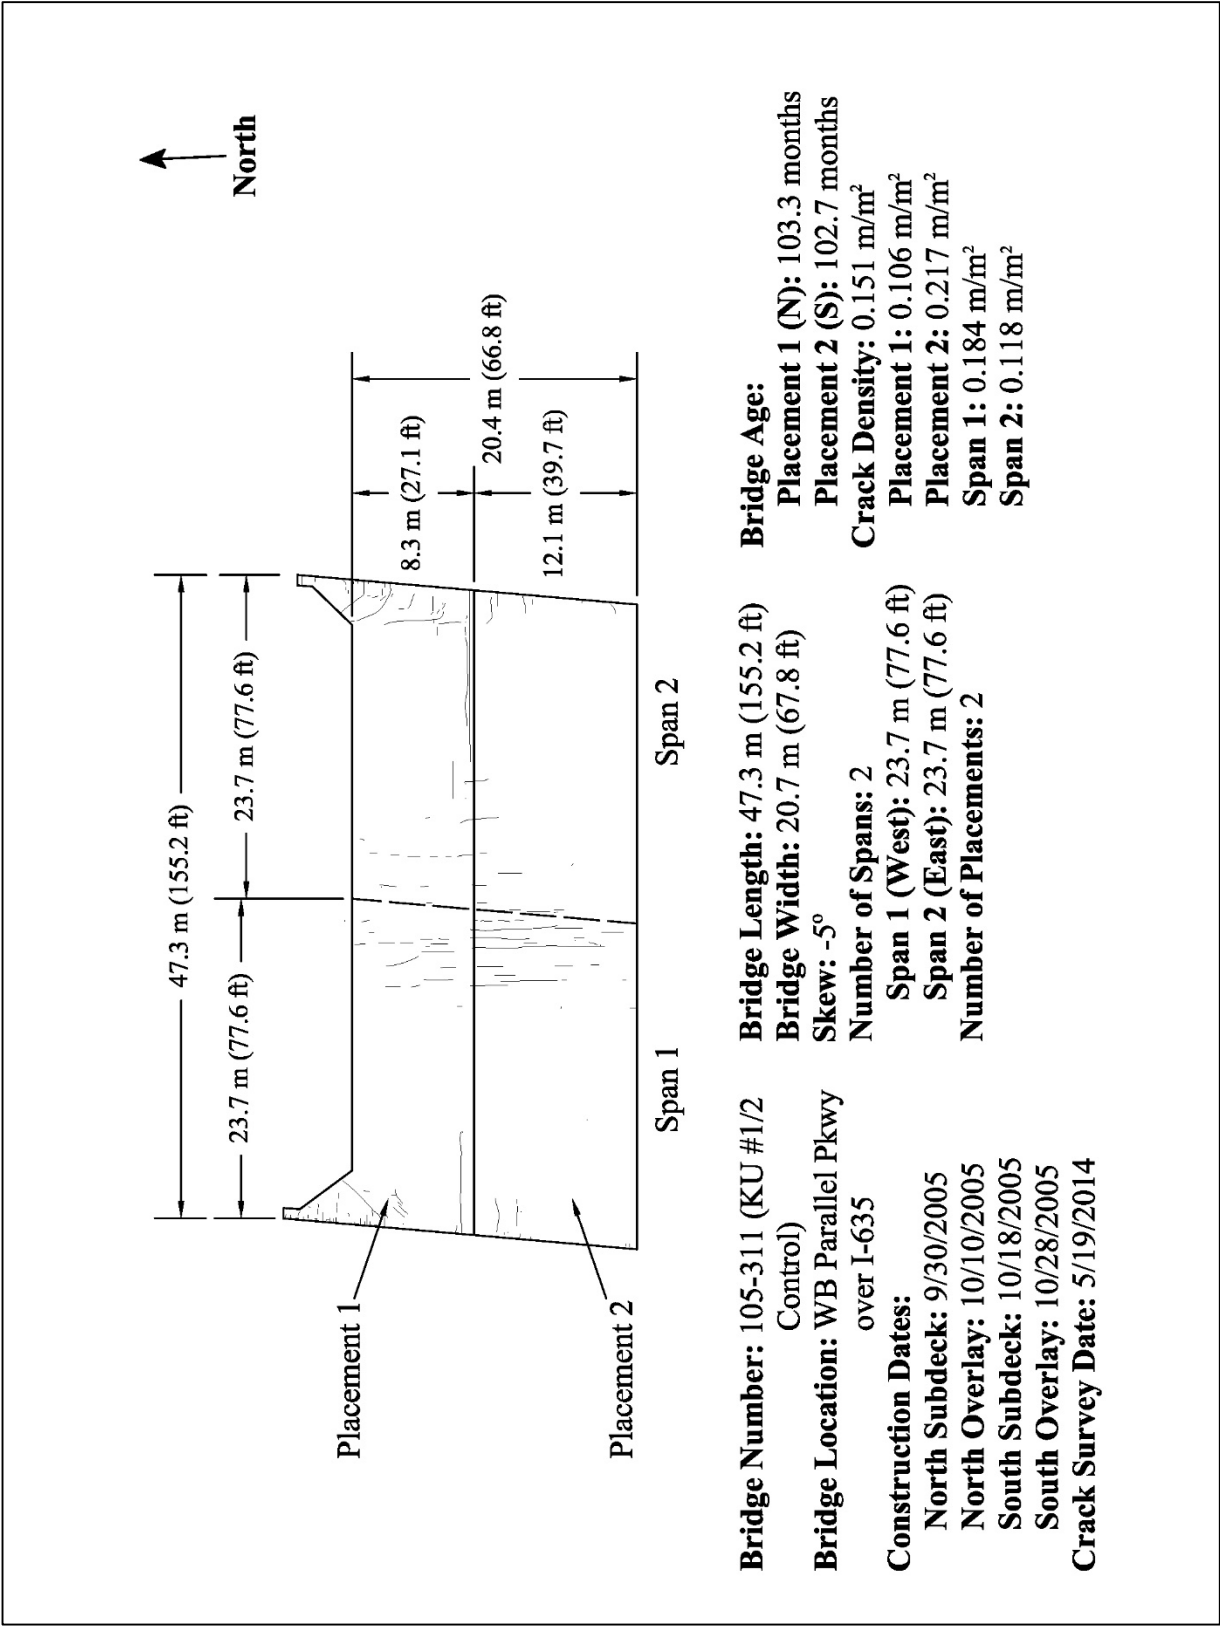
Figure 5: Control-1/2 (Survey 9)

Control-1/2 is paired with both LC-HPC-1 and LC-HPC-2, which have similar environmental conditions, age, and traffic volume. To date, Control-1/2 has been surveyed ten times. The deck was constructed in two placements; Placement 1 was constructed on 9/30/2005 and Placement 2 was constructed on 10/10/2005. The results of Surveys 9 and 10 of Control-1/2 are included in this report. Survey 9 was performed at a deck age of 103.3 months for Placement 1 and 102.7 months for Placement 2; the crack map from this survey is shown in Figure 5. Survey 10 was completed at a deck age of 115.6 months for Placement 1 and 115.3 months for Placement 2; the crack map from this survey is shown in Figure 6. Crack densities of 0.106 and 0.217 m/m² were observed in Survey 9 for Placements 1 and 2, respectively (Figure 5). Crack densities of 0.164 and 0.239 m/m² were observed in Survey 10 for Placements 1 and 2, respectively (Figure 6). These crack densities are greater than the densities from Survey 8 reported by Bohaty et al. (2013). Most of the cracking is transverse and took place above the pier. These cracks are parallel to the top reinforcement. Cracks have propagated longitudinally near the abutments. A limited amount of map cracking has occurred since Survey 9.

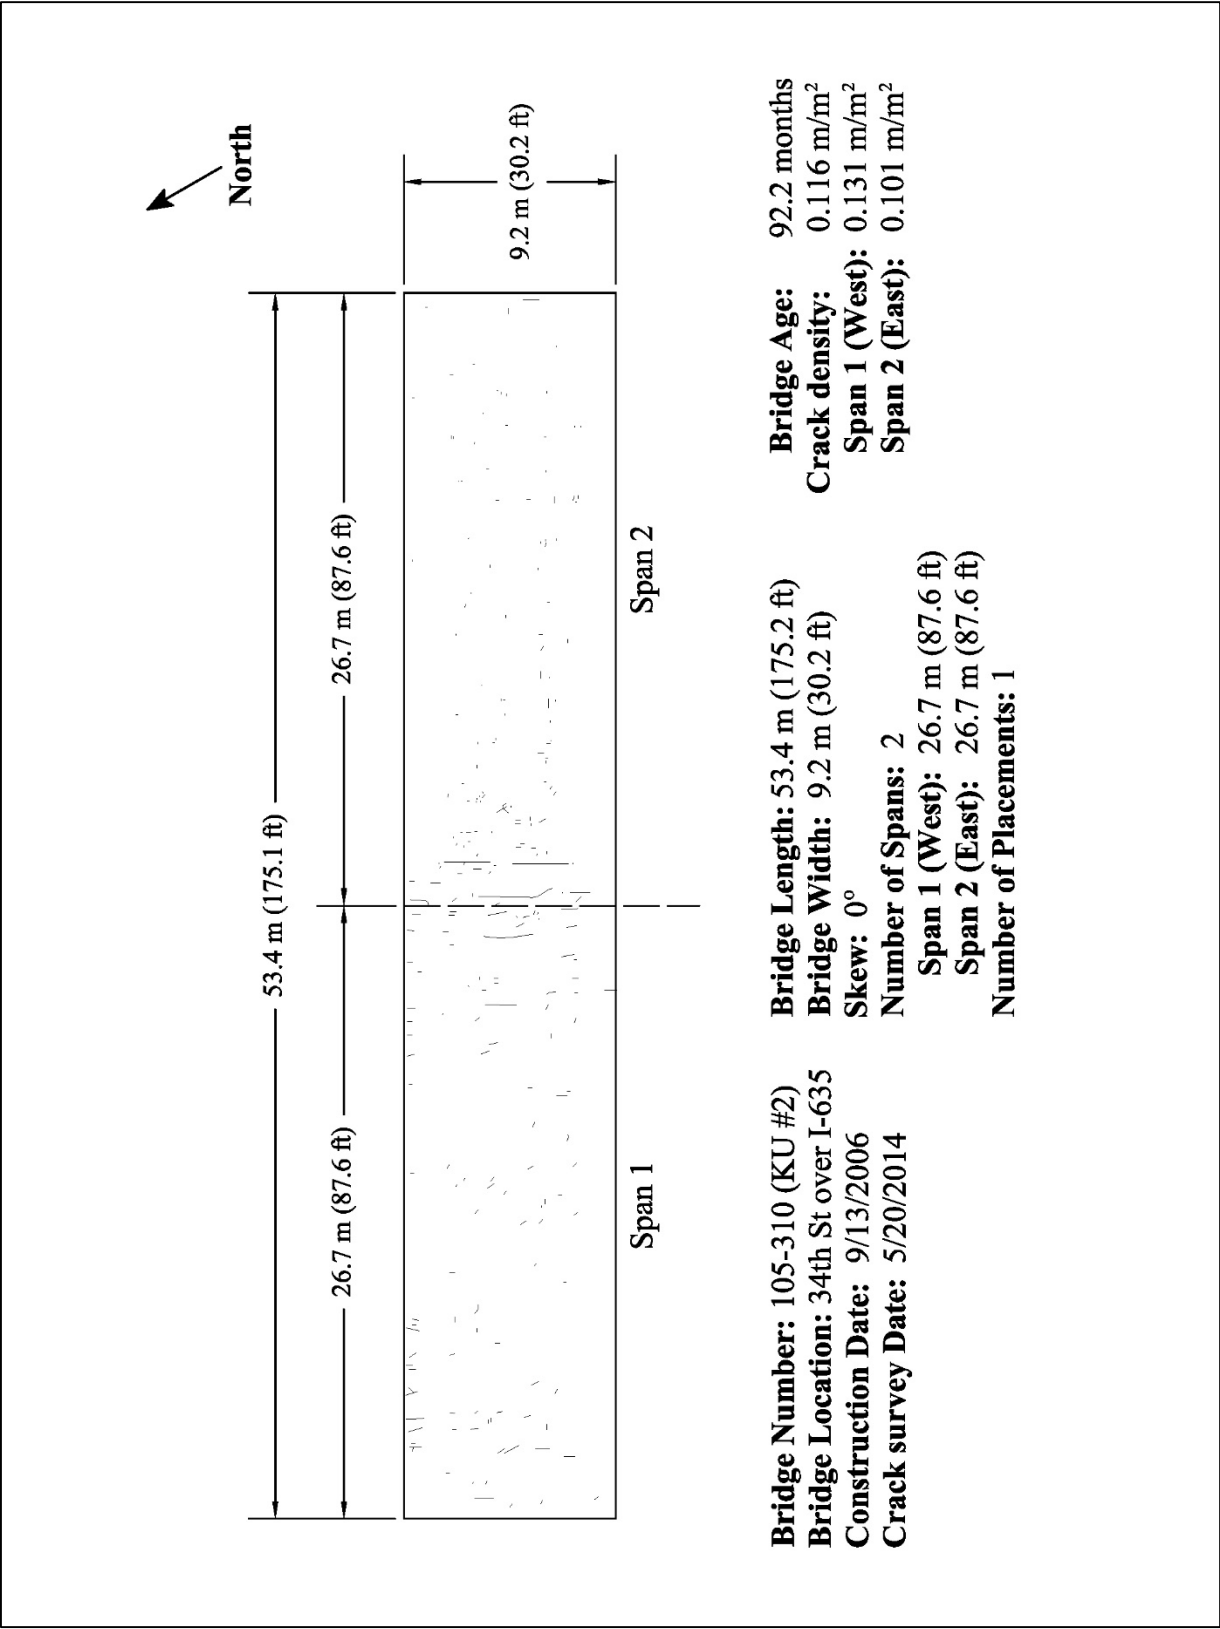
Figure 8: LC-HPC-2 (Survey 8)

Bridge deck LC-HPC-2 was constructed on 9/13/2006, and has been surveyed 9 times. Survey 8 was performed at a deck age of 92.2 months; the crack map from this survey is displayed in Figure 8. Survey 9 was completed at a deck age of 104.2 months; the crack map from this survey is shown in Figure 9. A crack density of 0.116 m/m^2 was observed in Survey 8 (Figure 8). This value is noticeably lower than observed in Survey 7, 0.141 m/m^2 , as reported by Bohaty et al. (2013) at an age of 80.3 months. A crack density of 0.220 m/m^2 was observed in Survey 9 (Figure 9), which is higher than all previously reported crack densities. As shown in Figure 10, LC-HPC-2 has a higher overall crack density than Placement 1 of Control-1/2 and a slightly lower crack density than Placement 2 of Control-1/2 at approximately the same age. Map cracking is the dominant type of crack that has been surveyed. Some transverse cracks appear in the middle of the bridge above the pier.

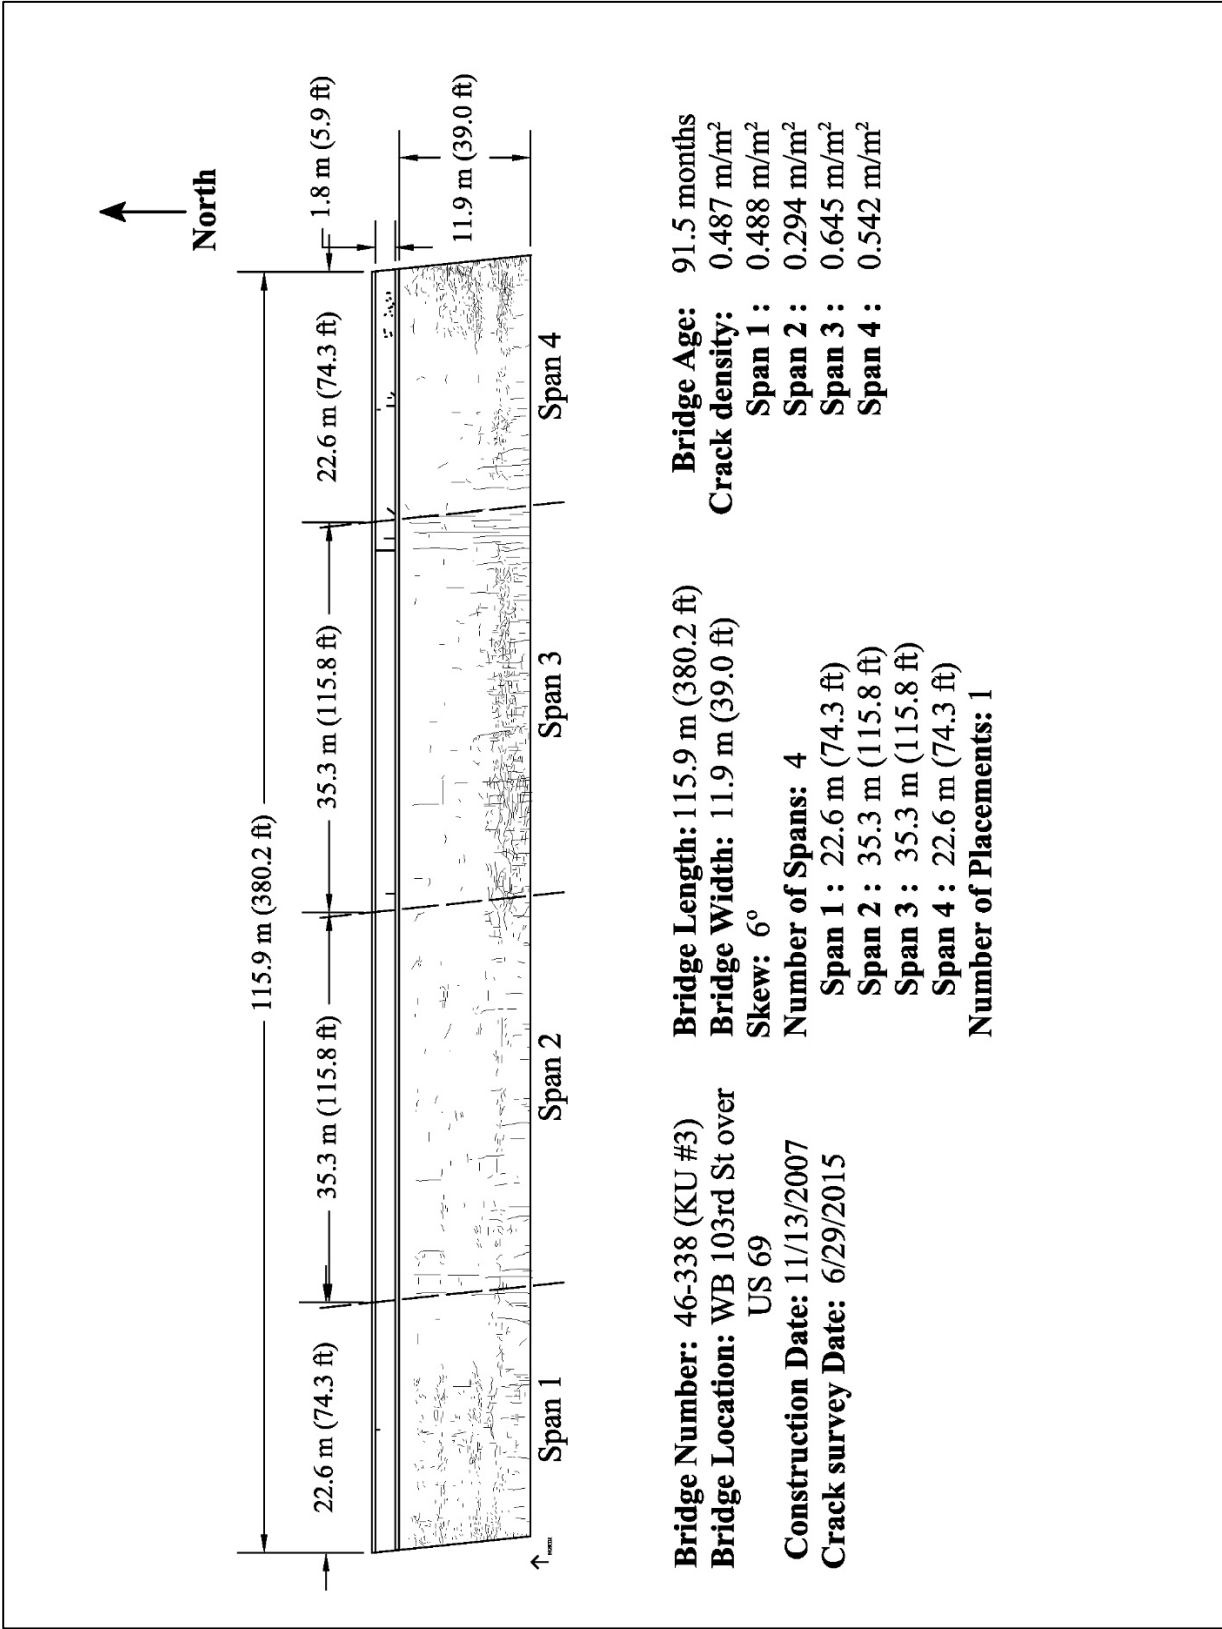
Figure 12: LC-HPC-3 (Survey 8)

Bridge deck LC-HPC-3 was constructed on 11/13/2007. To date, LC-HPC-3 has been surveyed eight times. The results from surveys 7 and 8 are included in this report. Survey 7 of LC-HPC-3 was completed at deck age of 83.2 months; the crack map is shown in Figure 11. Survey 8 of LC-HPC-3 was performed at a deck age of 91.5 months; the crack map is shown in Figure 12. A crack density of 0.663 m/m^2 was observed in Survey 7 (Figure 11), which is significantly higher than obtained in Survey 6 at 0.174 m/m^2 reported by Bohaty et al. (2013). A crack density of 0.487 m/m^2 was observed in Survey 8 (Figure 12). During Survey 7, the surveyors may have mistakenly misidentified the outlines of the aggregate as cracks. Survey 7 could be considered as an outlier. The vast majority of the cracks are relatively short in length. A few medium-length transverse cracks run parallel to the top layer of reinforcement, primarily over the two outer piers.

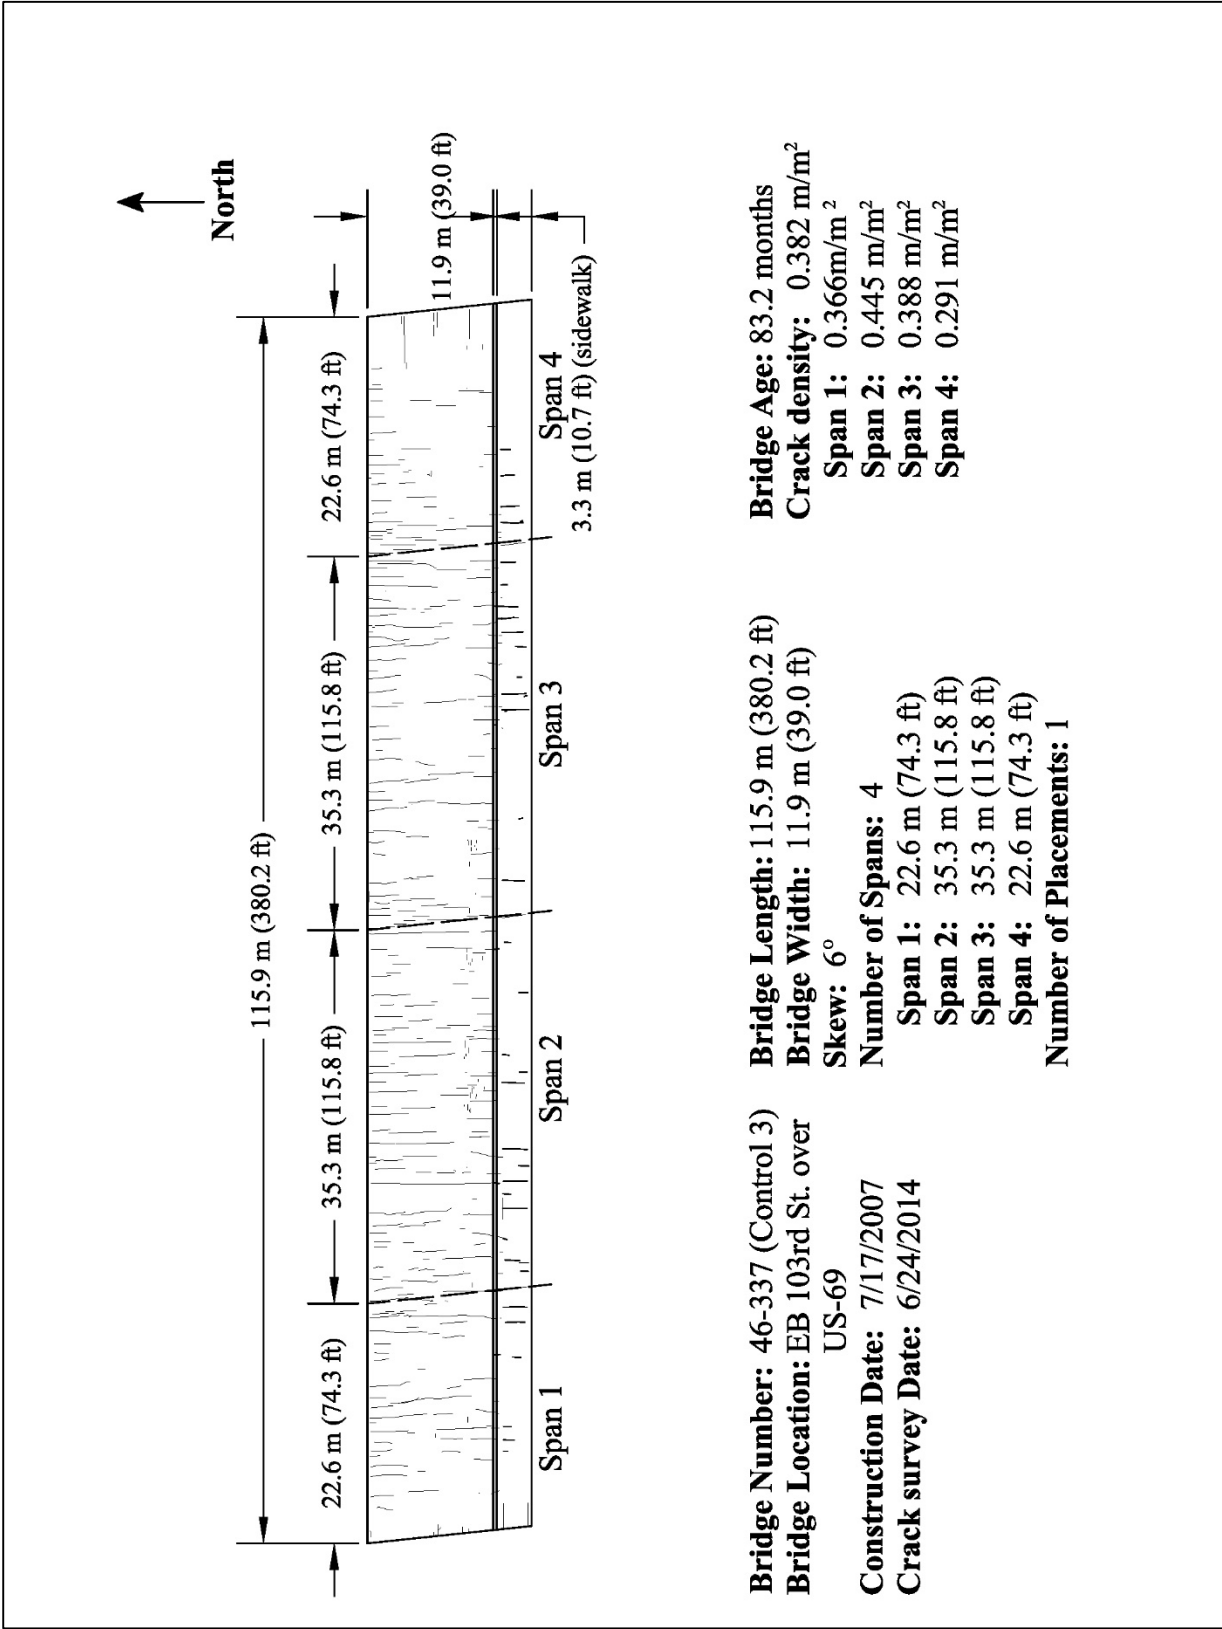
Figure 13: Control-3 (Survey 7)

Bridge deck Control-3 was placed on 7/17/2007, and has been surveyed eight times. The results of Surveys 7 and 8 of Control-3 are included in this report. Survey 7 was completed at a deck age of 83.2 months; the crack map appears in Figure 13. Survey 8 was completed at a deck age of 96.9 months; the crack map appears in Figure 14. A crack density of 0.382 m/m^2 was observed in Survey 7 (Figure 13), which is higher than obtained in Survey 6, 0.294 m/m^2 , reported by Bohaty et al. (2013). A crack density of 0.391 m/m^2 was observed in Survey 8 (Figure 14), slightly higher than the recorded crack density for Survey 7.

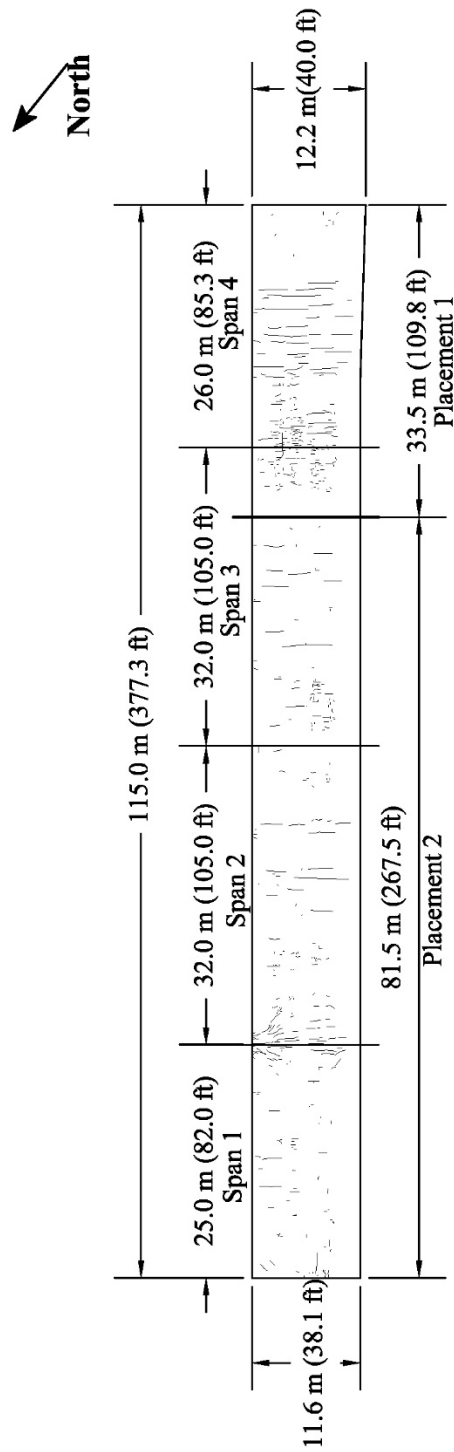
Figure 16: LC-HPC-4 (Survey 7)

Bridge deck LC-HPC-4 was constructed in two placements. Placement 1 was cast on 9/29/2007 and Placement 2 was cast on 10/2/2007. This deck has been surveyed eight times, and the results of Surveys 7 and 8 of LC-HPC-4 are discussed in this report. Survey 7 (Figure 16) was completed at a deck age of 80.4 and 80.3 months for Placements 1 and 2, respectively; the crack map appears in Figure 16. Survey 8 (Figure 17) was completed at a deck age of 93.3 and 93.2 months for Placements 1 and 2, respectively; the crack map appears in Figure 17. Crack densities of 0.371, 0.173, and 0.225 m/m² overall, and for Placements 1 and 2 were observed in Survey 7, respectively. In Survey 7, the crack density for Placement 1 was significantly higher than for Placement 2. Compared to Survey 6, reported by Bohaty et al. (2013), with respective crack densities of 0.147, 0.077, and 0.105 m/m². Crack densities of 0.305, 0.181, and 0.217 m/m² overall, and for Placements 1 and 2 were observed in Survey 8, respectively. These values are nearly the same to those recorded during Survey 7. Medium-length transverse cracks are present and distributed over the area of the deck. Near the deck's north western abutment, some cracks propagate longitudinally.

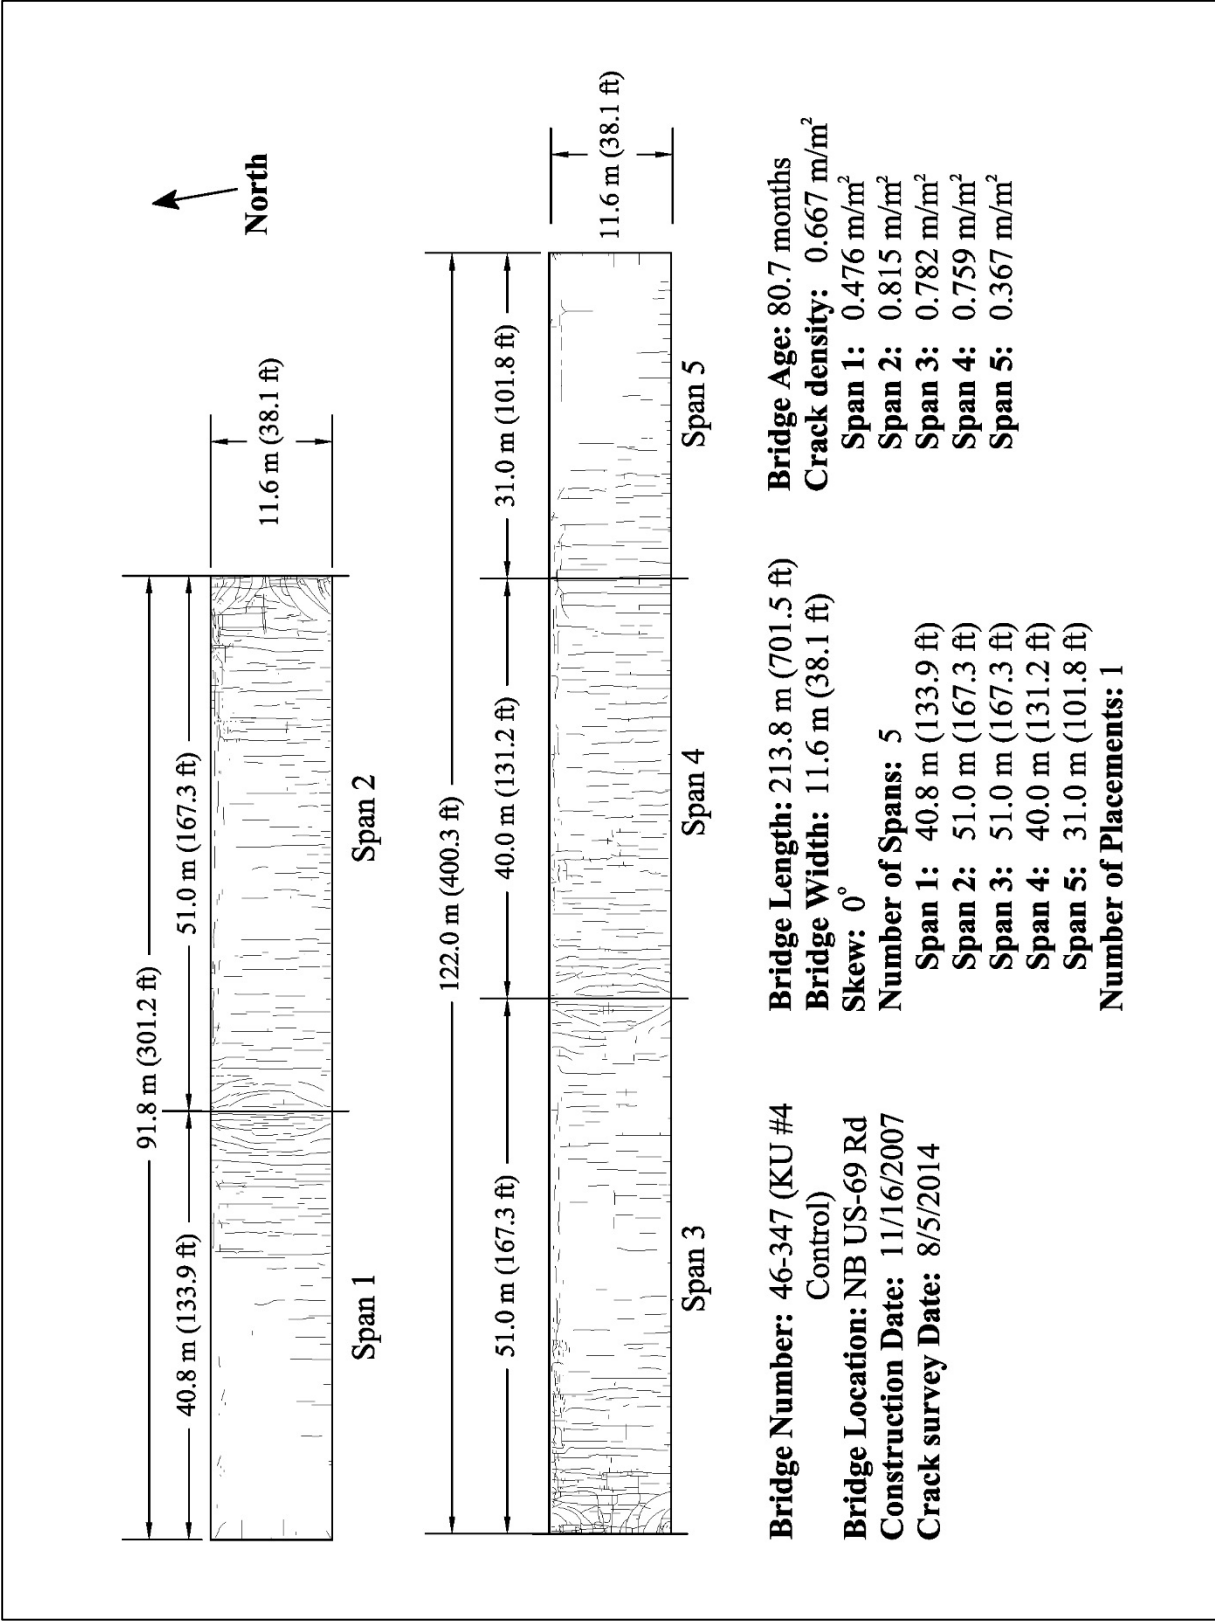
Figure 18: Control-4 (Survey 7)

Bridge deck Control-4 was constructed on 8/5/2014. This deck has been surveyed eight times. Surveys 7 and 8 are discussed in this report. Survey 7 was completed at a deck age of 80.7 months, and the crack map for this survey is shown in Figure 18. Survey 8 was completed at a deck age of 92.2 months, and the crack map for this survey is shown in Figure 19. A crack density of 0.667 m/m^2 was observed in Survey 7 (Figure 18), an increase from the value recorded in Survey 6 at 0.561 m/m^2 (Bohaty et al. 2013). A crack density of 0.755 m/m^2 was observed in Survey 8 (Figure 19). Cracking in Control-4 is significant in the outer portions of the end spans. The majority of the cracks are transverse and appear to run parallel to the top layer of reinforcement. Cracks propagate from both abutments. Longitudinal cracks are present near the northern side of the deck parallel to the parapet, and might be a result of the 3.2 ft (0.975-m) overhang at the exterior steel girder.

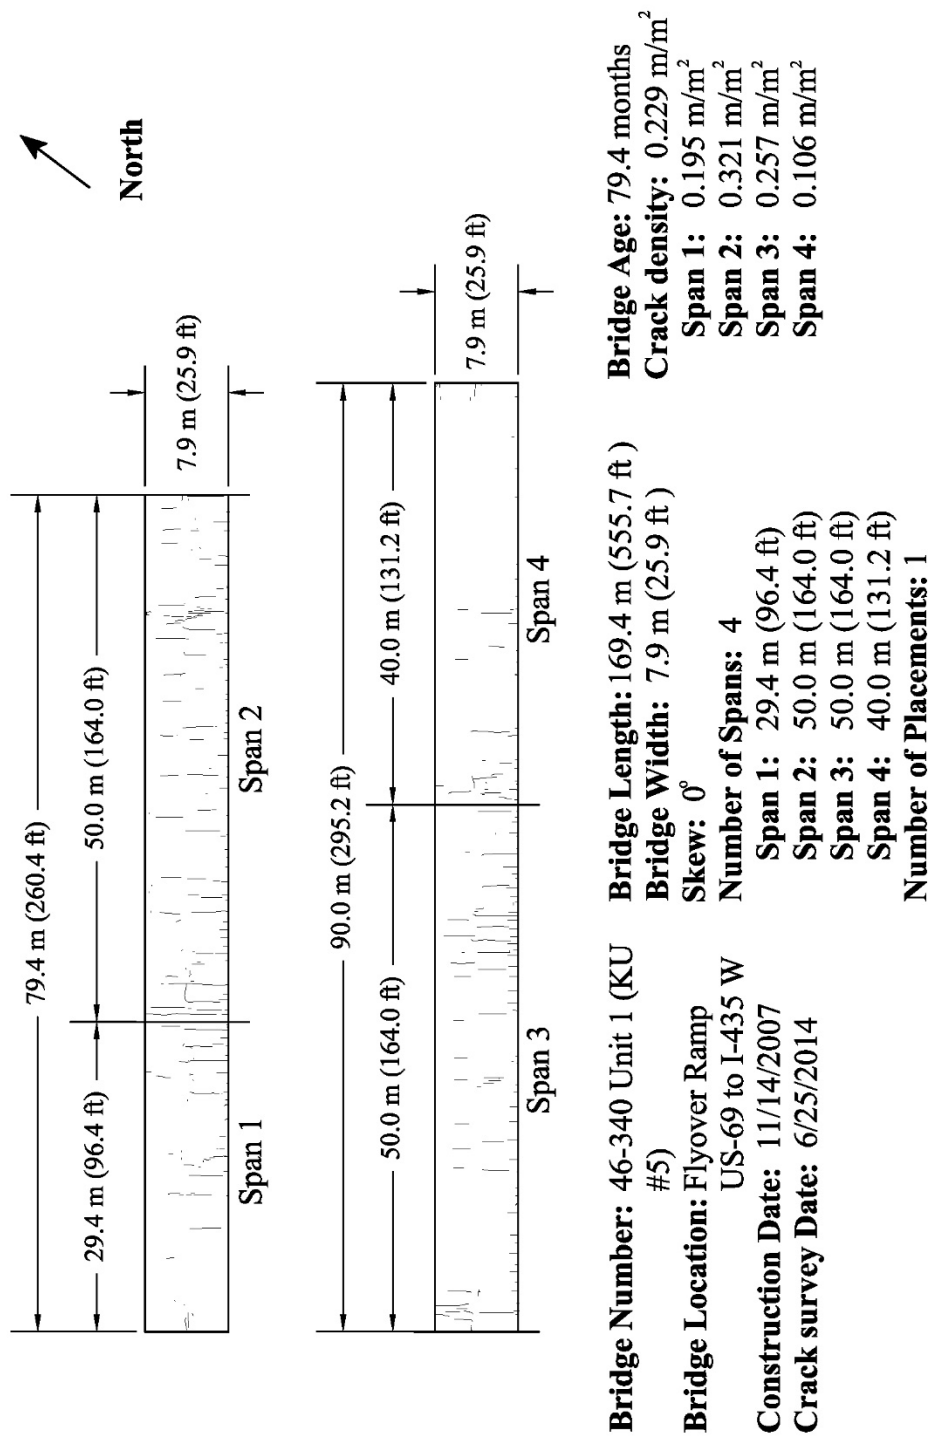
Figure 21: LC-HPC-5 (Survey 7)

Bridge deck LC-HPC-5 was placed on 11/14/2007. To date, LC-HPC-5 has been surveyed eight times. The results for Surveys 7 and 8 are included in this report. Survey 7 was completed at 79.4 months; the results are shown in Figure 21. Survey 8 was completed at 91.8 months; the results are shown in Figure 22. A crack density of 0.229 m/m^2 was observed in Survey 7 (Figure 21). This value indicates a nearly 70% increase in crack density compared to Survey 6 reported by Bohaty et al. (2013), which was 0.140 m/m^2 . A crack density of 0.247 m/m^2 was observed in Survey 8 (Figure 22). The majority of the cracks marked are medium-length transverse cracks. Also, some cracks have propagated longitudinally from both bridge ends near the abutments. It can be noted that most of the cracking has occurred on the southern side of the bridge. This may be related to the bridge being superelevated and the soaker hoses being placed at the centerline of the bridge at the time of construction, resulting a lack of water for curing at the more elevated side of the deck.

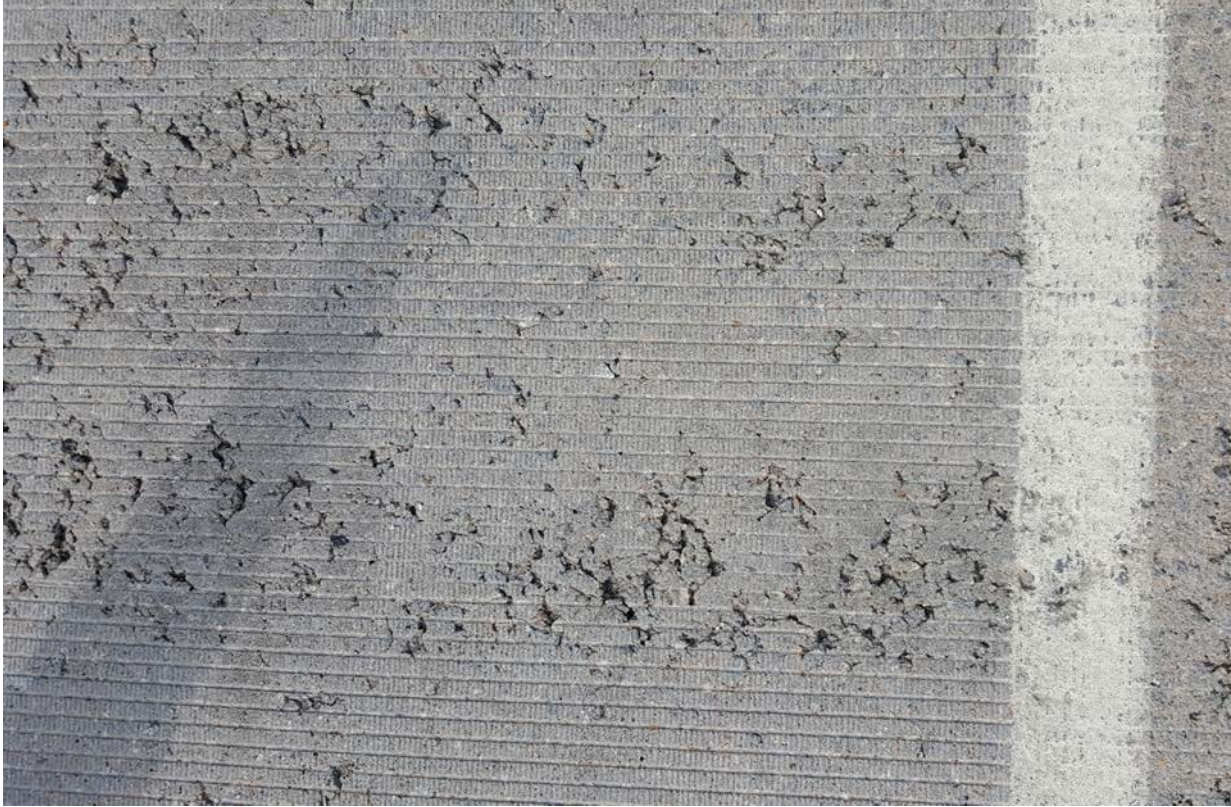
It was noted during the surveys that surface voids were present on the deck, likely due to incomplete finishing. These voids were noted in the construction report for LC-HPC-5 as being present immediately after bullfloating. Figure 23 shows a photo sample of the deck taken during Survey 8 illustrating these voids.

Figure 23: Surface Voids in LC-HPC-5 Bridge Deck

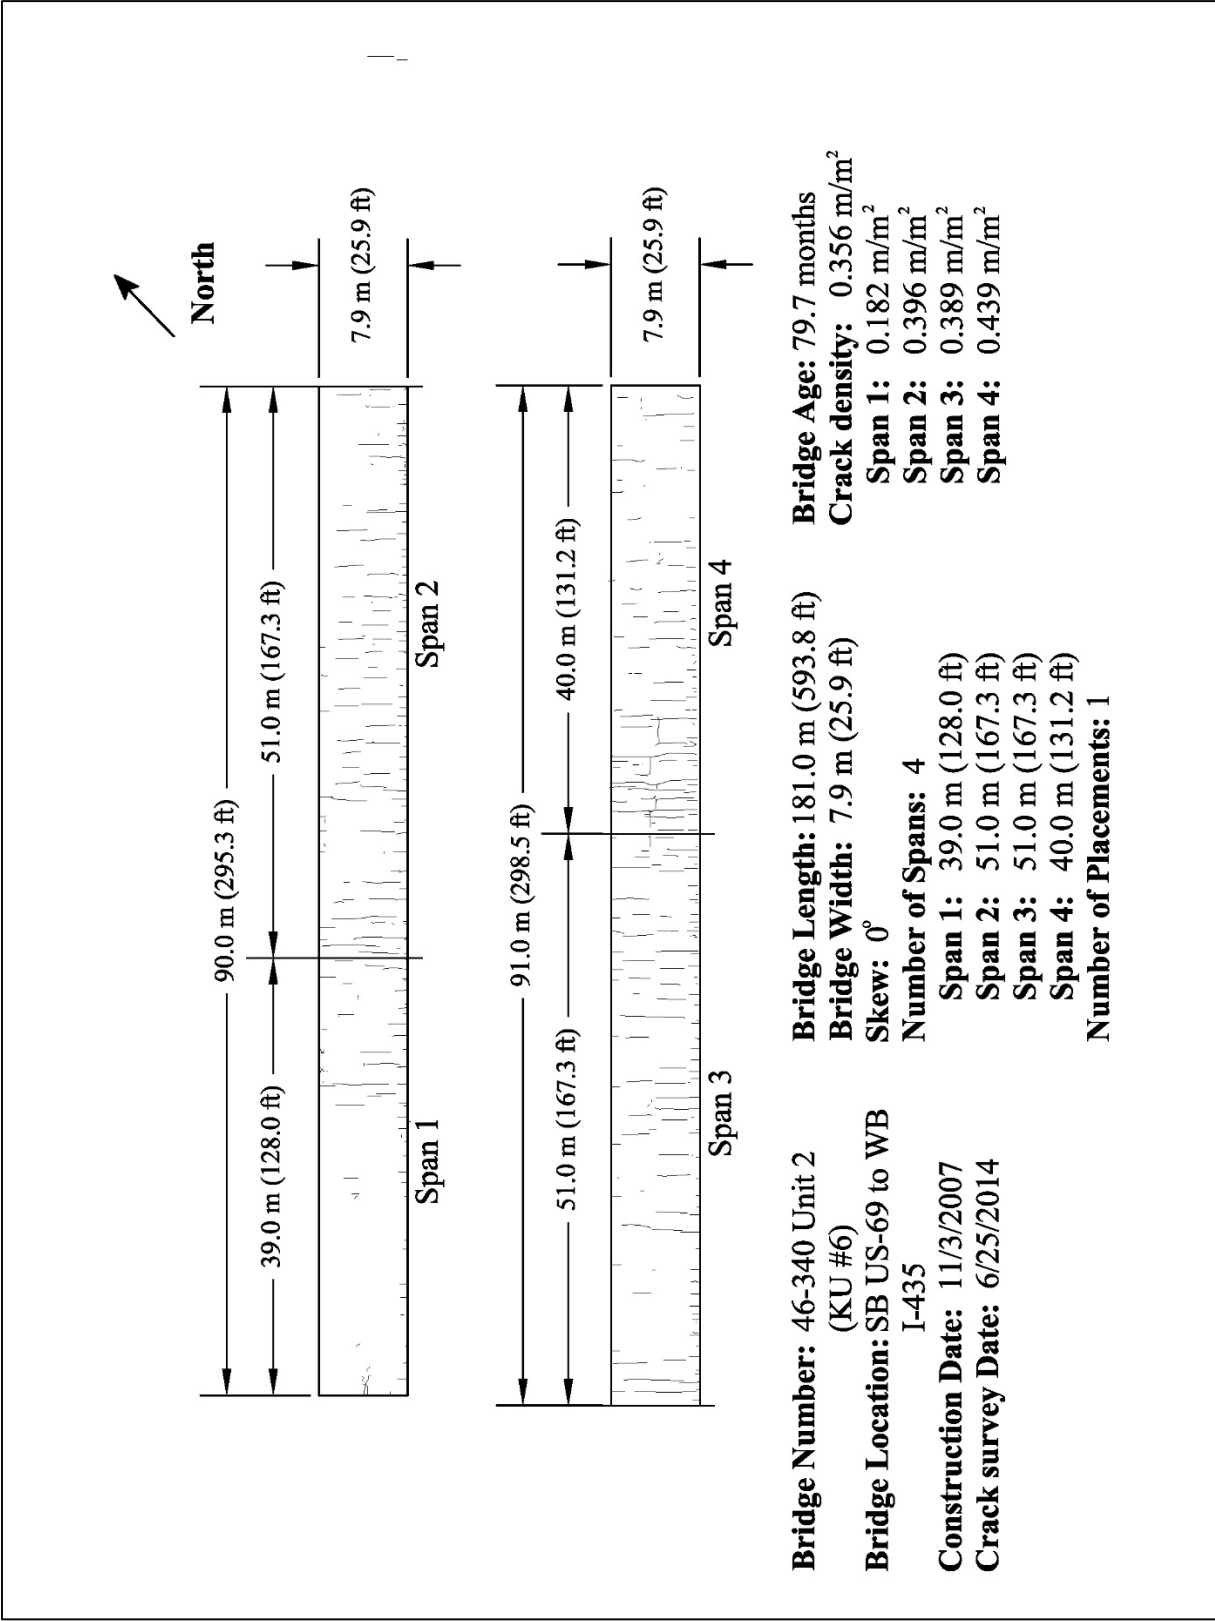
Figure 25: LC-HPC-6 (Survey 7)

Bridge deck LC-HPC-6 was constructed on 11/3/2007, and has been surveyed eight times. The results of Surveys 7 and 8 are included in this report. Survey 7 was performed at a deck age of 79.7 months; the crack map appears in Figure 25. Survey 8 was performed at a deck age of 92.2 months; the crack map appears in Figure 26. An overall crack density of 0.356 m/m^2 was observed in Survey 7 (Figure 25). This value represents an increase in crack density when compared to Survey 6, 0.303 m/m^2 , reported by Bohaty et al. (2013). An overall crack density of 0.386 m/m^2 was observed in Survey 8 (Figure 26). Similar to LC-HPC-5, surface voids were observed during construction and during the surveys. Most of the cracks are transverse.

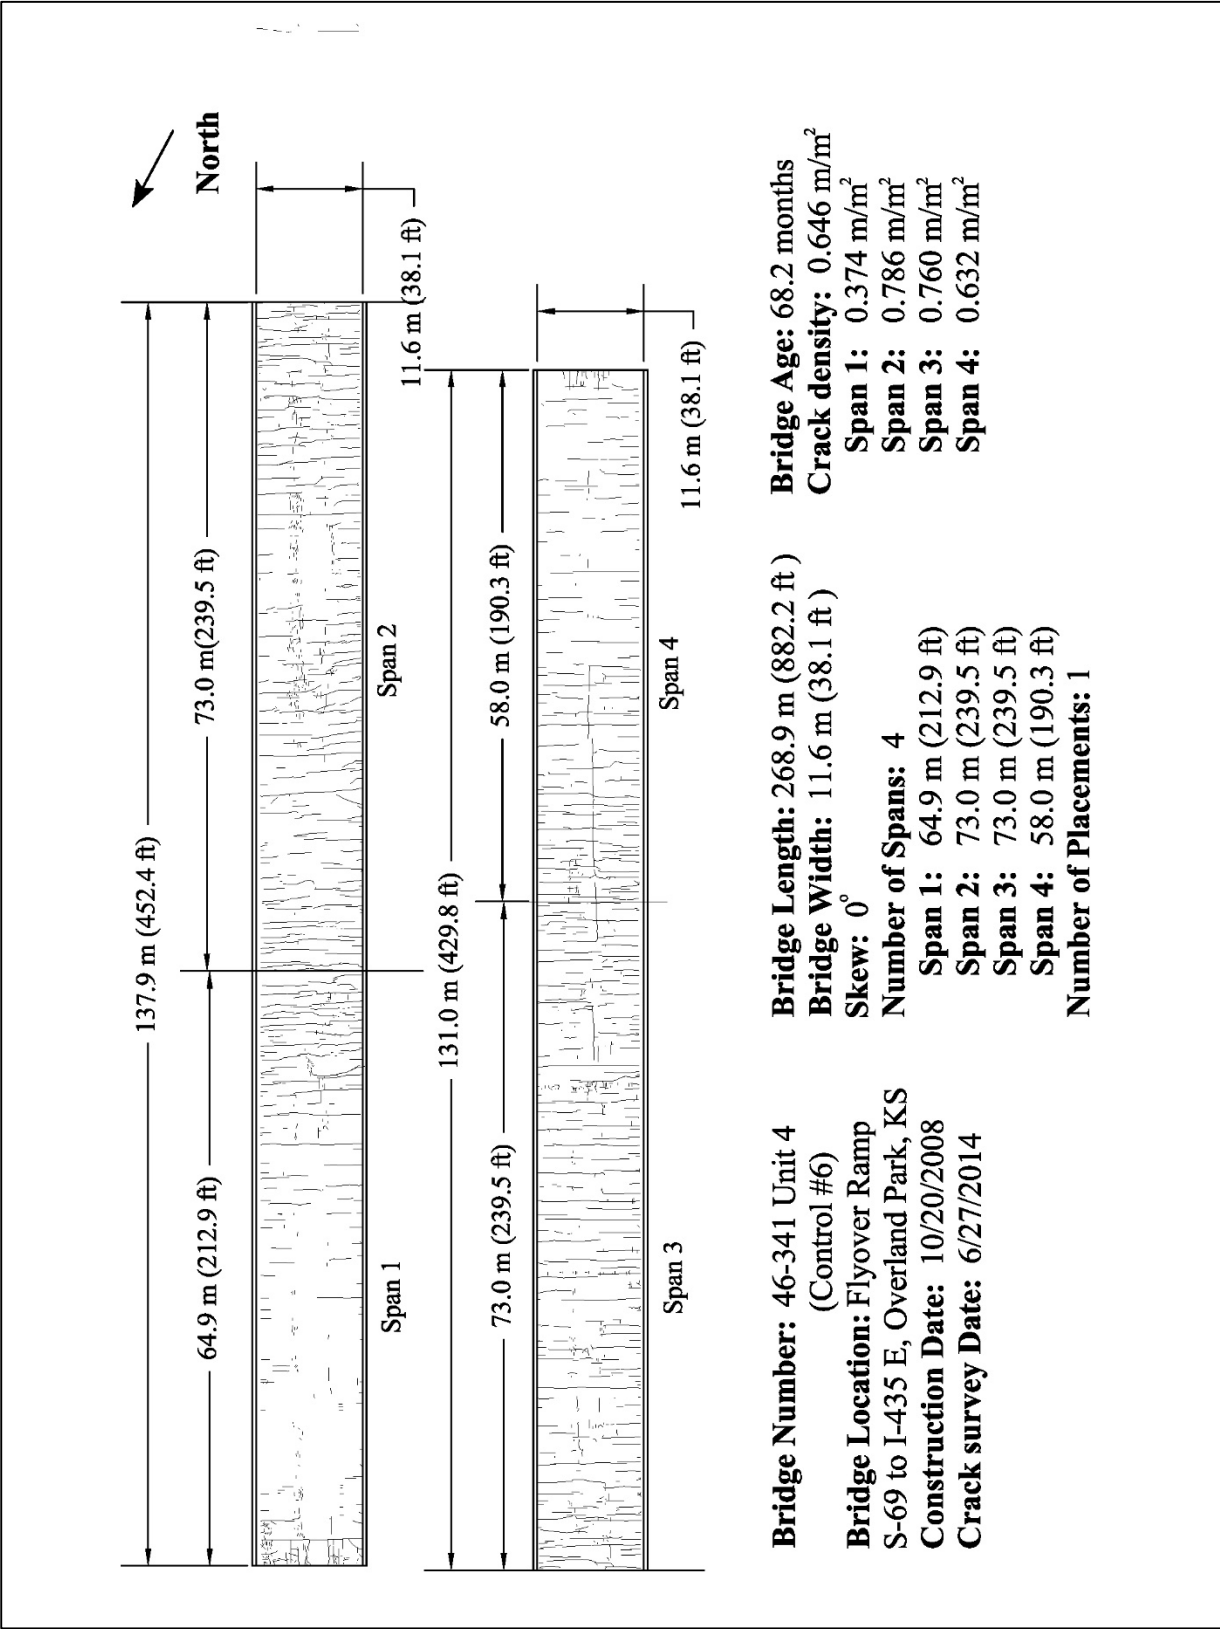
Figure 27: Control-6 (Survey 6)

Bridge deck Control-6 was placed on 10/20/2008 and has been surveyed seven times. The results for Surveys 6 and 7 are included in this report. Survey 6 was completed at 68.2 months; the crack map is shown in Figure 27. Survey 7 was completed at 81.9 months; the crack map is shown in Figure 28. A crack density of 0.646 m/m^2 was observed in Survey 6 (Figure 27), which is considerably higher than Survey 5 at 0.461 m/m^2 (Bohaty et al. 2013). A crack density of 0.628 m/m^2 was observed in Survey 7 (Figure 28), slightly lower than Survey 6. The majority of the cracks are transverse and run across the full width of the deck. The cracks are closer to each other over the piers than at other locations. Cracks propagate longitudinally adjacent the abutments. Some longitudinal cracks are present in the middle of the deck.
