**CRACK SURVEYS OF LOW-CRACKING HIGH-PERFORMANCE CONCRETE
BRIDGE DECKS IN KANSAS
2014-2015**

**Structural Engineering and Engineering Materials
SL Report 15-3**

**THE UNIVERSITY OF KANSAS CENTER FOR RESEARCH, INC.
LAWRENCE, KANSAS
September 2015**

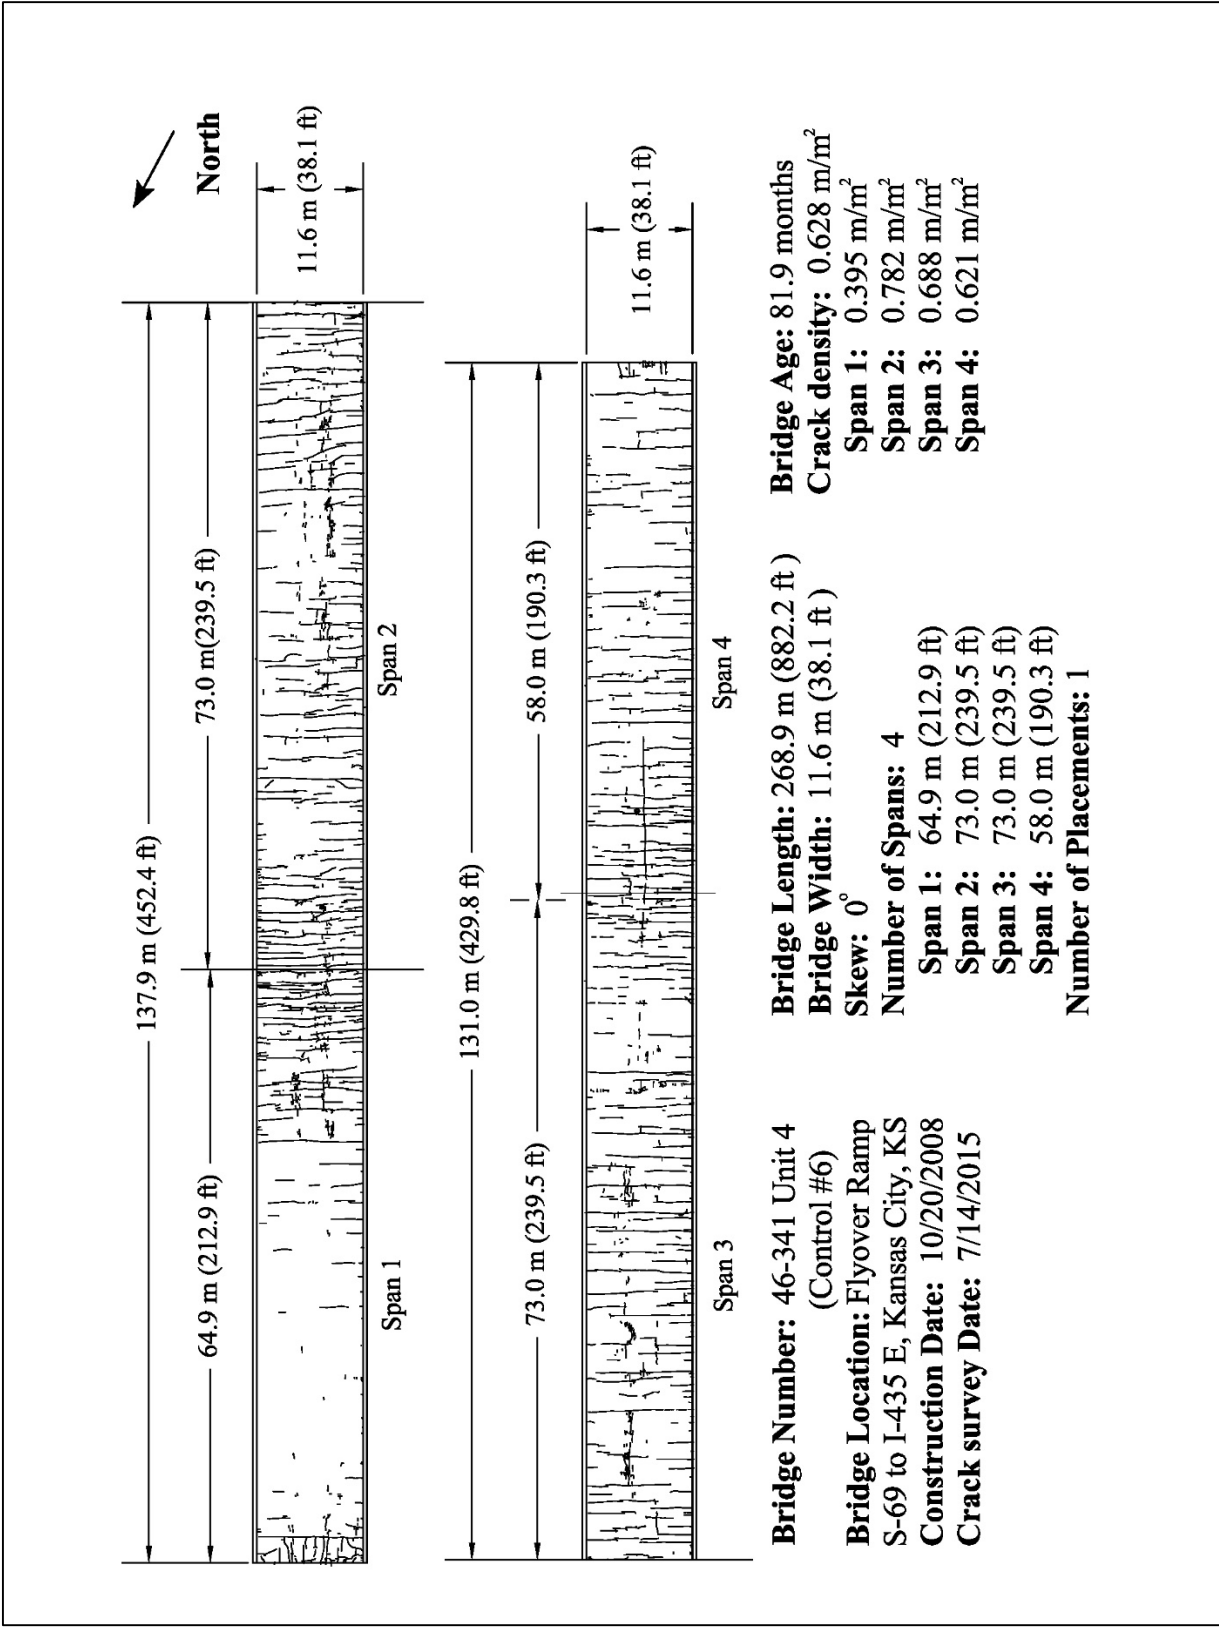
Figure 28: Control-6 (Survey 7)

Bridge deck Control-6 was placed on 10/20/2008 and has been surveyed seven times. The results for Surveys 6 and 7 are included in this report. Survey 6 was completed at 68.2 months; the crack map is shown in Figure 27. Survey 7 was completed at 81.9 months; the crack map is shown in Figure 28. A crack density of 0.646 m/m^2 was observed in Survey 6 (Figure 27), which is considerably higher than Survey 5 at 0.461 m/m^2 (Bohaty et al. 2013). A crack density of 0.628 m/m^2 was observed in Survey 7 (Figure 28), slightly lower than Survey 6. The majority of the cracks are transverse and run across the full width of the deck. The cracks are closer to each other over the piers than at other locations. Cracks propagate longitudinally adjacent the abutments. Some longitudinal cracks are present in the middle of the deck.

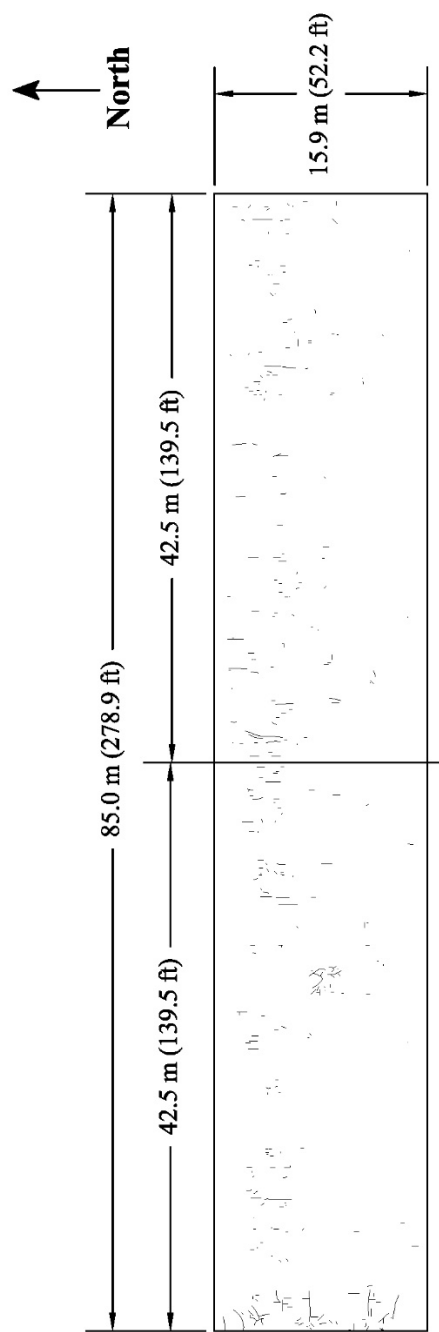
Figure 30: LC-HPC-7 (Survey 8)

Bridge deck LC-HPC-7 was constructed on 6/24/2006, and the deck has been surveyed nine times. The results of Surveys 8 and 9 of LC-HPC-7 are presented in this report. Survey 8 was completed at a deck age of 95.7 months; the crack map is shown in Figure 30. Survey 9 was completed at a deck age of 106.9 months; the crack map for this survey is shown in Figure 31. A crack density of 0.087 m/m^2 was observed in Survey 8 (Figure 30). This value is greater than the crack density reported by Bohaty et al. (2013) for Survey 7, 0.074 m/m^2 . In Survey 9, however, a crack density of only 0.036 m/m^2 was observed (Figure 31). The measured crack density might have dropped due to dirt present on some portions of the bridge deck at the time of Survey 9. As shown in Figures 31 and 32, most of the cracks are relatively short and are distributed over the whole area of the bridge. There are some cracks near the west abutment that have propagated

perpendicular to the abutment of the bridge. This deck has consistently exhibited the lowest crack density in this study.

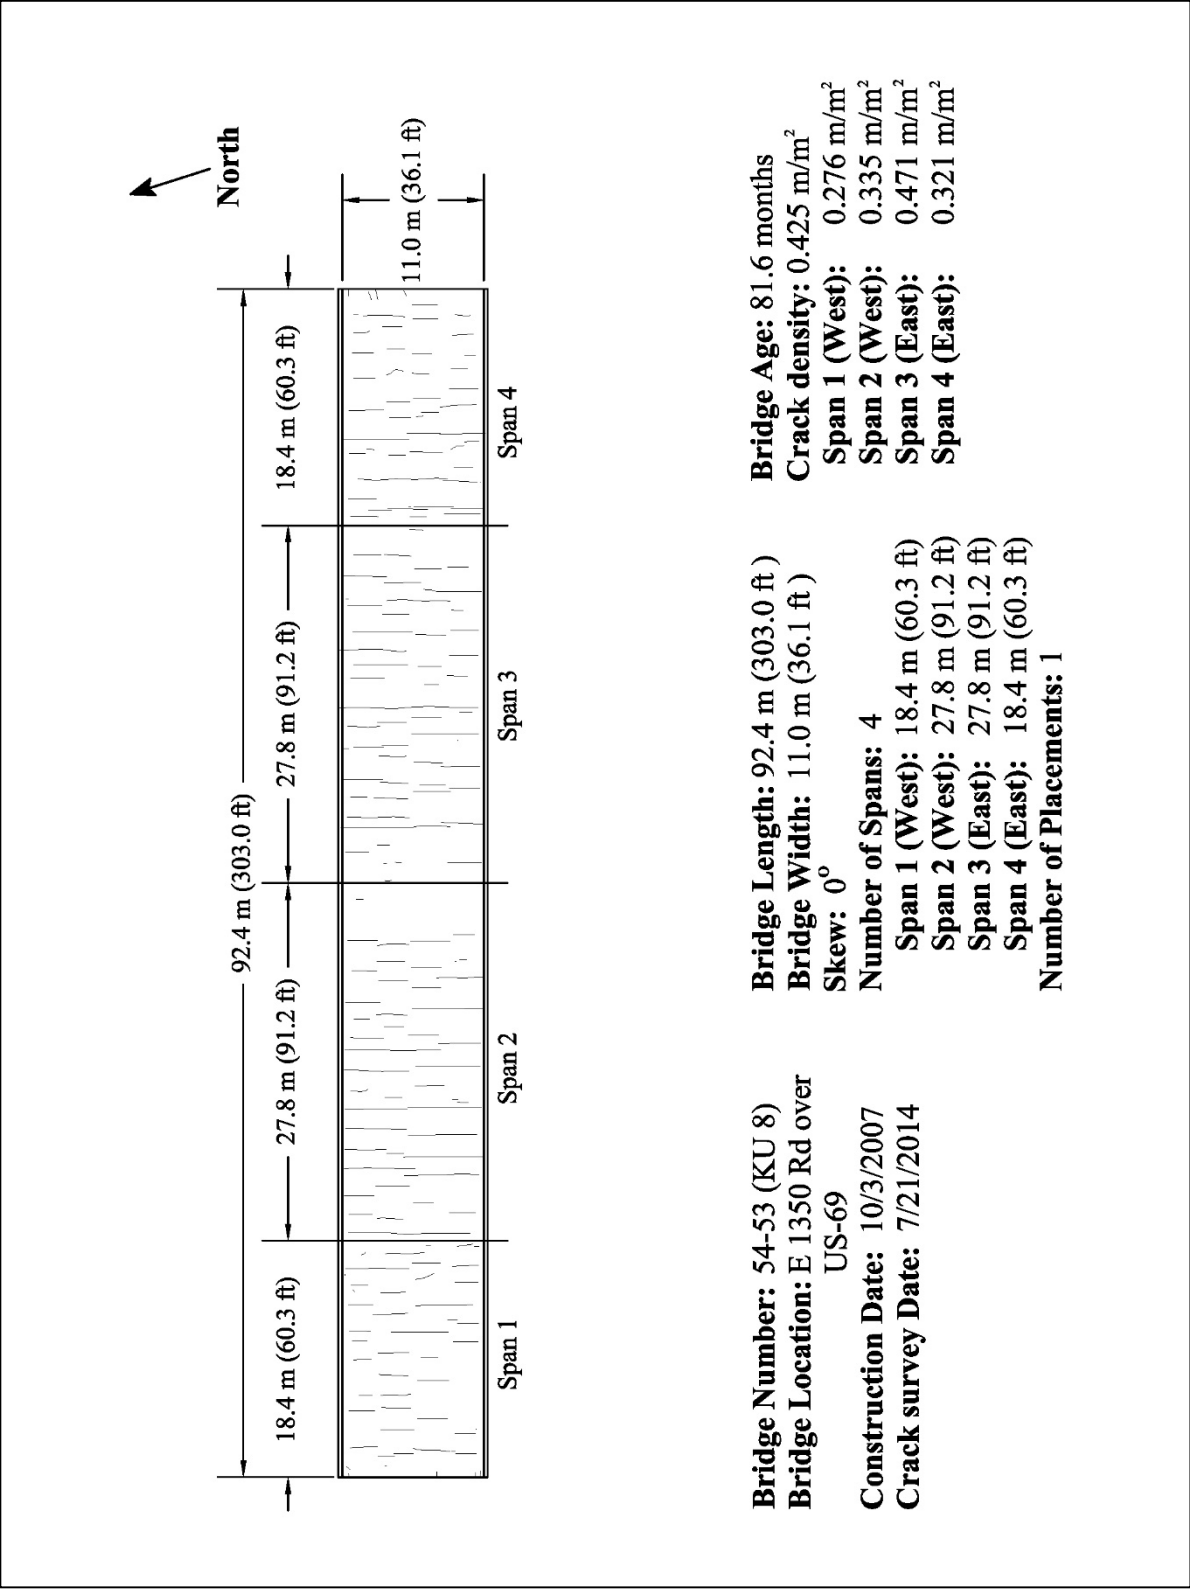
Figure 34: LC-HPCC-8 (Survey 6)

Bridge deck LC-HPC-8 is supported by on precast-prestressed girders and was constructed on 10/3/2007. LC-HPC-8 has been surveyed seven times, and the results of Surveys 6 and 7 are presented in this report. Survey 6 was completed at a deck age of 81.6 months; the crack map appears in Figure 34. Survey 7 was performed at a deck age of 92.0 months; the crack map appears in Figure 35. A crack density of 0.425 m/m² was observed in Survey 6 (Figure 34). In Survey 7, a crack density of 0.462 m/m² was observed (Figure 35). Both values exceed the crack densities that were observed in previous surveys. Figures 34 and 35 show that almost all of the cracks are transverse. Additionally, cracks are minor above the center pier, suggesting that cracking may be a result from increased girder camber. Small longitudinal cracks are present near the abutments.

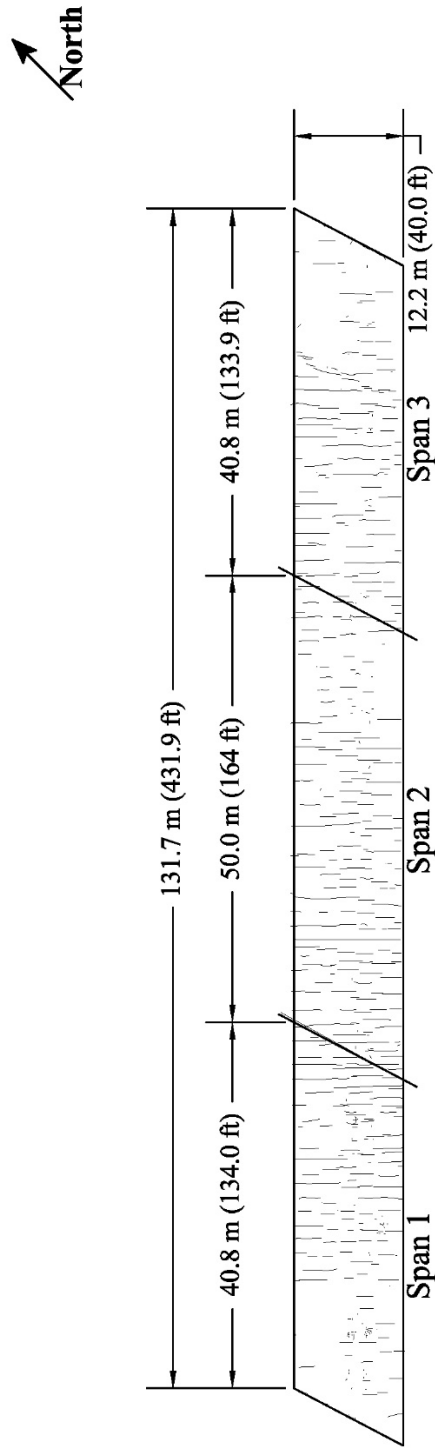
Figure 39: LC-HPC-9 (Survey 5)

Bridge deck LC-HPC-9 was constructed on 4/15/2009, and has been surveyed six times. This report includes the results of Surveys 5 and 6. Survey 5 was performed at a deck age of 62.0 months; the crack map is shown in Figure 39. Survey 6 was performed at a deck age of 73.6 months; the crack map is shown in Figure 40. In Survey 5, a crack density of 0.454 m/m² was observed (Figure 39). This value is significantly greater than that reported for Survey 4 by Bohaty et al. (2013), 0.299 m/m². A crack density of 0.430 m/m² was observed in Survey 6 (Figure 40), slightly lower than Survey 5. The cracks are uniformly distributed over much of the deck with the exception of the end spans, which exhibit a lower crack density.

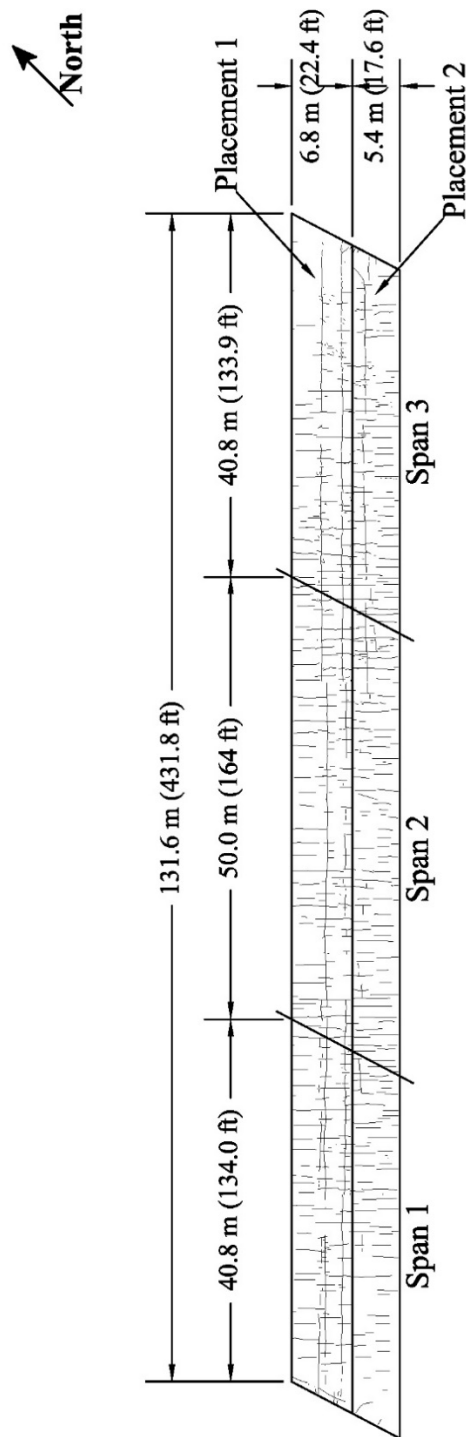
Figure 41: Control-9 (Survey 5)

Bridge deck Control-9 was constructed in two placements. Placement 1 was constructed on 5/21/2008 and Placement 2 was constructed on 5/29/2008. To date, Control-9 deck has been surveyed six times. The results of Surveys 5 and 6 are included in this report. Survey 5 was completed at deck 74.1 and 73.8 months; the crack map is shown in Figure 41. Survey 6 was performed at deck age of 84.4 and 84.1 months; the crack map is shown in Figure 42. In Survey 5, crack densities of 0.732 and 0.755 m/m² were observed for Placements 1 and 2, respectively. Both of these values are higher than Survey 4, which recorded crack densities of 0.561 and 0.635 m/m² for Placements 1 and 2, respectively (Bohaty et al. 2013). In Survey 6, crack densities of 0.722 and 0.845 m/m² were observed for Placements 1 and 2, respectively. For Survey 6, Placement 1 exhibited a slight decrease in crack density compared to Survey 5, while the crack density for Placement 2 increased compared to the previous survey. As shown in Figures 41 and 42, the majority of the cracks are transverse, parallel to the top layer of reinforcement. In Placement 1, there are two longitudinal cracks that run almost over the entire length of the deck. In Placement 2 some relatively short cracks run longitudinally. Some cracks are present near the abutments, where they have propagated longitudinally.

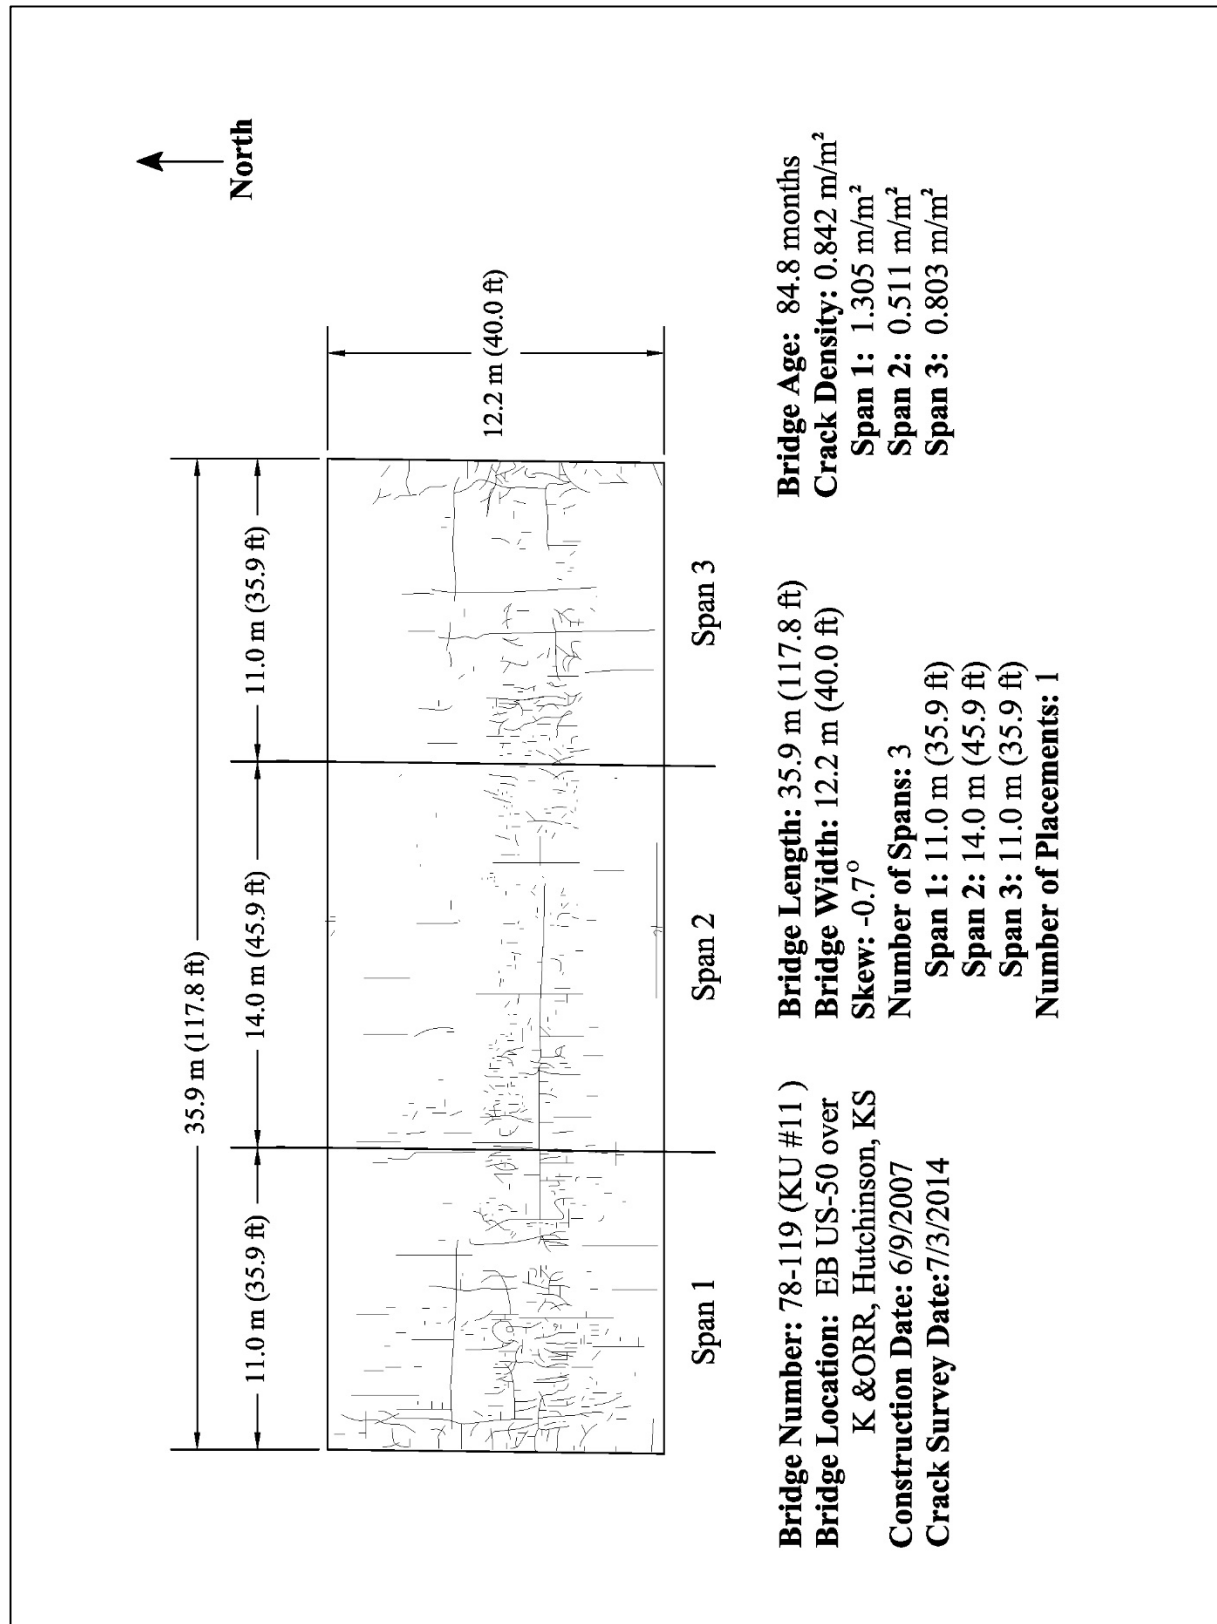
Figure 47: LC-HPC-11 (Survey 6)

Bridge deck LC-HPC-11 was constructed on 6/9/2007, and has been surveyed six times. This report includes the results of Survey 6. Survey 6 was completed at a deck age of 84.8 months; the crack map for this survey is shown in Figure 47. In Survey 6, a crack density of 0.842 m/m^2 was observed (Figure 47). The crack density almost doubled since the previous survey (Survey 5), reported by Bohaty et al. (2013), when the crack density was 0.420 m/m^2 . Due to high cracking, Survey 6 is considered to be the last survey of LC-HPC-11. The majority of the cracks are short cracks distributed over the middle portion of the deck. Also, there are some transverse and longitudinal cracks present in different areas of the deck. The west span (Span 1) exhibits the highest crack density.

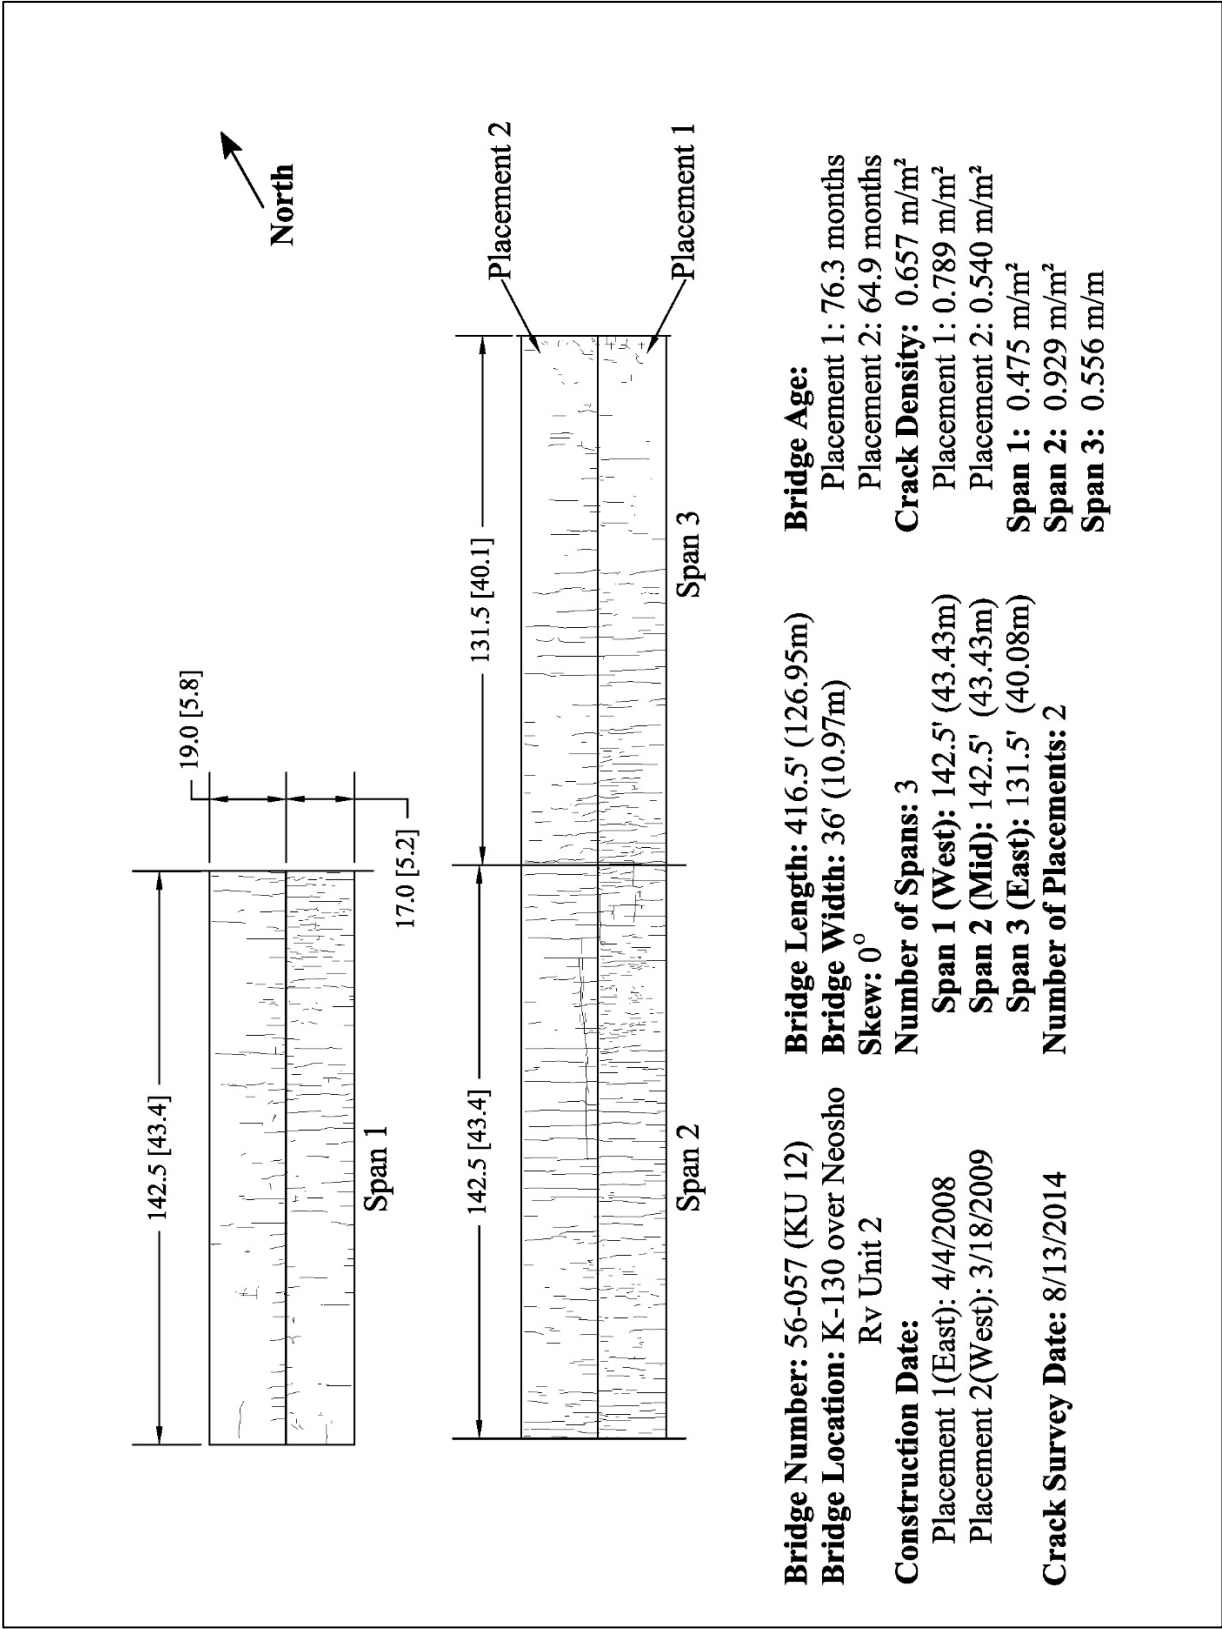
Figure 50: LC-HPC-12 (Survey 6)

Bridge deck LC-HPC-12 was constructed in two placements; Placement 1 was constructed on 4/4/2008, and Placement 2 was constructed on 3/18/2009. Six surveys have been performed on this bridge deck. The results of Survey 6 of LC-HPC-12 are included in this report. Survey 6 was completed at deck ages of 76.3 and 64.9 months for Placements 1 and 2, respectively; the crack map is displayed in Figure 50. In Survey 6, crack densities of 0.657 m/m² overall, and 0.789 and 0.540 m/m² for Placements 1 and 2, respectively, were measured (Figure 50). These values are considerably higher than recorded during Survey 5, 0.431, 0.478, and 0.381 m/m² (Bohaty et al. 2013). Because of the high crack density, Survey 6 is the last crack survey of LC-HPC-12 bridge deck. Most of the cracks are transverse and run through the full width of the deck. Shorter cracks are also present and propagate from the construction joint between the two placements. Cracks are closer to each other above the piers than in other areas of the deck. During the construction of

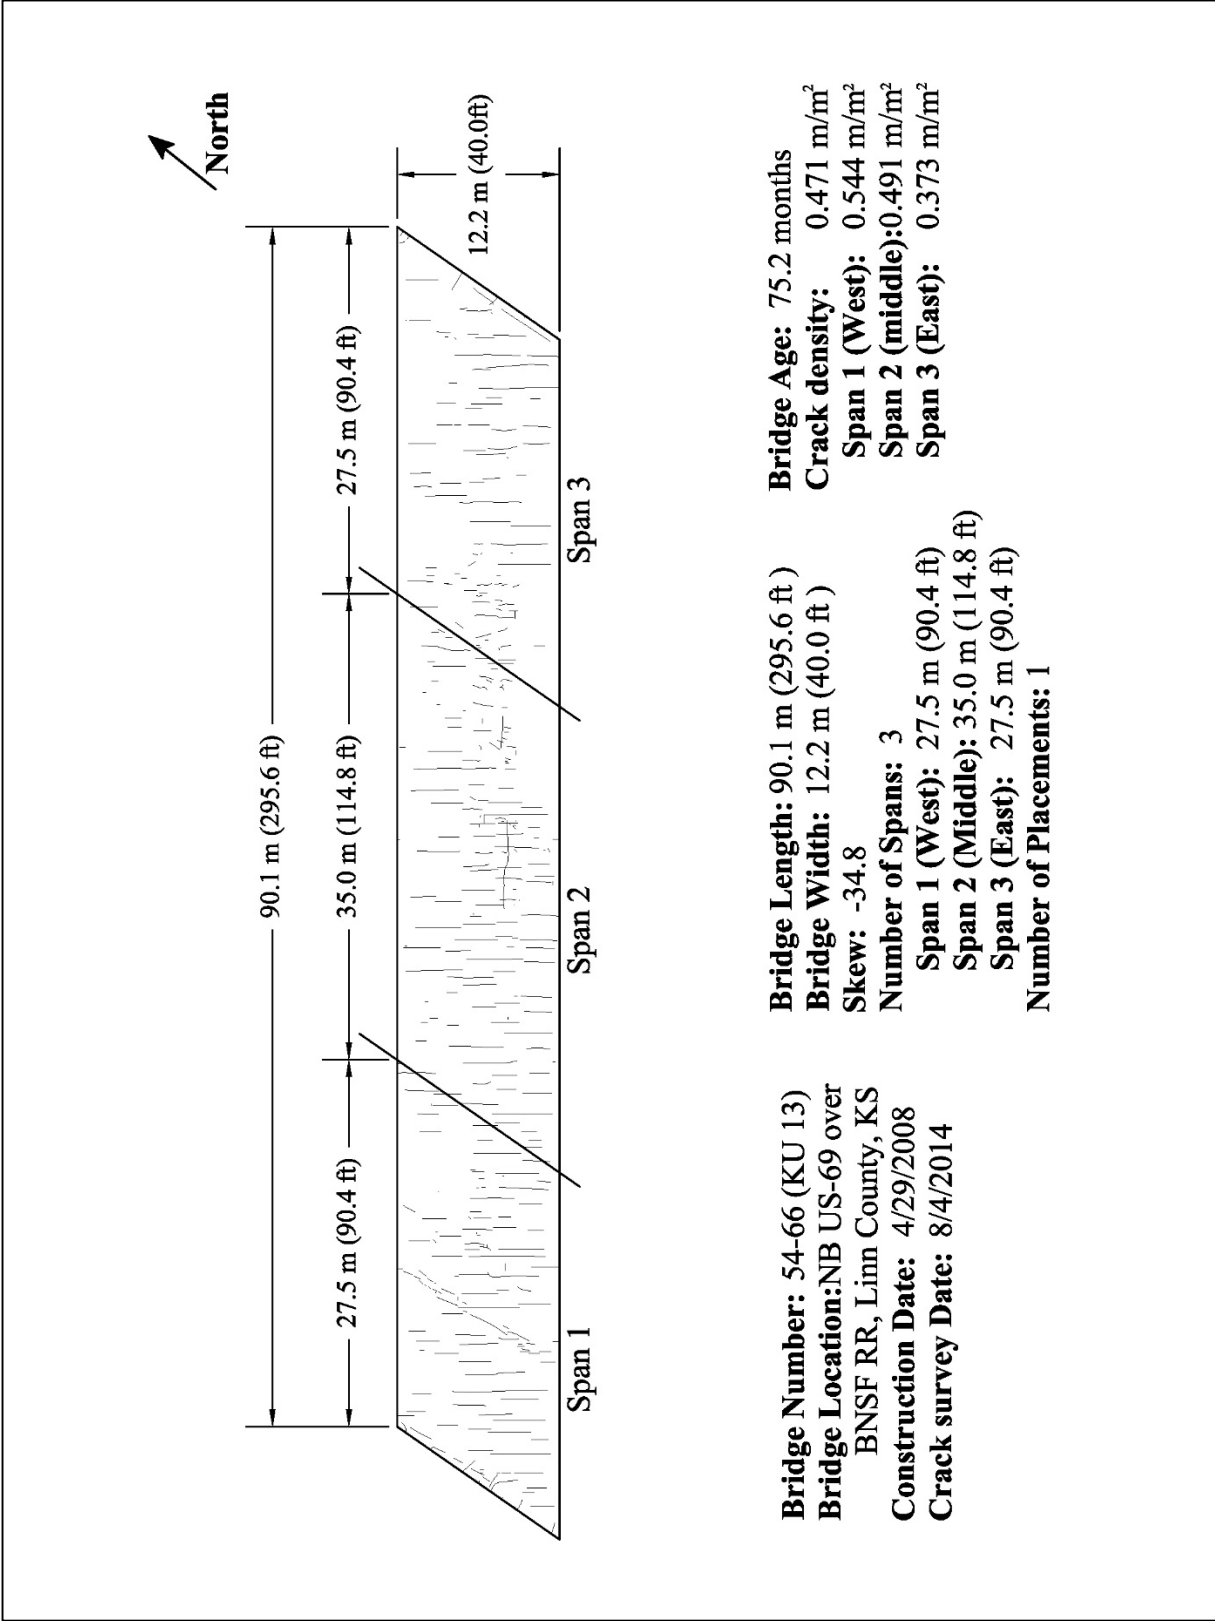
Figure 53: LC-HPC-13 (Survey 6)

Bridge deck LC-HPC-13 was constructed on 4/29/2008 and has been surveyed seven times. The results of Surveys 6 and 7 of LC-HPC-13 are included in this report. Survey 6 was completed at a deck age of 75.2 months; the crack map is shown in Figure 53. Survey 7 was completed at a deck age of 85.9 months; the crack map is shown in Figure 54. A crack density of 0.471 m/m² was observed in Survey 6 (Figure 53). This value is lower than recorded during Survey 5 at 0.576 m/m² (Bohaty et al. 2013). Based on surveys before and since, it appears that Survey 5 is an outlier. In Survey 7, a crack density of 0.486 m/m² was observed (Figure 54). Moderate sized cracks were marked during both surveys. Short cracks are present above the eastern pier.

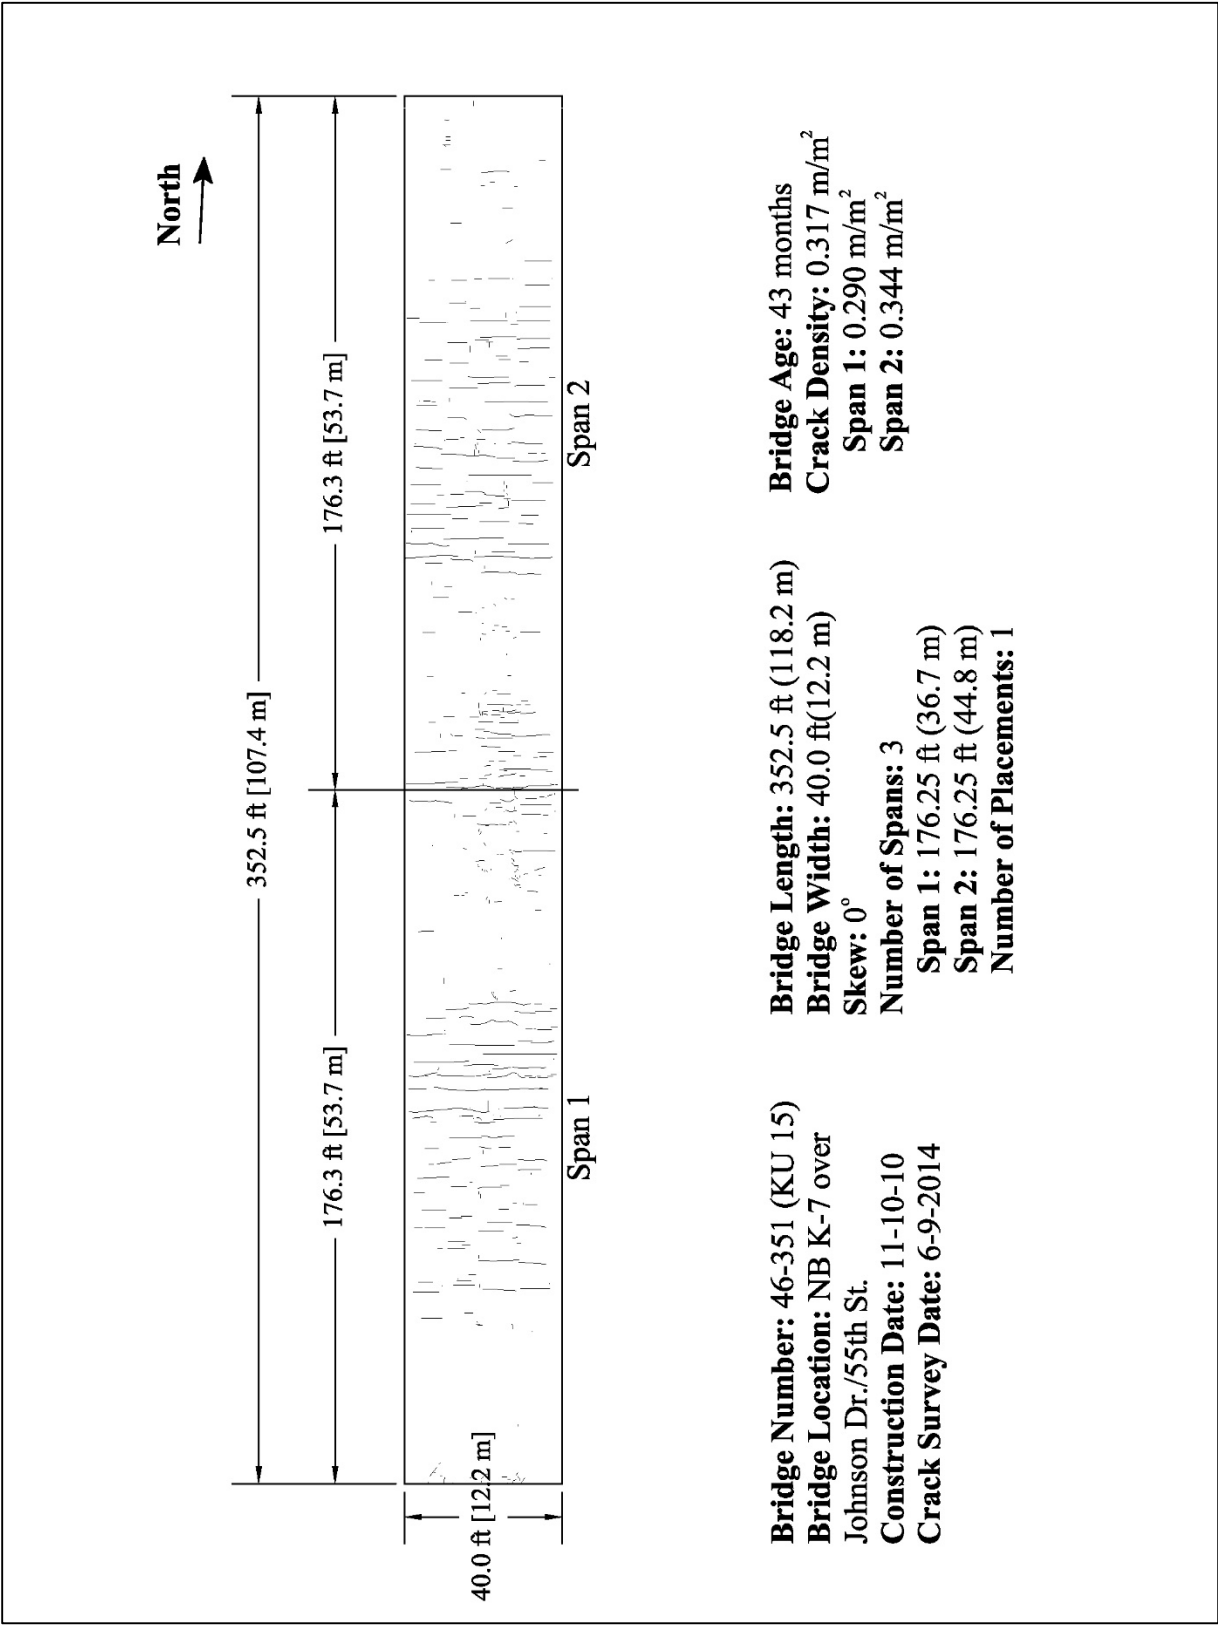
Figure 59: LC-HPC-15 (Survey 3)

Bridge deck LC-HPC-15 was constructed on 11/10/2010. This deck does not have a control deck for comparison. LC-HPC-15 has been surveyed four times and this report includes the results of Surveys 3 and 4. Survey 3 was performed at a deck age of 43.0 months; the crack map is shown in Figure 59. Survey 4 was performed at a deck age of 56.2 months; the crack map is shown in Figure 60. A crack density of 0.316 m/m^2 was observed in Survey 3 (Figure 58), a significant increase in crack density from Survey 2, 0.161 m/m^2 (Bohaty et al. 2013). In Survey 4, a crack density of 0.299 m/m^2 was observed (Figure 59), slightly lower than in Survey 3. As shown in Figures 59 and 60, the majority of the cracks in LC-HPC-15 are transverse, and appear to run parallel to the top reinforcement layer. A few short cracks appear near the abutments. Figure 61 displays the crack density versus deck age for LC-HPC-15.

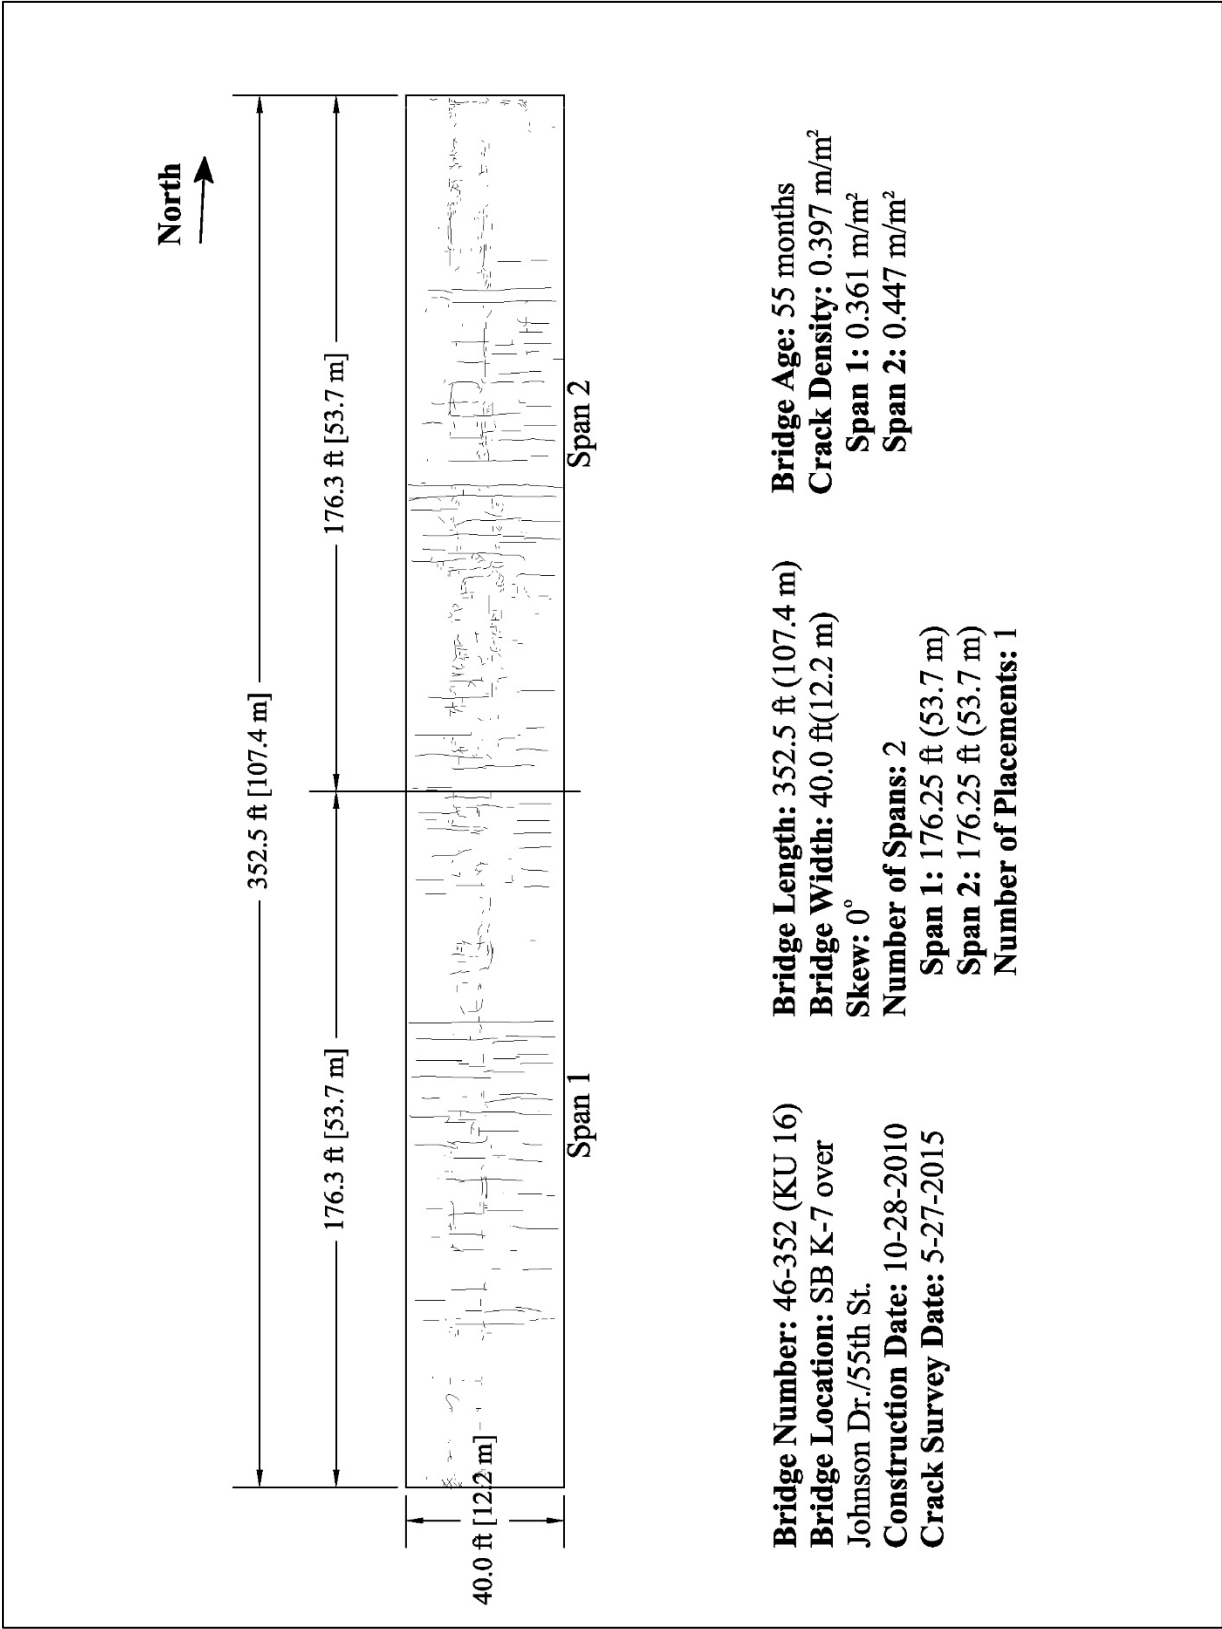
Figure 63: LC-HPC-16 (Survey 5)

Bridge deck LC-HPC-16 was constructed on 6/11/2014. This bridge does not have a control deck for comparison. This deck has been surveyed five times. The results of Surveys 4 and 5 of LC-HPC-16 are discussed in this report. Survey 4 was completed at a deck age of 43.5 months; the crack map is displayed in Figure 62. Survey 5 was completed at a deck age of 55.0 months; the crack map is displayed in Figure 63. A crack density of 0.311 m/m² was observed in Survey 4 (Figure 62) compared to a crack density of Survey 3, 0.211 m/m² (Bohaty et al. 2013). In Survey 5, a crack density of 0.397 m/m² was observed (Figure 63). Most of the cracks are transverse (Figures 62 and 63). Map cracking is also present on some portions of the deck. Near the abutments, some cracks have propagated longitudinally. Figure 64 shows the crack density as a function of age for LC-HPC-16.

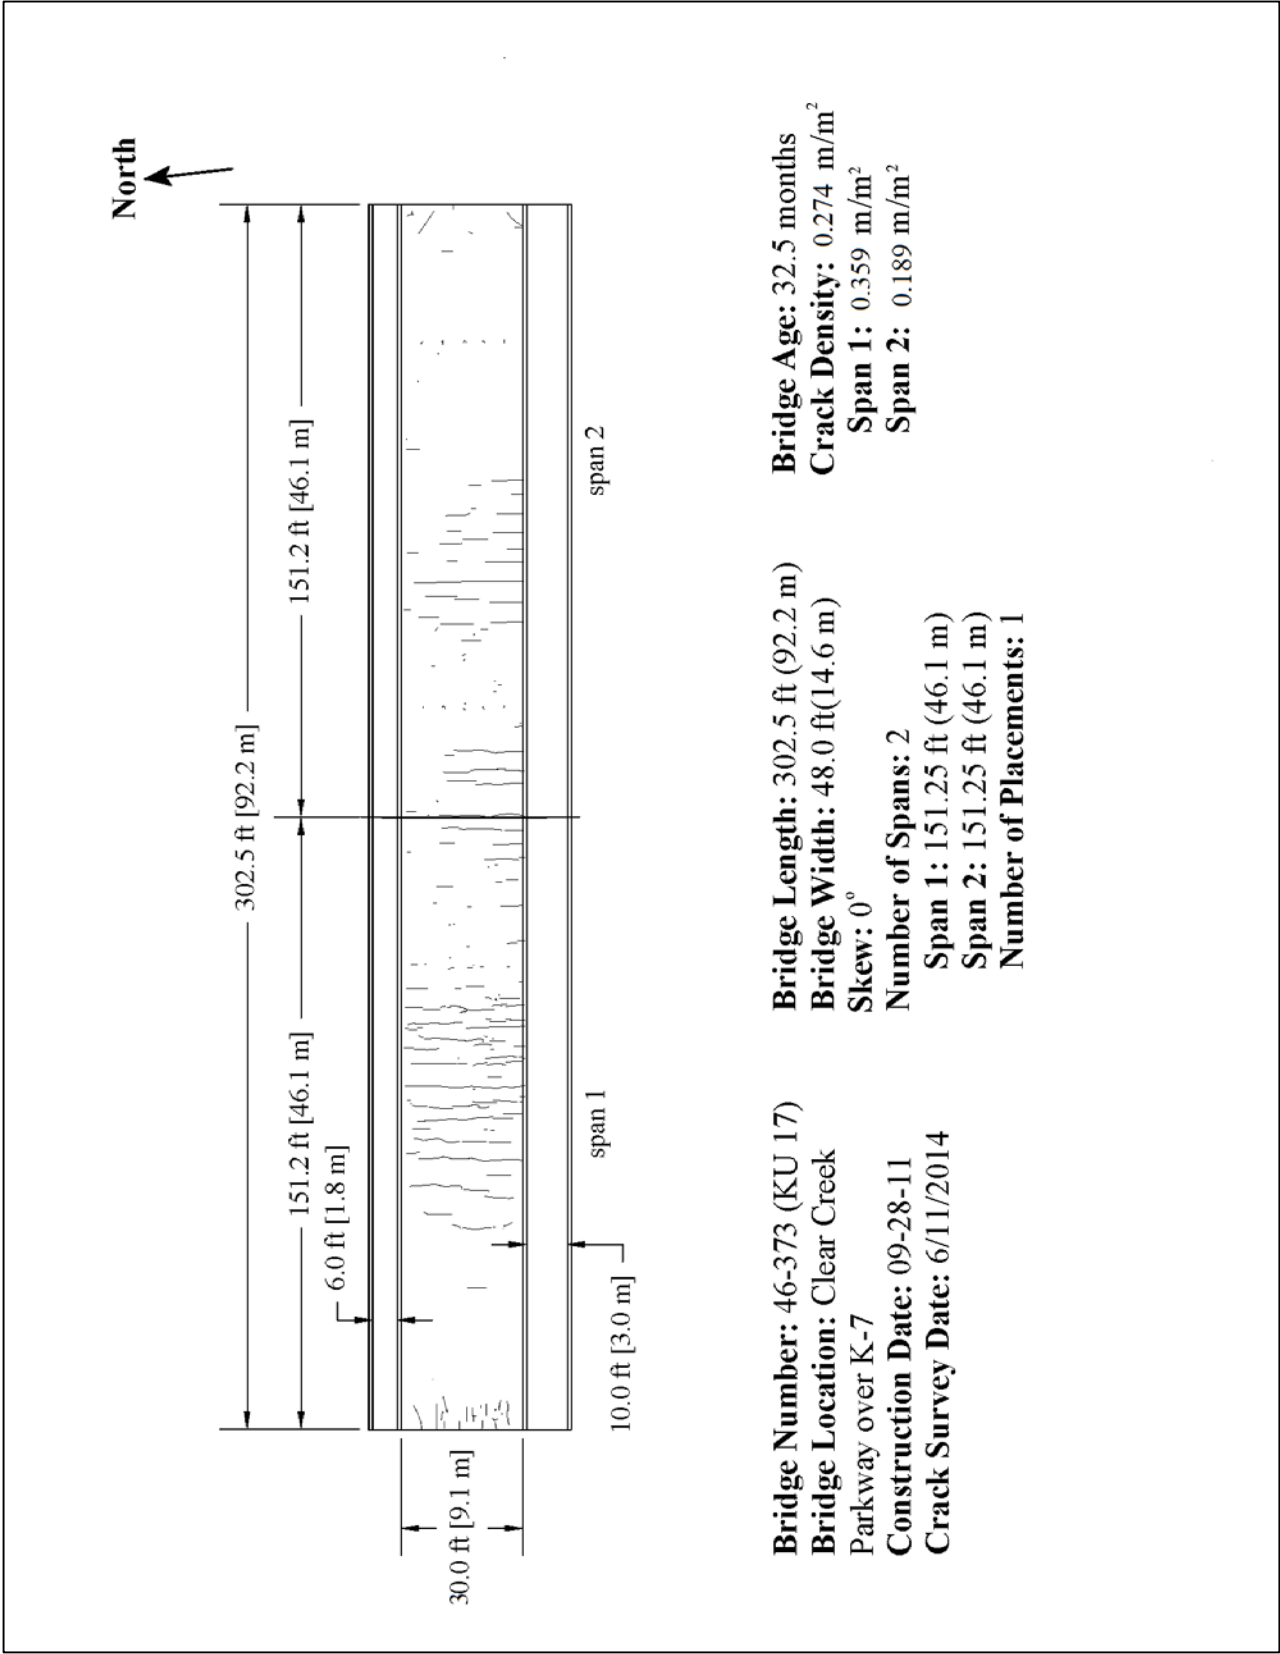
Figure 65: LC-HPC-17 (Survey 3)

Bridge deck LC-HPC-17 was placed on 9/28/2011. There is no control deck for this bridge. This deck has been surveyed four times, and the results of Surveys 3 and 4 are included in this report. Survey 3 was performed at a deck age of 32.5 months; the crack map is shown in Figure 65. Survey 4 was performed at a deck age of 45.5 months; the crack map is shown in Figure 66. In Survey 3, an overall crack density of 0.274 m/m² was observed (Figure 65), slightly higher than the value reported by Bohaty et al. (2013) for Survey 2, 0.240 m/m². An overall crack density of 0.308 m/m² was observed in Survey 4 (Figure 66). The surveys do not include the sidewalks. As shown in Figures 65 and 66, the majority of the cracks are transverse and located near the mid-span. There are, also, some transverse cracks above the pier. Survey 4 recorded some small areas of map cracking near the east abutment. Cracks also propagate longitudinally near the west abutment. Figure 67 shows the crack density for LC-HPC-17 over time.
