**APPLICATION OF ANGLES-WITH-PLATE RETROFIT IN REPAIRING
DISTORTION-INDUCED FATIGUE DAMAGES IN STRINGER TO FLOORBEAM
CONNECTIONS AND SKEWED GIRDER TO CROSS-FRAME CONNECTIONS**

Danqing Yu

Submitted to the graduate degree program in Civil, Architectural, and Environmental Engineering and the Graduate Faculty of the University of Kansas in partial fulfillment of the requirements for the degree of Master of Science.

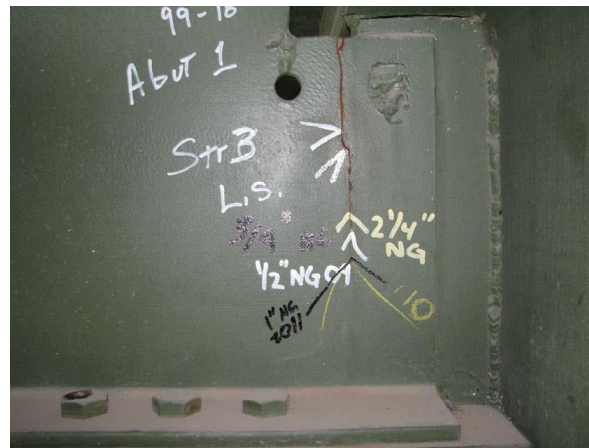
Figure 1-3: Stringer with cracked cope area

Figure 1-3 presents a cracked stringer cope. A cope is designed to accommodate the intersection of two members, but coped regions in bridge members have been shown to be susceptible to fatigue cracking (Haghani 2012; Roeder 2001). A coped area experiences a stress concentration due to the change of geometry, and for poorly-fabricated members the situation is worsened. It is reported that workmanship of flame-cut cope regions is often unsatisfactory (Mertz 2012).

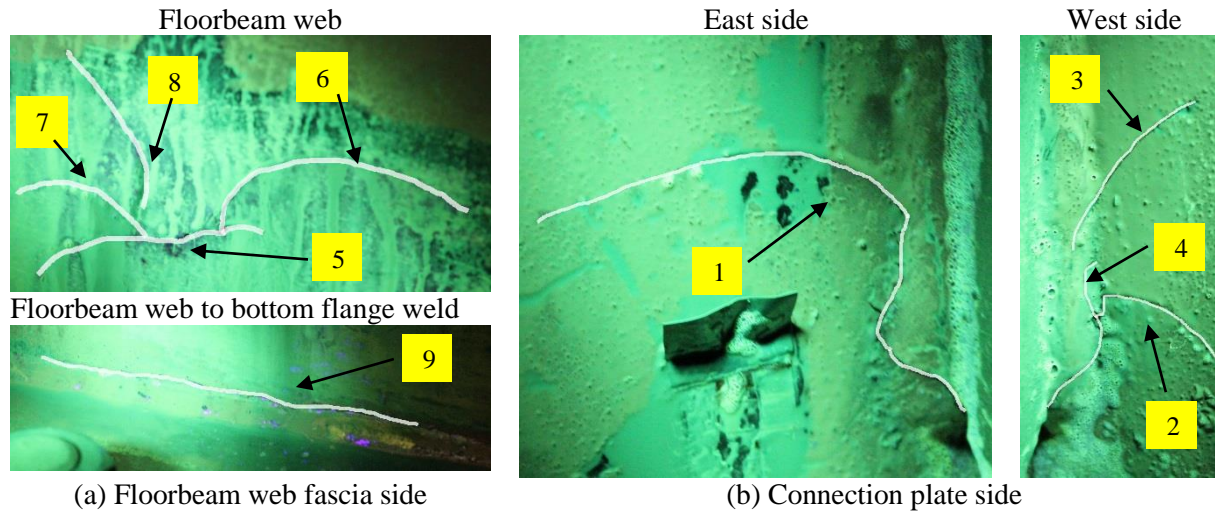
Figure 4-1: Cracks on single-plate connection specimen (FS1)

Figure 4-1 presents a photo of the crack pattern 85,000 cycles into Trial 8, with assigned labels for each crack that developed. Cracks 1-4 initiated on the connection plate side. Cracks 5-8 were on the floorbeam web fascia side. Crack 9 propagated along the fascia side floorbeam web-to-bottom flange weld. Each labeled crack indicated that the crack initiated at a point and propagated without breaking. Two cracks were treated as different if one crack initiated separately and joined an existing crack later.

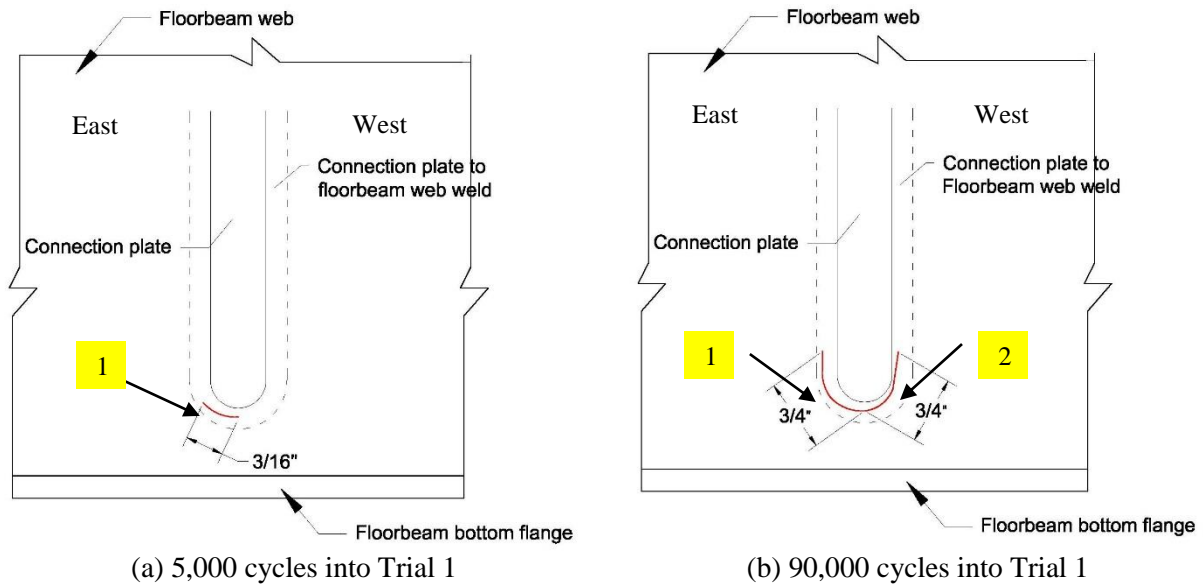
(a) 5,000 cycles into Trial 1
 (b) 90,000 cycles into Trial 1
Figure 4-2: Cracks on connection plate side in Trial 1

Trial 1 cycles	Total cycles	Crack initiation and propagation
5,000	5,000	A $\frac{3}{16}$ in. crack (Crack 1) was observed on the east connection plate-to-floorbeam web weld
13,000	13,000	A $\frac{1}{8}$ in. crack (Crack 2) was observed at the west connection plate-to-floorbeam web weld
90,000	90,000	Both cracks reached $\frac{3}{4}$ in. 90,000 cycles into Trial 1, then the angles-with-plate retrofit was installed.

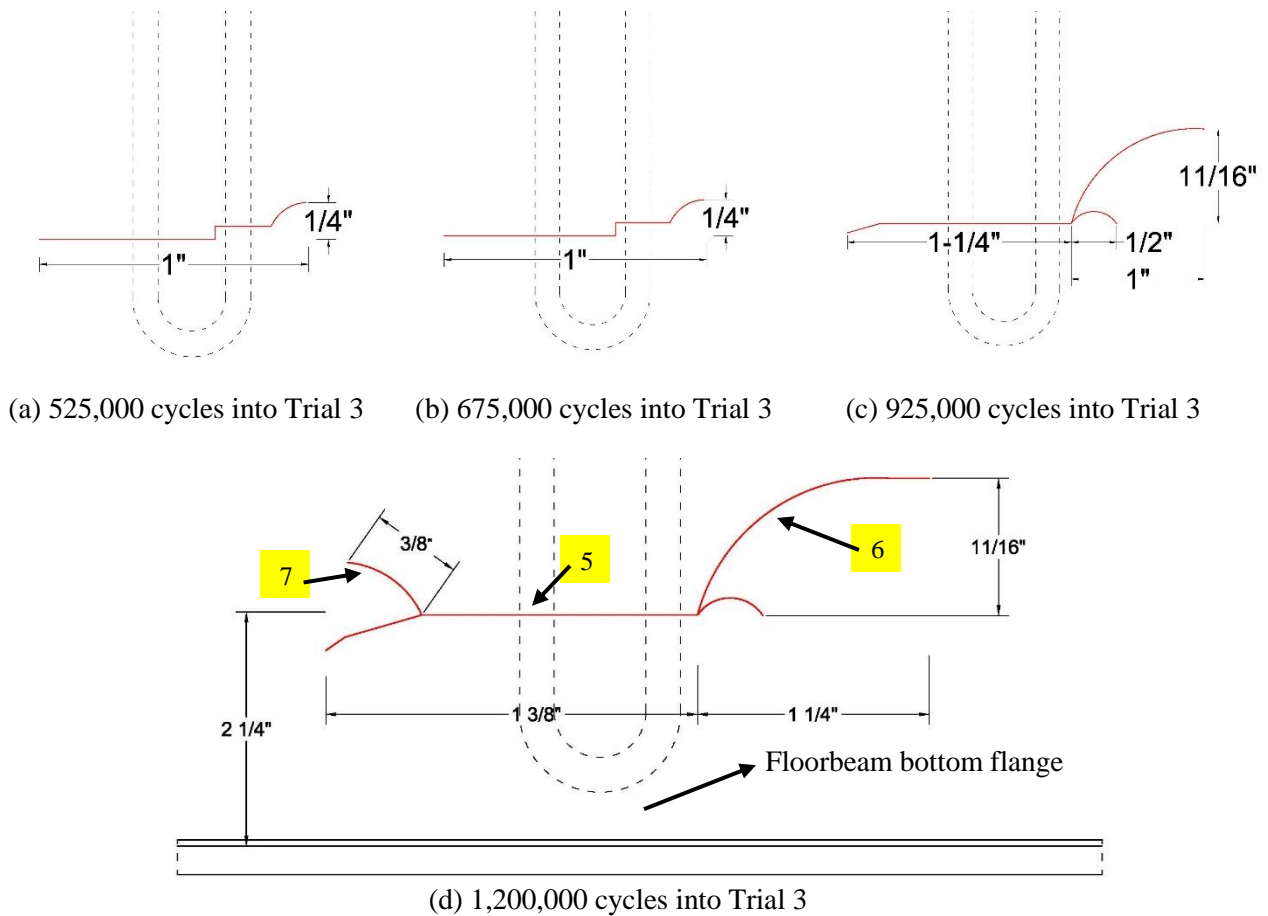
Figure 4-3: Cracks located on the floorbeam fascia side in Trial 3

Trial 3 cycles	Total cycles	Crack initiation
525,000	1,815,000	A 1 in horizontal crack (Crack 5) was observed 2¼ in. above the floorbeam bottom flange
675,000	1,965,000	A ¼ in branch crack (Crack 6) was observed. The small branch crack quickly connected with the horizontal crack
1,200,000	2,490,000	A ⅜ in branch crack (Crack 7) was observed

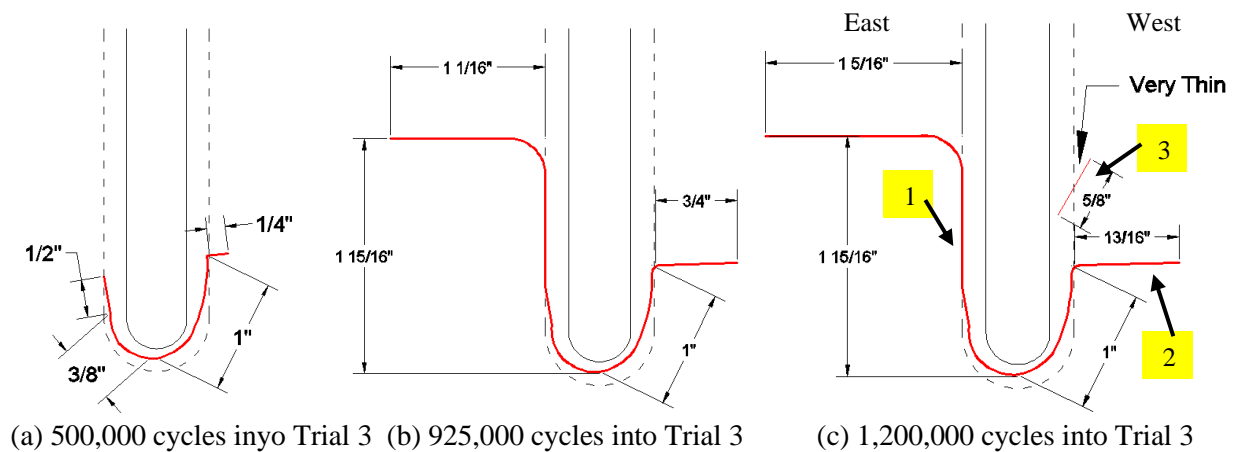
Figure 4-5: Cracks on connection plate side in Trial 3

Trial 3 cycles	Total cycles	Crack initiation and propagation
500,000	1,790,000	Crack 2 grew into the web
1,200,000	2,490,000	A 5/8 in. crack (Crack 3) was observed on the west floorbeam web-to-connection plate weld. The crack had penetrated a little into the web.

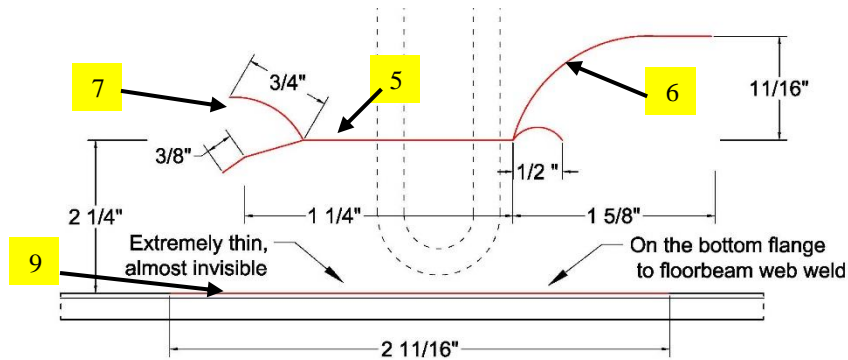
Figure 4-7: Crack on floorbeam web fascia side 400,000 cycles into Trial 5

Trial 5 Cycles	Total cycles	Crack initiation and propagation
400,000	4,090,000	A 3 in. crack (Crack 9) was observed on the weld connecting the floorbeam web and the bottom flange

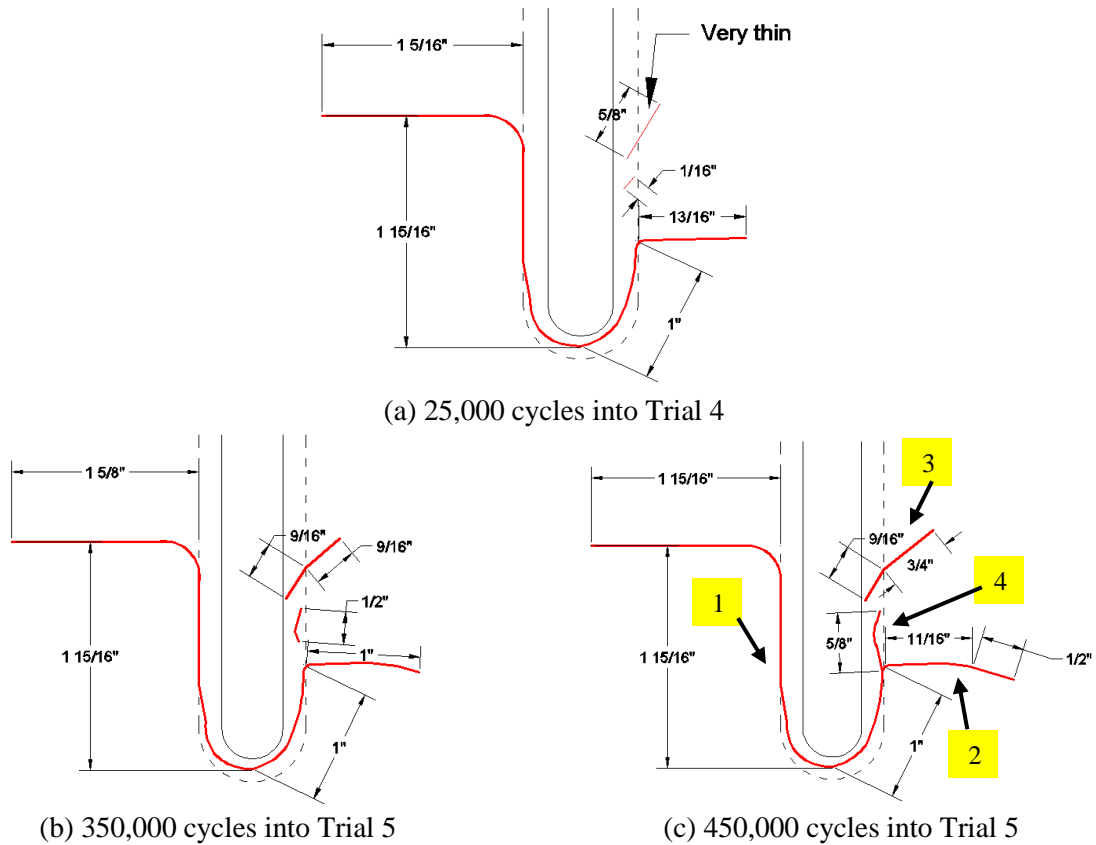
Figure 4-8: Crack on connection plate side in Trial 5

Trial 5 Cycles	Total cycles	Crack initiation and propagation
25,000	3,715,000	A 1/16 in. crack (Crack 4) was observed on the west floorbeam web – connection plate weld. This crack continued growing and eventually connected with the Crack 2.

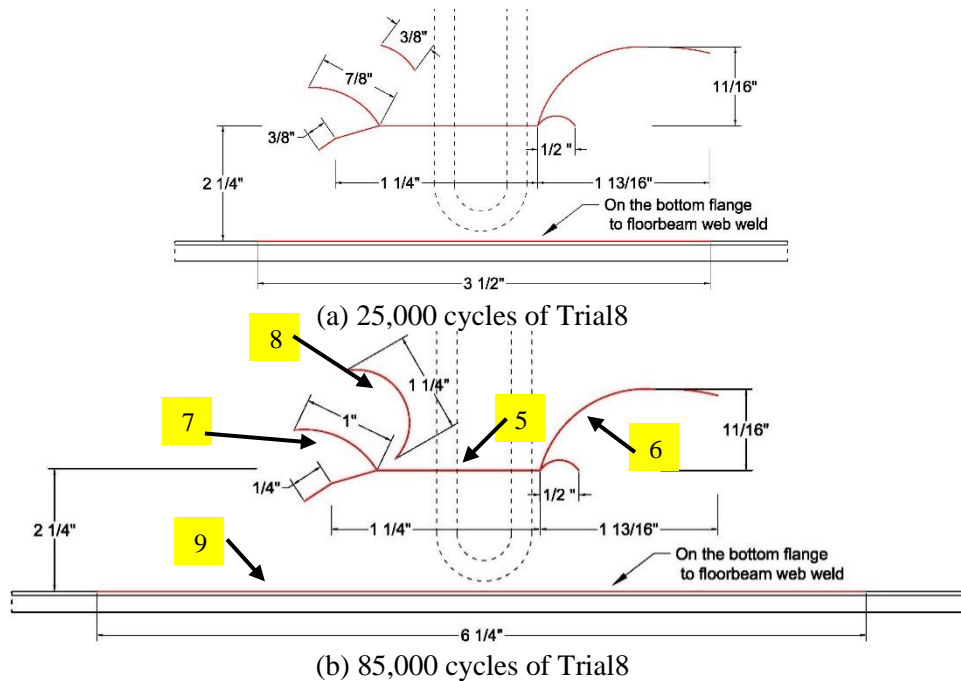
Figure 4-9: Cracks on floorbeam fascia side in Trial 8

Trial8 cycles	Total cycles	Crack initiation and propagation
25,000	6,565,000	A 3/8 in. crack (Crack 8) was observed
85,000	6,625,000	The crack on the floorbeam bottom flange to web weld (Crack 9) grew to 6¼ in.

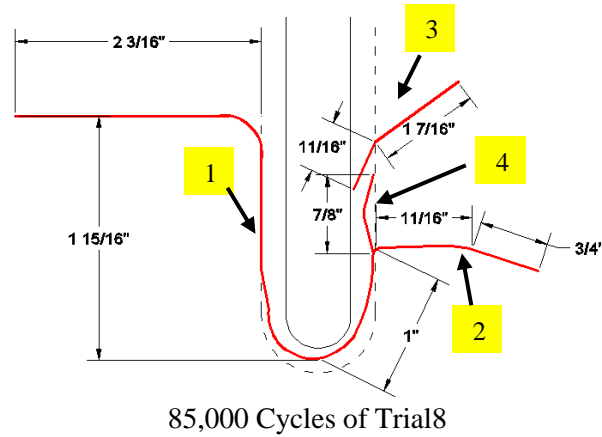
Figure 4-11: Cracks on connection plate side 85,000 cycles into Trial 8

Cracks continued growing on the connection plate side of the specimen throughout Trial 8, as shown in Figure 4-11 and Figure 4-12.

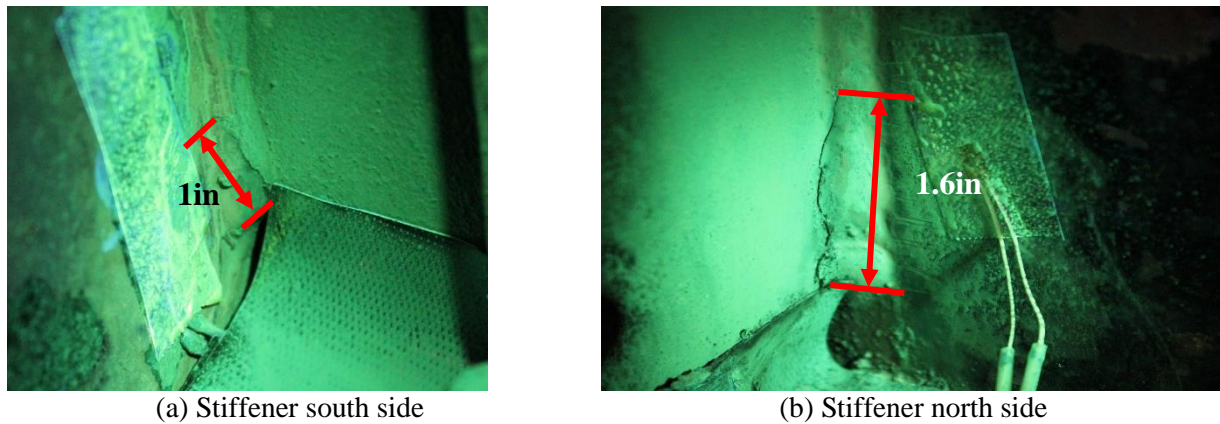
Figure 3-1: Cracks at bottom web-gap for 20-degree skewed specimen 1,200,000 cycles into Trial 20-2

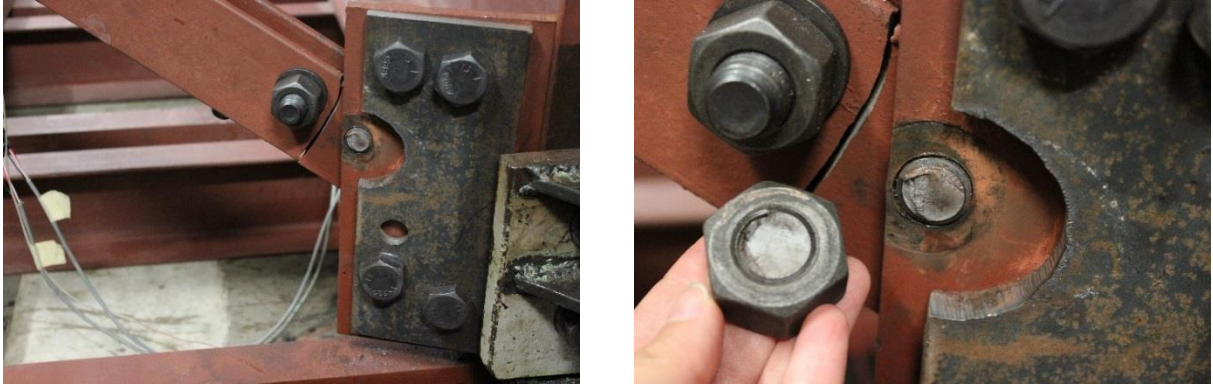
Figure 3-4: Shear failure of the bolt connecting the steel angle and cross-frame

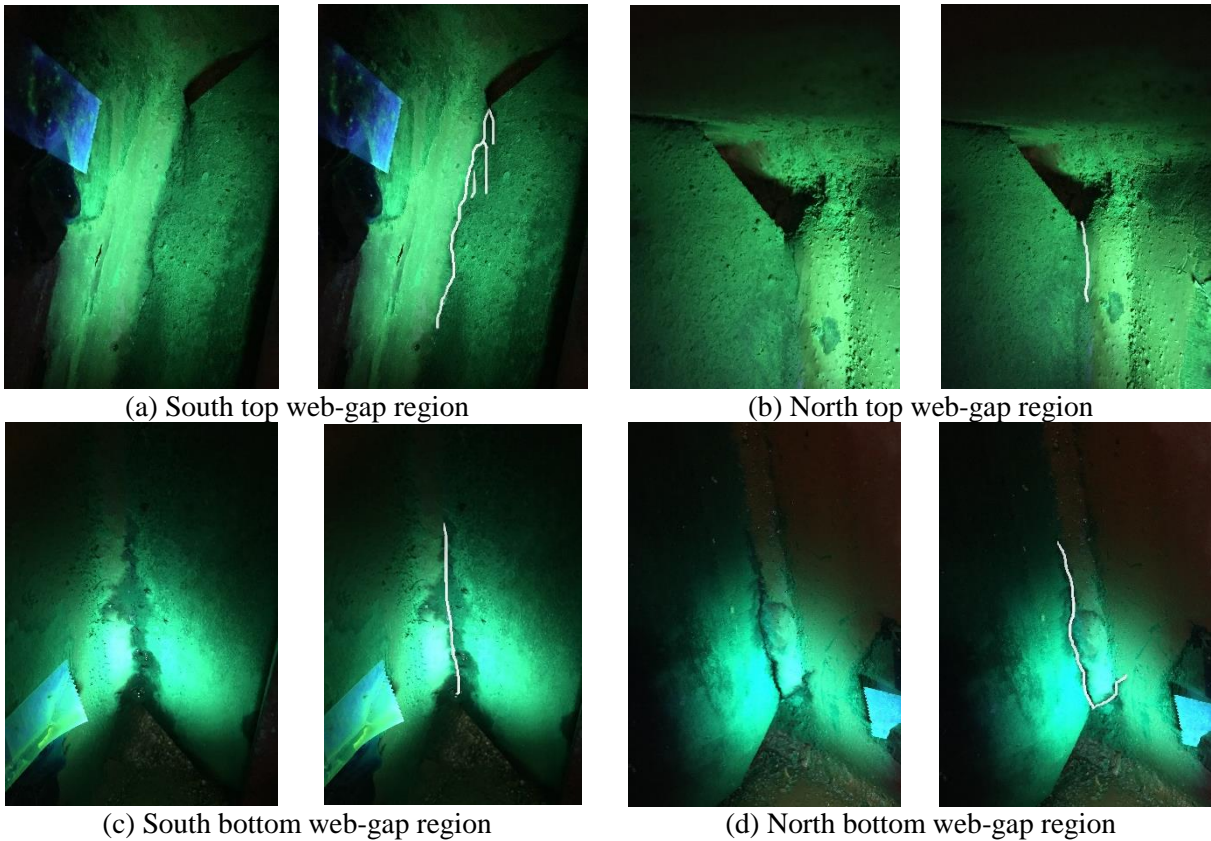
Figure 5-3: Cracks of 40-degree skewed specimen 1,150,000 cycles into Trial 40-3
