The Collapse of the Alto Río Building during the 27 February 2010 Maule, Chile, Earthquake

Cheng Song,^{a)} Santiago Pujol,^{a)} M.EERI, and Andrés Lepage,^{b)} M.EERI

The Alto Río Building, a 15-story building located in Concepción, Chile, collapsed during the 2010 Maule earthquake. Construction of the building was completed in 2009 following the Chilean building code of 1996. The building was provided with reinforced concrete structural walls (occupying nearly 7% of the floor area) to resist lateral and vertical loads. The walls failed in the first story, causing the overturning of the entire building. This paper provides detailed field observations and discusses plausible causes of the collapse. [DOI: 10.1193/1.4000036]

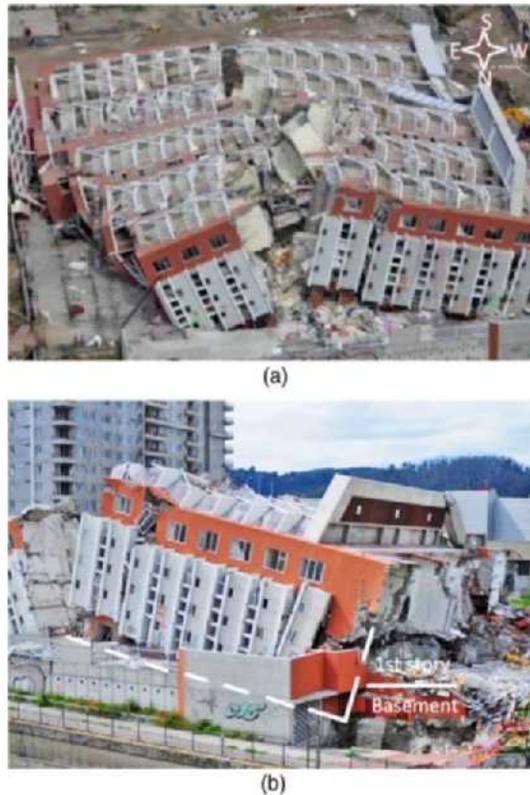
The Alto Río Building (Figure 4a) was the only building with more than three stories that suffered total collapse during the 2010 Maule Earthquake. The building overturned toward the east, rotating about the longitudinal axis of the building in the first story (Figure 4b). During the collapse, the building penetrated the slabs of underground parking spaces, which had a larger floor plan (extending further to the east) than the aboveground stories. Where it met an underground wall oriented in the NS direction, the building split in two (Figure 4).

Figure 4. General photos for the Alto Río Building: (a) the Alto Río building after collapse (from <http://skyscraperpage.com/cities/?buildingID=85186>); (b) the damage view from north.

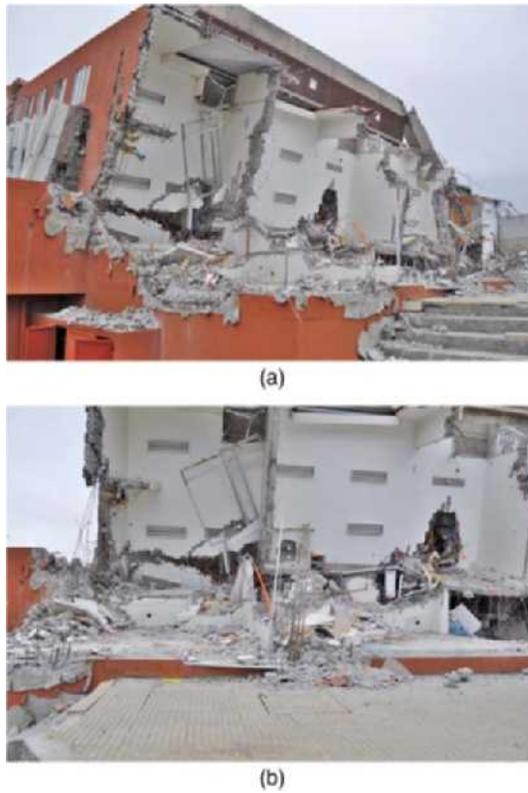
Figure 5. Damage photos for the first story: (a) damage in the first story (view from northwest); (b) observed shift of walls toward the south (view from west). Photo credit: E. Fierro and A. Iruretagoyena.

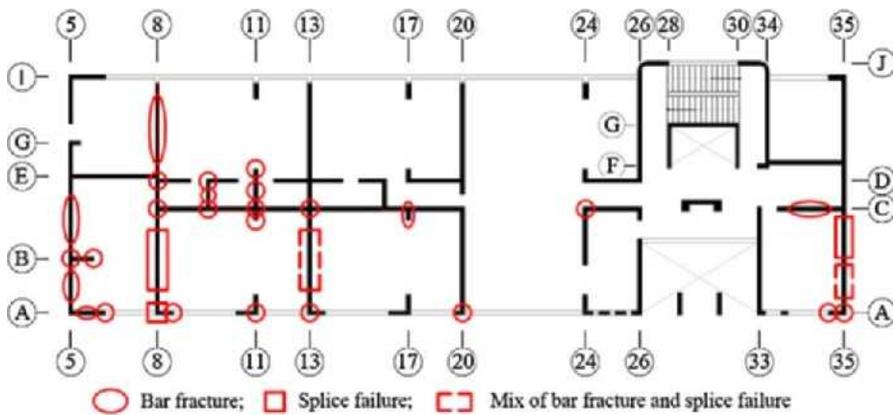
Walls in the first story failed along cracks that joined the ends of lap splices located in the first story. As the building collapsed, parts of the first-story walls that remained attached to the upper stories rotated approximately 90 degrees, with the ceiling of the first story becoming nearly vertical (Figure 5). The structure shifted as much as 0.8 m (2.6 ft) toward the south, and the east walls penetrated the basement (Figure 5). Both splice failures and bar fractures were observed on the west side of the first story. Bond failures were observed in bar splices of $\Phi 8$ mm, $\Phi 10$ mm, and $\Phi 25$ mm bars. Locations where splice failures and bar fractures were observed in the first story are shown in Figure 6.

Figure 6. Observed locations of splice failures and bar fractures in the first story (walls without marks could not be inspected).

The index was less than 0.10 for approximately 50% of the wall sections in both the first and second stories of Alto Río. This suggests that fracture of the reinforcement could have led to the collapse. Figure 6 shows that bar fractures occurred. But they occurred at the base of the first story rather than at the base of the second story. This fact and the conventional analyses presented suggest that the solid walls in the first story were weakened either by shear failures under openings (as suggested by the model by Moehle et al. 2011), or by bond failures along lap splices (Figure 6), or both.

Bond failures were observed in lap splices at the base of the first story (Figure 6). It is possible that these failures limited the strength of that story, enabling mechanism I (Figure 22) and/or shifting the critical section to resist overturning moments from the bottom of the second story to the bottom of the first story. The failure of lap splices may also have reduced the effective reinforcement ratio at the base of the structure, making bar fracture at that location more likely. A recent test at the University of Illinois³ showed that lap splices in structural walls can cause concentration of strains, leading to bar fracture at the ends of the splices, and that loss of bond in spliced bars and fracture of (other) bars are *not* mutually exclusive.

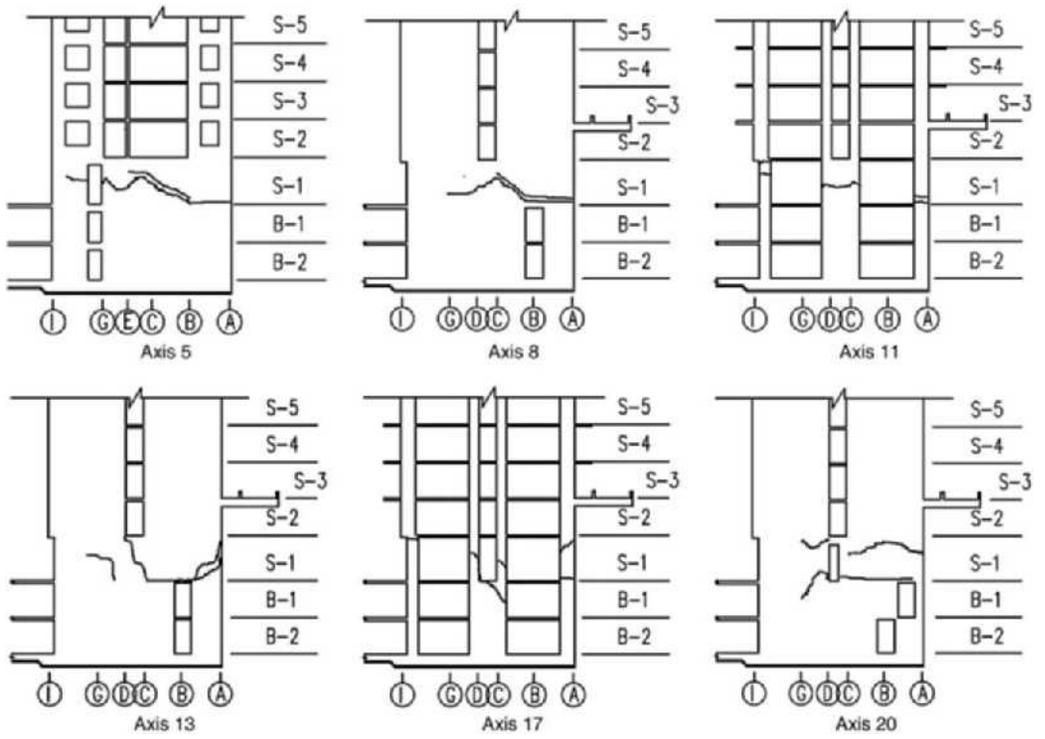
Failure surfaces observed along axes 5 to 20 (on 29 November 2010) are shown in Figure 7. Detailed descriptions of the damage observed along each axis are presented in the following sections.

Figure 7. Failure surfaces visible on November 2010 (view from north).

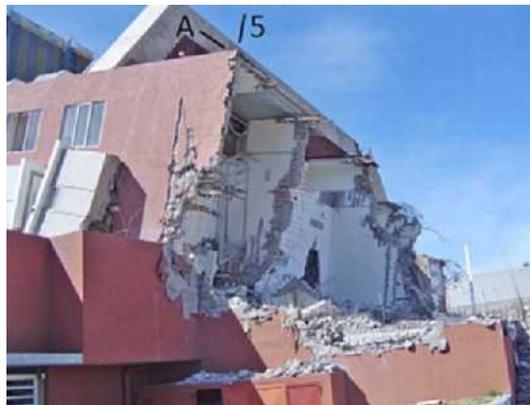
On the northwest side of the building, the wall along axis 5 failed at the base of the first story. The failure surface was horizontal from axis A to axis B, and ascended gradually from axis B to the top of 1.5 m (60 in.) lap splices near axis C (Figure 8).

Figure 8. Wall along axis 5, 29 March 2010. Photo credit: G. Alarcón.

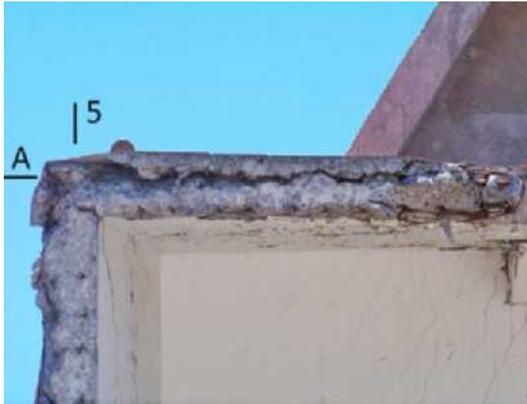
Bar fractures were observed in $\Phi 10$ mm reinforcing bars in the wall web between axes A and C. In the wall flanges along axes A and B, bar fracture was observed in $\Phi 18$ mm bars. The west end of the wall did not show signs of damage related to compression or shear, but splitting cracks were observed along vertical reinforcement layers (Figure 9).

Figure 9. Splitting cracks in wall segments.

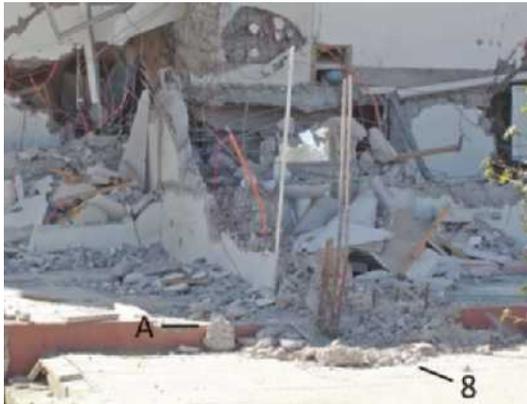
Figure 10. Wall along axis 8 (two of the vertical bars in the foreground had been cut for testing), 29 March 2010.

On the west side of the building, the wall along axis 8 failed along a nearly horizontal surface between axes A and B. The failure surface ascended from axis B to axis C, to reach a height of 1.7 m (68 in.) at the top end of lap splices of $\Phi 25$ mm bars at C (Figure 10). From axis C to axis D, the failure surface descended to reach the top end of lap splices of $\Phi 22$ mm bars at D, approximately 1.3 m (50 in.) above ground. Both bar fractures and splice failures were observed in the wall web between axes A and C. In the flange

along axis A, bar fracture was observed in $\Phi 16$ mm bars and bond failure was observed in bar splices of $\Phi 25$ mm bars (Figures 10 and 11).

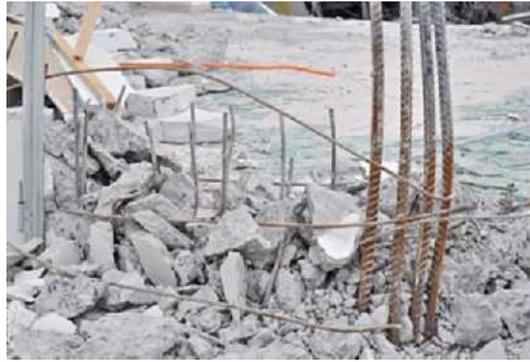
Figure 11. Wall at axes A and 8 (base of the first story), 16 March 2010. Photo credit: G. Alarcón.

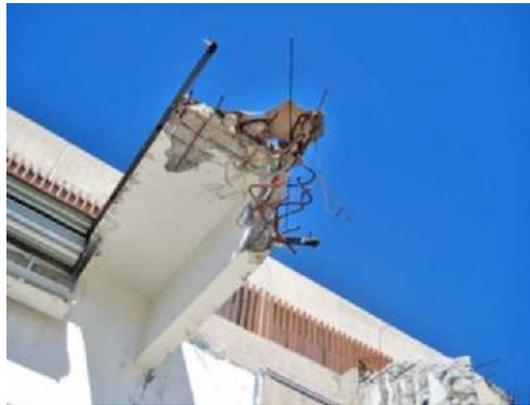
Figure 12. Pilaster at axes A and 11 (top of the first story), 29 November 2010.

In the first story, axis 11 had two pilasters (at A and I') and a short wall in the center of the building (between C' and F). The west pilaster failed near its base at the bottom of lap splices of four $\Phi 16$ mm bars at node A-11 (Figure 12). The bottom 0.3 m to 0.4 m (1 ft to 1.3 ft) of the pilaster appeared to have disintegrated. The pilaster at axis I' failed at its connection with a similar (but offset) pilaster in the second story.

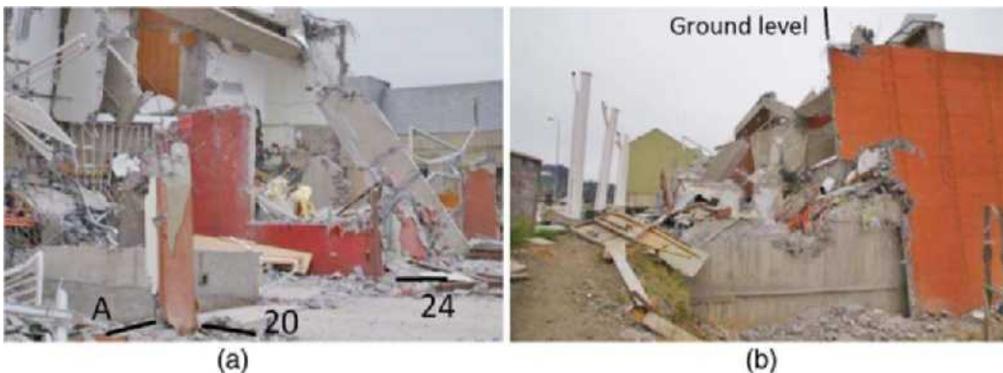
On the west side of the building, the wall along axis 20 failed near two thirds of the height of the first story. The wall flange below the observed failure surface, parallel to axis A, remained nearly intact, showing no clear signs of failure in compression at the base of the first story (Figure 13). The flange ruptured near the end of lap splices.

Photos taken before intervention (IDIEM 2010) are shown in Figure 13. Notice that large segments of walls along axes 24 and 35 show no large inclined cracks, nor signs of out-of-plane buckling. The lower half of the west boundary of the solid wall along axis 35 disintegrated at the base of the first story.

Figure 13. Damage photos before intervention: (a) Axis 24 (view from northwest); (b) axis 35 (view from south). Photo credit: IDIEM.

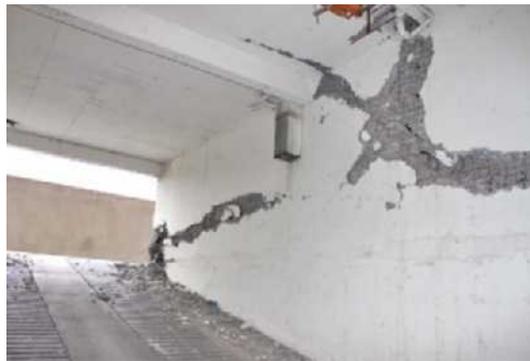
Damage in wall segments located under a “row” or stack of openings was observed in at least two other buildings surveyed after the 2010 Maule Earthquake: Centro Mayor, in Concepción (see Figure 18); and Torre Mayor, in Chillán. In both of these buildings, the boundary reinforcement next to the openings was anchored in the solid wall below the stories with openings (Figure 19). In Alto Río, all boundary reinforcement was anchored into the foundation (two stories below grade; Figure 19). Alto Río also had walls perpendicular to the panel presumed to have failed in shear (along axes C and D). The consequences of these differences deserve careful study. The task is not simple because we have found no experimental data to

Figure 18. Wall panel with inclined cracks under stack of openings and between anchorage zones of boundary reinforcement from upper stories, Centro Mayor Building, Concepción. Photo credit: J. Moehle, <http://nees.org/resources/3111>.)

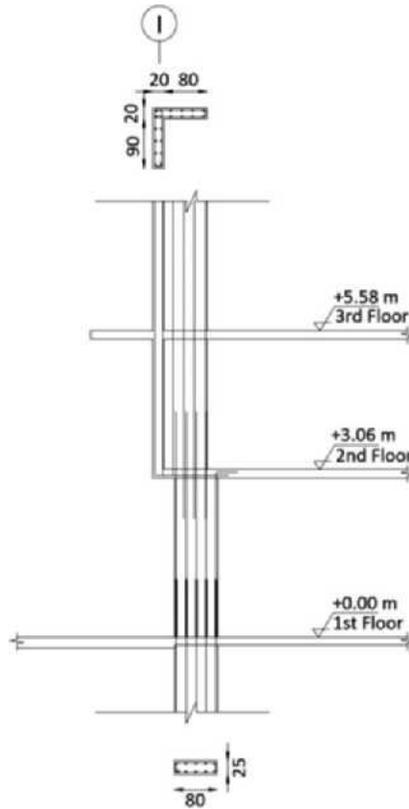
- 1) Pilasters at nodes I-11, I-17, and I-24 had an offset and a change in cross section (Figure 21).
- 2) Wall and pilaster flanges, and in a number of cases entire pilasters, present in the second and upper stories, did not extend into the first and underground stories (Figures 2 and 3).

Figure 21. Pilaster offset at I-11, I-17, and I-24 (view from north); cross-sectional dimensions in cm.

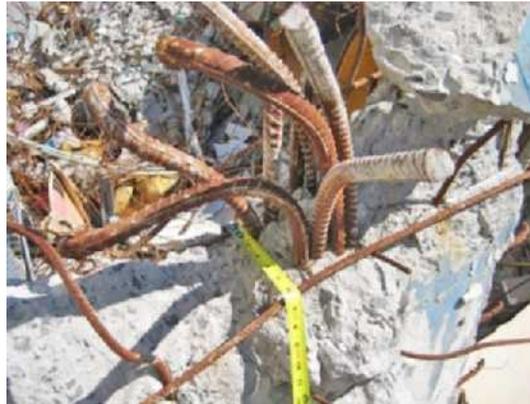
Walls in the first story had lap splices in all main boundary reinforcement and vertical web reinforcement. Walls in the second story had similar splices in one third of the main boundary reinforcement. Lengths of lap splices specified in structural drawings are listed in Table 6. These lap lengths are within current U.S. practice. But (1) current U.S. standards are based mostly on tests of lap splices shorter than 40 bar diameters, (2) mean unit bond strength decreases with splice length (within the lengths that have been tested so far), and (3) the clear spacing between the bars was observed to be less than 1 bar diameter in surviving lap splices (Figure 23).

Figure 23. Surviving lap splices.
