**POST RETROFIT ANALYSIS OF THE  
TUTTLE CREEK BRIDGE  
Br. No. 16-81-2.24**

**THE KANSAS DEPARTMENT OF TRANSPORTATION  
KDOT PROJECT NUMBER: KTRAN, KU-04-5**

**Structural Engineering and Engineering Materials  
SM Report No. 88  
January 2007**

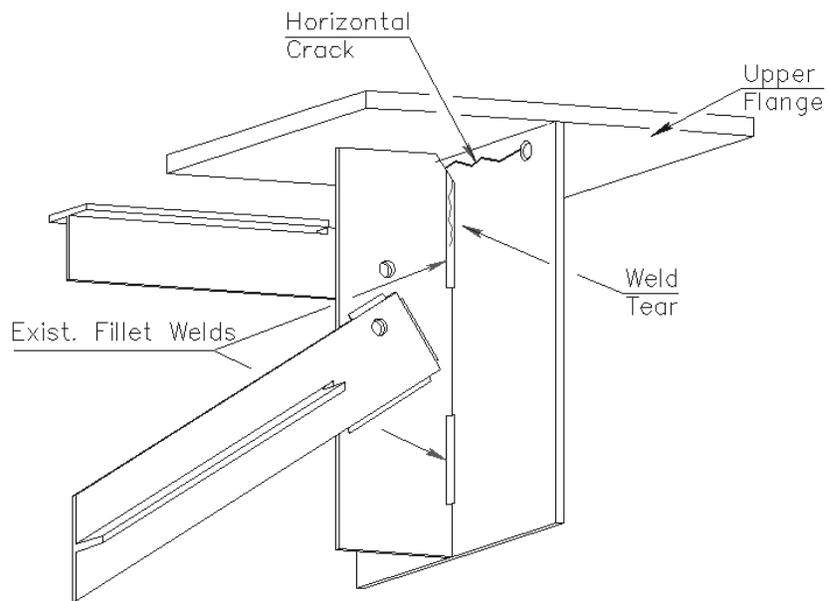
**Figure 2-3: Web-Gap Cracking Patterns**

The web gap region consisted of a 1"x 1" diagonal cut removed from the top and bottom of the stiffener as shown in Figures 2-1 and 2-2. This cut allowed the fillet weld between the web and flange to be continuous. This gap creates high stress concentrations in the web and creates the potential for fatigue cracks to propagate in this area. Two types of cracks that occurred in the upper web-gap region were designated as either weld tears or horizontal cracks. Figure 2-3 shows the two types of cracks, and Figure 2-4 presents a photograph of actual cracks.

Of the two types of cracking, weld tears were found to be the most common. The weld tears propagated down the 4 in. fillet weld between the upper portion of the stiffener and the web. Many of the 4 in. top intermittent welds on the stiffener were broken completely by weld tears. In addition, some weld tears propagated from the fillet weld into the web of the girder.

The other cracking pattern found in the web gap region was horizontal cracking. The horizontal cracks occurred at the base of the fillet weld that connects the upper flange to the web. Horizontal cracks were located mainly on the interior side of the girders, but were also found on the exterior side.

The primary source of fatigue cracking in the Tuttle Creek Bridge was the lack of attachment between the top of the stiffener and the tension flange. The web-gap cracking was the result of differential deflection of the girders. Braces in the diaphragms created a tension force on the stiffener due to the difference in deflections between the two girders. This caused the web-gap to undergo double-curvature bending. Figure 2-5 shows the tension force created by the diaphragms. This type of detail is classified as a category C fatigue detail according to the 2004 AASHTO LFRD specifications.

A previous repair of the web-gap region was implemented in 1986. To repair the weld tears, the joint was “softened” by cutting the stiffeners 1 in. below the termination of the existing cracks. A 0.5-in. radius was placed at the end of the cut. Even though this was supposed to have repaired the problem, weld tears continued to

grow in this region. To stop the horizontal cracks, 0.75 in. diameter stop holes were drilled at the tips of existing cracks. However, the horizontal cracks reinitiated after the retrofit.

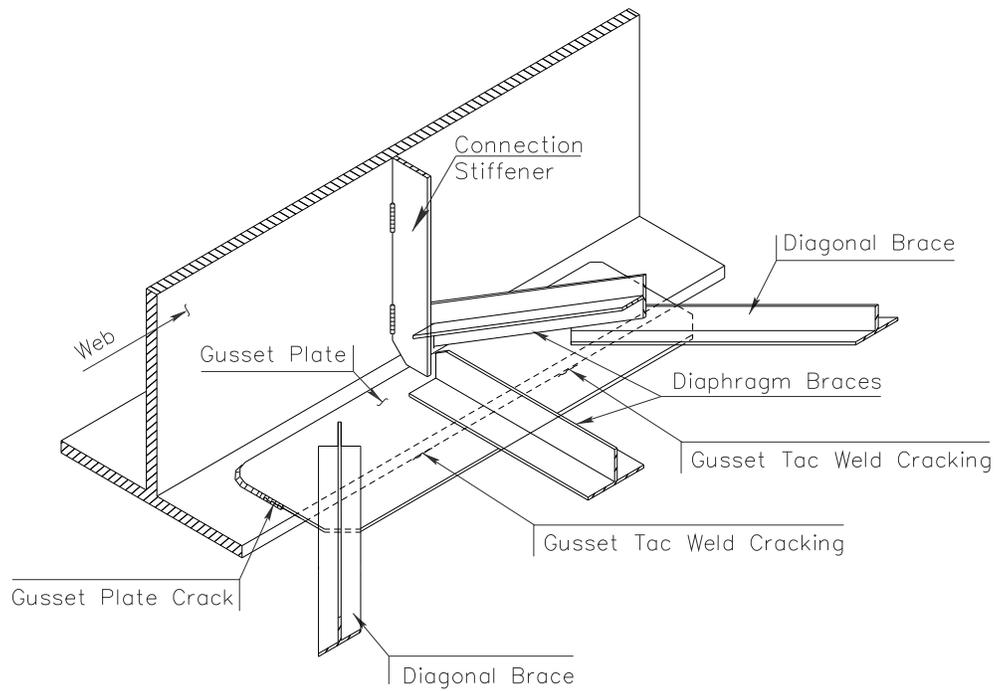
**Figure 2-6: Gusset Plate Cracking Patterns**

Cracks developed in welds that were both perpendicular and parallel to the gusset plate. Figure 2-6 shows a drawing of the cracking patterns, while Figure 2-7 displays an actual fillet weld crack.

The more common of the two was the cracking of the fillet weld perpendicular to the gusset plate. The fillet welds extended symmetrically across the back six inches along the sides of the gusset plate. This type of detail is classified as a Category E

detail according to the 2004 AASHTO Bridge Specifications. The cracks are found at the end of the weld along the sides of the plate. The cracks were assumed to be only in the weld material, but could potentially propagate into the lower tension flange.

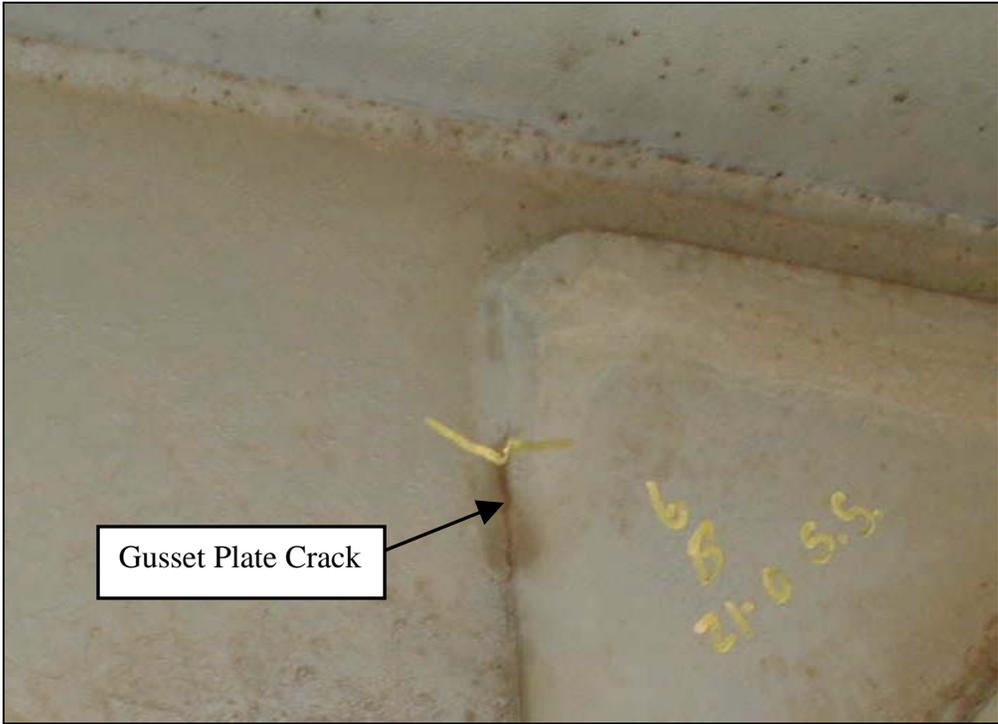
**Figure 2-7: Gusset Plate Cracking Patterns (Picture)**

Fatigue cracking also occurred in the fillet weld between the gusset plate and the lower flange of the girder. Gusset plates connect the girders to the lateral bracing of the girders. As shown in Figure 2-7, three structural tees enter the connection. Loads imposed by the lateral bracing caused cracking of the gusset plate connection.

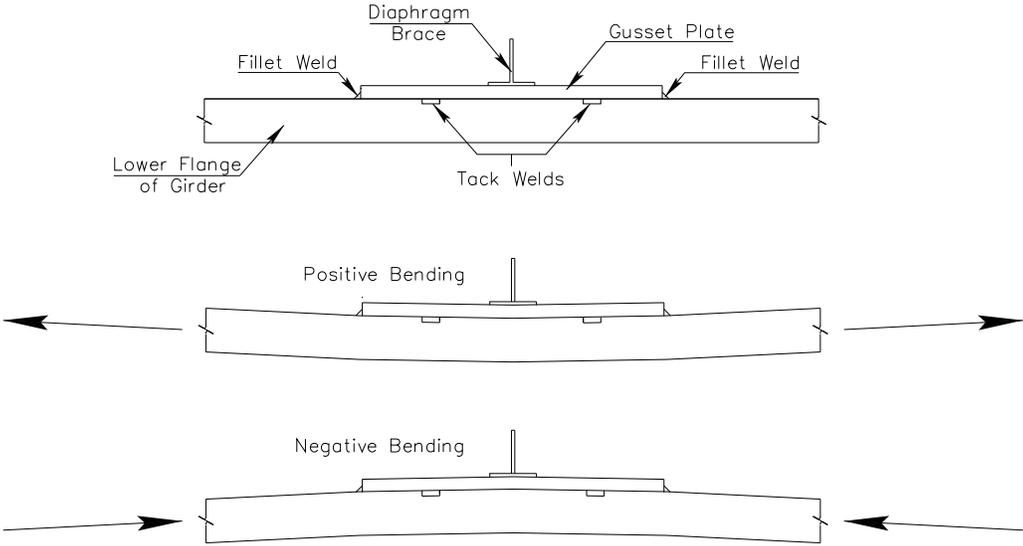
**Figure 2-8: Gusset Plate Cracking Source (Bending Stresses)**

The source of the gusset plate cracks was not clearly defined. One theory was that cracks developed from the bending stress of the girder (Figure 2-8). Another possibility considered was that distortion of the girder caused high compressive stresses in the diagonal bracing. The lateral bracing could potentially buckle upward along its weak axis introducing a prying action on the gusset plate (Figure 2-9). Another theory considered racking of the gusset plate due to loads from the diagonal bracing. Twisting of the gusset plate would cause cracking to develop at the ends of the fillet weld (Figure 2-10). To help clarify this issue, strain gages were placed on the top and the bottom of the plate as shown in Figure 2-11.

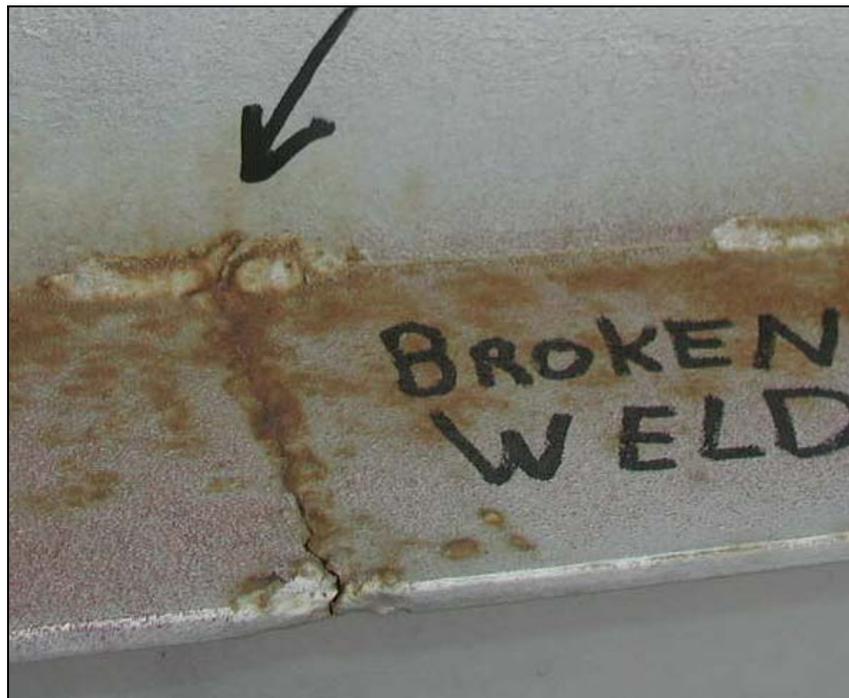
**Figure 2-12: Longitudinal Stiffener Crack**

Cracks had developed in the butt welds of the stiffener splices. The cracks are found only in the weld material. Figure 2-12 shows a crack in the longitudinal stiffener.

The crack was probably generated from a defect in the weld. Due to the bending of the girder, stress cycles occurred within the stiffener. These cycles propagated the crack in the stiffener.

Two repairs were performed on the longitudinal stiffener. First, cracks in the butt welds of the stiffener were repaired. This was accomplished by grinding off the butt welds and re-welding them. Second, the end of the longitudinal stiffener was tapered to reduce the stress concentration because the termination point of the stiffener is classified as a category E detail according to the 2004 AASHTO LRFD specifications. This repair was used as a preventative measure, and the second repair is shown in Figure 7-1.
