# **FIELD INSTRUMENTATION AND ANALYSIS OF THE TUTTLE CREEK BRIDGE**

**Br. No. 16-81-2.24 (017)**

**KDOT PROJECT NUMBER: KTRAN, KU-04-5  
KUCR PROJECT NUMBER: KAN 35730  
Final Report**

**Department of Civil, Environmental,  
and Architectural Engineering  
The University of Kansas  
Lawrence, Kansas 66045**

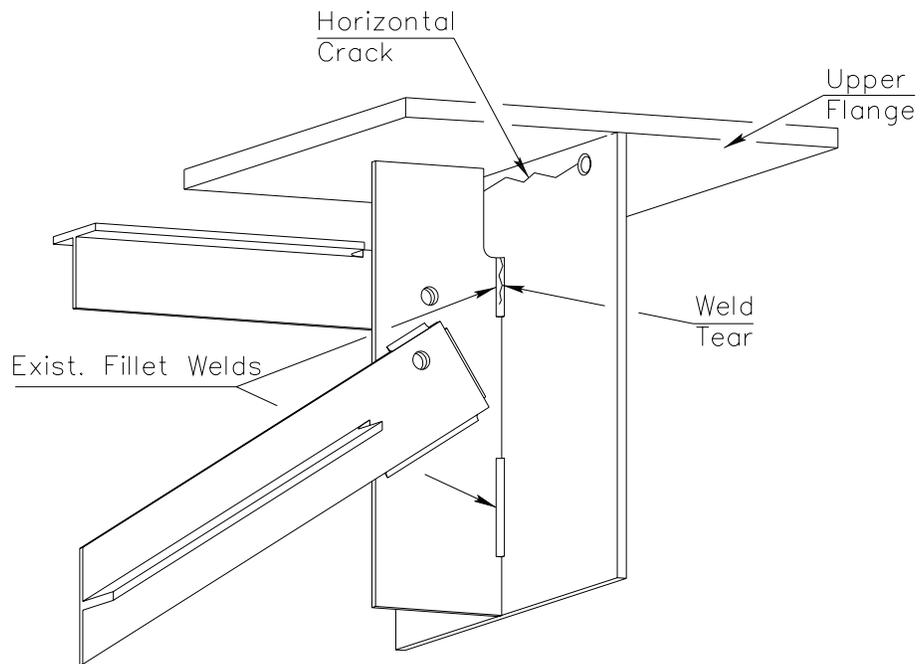
**Figure 2-3 Web-Gap Cracking Patterns**

Two distinct cracking patterns are found in the web-gap region. Figure 2-3 shows a drawing of the cracking patterns, while Figure 2-4 shows an actual picture of the cracking. The most common cracking pattern is a weld tear. The weld tears begin at the weld connecting the stiffener to the girder web. The stiffener is welded to the primary girder web with 4 in. fillet welds at each end and 6 in. welds spaced at 12 in. between the end welds. The cracks propagate down the top 4 in. weld

connecting the upper portion of the stiffener to the web. Some weld tears have tapered off from the fillet weld and into the web of the girder. Many of the 4 in. top intermittent welds on the stiffener have been broken completely by the weld tears. A total of 379 weld tears have been found in the bridge.

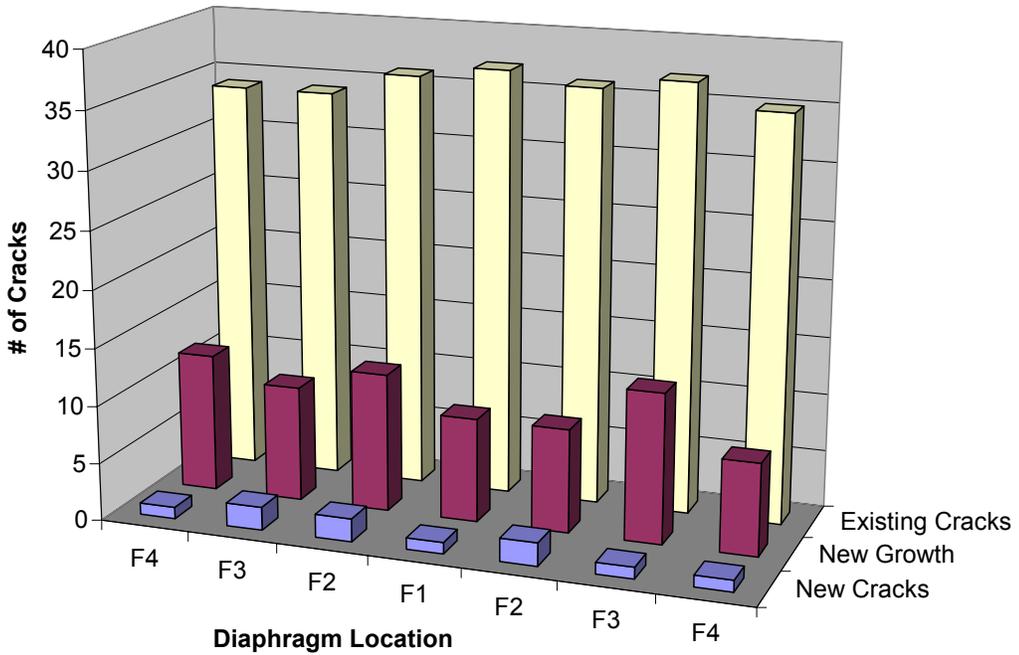
Figure 2-6 Weld Tear Survey (Full Spans)

The inspection reports revealed helpful information concerning the web-gap cracking problem. Surveys of each span indicated that web-gap cracks were not more or less abundant for any particular span. Full spans compared to hinged spans did not show any recognizable patterns. However, the comparison of diaphragm locations did indicate patterns for the cracking. Interior horizontal cracks showed a bell-shaped curve distribution, with larger number of cracks appearing in the middle diaphragms, as shown in Figures 2-5 and 2-7. Weld tears displayed a rather constant development regardless of diaphragm location, as shown in Figures 2-6 and 2-8.

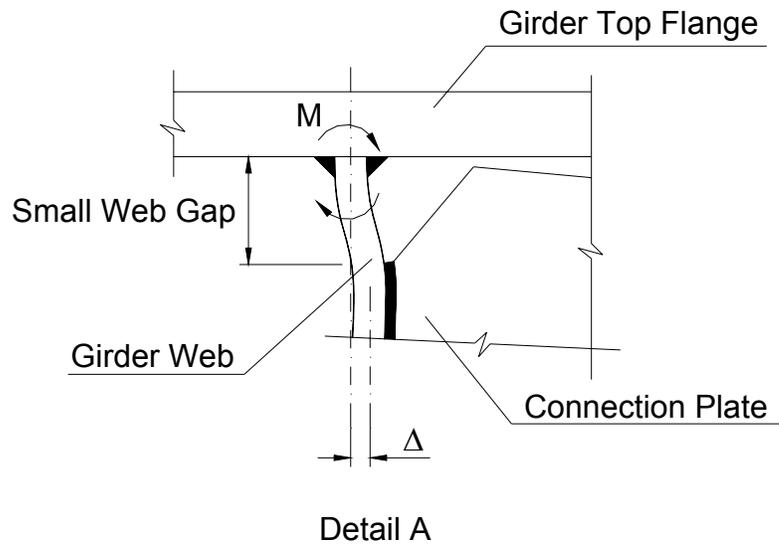
**Figure 2-9 Distortion in the Web-Gap Region**

The primary fatigue design problem with the Tuttle Creek Bridge is the lack of attachment of the connection stiffener to the tension flange, as shown in Figure 2-9. Past engineers believed that having transverse welds on the tension girder would initiate cracking. Unknowingly, they produced a region of high stress concentration in the web-gap region. Experience has shown that the web-gap region is much more fatigue-prone than the proposed tension flange welds. As a result, many older steel bridges have experienced web-gap cracking. New bridges, with the exception of heavily skewed bridges, do not have this problem since current design practice

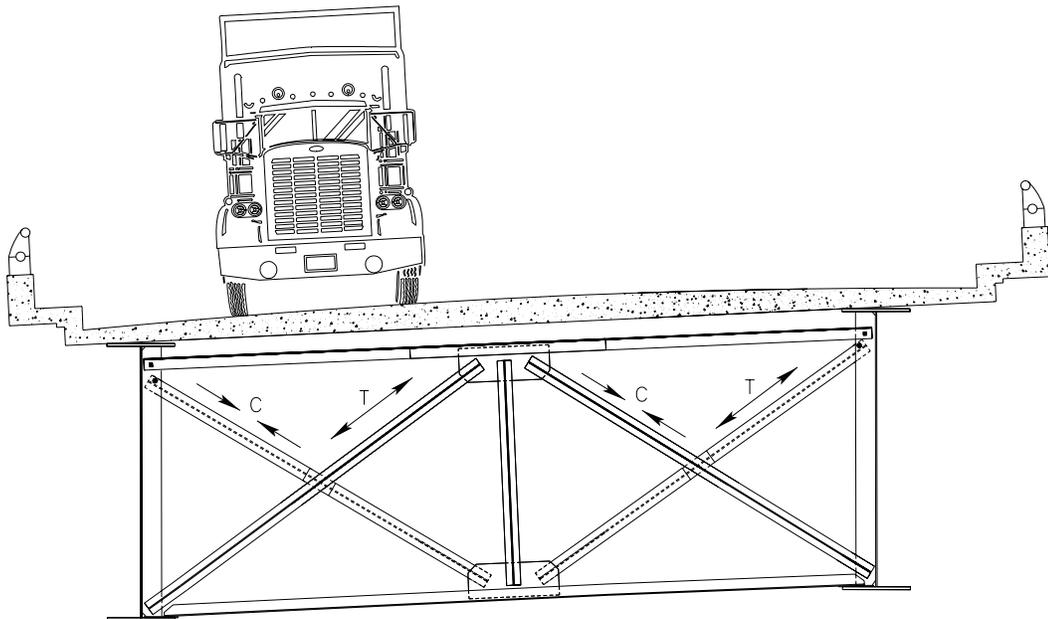
**Figure 2-10 Differential Deflection of Girders**

Web-gap cracking is a result of differential deflection of girders. When the braces in the diaphragms “pull” on the connection stiffener due to the varying deflections, the web-gap undergoes double-curvature bending. Figure 2-10 demonstrates the pulling of the diaphragm braces due to loading from a vehicle. Because this detail can quickly lead to crack initiation, AASHTO has labeled this design detail a fatigue category C (AASHTO LRFD, 2004).

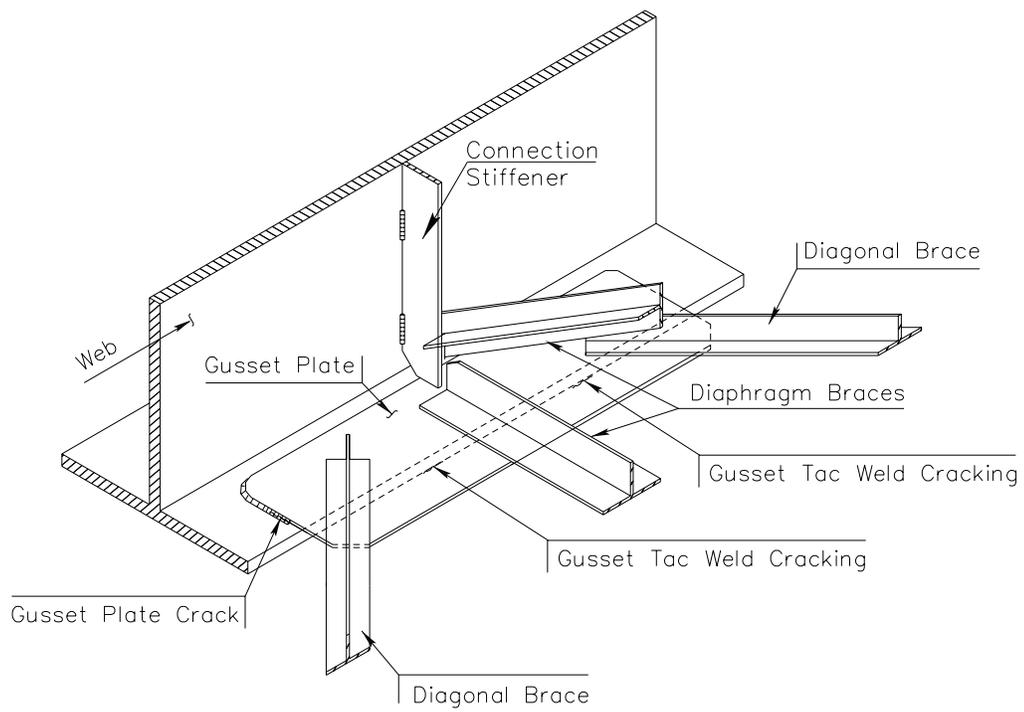
**Figure 2-11 Gusset Plate Cracking Patterns**

Two types of gusset plate cracks have developed: cracking of the fillet weld perpendicular with the girder and tack welds parallel with the girder. Figure 2-11 shows a drawing of the cracking patterns, while Figure 2-12 displays an actual fillet weld crack.

The most problematic gusset plate crack found on the Tuttle Creek Bridge is cracking of the fillet weld connecting the gusset plate with the primary girders. The fillet welds extend symmetrically across the back and extend six inches along the

sides of the gusset plate. The cracks are found at the termination of the weld along the sides of the plate. The cracks are assumed to be only in the weld material, however, their continued propagation could enter into the lower tension flange. A total of 20 cracks have been found in this AASHTO Category E detail.

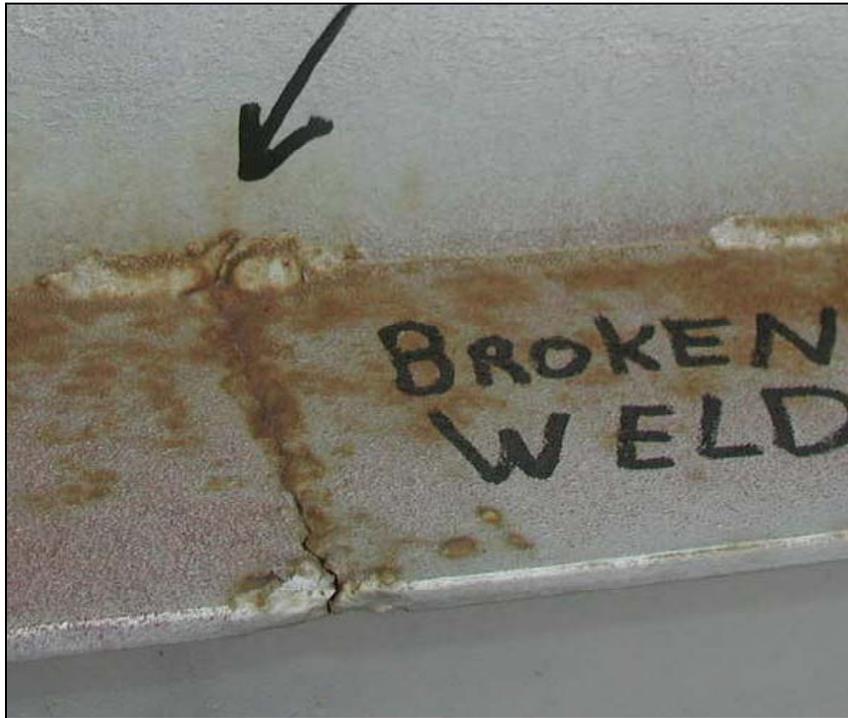
**Figure 2-17 Longitudinal Stiffener Crack**

A defect in the weld was the probable source of crack initiation in the stiffener. Stress cycles in the stiffener due to bending of the girder propagated the crack. Even during compression stress cycles, residual stresses would transform the stress cycles from compressive to tensile. The resulting tensile cycles would quickly propagate a crack.

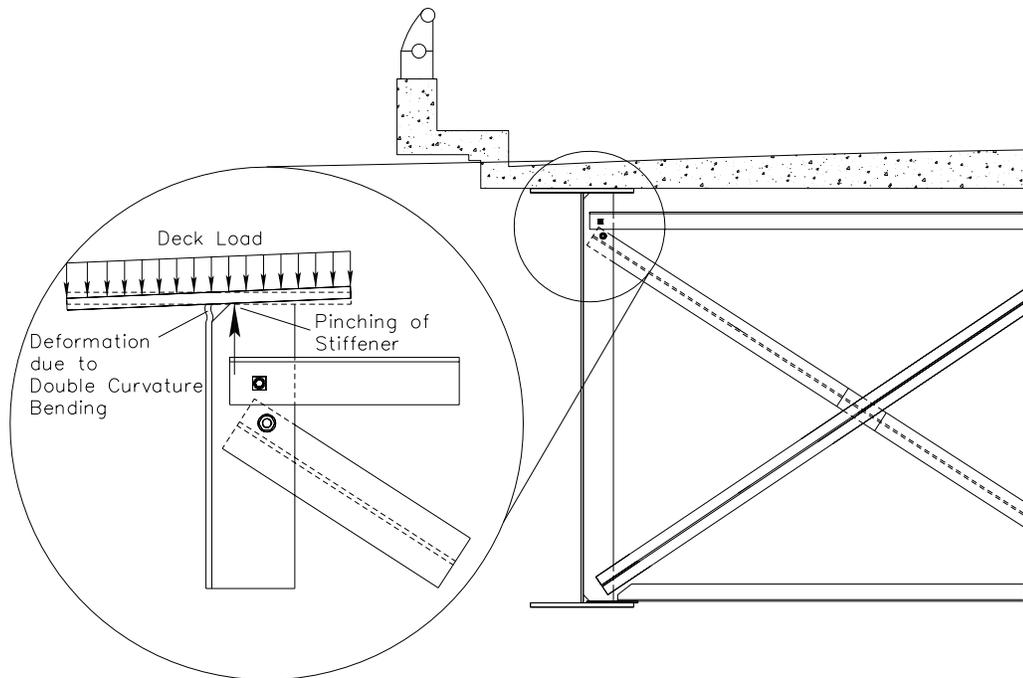
**Figure 5-12 Cracking Theory (Binding of the Stiffener)**

Another theory would be binding of the connection stiffener. The connection stiffeners, found only on the interior side, were designed to be the same height as the web at the diaphragm locations. Although designed as a secondary-loaded member, the connection stiffeners may have inadvertently created stress in the web-gap. When constructed in 1962, the girders were first loaded with the dead weight of the decking. The weight of the decking was transferred directly to the upper flange of the girders. The load may have then transferred to portions of the connection stiffener, which were at the same height as the girder web. Additional deformation of the web-gap, due to double curvature bending from differential deflection of the girders, would cause further load to be applied to the stiffener. Since the stiffener is found only on the interior side, the distributed load from the decking onto the upper flange would be unbalanced. A moment is thus created in the web-gap region, placing the interior side

into tension, as shown in Figure 5-12. If the interior side of the web-gap were in tension prior to large live loads, fatigue cracks would be likely to initiate. The live loads producing compressive stress cycles would actually be creating tensile residual stress cycles, thus causing crack initiation.
