**Fabrication error  
Indexed eXamples and Solutions:  
FIXS**

**A Report on Research Sponsored by  
Kansas Department of Transportation  
KTRAN Project No. KU-98-8  
Mid America Transportation Center  
MATC/KU 98-2  
National Steel Bridge Alliance**

**UNIVERSITY OF KANSAS CENTER FOR RESEARCH, INC.  
LAWRENCE, KANSAS  
JUNE 1999**

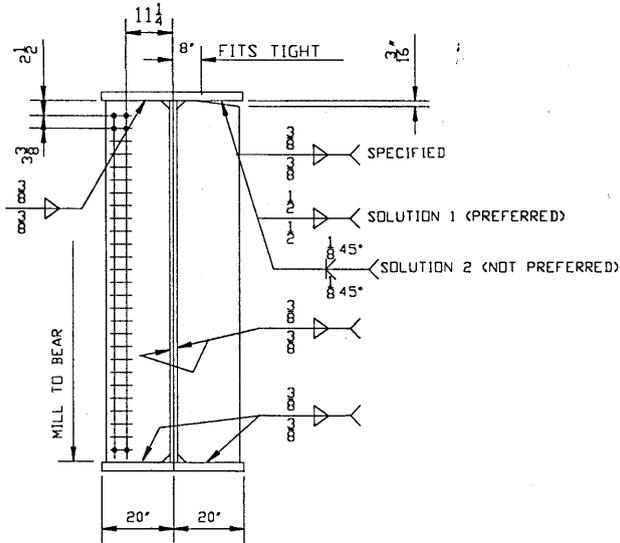
### Case # TF176:

A bearing stiffener does not have the required tight fit at stiffener to flange. There is a gap of  $3/16$  in. that occurs at about midway on the stiffener to the outer edge of the stiffener. Either increase the current fillet weld size of stiffener to flange or (avoid full penetration weld if possible) use a full penetration weld of stiffener to flange.

Solution Recommended: Either increase the current  $3/8$  fillet weld size to  $1/2$  inch or (avoid full penetration weld if possible) use a full penetration weld of stiffener to flange whichever is acceptable to DOT.

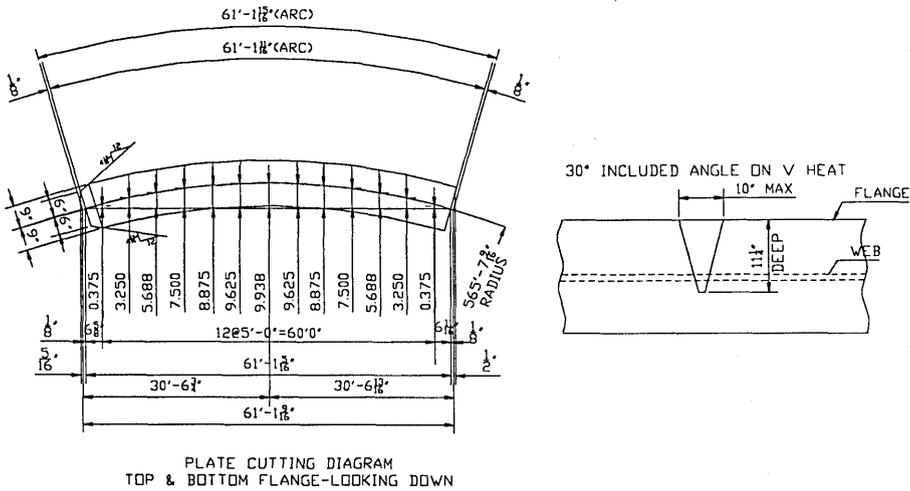
**Case # FB160:**

The flanges could not be burned to the proper sweep.

**Description of Error:** Due to purchasing error, girder top and bottom flange plates could not be burned with the detailed 9 15/16" of sweep but only 4" of sweep.

Heat curve the flanges to meet the sweep requirements by following the appropriate DOT Special Provisions Section.

**Solution Recommended:** Add the remaining 5 15/16" of sweep by the heat curving method following the procedure outlined in the appropriate Special Provisions Section for heat curved rolled beams and welded plate girders. Fabricator will locate the heats working from center line of girder and heating at 5' increments of the length of the girder. Maximum temperature of 1100 ° F. Top flange and bottom flange to be heated at same time with two rose buds per flange (one rose bud on each side of flange). Additional heat may be needed. Heating to be done in horizontal position, blocked at both ends with middle unsupported (1' gap between girder and center blocking).

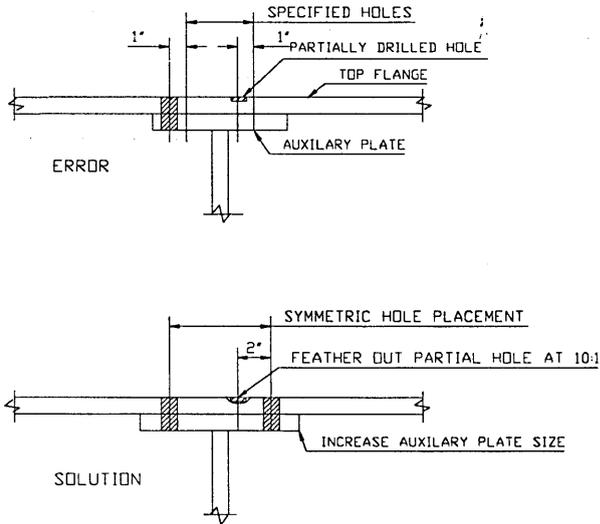
### Case #DL126:

**Description of Error:** A hole (see left hole in error sketch) was drilled 1" off in the top flange for the auxiliary plate. This causes auxiliary plate to be too small (see left edge of auxiliary plate in error sketch). Next hole in pattern was partially drilled.

Make a larger auxiliary plate to fit the hole spacing pattern on the top flange.

**Solution Recommended:** Make larger auxiliary plate to fit the hole spacing. Feather out partial hole at 10:1. Locate new right hole to be in symmetry with existing left hole.

**Additional Comments:** This repair approach is suitable for shallow partial holes. See tutorial topic on partially drilled holes for further discussion.

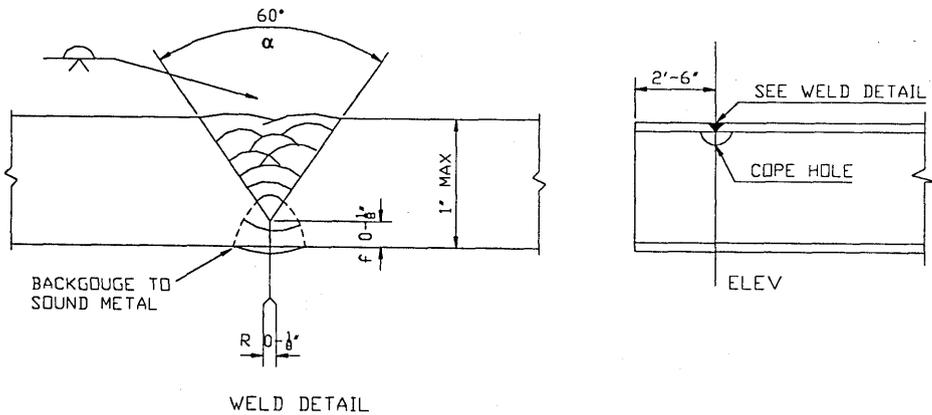
**Case # TF189:**

Required holes in top flange have been drilled and were gaged from centerline of misaligned web. This has caused these holes to be 1/2 in. off theoretical centerline therefore reducing edge distance on one side.

**Description of Error:** Web plate is misaligned 1/2" off centerline of top flange plate approximately 1'-10 1/2" from left hand end. Required holes in top flange have been drilled and were gaged from centerline of mis-aligned web. This has caused these holes to be 1/2" off theoretical centerline, reducing edge distance from 1 1/2" to 1" on far side and increasing edge distance near side to 2".

Air carbon arc gouge web to flange weld 2 ft. 6in. from left hand end and add 1" web cope hole. Cut out top flange 2 ft. 6 in from left hand and splice new flange. Radiograph flange splice 100% Web will be realigned and welded with 100 percent MT. Holes will be drilled in new flange plate.

**Solution Recommended:** Air carbon arc gouge web-to-flange weld 2'-6 from left hand end, and add 1" web cope hole. The cope hole is to allow 100% RT of flange weld. Cut out top flange 2'-6 from left hand end and splice new flange using approved weld procedure (see sketch) and RT splice 100%. Web will then be re-aligned and welded with 100% MT. Holes will then be drilled in new flange plate. All work to be witnessed by DOT.

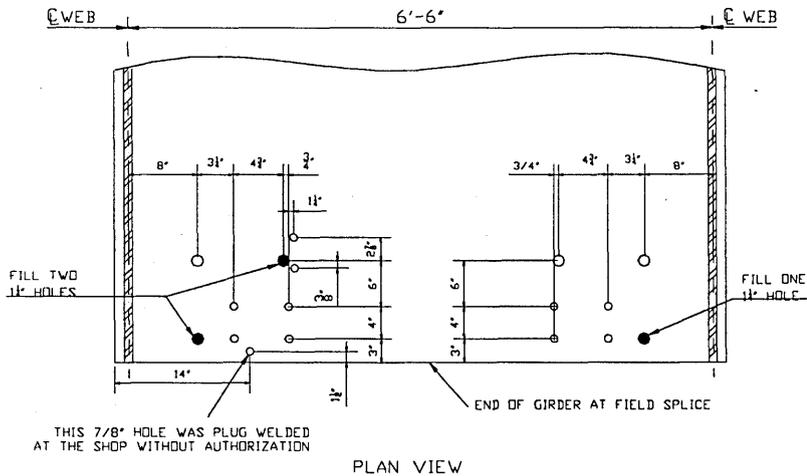
### Case #MG102:

**Description of Error:** The 7/8" diameter hole shown on the diagram was drilled and plug welded without any permission at the shop and was discovered by chance during field radiography. The six 1 1/4" holes were also drilled wrong but were evaluated, repaired and NDT tested before acceptance of the girder. (see case 'MLCH-C013' for following error on same member)

Plug weld the hole and NDT test.

**Solution Recommended:** This is a two-part problem.

- 1) Since conditions allowed filling and NDT testing of the 1 1/4"  $\phi$  holes, the same technical fix should be possible on the 7/8" hole.
- 2) Since the fabricator did not bring the 7/8" hole to the attention of the owner, the fabricator's QC is called into question. For this reason, repair of this defect will be decided on by design department and the consulting engineers handling the project.

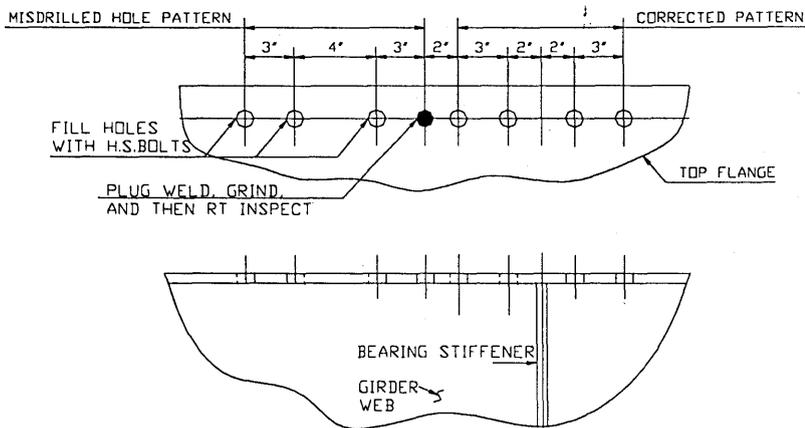
### Case #TF200:

The holes drilled in the wrong location were filled with bolts. \*\*\*However the hole nearest the correct location is too close to the correct pattern and was filled with weld material and ground smooth. THIS IS NOT A RECOMMENDED REPAIR.\*\*\*

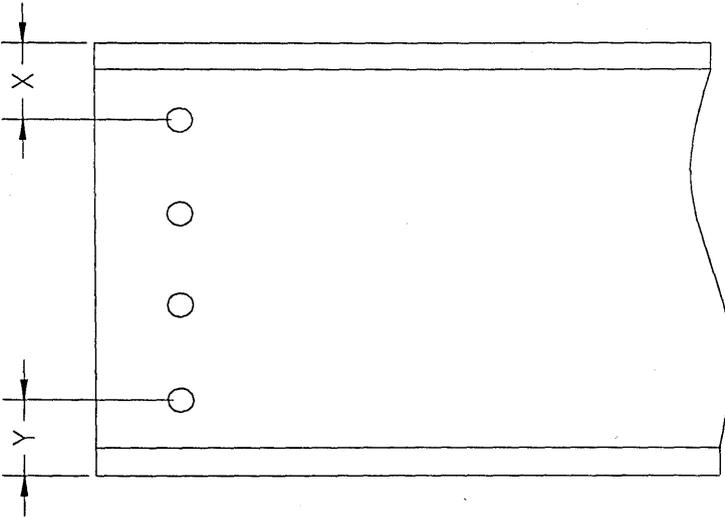
Description of Error: Dimensions X and Y were reversed when putting in holes and slots. This made them all 3 1/4" too low.  
Solution Recommended: Ok to leave as is. Reinforcing steel to be adjusted in the field.

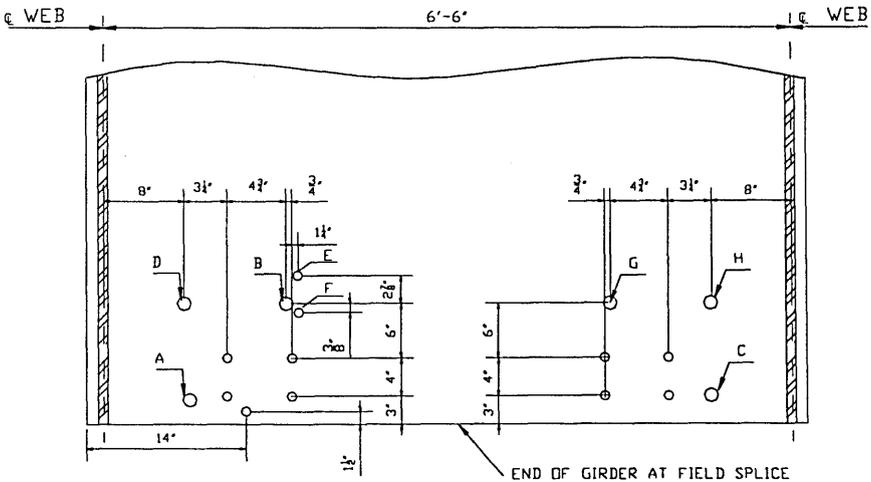
Description of Error: The 1 1/4" holes are supposed to be at the abutment end of bottom flange plate, but were drilled at field splice by mistake. The 1" holes (E, F) are also extraneous. The 8 smaller holes at the splice attach temp. field erection channels and are later filled with 7/8" bolts.  
 Solution Recommended: 1.) Fill A, B & C with weld material in compliance with section 3.7.7 (2) of AWS D1.1-88. A repair welding procedure specification is to be generated and submitted for review before commencing the repair. The commentary to AWS Section 3.7.7 may be of help in establishing an acceptable repair procedure. 2) Fill D, E, F, G, & H with bolts. 3) Remainder use as intended for erection aid devices and fill with 7/8" bolts. (see case 'MLCH-C005' for following error on same member)

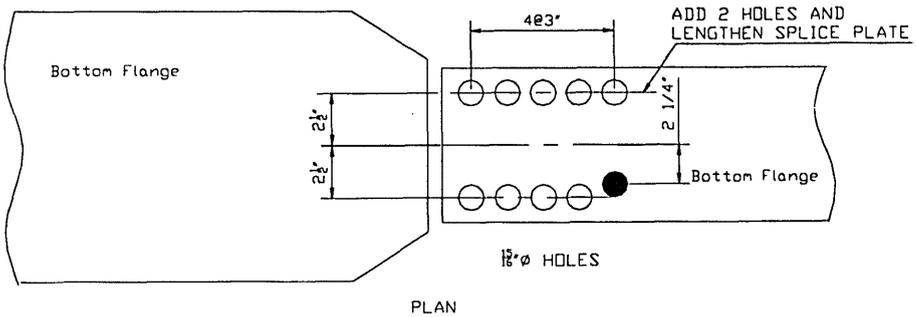
Description of Error: Plate girder has a mislocated bottom flange splice hole.  
 Solution Recommended: To custom fabricate new splice plates to match as built conditions. The new splice plate will require 2 addition holes, due to a lack of edge distance on the inside splice plate for the mislocated hole.

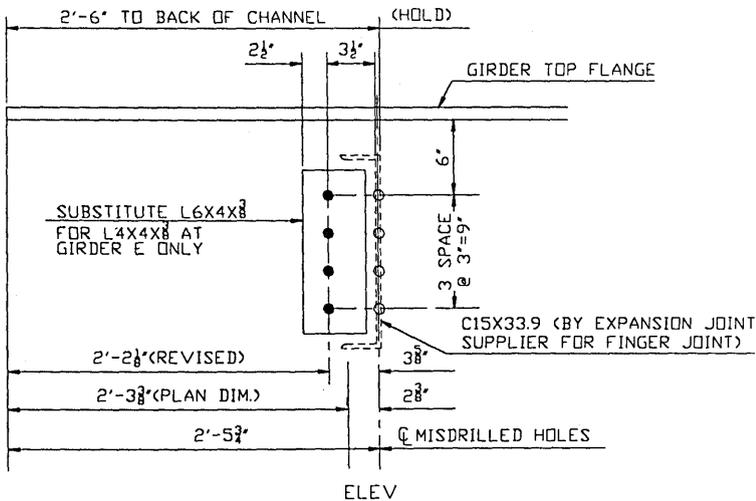
Description of Error: Holes were misdrilled in a girder for connection to exp. joint supports.  
 Solution Recommended: Since the holes are nearly aligned with channel web, filling the misdrilled holes with bolts would cause interference with channel. Leave the misdrilled holes as built, and drill new holes in correct location.
