**FIELD, LABORATORY, AND ANALYTICAL INVESTIGATION OF
ANGLES-WITH-PLATE RETROFIT FOR DISTORTION-INDUCED
FATIGUE IN STEEL BRIDGES**

Submitted to the graduate degree program in
Civil, Environmental, and Architectural Engineering
and the Graduate Faculty of the University of Kansas
in partial fulfillment of the requirements for the degree of
Doctor of Philosophy.

Prior to the mid-1980s, steel girder bridges were designed with a detail susceptible to distortion-induced fatigue cracking. While a number of retrofit measures have been developed to repair this problem, many of those retrofits have long-term performance issues or are difficult and expensive to implement. Recent research at the University of Kansas has focused on the development of a new retrofit measure that could be effective in repairing distortion-induced fatigue cracking while also being inexpensive and easier to install than currently available retrofits. This new retrofit measure, referred to as the “angles-with-plate” retrofit, stiffens the problematic region and redistributes distortion-induced fatigue stresses away from cracking prone areas. By eliminating the need for cumbersome installation procedures, the angle

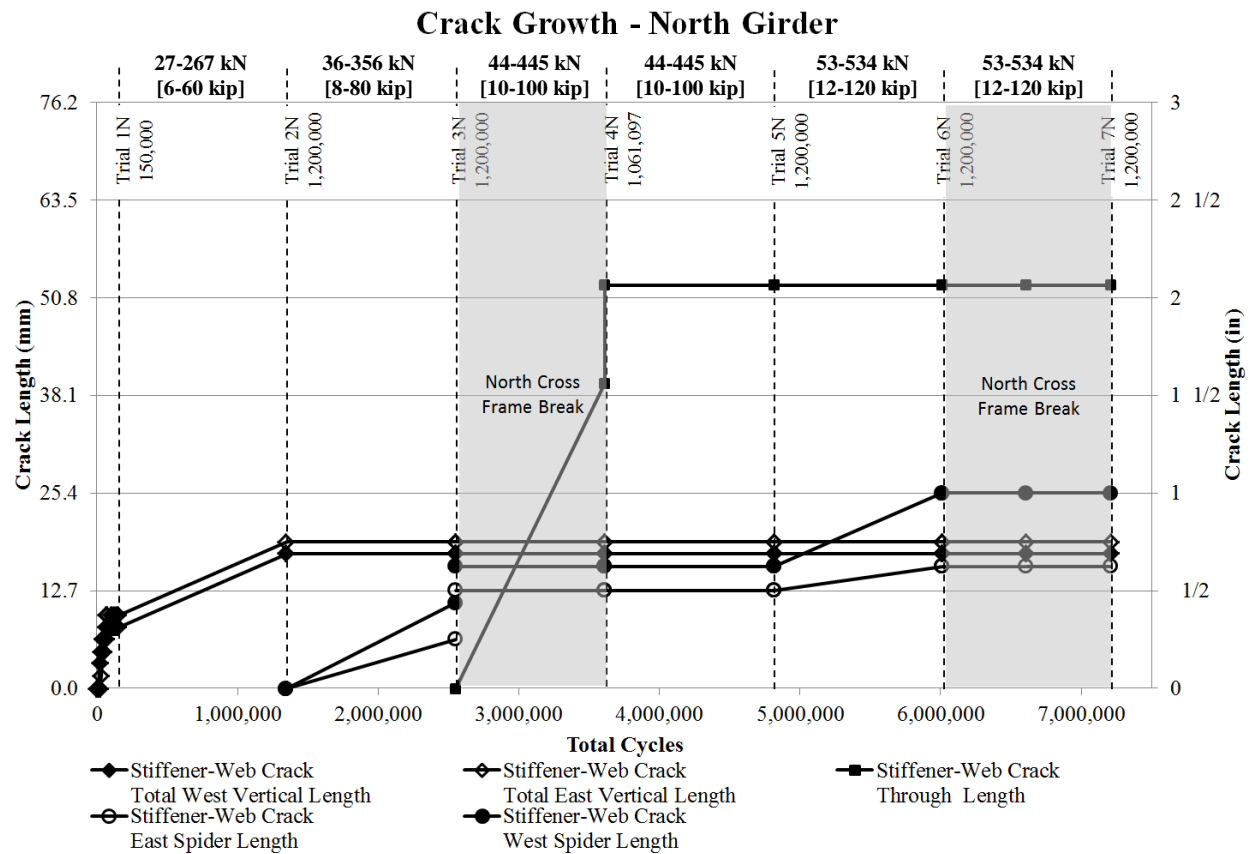
propagation plot in Figure 10 is also labeled with other notable test events, including cross frame failures that occurred during Trial 1.4N and Trial 1.7N.

Figure 10: North girder crack growth around transverse connection plate in Test 1.

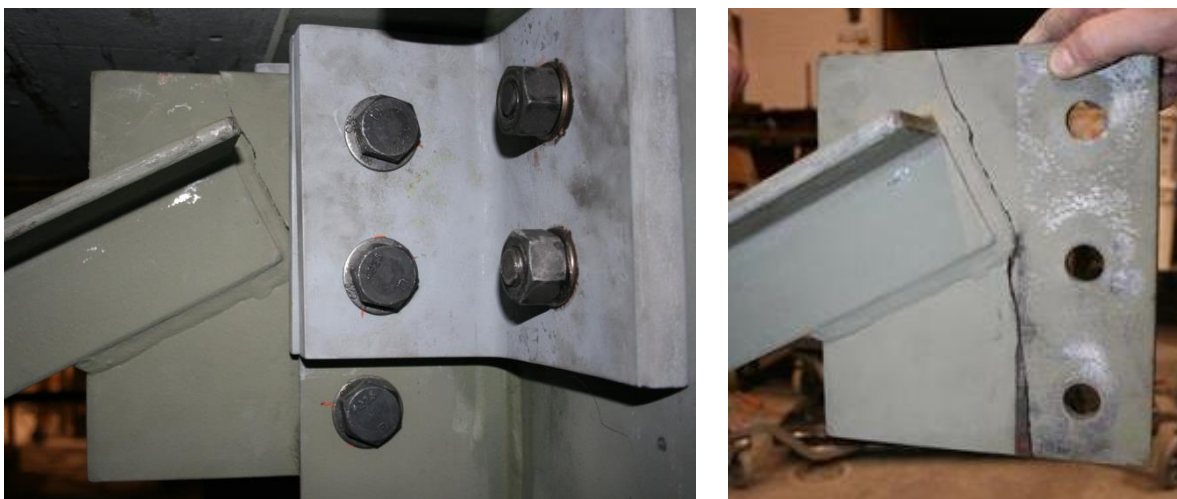
Small crack-arrest holes with a 6-mm [$1/4$ -in.] diameter were drilled at the crack tips before the start of Trial 1.4N, the angles-with-plate retrofit was reapplied, and the load range was increased to 44-445 kN [10-100 kip]. Approximately 650,000 cycles into Trial 1.4N, a faint clicking noise was observed originating from the connection plate in the north girder. After inspection of strain data, no notable change in bridge response was noticed. However, when the bridge was visually inspected 1.06 million cycles into Trial 1.4N, the cross frame between the north and middle girders was found to be cracked completely through at the tab plate, as shown in Figure 11.

Figure 11: North cross frame failure during Trial 4N.

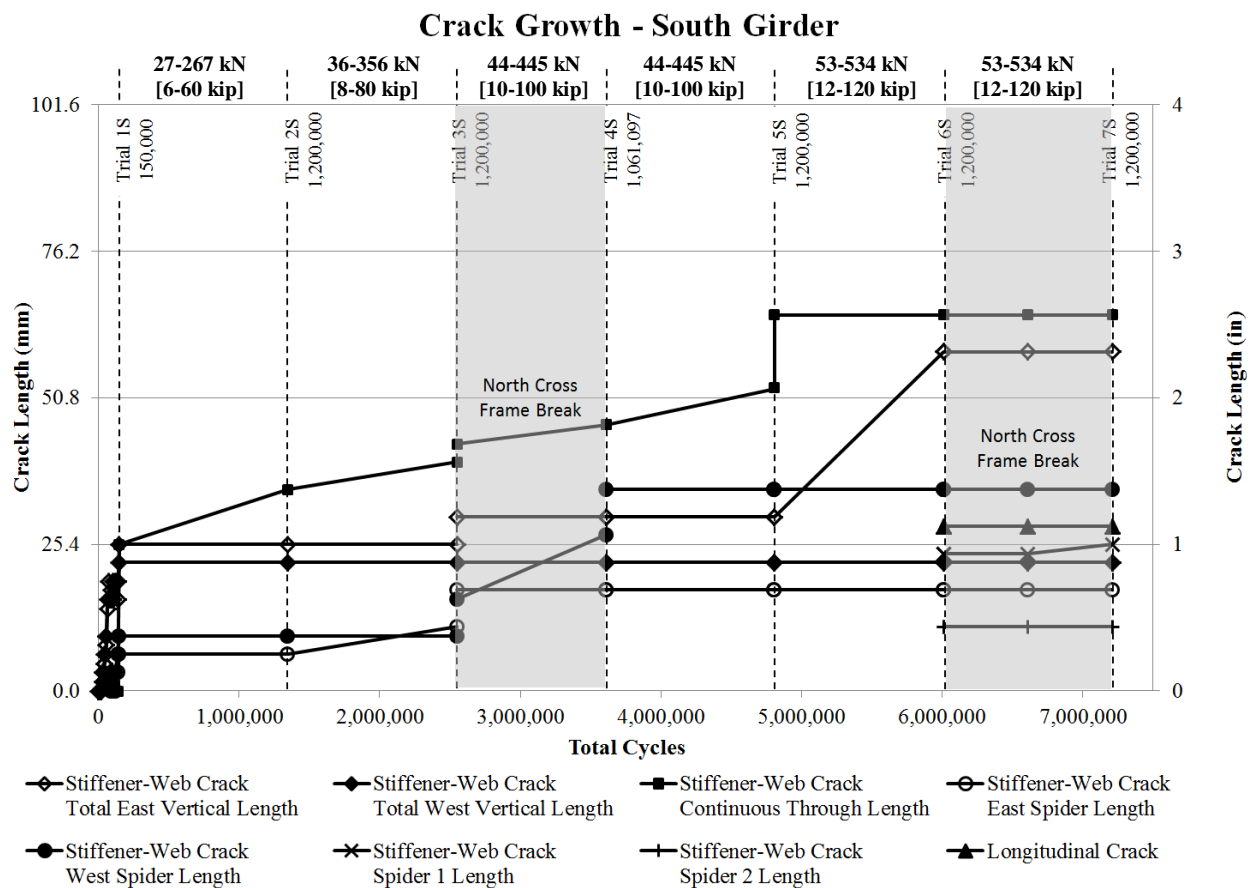
Cracking experienced around the transverse connection plate in the south girder in Test 1 is shown in Figure 12. The same crack definitions were applied as those used in the north girder as described in the previous section. Drilled holes are denoted by an instantaneous jump with no line, and cracks that propagated into an existing hole were denoted by an instantaneous jump with a connecting solid line.

Figure 12: South girder crack growth around transverse connection plate in Test 1.

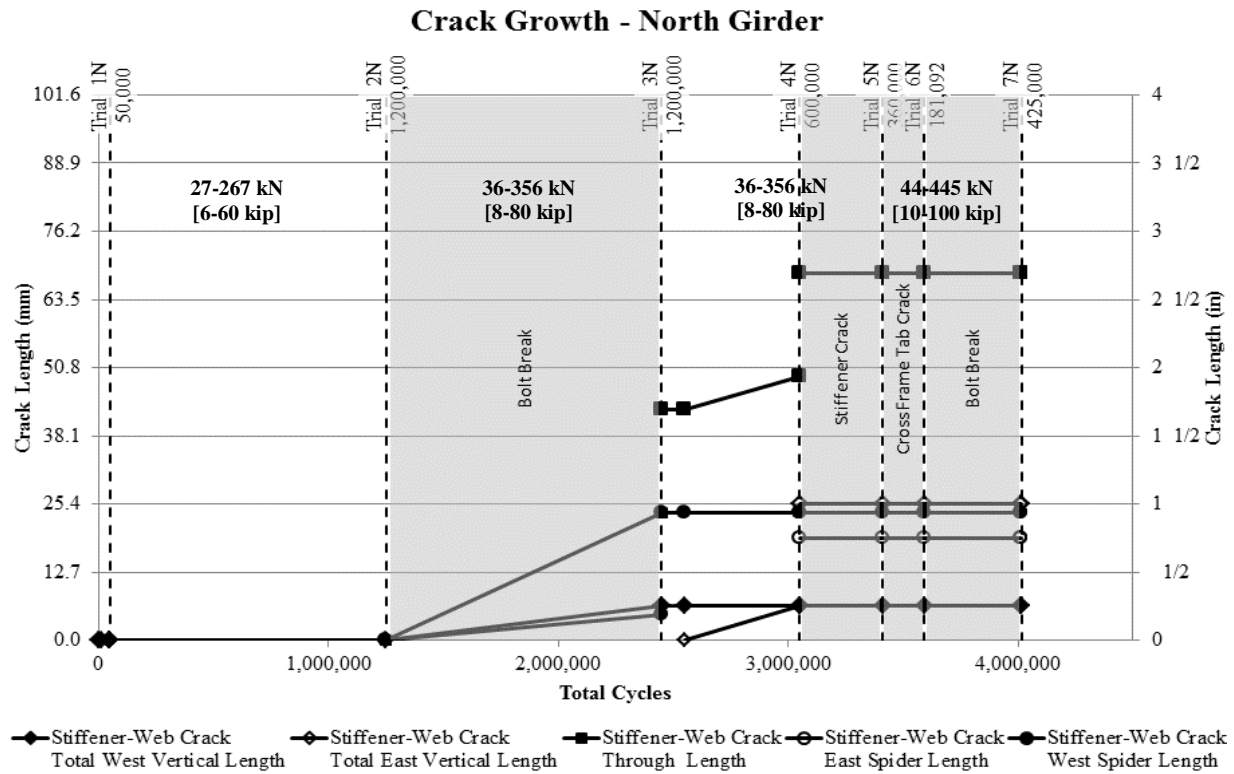
Cracking in the top web gap of the north girder during Test 2 trials is shown in Figures 13 and 14. Figure 13 shows crack growth around the transverse connection plate, while Figure 14 shows longitudinal crack growth along the flange-web weld. The cracks were each categorized using the same definitions from Test 1, as vertical cracks, spider cracks, through cracks, or longitudinal cracks. An instantaneous jump in crack length not connected by a solid line indicates where crack-arrest holes were drilled at crack tips. If a crack grew into an existing crack-arrest hole, the crack propagation was depicted by connecting the instantaneous jump with a solid line.

Figure 13: North girder crack growth along transverse connection plate in Test 2.

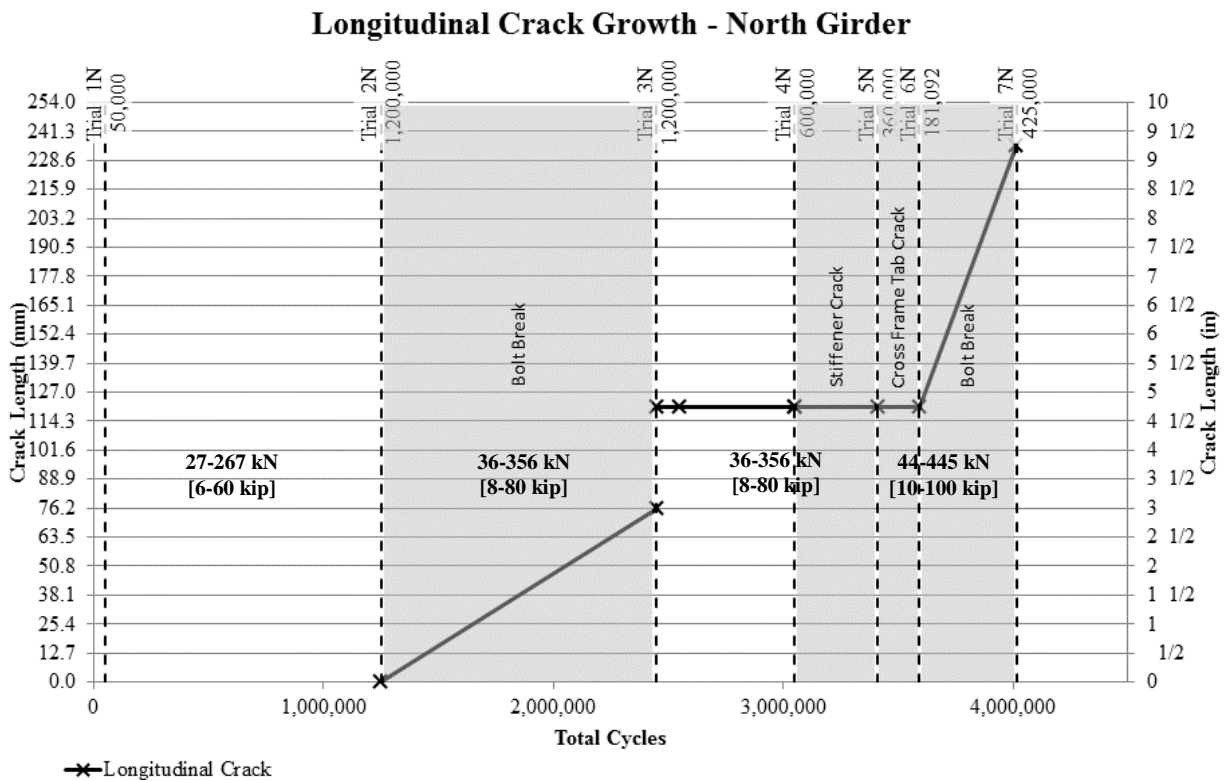
Figure 14: North girder crack growth along flange-web weld in Test 2.

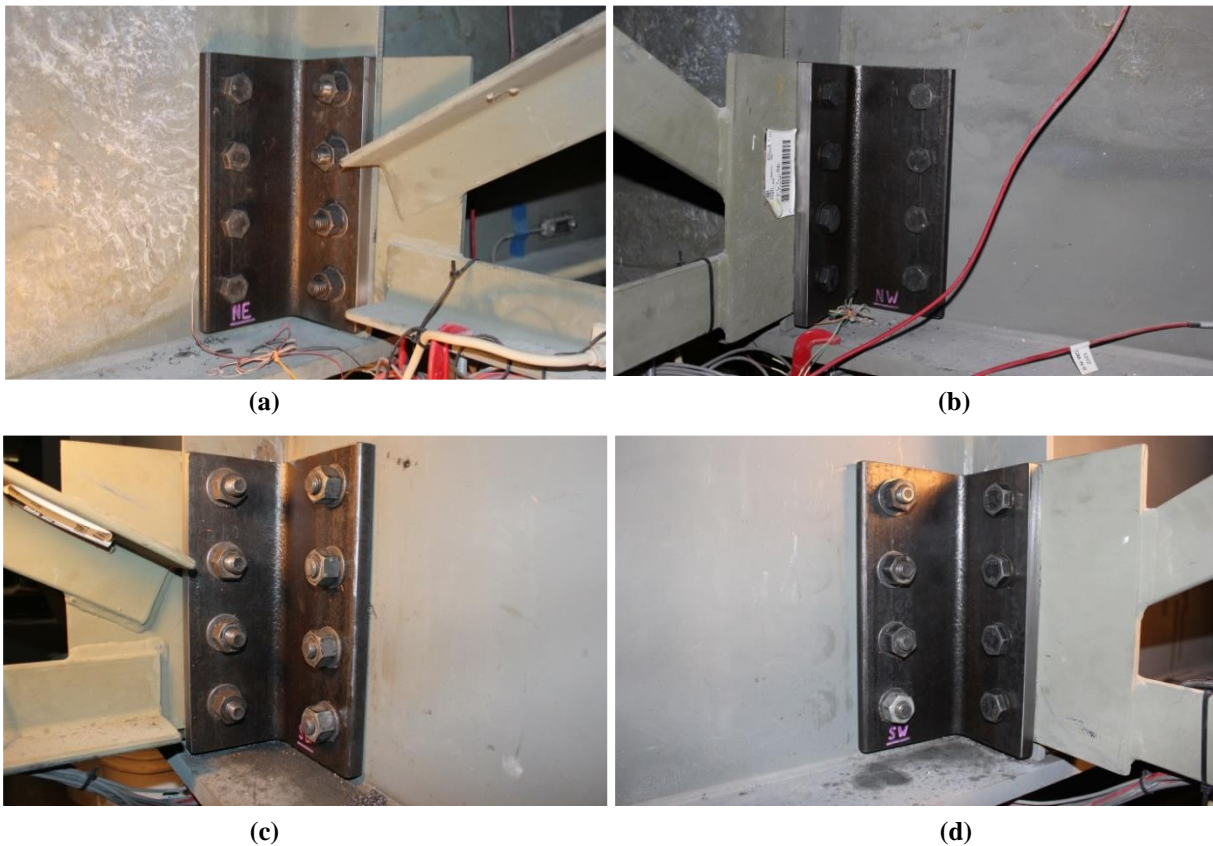
Figure 17: South cross frame connection plate four-angle repair from (a) northeast, (b) northwest, (c) southeast and (d) southwest face of center girder.

The connection plate failure was repaired using four 25 mm [1 in.] thick angles. Two angles were placed back-to-back on both sides of the connection plate and bolted through the center girder web to another pair of back-to-back angles. The four-angle repair is shown in Figure 17.

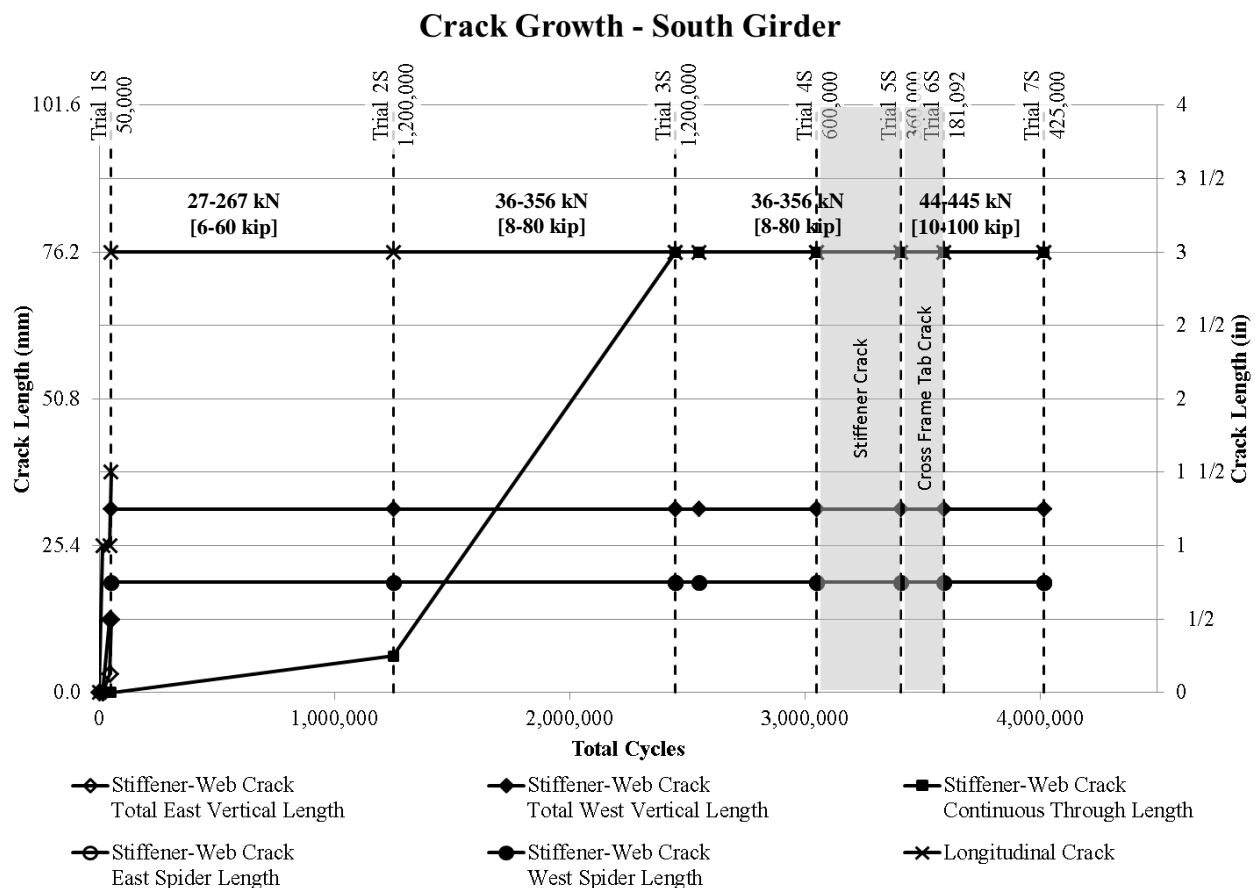
Cracking experienced around the transverse connection plate and along the flange-web weld in the south girder is shown in Figure 19. Crack definitions were the same as those used in the north girder and described in the previous sections. Application of crack-arrest holes is indicated by an instantaneous jump in the graph with no connecting line. Cracks that propagated to an existing crack-arrest hole are indicated by an instantaneous jump connected by a solid line.

Figure 19: South girder crack growth around transverse connection plate and flange-web weld in Test 2.

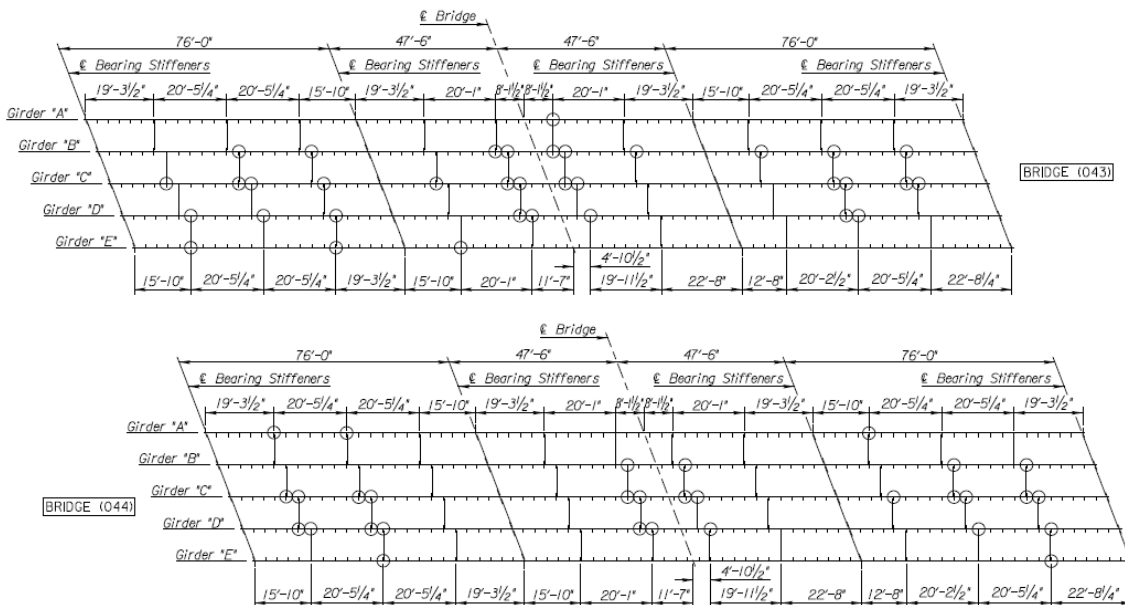
Figure 4: Plan of Kansas Bridge 135-87(043/044); circled areas indicate locations where cracks have been reported.

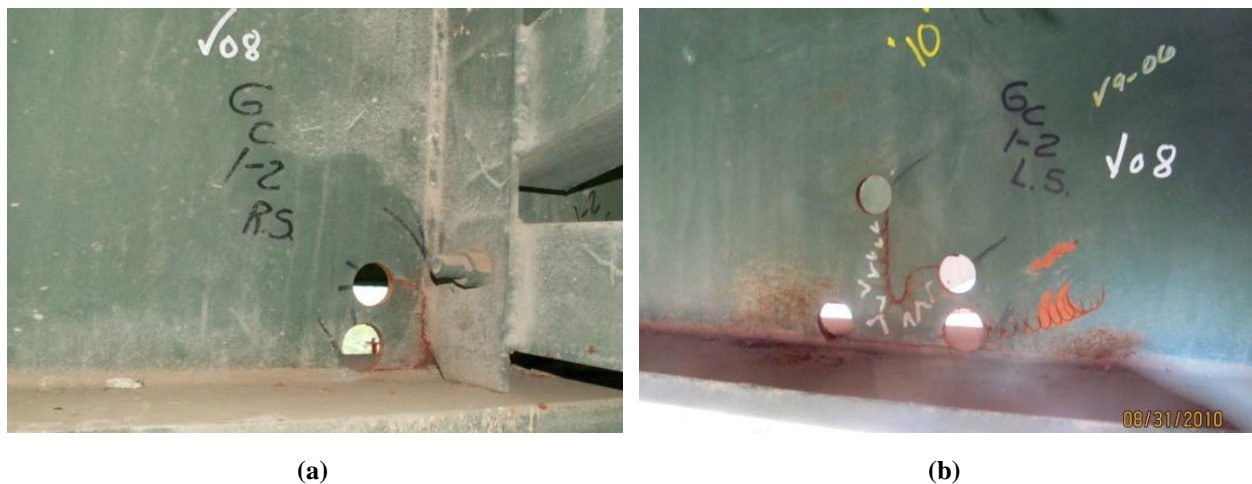
Figure 9: Cracking at the instrumentation location on the (a) stiffener side (b) non-stiffener side.

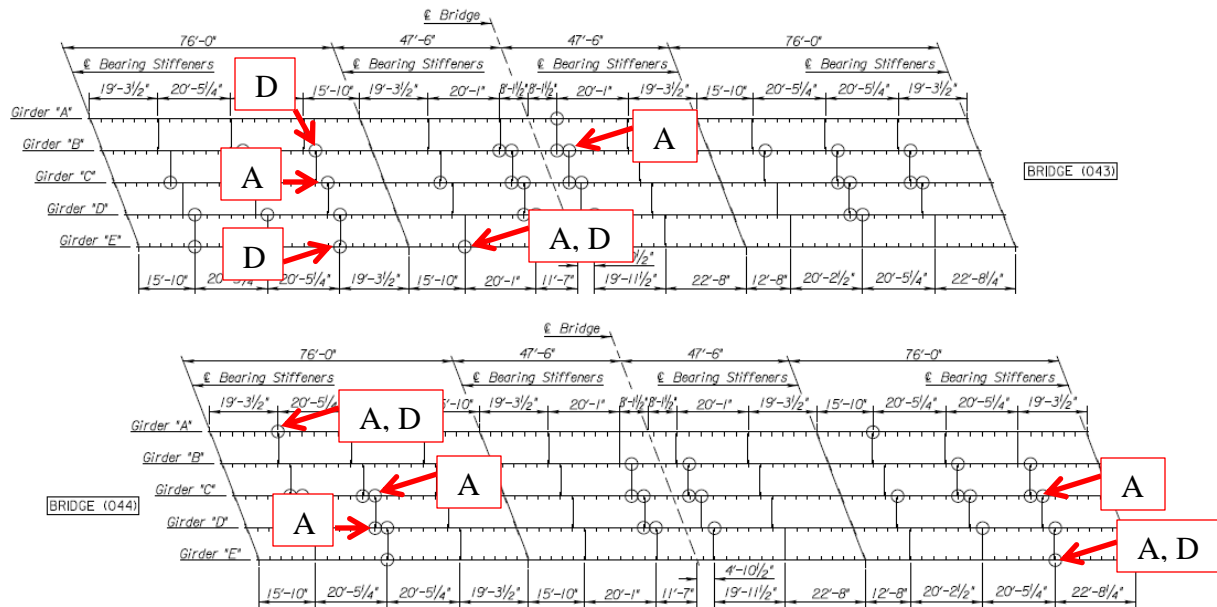
Figure 30: Top web gap crack locations in Kansas Bridge 135-87(043/044) with crack types indicated.
