# **EVALUATION OF CRACKING PERFORMANCE OF BRIDGE DECKS IN MINNESOTA**

**CONSTRUCTION OF CRACK-FREE BRIDGE DECKS  
TRANSPORTATION POOLED-FUND STUDY  
PROJECT NO. TPF-5(174)**

**Structural Engineering and Engineering Materials  
SL Report 13-4**

**THE UNIVERSITY OF KANSAS CENTER FOR RESEARCH, INC.  
LAWRENCE, KS  
OCTOBER 2013**

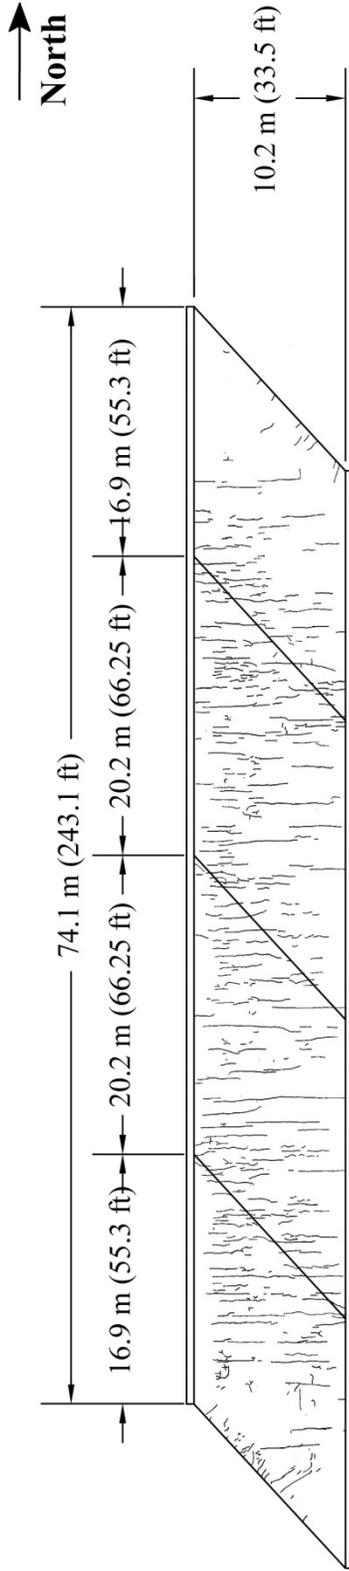
**Figure 1** Crack survey of Bridge 9725 (MN LC #1) at 48.2 months of age

The crack map for MN LC #1 is shown in Figure 1. At an age of 48.2 months, the deck had a crack density of 0.702 m/m<sup>2</sup>. A majority of the cracks have propagated in the transverse direction, parallel to the deck reinforcement and not parallel to the skew of the bridge and piers. Many of the transverse cracks are long, at times extending across much of the deck width. Smaller cracks have developed throughout the deck between the longer cracks. Cracks have developed relatively evenly throughout the deck, with slight reductions in cracking near the abutments. Small, longitudinal cracks have propagated from the south abutment. These longitudinal cracks at the abutment were likely caused by restraint provided by the abutment.

<b>Bridge Number:</b> 9725	<b>Bridge Length:</b> 74.1 m (243.1 ft)	<b>Bridge Age:</b> 48.2 months
<b>Bridge Location:</b> 47 SB over TH 10	<b>Bridge Width:</b> 10.2 m (33.5 ft)	<b>Crack density:</b> 0.702 m/m <sup>2</sup>
<b>Construction Date:</b> 07/11/2009	<b>Skew:</b> -47.4°	<b>Span 1 (South):</b> 0.712 m/m <sup>2</sup>
<b>Crack survey Date:</b> 07/17/2013	<b>Number of Spans:</b> 4	<b>Span 2 (South):</b> 0.814 m/m <sup>2</sup>
	<b>Span 1 (South):</b> 16.9 m (55.3 ft)	<b>Span 3 (North):</b> 0.796 m/m <sup>2</sup>
	<b>Span 2 (South):</b> 20.2 m (66.25 ft)	<b>Span 4 (North):</b> 0.449 m/m <sup>2</sup>
	<b>Span 3 (North):</b> 20.2 m (66.25 ft)	
	<b>Span 4 (North):</b> 16.9 m (55.3 ft)	
	<b>Number of Placements:</b> 1

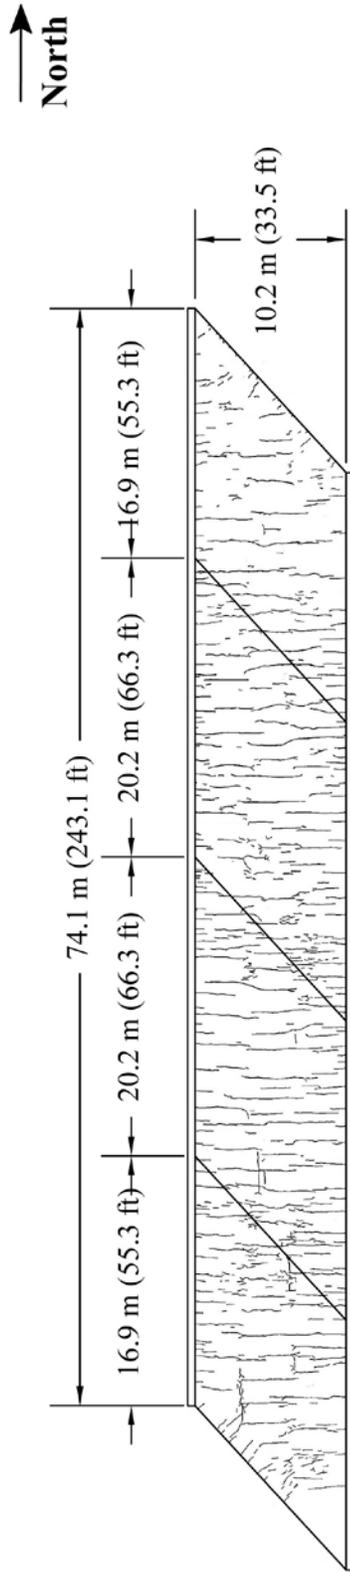
**Figure 2** Crack survey of Bridge 9726 (MN Control #1) at 62.0 months of age

The crack map for MN Control #1, the companion deck for MN LC #1, is shown in Figure 2. At an age of 62.0 months, the deck has a crack density of 0.939 m/m<sup>2</sup>, approximately 30 percent greater than the crack density of MN LC #1 at 48.2 months. This deck has the highest crack density of the six decks surveyed. Significant transverse cracking was found throughout the deck. The transverse cracks extend across the entire deck width along the full length of the bridge. As with MN LC #1, the transverse cracking has developed parallel to the deck reinforcement, not parallel to the skew of the bridge and piers. Small, longitudinal cracks have developed from each abutment, likely due to the restraint provided by the abutments. The

<b>Bridge Number:</b> 9726	<b>Bridge Length:</b> 74.1 m (243.1 ft)	<b>Bridge Age:</b> 62.0 months
<b>Bridge Location:</b> 47 NB over TH 10	<b>Bridge Width:</b> 11.2 m (33.5 ft)	<b>Crack density:</b> 0.939 m/m <sup>2</sup>
<b>Construction Date:</b> 05/16/2008	<b>Skew:</b> -47.4°	<b>Span 1 (South):</b> 0.950 m/m <sup>2</sup>
<b>Crack survey Date:</b> 07/17/2013	<b>Number of Spans:</b> 4	<b>Span 2 (South):</b> 1.057 m/m <sup>2</sup>
	<b>Span 1 (South):</b> 16.9 m (55.3 ft)	<b>Span 3 (North):</b> 0.995 m/m <sup>2</sup>
	<b>Span 2 (South):</b> 20.2 m (66.25 ft)	<b>Span 4 (North):</b> 0.704 m/m <sup>2</sup>
	<b>Span 3 (North):</b> 20.2 m (66.25 ft)	
	<b>Span 4 (North):</b> 16.9 m (55.3 ft)	
	<b>Number of Placements:</b> 1

distribution of cracking on MN Control #1 is similar, but more pronounced than the cracking distribution on MN LC #1.

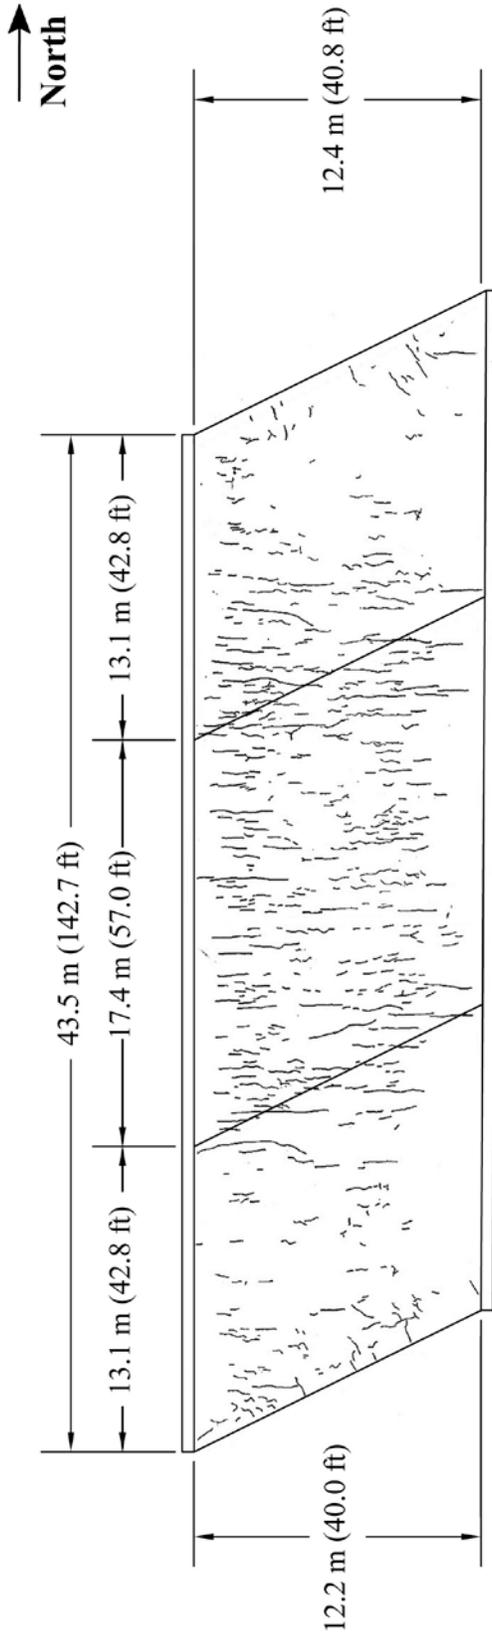
**Figure 3** Crack survey of Bridge 82806 (MN LC #2) at 37.6 months of age

The crack map for MN LC #2 is shown in Figure 3. At an age of 37.6 months, the deck had a crack density of  $0.648 \text{ m/m}^2$ , the lowest of the six decks surveyed. Many small cracks have propagated in the transverse direction throughout the deck. A greater amount of cracking is found in the middle span than in the outer spans. The cracks have generally developed parallel to the deck reinforcement, not parallel to the skew of the bridge or piers. A few small cracks have propagated from each abutment. Smaller cracks, like those found in this deck, are commonly caused by plastic shrinkage. Plastic shrinkage cracking results from the evaporation of water from the surface while the concrete is in the plastic condition. Plastic shrinkage cracking may be increased as the result of slow initiation of wet-curing, over finishing of the surface, or over vibrating during consolidation – the latter two contribute to excess surface paste. The average temperatures of the concrete [ $61^\circ \text{ F}$  ( $16^\circ \text{ C}$ )] and ambient air [ $62^\circ \text{ F}$  ( $17^\circ \text{ C}$ )] recorded during the construction of this deck, however, are not characteristic of a high evaporation rate or plastic shrinkage cracking. In addition, burlap placement was completed quickly during construction, minimizing the potential for plastic shrinkage cracking. These observations suggest that the cracks were likely caused by extra paste worked to the surface as a result of over finishing or by improper vibration techniques, which can lead to increased plastic or settlement cracking, or both.

<b>Bridge Number:</b> 82806	<b>Bridge Length:</b> 43.5 m (142.7 ft)	<b>Bridge Age:</b> 37.6 months
<b>Bridge Location:</b> 694 NB over UP RR in Oakdale	<b>Bridge Width:</b> 12.2 - 12.4 m (40 - 40.8 ft)	<b>Crack density:</b> 0.648 m/m <sup>2</sup>
<b>Construction Date:</b> 05/28/2010	<b>Skew:</b> 26.4°	<b>Span 1 (South):</b> 0.422 m/m <sup>2</sup>
<b>Crack survey Date:</b> 07/15/2013	<b>Number of Spans:</b> 3	<b>Span 2 (South):</b> 0.859 m/m <sup>2</sup>
	<b>Span 1 (South):</b> 13.1 m (42.8 ft)	<b>Span 3 (North):</b> 0.549 m/m <sup>2</sup>
	<b>Span 2 (South):</b> 17.4 m (57 ft)	
	<b>Span 3 (North):</b> 13.1 m (42.8 ft)	
	<b>Number of Placements:</b> 1

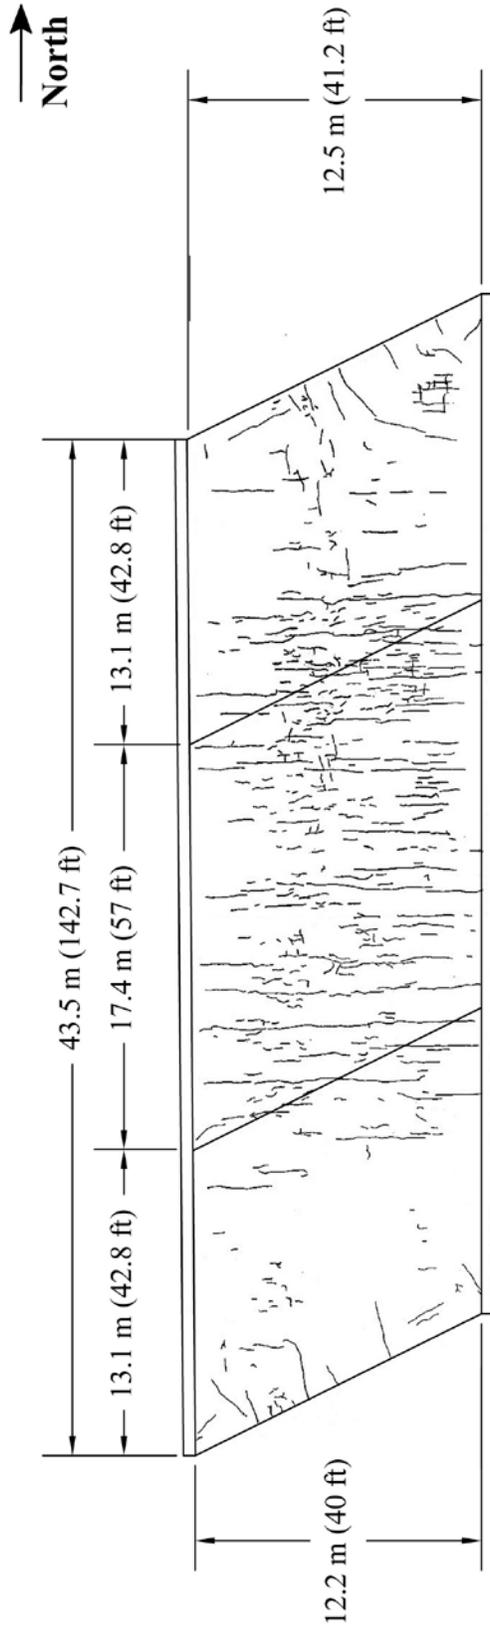
**Figure 4** Crack survey of Bridge 82805 (MN Control #2) at 35.2 months of age

The crack map for MN Control #2, the companion deck for MN LC #2, is shown in Figure 4. At an age of 35.2 months, the deck had a crack density of  $0.744 \text{ m/m}^2$ , approximately 15 percent greater than the crack density of MN LC #2. As with the other decks, a majority of the cracks have developed in the transverse direction, parallel to the deck reinforcement. A number of long transverse cracks are found in the middle span, occasionally extending across the entire deck width. Transverse cracking is somewhat higher above the north pier (again, not parallel to the pier). Less cracking is found near the south abutment. Similar to other decks, short longitudinal cracks extend from each abutment.

<b>Bridge Number:</b> 82805	<b>Bridge Length:</b> 43.5 m (142.7 ft)	<b>Bridge Age:</b> 35.2 months
<b>Bridge Location:</b> 694 SB over UP RR in Oakdale	<b>Bridge Width:</b> 12.2 - 12.5 m (40 - 41.2 ft)	<b>Crack density:</b> 0.744 m/m <sup>2</sup>
<b>Construction Date:</b> 08/10/2010	<b>Skew:</b> 26.4°	<b>Span 1 (South):</b> 0.366 m/m <sup>2</sup>
<b>Crack survey Date:</b> 07/15/2013	<b>Number of Spans:</b> 3	<b>Span 2 (South):</b> 1.04 m/m <sup>2</sup>
	<b>Span 1 (South):</b> 13.1 m (42.8 ft)	<b>Span 3 (North):</b> 0.688 m/m <sup>2</sup>
	<b>Span 2 (South):</b> 17.4 m (57 ft)	
	<b>Span 3 (North):</b> 13.1 m (42.8 ft)	
	<b>Number of Placements:</b> 1

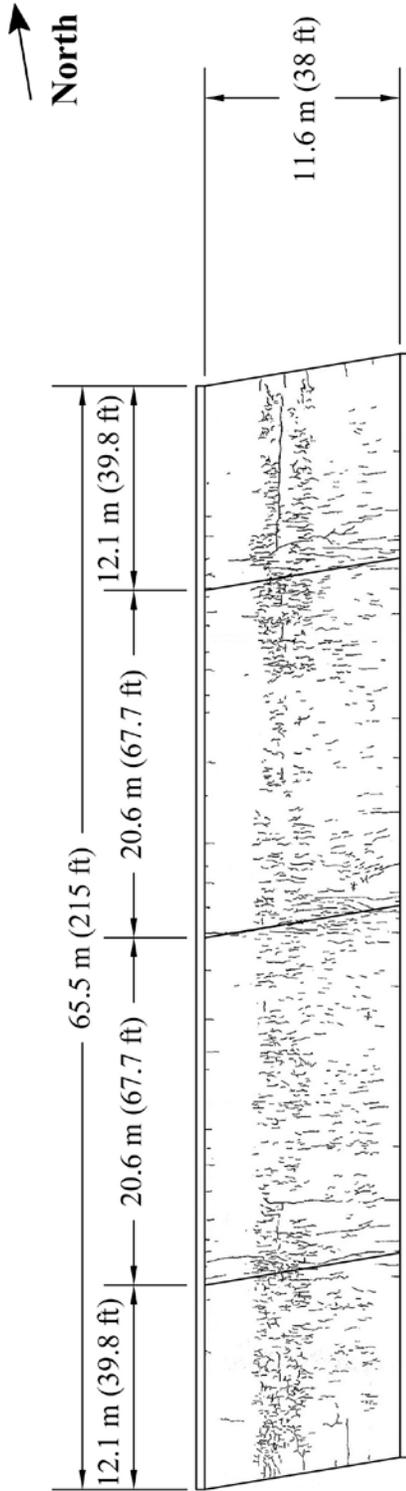
**Figure 5** Crack survey of Bridge 82807 (MN Control #3) at 35.3 months of age

The crack map for MN Control #3 is shown in Figure 5. At an age of 35.3 months, the deck had a crack density of  $0.841 \text{ m/m}^2$ . The cracks on this deck are significantly smaller than on the other decks. The small cracks are observed throughout the deck, increasing in density near the piers. The greatest cracking occurs along the outer edge of the driving lane. Little cracking is found outside of the lane line, in the shoulder area (west side of deck). The small cracks are typical to those caused by plastic shrinkage cracking. The construction data indicates that the average concrete temperature was  $78^\circ \text{ F}$  ( $26^\circ \text{ C}$ ), above the limit of  $70^\circ \text{ F}$  ( $21^\circ \text{ C}$ ) allowed in the LC-HPC specifications. The construction records also show that burlap placement was slow (average of 30 minutes between strike off and burlap placement). Increasing concrete temperatures and decreasing rates of burlap placement both can increase evaporation and the potential for plastic shrinkage cracking. As with MN LC #2, over vibration may have also contributed to plastic shrinkage cracking. A few long, transverse cracks have formed above and parallel to the south pier, in the negative moment region of the deck, a region in which the upper surface of the deck is in tension, increasing the potential for cracking. Although flexural stresses are significantly lower than shrinkage and thermal stresses induced in bridge decks, the combination of the different mechanisms increases the potential for cracking. A single, longitudinal crack, extending approximately 30 ft (9.1 m), has formed along the outer lane line in the north span. A few longitudinal cracks propagate from the abutments.

<b>Bridge Number:</b> 82807	<b>Bridge Length:</b> 65.5 m (215 ft)	<b>Bridge Age:</b> 35.3 months
<b>Bridge Location:</b> 694 SB over TH 5 in Oakdale	<b>Bridge Width:</b> 11.6 m (38 ft)	<b>Crack density:</b> 0.841 m/m <sup>2</sup>
<b>Construction Date:</b> 08/06/2010	<b>Skew:</b> 9.4°	<b>Span 1 (South):</b> 0.882 m/m <sup>2</sup>
<b>Crack survey Date:</b> 07/15/2013	<b>Number of Spans:</b> 4	<b>Span 2 (South):</b> 0.850 m/m <sup>2</sup>
	<b>Span 1 (South):</b> 12.1 m (39.8 ft)	<b>Span 3 (North):</b> 0.801 m/m <sup>2</sup>
	<b>Span 2 (South):</b> 20.6 m (67.7 ft)	<b>Span 4 (North):</b> 0.848 m/m <sup>2</sup>
	<b>Span 3 (North):</b> 20.6 m (67.7 ft)	
	<b>Span 4 (North):</b> 12.1 m (39.8 ft)	
	<b>Number of Placements:</b> 1

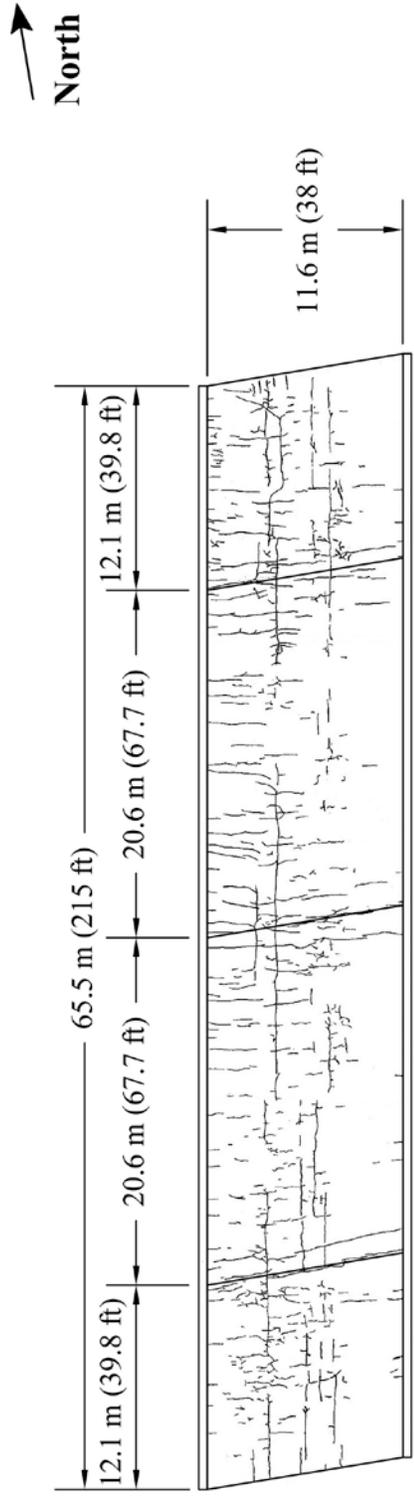
**Figure 6** Crack survey of Bridge 82808 (MN Control #4) at 37.8 months of age

The crack map for MN Control #4 is shown in Figure 6. At an age of 37.8 months, the deck had a crack density of  $0.735 \text{ m/m}^2$ . A greater number of longitudinal cracks have formed on this deck than on the other decks. A number of longitudinal cracks, located approximately 15 ft (4.6 m) from the west edge of the deck, extend along most of the bridge length. Another group of longitudinal cracks have formed approximately 15 ft (4.6 m) from the east edge of the deck, extending along portions of the bridge length. Many transverse cracks have propagated from the west edge of the deck. As with MN Control #3, minimal cracking is noted in the shoulder area of the deck. A number of long, transverse cracks extend across most of the deck width, directly above and parallel to the piers in the negative moment region.

<b>Bridge Number:</b> 82808	<b>Bridge Length:</b> 65.5 m (215 ft)	<b>Bridge Age:</b> 37.8 months
<b>Bridge Location:</b> 694 NB over TH 5 in Oakdale	<b>Bridge Width:</b> 11.6 m (38 ft)	<b>Crack density:</b> 0.735 m/m <sup>2</sup>
<b>Construction Date:</b> 05/22/2010	<b>Skew:</b> 9.4°	<b>Span 1 (South):</b> 0.729 m/m <sup>2</sup>
<b>Crack survey Date:</b> 07/15/2013	<b>Number of Spans:</b> 4	<b>Span 2 (South):</b> 0.705 m/m <sup>2</sup>
	<b>Span 1 (South):</b> 12.1 m (39.8 ft)	<b>Span 3 (North):</b> 0.674 m/m <sup>2</sup>
	<b>Span 2 (South):</b> 20.6 m (67.7 ft)	<b>Span 4 (North):</b> 0.879 m/m <sup>2</sup>
	<b>Span 3 (North):</b> 20.6 m (67.7 ft)	
	<b>Span 4 (North):</b> 12.1 m (39.8 ft)	
	<b>Number of Placements:</b> 1

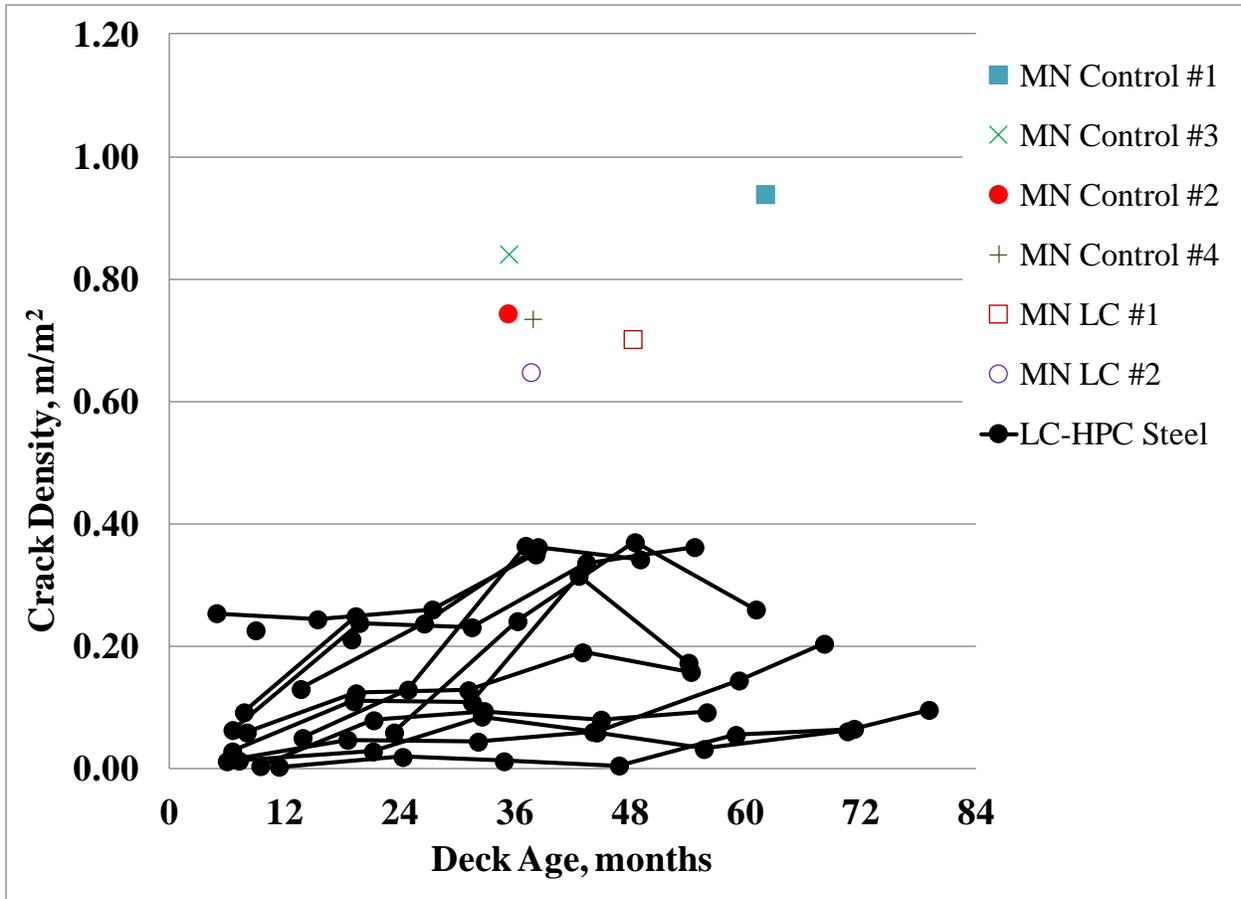
**Figure 7** Crack density versus deck age for the standard Minnesota decks (MN Control), low-cracking Minnesota decks (MN LC), and low-cracking high-performance concrete decks constructed in Kansas on steel girders (LC-HPC Steel)

The comparison of the Minnesota decks with the Kansas LC-HPC decks in Figure 7 shows that all six Minnesota decks have significantly more cracking than the Kansas LC-HPC decks at similar ages. No Kansas LC-HPC deck has a crack density greater than 0.400 m/m<sup>2</sup>, while all six Minnesota decks have crack densities above 0.600 m/m<sup>2</sup>.

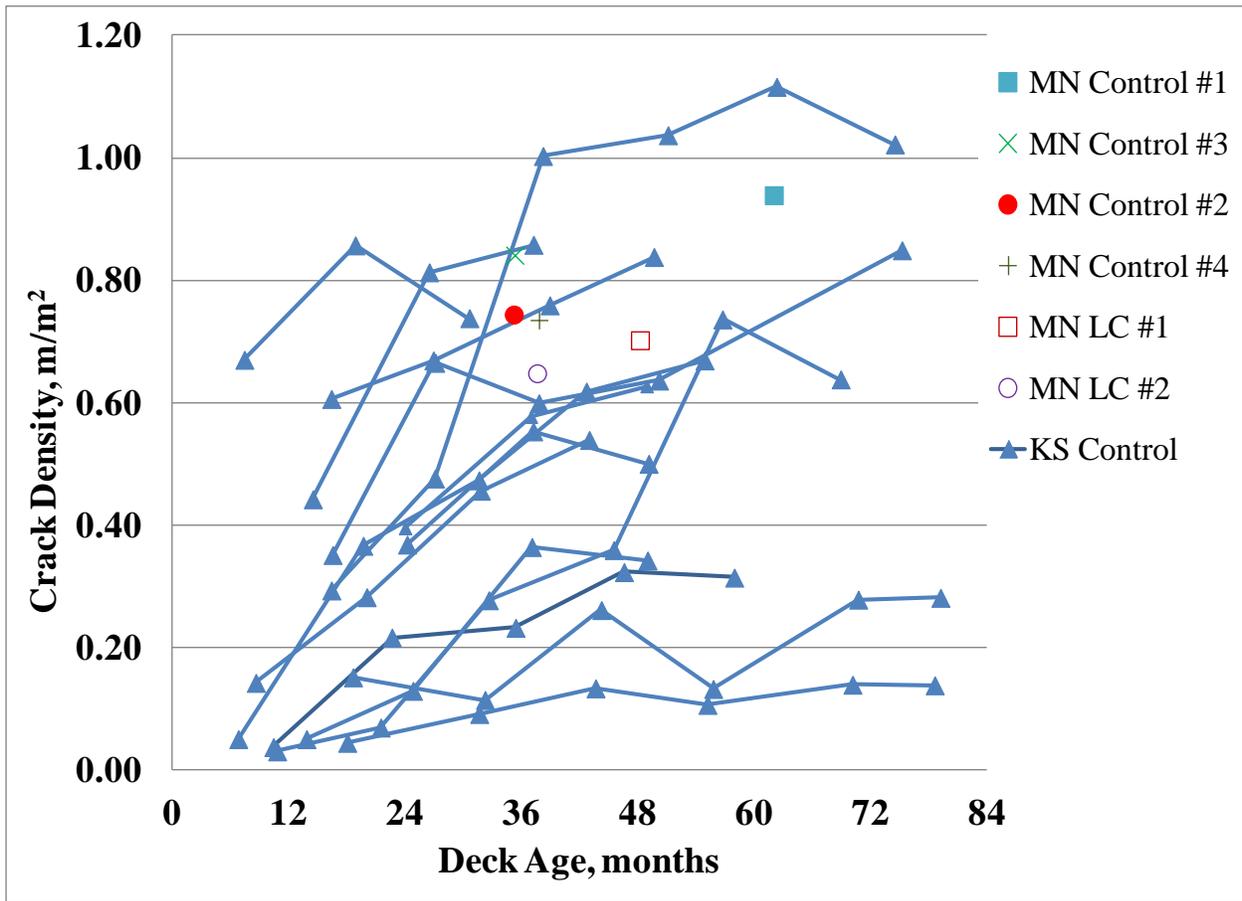
**Figure 8** Crack density versus deck age for the standard Minnesota decks (MN Control), low-cracking Minnesota decks (MN LC), and decks constructed in Kansas on steel girders in accordance with the standard Kansas Department of Transportation (KDOT) specifications (KS Control)

Figure 8 compares the cracking performance of the Minnesota decks with the decks constructed in Kansas in accordance with the standard KDOT specifications (KS Control). The figure shows that the Minnesota decks yielded higher crack densities than a majority of the KS Control decks. Four of the fourteen KS Control decks have equal or greater cracking than the Minnesota decks at similar ages. Previous studies at the University of Kansas observed greater cracking in decks with silica fume overlays, such as the KS Control decks and three of the Minnesota standard decks (MN Control #1, #3, and #4) (Lindquist et al. 2005). Additional surveys of the Minnesota decks would provide a better understanding of the progression of cracking performance over time.
