Repair of Distortion-Induced Fatigue Damage in Bridge No. 135-87 (043SB and 044NB) Using Newly-Developed Strengthening Schemes

Structural Engineering and Engineering Materials
SM Report No. 112

September 2015

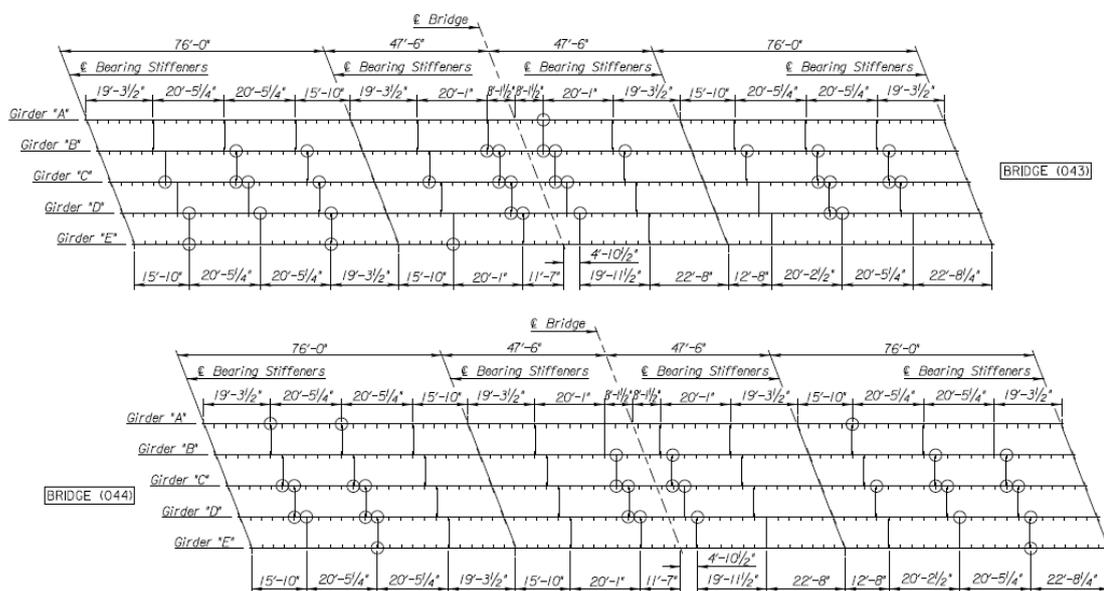
Figure 4: Plan of Kansas Bridge 135-87(043/044); circled areas indicate locations where cracks have been reported.

Crack types A, B, C, and D (Figure 5) have all been reported on Kansas Bridge 135-87(043/044). Type A cracks occur horizontally at the connection plate-to-web weld. Type B cracks occur vertically along the connection plate-to-web weld. Type C cracks propagate away from the connection plate-to-web weld into the base metal of the girder web, and Type D cracks occur along the flange-to-web weld. Drilled crack-arrest holes were implemented in past repairs, but no additional retrofits have previously been applied to the bridge.

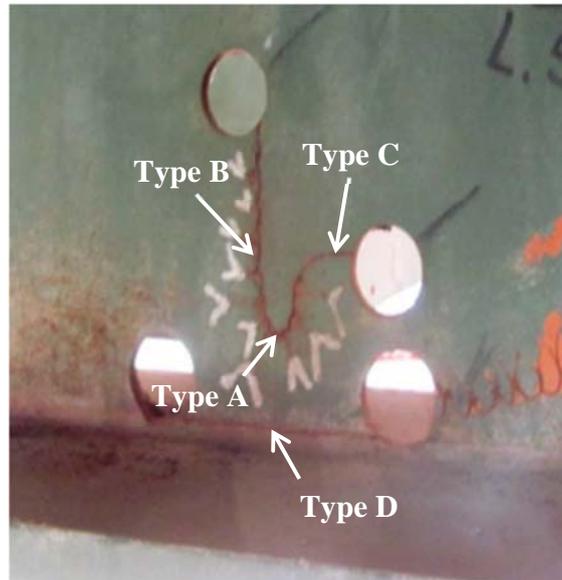
Figure 5: Types of cracks occurring in Kansas Bridge 135-87(043/044).

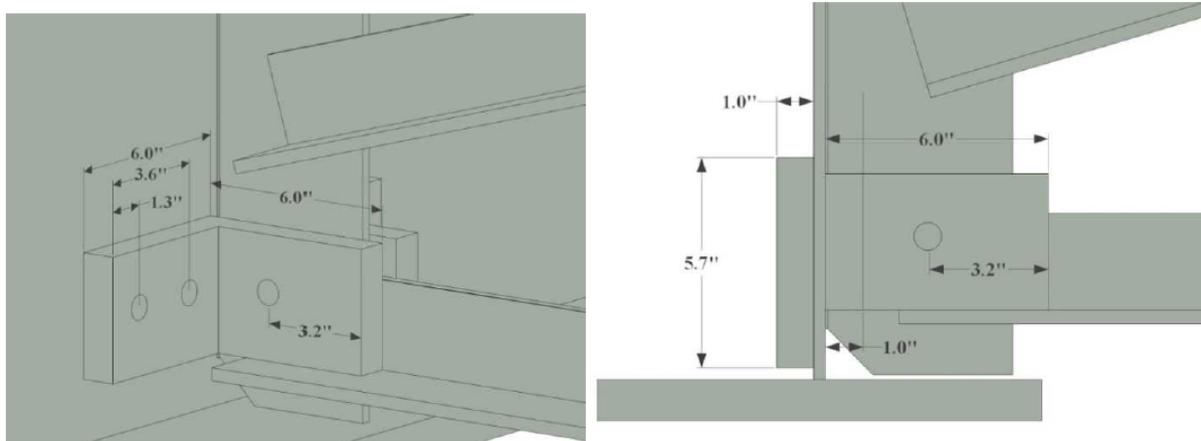
Figure 7: Angles-with-plate retrofit recommended to KDOT for repair of Kansas Bridge 135-87(043/044) (Richardson 2012).

Richardson (2012) concluded that the angles-with-plate retrofit was effective in reducing stresses in the web gap regions and would be the most cost effective and convenient repair technique. Since this retrofit technique does not require attachment to the girder flange, field implementation would be simplified in both web gap regions. In the top web gap, bridge deck removal would not be required. In both web gap regions, cross frame removal would be unnecessary, because the angles-with-plate retrofit could be bolted through the horizontal cross frame members while avoiding their outstanding legs. These benefits would reduce labor costs and allow for maintaining daily traffic. Therefore, it was recommended to KDOT that they use the angles-with-plate retrofit on Kansas Bridge 135-87(043/044) to repair distortion-induced fatigue cracking in the susceptible web gap regions. Based on the parametric results of the angles-

with-plate retrofit, recommended dimensions for the angles and backing plate were L152x152x25 mm (L6x6x1 in.) and L457x145x25 mm (PL18x5-11/16x1 in.), as shown in Figure 7.

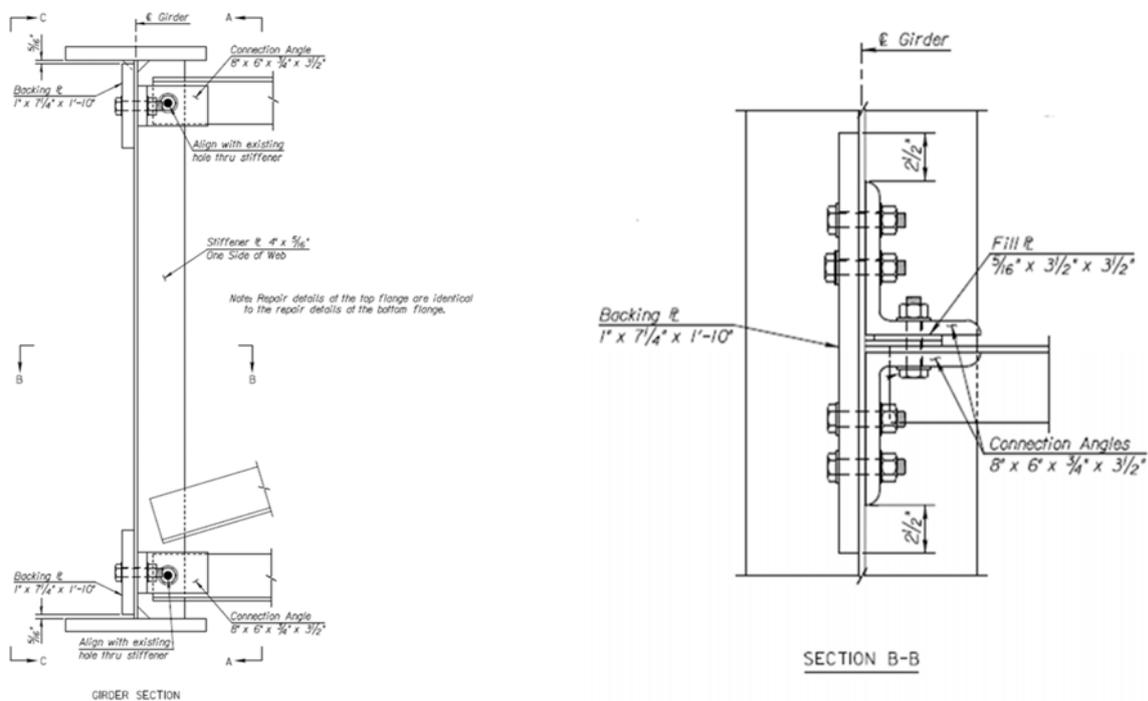
Figure 8: Details of retrofit applied to the bridges.

Field testing was performed on the northbound bridge, Bridge 044. This bridge was selected for testing because KDOT installed the angles-with-plate retrofit in both its top and bottom web gaps, as opposed to only in the bottom web gap for the southbound bridge (Bridge 043). KDOT chose to do this so that the cracking behavior in the southbound bridge could be compared with that in the northbound bridge in the future to examine the repair's effectiveness. Figure 8 shows details of the retrofit that was installed. Member sizes and bolt-hole spacings were slightly different from those recommended by the University of Kansas due to member availability, edge distance requirements, and installation clearances.

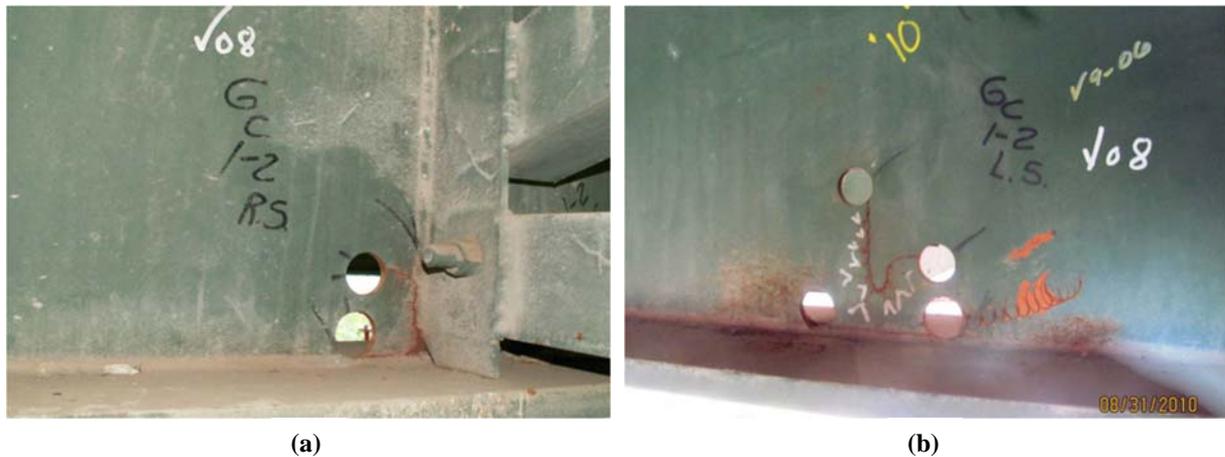
The selected location for testing on the bridge was chosen based on the types of fatigue cracks reported in the web gaps and ease of access for placing instrumentation. The selected location for instrumentation was Girder C of the northbound bridge at cross frame 1-2, which was the second cross frame from the south end of the bridge. This location had Types A, B, C, and D cracks. Types B, C, and D cracks were located in the bottom web gap region and crack-arrest holes had been previously drilled. The top web gap had one 19 mm (3/4 in.) Type A crack that had not

been previously repaired. Figure 9 shows a photograph of the bottom web gap at the location where the majority of the instrumentation was placed.

Figure 9: Cracking at the instrumentation location on the (a) stiffener side (b) non-stiffener side.

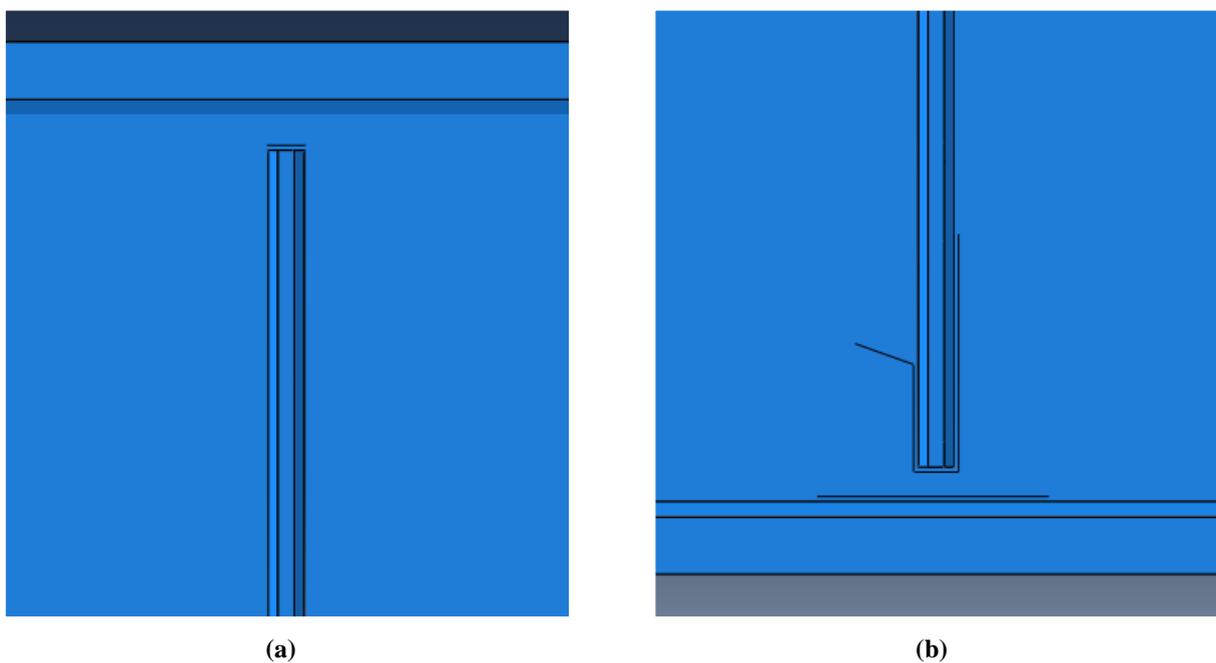
dimensional extruded shell elements and given depths equal to the girder web thickness. The lengths of the cracks were modeled as closely as possible to those observed in the field at the testing location, as shown in Figure 14. The crack pattern in the bottom web gap included a 116 mm (4-9/16 in.) Type D crack, a 117 mm (4-5/8 in.) Type B crack on the north side of the connection plate, and a 51 mm (2 in.) Type B crack that spidered out into a 33 mm (1-5/16 in.) Type C crack on the south side of the connection plate. The crack pattern in the top web gap included a 19 mm (3/4 in.) Type A crack.

Figure 14: Crack patterns modeled at (a) top web gap (b) bottom web gap.
