KU-16-1
**Determination of Fatigue Resistance of Coupler
Connections in Aluminum Overhead Truss Structures**

A Report on Research Sponsored by
The Kansas Department of Transportation

Structural Engineering and Engineering Materials
SM Report No. 137
August 2020

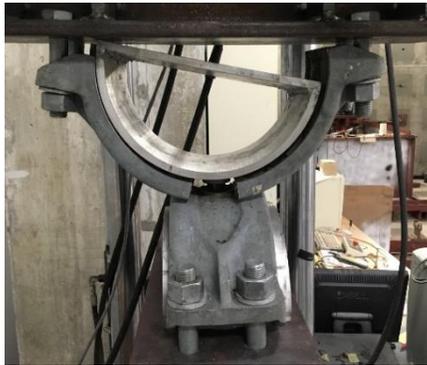
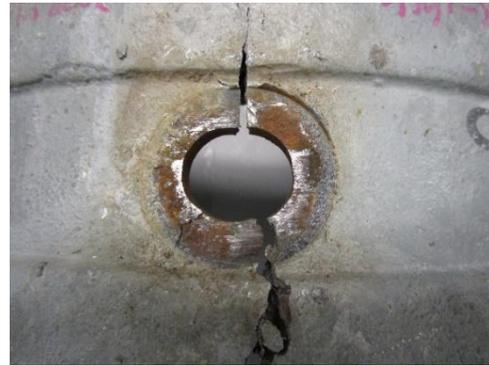
Figure 22. Failure of FAT-TENS(USED)1 Tested at 26.6 ksi

4.2.1.1 *FAT-TENS(USED)1*: This specimen was one of the couplers from an OHTSS taken out of service, and thus had accumulated prior fatigue damage over a life of service. It was one of the first specimens tested as part of this research program and was loaded at a high stress range. The specimen failed at approximately 3,000 cycles. The failure occurred by a rapid fracture of the

10-in. coupler, in a brittle manner. There were no warning signs before the fracture. The photographs of the coupler after failure are presented in Figure 22.

(a) Failure of FAT-TENS(USED)1

(b) Cracked 10-in. Coupler

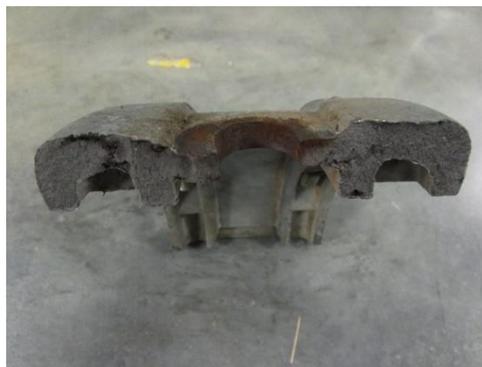
Figure 23. Failure Surface of FAT-TENS(USED)1

Some corrosion products were observed on the failure surface, as shown in Figure 22. This raised some concern whether there may have been pre-existing cracks before testing. The surface was examined under a microscope. The results were not conclusive. Section 8 of the report discusses more details regarding this topic.

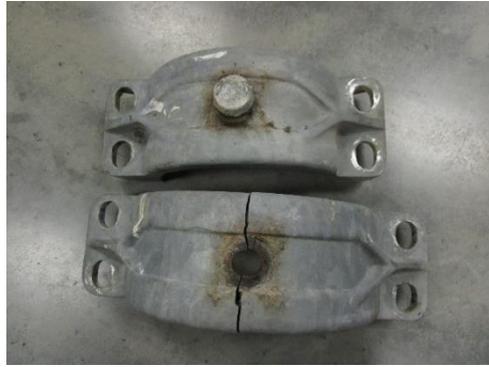
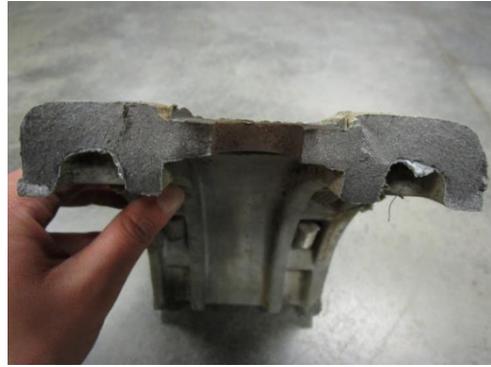
Figure 24. Failure of FAT-TENS(USED)2 Tested at 26.6 ksi

4.2.1.2 FAT-TENS(USED)2: This specimen was also one from a structure taken out of service, and thus also had previously accumulated a lifetime of fatigue cycles. The specimen was tested at a high stress range of 26.6 ksi, and failed at 10,581 cycles. The failure mode was cracking of the 10-in. coupler. Photographs showing the specimen after failure are presented in Figure 24.

(a) Failure of FAT-TENS(USED)2

(b) Failure Surface of FAT-TENS(USED)2

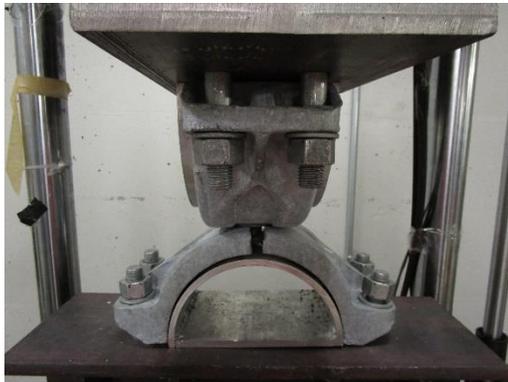
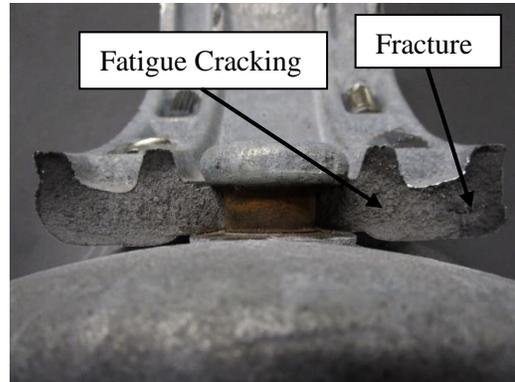
Figure 25. Failure of FAT-TENS1 Tested at 26.6 ksi

4.2.1.3 *FAT-TENS1*: *FAT-TENS1* was a new “off-the-shelf” coupler, tested at a high stress range of 26.6 ksi. Failure occurred in a brittle manner at 6,708 cycles. The 8-in. coupler broke into half at the position of the rivet hole in a brittle fashion, without no noticeable signs of distress before failure. After the test was concluded, the failure surface was inspected and two regions were identified: a smoother and brighter region, and a coarser and darker region. The smoother region was created during fatigue crack propagation, and the coarser region was the result of fracture. The failure surface indicated that cracks initiated at the rivet hole and propagated perpendicular to the tensile bending stress in the coupler. These two regions can be clearly seen in most of the specimens for which failures were characterized by cracking of the coupler.

(a) Failure of FAT-TENS1

(b) Failure Surface of FAT-TENS1

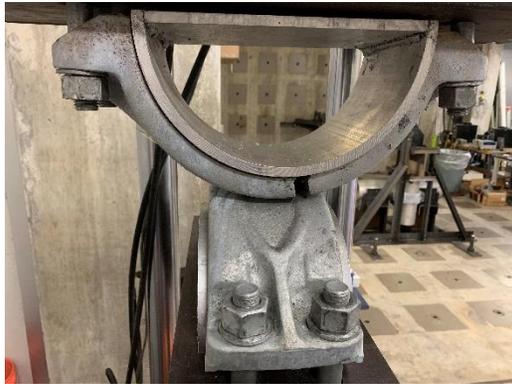
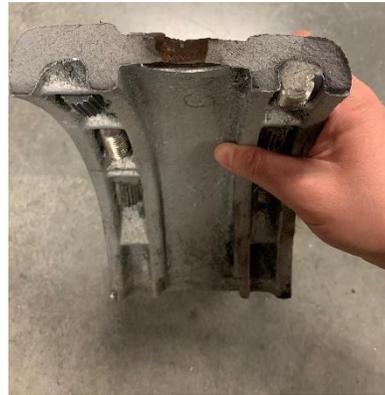
Figure 26. Failure of *FAT-TENS13* Test at 15.1 ksi

4.2.2.1 *FAT-TENS13*: *FAT-TENS13* was a new “off-the-shelf” coupler, tested at 15.1 ksi. The specimen failed at 78,818 cycles, characterized by brittle cracking of the 10-in. coupler. Inspections were regularly performed during testing, but no cracks were observed before failure. Photographs of the specimen after failure are presented in Figure 26.

(a) Failure of *FAT-TENS13*

(b) Failure Surface of *FAT-TENS13*

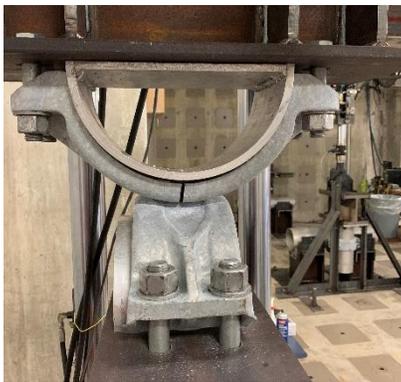
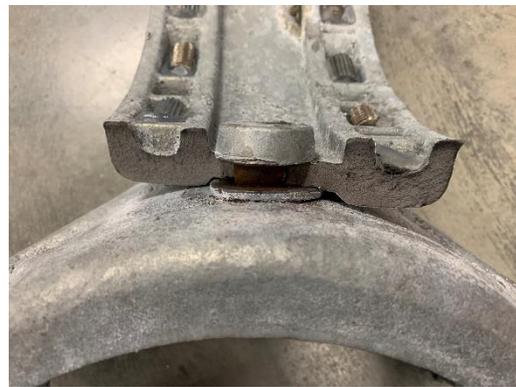
Figure 28. Failure of *FAT-TENS11* Tested at 10.5 ksi

4.2.3.1 *FAT-TENS11*: *FAT-TENS11* was a new “off-the-shelf” coupler tested at 10.5 ksi. During an inspection at 195,754 cycles, it was observed that the stiffness of the assembly decreased, but no crack was observed. Over the next 3,000 cycles, stiffness continued decreasing but there was still no visible damage. At 228,327 cycles, a crack was identified as having propagated in the 10-in. coupler wall, extending through approximately 2/3 of it. After another 55 cycles, the 10-in. coupler broke in half. The final failure occurred at 228,382 cycles. Photographs of the specimen after failure are shown in Figure 28.

(a) Failure of *FAT-TENS11*

(B) Failure Surface of *FAT-TENS11*

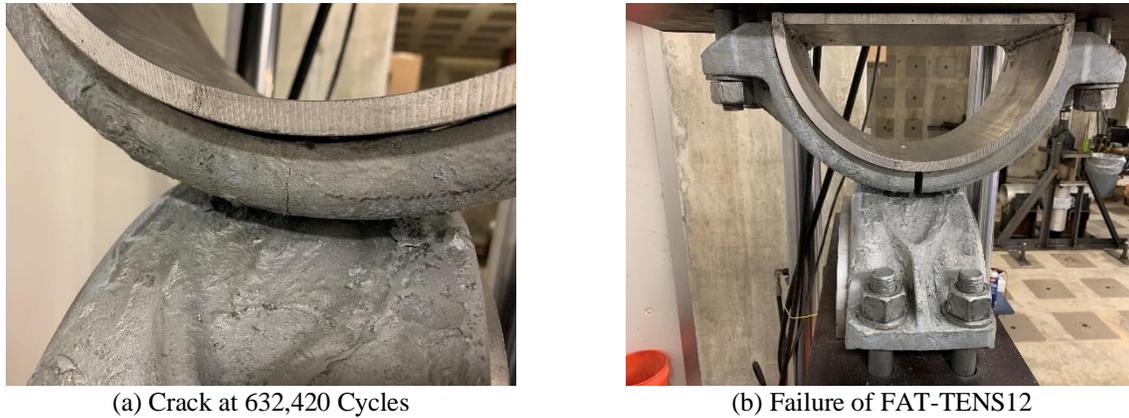
Figure 30. Failure of *FAT-TENS12* Tested at 10.5 ksi

4.2.3.2 *FAT-TENS12*: *FAT-TENS12* was a new “off-the-shelf” coupler, tested at 10.5 ksi. During an inspection performed at 632,420 cycles, a thin crack was found on one side of the 10-in. coupler. The crack had not yet propagated through the thickness of the coupler. After another 323 cycles, the 10-in. coupler broke in half. The final failure occurred at 632,743 cycles. Photographs of the specimen are presented in Figure 30.

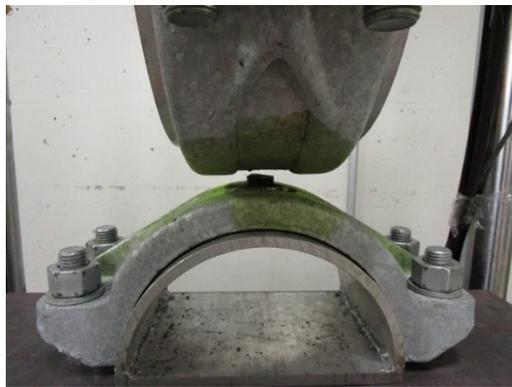
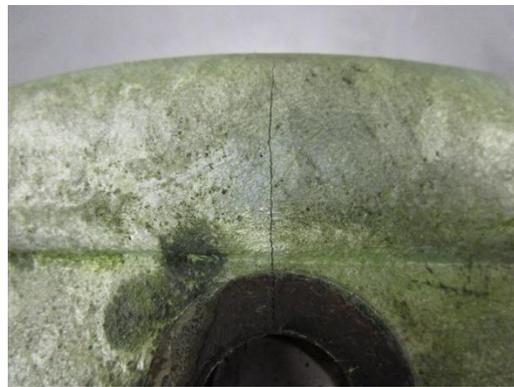
Figure 32. Failure of *FAT-TENS2* Tested at 8.3 ksi

4.2.4.1 *FAT-TENS2*: *FAT-TENS2* was a new “off-the-shelf” coupler, tested at 8.3 ksi. The specimen failed by rivet cracking at 952,738 cycles. No visible signs of damage were observed before failure. As shown in Figure 32(a), cracking occurred at the intersection of the rivet head and shank, at the side connecting to the 10-in. coupler. After uninstalling and inspecting the specimen, a crack was also observed on the 10-in. coupler as shown in Figure 32(b). The failure of this specimen was classified as a combined mode, since both of the coupler and the rivet were damaged.

(a) Rivet Cracking

(b) Crack on the 10-in. Coupler

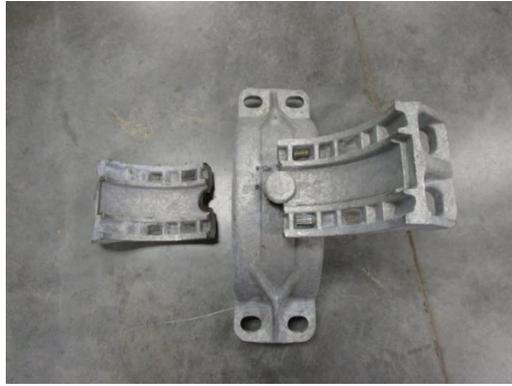
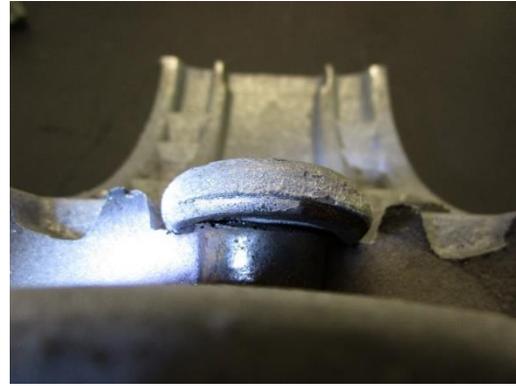
Figure 33. Failure of FAT-TENS3 Tested at 8.3 ksi

4.2.3.2 *FAT-TENS3*: *FAT-TENS3* was a new “off-the-shelf” specimen, tested at 8.3 ksi. The final failure of the specimen occurred at 1,263,601 cycles, and was classified as a combined mode. At 1,263,000 cycles, the 8-in. coupler wall cracked on one side. Fatigue loading was continued, and the other side of the 8-in. coupler wall cracked after another 600 cycles. Upon specimen removal and inspection, a crack was observed on the rivet at the intersection of the rivet head and shank, on the side that was connected to the 8-in. coupler. The crack had propagated more than halfway through the rivet. Photographs of the specimen after failure are presented in Figure 33.

(a) Coupler Cracking

(b) Rivet Cracking

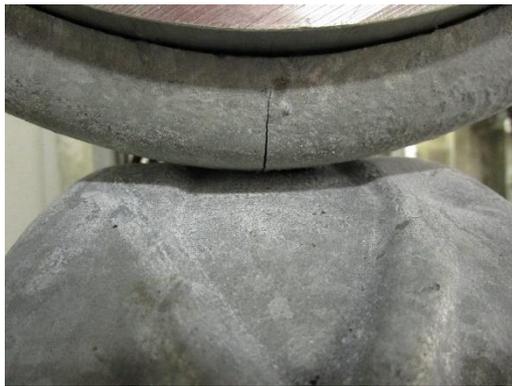
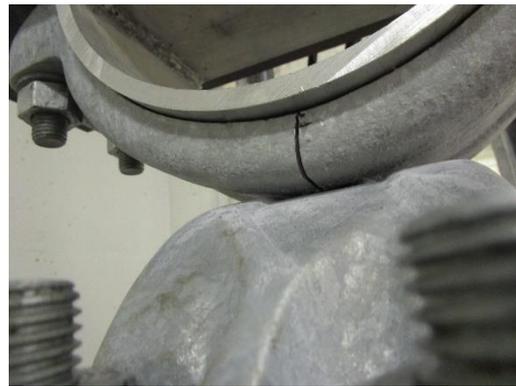
Figure 37. Cracking of FAT-TENS4 Tested at 5.8 ksi

(a) Crack at 7,214,300 Cycles

(b) Crack at 9,327,091 Cycles

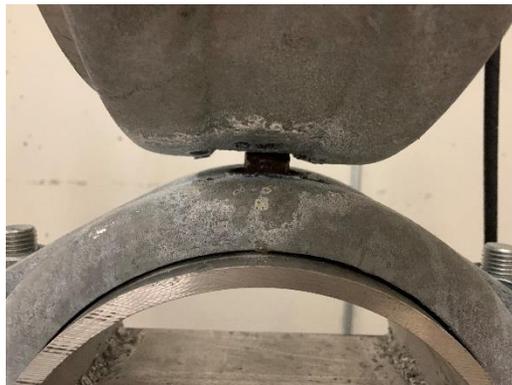
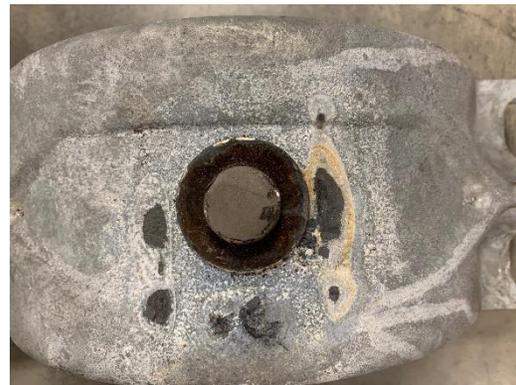
(a) Failure of *FAT-TENS7*

(b) Failure Surface of *FAT-TENS7*

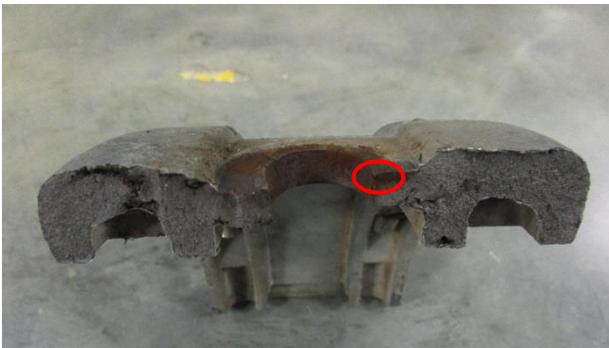
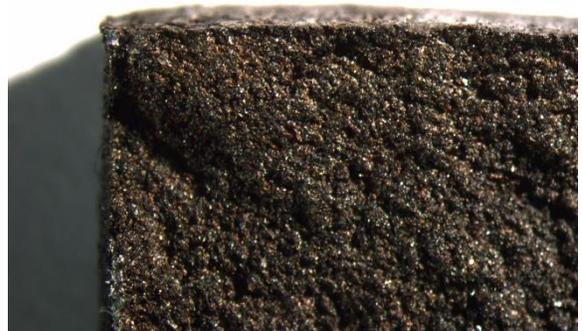
(a) Fracture Surface of FAT-TENS(USED)1

(b) Microscopic Photograph of FAT-TENS(USED)1

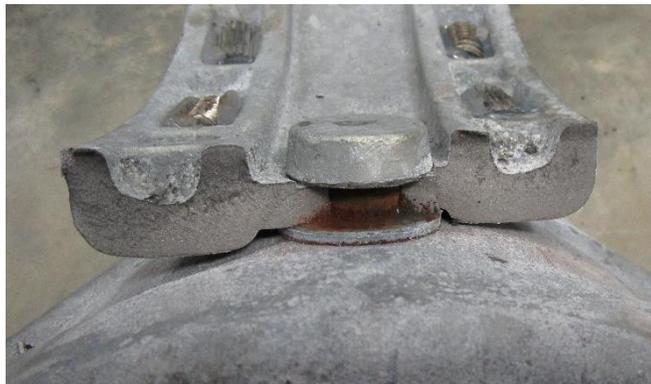
Figure 47. Corrosion Products on Failure Surface of FAT-TENS4
