# Lessons Learned from an Emergency Bridge Replacement Project

Yong Bai, P.E., M.ASCE<sup>1</sup>; William R. Burkett, P.E.<sup>2</sup>; and Phillip T. Nash, P.E.<sup>3</sup>

**DOI:** 10.1061/(ASCE)0733-9364(2006)132:4(338)

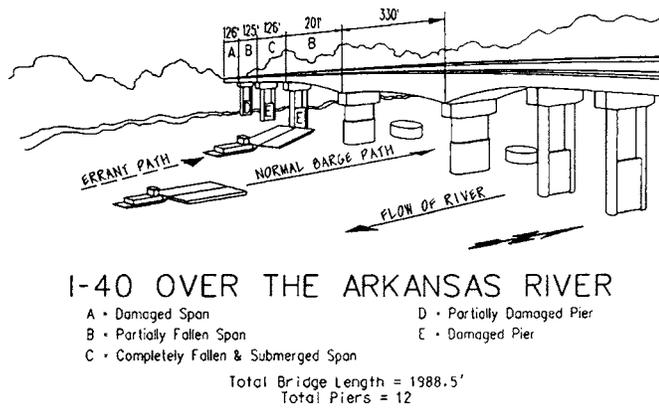
**Fig. 1.** I-40 bridge incident sketch

On the Memorial Day weekend of May 26, 2002, the towboat Robert Y. Love, pushing two empty barges owned by the Magnolia Marine Transport Company of Vicksburg, Mississippi, was moving upstream on the Arkansas River when it hit the I-40 Webbers Falls Bridge around 7:47 am. The incident caused a portion of the bridge, which is part of McClellan-Kerr Arkansas River Navigation System (waterway), to fall into the river. Drivers of 11 vehicles were unaware of the bridge collapse and plunged 19 m (62 ft) into the river. A total of 14 people died in the incident. The Oklahoma Department of Transportation (ODOT) closed I-40 near the bridge and the Navigation System. Interstate 40, one of the nation's three major east-west interstate highways, carries about 20,000 vehicles each day, transporting people, goods, and materials coast to coast (Stidger 2002).

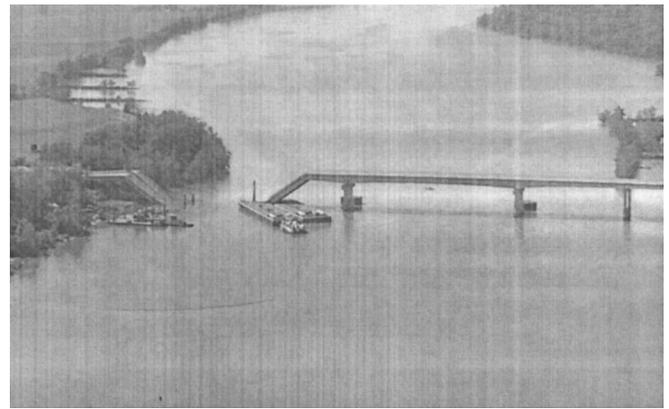
**Fig. 2.** Overview of damaged bridge

piers of the bridge, knocking down two piers (indicated as E piers) and partially damaging another (indicated as the D pier). Four spans totaling approximately 152 m (500 ft) were also damaged. Span 1 [38 m (126 ft), shown as damage type A] was damaged, but did not fall. Span 2 [38 m (125 ft), shown as damage type B] and Span 4 [61 m (201 ft), shown as damage type B] partially fell into the river. Span 3 [38 m (126 ft), shown as damage type C] completely collapsed into the river. Fig. 2 shows the damaged bridge.

The demolition crews knocked down the remaining piers first, and then began breaking up the concrete on the spans. Spans 1 and 2 were brought down using explosives, and the debris was removed from the site. Span 3, which had completely fallen into the river, had to be removed using underwater demolition. The working environment for the underwater demolition was hazardous due to poor visibility. Demolition of the damaged section of Span 4 was the most challenging task. This span was partially damaged. One end rested on the barges, while the other end was

still attached to the undamaged bridge, as shown in Fig. 2. The remainder of the bridge structure could have been further damaged if the crews had not been careful during the demolition. To prevent this from happening, the Magnolia Marine Transport Company stabilized the barges and the crews constantly monitored the movements of the bridge and barges. Combinations of demolition devices including a wrecking ball, explosives, concrete shears, and other cutting devices were used to meet the different needs at the site. The debris removed from the accident site was piled on a 2 ha (5 ac) site on the river's west bank and was trucked or floated away during the demolition.

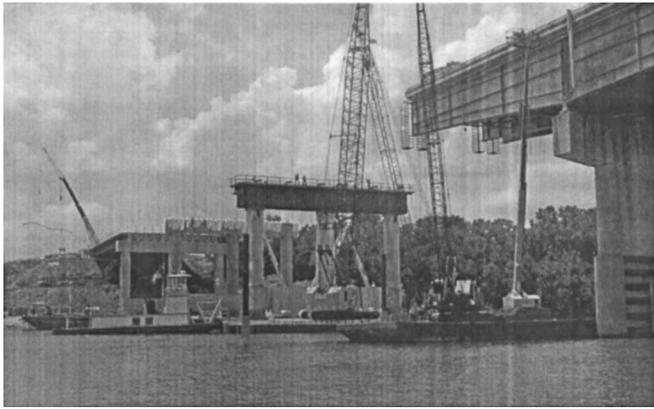
**Fig. 4.** New pier structures under construction

The old piers had two columns supporting them. The new piers were three column structures supported by drilled shafts. Pier 3 was rebuilt at the original station. Its three columns were spaced to straddle the existing spread footings that were left in place. The new piers were 2.7 m (9 ft) in diameter (under web wall portions), which was 0.6 m (2 ft) larger than the original. Fig. 4 shows the new pier structure under construction. The new piers were constructed with a construction joint at the top of web walls, which were full column width with some chamfering at the ends for ease of forming. Substructure concrete was permitted to be loaded at 75% of design strength.

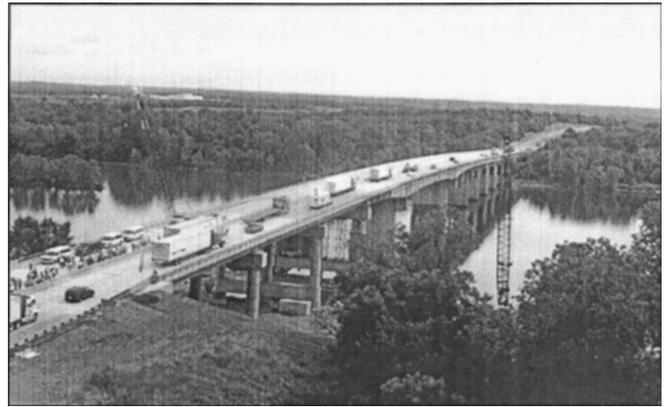
Fig. 5. I-40 bridge reopened to traveling public

streamline the bid review and approval procedures and get the reconstruction contract ready to put out for bid. ODOT also received technical help and cooperation from the U.S. Army Corps of Engineers, the U.S. Coast Guard, and other state DOTs. Fig. 5 shows the bridge as it was reopened to the traveling public on July 29, 2002.
