# Observations about the Seismic Response of RC Buildings in Mexico City

Over 2000 buildings were surveyed by members of the Colegio de Ingenieros (CICM) and Sociedad Mexicana de Ingenieria Estructural (SMIE) in Mexico City following the Puebla-Morelos Earthquake of 2017. This inventory of surveyed buildings included 40 collapses and over 600 buildings deemed to have structural damage. Correlation of damage with peak ground acceleration (PGA), peak ground velocity (PGV), predominant spectral period, building location, and building properties including height, estimated stiffness, and presence of walls or retrofits was investigated for the surveyed buildings. The evidence available suggests that: 1) ground motion intensity (PGV) and not ground motion predominant period drove the occurrence of damage, and 2) buildings with more infill and stiff retrofit systems did better than other buildings.

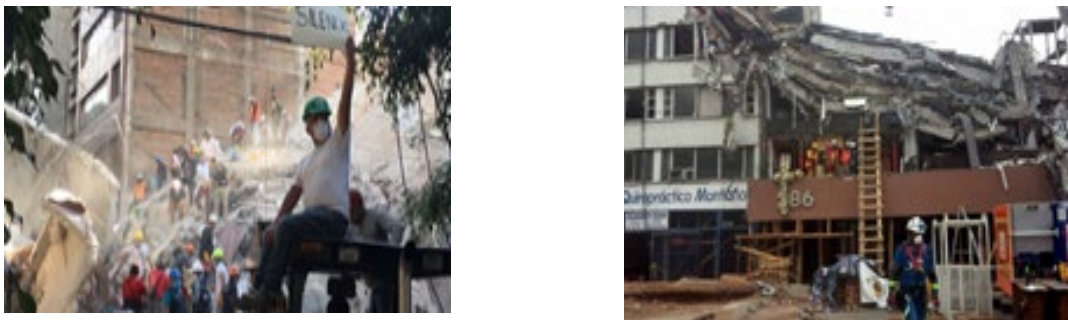
subsequent surveys or via news reports. Structures identified by CICM and SMIE as exhibiting partial collapse were omitted from this study because the definition was less clear. In relation to the survey done by CICM and SMIE, the term damage is used herein to refer to instances of “structural damage” where one or more structural elements exhibited clear signs of distress caused by shear, bond, or axial stresses (**Fig. 3**). Buildings with damage to only non-structural elements are not included among damaged buildings considered in this paper.

**Figure 2.** Examples of collapses in buildings surveyed by CICM and SMIE (2017) [COLOR]

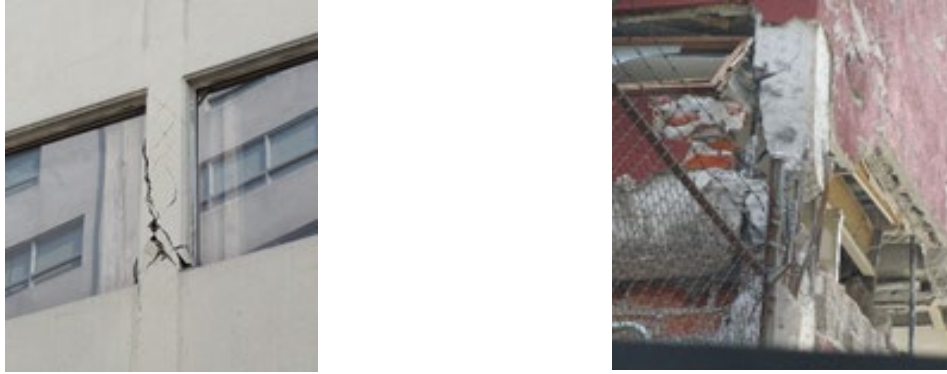
**Figure 3.** Examples of structural damage in buildings surveyed by CICM and SMIE (2017)  
 (COLOR)
