ANALYTICAL INVESTIGATION OF REPAIR METHODS FOR FATIGUE
CRACKS IN STEEL BRIDGES

Submitted to the graduate degree program in Civil, Environmental and Architectural Engineering
and the Graduate Faculty of the University of Kansas in partial fulfillment of the requirements
for the degree of Master of Science.

Part III: Repair of Distortion-Induced Fatigue Cracks on 135-87-43/44 over Chisholm Creek

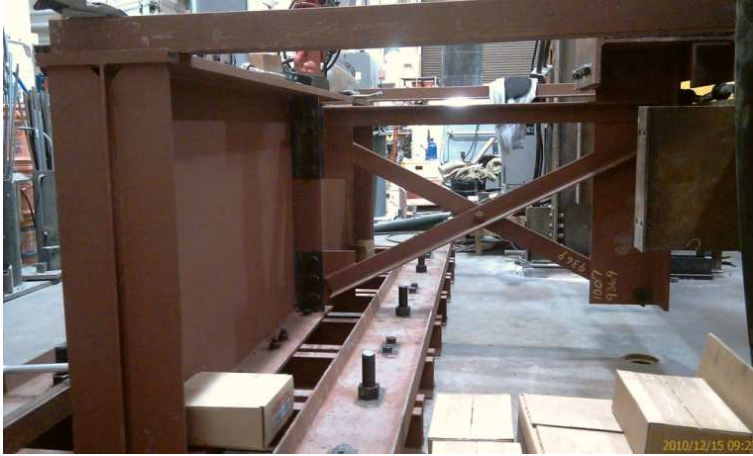
Figure 1. View of girder specimen

The test specimens were proportioned such that they were each 2,845-mm (112-in.) long with web dimensions of 876×10 mm ($34.5 \times 3/8$ in.). The width of the top and bottom flanges was 279 mm (11 in.), with the top flange having a thickness of 25 mm (1.0 in.) and the bottom flange width being 16 mm ($5/8$ in.). In the physical model, the girder specimen was connected to the laboratory floor through a series of channels post-tensioned to the concrete floor, as shown in Figures 1 and 2. The girder was tested upside-down, with the laboratory floor simulating the restraint offered by a concrete bridge deck. The top flange in the laboratory model (*top flange_{test}*) reflected behavior for a discretely braced bottom flange in a bridge girder (*bottom flange_{bridge}*). The top flange_{test} was restrained at both ends in the out-of-plane direction by angles connected back to a stiff anchorage (a channel member on the load frame), to simulate the restraint effects provided by intermediate cross-frames and lateral flange bending resistance of the bottom flange_(bridge). Full-depth stiffeners were provided at the girder ends to ensure web stability in those regions.

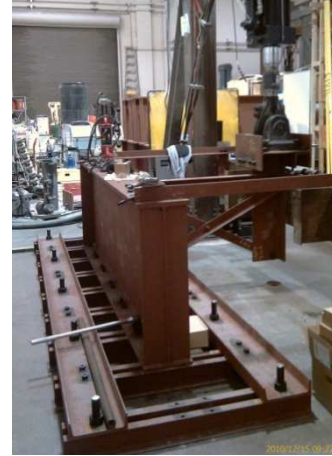
Figure 2. View of fascia side of girder specimen

The specimen was tested cyclically using load control, with the actuator applying a tensile force with a maximum load of 205 kN (4.6 K) and a minimum of 356 kN (0.8 K). The load was applied to the specimen through an assemblage comprised of a WT section which was directly connected to the actuator at the top, and directly connected to the cross-frame members.

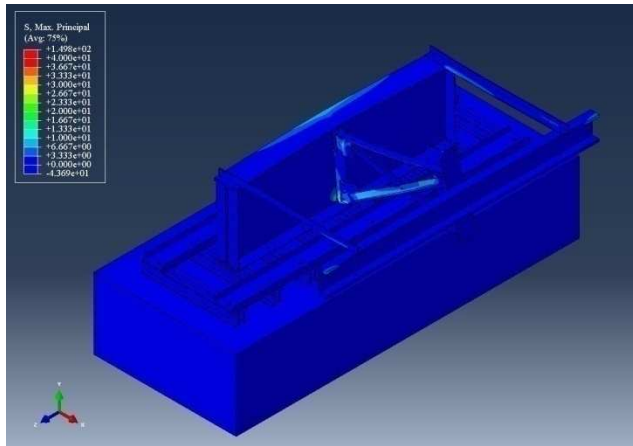
Figure 3. Overall view of girder FE model

The specimen and loading apparatus were modeled closely, as shown in Figures 3 and 4, using the commercially-available FEA software ABAQUS v6.10. The concrete laboratory floor and the girder tie-down system were simulated in the models. Movement of the actuator in the lateral or longitudinal direction of the girder was prevented. In the simulation, the loading step was divided into five increments, with a static load of 5 kips.

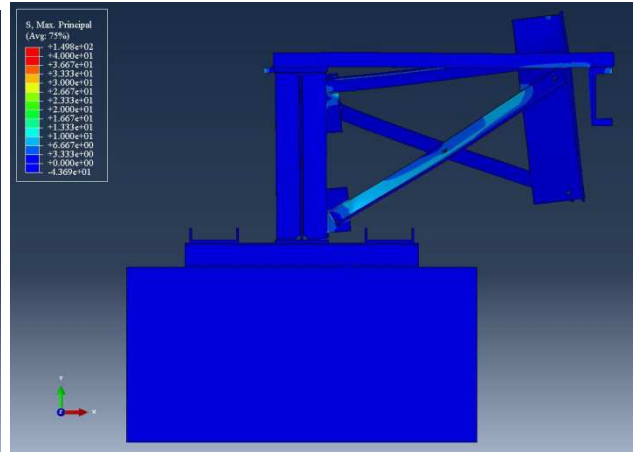
Figure 4. Cross-section view of girder FE model

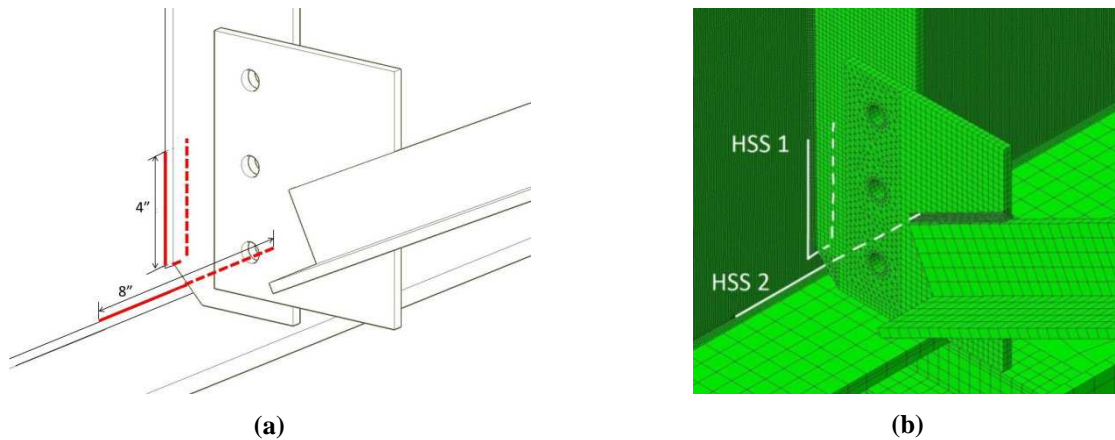
Figure 5. (a) Diagram of modeled 4-in. long horseshoe-shaped crack and 8-in. long horizontal crack geometry at weld toes; redlines represent modeled cracks.; (b) Location of HSS extraction paths, HSS1 and HSS2, in the bottom web gap_(test)

Figure 5. (a) presents the location of the cracks modeled, and Figure 5b shows the two HSS paths considered in the bottom web gap_(test). In scenarios where crack length was varied, cracks were symmetric about mid-thickness of the stiffener. When comparing retrofits with varying crack lengths, the HSS path lengths were always kept constant. Therefore, the length of HSS2 was maintained at 203 mm (8 in.) and the height of HSS1 maintained at 102 mm (4 in.), regardless of the crack length examined. This approach allowed for the maximum principal stresses to be extracted for every element along the two paths in the various models; the reported HSS value for each path always corresponded to the greatest value of maximum principal stress along that path for the model being examined.

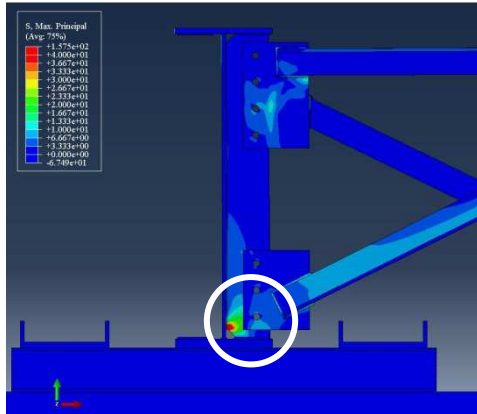
Figure 6. Overall view of specimen, with bottom web gap_(test) shown by the circle.

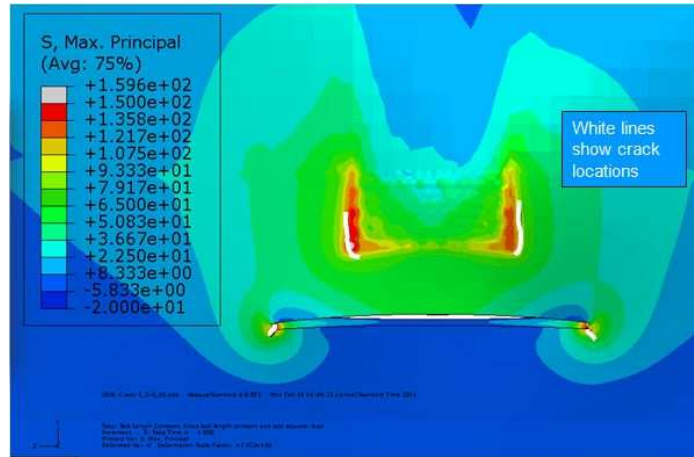
Figure 7. View of maximum principal stress contours in the cracked web gap region in the finite element model of Specimen 1. Superimposed white lines represent experimentally-observed cracks locations.

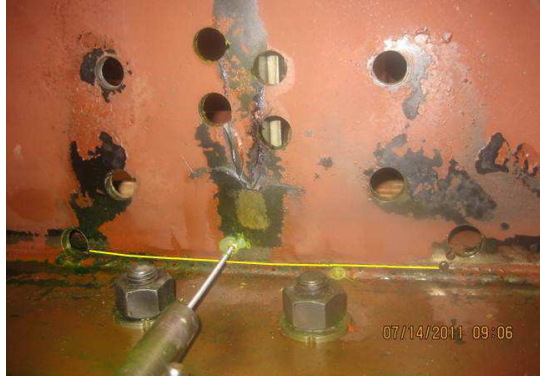
Figure 9: Retrofit measure 1: drilled crack-arrest holes (a) Schematic of drilled crack-arrest holes, where redlines represent hot spot paths; (b) Maximum principal stress contour plot (cracks modeled explicitly); arrows point to point of highest maximum principal stress along HSS Paths 1 and 2; (c) Photograph of cracking pattern on fascia side of girder. Horseshoe-shaped cracking is visible, horizontal crack has been highlighted in yellow.

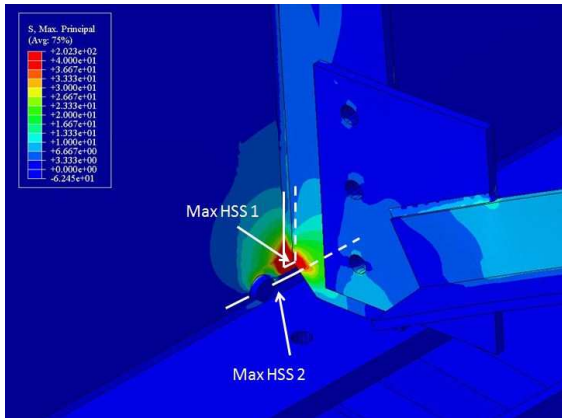
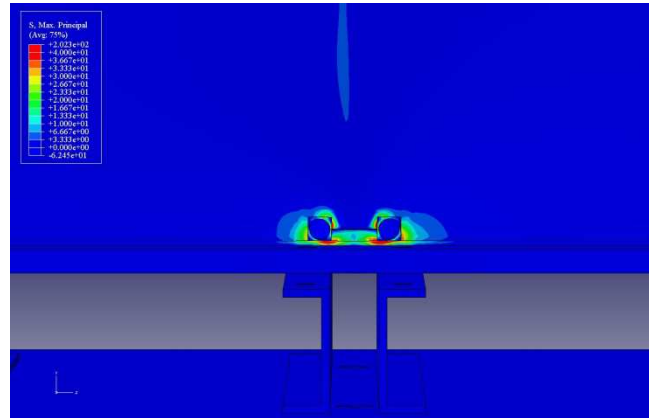
Figure 10. Retrofit measure 2: Tensioned bolts (a) view of stress contour plot for interior face of girder; (b) view of maximum principal stress contour plot for fascia side of girder; cracks modeled explicitly; arrows point to point of highest maximum principal stress along HSS Paths 1 and 2.

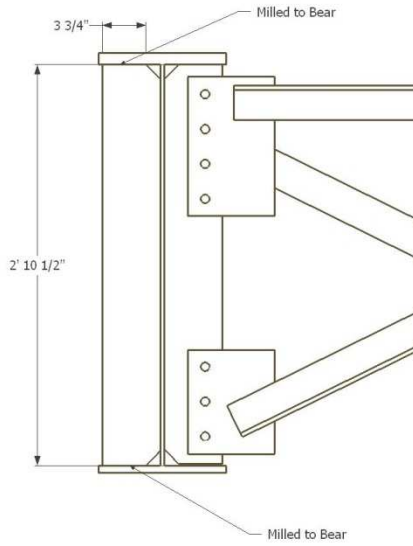
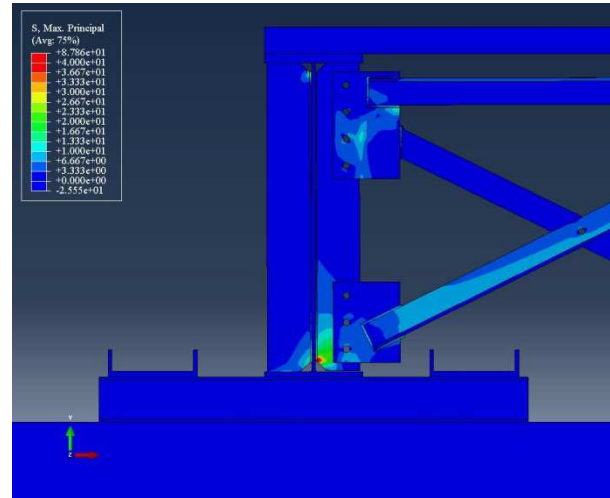
Figure 11. Retrofit measure 3a: (a) Schematic of full-depth transverse back-up stiffener; (b) Maximum principal stress contour plot for full-depth transverse back-up stiffener; cracks modeled using XFEM

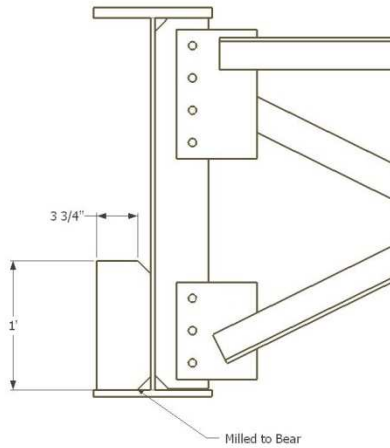
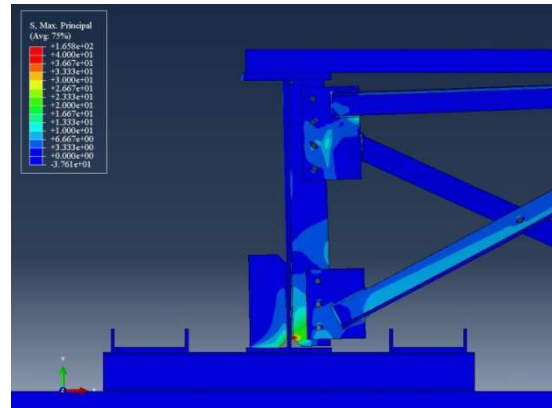
Figure 12. Retrofit measure 3b: (a) Schematic of partial-depth transverse back-up stiffener; (b) Maximum principal stress contour plot for 305-mm (12-in.) partial-depth transverse back-up stiffener; cracks modeled using XFEM

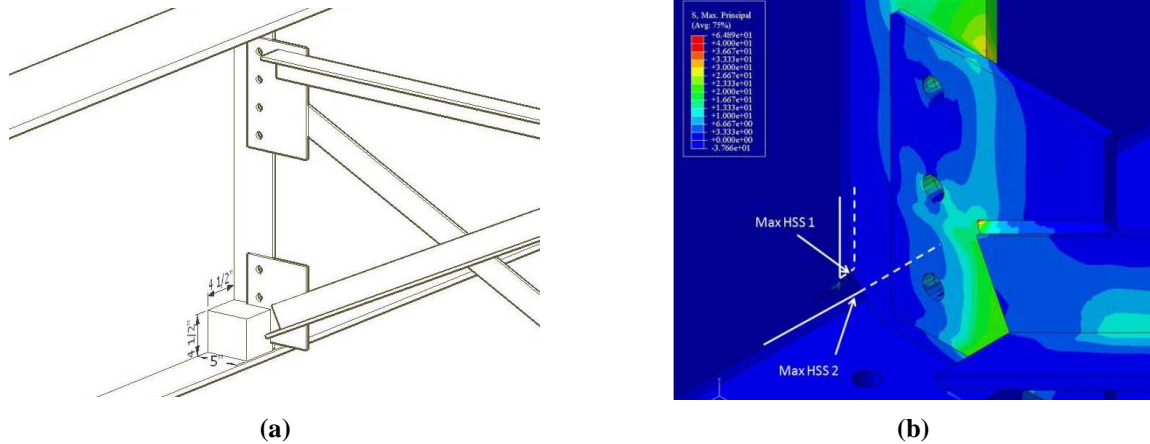
Figure 13. Retrofit measure 4: (a) Schematic of modeled geometry for the CFRP block (b) Maximum principal stress contour plot for steel beneath composite block; Cracks modeled explicitly. Arrows point to point of highest maximum principal stress along HSS Paths 1 and 2.

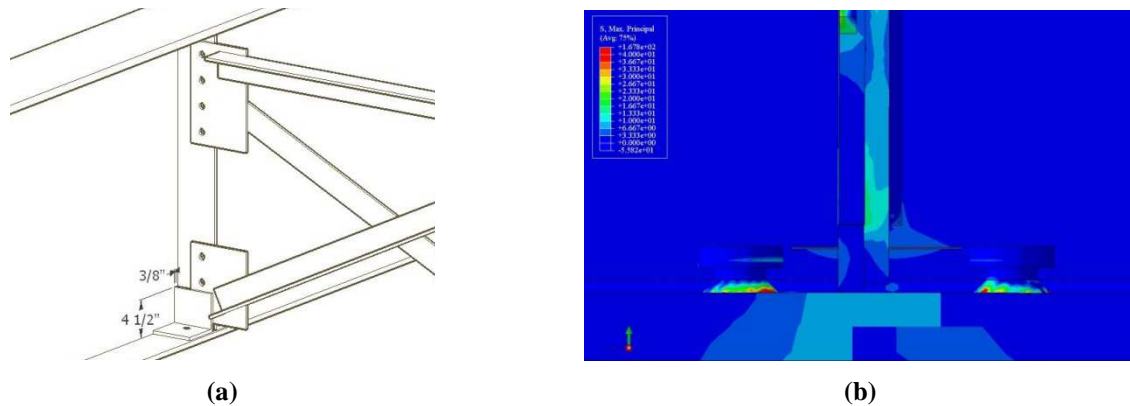
Figure 14. Retrofit measure 5: (a) Schematic of bolted stiffener-to-flange double angles modeled; (b) Maximum principal stress contour plot showing welded bolts at inside face of flange.

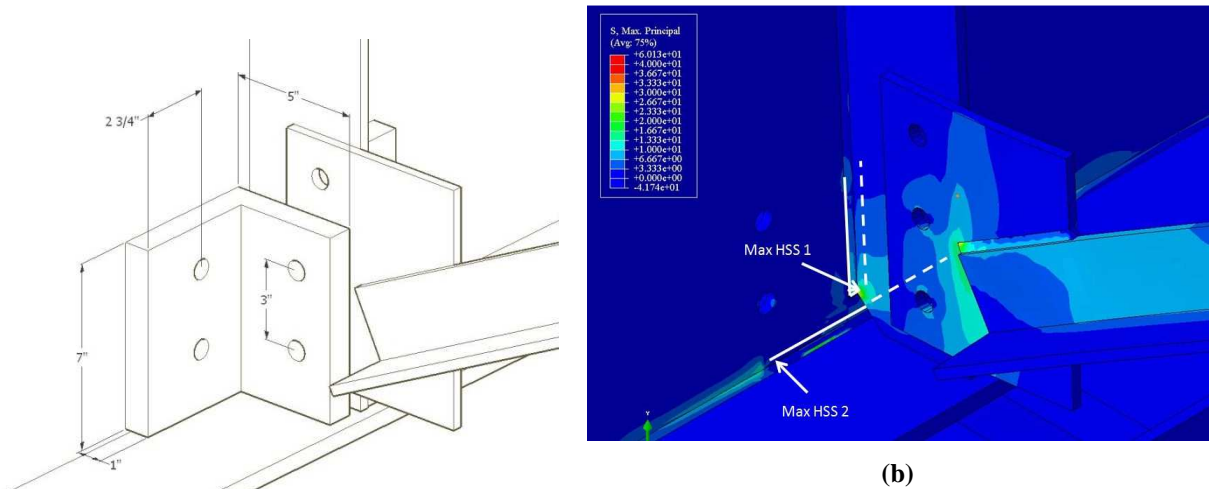
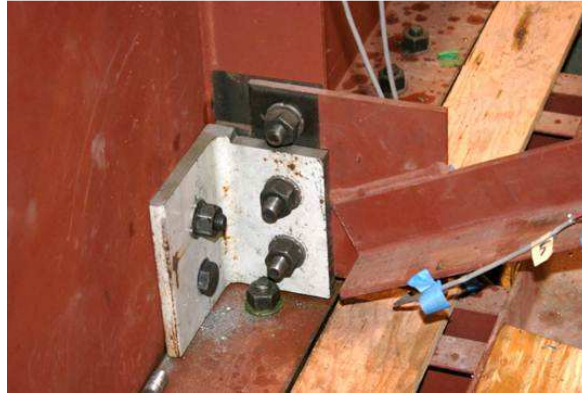
Figure 15. Retrofit measure 6: (a) Schematic of retrofit 6 (interior view); (b) Maximum principal stress contours in the web gap region with the angles removed from view; arrows point to point of highest maximum principal stress along HSS Paths 1 and 2. Cracks were modeled with XFEM and contour integrals. (c) Photograph of interior side of girder with stiffener-to-web angle and backing plate retrofit.

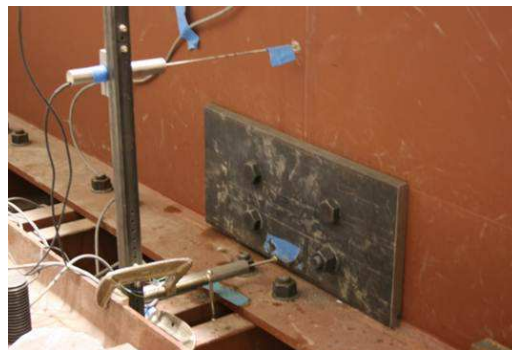
(c)

Figure 16. Retrofit measure 6: (a) 457-mm (18-in. long) backing plate on exterior side of web; (b) Maximum principal stress contours on the exterior side of web with the back plate removed from view; arrows point to point of highest maximum principal stress along HSS Paths 1 and 2. Cracks modeled using XFEM and

Retrofit measure 6 was studied both analytically and experimentally. This retrofit measure consists of bolting two angles to the web and connection plate, one on each side of the connection plate (Figure 15a; Figure 15c). A backing plate was also bolted to the fascia side of the web to distribute stress away from the bottom web gap_(test) (Figure 16(a); Figure 16(c)). As discussed in the following, thicknesses of the back-to-back steel angles and the back plate were varied to investigate the impact of the stiffness of the structural components on the stresses in the web gap area. In the simulations, all parts were connected through 19-mm (0.75-in.) diameter A325 bolts. Shims were used on both sides of the connection plate to avoid interferences with the welds.

L6×6×3/4 angles and a 457×203×19-mm (18×8×0.75-in.) backing plate were modeled to reflect the dimensions of the retrofit elements used in the physical simulations. In this model, there was a 102-mm (4-in.) horseshoe-shaped crack and a 203-mm (8-in.) horizontal crack in the bottom web gap_(test), dimensions that were consistent with the crack lengths achieved in the physical simulation of the specimen before it was retrofitted. Stresses in the web gap region decreased by 98% for HSS1 and 91% for HSS2 after application of retrofit method 6, compared with the unretrofitted case with a 102-mm (4-in.) horseshoe-shaped crack and a 203-mm (8-in.) horizontal crack. Maximum principal stress contours on the interior of the girder can be seen in Figure 15b, and maximum principal stresses in the web under the backing plate are presented in Figure 16b.

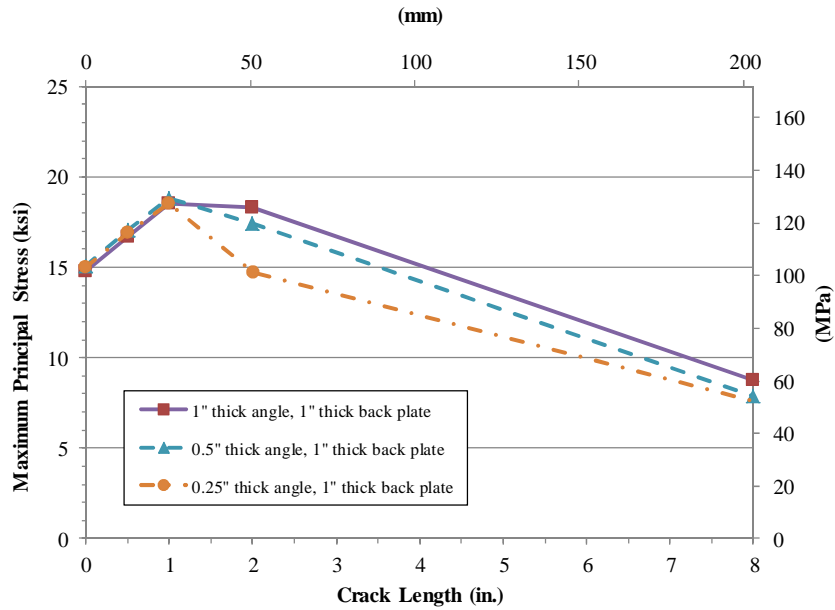
Figure 17. Change in maximum principal stress along HSS path 2 (horizontal web-to-flange weld) as crack length increased.

decreased with further increase in crack length. These findings are important because they shed light on the effect of crack growth on stress when the retrofit is implemented. For the crack lengths studied, it was found that configurations with intermediate crack lengths of 25 mm (1.0 in.) at the web-to-bottom flange_(test) weld produced the greatest demands on the retrofit.

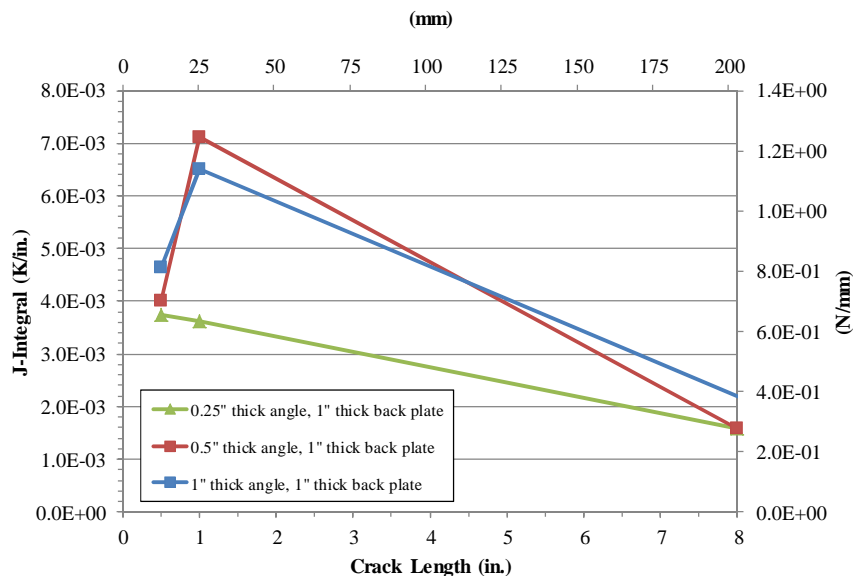
Figure 18. Change in J-Integral for horizontal web-to-flange weld crack as crack length increased.

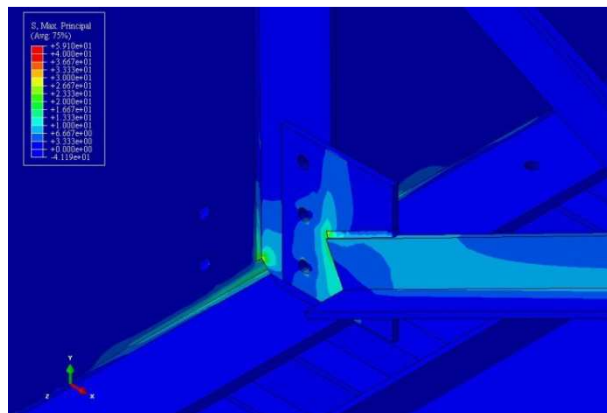
Figure 19. Maximum principal stress contours in an uncracked model with stiff web-to-stiffener angles and backing plate (Retrofit 6) applied.

As mentioned, the bolted web-to-stiffener angles with backing plate retrofit was modeled on cracked and uncracked specimen geometries to examine the effectiveness of the retrofit if used as a preventative measure. It was seen that HSS 1 and 2 values were similar in magnitude when comparing retrofitted models with various crack lengths to a retrofitted, uncracked model. When 25 mm (1 in.) thick angles and backing plate were used, the uncracked configuration saw an HSS1 value of 60 MPa (8.7 ksi), while the model with a 102-mm (4-in.) crack had an HSS1 value of 38 MPa (5.5 ksi). Similar results were found for HSS2. The web-to-stiffener angles and backing plate retrofit exhibited a high level of stress reduction for both HSS1 and HSS2 in the web gap region for both the uncracked, retrofitted and the cracked, retrofitted scenarios. Therefore, this retrofit shows merit as a preemptive retrofit technique as well as a post-cracking retrofit technique.

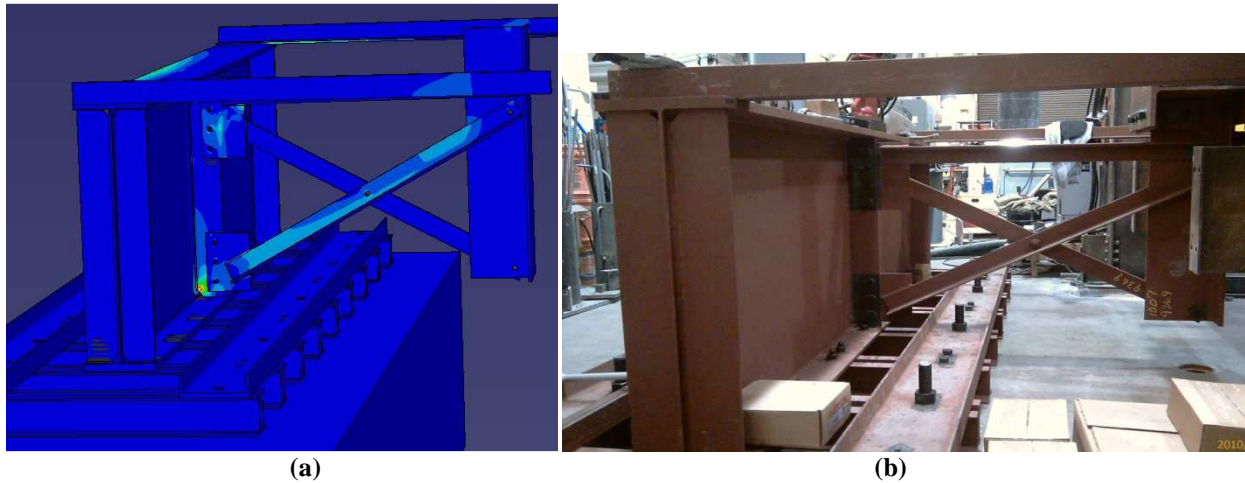
Figure 1(a.) Detailed finite element model of the 2.7-m (9-ft) girder and (b.) the physical specimen tied to the laboratory floor.

on both sides were used to connect the channels running perpendicular to the girder which were connected to the concrete strong floor. Both the analytical and physical specimens can be seen in Figure 1.

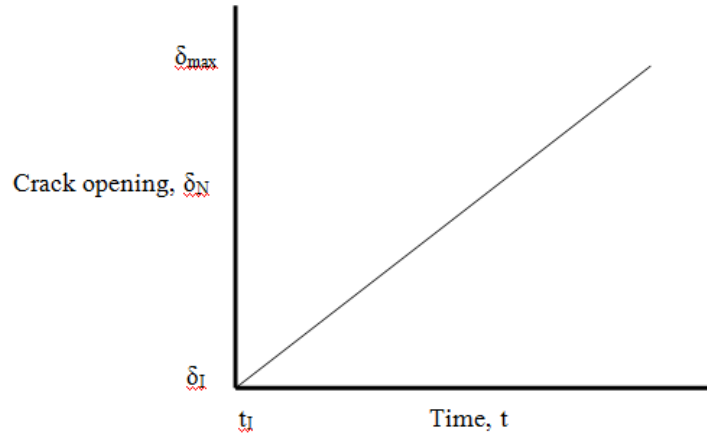
Figure 4. Linear progression of crack opening after initiation occurs (Simulia, 2010).

The next important consideration for LEFM in ABAQUS is the determination of damage evolution. In ABAQUS, damage evolution is a function of the maximum width of the crack opening, δ_{max} , and has a default linear degradation of stiffness for an element intersected by a XFEM crack. While other rules of degradation may be specified, linear degradation was deemed adequate when analyzing the effect of varying values for δ_{max} for these simulations. Figure 4 shows the relationship between crack opening and time while Figure 5 shows the relationship between stiffness and crack opening as modeled in ABAQUS.

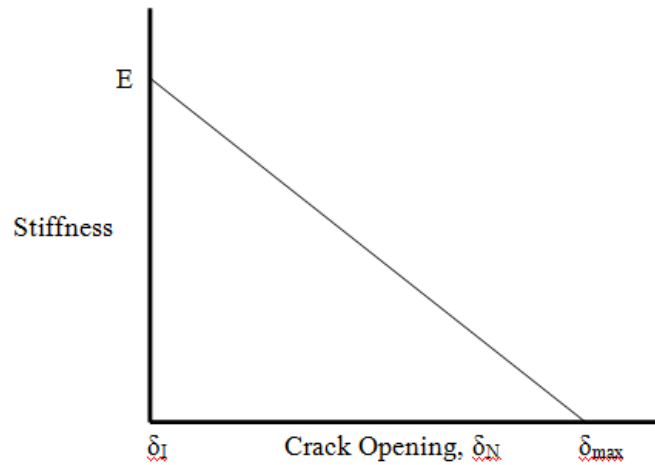
Figure 5. Linear degradation of stiffness across a crack as the crack opening widens (Simulia, 2010).

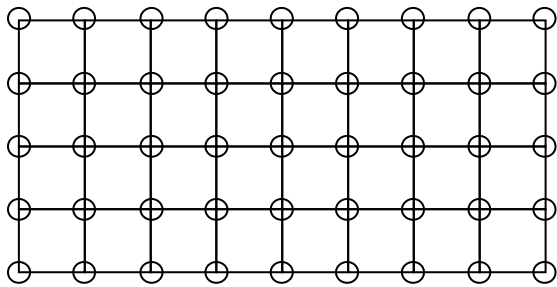
Figure 6. A 9 x 5 node two-dimensional mesh before increment 1.

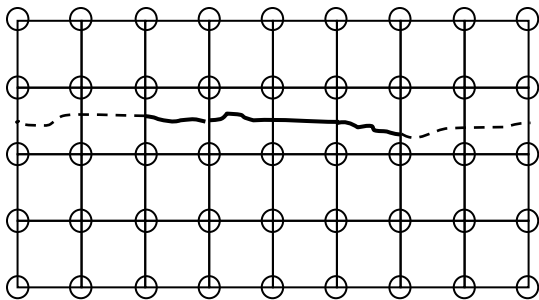
Figure 11. Two-dimensional mesh after calculation of increment 3.

applies additional refinement to the approximation due to the presence of a new crack near these nodes. Figure 9 presents the result of the computation of the second increment, wherein two new elements have now met the inequality in Eqn. 5. This leads to Figure 10, which presents the scenario considered for calculation at the start of the third increment. The original crack has now widened and is represented by the solid line cutting across the elements. Crack growth is based off of the relationship between stiffness and time, as shown in Figures 4 and 5. The blackened nodes in Figure 10 represent where ABAQUS will apply solution refinements to represent the discontinuity created by the crack. Just as in Figure 8, the dotted lines in Figure 10 represent the part of the crack that has just initiated and has a zero width, and the lightly shaded nodes represent where a solution refinement due to the crack tip will be applied. This process repeats in ABAQUS until the full solution is computed or until the approximation cannot reach a convergence for a particular time step. Figure 12 shows the resulting crack propagation after three completed increments for this example.

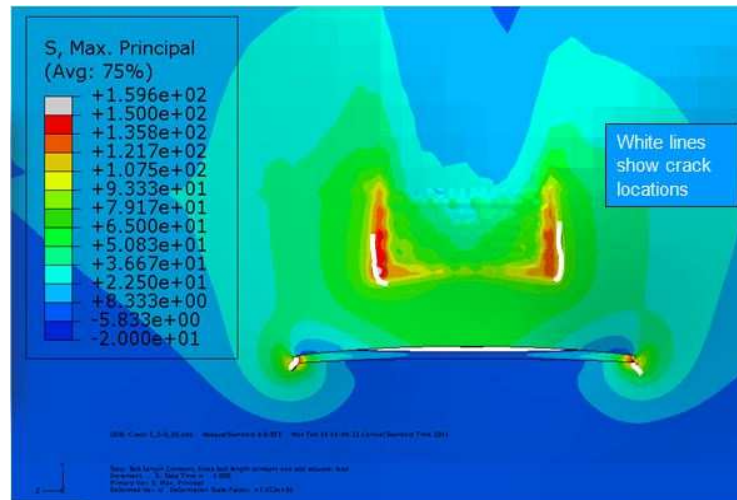
Figure 13. Good agreement between the experimental crack locations shown in white and areas of high maximum principal stress in the analytical model.

growth in the experimental specimen closely followed the direction of highest maximum principal stress in the FE model.

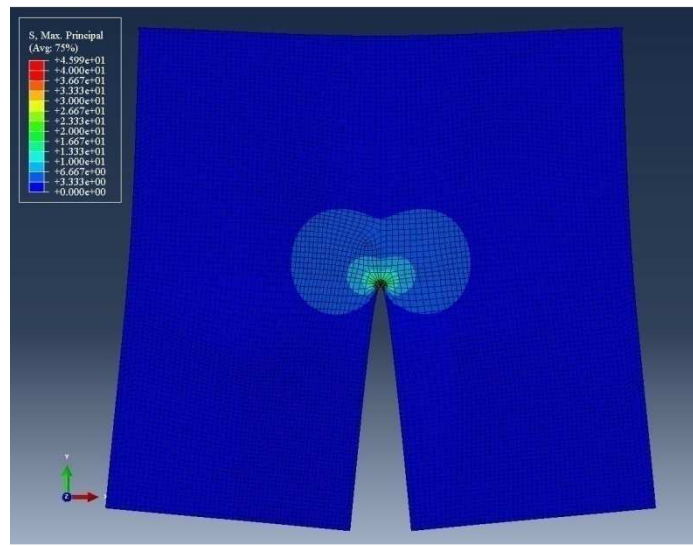
Figure 14. Focused mesh surrounding crack tip.

length of the plate, as seen in Figure 14. This model was studied in two and three dimensions. First, a 6.9-MPa (1-ksi) compressive force was applied to the left and right sides of the plate to force the crack to close. Next, a tensile force replaced the compressive force to simulate opening of the crack. In the model, a surface-to-surface interaction was placed between both sides of the crack to prevent them from intersecting each other. From this smaller model, it was found that when loading caused a crack to close, SIFs become negative, and when the crack opened, SIFs remained the same magnitude but opposite in sign. The loading applied was used to force a Mode I crack opening.

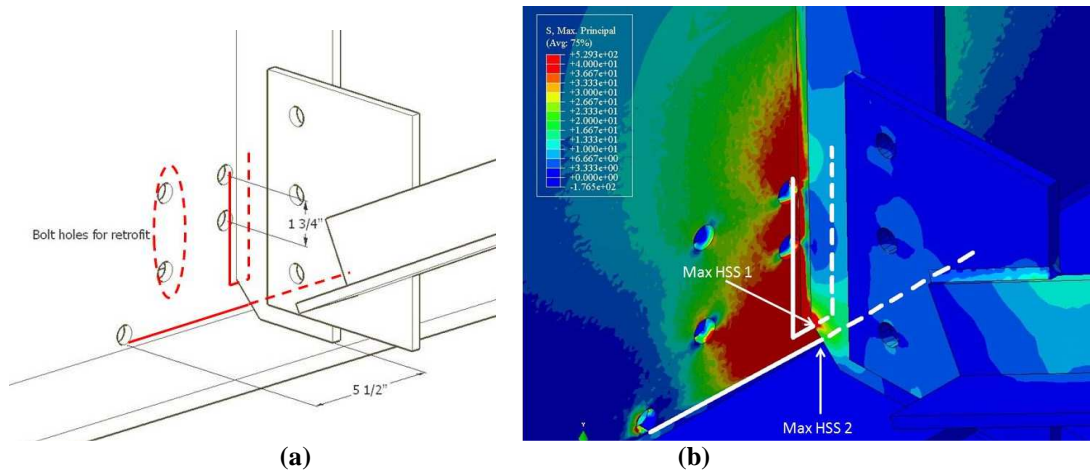
Figure 15. (a) Setup of crack-arrest holes in bottom web gap (b) Stress distribution in web gap region after crack-arrest holes have been drilled.

arrest hole and grew 70-mm (2 ¾-in.) after 39,700 cycles. The results between the analytical and experimental models closely matched when comparing the high stresses in the analytical model to the rate of reinitiation of the web-to-stiffener weld crack in the experimental specimen. The two bolts holes circled in Figure 15(a) were drilled for the stiffener-to-web angles with backing plate.

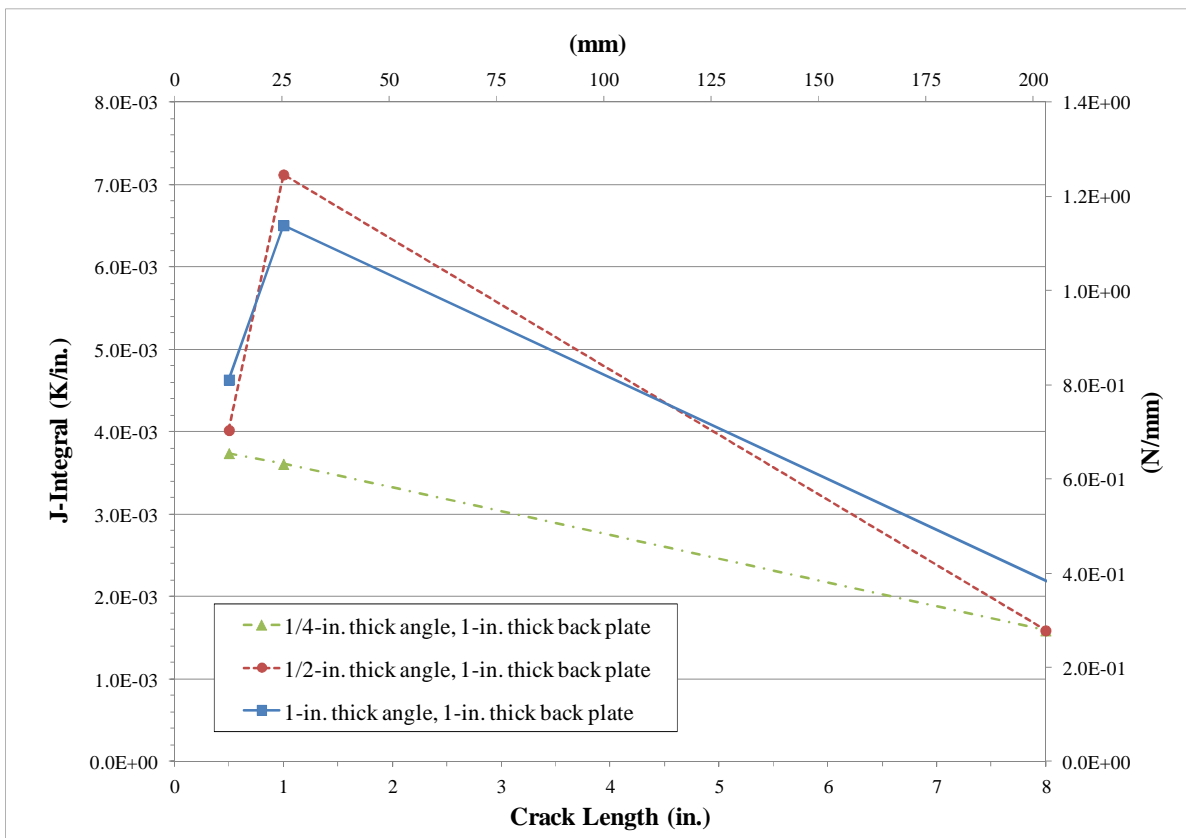
Figure 17. *J*-Integral values for the web-to-flange crack lengths and angle thicknesses.

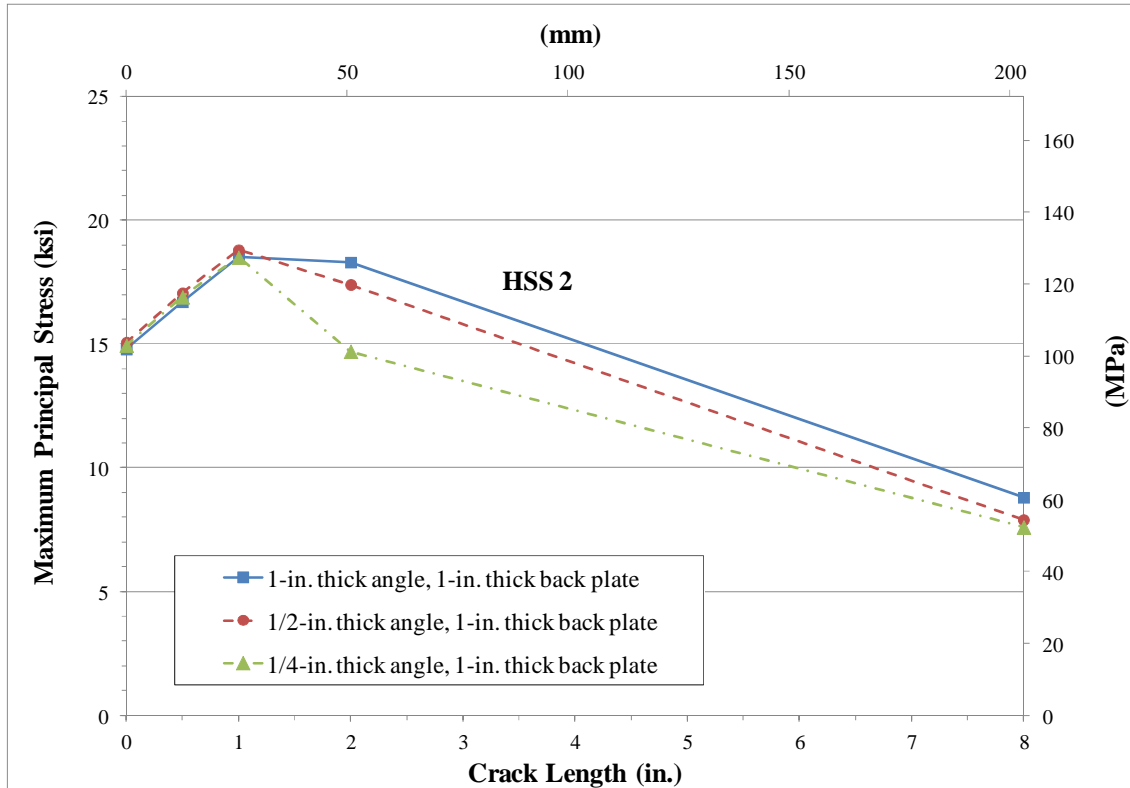
Figure 18. HSS 2 values for varying web-to-flange crack lengths and angle thicknesses.

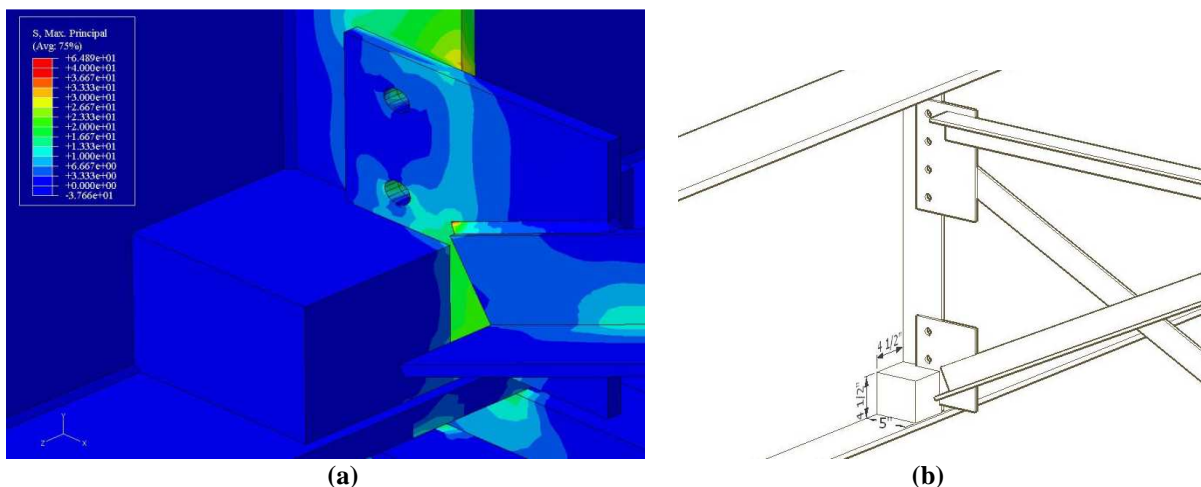
Figure 19. (a) Stress distribution with composite block (b) Schematic of 127×114×114-mm (5×4.5×4.5-in.) composite block on both sides of the connection plate.

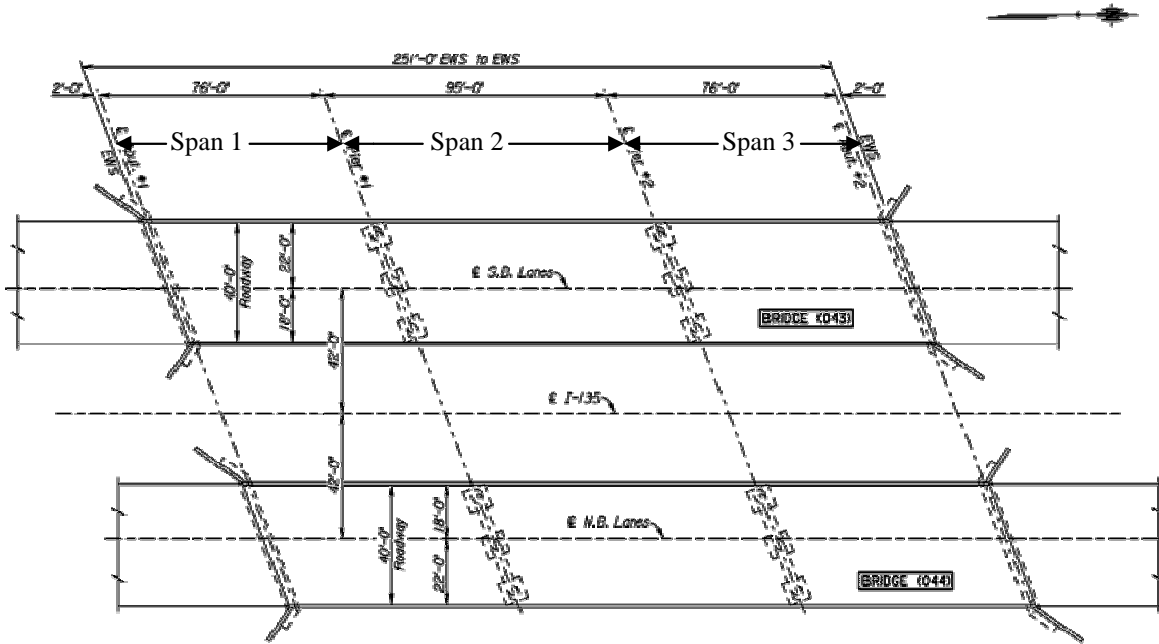
PLAN
 (Twin) 76'-95'-76' Cont. Steel Girder Spans
 Pedestal Type Piers, Pile Bent Abutments,
 40'-0" Roadway, 21°-00' Skew Lt.

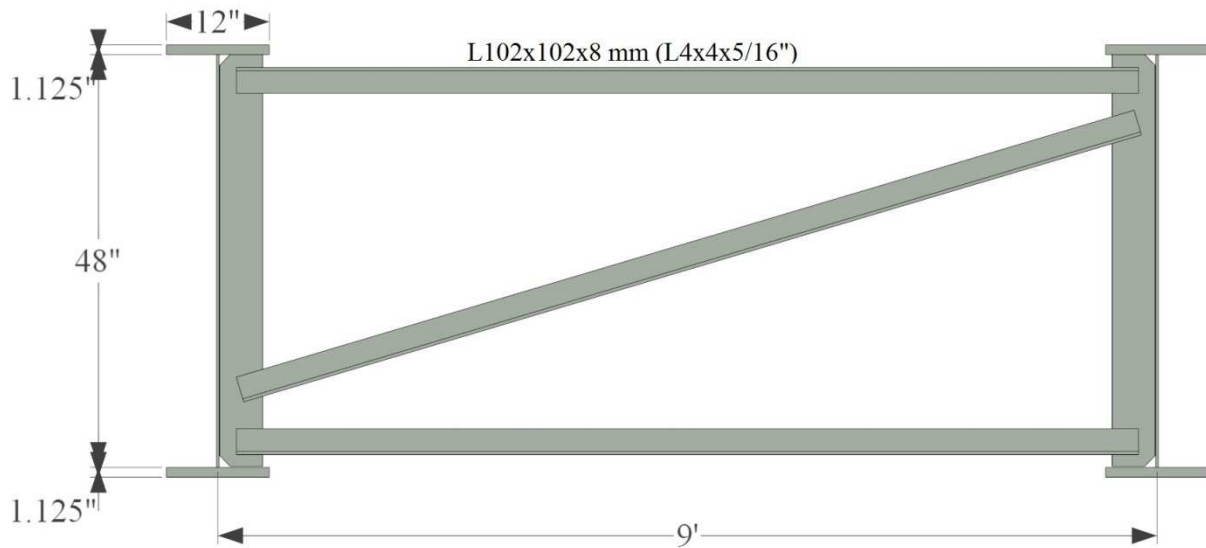
Figure 2. Schematic of interior section of bridge over the middle span.

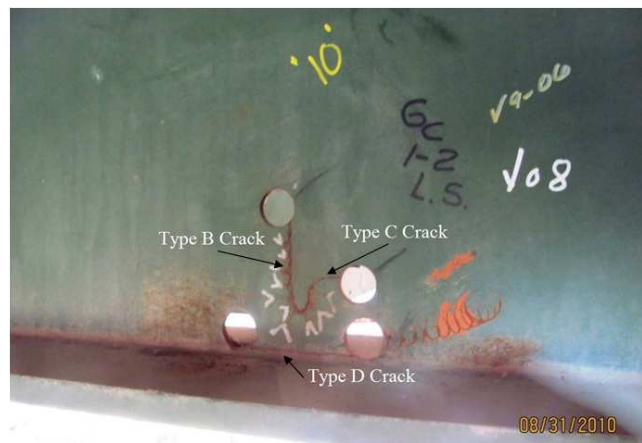
Figure 4. Drilled crack-stop holes at tips of type B, C, and D cracks.

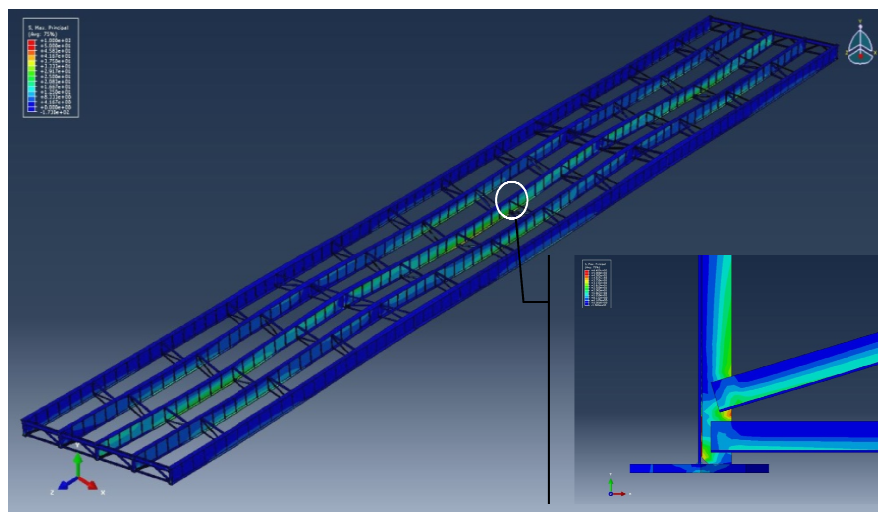
Figure 5. Full scale model of bridge with concrete deck removed for clarity. Close-up of cross frame three at Girder C is shown in the insert.

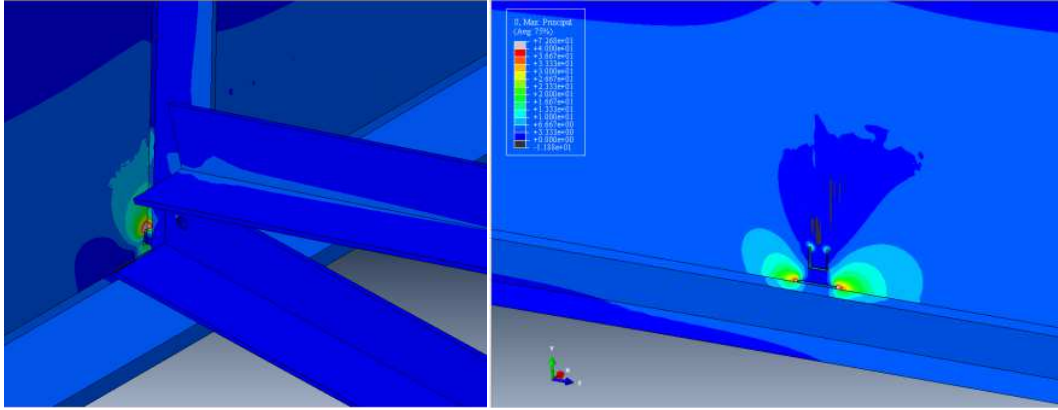
Figure 6. Two crack locations in cross frame number three of Girder C. (a) 25-mm (1-in.) long web-to-stiffener weld crack (b) 51-mm (2-in.) long flange-to-stiffener weld crack.

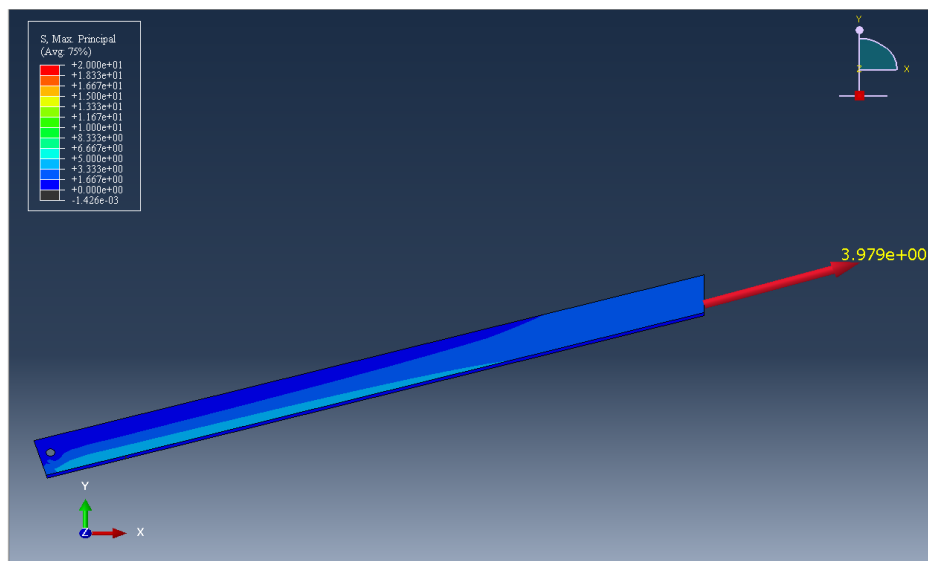
Figure 9. Force in middle cross-frame framing into the bottom web gap of Girder C.

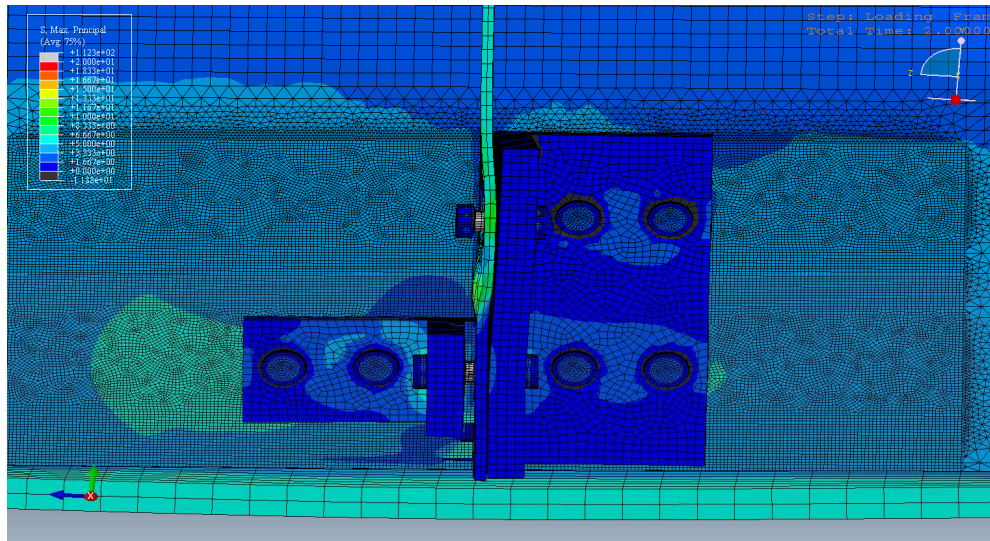
Figure 10. Angles with backing plate retrofit. Angle on the right is 305-mm (12-in.) long; angle on left is 152-mm (6-in.) long. Cross-frames have been removed for clarity. (Stress scale is from 0 – 140 MPa (0 – 20 ksi); deformation scale is 100).

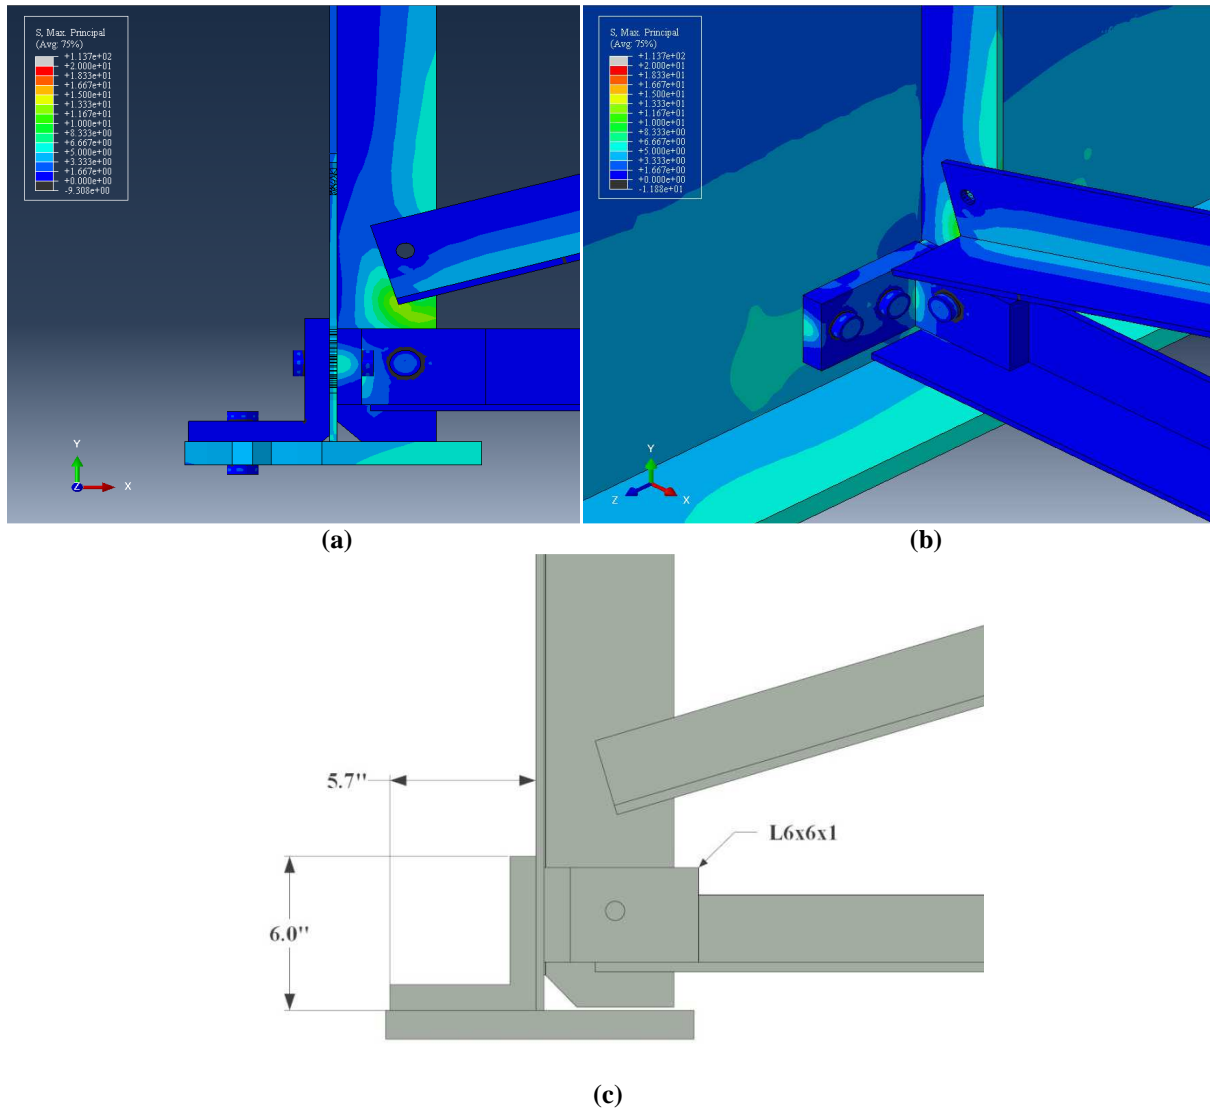
Figure 12. (a) Cross section view of angles connected to the stiffener and web with a backing angle bolted to the bottom flange and web. (b) view of stiffener-to-web. (c) schematic of retrofit.

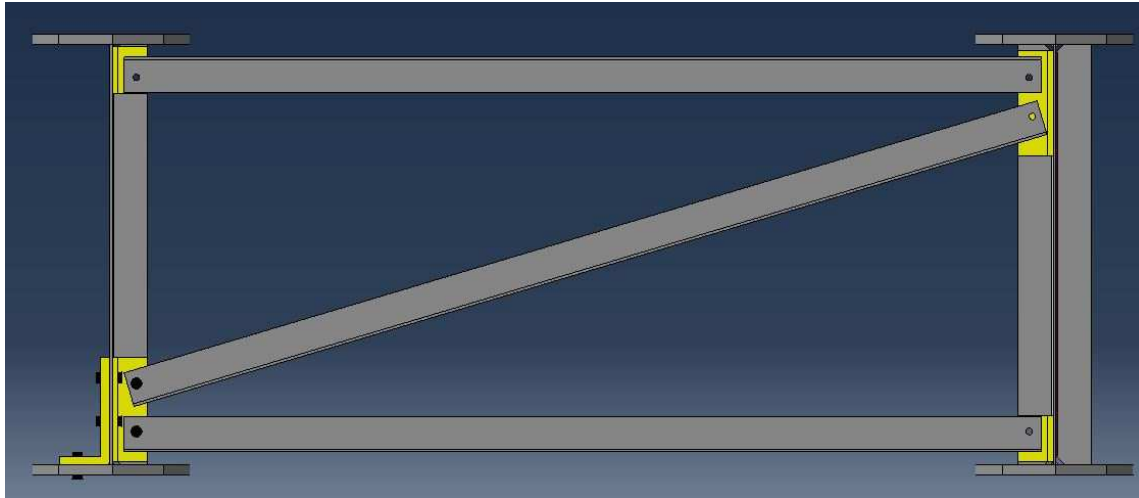
Figure 14. Placement of angles in four corners of the K-brace configuration. Girders C is on the left and Girder D is on the right. Angles are shown in yellow.

Placement of all angles is shown in Figure 14.

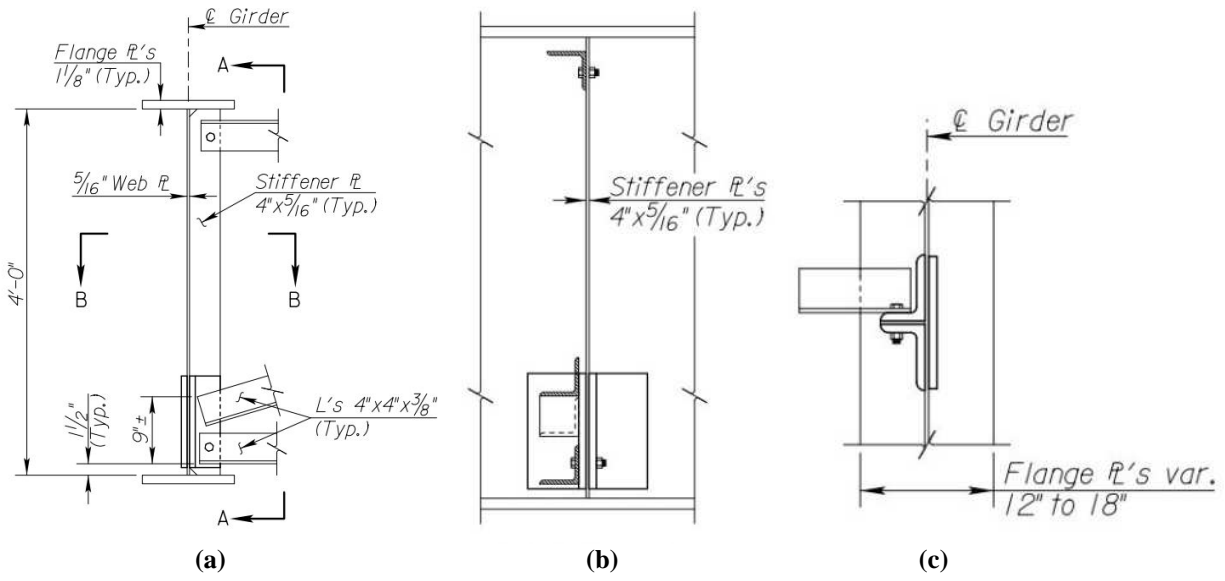
Figure 15. Proposed retrofit elevation from KDOT (a) Side view (b) Section A-A (c) Section B-B.
