ANALYTICAL INVESTIGATION OF REPAIR METHODS FOR FATIGUE
CRACKS IN STEEL BRIDGES

Submitted to the graduate degree program in Civil, Environmental and Architectural Engineering
and the Graduate Faculty of the University of Kansas in partial fulfillment of the requirements
for the degree of Master of Science.

Part III: Repair of Distortion-Induced Fatigue Cracks on 135-87-43/44 over Chisholm Creek

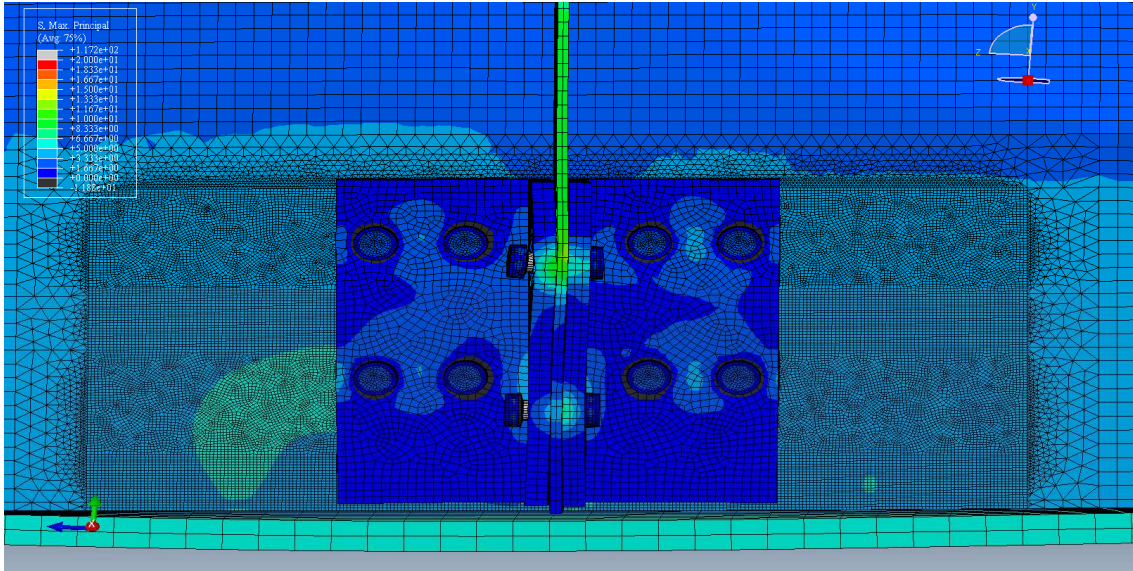
Figure 16. Stress in the bottom web gap of Girder C for the 4Angles retrofit. (Stress scale is from 0 – 140 MPa (0 – 20 ksi; Deformation scale = 100).

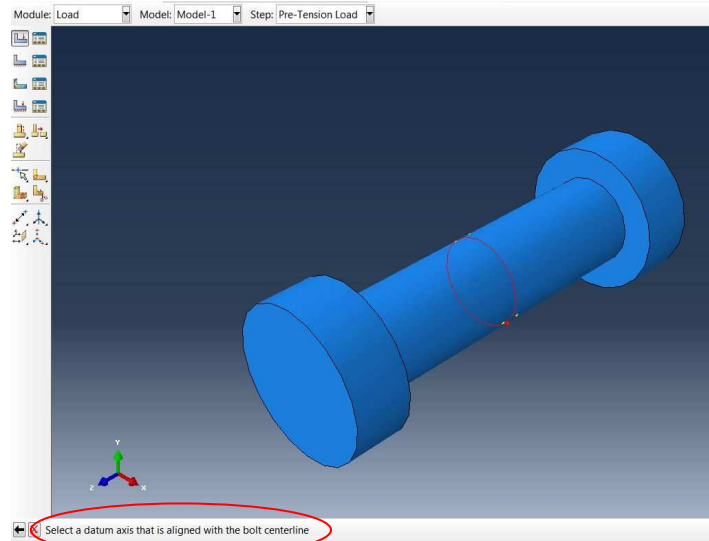
Figure B.7. Select the datum axis that corresponds to the longitudinal axis of the bolt. In this case, the datum axis should be z.

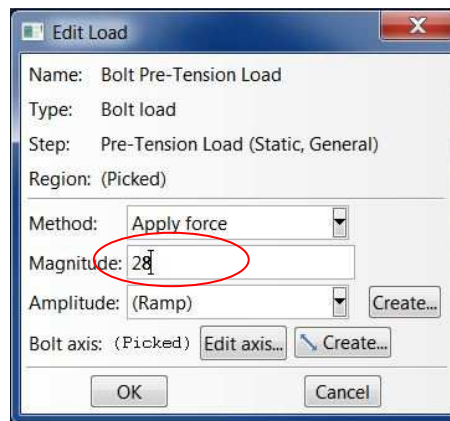
Figure B.8. Enter the bolt load found in the AISC Specification.

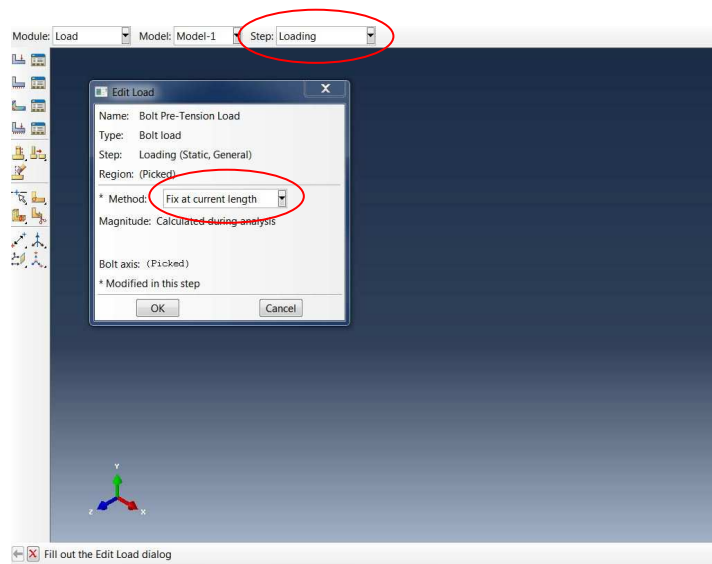
Figure B.9. Fix the length of the bolt in the step where a global load is applied to the model. This stops the bolt from continuing to have a pre-tension load.
