HISTORICAL RESPONSE OF THE WAKARUSA RIVER CHANNEL  
TO ANTHROPOGENIC INFLUENCES

Submitted to the graduate degree program in the Department of Geography  
and the Faculty of the Graduate School of the University of Kansas  
in partial fulfillment of the requirements for the degree of  
Master's of Arts.

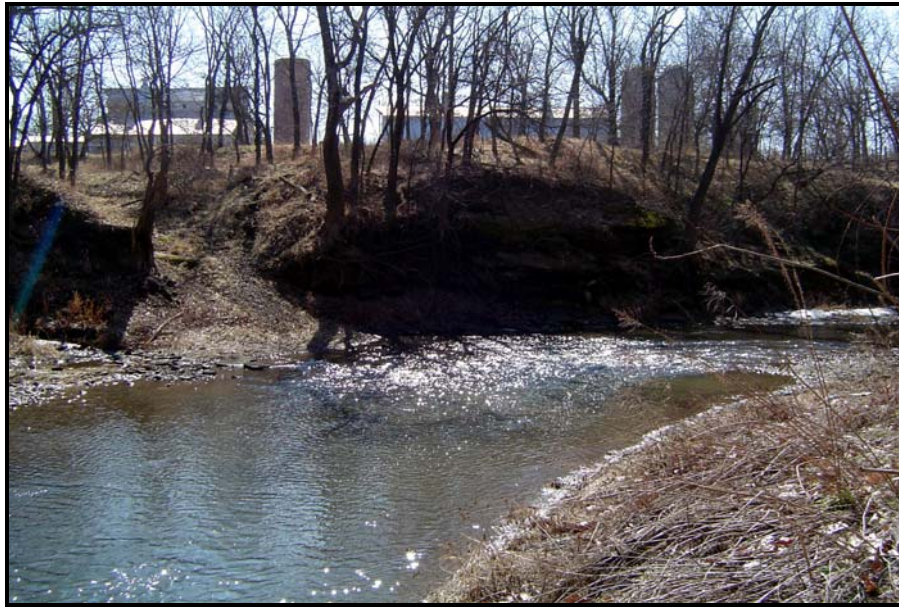
Figure 7: Blue Jacket's Crossing at low-flow level, approximately 7 km East of Lawrence, photo taken in 2005.

At many locations, limestone and sandstone strata produce steep-sided creek banks that are difficult to cross, such as the banks of the river near Deichman's Crossing (Figure 6) and at Blue Jacket's Crossing (Figure 7). The prospect of having to cross this river most likely deterred many of the first travelers from going across the Wakarusa valley, but at some localities this same bedrock offered a solid river bottom for easier crossing as long as a path could be cut through the steep-sided banks (Harvey 1917).

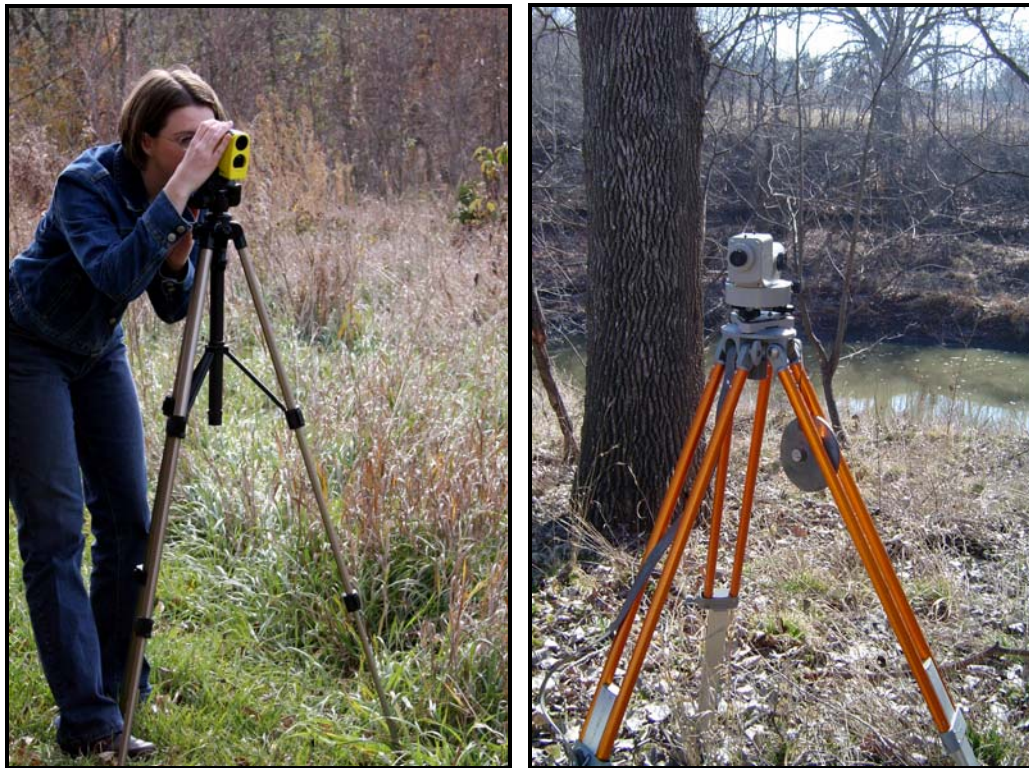
Figure 9: Laser rangefinder (left) and automatic level (right) used for distance and elevation measurements

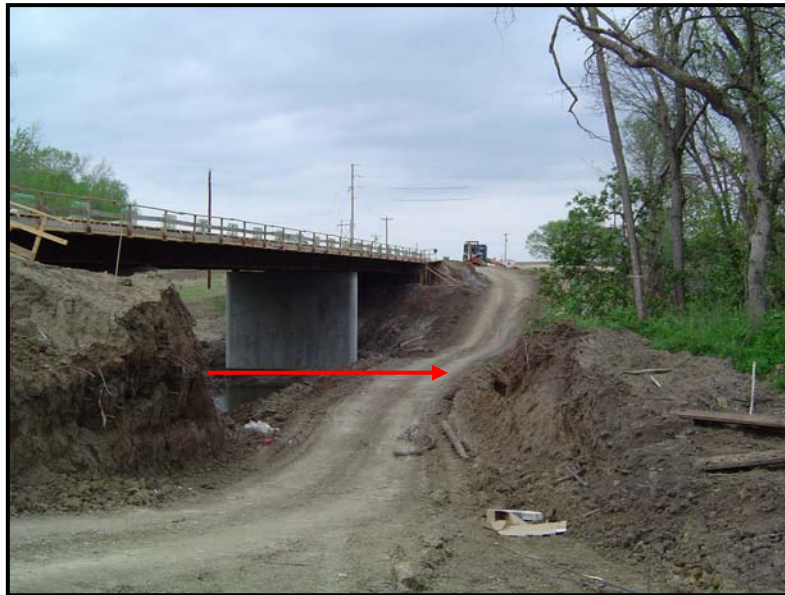
Figure 10: Bridge construction near Auburn, Kansas in April 2004, showing a secondary road built for construction access, cutting down through the channel bank and fill added to the channel bed. The original channel bed is indicated in red.

All sites were located near section-line crossings for comparison to widths measured in the original federal land survey. During field reconnaissance, it was noted that modern, and possibly previous, bridge construction for roadways is destructive to the natural channel cross section (Figure 10). The choice to take profile measurements upstream or downstream of a section-line bridge was necessary due to bridge effects on water flow patterns and due to channel dimension changes that may occur during bridge construction.

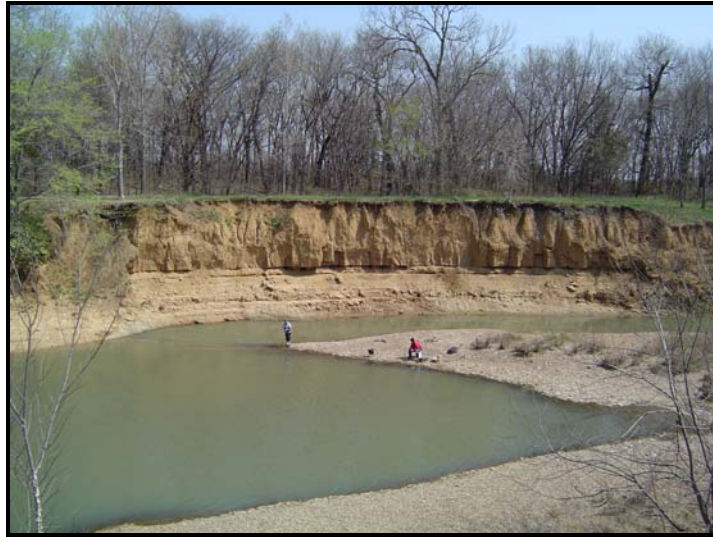
Figure 12: Cutbank erosion on the north side of the channel located downstream from the reservoir outlet, April 2004

The outlet channel below the dam has not been chosen as a study site since it is a new, man-made channel. Original widths of the channel at the date of construction are not indicated here, but, nonetheless, cutbank and channel bed erosion has been occurring (Figures 12 and 13).

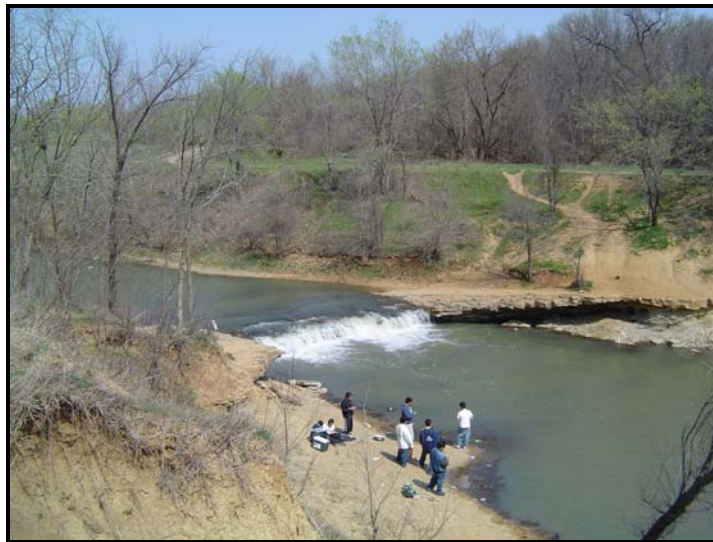
Figure 13: Channel bed erosion located downstream from the reservoir outlet, April 2004

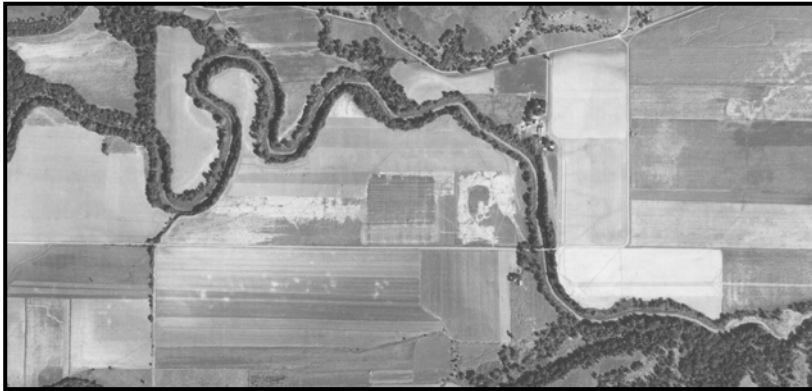
Figure 15: Channel width in 1941 above where present-day Clinton Reservoir is located (KARS 1941)

Qualitative comparisons of the entire river between 1959 and 1991, along with additional photo years available, show an outcome similar to the statistical analysis. There is no detectible width change in the upstream portion of the river or the downstream portion. Visual confirmation of widening just above Clinton Reservoir is first illustrated in the color infrared image from 1981, and further expansion is seen in the 2006 color infrared image (Figures 15, 16, and 17).

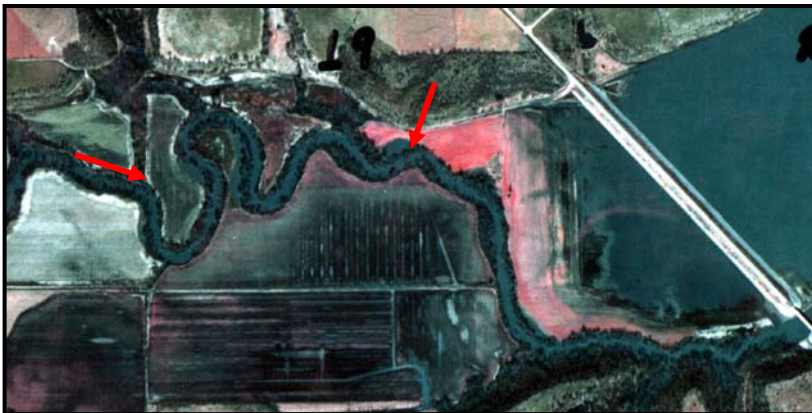
Figure 16: Channel width increase seen in 1981 after reservoir impoundment. Red arrows indicate areas where water flow is beyond previous channel banks (NRCS 1981)

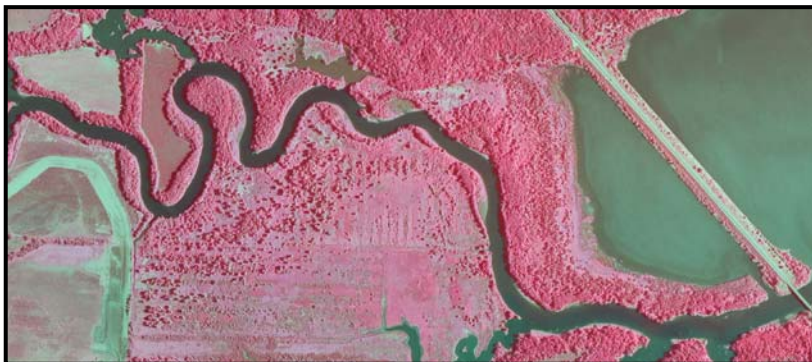
Figure 17: Continued channel width increase showed in the 2006 NAIP image (DASC 2007)

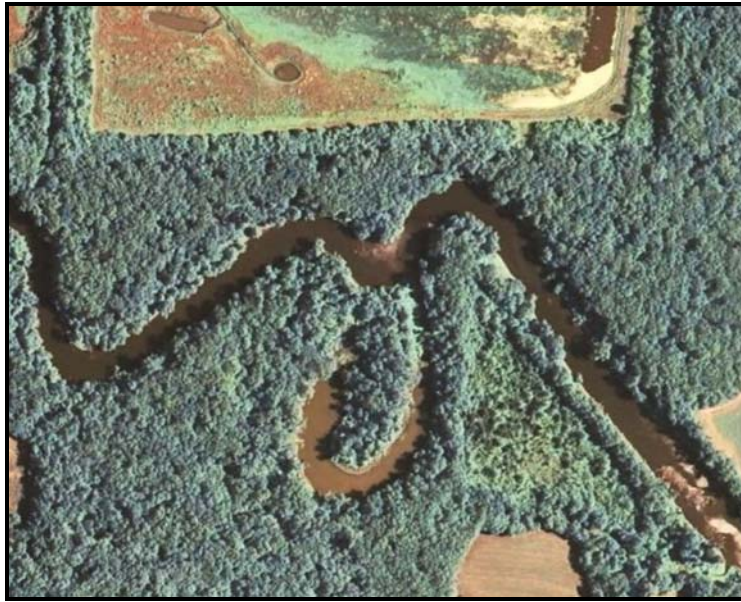
Figure 20: 2006 NAIP image of a meander cutoff forming an oxbow lake located in Douglas County, 3 km upstream of Clinton Reservoir. (DASC 2007)

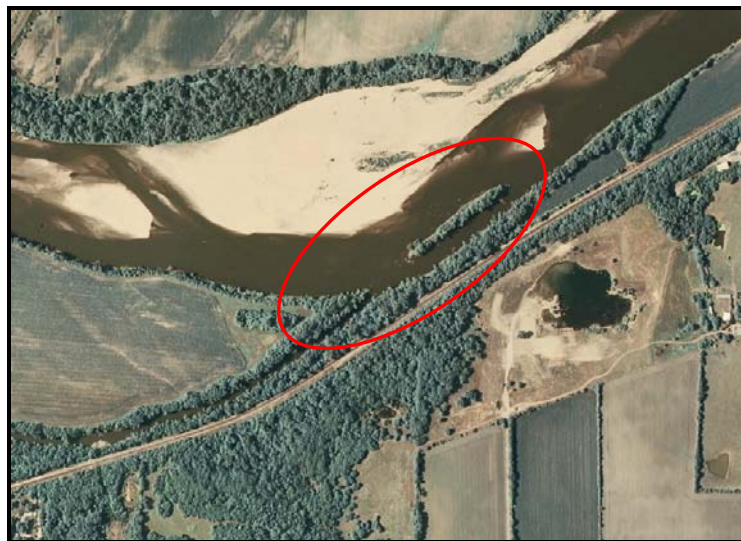
Figure 21: 2006 NAIP imagery showing the decrease in channel length at the confluence with the Kansas River. Riparian vegetation is still visible where the previous bank existed. (DASC 2007)

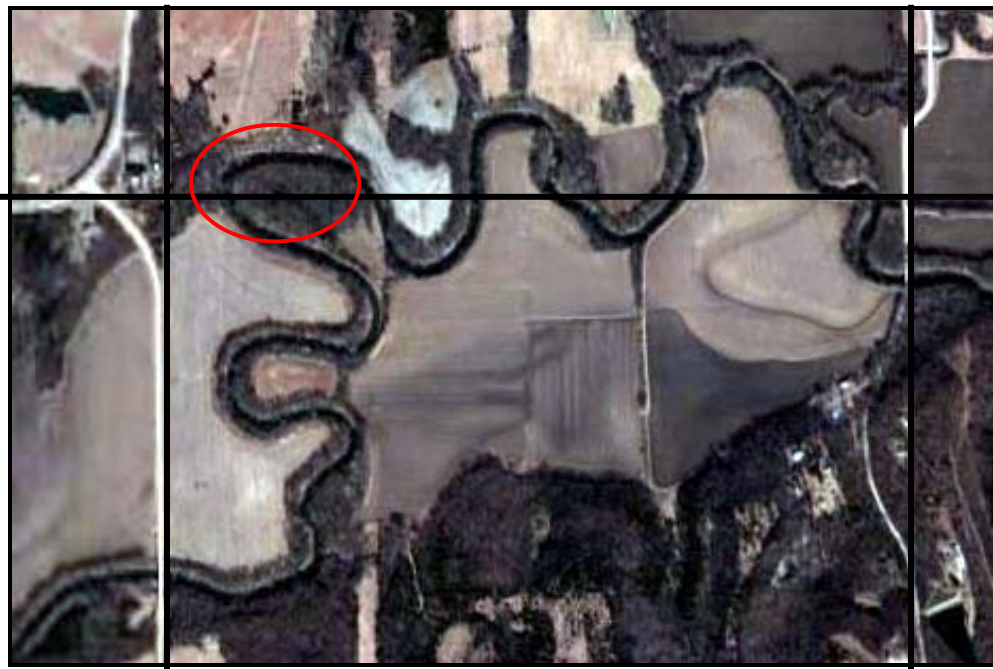
Figure 23: Modern meanders along section line have shifted and a previous meander has been cutoff between sections 24 and 25, T. 13 S., R. 16 E. in Shawnee County (DASC 2002)

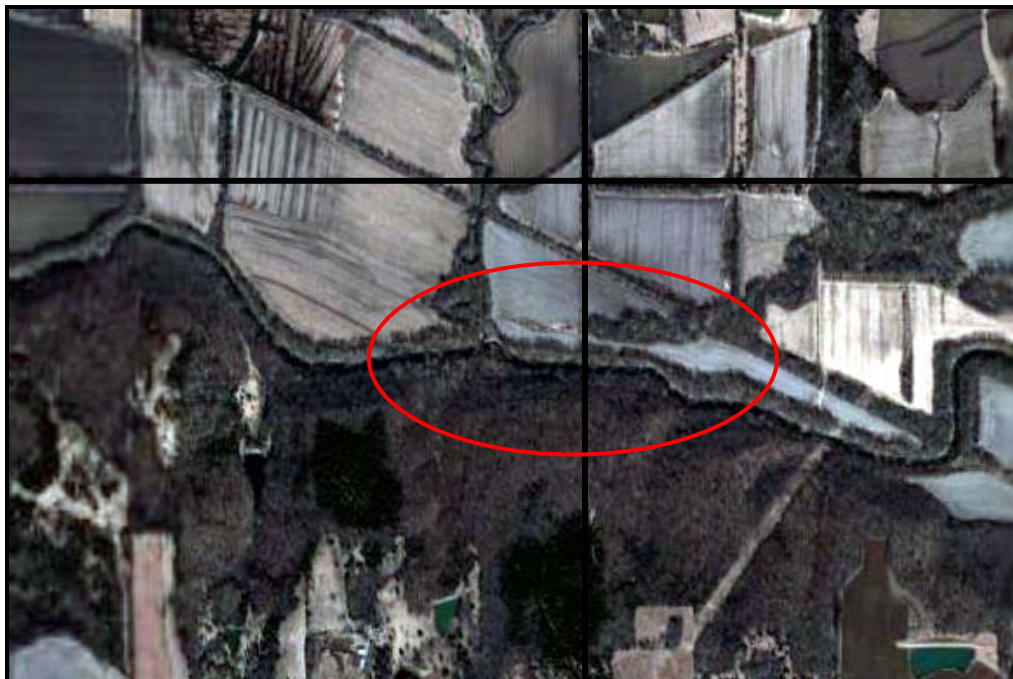
Figure 25: Modern river has straightened and shifted southward against the valley wall in sections 29 and 30, T. 13 S., R. 17 E. in Shawnee County (DASC 2002)

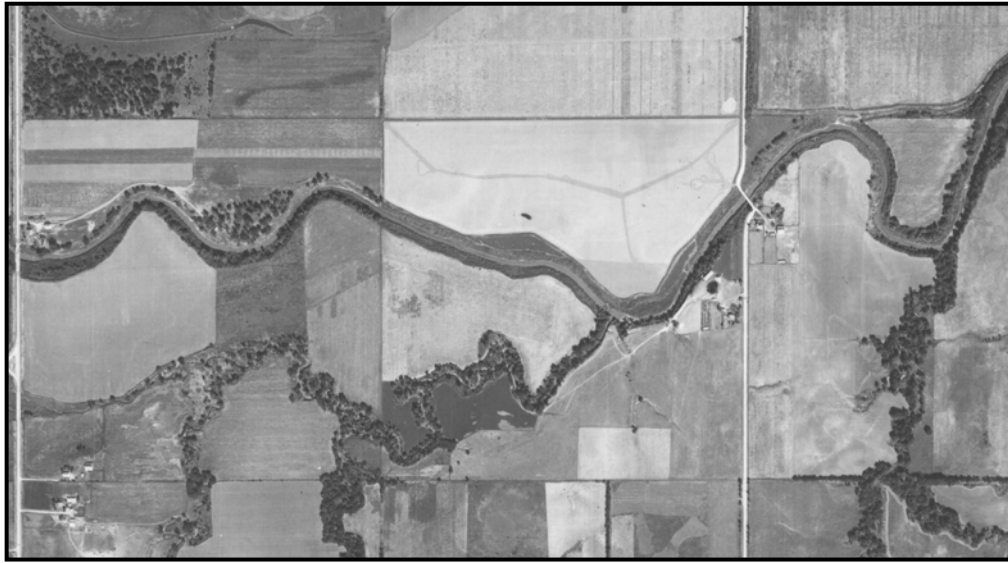
Figure 28: A 1941 aerial photograph showing the lack of trees along the Wakarusa River at a location east of Highway 59, directly south of Lawrence (KARS 1941)

Today the riparian zone is narrow but contains dense tree growth and woody undergrowth along most of the channel. Aerial photographs of the Wakarusa channel south of Lawrence from 1941 (Figure 28) and 2006 (Figure 29) illustrate one of the many locations where expansion of riparian vegetation has occurred. Native prairie grass communities that were once seen in the valley bottom have been replaced with cultivated crops. The decrease in riparian vegetation after Euro-American settlement and the destruction of native prairies in favor of agricultural crops may also be responsible for the channel position changes seen prior to increased conservation practices implemented in the 1950s.

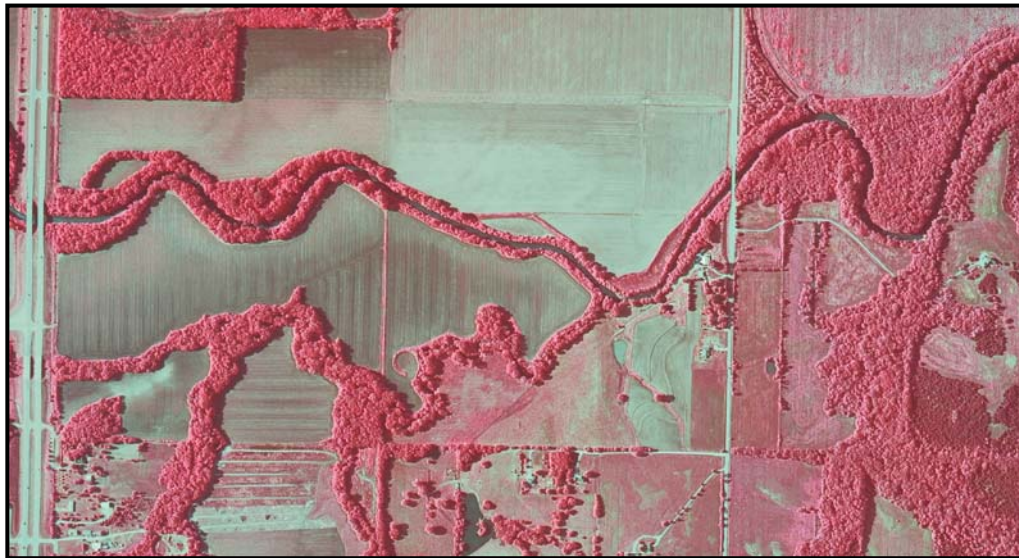
Figure 29: A 2006 color infrared image of the Wakarusa River channel east of Highway 59 showing the increase of woody riparian vegetation (DASC 2007)

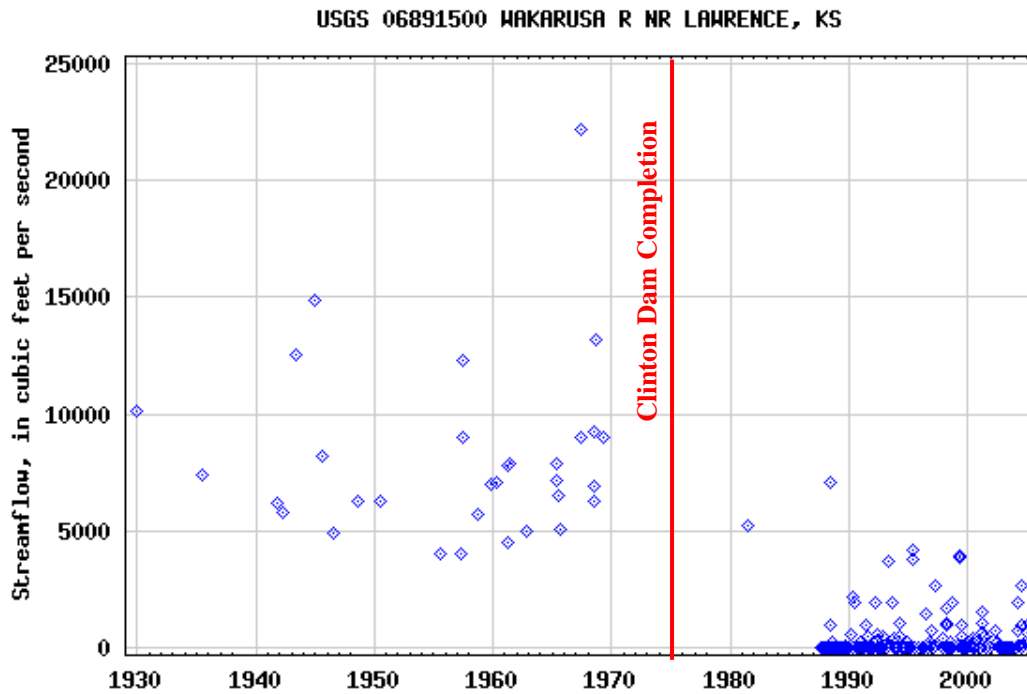
Figure 30: Streamflow measurements taken at the gaging station near Lawrence before and after dam completion in 1975. (USGS 2002)

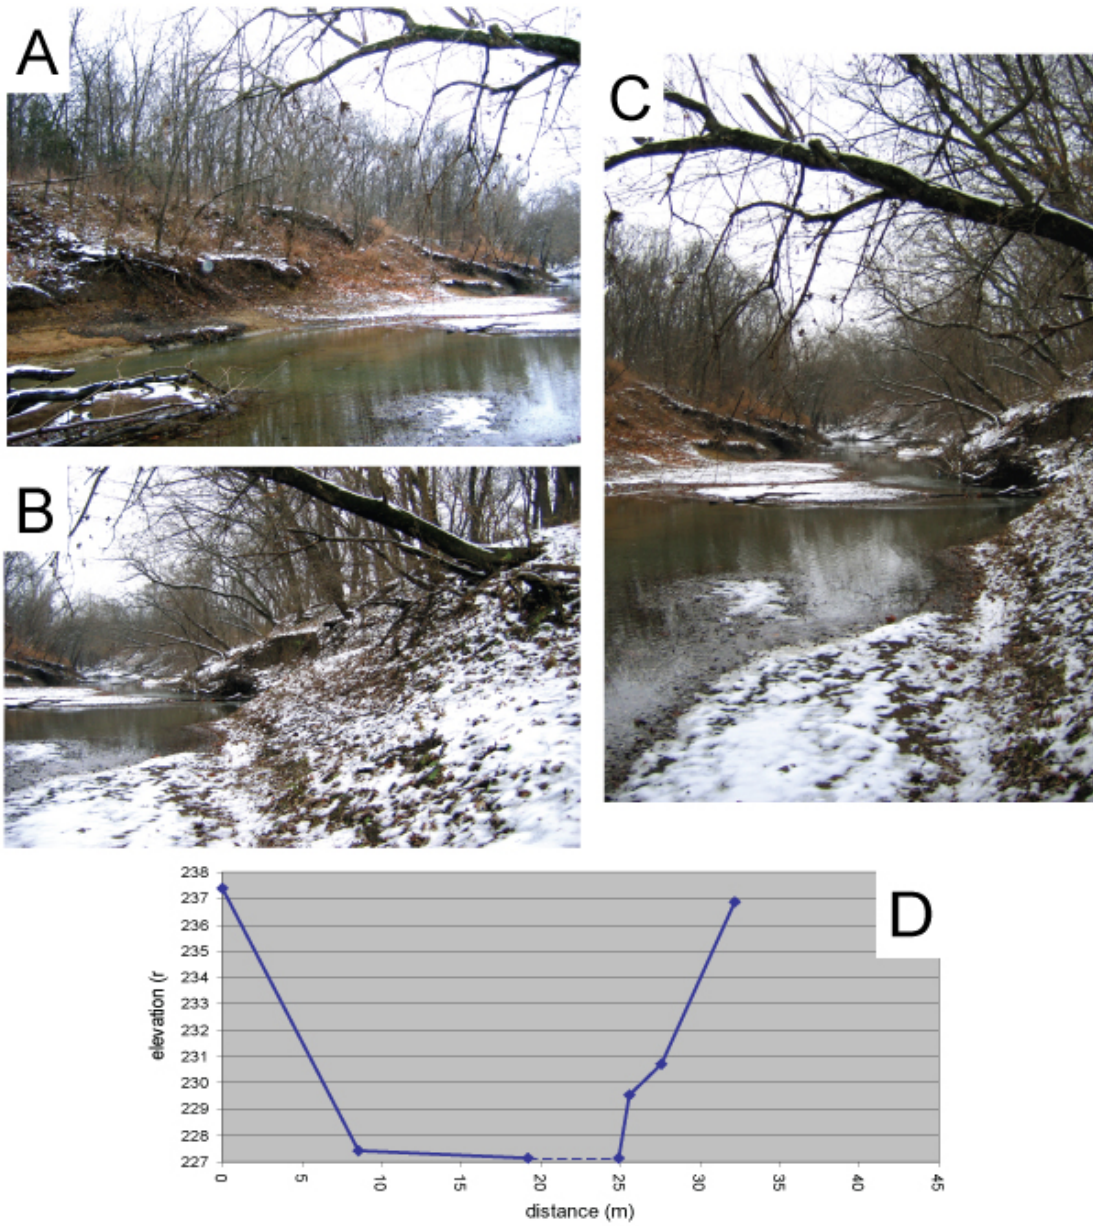
**Plate 9:** Site location: 38.92640° N, 95.31801° W. A) North bank showing bank erosion downstream of the dam outlet channel, B) south bank, C) downstream view showing channel sandbars, D) channel profile facing downstream
