REPAIR OF BRIDGE STEEL GIRDERS DAMAGED BY DISTORTION-INDUCED  
FATIGUE

Submitted to the graduate degree program in Civil Engineering and the Graduate Faculty of the  
University of Kansas in partial fulfillment of the requirements for the degree of Doctor of  
Philosophy.

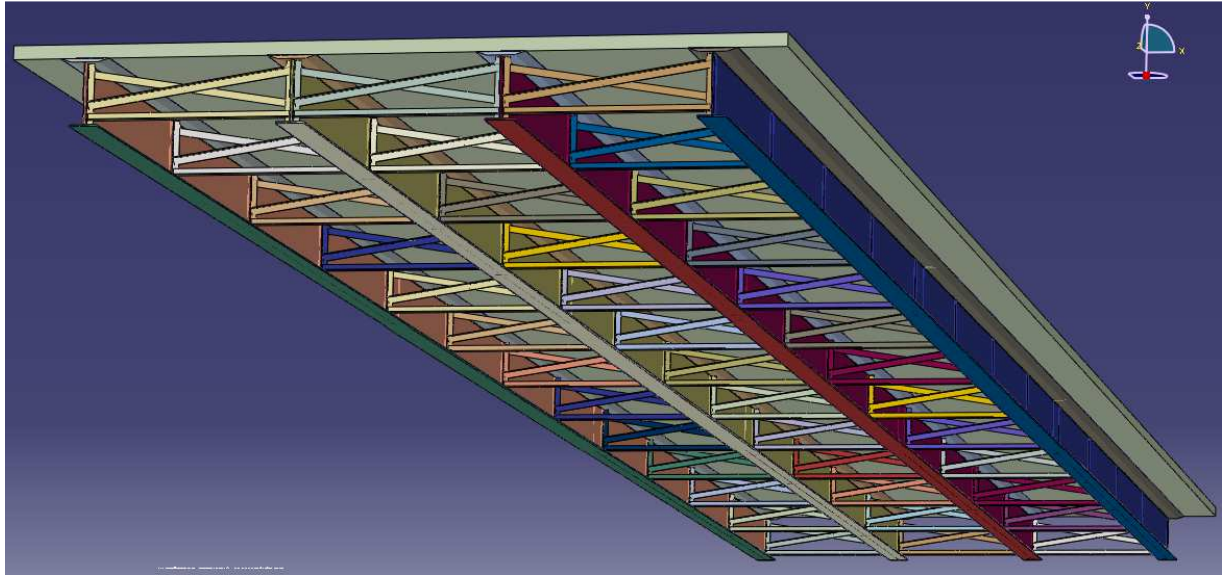
**Figure 1-1: Bottom view of bridge model from simulation (Hassel, 2011)**

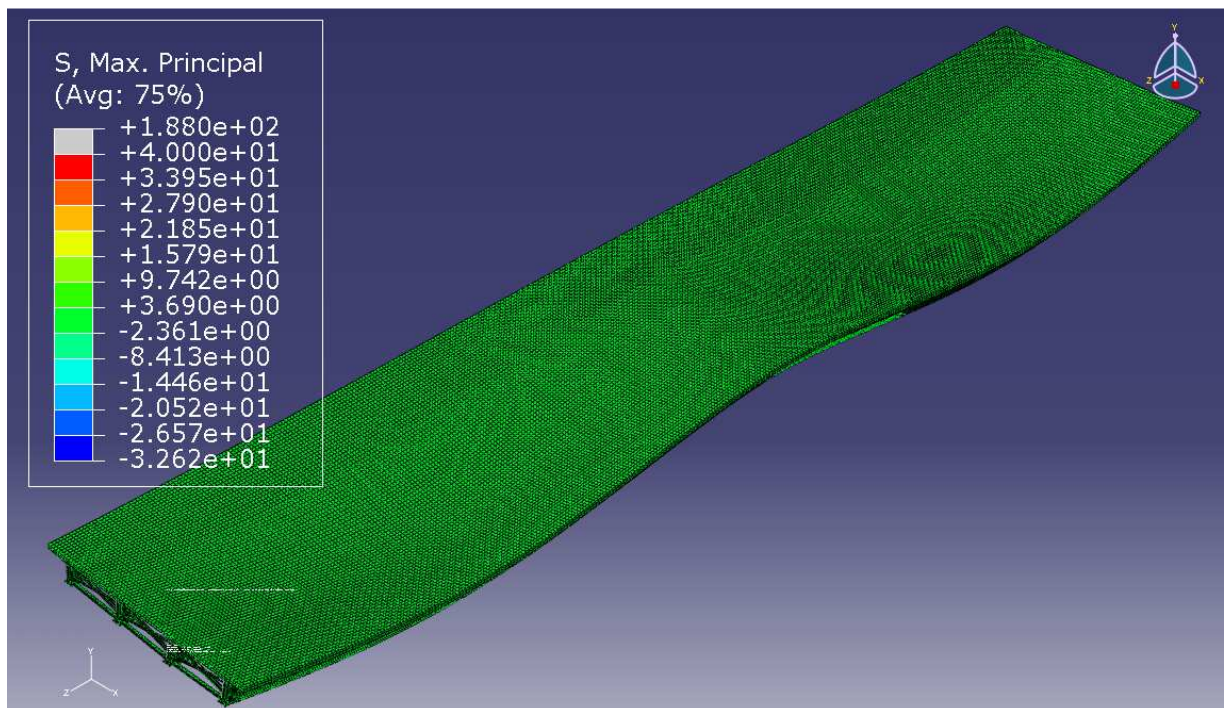
**Figure 1-2: Deflected shape of the bridge model under truck load (Hassel, 2011)**

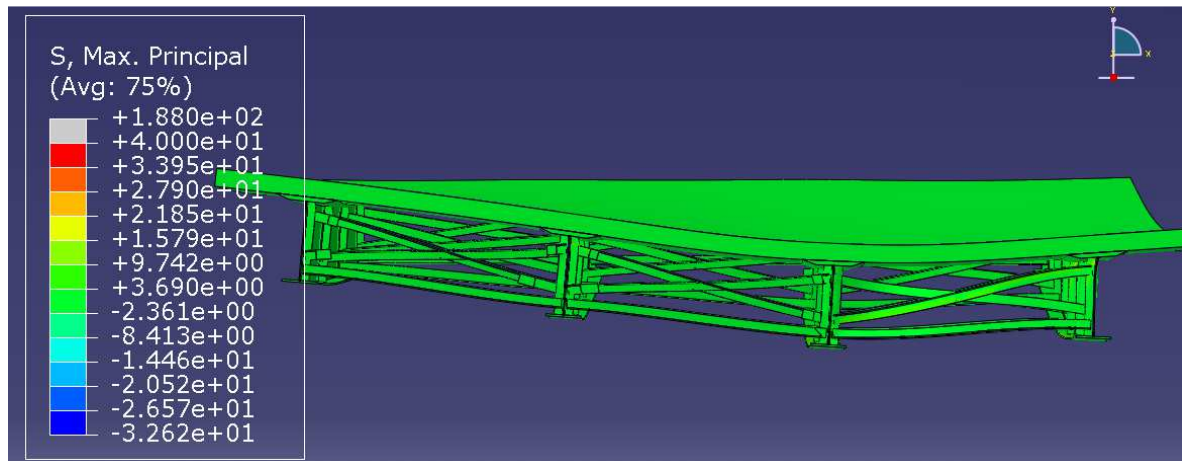
**Figure 1-3: Deflected shape of bridge section in a region of positive moment (Hassel, 2011)**

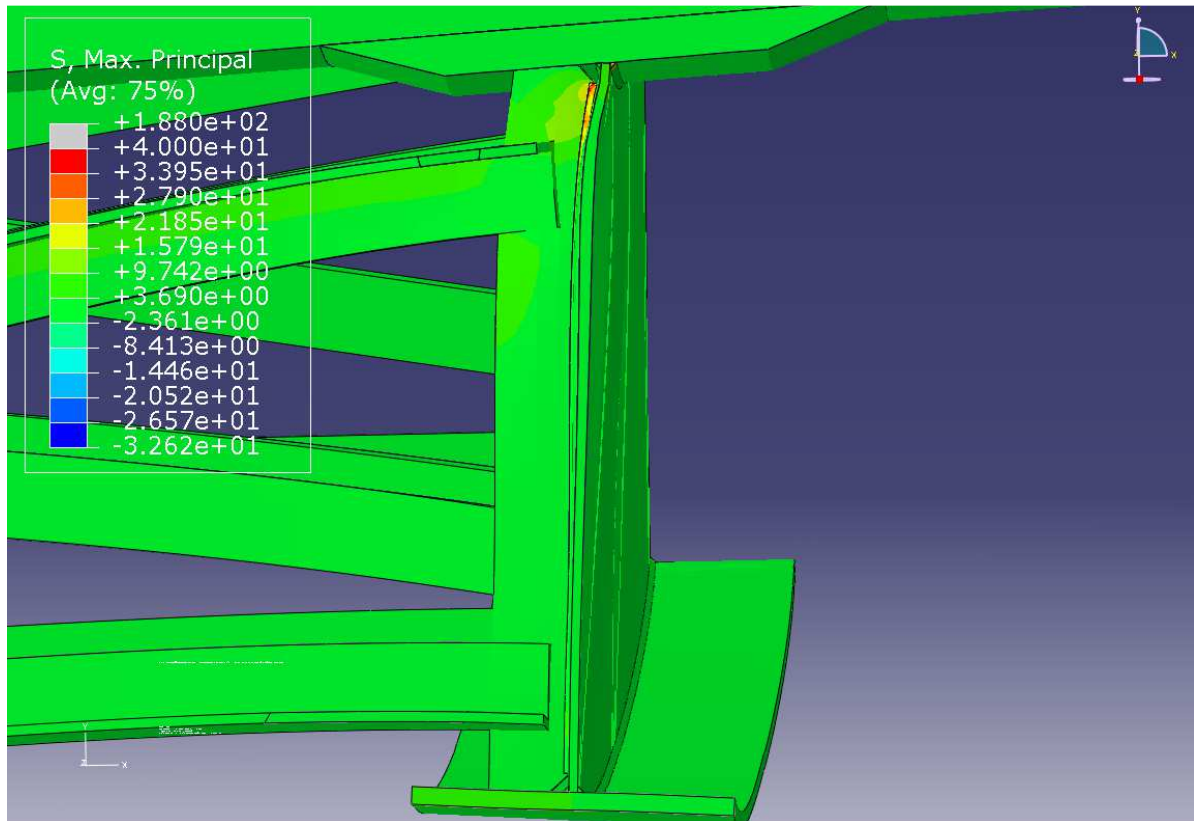
**Figure 1-4: Close-up showing stress demand at the web gap region of the deflected girder (Hassel, 2011)**

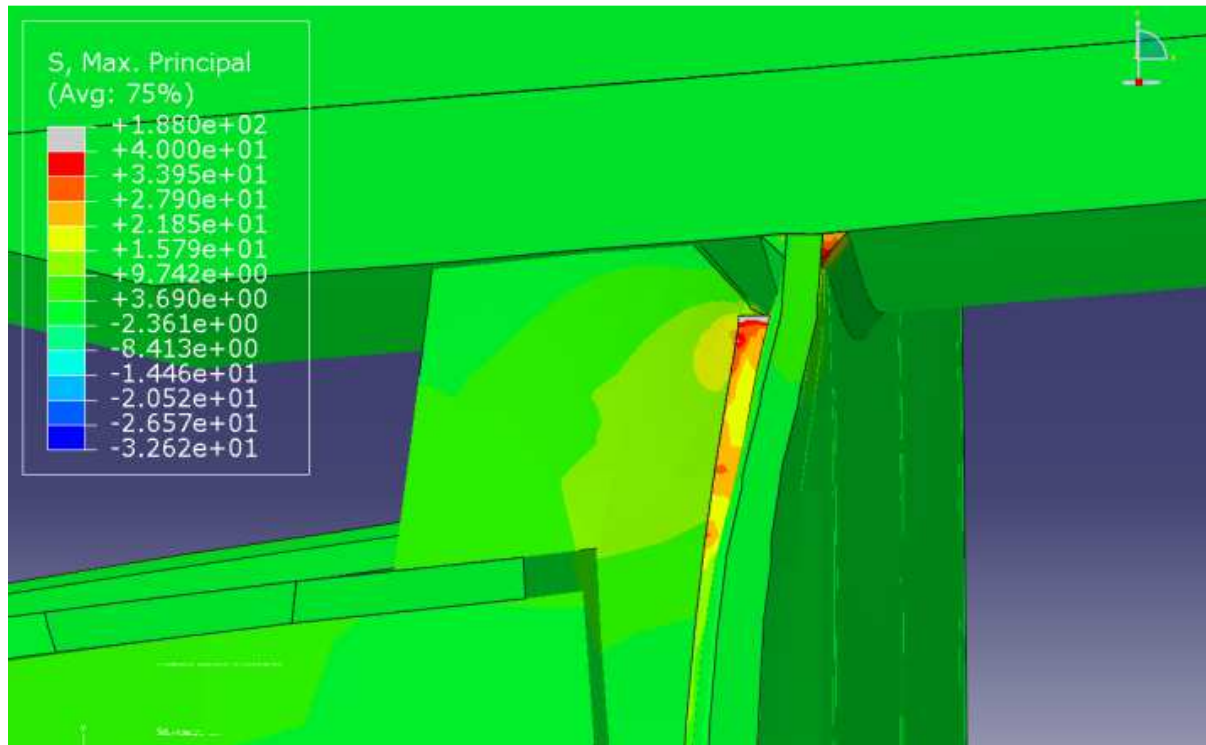
**Figure 1-5: Detailed view of the stress demand at the web gap region of the an external bridge girder (Hassel, 2011)**

The distortion-induced fatigue problem presents many challenges, in terms of analysis and repair. The distribution of stresses in web gap regions of steel bridges (Fig. 1-5), where fatigue cracks due to distortion-induced fatigue often originate, is very complex. Due to the complexity of the stress field, cracked areas are subjected to loadings that produce mixed mode fracture. Repairing distortion-induced fatigue damage is also difficult because geometric constraints limit the type of repair methods that can be applied to prevent further growth of fatigue cracks. Given the unique nature of this problem it is important for engineers to have at their disposal various alternatives for repair. The development of new techniques to repair distortion-induced fatigue damage is the focus of this study.

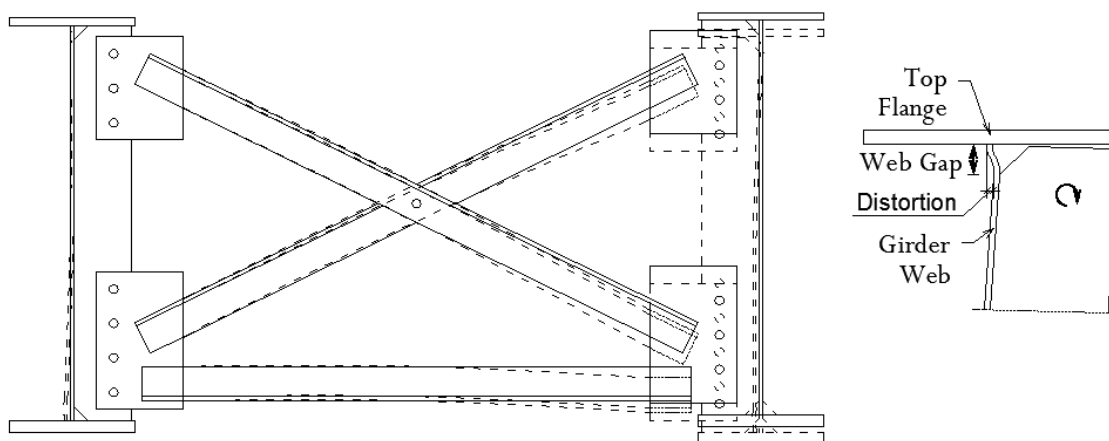
**Figure 2-1 : Out of plane distortion in bridge girder**

A web gap region is created when a connection plate is clipped at the top or bottom, leaving a gap between the edge of the connection plate and the unconnected girder flange (Fig. 2-1). This type of connection detail was widely used in the United States before the mid 1980s. The connection detail was implemented in this manner because it is very difficult to achieve a good quality weld at the intersection of the web and flange (Castiglioni et al., 1988), and because of fears that welding the connection plate to the tension flange would lead to fatigue damage in the flange similar to that observed in European bridges early in the last century (Roddiss and Zhao, 2001). Roddis and Zhao (2001) indicate that it was common practice not to weld connection plates to the compression flange also to avoid the introduction of AASHTO fatigue category E connection details.

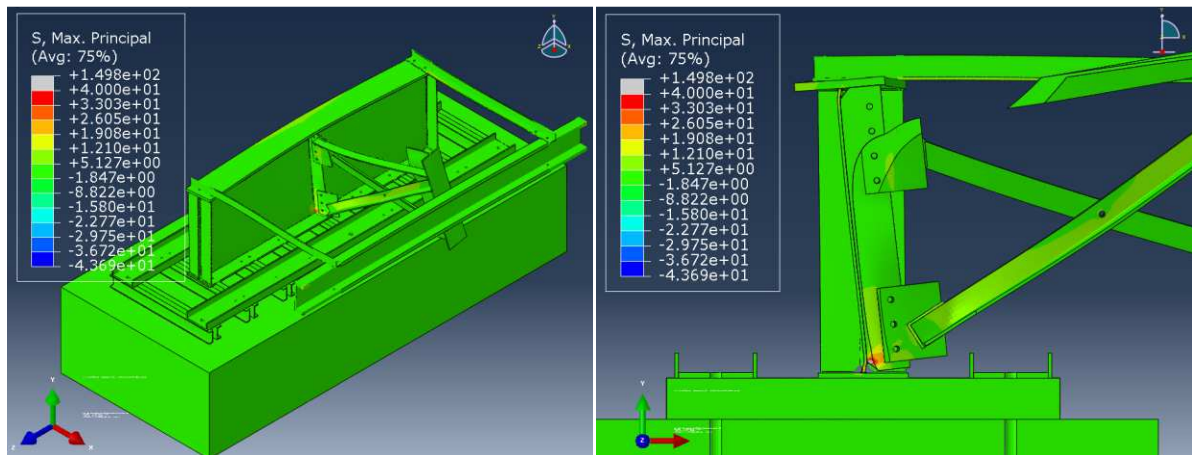
**Figure 2-2: Deformed configuration of girder specimen: a) aerial view b) center cut**

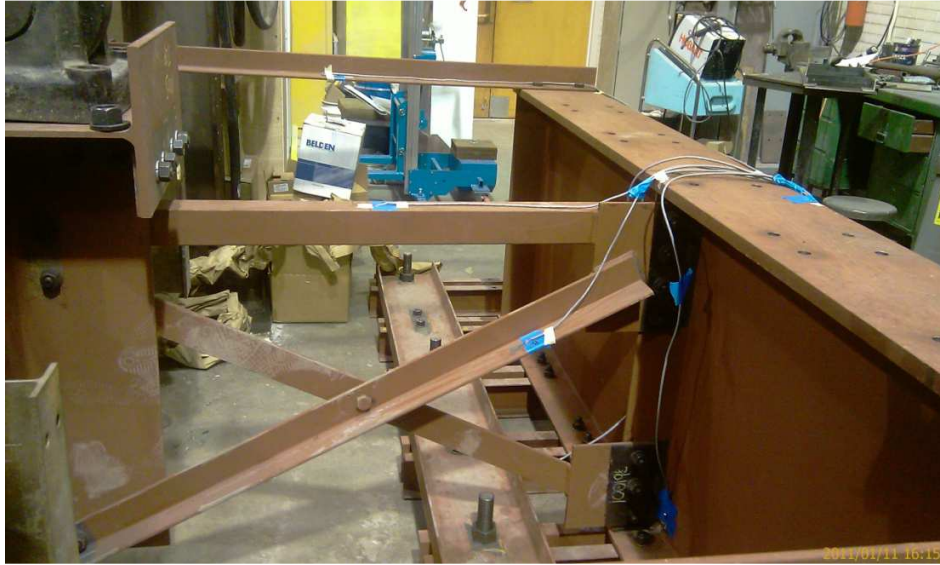
**Figure 2-3: Experiment setup.**

The model was loaded with a single 22,240 N (5 kip) force, applied to a WT section that was used to connect the cross braces to the actuator. The bottom of the concrete block below the specimen was modeled as fully fixed, and so were both ends of a channel connecting the two end angles to the reaction frame (Fig. 2-3). The WT section connected to the actuator was restrained from moving along the direction parallel to the longitudinal axis of the girder. Figures 2-3 and 2-4 show the girder specimen and the experimental setup.

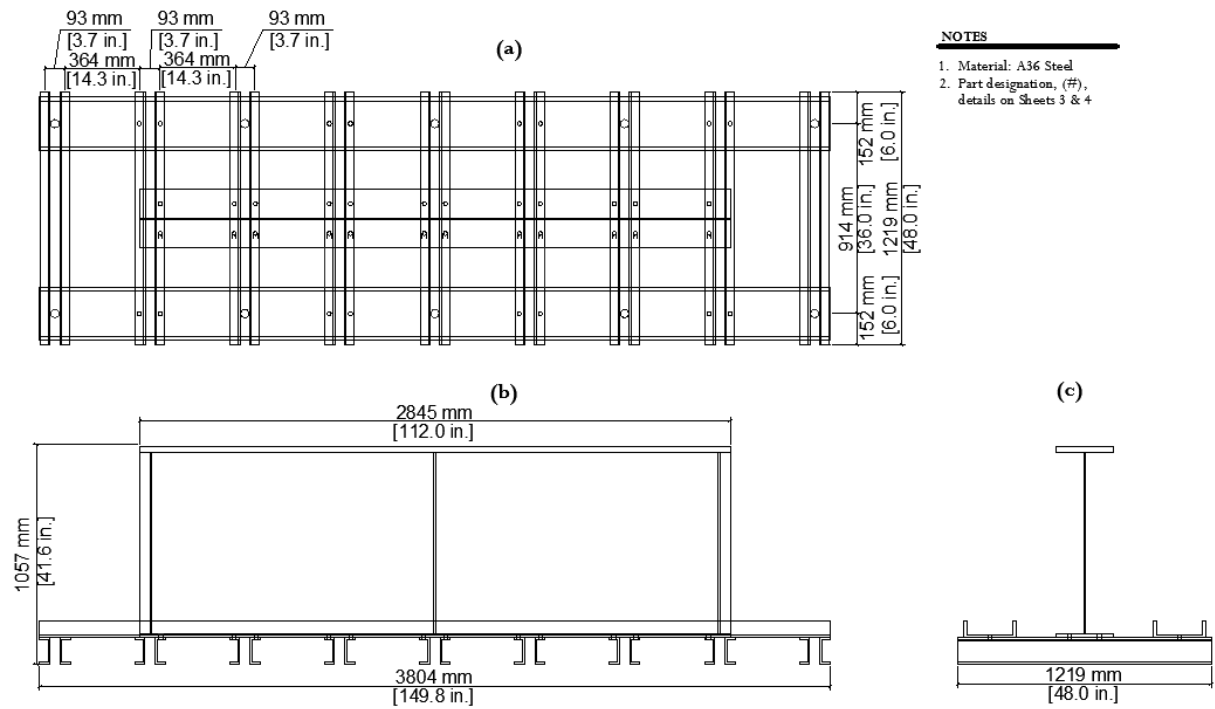
**Figure 2-4: Girder specimen a) plan b) elevation c) section**

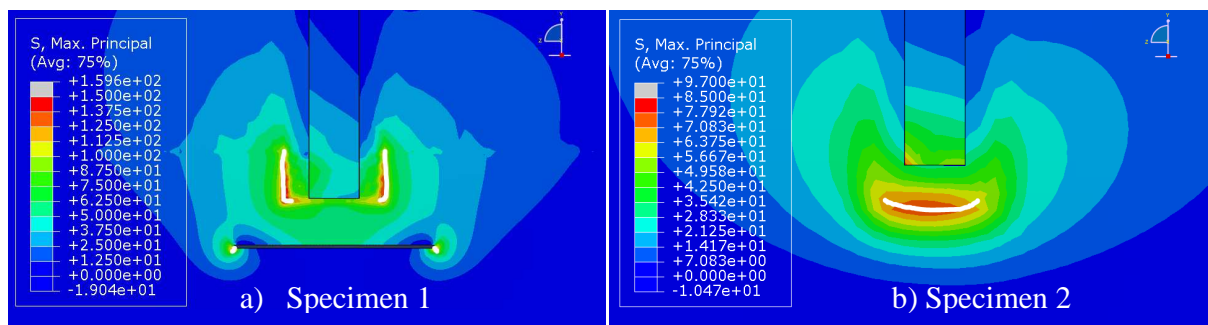
**Figure 2-5: Observed crack patterns superimposed on the results from the simulation models for web gap regions of specimens 1 and 2.**

measure of demand in areas of the web gap region where there were large stress gradients, such as near welded or bearing connections. Maximum principal stresses were used as a measure of vulnerability to fatigue damage because areas with the largest maximum principal stress demands in the model correlated well with locations where cracks formed in the specimens (Fig. 2-5).

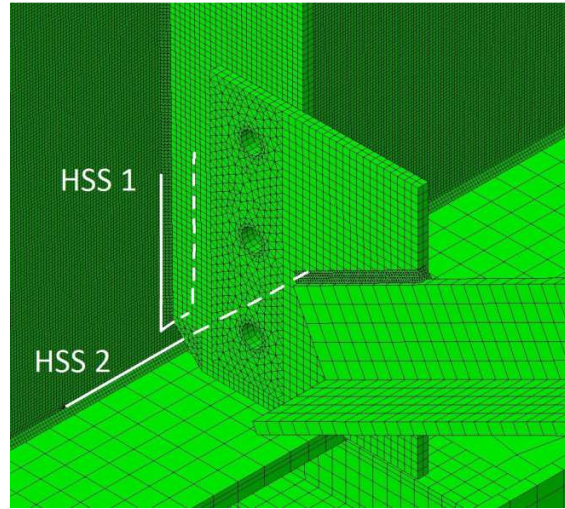
**Figure 2-6: Pre-defined paths for sampling of stress demands in the various FE models.**

In accordance with the definition of HSS used in this study, paths for sampling the stresses were defined at a distance of 5 mm (0.19 in.) away from the weld, equivalent to half the thickness of the web (10 mm,  $\frac{3}{8}$  in.) (Fig. 2-6). HSS sampling paths were defined only at locations where cracks were observed in the specimens. HSS Path #1 Bottom was defined as a horseshoe-shaped path in the bottom web gap of the subassembly. HSS Path #2 Bottom was defined as a horizontal path above the crack that formed in the web-to-flange weld in the bottom web gap of the subassembly. Similar paths were defined and sampled in the top web gap of the subassembly when cracks were observed in the experiment. The J-Integral and stress intensity factors (SIF) at the tip of simulated cracks were computed as a measure of propensity for crack growth. A total of 5 contours were evaluated in the calculations, at points evenly spaced through the thickness of the web.

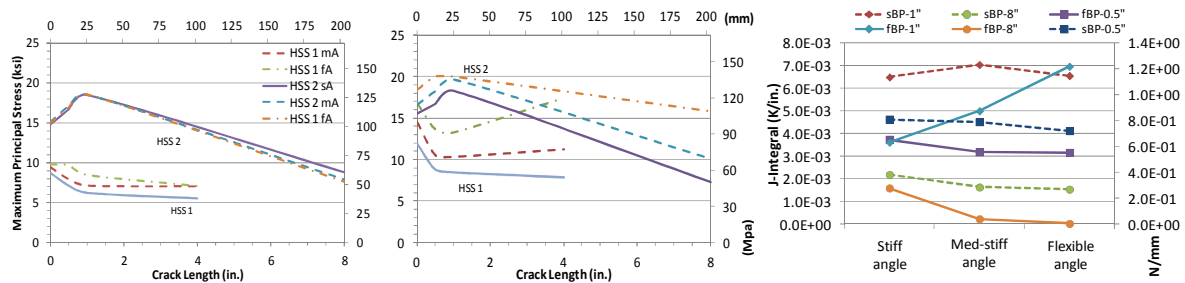
**Figure 2-8: Peak demand at web gap region vs. crack length for retrofitted specimens a) HSS for stiff back plate configurations b) HSS for flexible back plate configurations, c) J-Integral for various back plate configurations.**

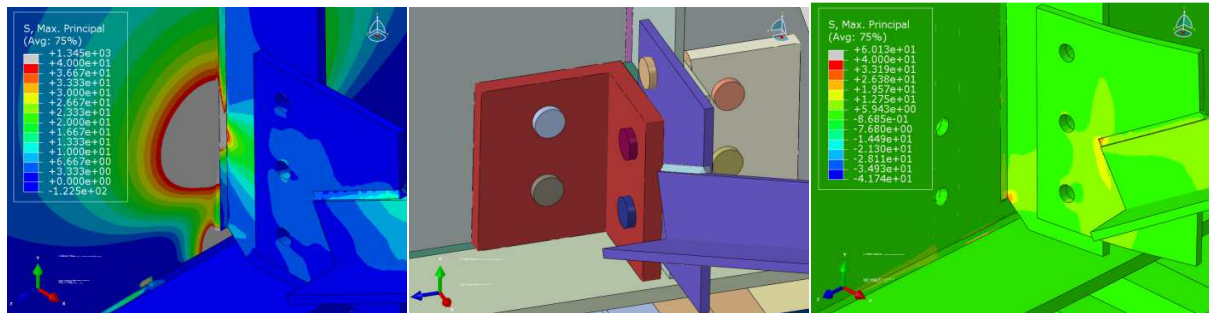
**Figure 2-9: a) computed stresses without retrofit b) angle retrofit configuration c) computed stresses with retrofit.**

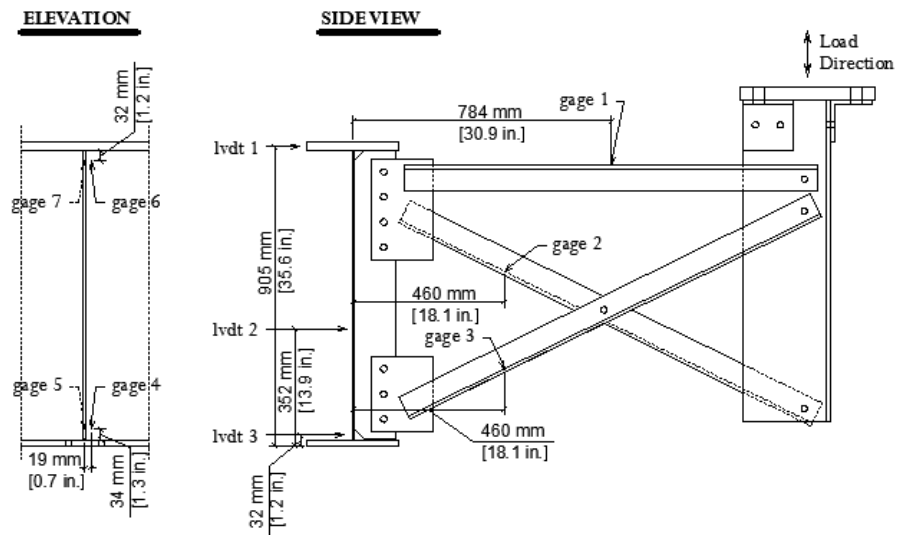
**Figure 2-10: Instrumentations on 9-ft girder specimen.**

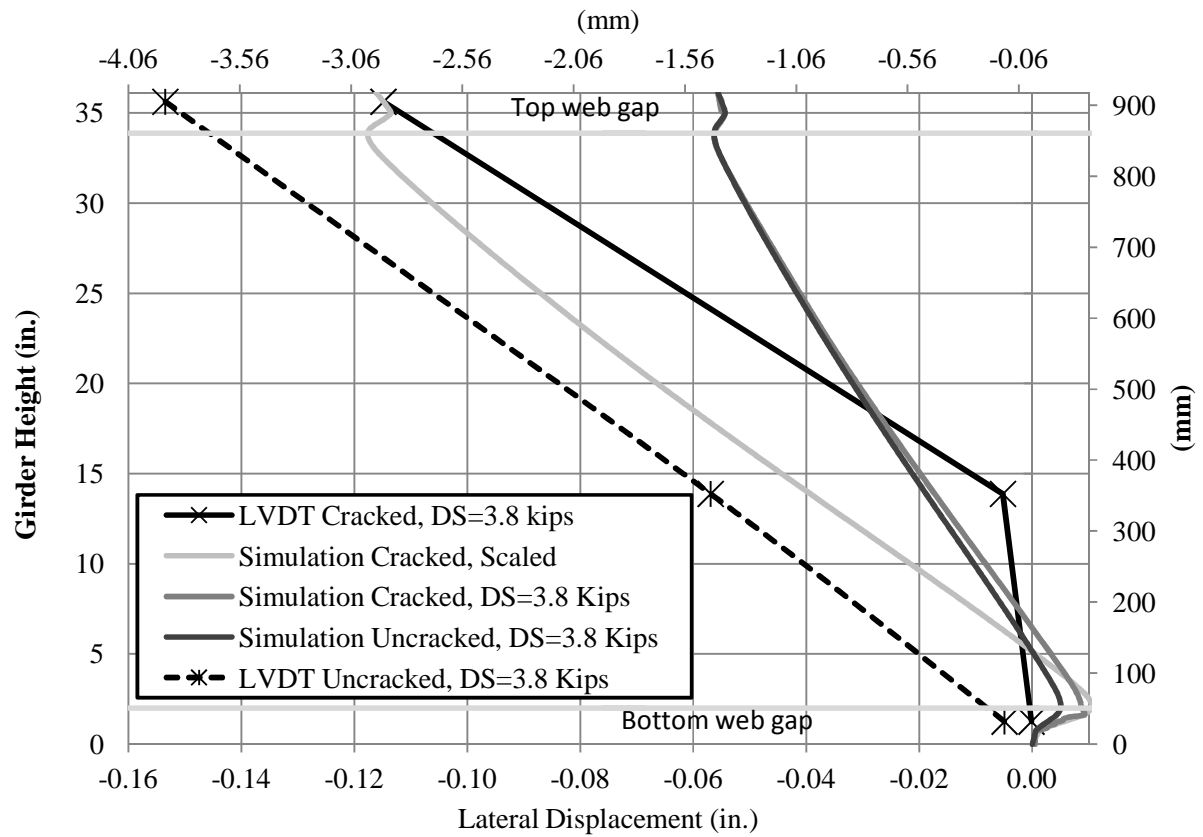
**Figure 2-11: Comparison between LVDT readings and computed deformations**

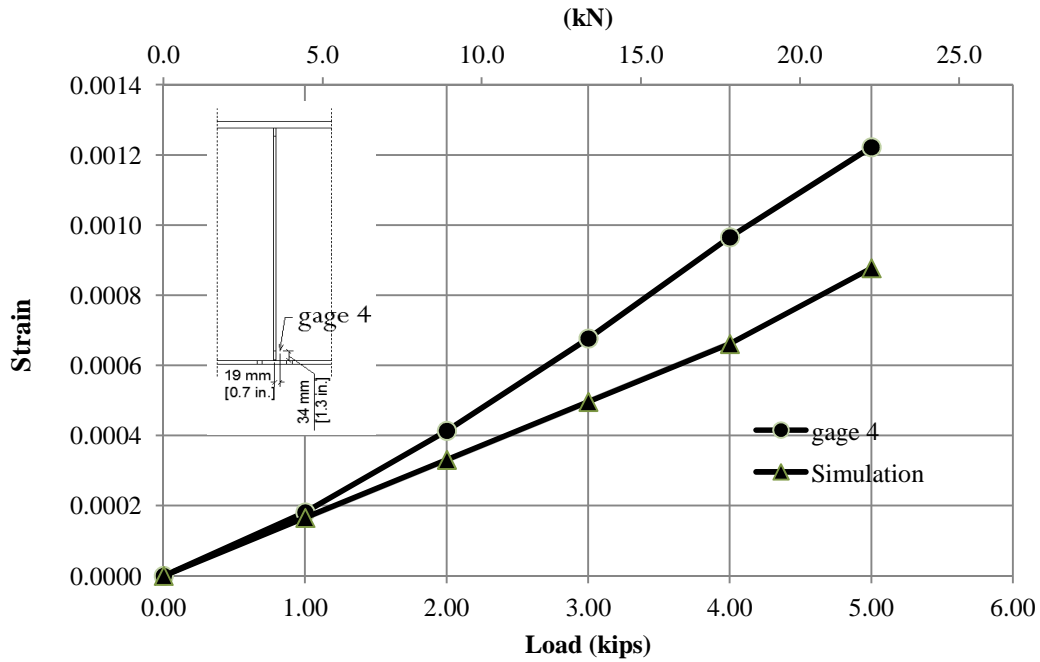
**Figure 2-12: Strain gage readings compared with simulation model results.**

Figure 2-12 shows a comparison between strain gage readings and simulation results. The computed strains shown in the figure represent average values over the area occupied by the gages. The gage readings were slightly higher than the simulation values, which is consistent with the results for the deflected shapes.

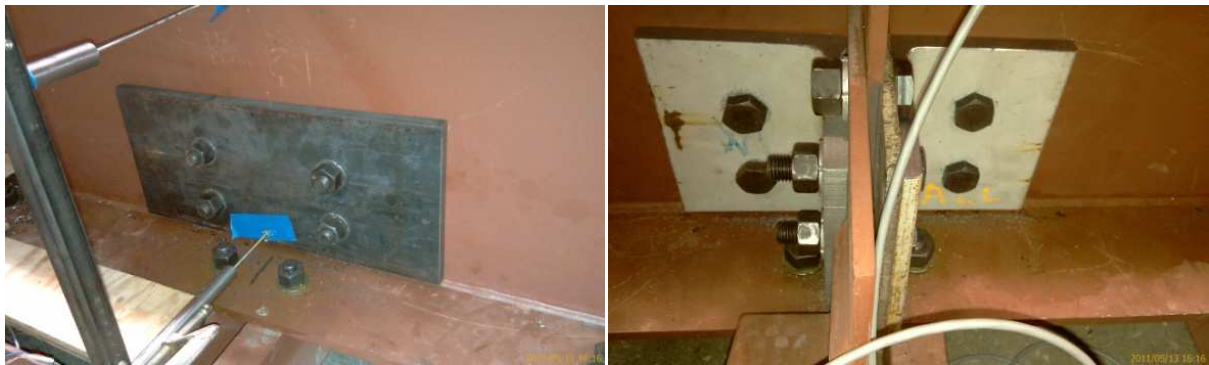
**Figure 2-14: Angle retrofit with plate a) back plate, b) angles**

The configuration of this retrofit measure is shown in Fig. 2-7a, Fig. 2-13 and Fig. 2-14. Parametric analyses of the angles-with-plate retrofit measure were performed to determine the optimal back plate and angle dimensions. The first parametric study involved varying the angle and back plate thicknesses, while the other dimensions were kept constant. The crack pattern in the model was the same used to evaluate the performance of the crack-stop hole retrofit, with a 102-mm (4-in.) tall horseshoe crack and a 203-mm (8-in.) horizontal crack in the bottom web gap of the subassembly. The horseshoe-shaped crack followed the toe of the CP-to-web fillet weld, while the horizontal crack was placed along the web-to-bottom flange weld. The back cover plate and angle thicknesses evaluated were 6 mm ( $\frac{1}{4}$  in.), 13 mm ( $\frac{1}{2}$  in.), and 25 mm (1 in.). Computed stress demands are summarized in Table 2-2. All values in Table 2-2 correspond to reductions in the calculated elastic stress demand with respect to the unretrofitted configuration ranging from 93 to 98%, which clearly shows that this retrofit significantly reduced the computed stress demand in the bottom web gap region. Although variations in the stress demands were found to be small, some trends can be discerned that are helpful in choosing an optimum configuration for the retrofit measure.

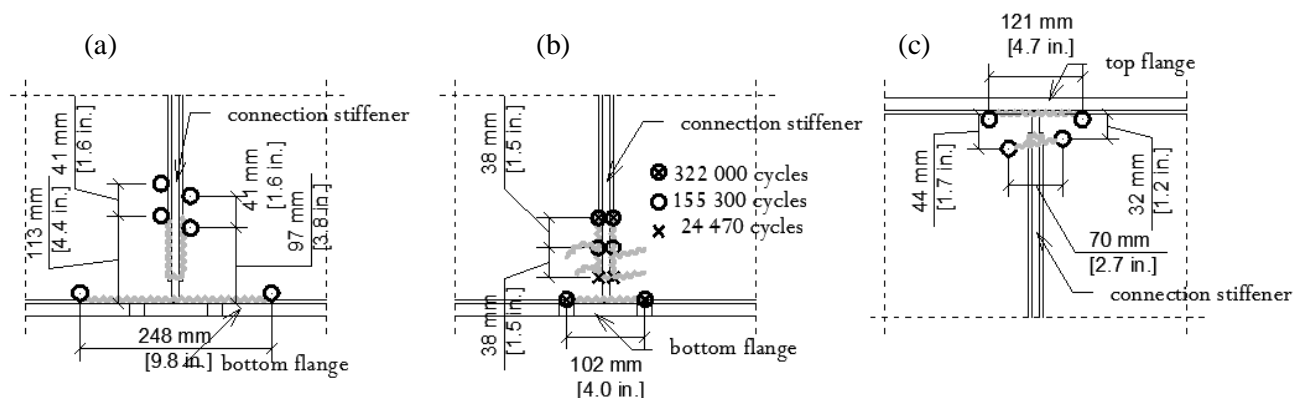
**Figure 2-15: a) Crack stop holes in bottom web-gap region specimen 2, b) Crack progression at the bottom web gap region of specimen 2, un-retrofitted, c) Crack stop holes at the top web gap region**

Crack-stop holes were placed in the FE models in the same locations that they were drilled in the specimen. The location of the crack stop holes is shown in Figure 2-15. Holes were placed at the tips of the 102-mm (4-in.) horseshoe crack and the 203-mm (8-in.) horizontal crack in the bottom web gap of the subassembly. Holes were also drilled at the tips of the cracks in the top web gap of the subassembly. The diameter of the holes was 19 mm (0.75 in.). Not all holes shown in Fig. 2-7b are crack-stop holes. Four of the holes were used to attach angles to the web. Figure 2-7 shows the computed stress fields with and without crack-stop holes. The comparison shows that the stress demands were virtually the same.

The crack-stop holes were drilled so that the edge of the hole would coincide with the corresponding crack tip. When two cracks were found closely located to each other a single crack stop hole was drilled to encompass both crack tips. Crack stop holes were not drilled at cracks that had stabilized in the unretrofitted configuration. The hole placement in the bottom and top web gaps of specimen 2 are shown in Fig. 2-15. As shown in Fig. 2-15 some cracks intersected others; for example, horizontal cracks on the front and back of the web. In that case, crack stop holes were placed on the longer cracks and the smaller diameter holes were drilled at the tips of the shorter cracks. The smaller holes had a diameter of 6 mm ( $\frac{1}{4}$  in.). The diameter of the crack stop holes was 21 mm ( $\frac{13}{16}$  in.) and they were drilled using a hole saw with guide.

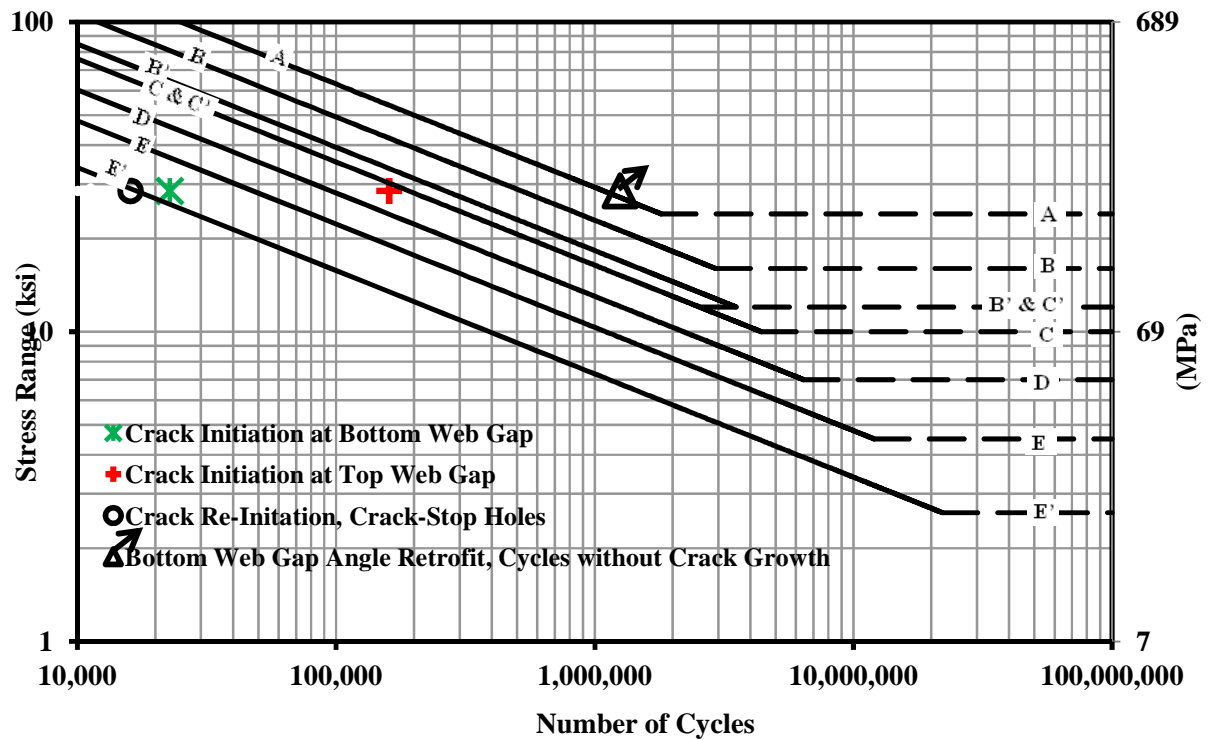
Figure 2-16: Experimental results for specimen 2 trials.

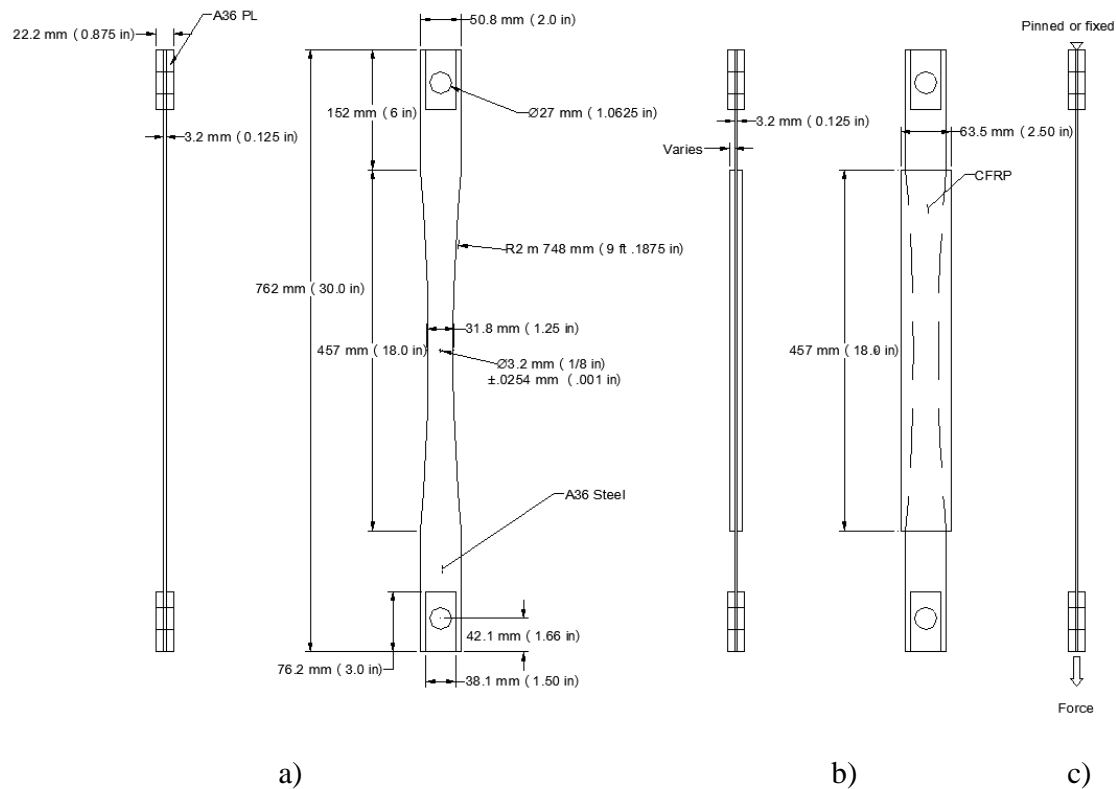
Figure 3-1 : Tension specimen: a) bare steel b) specimen with CFRP overlay attached c) boundary and loading conditions imposed on the FE model.

Finite element simulations of the specimens tested during the experimental program (Fig. 3-1) were carried out using the commercially-available Finite Element analysis software ABAQUS version 6.8.2 (Simulia, 2009).

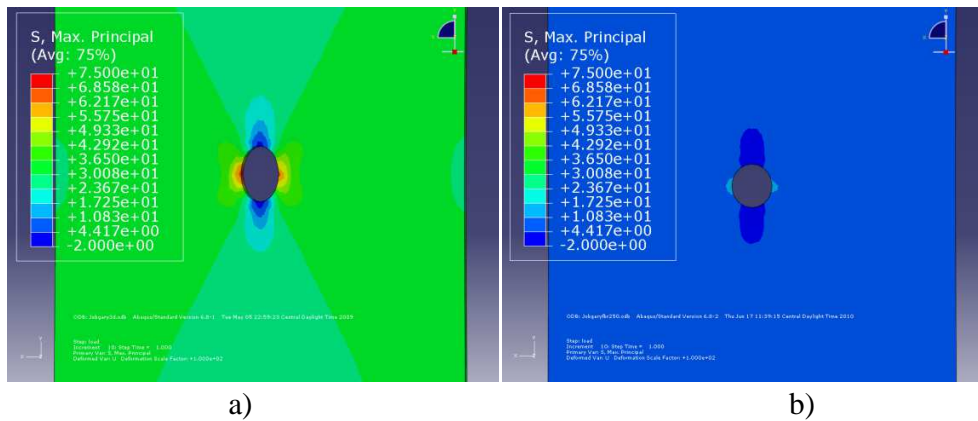
**Figure 3-2 : Maximum principal stresses at the center of the specimen for the a) unreinforced configuration, and b) reinforced configuration**

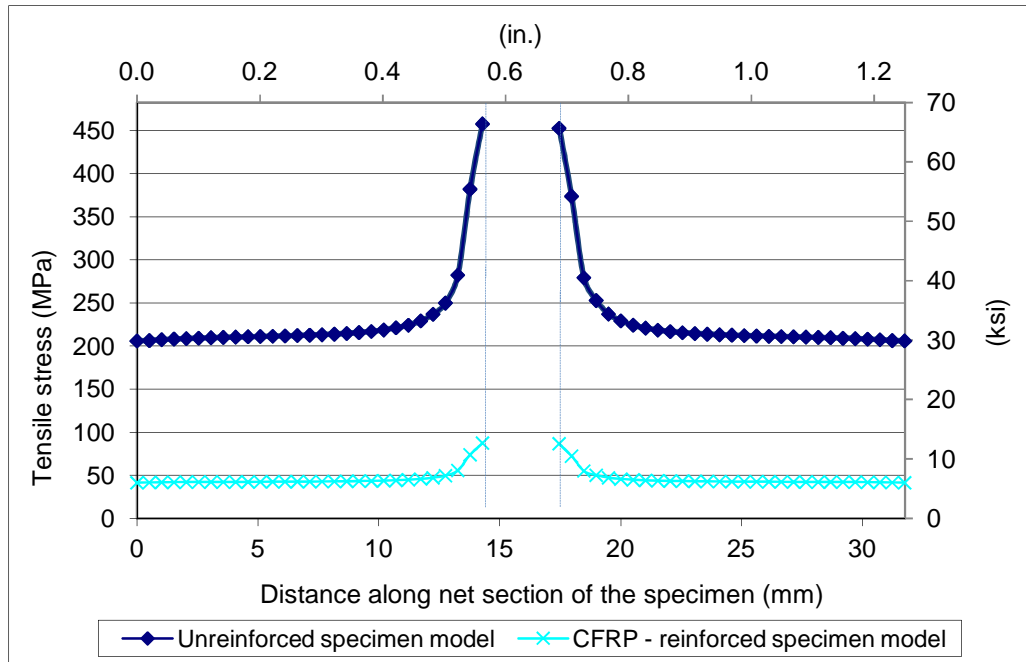
**Figure 3-3 : Maximum principal stresses at the location of net cross-section for CFRP-reinforced and unreinforced specimens**

within a region 51 mm (2.0 in.) from the center hole, and 2.5 mm (0.1 in.) in all other parts of the specimen. Interfaces between the steel and composite parts of the model were defined using tie constraints. Motion was restrained at one end of the model while the other end was free to move only in the vertical direction (Fig. 3-1c). Two concentrated loads were applied in the vertical direction at the unrestrained end, one on each face of the model. Fig. 3-2 shows maximum principal stresses for models with and without CFRP overlays attached. These maximum principal stresses were extracted along a path starting at the center of the steel plate and ending at the edge (Fig. 3-3) for comparison with other model results.

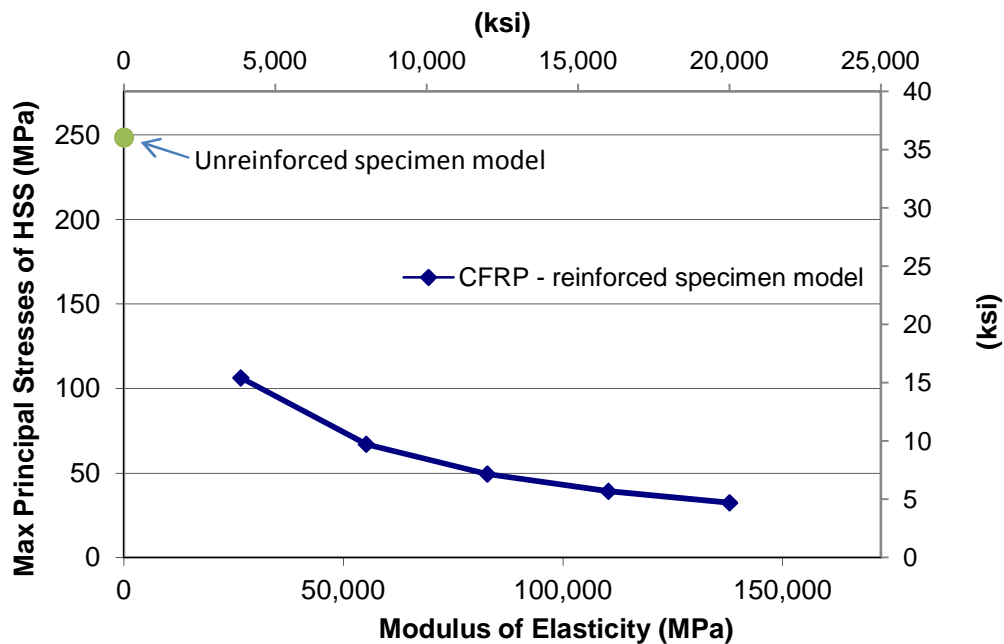
**Figure 3-4 : Effect of the stiffness of the CFRP overlays on maximum principal Hot Spot Stresses in the steel specimen**

3,860 ksi) when compared with the unreinforced case. Increasing the modulus of elasticity of the CFRP by a factor of five, from 26,000 MPa (3,860 ksi) to 138,000 MPa (20,000 ksi), led to a reduction in HSS by a factor of approximately three. This data shows that increasing the modulus of elasticity of the CFRP material exhibits diminishing returns, which is important to consider when determining optimal configuration of the overlay. If infinite fatigue or propagation life can be achieved with a relatively inexpensive overlay, there is no economic incentive for using stiffer, and often much more expensive, fibers.

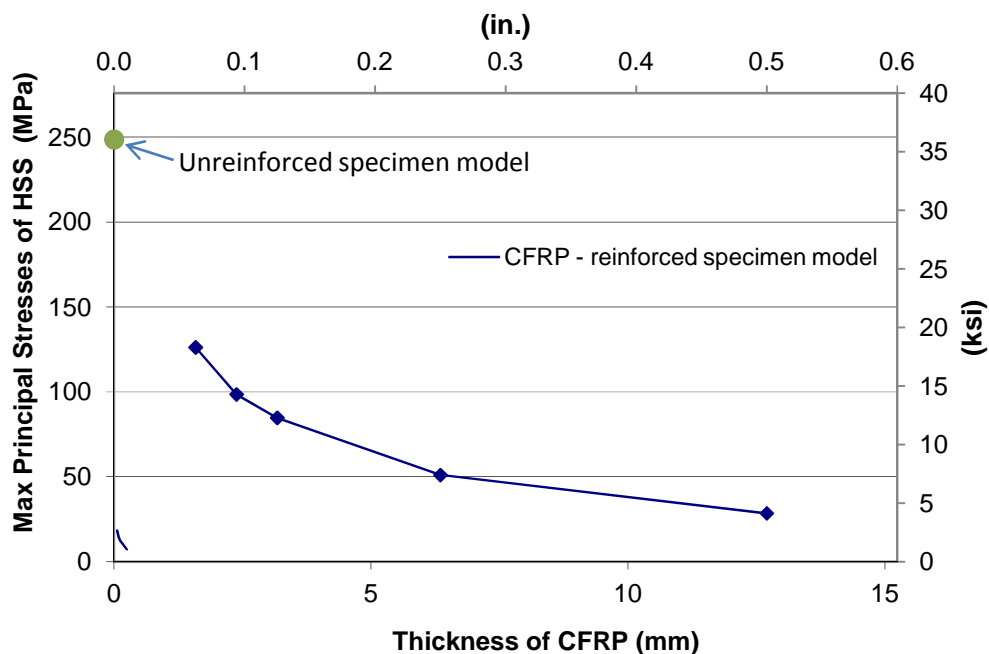
**Figure 3-5 : Effect of the CFRP overlay thickness on maximum principal Hot Spot Stresses in the steel specimen (update graph)**

overlay on each side was varied using values of 1.6, 2.4, 3.2, 6.4, and 12.7 mm (63, 94, 125, 250, and 500 mils). For all models discussed in this section, the modulus of elasticity of the overlay was maintained at 83 GPa (12,000 ksi), the length of the CFRP overlay was kept as 457 mm (18 in.), and the thickness of the interface resin layer was held at 0.6 mm (25 mils). Results are presented in Fig. 3-5. The relationship between the CFRP overlay thickness and the maximum principal HSS was found to be inversely proportional. Similar to the behavior found when the CFRP modulus of elasticity was varied, increasing the thickness of the overlay exhibited diminishing returns, with the largest change in HSS observed between the unreinforced case and the case in which a 1.6-mm (63-mil) thick overlay was utilized.

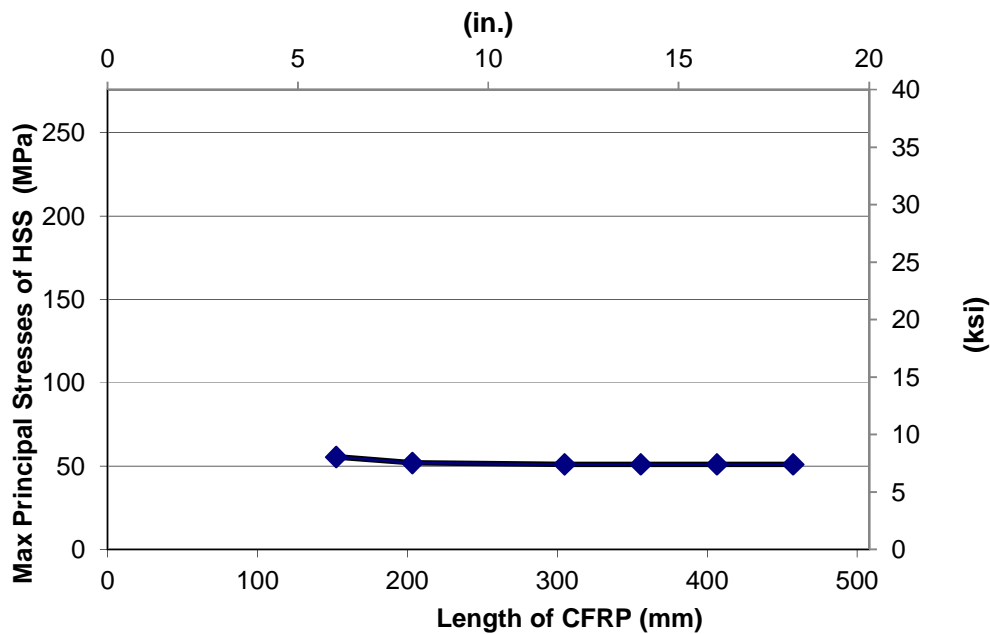
**Figure 3-6 : Effect of the CFRP overlay length on maximum principal Hot Spot Stresses in the steel specimen**

Six different configurations were defined to investigate the effect of the length of the CFRP overlay on the HSS along the critical path in the steel substrate. This effect was evaluated in terms of the total length of the CFRP overlay, with the overlay centered with respect to the center of the hole of the steel specimen. A total of six models were developed, with overlay lengths varied from 152 mm (6 in.) to 457 mm (18 in.), which is a dimensional range equivalent to 24-72 hole diameters. For all models, the modulus of elasticity of the overlay was held at 83 GPa (12,000 ksi), the thickness of the CFRP overlay was maintained as 6.4 mm ( $\frac{1}{4}$  in.), and the thickness of the interface layer was kept as 0.6 mm (25 mils). The results, presented in Fig. 3-6, show that there was a very small reduction in HSS in the steel substrate when the CFRP overlay length was changed from 152 mm (6 in.) to 203 mm (8 in.). For overlay lengths greater than 203 mm (8 in.) the effect of the overlay length on maximum principal HSS was found to be negligible.

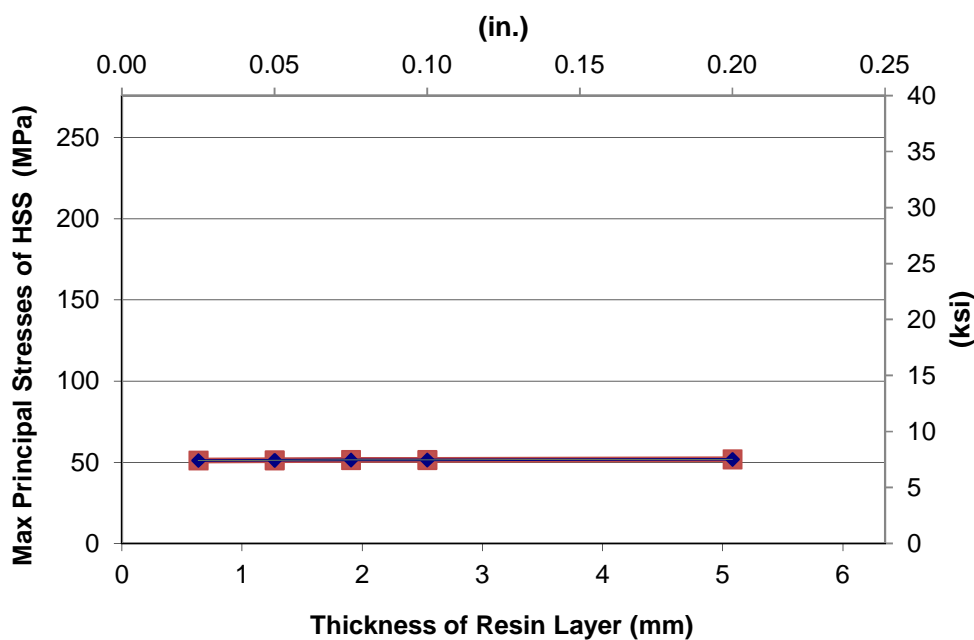
**Figure 3-7 : Effect of the resin bond layer thickness on maximum principal Hot Spot Stresses in the steel specimen**

A total of five different models were defined to investigate the effect of the thickness of the interface bond layer between the CFRP overlay and the steel substrate, with the interface layer thickness ranging from 0.6 mm (20 mils) to 5 mm (200 mils). For all models discussed in this section, the modulus of elasticity of the overlay was maintained as 83 GPa (12,000 ksi), the thickness of the CFRP overlay was kept as 6.4 mm ( $\frac{1}{4}$  in.), the length of the CFRP overlay was held at 457 mm (18 in.), and the modulus of elasticity of the bond layer maintained as 2 GPa (300 ksi). The analyses results presented in Fig. 3-7 indicate that the maximum principal HSS was not affected by the thickness of the resin layer, suggesting that an increase in the thickness of the resin layer has a negligible effect on the effectiveness of the retrofit measure.

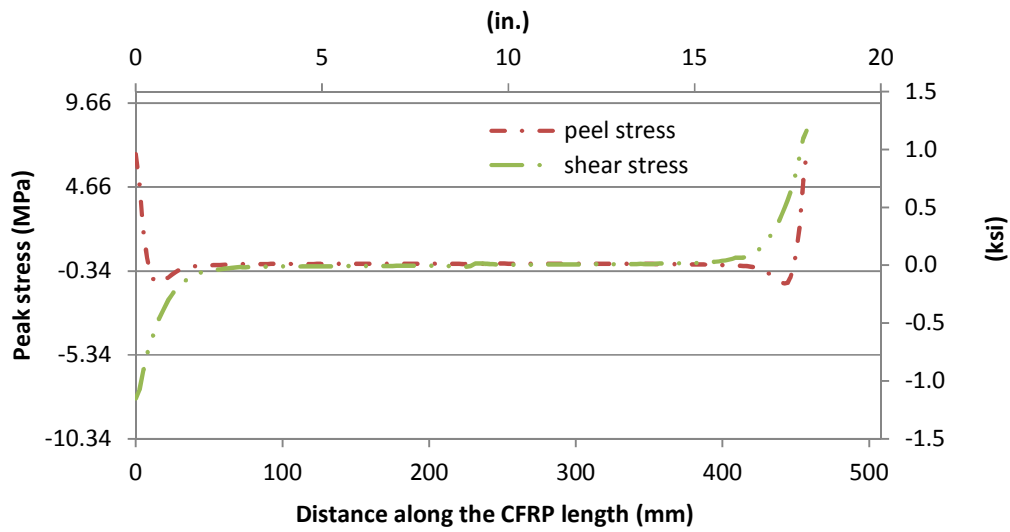
**Figure 3-8 : Peak stresses along the CFRP overlay on resin layer end of hole**

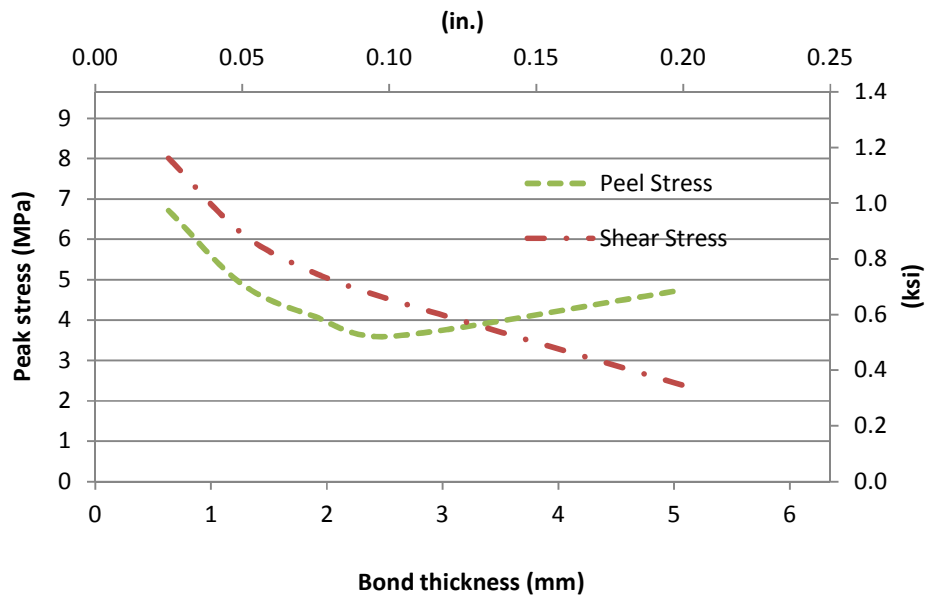
**Figure 3-9 : Peak stress demands on the CFRP layer as a function of resin layer thickness**

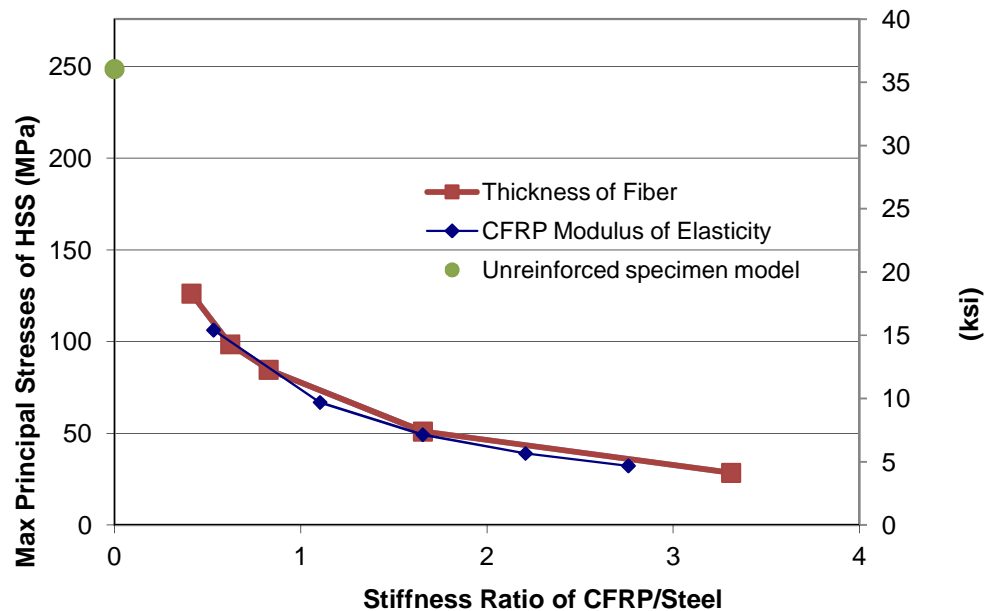
Figure 3-10 : Effect of the stiffness ratio on stress demand

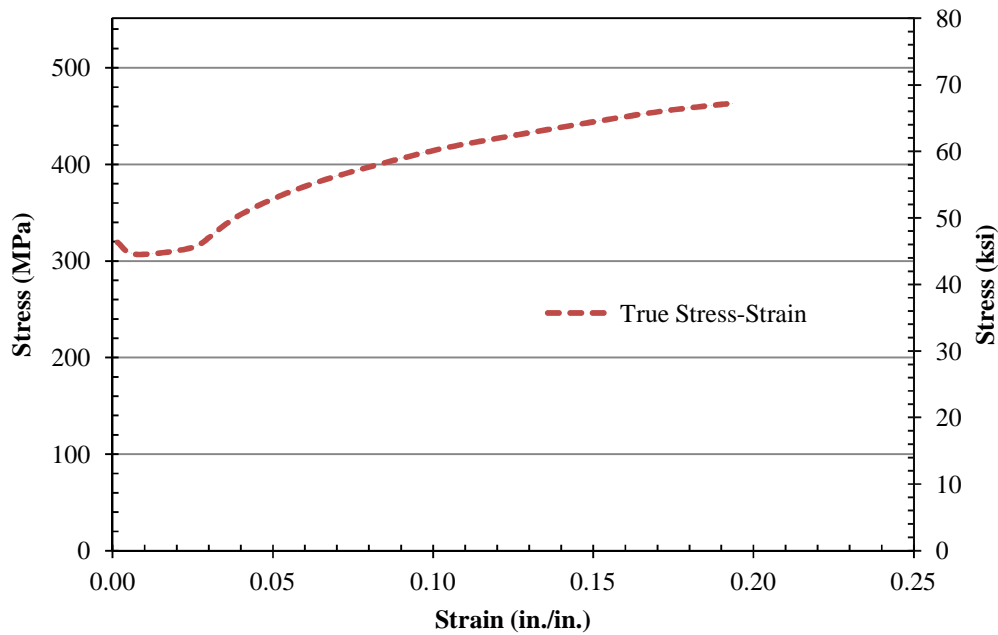
**Figure 3-11 : Stress strain curve for steel**

The specimens were fabricated using grade A36 steel and were either 3 mm ( $\frac{1}{8}$  in.) or 6 mm ( $\frac{1}{4}$  in.) thick. The stress-strain relationship obtained for the steel is presented in Fig. 3-11. The measured yield strength of the steel was 303 MPa (44 ksi), and the tensile strength was 460 MPa (67 ksi).
