REPAIR OF BRIDGE STEEL GIRDERS DAMAGED BY DISTORTION-INDUCED  
FATIGUE

Submitted to the graduate degree program in Civil Engineering and the Graduate Faculty of the  
University of Kansas in partial fulfillment of the requirements for the degree of Doctor of  
Philosophy.

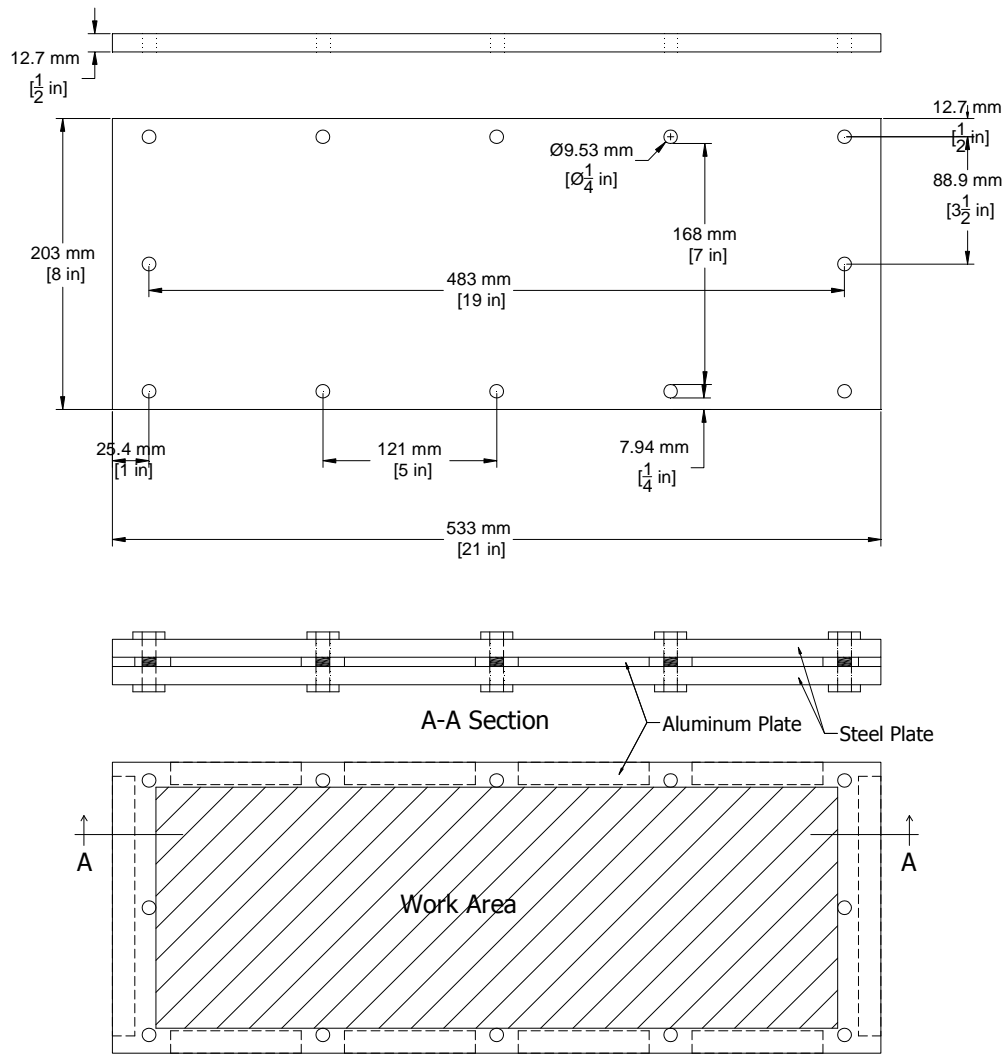
**Figure 3-12 : Steel plates for making FRP plate**

The CFRP was surrounded by an aluminum spacer with a thickness of 6 mm ( $\frac{1}{4}$  in.). Due to voids in the interfaces between layers of CFRP plies, the total thickness of the overlay was greater than the intended target thickness after all of the CFRP plies were placed in the mold. The top steel plate of the mold was then placed on top of the CFRP stack, and pressure was applied by tightening the bolts around the perimeter of the mold to reach the target thickness. At this point, the overlay was placed in the oven for curing. The curing oven was preheated to a temperature of 175 C (347 F). The CFRP overlays were cured inside the metal mold for three hours, and subsequently allowed to cool to room temperature for 48 hours. After the curing process was completed, the CFRP overlays were taken out of the metal molds and cut to final dimensions of 457 x 64 mm (18 x 2.5 in.) using a diamond saw. Sand paper (grade 400) was used to smooth the edges of the CFRP. For specimens summarized in Table 3-1, a hole was drilled in the middle of the CFRP overlays with a diameter of 3 mm ( $\frac{1}{8}$  in.) to facilitate alignment with the steel specimen.

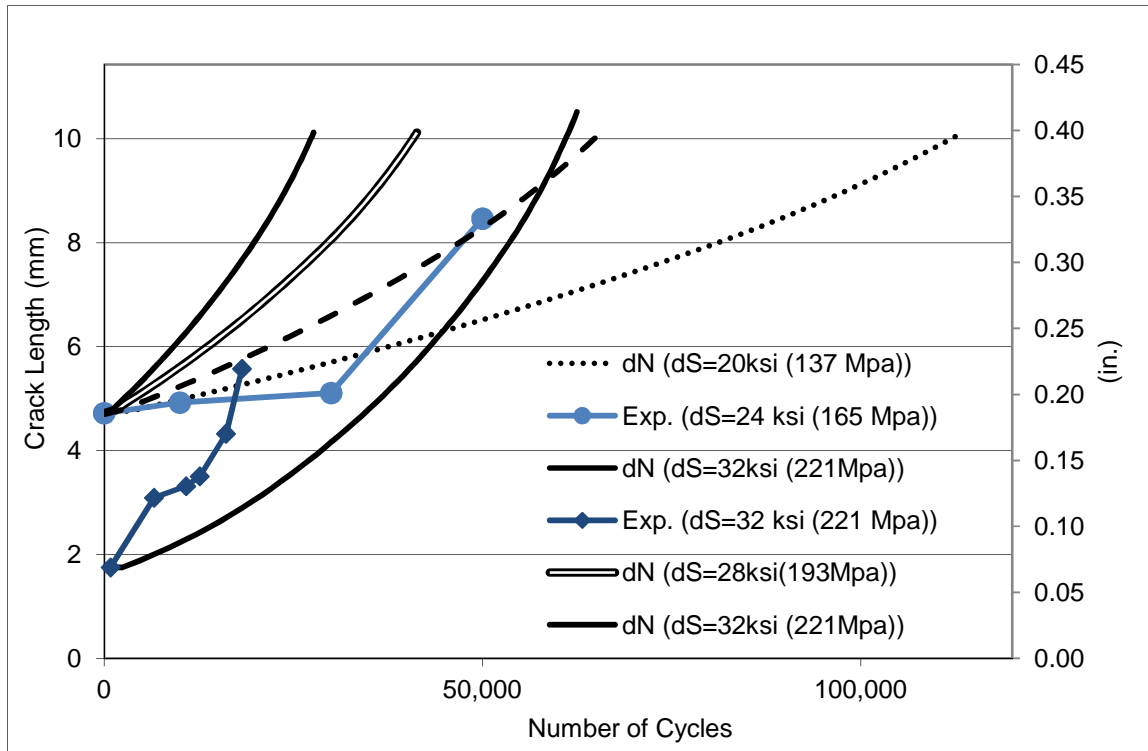
**Figure 3-13 : Comparison between theoretical and experimental values for the fatigue-crack propagation life of unreinforced specimens**

As shown in Fig. 3-13, the parameters in the expression provided a close correlation between the fatigue-crack propagation life of unrepaired specimens and the theoretical propagation life for the corresponding stress range.

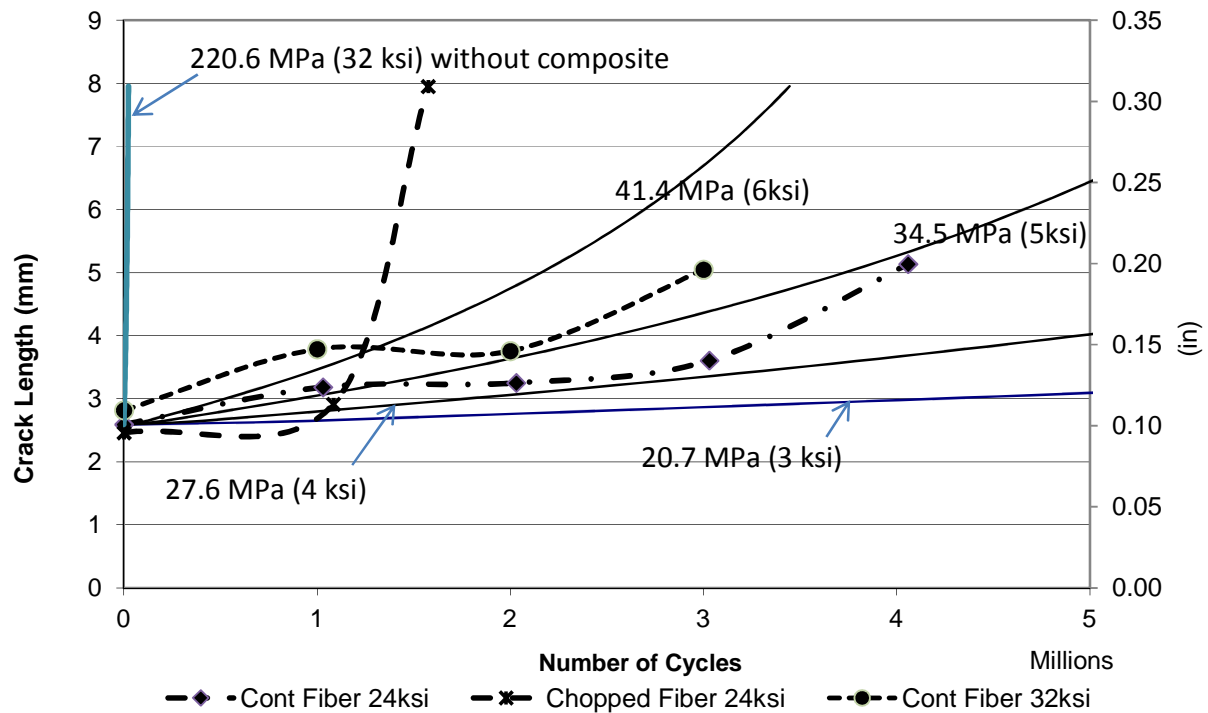
**Figure 3-14 : Crack propagation in specimens with CFRP overlays and theoretical values calculated for specimens without overlays**

As indicated in Section 3, the Three nominal stress ranges  $\Delta G$ , that the specimens were tested at were 166 MPa (24 ksi), 221 MPa (32 ksi) and 263 MPa (38 ksi) . These values were computed by dividing the applied force by the cross sectional area at the net section of the specimen, which was approximately  $90 \text{ mm}^2$  ( $0.14 \text{ in}^2$ ). A comparison between observed fatigue-crack propagation rate of the specimens with CFRP overlays summarized in Table 3-1 and the calculated fatigue-crack propagation rate in unreinforced specimens with low stress demands is presented in Fig. 3-14.

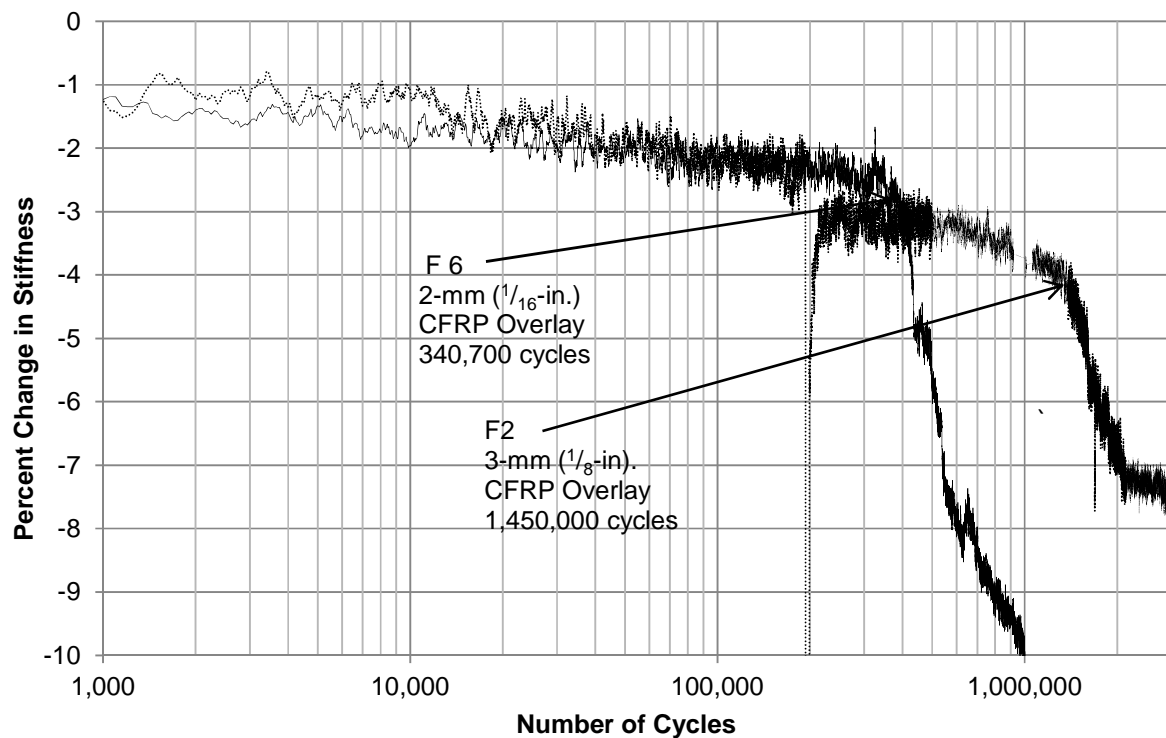
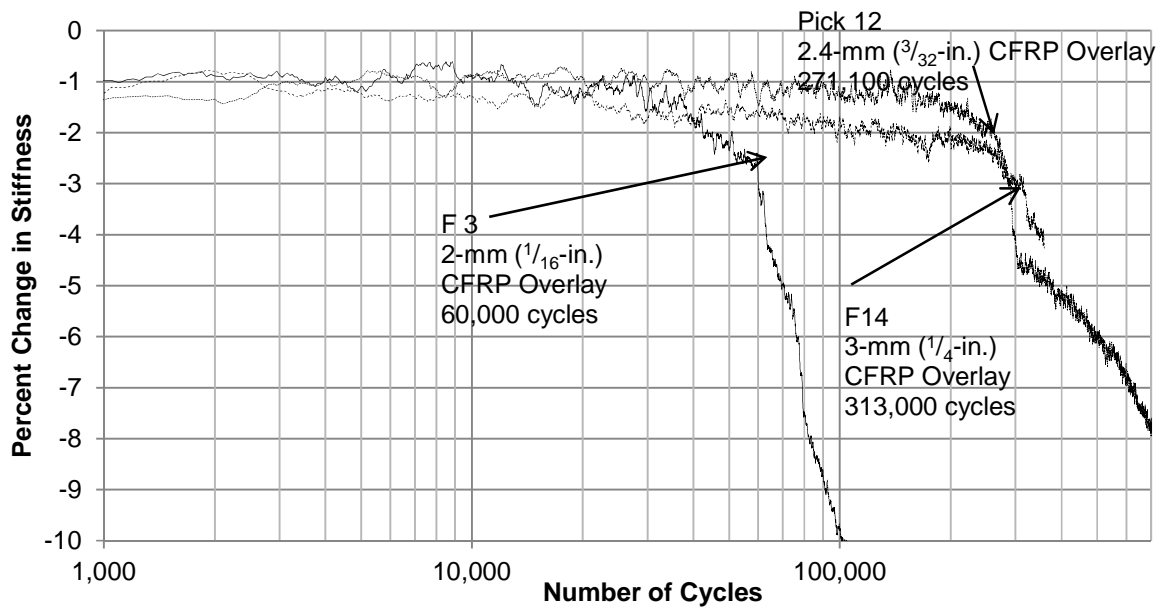
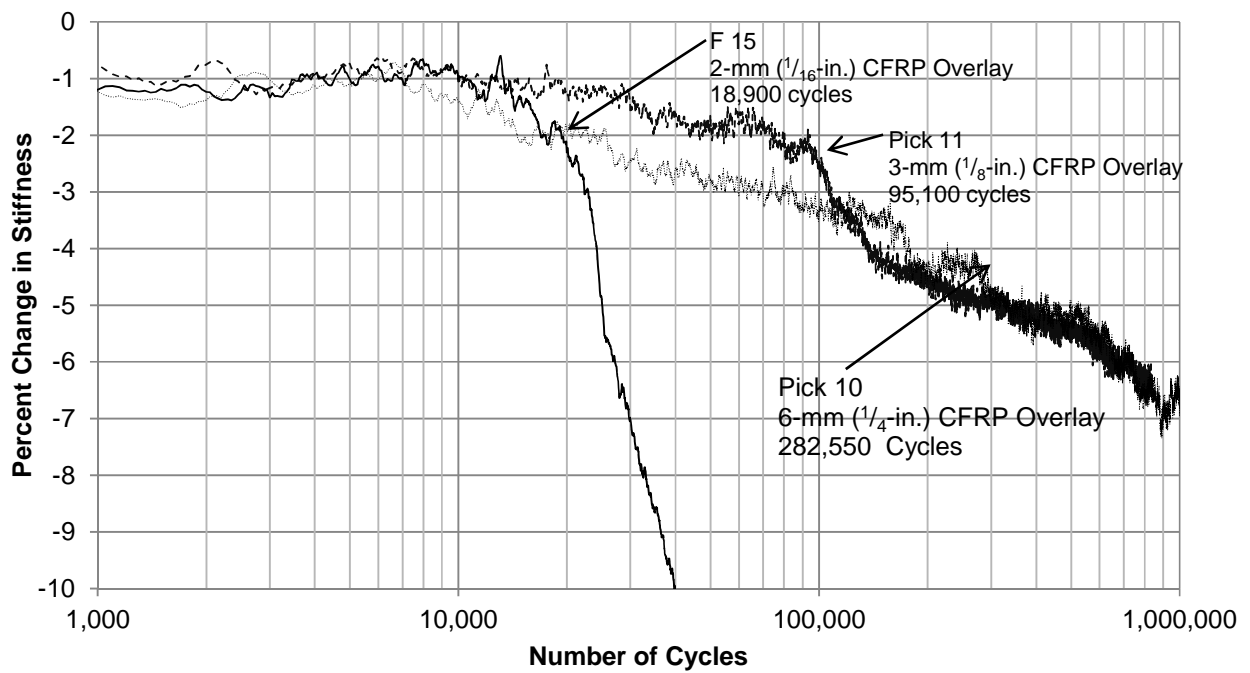
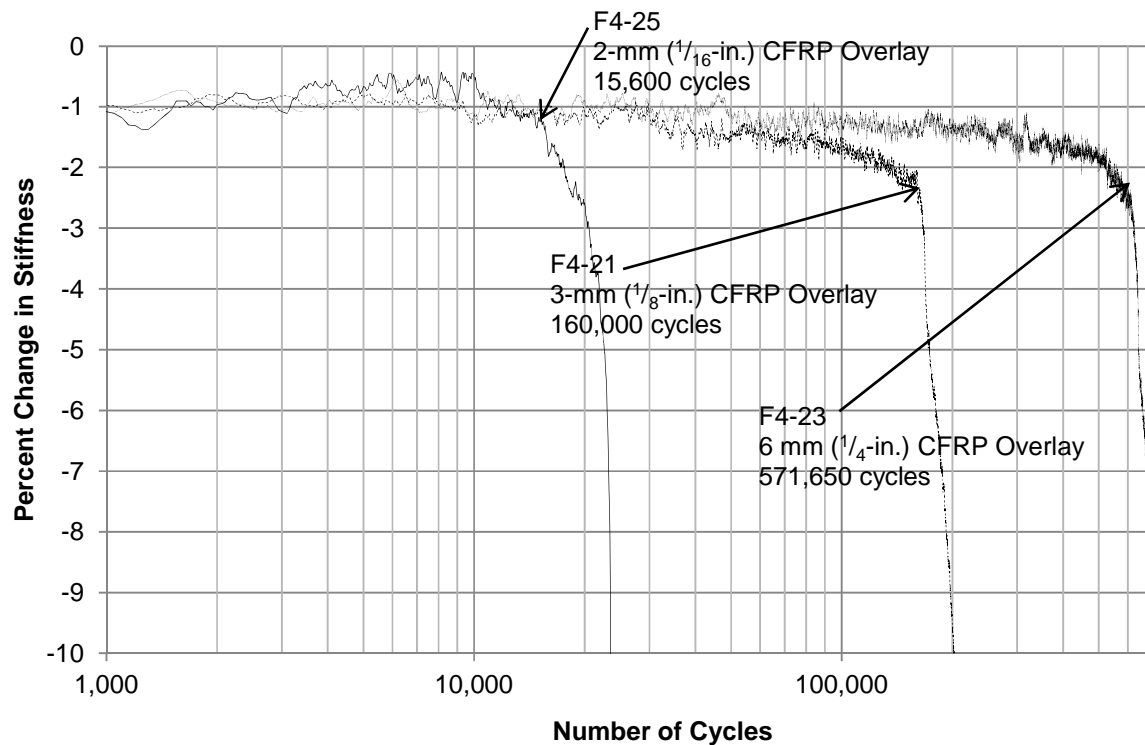
**Figure 3-15 : Percent change in stiffness of 3-mm ( $\frac{1}{8}$ -in.) thick specimens tested at 166 MPa (24 ksi)**

Figure 3-16 : Percent change in stiffness of 3-mm ( $\frac{1}{8}$ -in.) thick specimens tested at 221 MPa (32 ksi)

Figure 3-17 : Percent change in stiffness of 3-mm ( $\frac{1}{8}$ -in.) thick specimens tested at 263 MPa (38 ksi)

**Figure 3-18 : Percent change in stiffness of 6-mm ( $\frac{1}{4}$ -in.) thick specimens tested at 221 MPa (32 ksi)**

Upon the conclusion of testing, the CFRP overlays were removed to inspect the steel specimen and it was confirmed that in all specimens shown in Fig.15-18 the fatigue crack had in fact propagated through the entire net section of the steel.

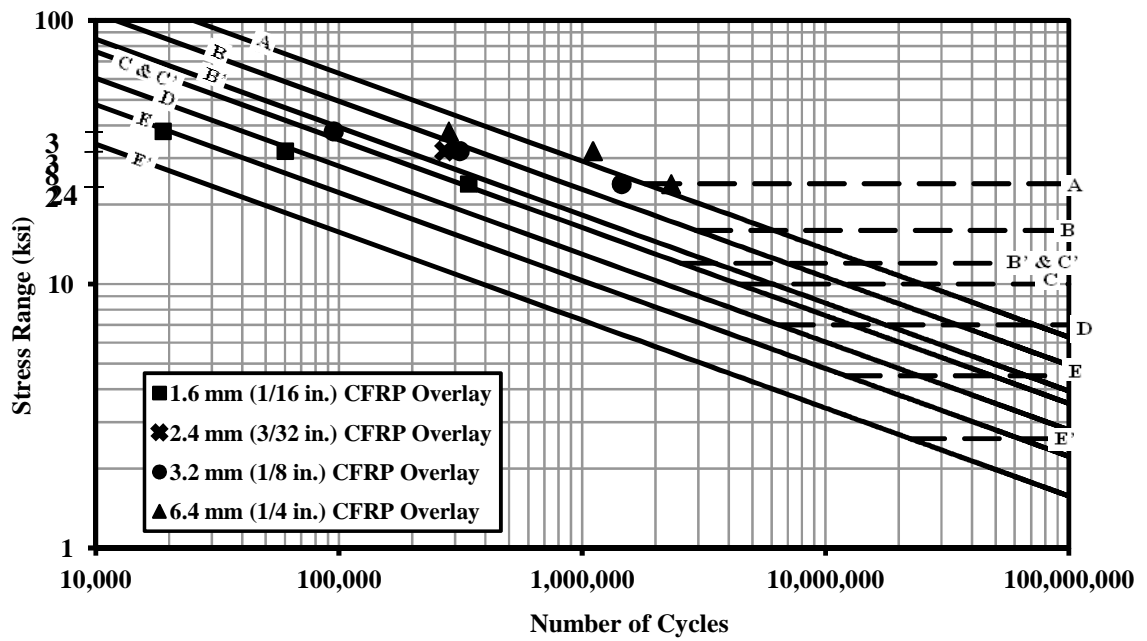
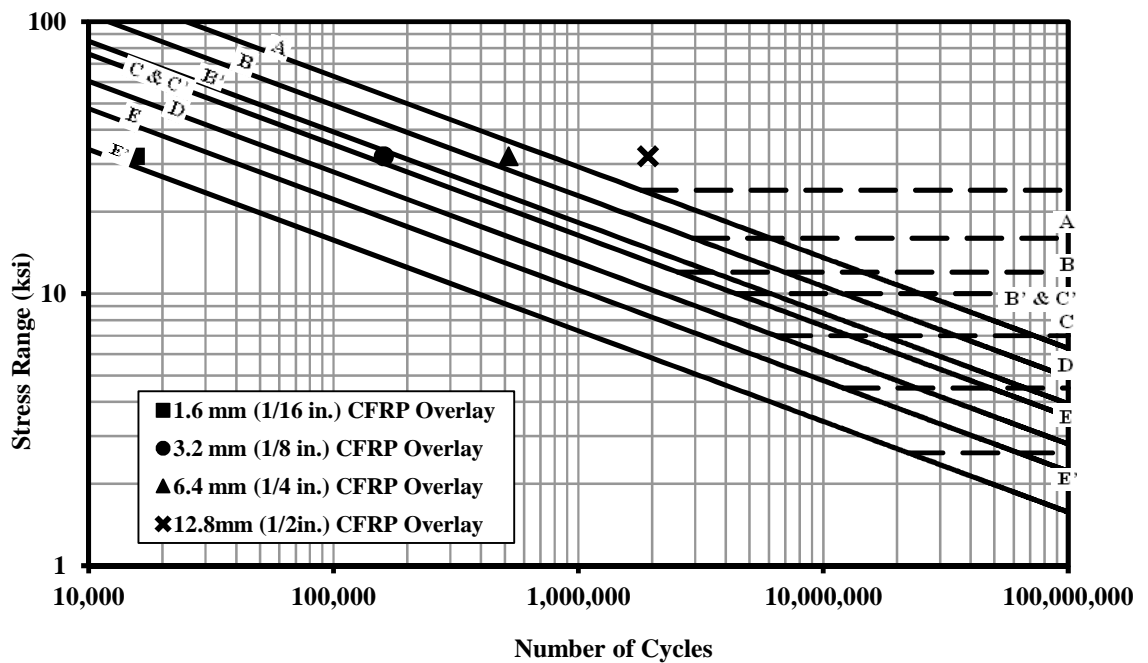
Figure 3-19 : S-N diagram for 3-mm ( $\frac{1}{8}$ -in.) thick specimens showing fatigue-crack propagation life

Figure 3-20 : S-N diagram for 6-mm ( $\frac{1}{4}$ -in.) thick specimens showing fatigue-crack propagation life

Figures 19 and 20 show the fatigue-propagation life for all specimens summarized in Table 3-2. S-N curves for the various fatigue categories in the AASTHO Bridge Specifications (AASHTO 2007) are presented for reference. For specimens that were 3-mm ( $\frac{1}{8}$ -in.) thick (Fig 19), doubling the thickness of the CFRP increased propagation life approximately by the number of cycles corresponding to one AASHTO fatigue category. For specimens that were 6-mm ( $\frac{1}{4}$ -in.) thick (Fig. 3-20), doubling the thickness of the CFRP increased propagation life approximately by the number of cycles corresponding to two or more AASHTO fatigue categories. Regardless of the thickness of the steel, all specimens with CFRP overlays with a thickness of 6.4 mm ( $\frac{1}{4}$  in.) had fatigue-propagation lives exceeding the initiation life of a Category B detail.

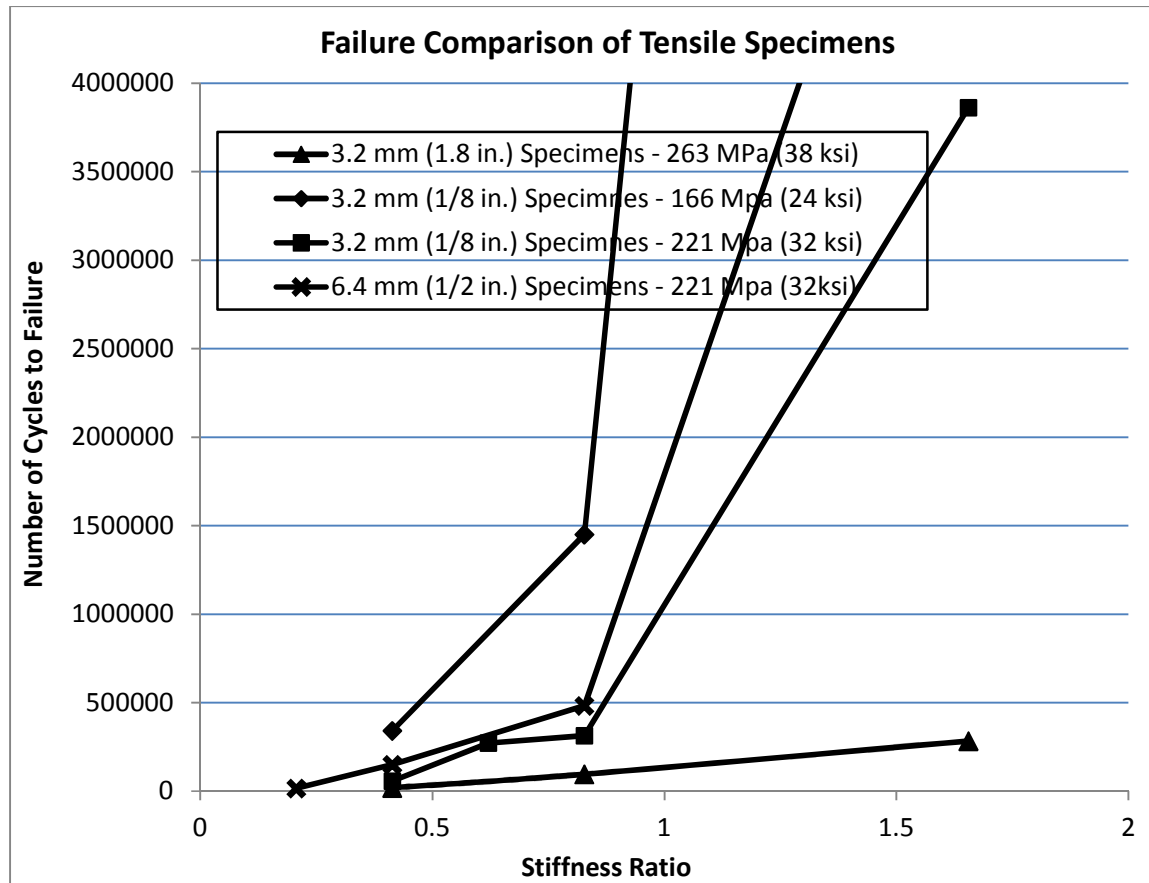
**Figure 3-21 : Fatigue-crack propagation life for all specimens treated with CFRP overlays and an initial crack length of 7.7 mm (0.3 in.)**

regardless of specimen size, allowing a direct comparison between the two. A direct comparison between the 3-mm ( $\frac{1}{8}$ -in.) thick and the 6-mm ( $\frac{1}{4}$ -in.) thick specimen tested 221 MPa (32 ksi) in Fig. 3-21, shows that for the same stiffness ratio the thicker specimen had the larger propagation life. However, both specimens had approximately the same critical stiffness ratio.

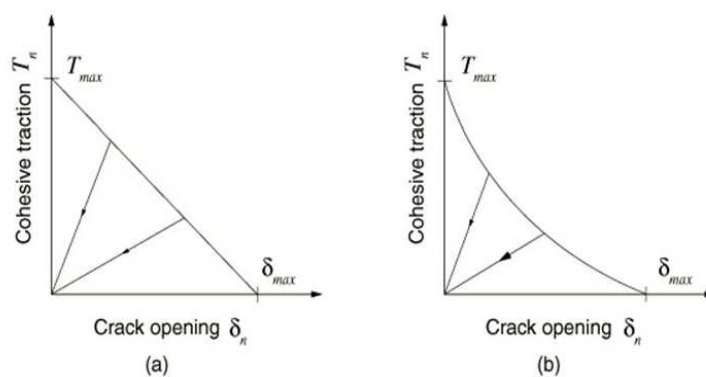
**Figure 4-1: Traction separation response a) linear b) nonlinear**

The damage evolution components specified describe how the material will displace after the maximum stress or strain is reached. The relationship between the damage evolution property and displacement can be linear or nonlinear as shown in the figure below. For damage evolution properties based on stress, the maximum cohesive traction,  $T_{max}$ , is the failure parameter that defines the initiation or propagation of the crack. In the 9-ft specimen models, a maximum principal stress criterion was chosen with a cohesive traction of 276 MPa (40 ksi) and a maximum displacement of 2.5 mm (0.1 in.) was used as the damage evolution properties.

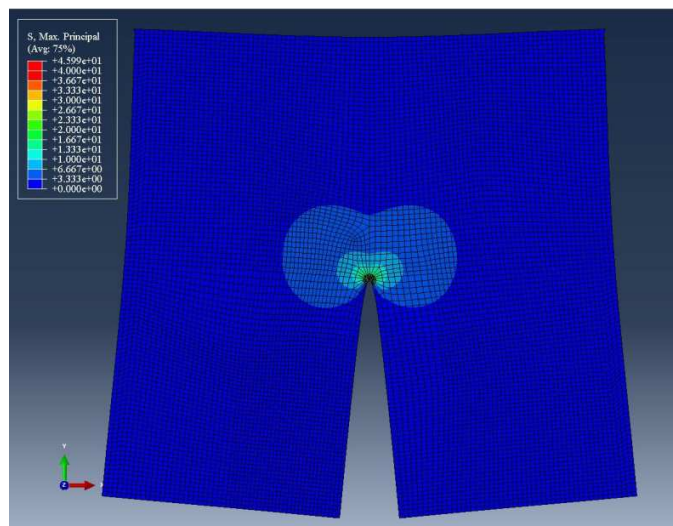
**Figure 4-2 Focused mesh surrounding crack tip in a 3-dimensional model.**

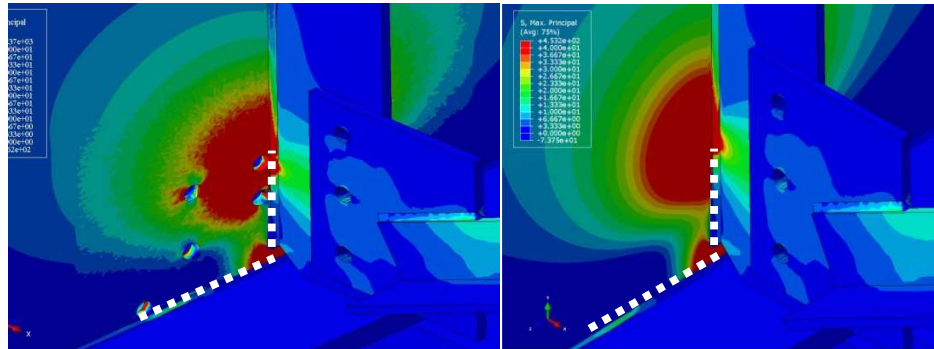
**Figure 4-4: Calculated stress demands for a) crack-stop holes retrofit and b) unretrofitted specimen  
(white lines show crack locations)**

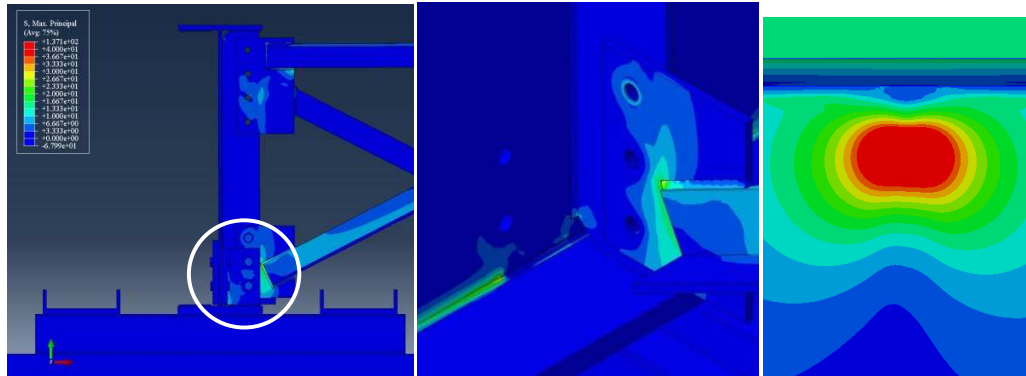
**Figure 4-5: a) Retrofit location shown by the circle b) stress distribution in the bottom web gap c) stress demand at the fascia side of web in top web gap**

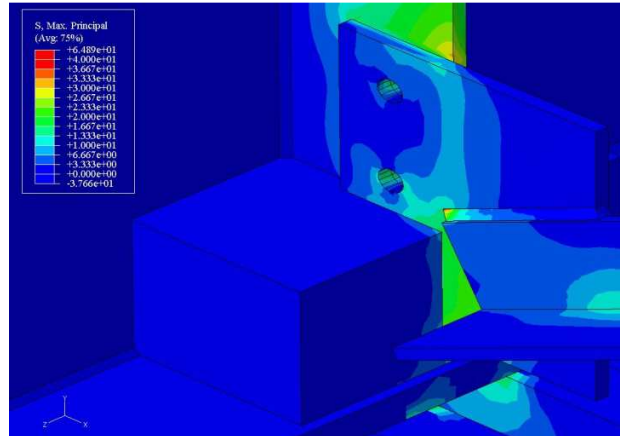
**Figure 4-6: Calculated stress demand for composite block repair.**
