Water Resources Report

2008—2010

Oneida Environmental, Health & Safety Division  
Water Resources Program

# 2008-2010 Water Resources Report for the Oneida Reservation

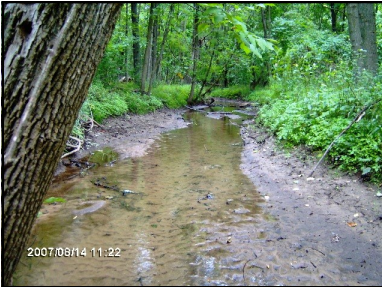
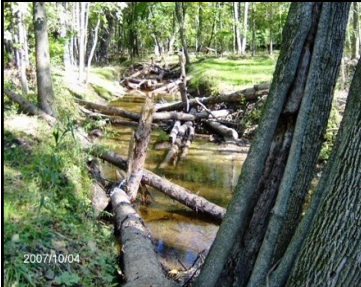
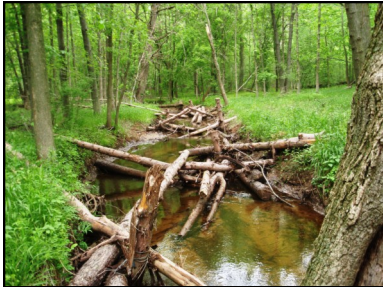
Large Woody Habitat (LWH), in the form of strategically placed logs and rootwads, were anchored in an 1800 foot reach of Lancaster Brook (2007). A native seed mix and erosion mat were used to stabilize the banks of the stream. Tree seedlings were planted along the stream corridor (2008). One year after the project, pools and scouring were evident in the LWH reach. Post-project monitoring indicated Brook trout were in the restoration area. Strategically placed red pine logs took place in a 250 foot reach to enhance in-stream habitat (August 2010). This addition will provide: food for invertebrates as the logs decay; cover for aquatic organisms such as fish, amphibians, turtles; as well as habitat for mammals such as mink. The LWH placement will improve habitat for brook trout and provide food and cover for a variety of aquatic animals. Trees will be planted to provide shade, cooler temperatures, and future LWH.

Before LWH project—2007

After LWH project—2007

After LWH—2008

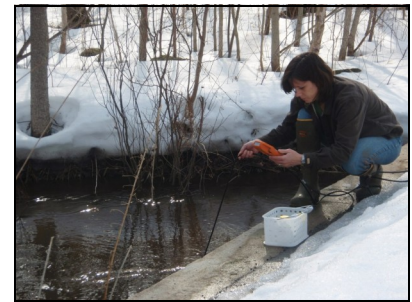
Water quality sampling using modern technology

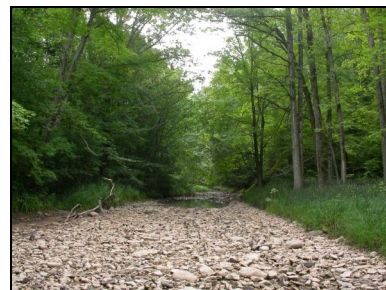
Oneida Creek during dry period

Certain areas of **Oneida Creek** have high quality riparian zones (*areas along the bank of the river*), but overall this stream is of fair quality. Land use is 84% agriculture, 9% forested, 4% forested wetland, 3% non-forested wetland. This stream is usually fairly dry in the summer months. Monthly monitoring shows good oxygen levels, but Oneida Creek continues to have high nutrient levels, which lowers the water quality and affects fish and wildlife.

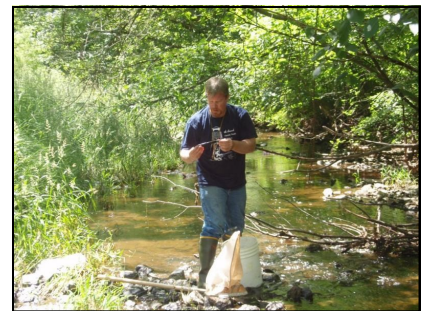
Invertebrate sampling

Fish surveys were also conducted annually at the Lambie Road site. Invertebrate surveys indicate a “fair” condition based on HBI scores. In the summer of 2010 a rare caddisfly was found in a tributary to Fish Creek. This caddisfly, *Wormaldia shawnee*, is on the “Special Concern” list for Wisconsin. *Wormaldia shawnee* has only been found in two areas in Wisconsin, both on the Oneida Reservation.

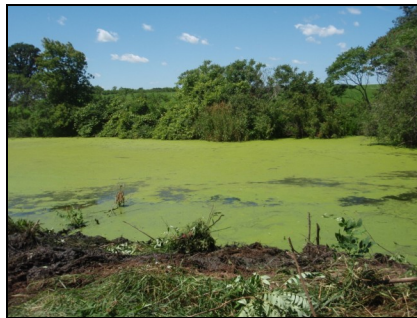
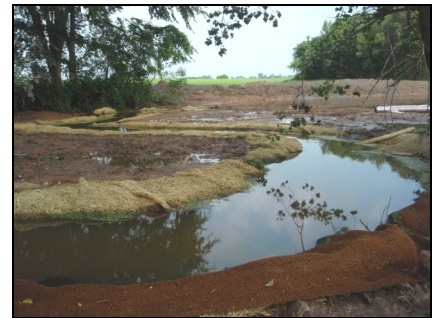
**The Silver Creek Channel Restoration Project (2008):** the natural stream morphology has been restored as well as the riparian wetlands. A wildlife corridor has been established as well as a buffer from adjacent farm fields.

Silver Creek restoration project before (left) and after (right) 2008.

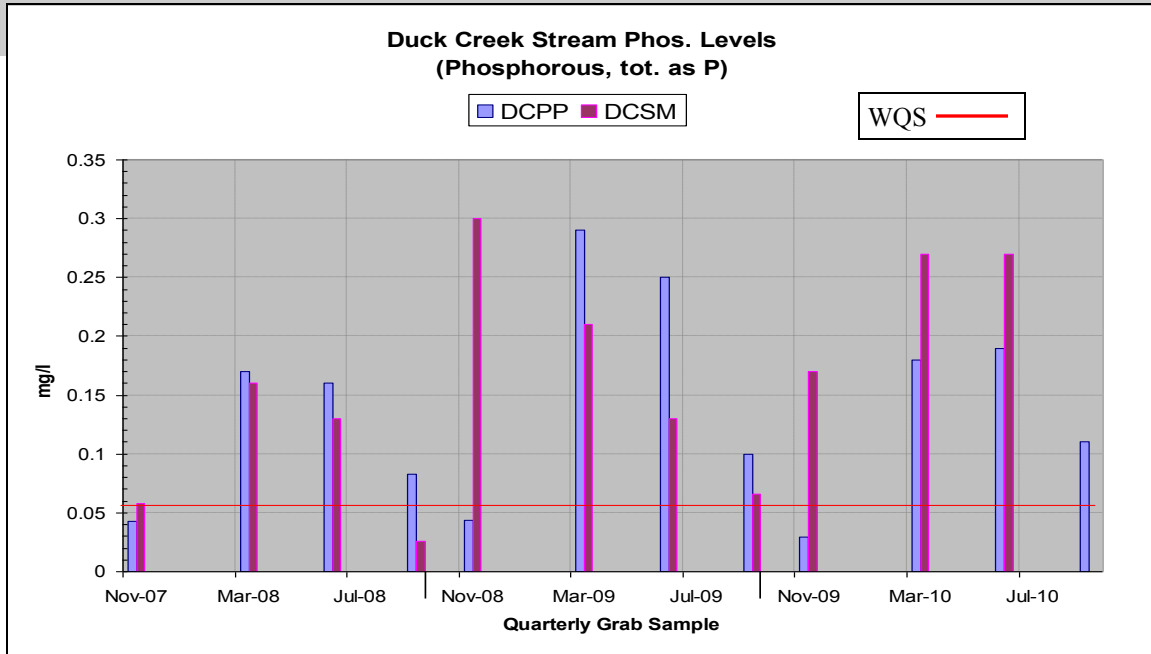
**Figure 1.** Phosphorous levels for sampling events in FY08, FY 09, and FY10. The Oneida Water Quality Standard for Duck Creek is 0.05 mg/L. In FY08 25% of samples met the WQS. In FY 09 12.5% of samples met the WQS. In FY10 14% of samples met the WQS. This graphs shows that levels are heightened by increased rain in Nov 08 and 09.

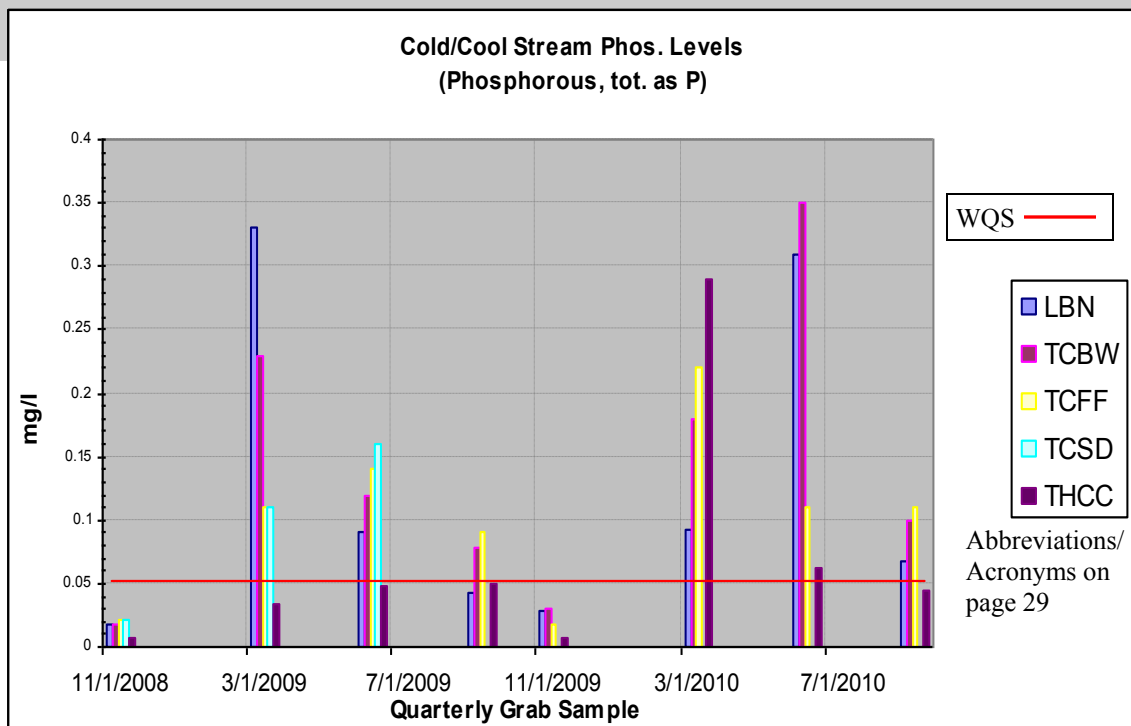
**Figure 2.** Phosphorous levels for sampling events in FY08, FY09, and FY10. The Oneida Water Quality Standard for these streams is 0.1 mg/L. There is no data for FY08. FY 09 47% of samples met WQS. FY 10 31% of samples met WQS.

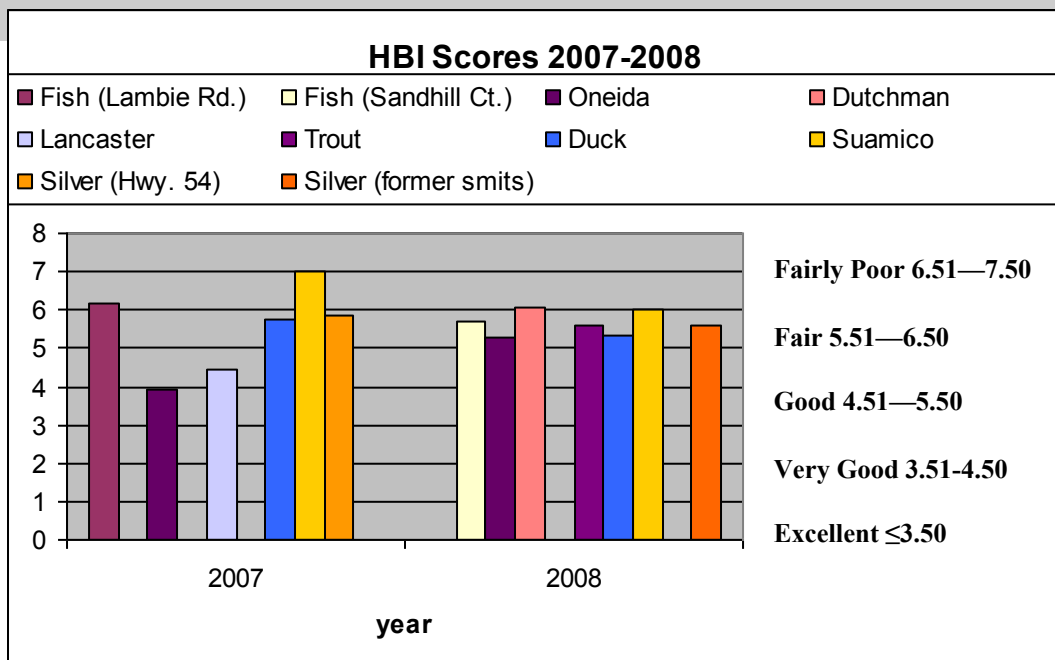
**Figure 3.** Hilsenhoff scores (HBI) for Oneida Streams in 2007-2008. Data from 2009 and 2010 has not yet been compiled. These scores are assigned based on invertebrate populations collected during annual surveys.

The surface waters of Oneida are monitored for biological indicators of stream health. Biological monitoring or “bioassessment” uses the known habitat preferences of aquatic animals to see how healthy the aquatic community is. Pollution and other negative factors can eliminate low tolerance organisms from streams. With successful restoration, these species should reappear. We use fish and invertebrate populations to determine how healthy the aquatic communities are. HBI scores are assigned to macroinvertebrates depending on the level of tolerance each bug has to pollution (see figure 3.)
