Effects of Small Impoundments on Total Watershed Sediment Yield in Northeast Kansas, April through August 2011

Submitted to the graduate degree program in Civil, Environmental, and Architectural
Engineering and the Graduate Faculty of the University of Kansas in partial fulfillment of the
requirements for the degree of Master of Science.

Abstract

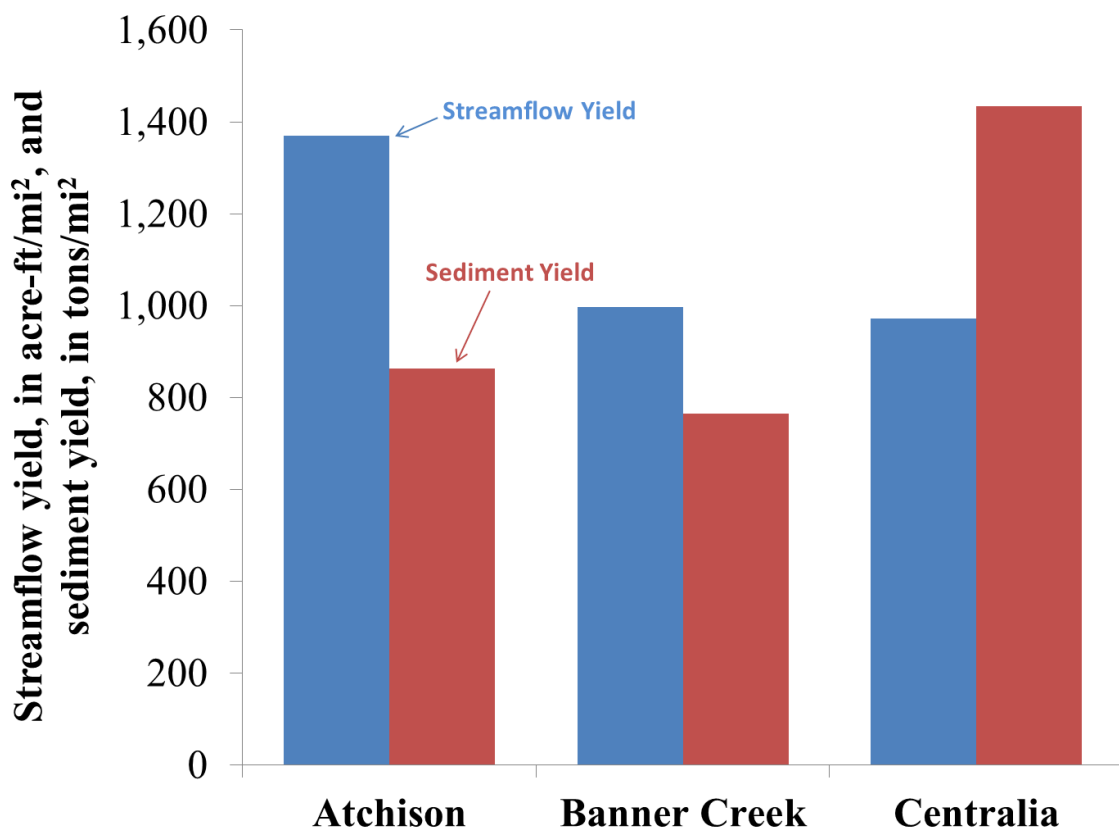
Figure 4: Streamflow and sediment yield in the three Baseline Sediment Study watersheds based on data collected from March 2009 to May 2011 (source USGS KSWSC).

Initial results from the SBS indicate a possible correlation between the number of small impoundments in a watershed, as listed by the National Inventory of Dams (NID) (US Army Corps of Engineers, 2010) and watershed sediment yield (Figures 4 & 5). Figure 4 indicates that Centralia's sediment yield was nearly twice as high as Atchison's, even though the two watersheds share similar land-use characteristics. The Atchison watershed was much closer in yield to the Banner watershed, which is considered the reference condition with land-use primarily of pasture and hay (Figure 3). One possible explanation for the drastic difference in sediment yield is the presence of a large number of small impoundments in the Atchison and Banner watersheds (Figure 5).

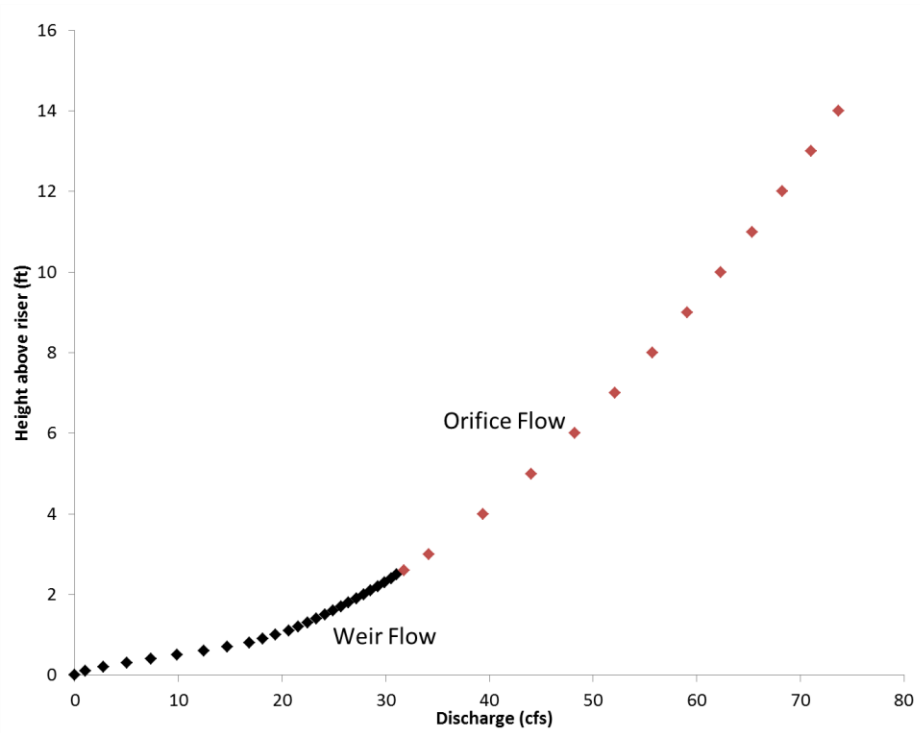
Figure 14: Rating Curve for LDMD 17.

Where vertical pipes acted as outflow structures, flow equations based on weir flow and orifice flow were applied, depending on water elevation above the riser, to compute outflow discharge (Equations 2, 3; Figures 13, 14; U.S. Bureau of Reclamation, 1987). Rating tables for LDMD 5 and 17 can be found in Appendix C.

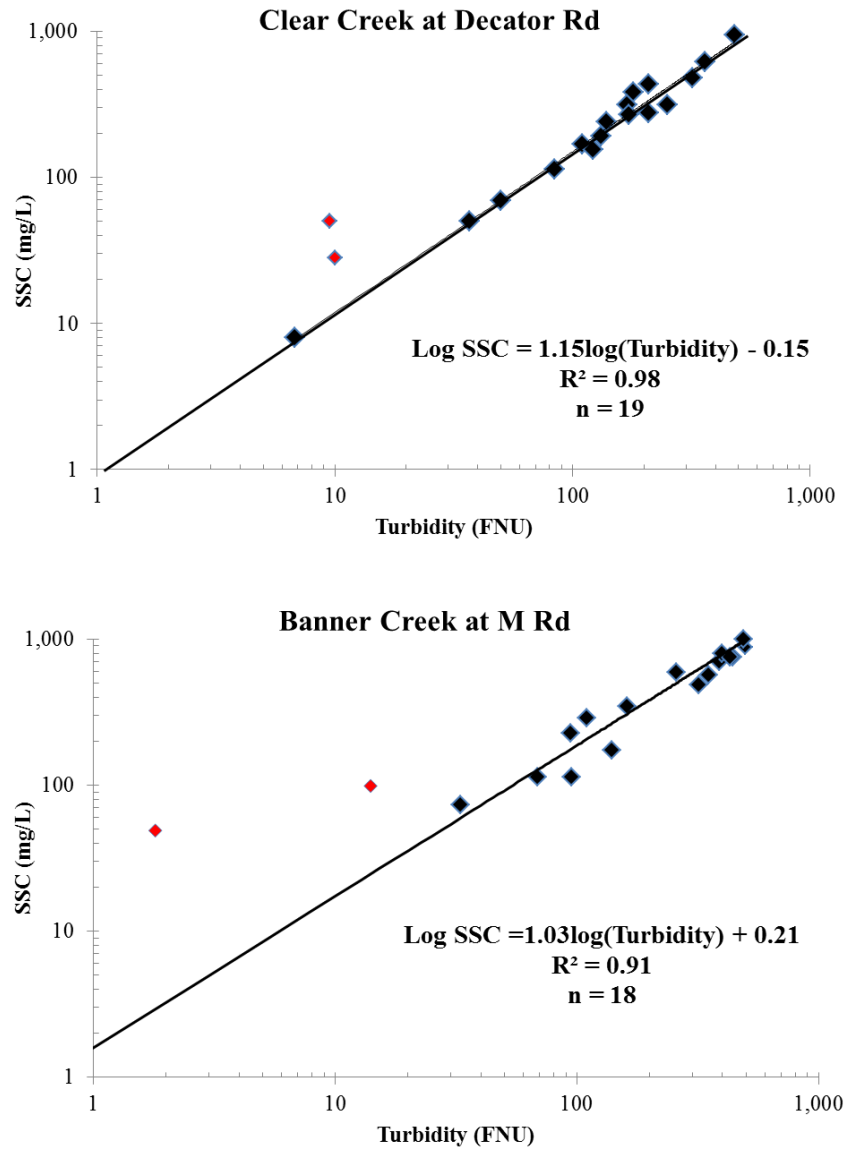
Figure 16: Turbidity-SSC regressions developed for USGS stream gages at Clear Creek at Decator Rd. and Banner Creek at M. Rd.

SSC was computed using YSI 6136 turbidity sensors and procedures outlined in Rasmussen et al. (2009). The regression developed for Clear Creek at Decatur Rd (Equation 4; Figure 14) was used for SSC calculations in the Atchison watershed, and the regression developed for Banner Creek at M Rd. (Equation 5; Figure 16) was used for SSC calculations in the Banner watershed. Red diamonds represent outliers which were not used in the final regression equation. Currently not all collected samples have been built into this equation for QA/QC reasons. These regressions were built with data up to May 15, 2011. The USGS classifies these regressions currently as “provisional” and subject to change, though changes to the equations from additional samples are likely to have minor or negligible consequences to computed SSC. Lee and Ziegler (2010) showed that turbidity-SSC regressions collected within the same watershed were typically the same, likely due to similar geology and other site-specific characteristics. SSC samples taken at Clear Creek at Decatur Rd. averaged 94% silts and clays (n=22) and Banner Creek at M. Rd averaged 84% silts and clays (n=26).

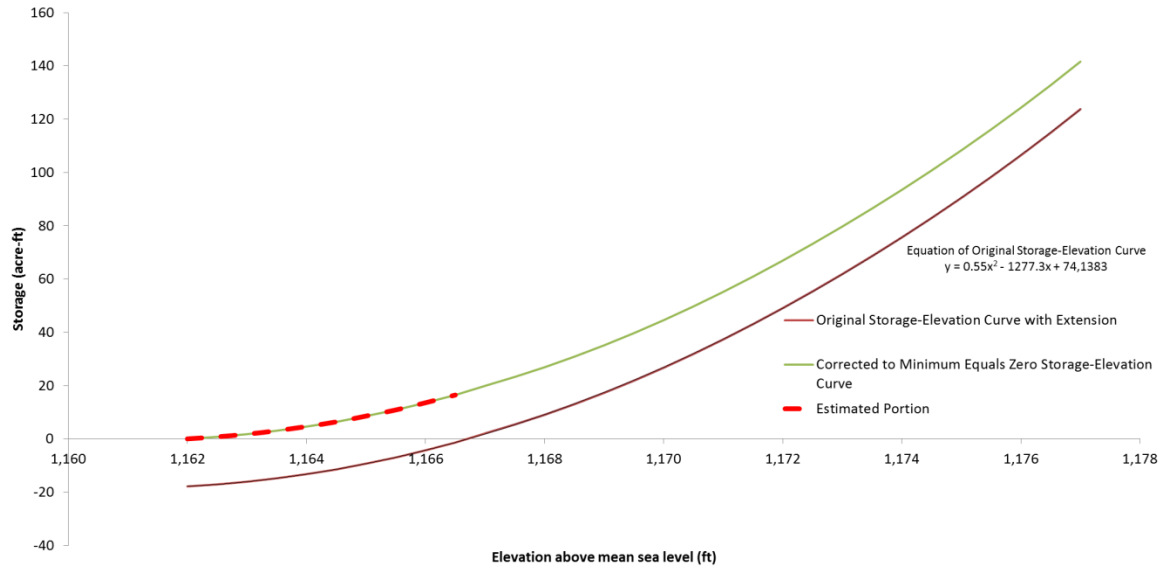
Figure 19: Elevation-storage curves showing extension below surveyed area and corrections applied to set minimum elevation to zero storage.

To analyze the available data, elevation-storage was estimated below the lowest surveyed elevation by simple curve fit (Figure 19, Table 9). The lake elevation never reached the level of the main outflow pipe, and the small riser was not measured (and likely negligible), so outflow was not calculated. Decreasing lake elevation was likely a combination of evaporation, seepage, and water lost through the small outflow riser. To calculate inflow discharge, change in storage with respect to time was converted to inflow discharge. All other computations were performed as discussed in “Data Analysis Techniques.”

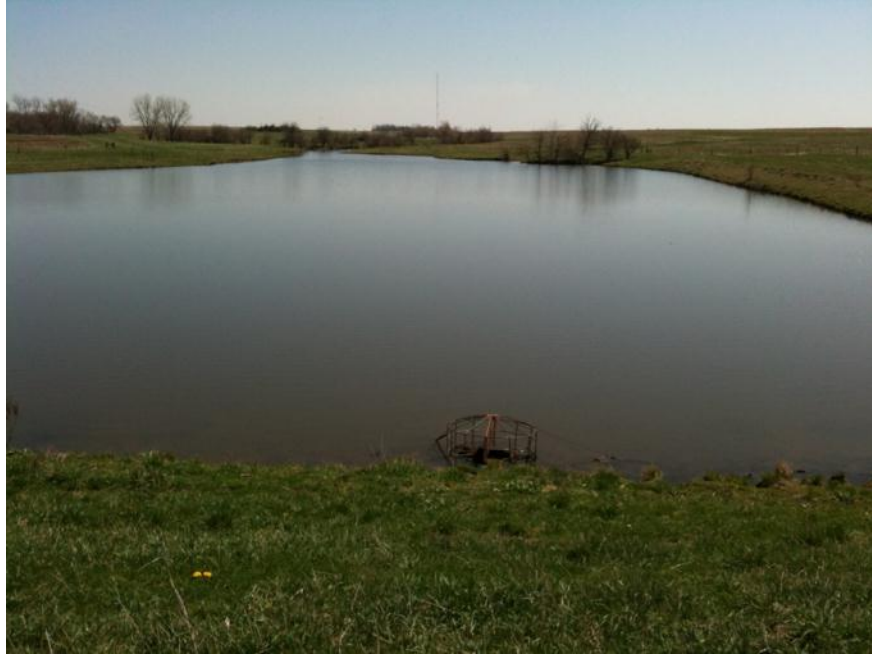
Figure 22: View looking upstream LDMD 5 from the top of the dam. The outflow structure is visible in the foreground. Photo taken April 2011.

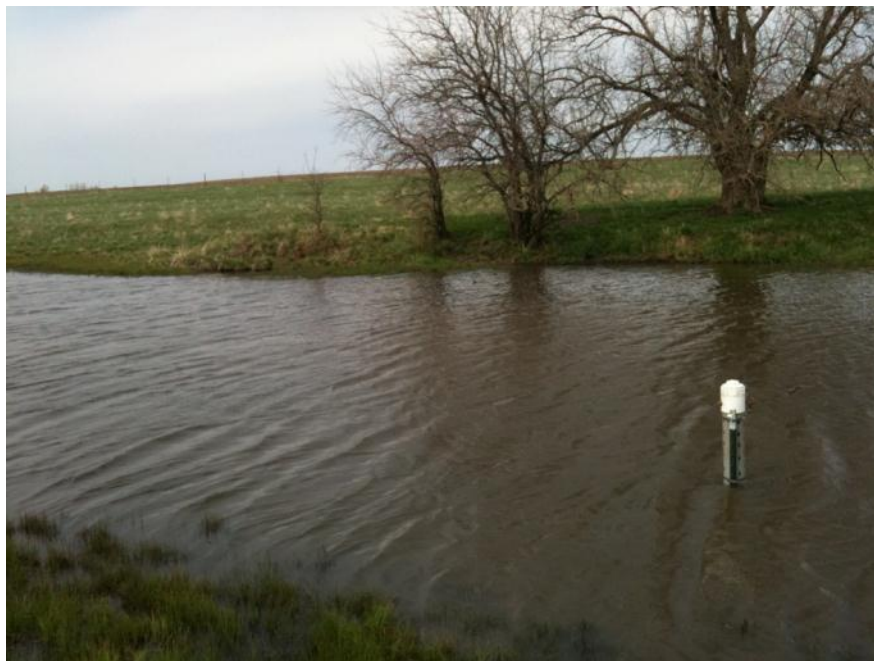
Figure 23: View of inflow turbidity sensor at LDMD 5 looking north. Photo taken April 2011.

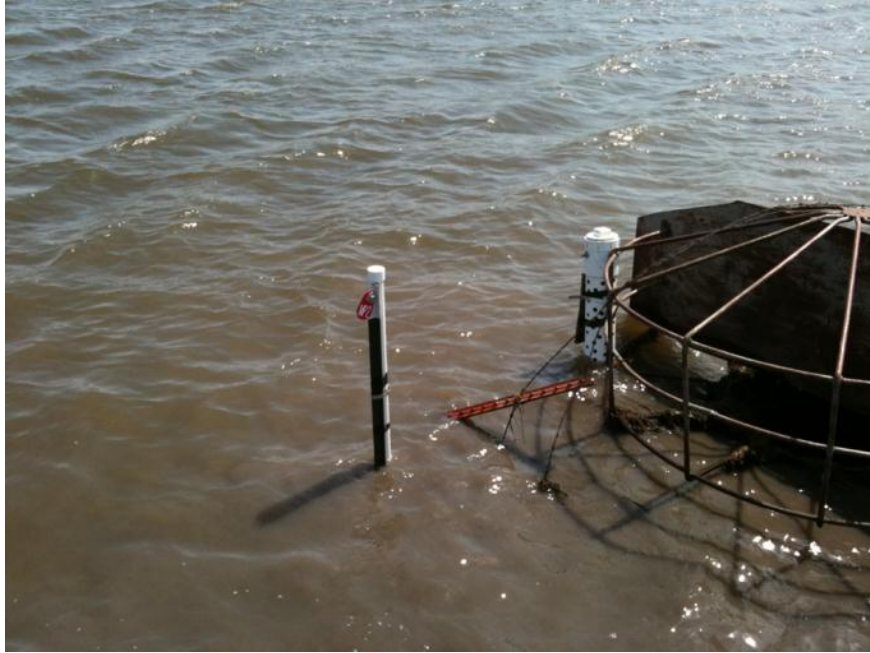
Figure 24: View of outflow elevation sensor (right) and turbidity sensor (left attached to outflow structure) at LDMD 5. Photo taken April 2011.

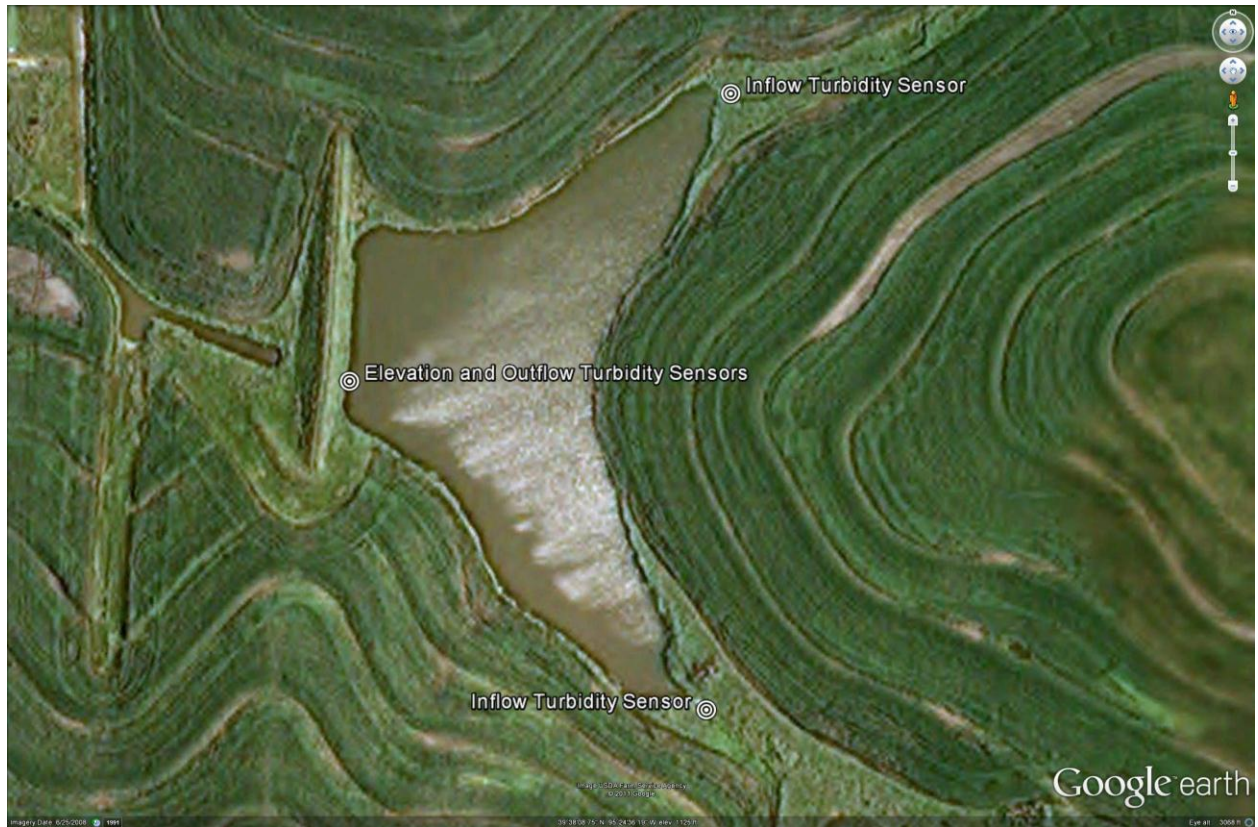
Figure 25: Aerial view of LDMD 17 showing general locations of elevation and turbidity sensors (photo source: Google Earth).

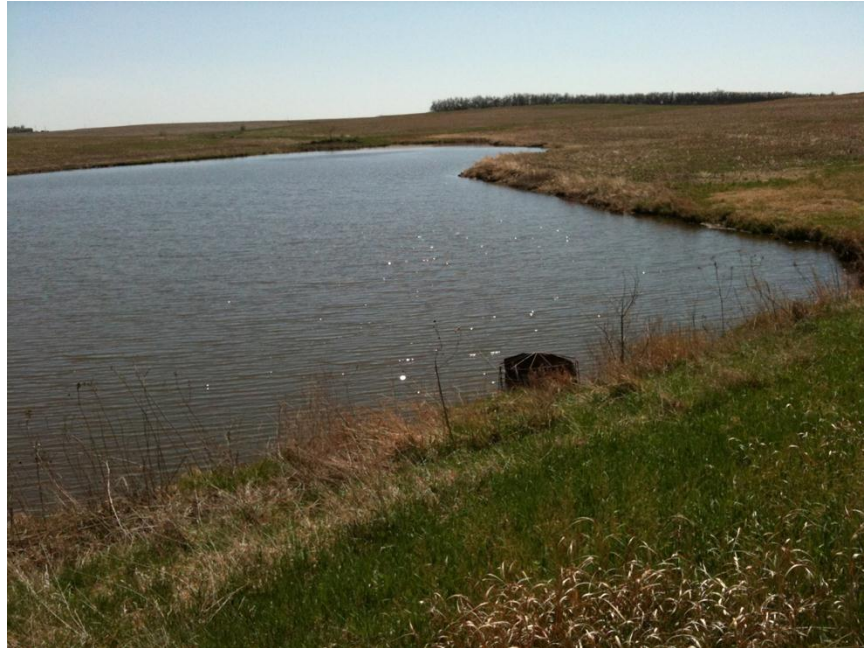
Figure 26: View looking upstream towards the south fork of LDMD 17 from the top of the dam. The outflow structure is visible in the foreground. Photo taken April 2011.

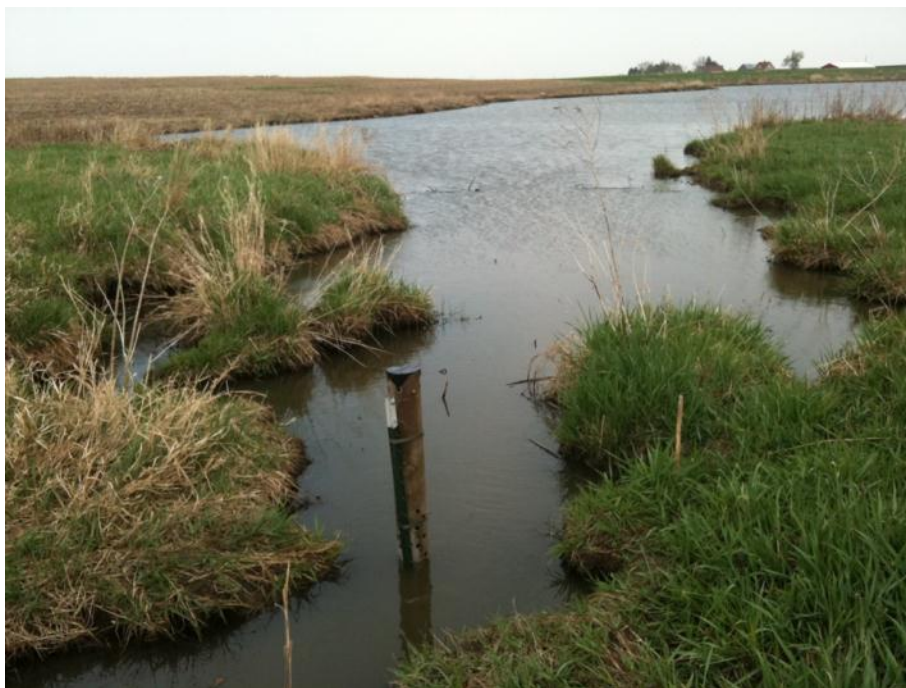
Figure 27: View of the north fork inflow turbidity sensor at LDMD 17 looking northwest. Photo taken April 2011.

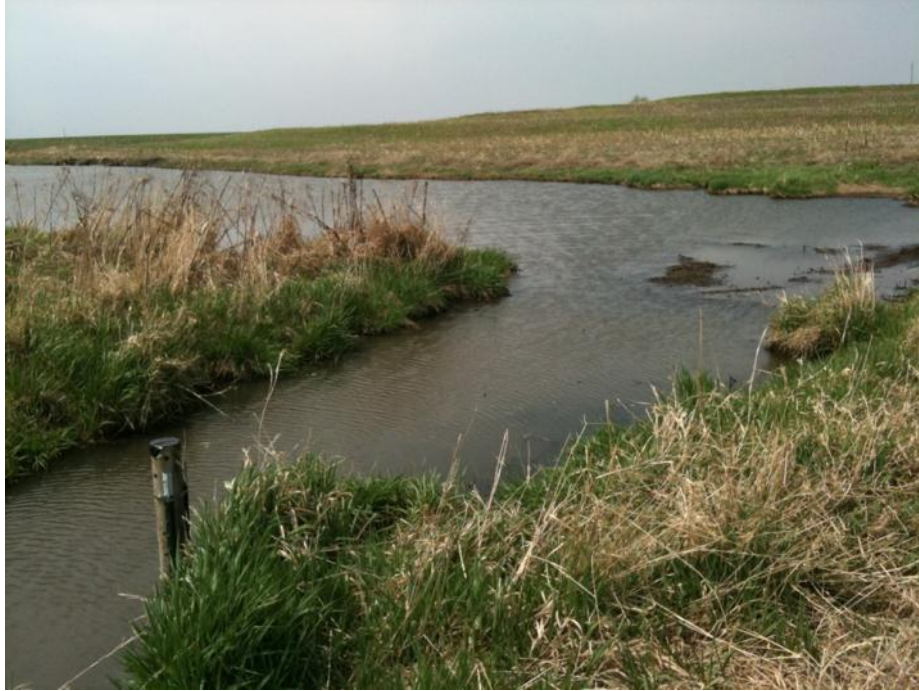
Figure 28: View of the south fork inflow turbidity sensor at LDMD 17 looking southwest. Photo taken April 2011.

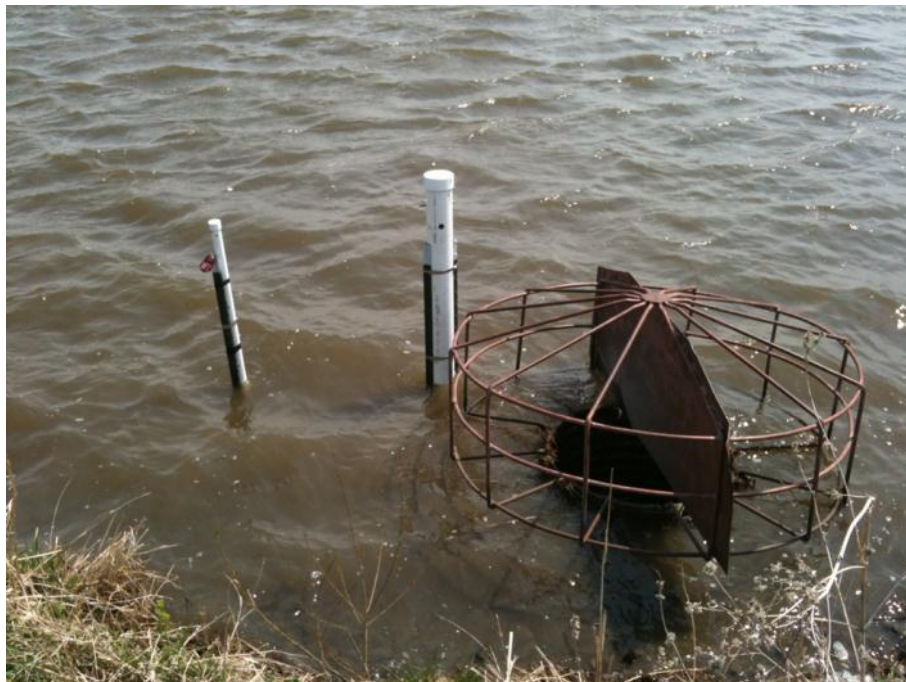
Figure 29: View of outflow elevation sensor (right) and turbidity sensor (left attached to outflow structure) at LDMD 17. Photo taken April 2011.

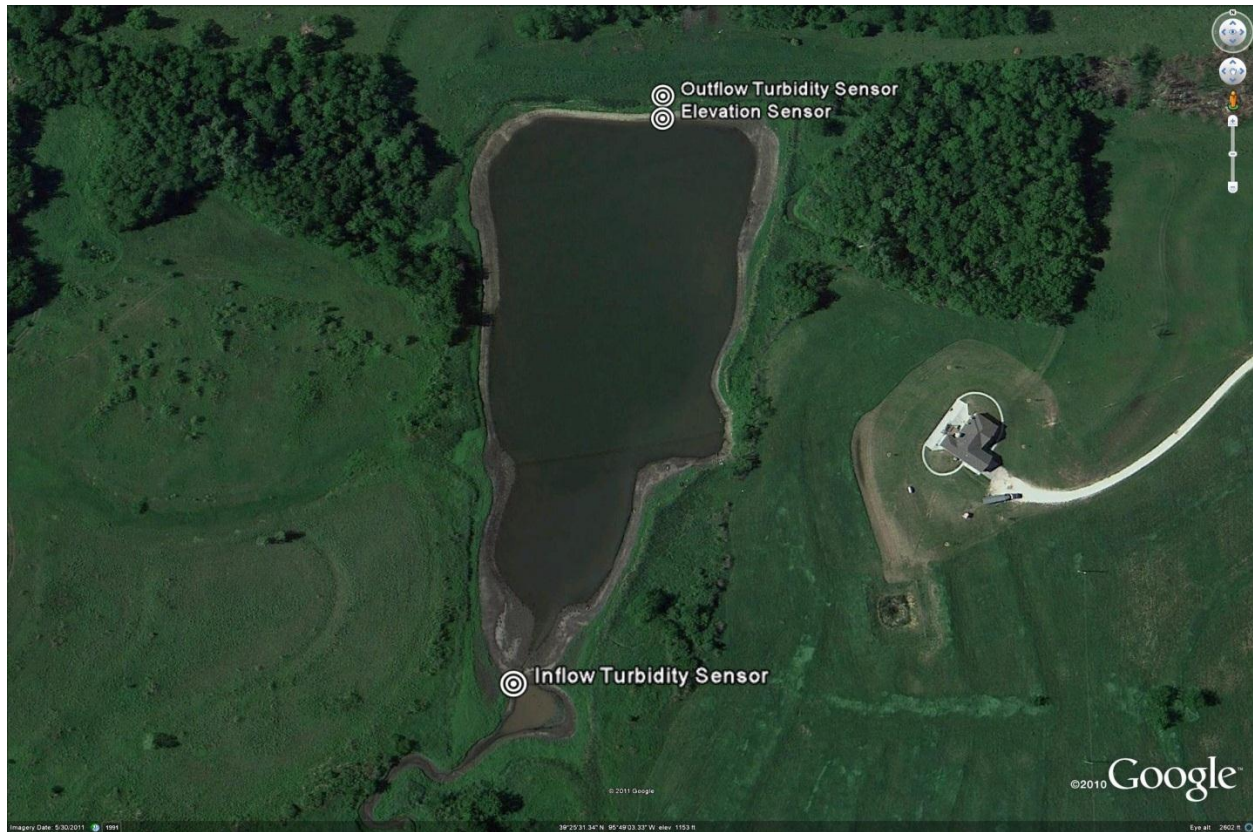
Figure 30: Aerial view of Dam 38 showing general locations of elevation and turbidity sensors (photo source: Google Earth).

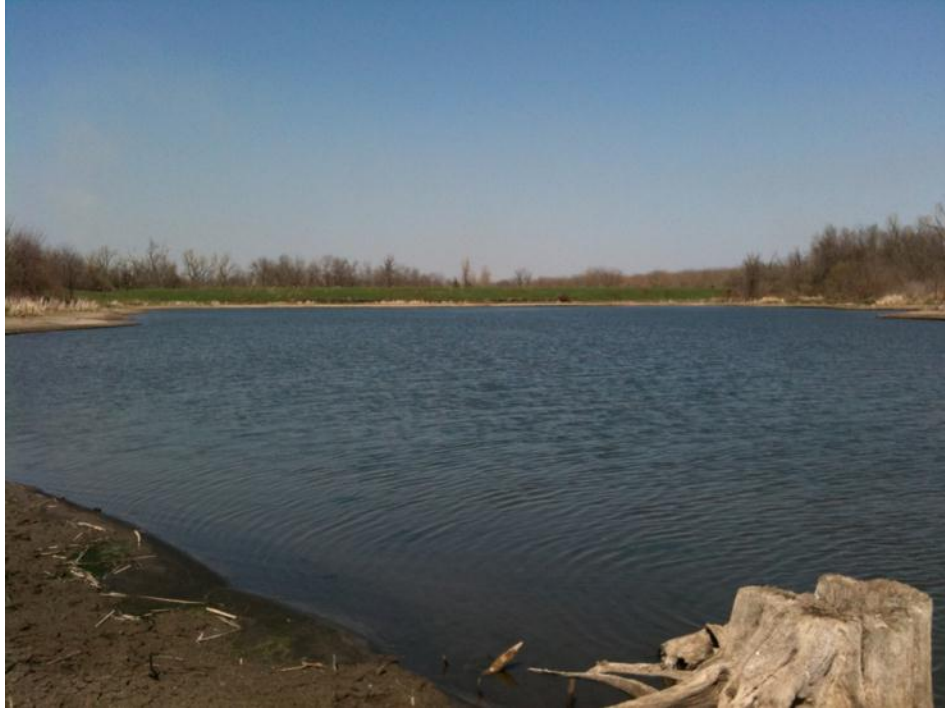
Figure 31: View looking downstream Dam 38 near the inflow turbidity sensor. Photo taken April 2011.

Wide variations in elevation (+/- ~7 feet) observed at Dam 38 made continuous data collection throughout the study period tenuous at best. Bank and lakebed material was extremely soft at low elevations, so no wading out to deeper waters to move sensors was possible due to safety concerns. Additionally, a second, small, perforated outflow riser was noted at extremely low elevations, which could not be measured to determine its hydraulic properties.

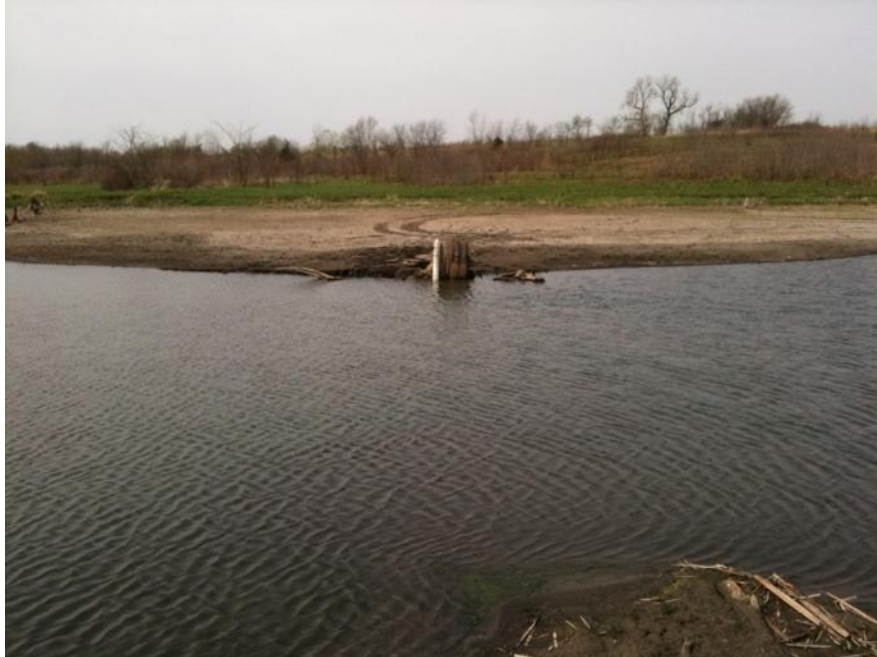
Figure 32: View of inflow turbidity sensor at Dam 38 looking west. Photo taken April 2011.

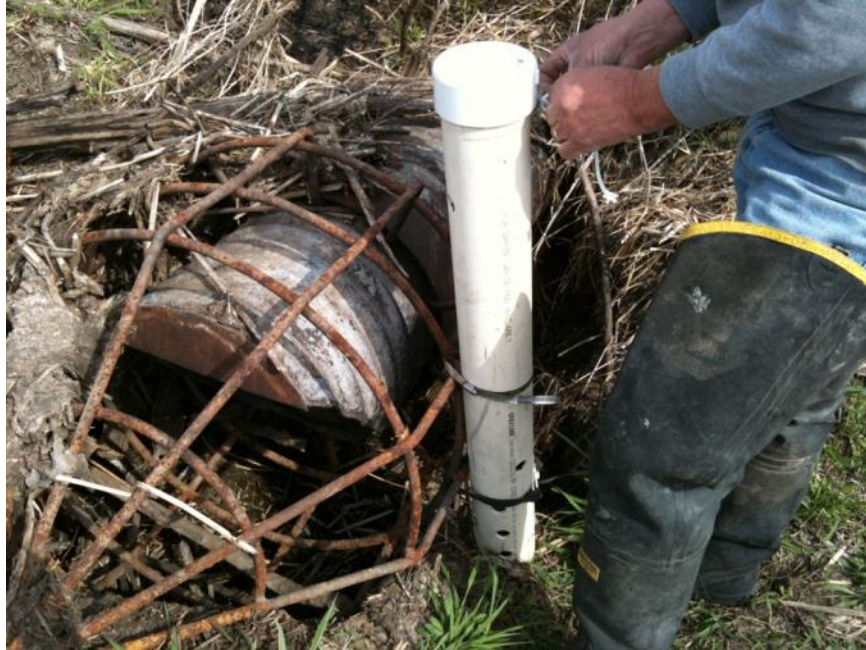
Figure 33: View of outflow turbidity sensor at Dam 38. Photo taken April 2011.

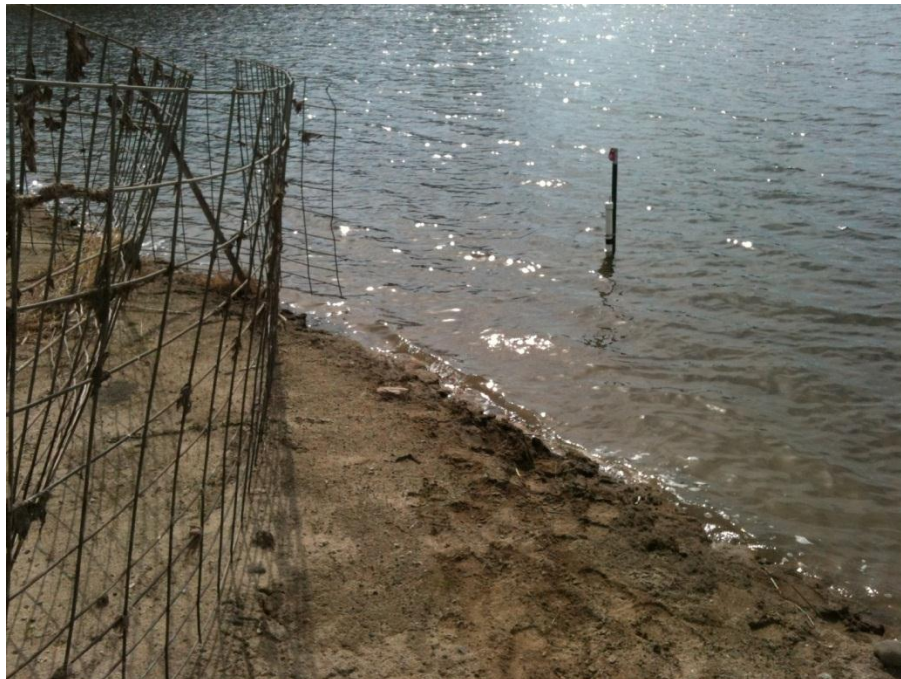
Figure 34: View of outflow elevation sensor at Dam 38. Photo taken April 2011.

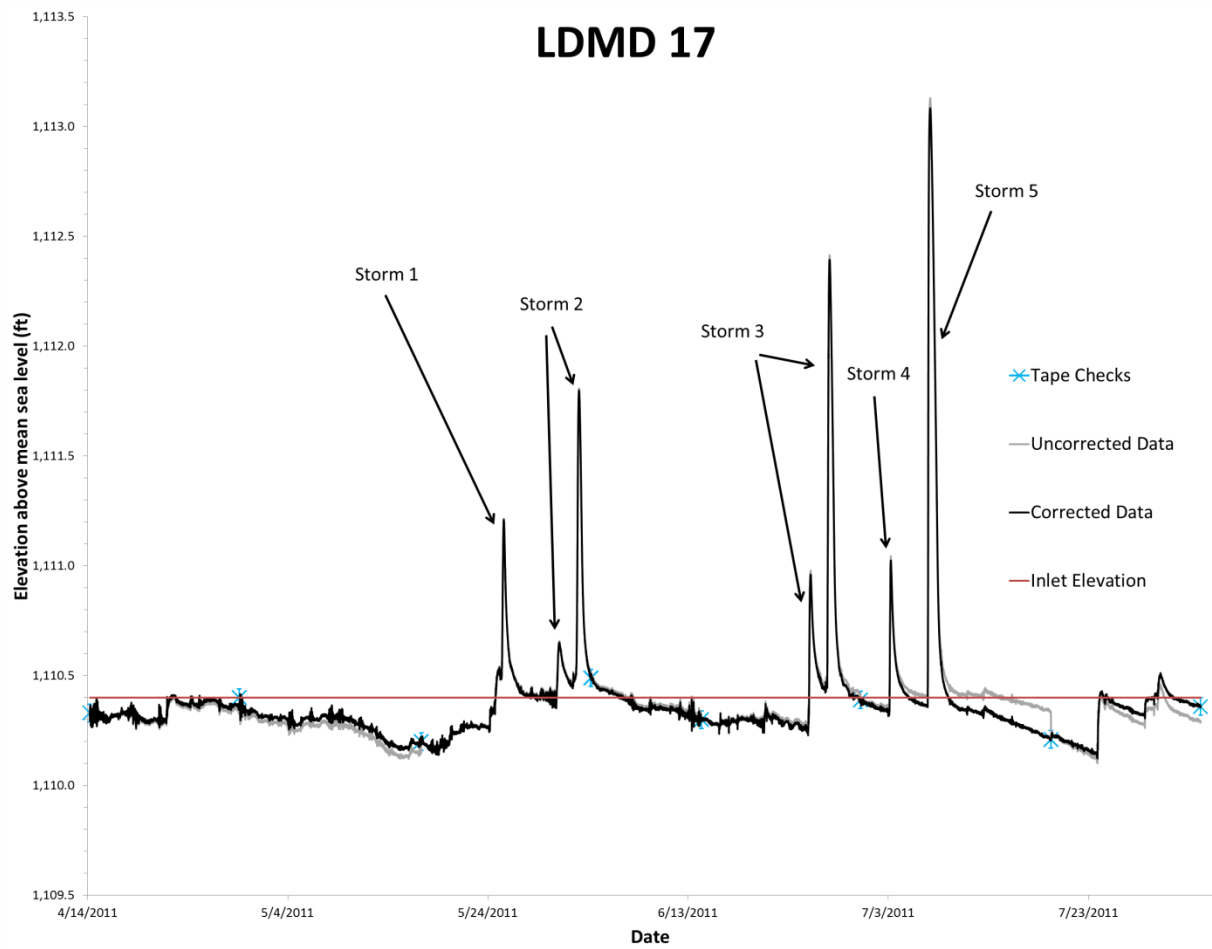
Figure 36: Elevation hydrograph over entire period of study for LDMD 17.
