**HISTORICAL METAMORPHOSIS OF THE ARKANSAS RIVER
ON THE KANSAS HIGH PLAINS**

Submitted to the graduate degree program in Geography and the Graduate Faculty
of the University of Kansas in partial fulfillment of the requirements for the
degree of Master of Science.

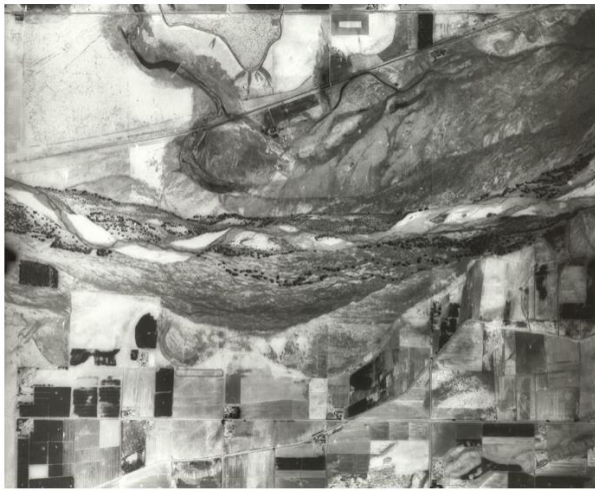
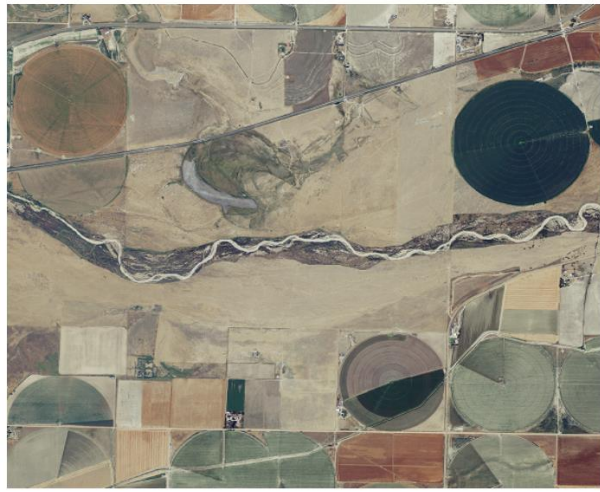
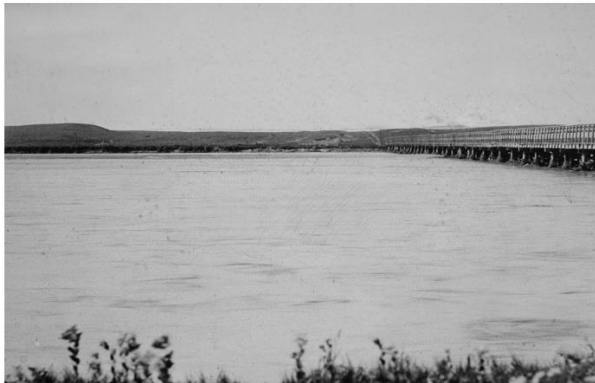
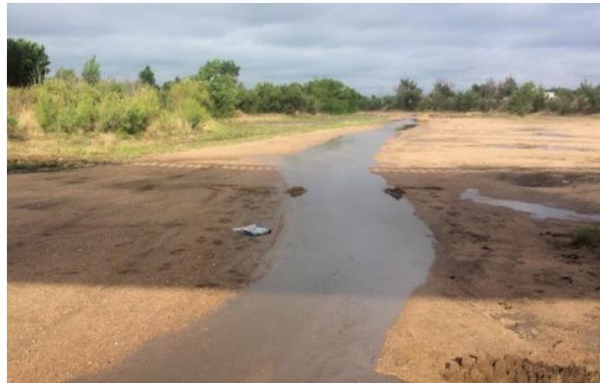
Figure 2: Past (left) and present (right) comparison of the Arkansas River in western Kansas. Top Left- 1939 aerial image of the Arkansas River as a braided channel pattern in Finney County (National Archives). Top Right- 2012 aerial image depicting the same reach of the Arkansas River as the top left image but as a meandering pattern (National Agriculture Imagery Program). Bottom left- Historical ground perspective image of the Arkansas River bridge at Garden City (view south/southwest) during the late 1800s (Kansas State Historical Society). Bottom right- Present day upstream (west) view from the Garden City bridge at U.S. Highway 83 (United States Geological Survey).

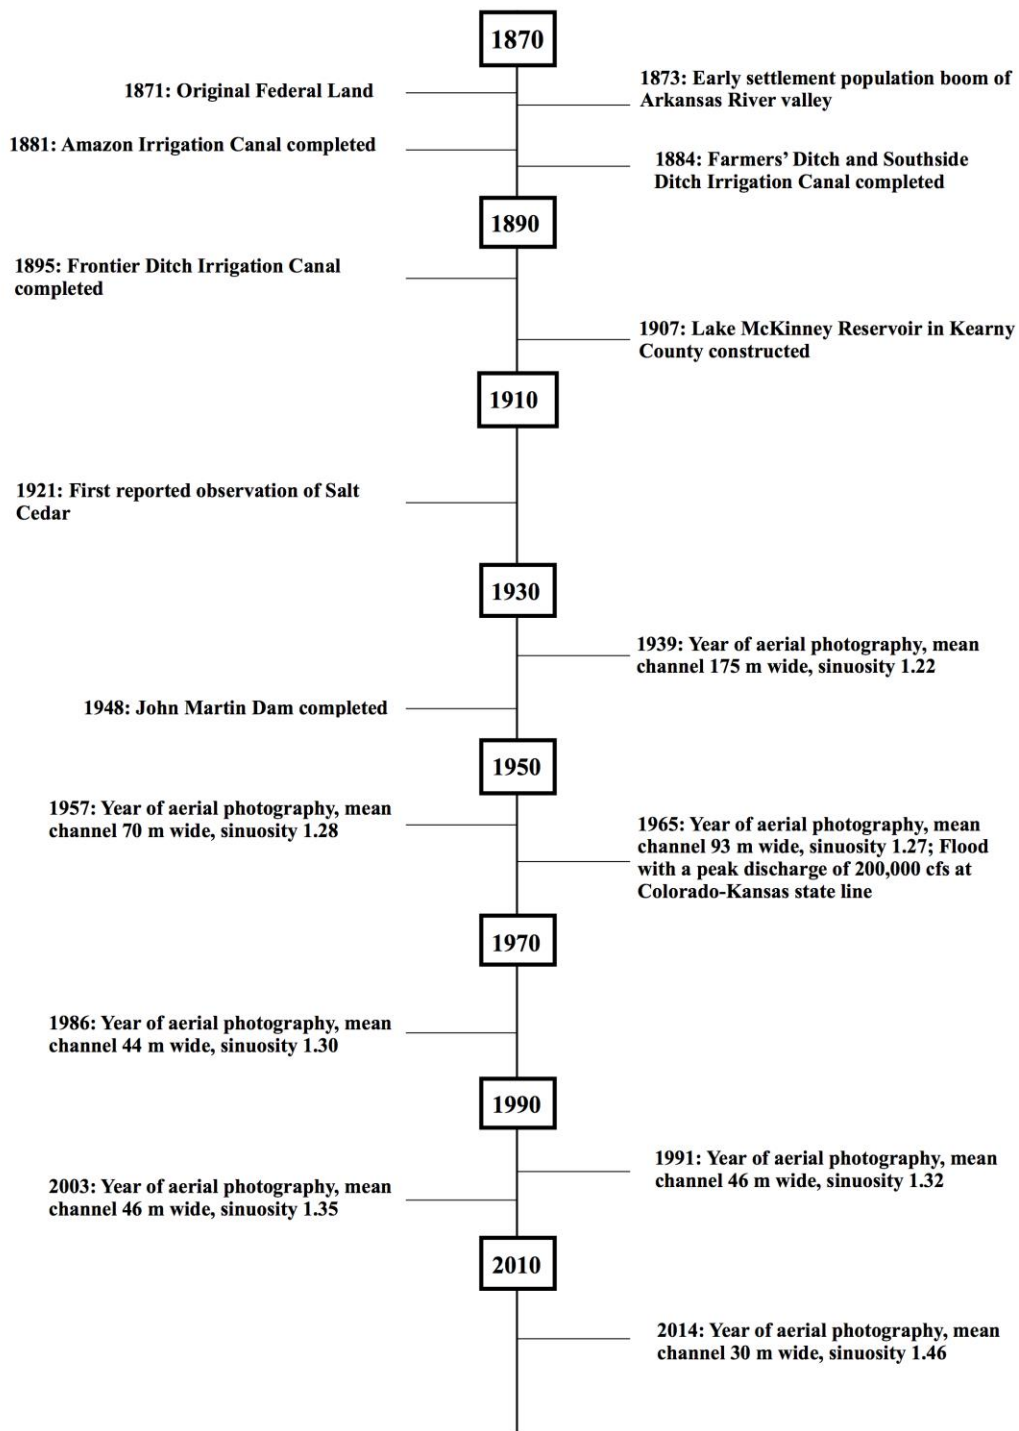
Figure 6: Timeline of the major floods, river engineering projects, and years of aerial photography for the study reach of the Arkansas River valley.

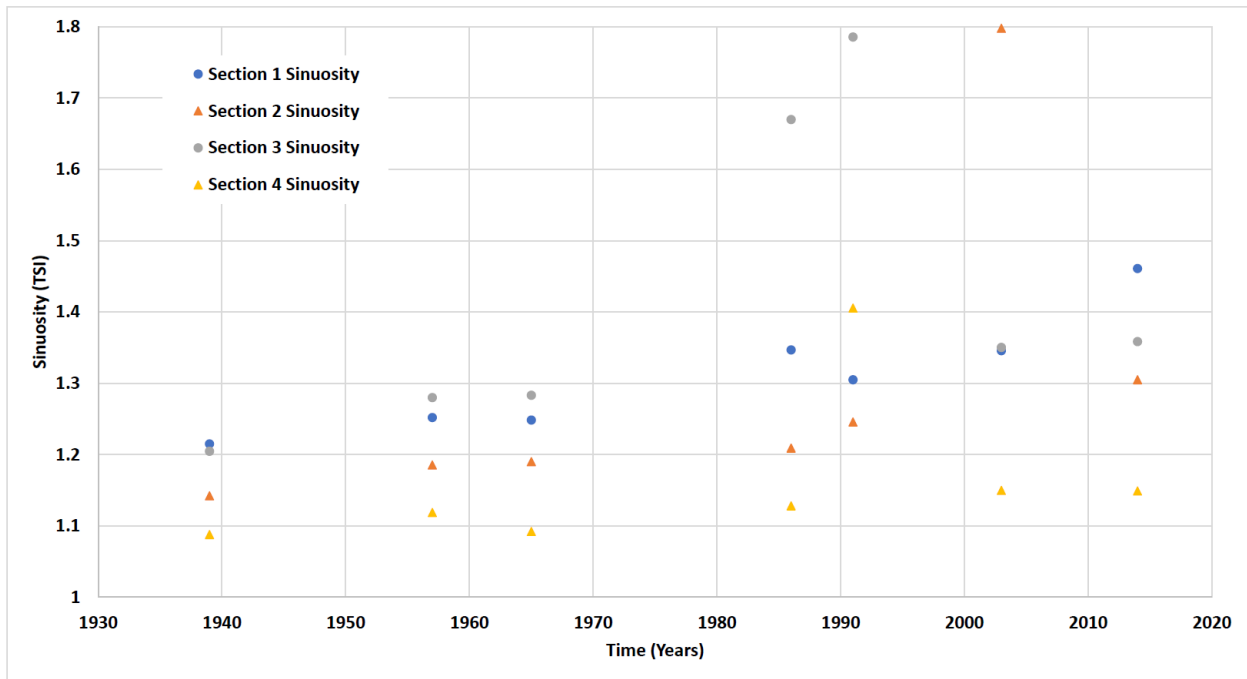
Figure 15: The study reach classified into four sections based on valley width. Sections 1 and 3 have wide valleys (circles) and sections 2 and 4 (triangles) have narrow valleys.

Maps illustrating the channel courses for each year of aerial photography were compiled with the latest year as top map layer as shown in the sample reach, where the middle portion of the study area reach is depicted (Figure 12). Only a portion of reaches resemble the sample reach, whereas major changes in channel morphology occurred east of Syracuse (western portion of study reach), where the sinuosity increased dramatically and the channel narrowed considerably in comparison to downstream reaches of the river (Figure 13). Minor modifications to the channel were documented at the eastern portion of the study reach in Finney County, where channel sinuosity has remained relatively stable from 1.1-1.2 during the 75 years of record (Figures 14 and 15).

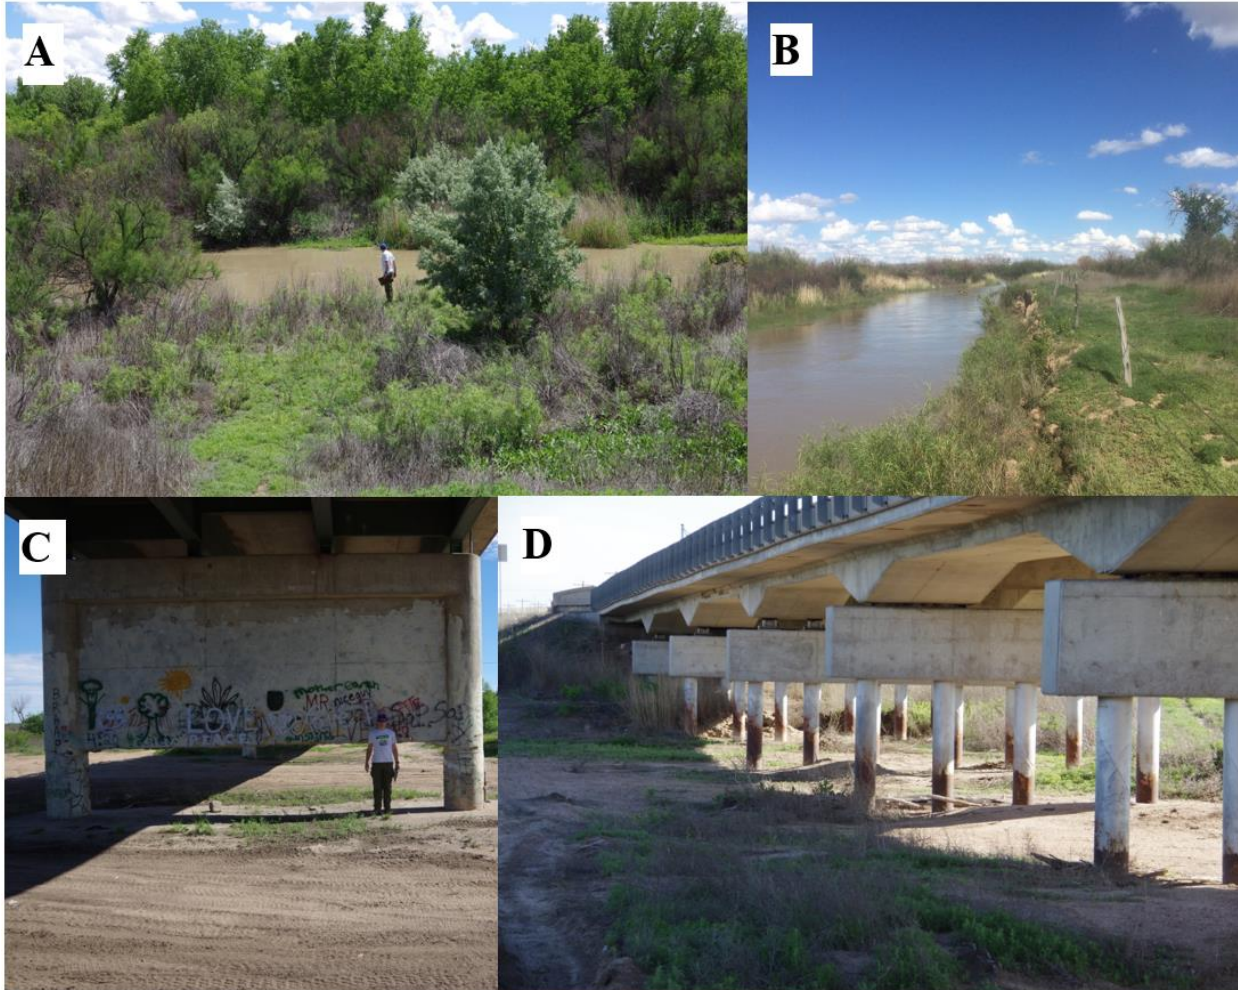
Figure 19: Examples of evidence for channel entrenchment at four locations within the study area reach: A) author standing on the former braided channel bed, B) the change in elevation of the river flowing east near Kendall, C) author standing on the present-day channel bed (dry); when the Garden City West Bridge pilings were emplaced in 1957 the channel bed was at the base of the cross panel between the support columns (entrenchment of about 1.5 m), and D) Pierceville Bridge with similar conditions to that of C.
