EVALUATION OF CRACKING PERFORMANCE OF BRIDGE DECKS INCORPORATING NONMETALLIC FIBERS

A Report on Research Sponsored by
CONSTRUCTION OF LOW-CRACKING HIGH-
PERFORMANCE BRIDGE DECKS
INCORPORATING NEW TECHNOLOGY
TRANSPORTATION POOLED-FUND PROGRAM
PROJECT NO. TPF-5(392)

Structural Engineering and Engineering Materials
SL Report 22-1
July 2022

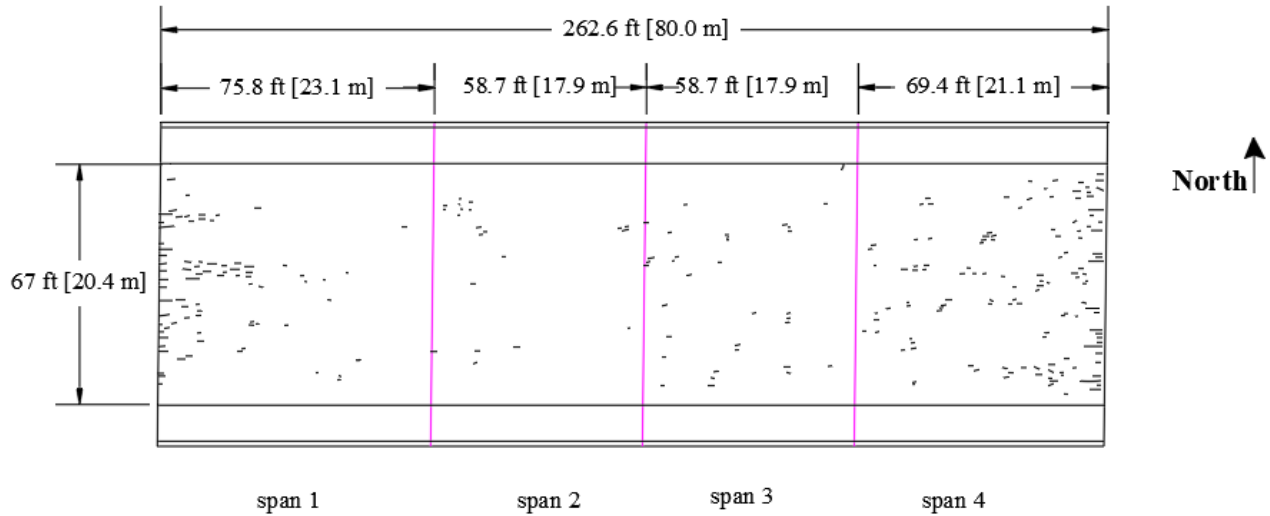
Figure 3.1: Crack survey of bridge 27W06

Bridge 27W06 was constructed in one placement on April 30, 2018. The bridge carries two-way traffic on Franklin Ave. over I-35 W and T.H. 65 in Minneapolis, Minnesota. The concrete supplier and the contractor were Aggregate Industries and Lunda Construction, respectively. The bridge has four spans with lengths of 75 ft-9 $\frac{3}{4}$ in. (23.1 m), 58 ft-9 in. (17.9 m), 58 ft-9 in. (17.9 m), and 68 ft-3 in. (21.1 m), with a total length of 262 ft-6 $\frac{3}{4}$ in. (80.0 m). The deck has a 67 ft (20.4 m) wide roadway, a 1 ft-5 in. (430 mm) wide barrier and a 10 ft (3.0 m) sidewalk on each side, for a total deck width of 89 ft-10 in. (27.3 m). The nominal deck thickness is 9 in. (230 mm). The bridge deck is supported by prestressed concrete girders with a skew of $-0^{\circ} 40' 15''$. The crack survey was performed at a deck age of 26.7 months, and the deck had a crack density of 0.066 m/m². The crack map is shown in Figure 3.1.

Crack Density: 0.066 m/m^2

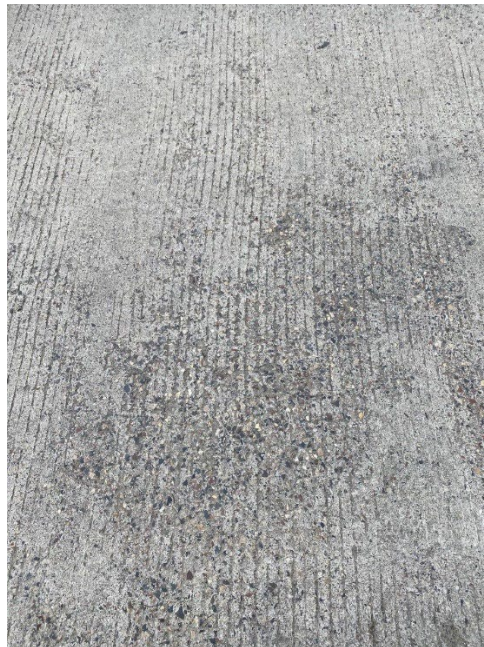
Figure 3.2: Scaling damage of bridge 27W06

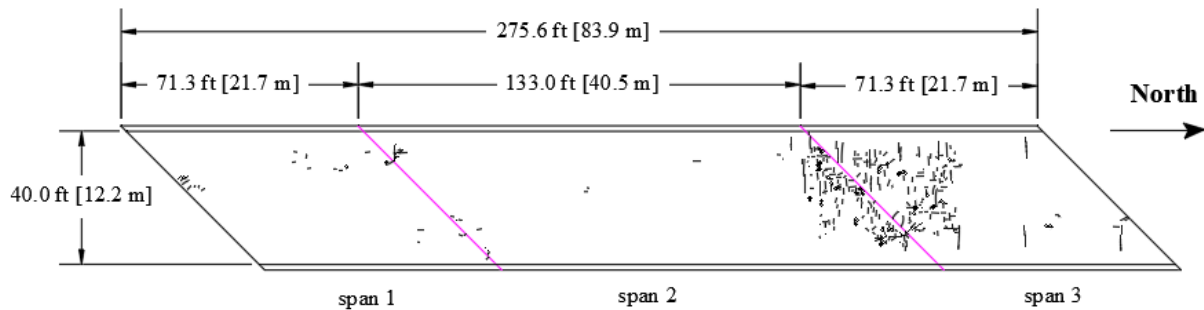
Figure 3.3: Crack survey of bridge 07051

Bridge 07051 was constructed in one placement on August 24, 2017. The two-lane bridge carries traffic on T.H. 22 over Big Cobb River in Beauford Township, Minnesota. The concrete supplier and the contractor were Cemstone Products Company and Minnowa Construction Inc, respectively. The bridge has three spans with lengths of 71 ft-4 in. (21.7 m), 133 ft (40.5 m), and 71 ft-4 in. (21.7 m), with a total length of 275 ft-8 in. (83.9 m). The deck has a 40 ft (12.1 m) wide roadway and a 1 ft-8 in. (490 mm) wide barrier on each side, for a total deck width of 43 ft-4 in. (13.1 m). The nominal deck thickness is 9 in. (230 mm). The bridge deck is supported by prestressed concrete girders with a skew of 45°. The crack survey was performed at a deck age of 35.3 months, and the deck had a crack density of 0.139 m/m². The crack map is shown in Figure 3.3.

Bridge Number: 07051	Bridge Length: 275.6 ft (83.9 m)	Bridge Age: 35.3 months
Bridge Location: T.H.22 over Big Cobb river, Beauford Township, MN	Bridge Width: 40.0 ft (12.2 m)	Crack Density: 0.139 m/m ²
Construction Date: 8/24/2017	Skew: 45°	Span 1: 0.032 m/m ²
Crack Survey Date: 8/3/2020	Number of Spans: 3	Span 2: 0.120 m/m ²
	Span 1: 71.3 ft (21.7 m)	Span 3: 0.282 m/m ²
	Span 2: 133 ft (40.5 m)	
	Span 3: 71.3 ft (21.7 m)	
	Number of Placements: 1

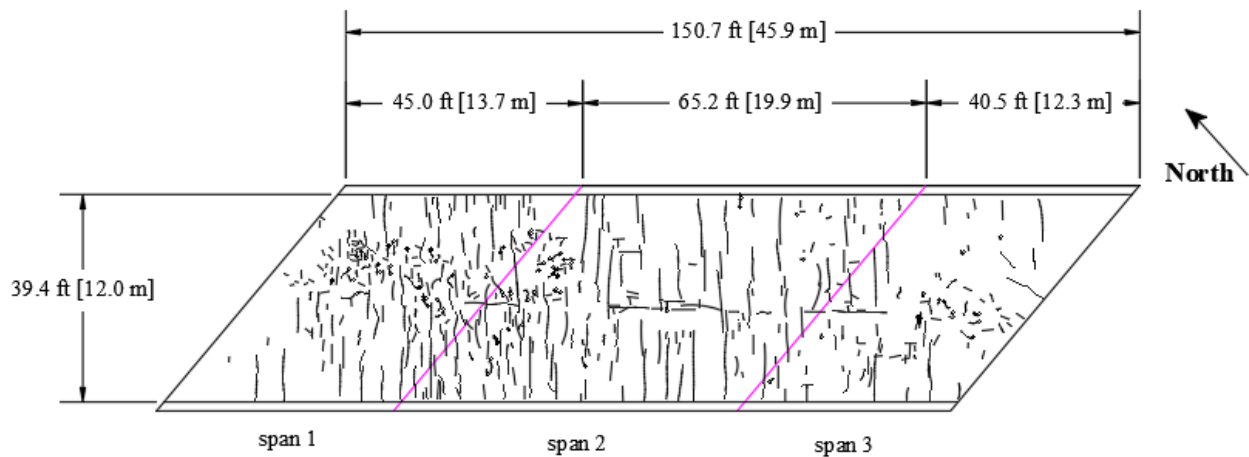
Bridge 9691 was constructed in one placement on August 11, 2016. The bridge carries westbound traffic on I-94 WB over C.S.A.H. 88. in Fergus Falls, Minnesota. The concrete supplier and the contractor were Aggregate Industries and PCI Roads LLC, respectively. The bridge has three spans with lengths of 45 ft (13.7 m), 65 ft-2 5/8 in. (19.9 m), and 40 ft-6 in. (12.3 m), with a total length of 150 ft-8 5/8 in. (45.9 m). The deck has a 39 ft-5 in. (12.0 m) wide roadway and a 1 ft-8 in. (490 mm) wide barrier on each side, for a total deck width of 42 ft-9 in. (13.0 m). The nominal deck thickness is 9 in. (230 mm). The bridge deck is supported by steel girders with a skew of $-39^{\circ} 57'$. The crack survey was performed at a deck age of 46.8 months, and the deck had a crack density of 0.779 m/m^2 . The crack map is shown in Figure 3.4.

Bridge Number: 9691	Bridge Length: 150.7 ft (45.9 m)	Bridge Age: 46.8 months
Bridge Location: I-94 WB over CSAH 88, Fergus Falls, MN	Bridge Width: 39.4 ft (12.0 m)	Crack Density: 0.779 m/m^2
Construction Date: 8/11/2016	Skew: $-39^{\circ} 57'$	Span 1: 0.803 m/m^2
Crack Survey Date: 7/6/2020	Number of Spans: 3	Span 2: 0.869 m/m^2
	Span 1: 45.0 ft (13.7 m)	Span 3: 0.609 m/m^2
	Span 2: 65.2 ft (19.9 m)	
	Span 3: 40.5 ft (12.3 m)	
	Number of Placements: 1

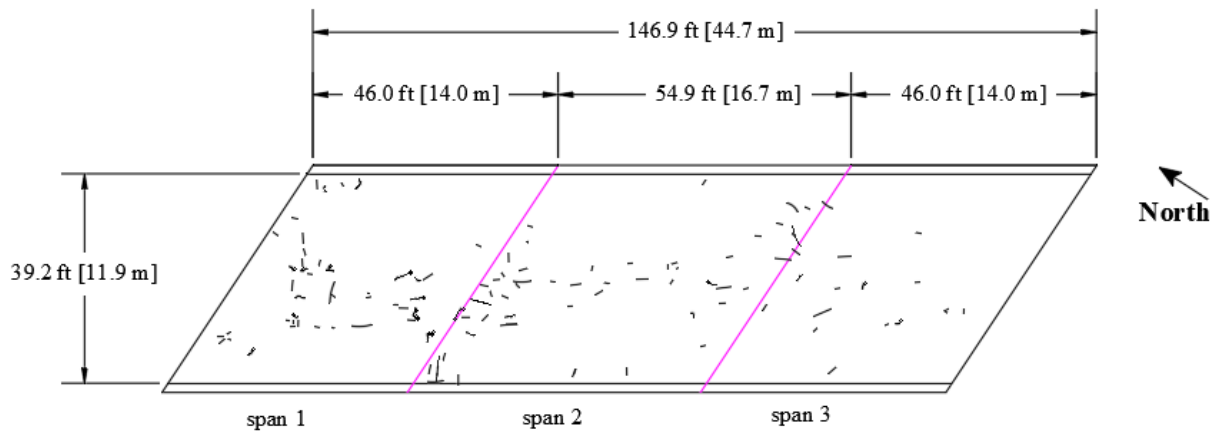
Bridge 21802 was constructed in one placement on September 19, 2017. The bridge carries eastbound traffic on I-94 EB over T.H. 79 in Evansville Township, Minnesota. The concrete supplier and the contractor were Alexandria Concrete and Lunda Construction Company, respectively. The bridge has three spans with lengths of 45 ft-11 5/8 in. (14.0 m), 54 ft-11 in. (16.8 m), and 45 ft-11 5/8 in. (14.0 m), with a total length of 146 ft-10 1/4 in. (44.7 m). The deck has a 39 ft-2 in. (11.9 m) wide roadway and a 1 ft-8 in. (490 mm) wide barrier on each side, for a total deck width of 42 ft-6 in. (12.9 m). The nominal deck thickness is 9 in. (230 mm). The bridge deck is supported by prestressed concrete girders with a skew of -33° 39'. The crack survey was performed at a deck age of 33.6 months, and the deck had a crack density of 0.103 m/m². The crack map is shown in Figure 3.5.

Bridge Number: 21802	Bridge Length: 146.9 ft (44.7 m)	Bridge Age: 33.6 months
Bridge Location: I-94 EB over T.H.79, Evansville Township, MN	Bridge Width: 39.2 ft (11.9 m)	Crack Density: 0.103 m/m ²
Construction Date: 9/19/2017	Skew: -33°39'	Span 1: 0.125 m/m ²
Crack Survey Date: 7/6/2020	Number of Spans: 3	Span 2: 0.135 m/m ²
	Span 1: 46.0 ft (14.0 m)	Span 3: 0.042 m/m ²
	Span 2: 54.9 ft (16.8 m)	
	Span 3: 46.0 ft (14.0 m)	
	Number of Placements: 1

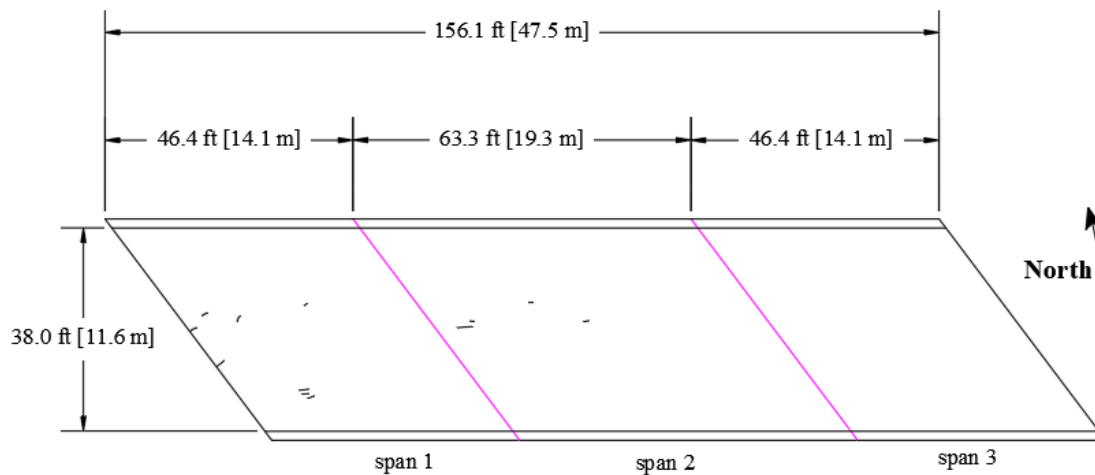
Bridge 21803 was constructed in one placement. The date of construction is not available. The bridge carries westbound traffic on I-94 WB over T.H. 114 in La Grand Township, Minnesota. Information on the concrete supplier and the contractor is not available. The bridge has three spans with lengths of 46 ft-5 1/8 in. (14.1 m), 63 ft-3 1/8 in. (19.3 m), and 46 ft-5 1/8 in. (14.1 m), with a total length of 156 ft-1 3/8 in. (47.5 m). The deck has a 38 ft (11.6 m) wide roadway and a 1 ft-8 in. (490 mm) wide barrier on each side, for a total deck width of 41 ft-4 in. (12.5 m). The nominal deck thickness is 9 in. (230 mm). The bridge deck is supported by prestressed concrete girders with a skew of 37° 2'30". The crack density was 0.009 m/m². The age of the deck at the time of the survey is not known. The crack map is shown in Figure 3.6.

Bridge Number: 21803	Bridge Length: 156.1 ft (47.5 m)	Bridge Age: months
Bridge Location: I-94 WB over T.H.114, La Grand Township, MN	Bridge Width: 38.0 ft (11.6 m)	Crack Density: 0.009 m/m ²
Construction Date: / /2017	Skew: 37°2'30"	Span 1: 0.021 m/m ²
Crack Survey Date: 7/7/2020	Number of Spans: 3	Span 2: 0.008 m/m ²
	Span 1: 46.4 ft (14.1 m)	Span 3: 0.000 m/m ²
	Span 2: 63.3 ft (19.3 m)	
	Span 3: 46.4 ft (14.1 m)	
	Number of Placements: 1

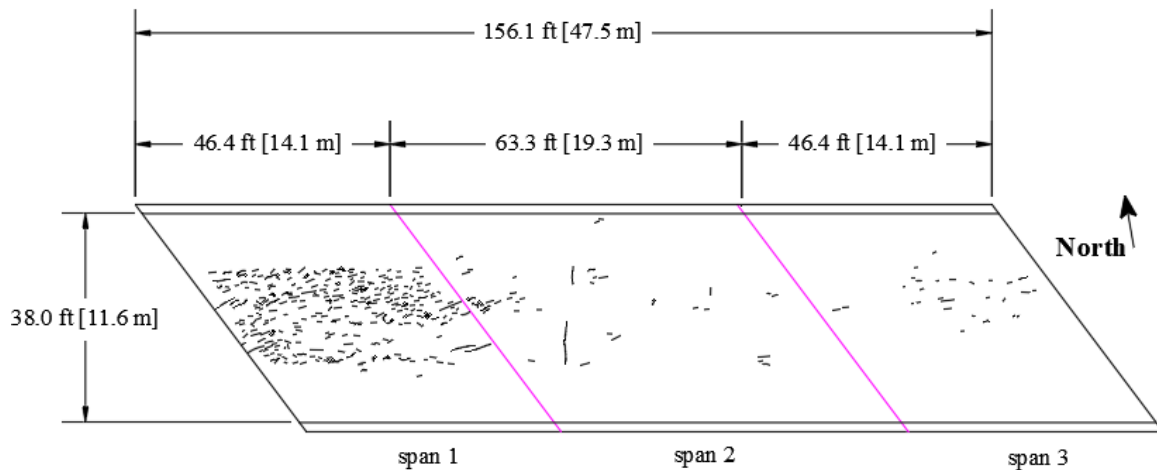
Bridge 21804 was constructed in one placement on September 5, 2017. The bridge carries eastbound traffic on I-94 EB over T.H. 114 in La Grand Township, Minnesota. The concrete supplier and the contractor were Alexandria Concrete and Lunda Construction Company, respectively. The bridge has three spans with lengths of 46 ft-5 1/8 in. (14.1 m), 63 ft-3 1/8 in. (19.3 m), and 46 ft-5 1/8 in. (14.1 m), with a total length of 156 ft-1 3/8 in. (47.5 m). The deck has a 38 ft (11.6 m) wide roadway and a 1 ft-8 in. (490 mm) wide barrier on each side, for a total deck width of 41 ft-4 in. (12.5 m). The nominal deck thickness is 9 in. (230 mm). The bridge deck is supported by prestressed concrete girders with a skew of 37° 2'30". The crack survey was performed at a deck age of 34.1 months, and the deck had a crack density of 0.206 m/m². The crack map is shown in Figure 3.7.

Bridge Number: 21804	Bridge Length: 156.1 ft (47.5 m)	Bridge Age: 34.1 months
Bridge Location: I-94 EB over T.H.114, La Grand Township, MN	Bridge Width: 38.0 ft (11.6 m)	Crack Density: 0.206 m/m ²
Construction Date: 9/5/2017	Skew: 37°2'30"	Span 1: 0.549 m/m ²
Crack Survey Date: 7/7/2020	Number of Spans: 3	Span 2: 0.071 m/m ²
	Span 1: 46.4 ft (14.1 m)	Span 3: 0.047 m/m ²
	Span 2: 63.3 ft (19.3 m)	
	Span 3: 46.4 ft (14.1 m)	
	Number of Placements: 1

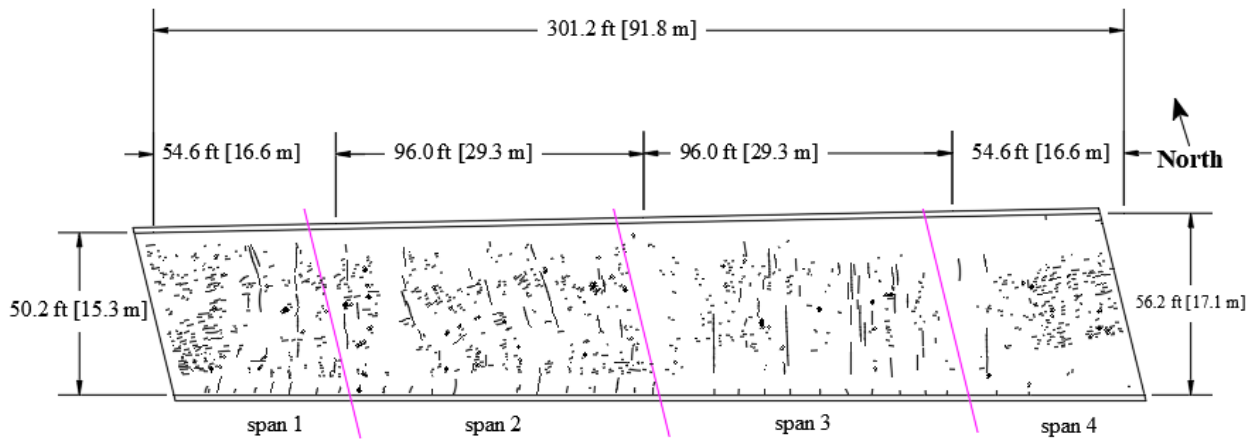
Bridge 55009 was constructed in one placement on August 31, 2016. The bridge carries westbound traffic on T.H.52 WB over T.H.63 in Rochester, Minnesota. The concrete supplier and the contractor were Ready Mix Concrete Company and Icon Construction LLC, respectively. The bridge has four spans with a polygonal surface in plan view. The nominal lengths of the spans are 54 ft-7 1/8 in. (16.6 m), 96 ft (29.3 m), 96 ft (29.3 m), and 54 ft-7 1/8 in. (16.6 m), with a total length of 301 ft-2 1/4 in. (91.8 m). The deck has a nominal 50 ft-2 5/8 in. (15.3 m) to 56 ft-1 7/8 in. (17.1 m) wide roadway and a 1 ft-8 in. (490 mm) wide barrier on each side. The nominal deck thickness is 8 in. (205 mm). The bridge deck is supported by steel girders with a skew of 13° 48'0". The crack survey was performed at a deck age of 47.1 months, and the deck had a crack density of 0.293 m/m². The crack map is shown in Figure 3.8.

Bridge Number: 55009	Bridge Length: 301.2 ft (91.8 m)	Bridge Age: 47.1 months
Bridge Location: T.H.52WB over T.H.63, Rochester Township, MN	Bridge Width: 50.2 ft (15.3 m)-56.2 ft (17.1 m)	Crack Density: 0.293 m/m ²
Construction Date: 8/31/2016	Skew: 13°48'	Span 1: 0.460 m/m ²
Crack Survey Date: 8/4/2020	Number of Spans: 4	Span 2: 0.316 m/m ²
	Span 1: 54.6 ft (16.6 m)	Span 3: 0.214 m/m ²
	Span 2: 96.0 ft (29.3 m)	Span 4: 0.238 m/m ²
	Span 3: 96.0 ft (29.3 m)	
	Span 4: 54.6 ft (16.6 m)	
	Number of Placements: 1

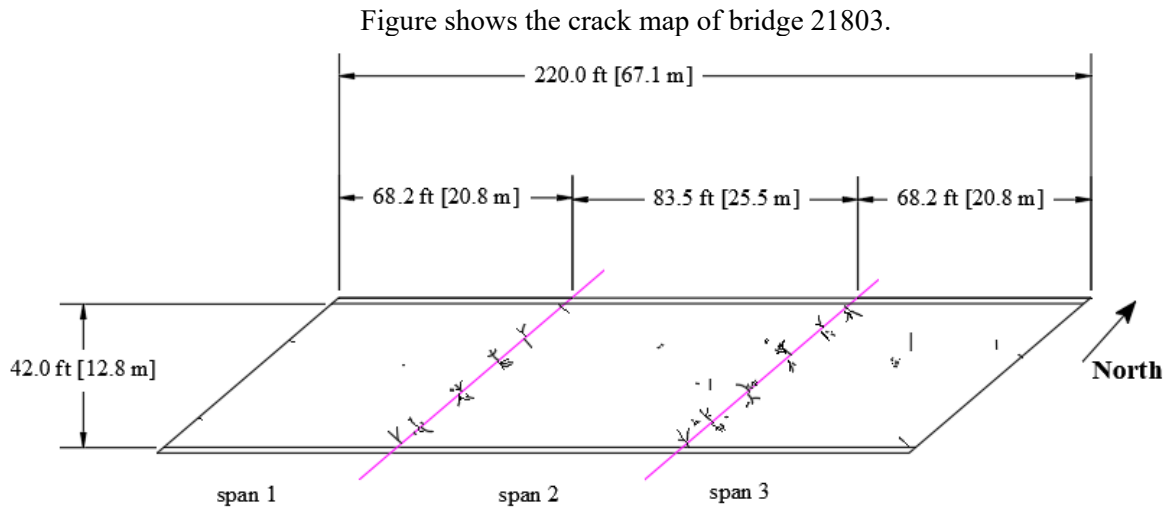
Bridge 58821 was constructed in one placement on October 6, 2016. The bridge carries southbound traffic on I-35 SB over St. Corix Valley Railroad in Pine City, Minnesota. The concrete supplier and the contractor were Cemstone Products Company and Redstone Construction Company, respectively. The bridge has three spans with lengths of 68 ft-3 in. (20.8 m), 83 ft-6 in. (25.5 m), and 68 ft-3 in. (20.8 m), with a total length of 220 ft (67.1 m). The deck has a 42 ft (12.8 m) wide roadway and a 1 ft-8 in. (490 mm) wide barrier on each side, for a total deck width of 45 ft-4 in. (13.8 m). The nominal deck thickness is 9 in. (230 mm). The bridge deck is supported by prestressed concrete girders with a skew of $-49^{\circ} 29' 30''$. The crack survey was performed at a deck age of 46.1 months, and the deck had a crack density of 0.071 m/m^2 . The crack map is shown in Figure 3.9.

Bridge Number: 58821
Bridge Location: I-35 SB over St. Croix Valley Railroad, Pine county, MN
Construction Date: 10/6/2016
Crack Survey Date: 8/10/2020

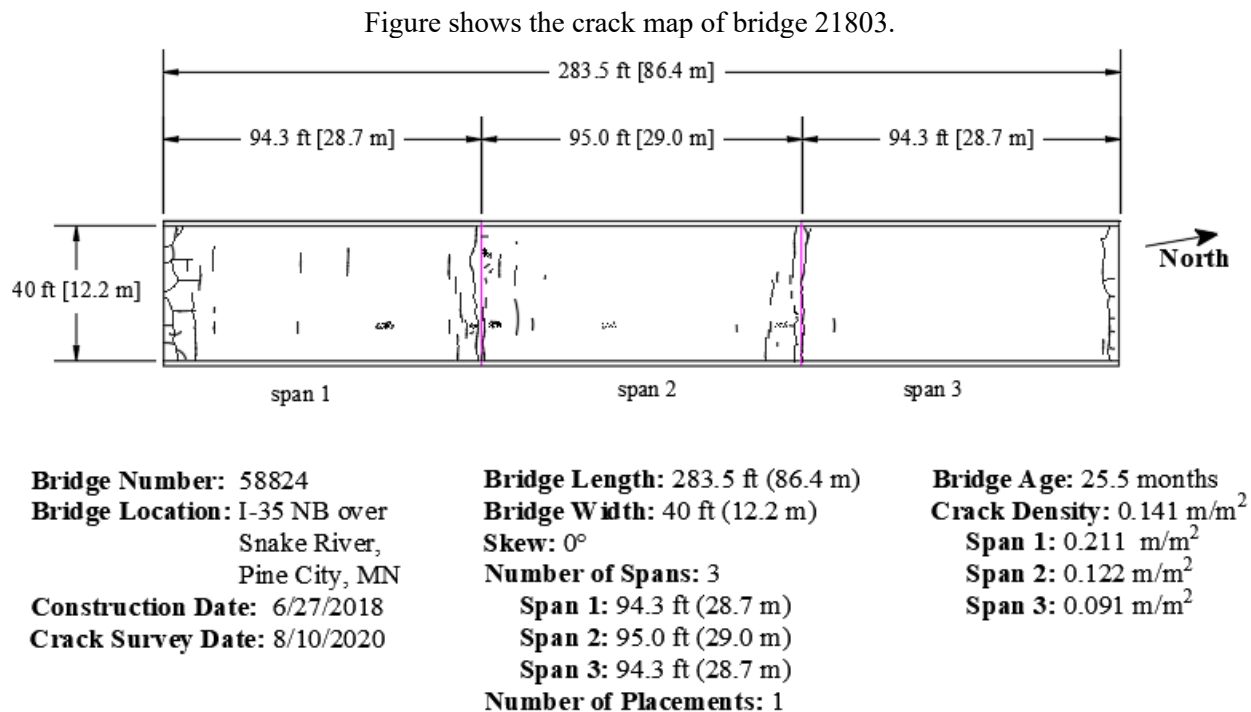
Figure 3.10: Crack survey of bridge 58824

Bridge 58824 was constructed in one placement on June 27, 2018. The bridge carries southbound traffic on I-35 SB over St. Croix Valley Railroad in Pine City, Minnesota. The concrete supplier and the contractor were Cemstone Products Company and Ames Construction, respectively. The bridge has three spans with lengths of 94 ft-3 in. (28.7 m), 95 ft (29.0 m), and 94 ft-3 in. (28.7 m), with a total length of 283 ft-6 in. (86.4 m). The deck has a 40 ft (12.2 m) wide roadway and a 1 ft-6 in. (460 mm) wide barrier on each side, for a total deck width of 43 ft (13.1 m). The nominal deck thickness is 9 in. (230 mm). The bridge deck is supported by prestressed concrete girders with a skew of 0°. The crack survey was performed at a deck age of 25.5 months, and the deck had a crack density of 0.141 m/m². The crack map is shown in Figure 3.10.

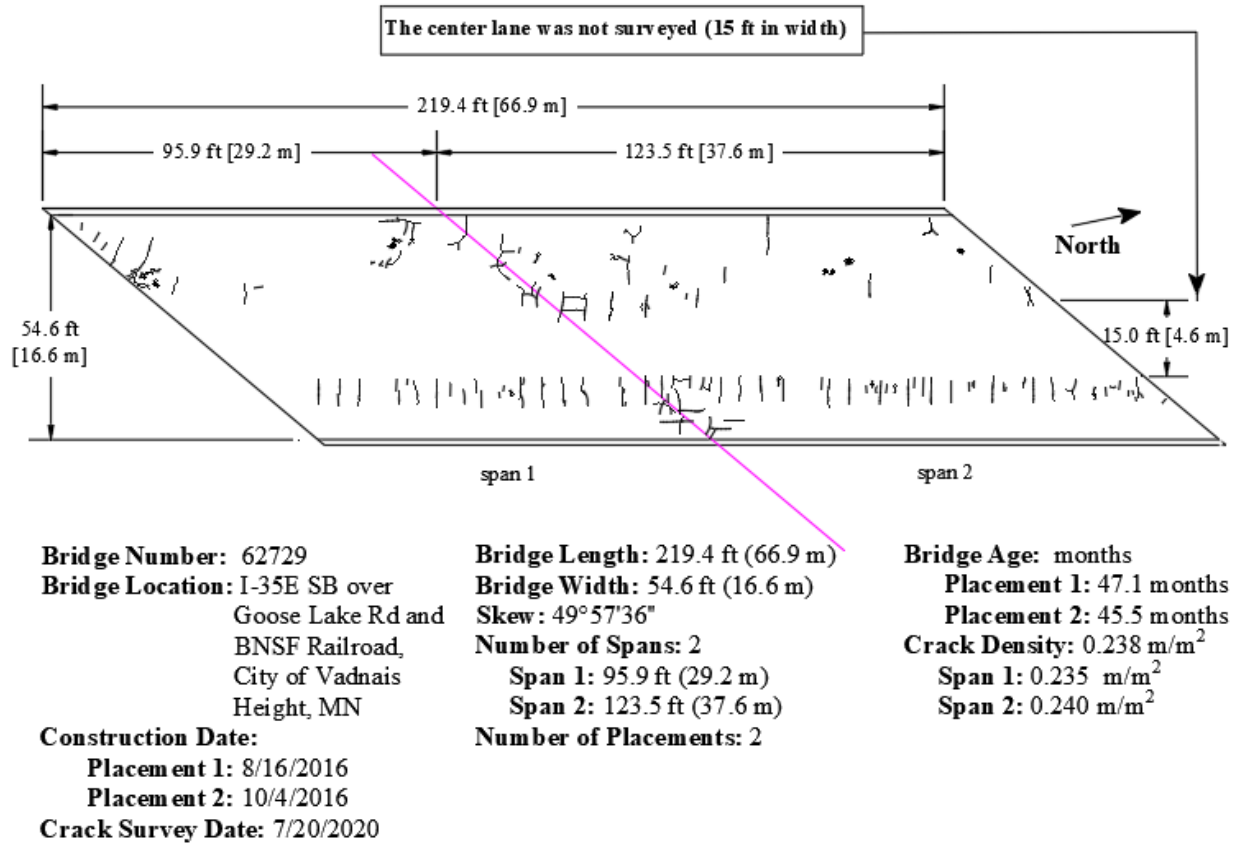
Figure 3.11: Crack survey of bridge 62729

Bridge 62729 was constructed in two placements. Placement 1 was constructed on August 16, 2016, and Placement 2 was constructed on October 4, 2016. The bridge carries southbound traffic on I-35 SB over Goose Lake Rd. in Vadnais Height, Minnesota. The concrete supplier and the contractor were Cemstone Products Company and Ames Construction, respectively. The bridge has two spans with lengths of 95 ft-11 $\frac{3}{4}$ in. (29.2 m) and 123 ft-5 $\frac{3}{4}$ in. (37.6 m), with a total length of 219 ft-5 $\frac{1}{2}$ in. (69.3 m). The deck has a 54 ft-7 $\frac{1}{2}$ in. (16.6 m) wide roadway, a 1 ft-8 in. (490 mm) wide barrier on the west side, and a 1 ft-4 in. (390 mm) wide barrier on the east side, for a total deck width of 57 ft-7 $\frac{1}{2}$ in. (17.6 m). The nominal deck thickness is 9 in. (230 mm). The bridge deck is supported by prestressed concrete girders with a skew of 49° 57'36". The crack survey was performed at a deck age of 47.1 months for Placement 1 and 45.5 months for Placement 2. The concrete placement locations are not available. The crack density of 0.238 m/m² was calculated for the entire deck. The crack map is shown in Figure 3.11.

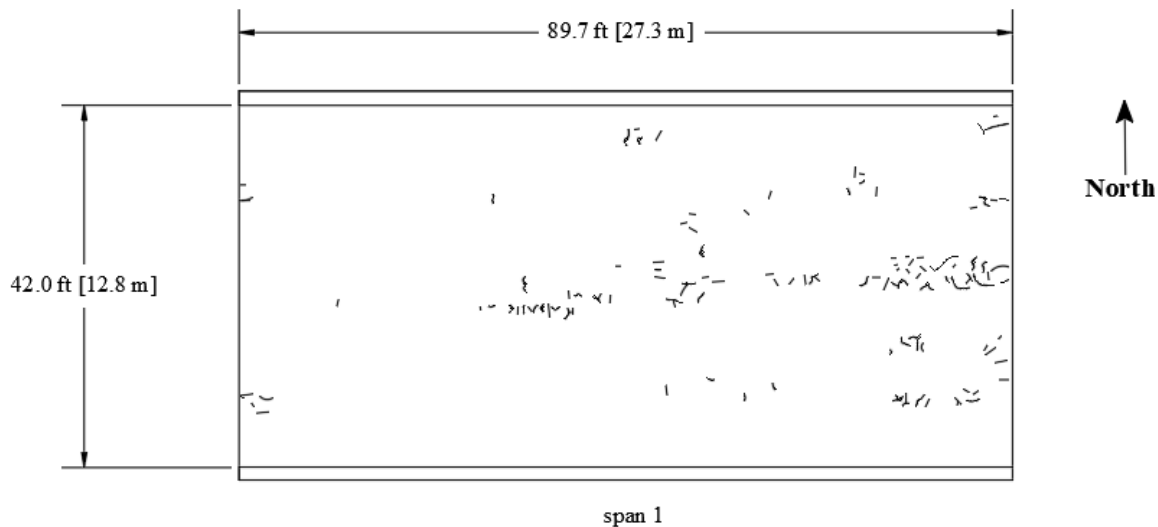
Figure 3.12: Crack survey of bridge 62731

Bridge 62731 was constructed in one placement on August 8, 2016. The bridge carries westbound traffic on T.H. 36 over Lexington Ave. in Roseville, Minnesota. The concrete supplier and the contractor were Cemstone Products Company and Ames Construction, respectively. The bridge has one span with a total length of 89 ft-8 in. (27.3 m). The deck has a 42 ft (12.8 m) wide roadway, a 1 ft-8 in. (490 mm) wide barrier on the north side, and a 1 ft-6 in. (460 mm) wide barrier on the south side, for a total deck width of 45 ft-2 in. (13.8 m). The nominal deck thickness is 9 in. (230 mm). The bridge deck is supported by prestressed concrete girders with no skew. The crack survey was performed at a deck age of 47.4 months, and the deck had a crack density of 0.120 m/m². The crack map is shown in Figure 3.12.

Bridge Number: 62731	Bridge Length: 89.7 ft (27.3 m)	Bridge Age: 47.4 months
Bridge Location: T.H.36 WB over Lexington Ave. , City of Roseville, MN	Bridge Width: 42.0 ft (12.8 m)	Crack Density: 0.120 m/m ²
Construction Date: 8/8/2016	Skew: 0°	Span 1: 0.120 m/m ²
Crack Survey Date: 7/21/2020	Number of Spans: 1	
	Span 1: 89.7 ft (27.3 m)	
	Number of Placements: 1

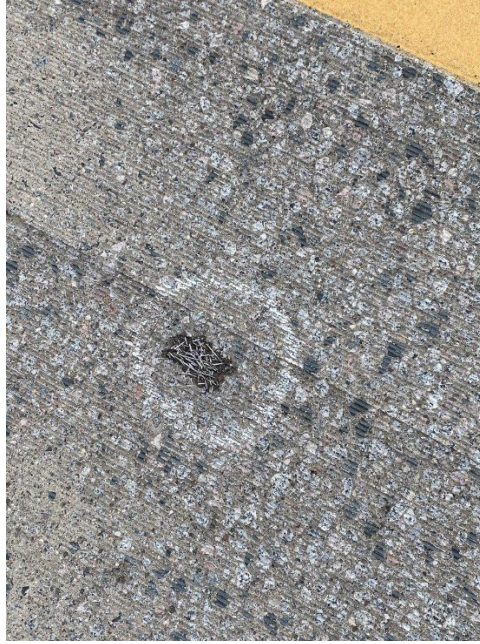
Figure 3.13: Fiber ball pop-out in 62731

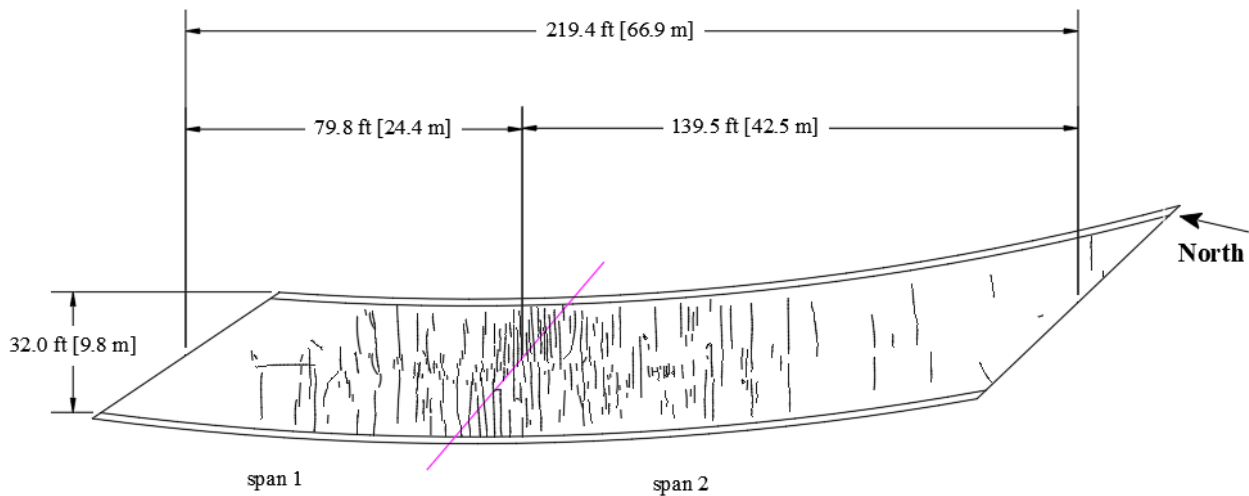
Bridge 62831 was constructed in one placement on October 2, 2015. The bridge carries eastbound traffic on I-94 EB over I-94 WB in St. Paul, Minnesota. The concrete supplier and the contractor were Aggregate Industries and Lunda Construction Company, respectively. The curved bridge has two spans. The lengths of the spans as shown on the plans are 79 ft-10¹/₈ in. (24.4 m) and 139 ft-6¹/₄ in. (42.5 m), with a total length of 219 ft-4³/₈ in. (69.9 m). The deck has a 32 ft (9.8 m) wide roadway and a 1 ft-8 in. (490 mm) wide barrier on each side. The nominal deck thickness is 9 in. (230 mm). The bridge deck is supported by steel girders with a skew ranging from -33° 54'33" to -43° 34'3". The crack survey was performed at a deck age of 57.6 months, and the deck had a crack density of 0.567 m/m². The crack map is shown in Figure 3.14.

Bridge Number: 62831
Bridge Location: I-94EB (on ramp)
 over I-94WB, City
 of St. Paul, MN

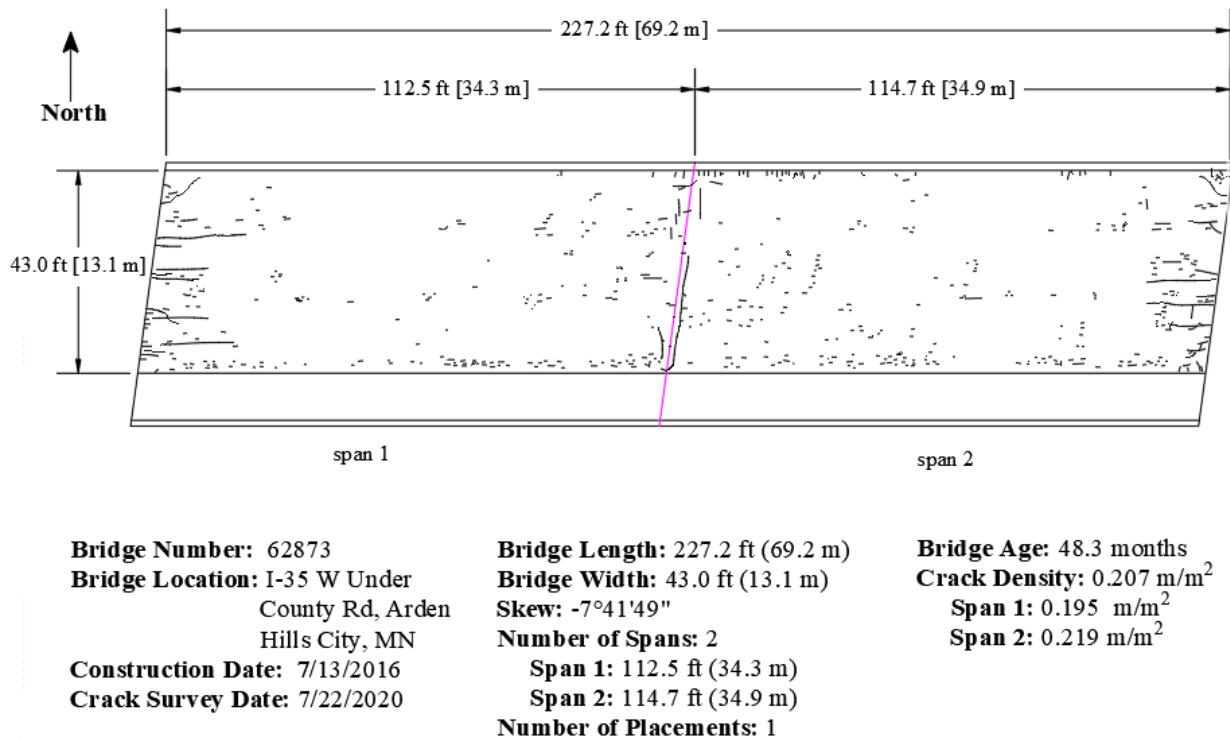
Figure 3.15: Crack survey of bridge 62873

Bridge 62873 was constructed in one placement on July 13, 2016. The bridge carries eastbound traffic on I-35 W under County Rd. in Arden Hills, Minnesota. The concrete supplier and the contractor were AVR Inc. and Ames Construction, respectively. The bridge has two spans with lengths of 112 ft-5 ½ in. (34.3 m) and 114 ft-8 ½ in. (34.9 m), with a total length of 227 ft-2 in. (69.2 m). The deck has a 43 ft (13.1 m) wide roadway with a 10 ft (3.1 m) sidewalk on the south side, a 1 ft-8 in. (490 mm) wide barrier on the north side, and a 1 ft-3 in. (380 mm) wide barrier on the south side, for a total deck width of 55 ft-11 in. (17.0 m). The nominal deck thickness is 9 in. (230 mm). The bridge deck is supported by prestressed concrete girders with a skew of -7° 41'49". The crack survey was performed at a deck age of 48.3 months, and the deck had a crack density of 0.207 m/m². The crack map is shown in Figure 3.15.

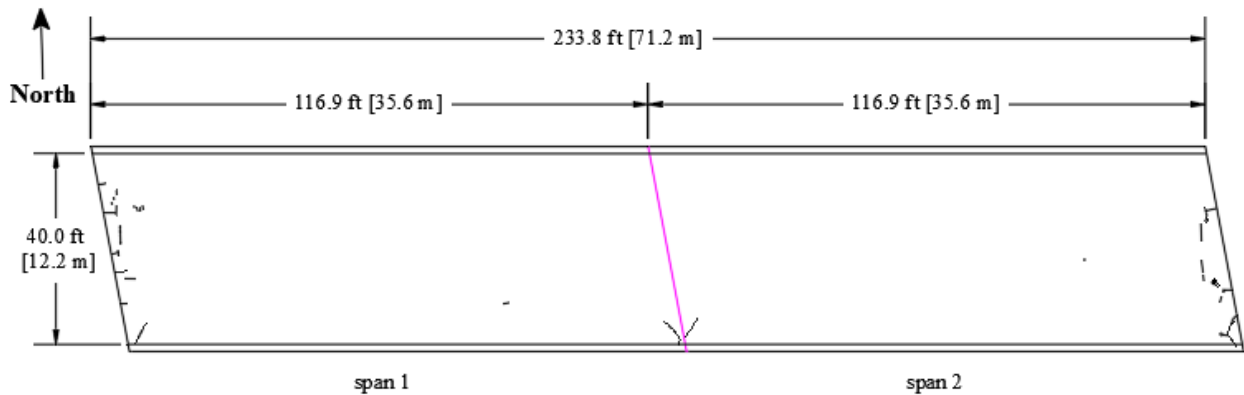
Bridge Number: 69137	Bridge Length: 233.8 ft (71.2 m)	Bridge Age: 23.5 months
Bridge Location: T.H.37 over T.H.53, Fayal TWP, MN	Bridge Width: 40.0 ft (12.2 m)	Crack Density: 0.026 m/m ²
Construction Date: 8/29/2018	Skew: 10°37'4.1"	Span 1: 0.026 m/m ²
Crack Survey Date: 8/12/2020	Number of Spans: 2	Span 2: 0.025 m/m ²
	Span 1: 116.9 ft (35.6 m)	
	Span 2: 116.9 ft (35.6 m)	
	Number of Placements: 1

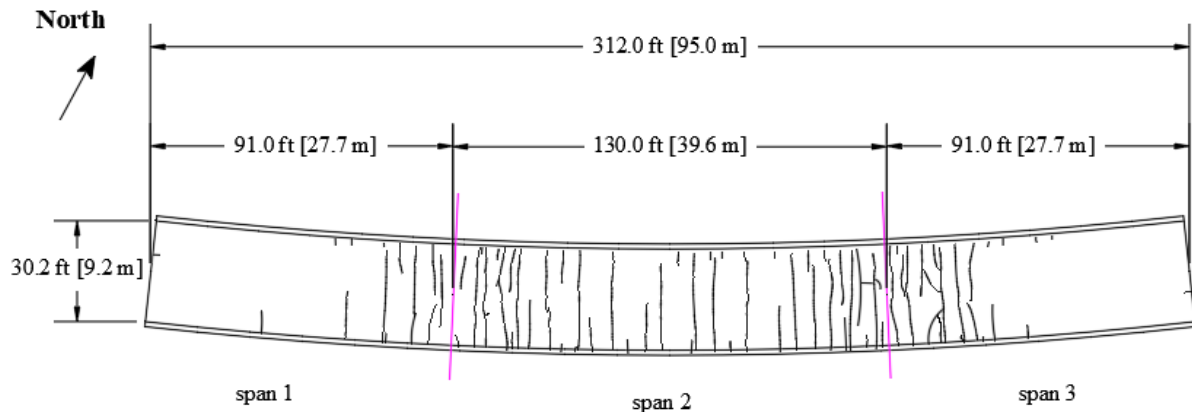
Bridge Number: 69839	Bridge Length: 260.0 ft (79.2 m)	Bridge Age: 22.8 months
Bridge Location: Michigan St. over T.H. 194 SB, City of Duluth, MN	Bridge Width: 30.2 ft (9.2 m)	Crack Density: 0.374 m/m^2
Construction Date: 9/19/2018	Radius: 1432.395 ft	Span 1: 0.182 m/m^2
Crack Survey Date: 8/11/2020	Number of Spans: 3	Span 2: 0.566 m/m^2
	Span 1: 91.0 ft (27.7 m)	Span 3: 0.292 m/m^2
	Span 2: 130.0 ft (39.6 m)	
	Span 3: 91.0 ft (27.7 m)	
	Number of Placements: 1

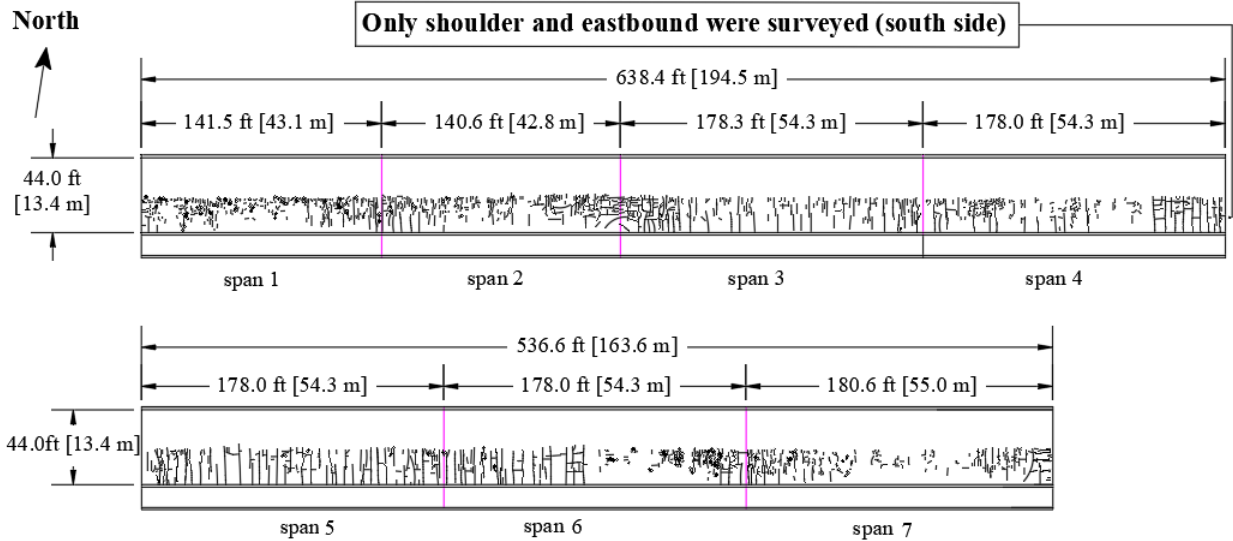
Bridge Number: 71004	Bridge Length: 1175.0 ft (358.1 m)	Bridge Age:
Bridge Location: T.H.24 over Mississippi River, Clearwater, MN	Bridge Width: 44.0 ft (13.4 m)	Placement 1: 38.6 months
	Skew: 0°	Placement 2: 38.2 months
	Number of Spans: 7	Placement 3: 37.3 months
Construction Date:	Span 1: 141.5 ft (43.1 m)	Placement 4: 37.1 months
Placement 1: 4/21/2017	Span 2: 140.6 ft (42.8 m)	Crack Density: 0.699 m/m ²
Placement 2: 5/4/2017	Span 3: 178.3 ft (54.3 m)	Span 1: 0.667 m/m ²
Placement 3: 6/1/2017	Span 4: 178.0 ft (54.3 m)	Span 2: 0.752 m/m ²
Placement 4: 6/6/2017	Span 5: 178.0 ft (54.3 m)	Span 3: 0.751 m/m ²
Crack Survey Date: 7/9/2020	Span 6: 178.0 ft (54.3 m)	Span 4: 0.625 m/m ²
	Span 7: 180.6 ft (55.0 m)	Span 5: 0.722 m/m ²
	Number of Placements: 4	Span 6: 0.707 m/m ²
		Span 7: 0.672 m/m ²

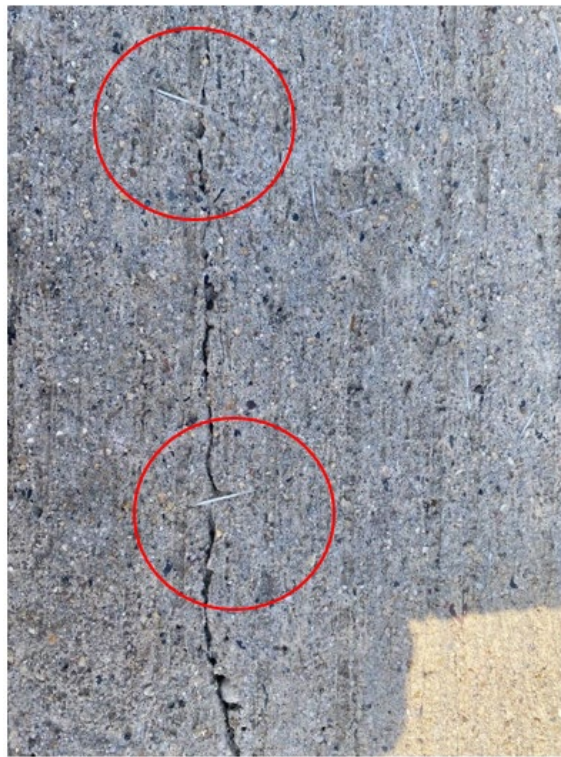
Figure 3.21: Crack propagation in the presence of fibers

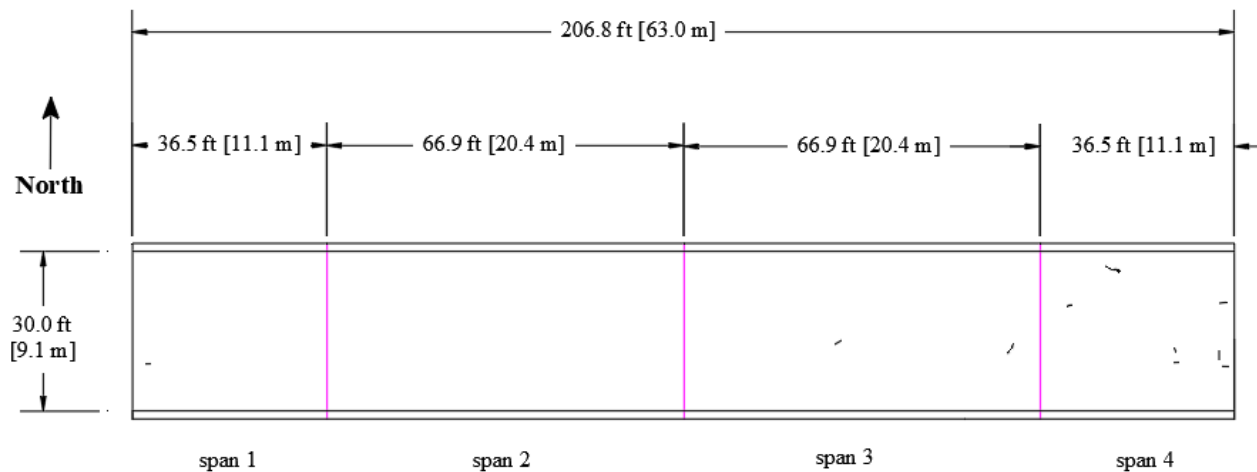
Bridge Number: 74805	Bridge Length: 206.8 ft (63.0 m)	Bridge Age: 33.9 months
Bridge Location: C.S.A.H 31 over I-35, Owatonna, MN	Bridge Width: 30 ft (9.1 m)	Crack Density: 0.007 m/m ²
Construction Date: 10/4/2017	Skew: 0°	Span 1: 0.002 m/m ²
Crack Survey Date: 8/3/2020	Number of Spans: 4	Span 2: 0.000 m/m ²
	Span 1: 36.5 ft (11.1 m)	Span 3: 0.005 m/m ²
	Span 2: 66.9 ft (20.4 m)	Span 4: 0.030 m/m ²
	Span 3: 66.9 ft (20.4 m)	
	Span 4: 36.5 ft (11.1 m)	
	Number of Placements: 1

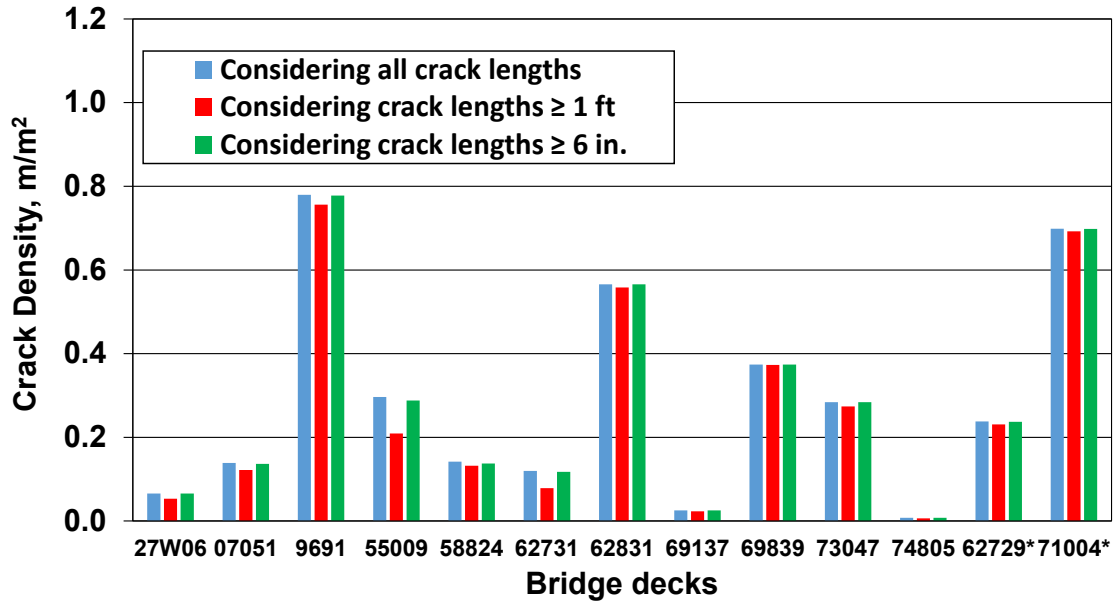
Figure 3.24: Comparison of crack densities, total, cracks with lengths ≥ 1 ft (305 mm), and cracks with lengths ≥ 6 in. (150 mm), for decks containing fibers

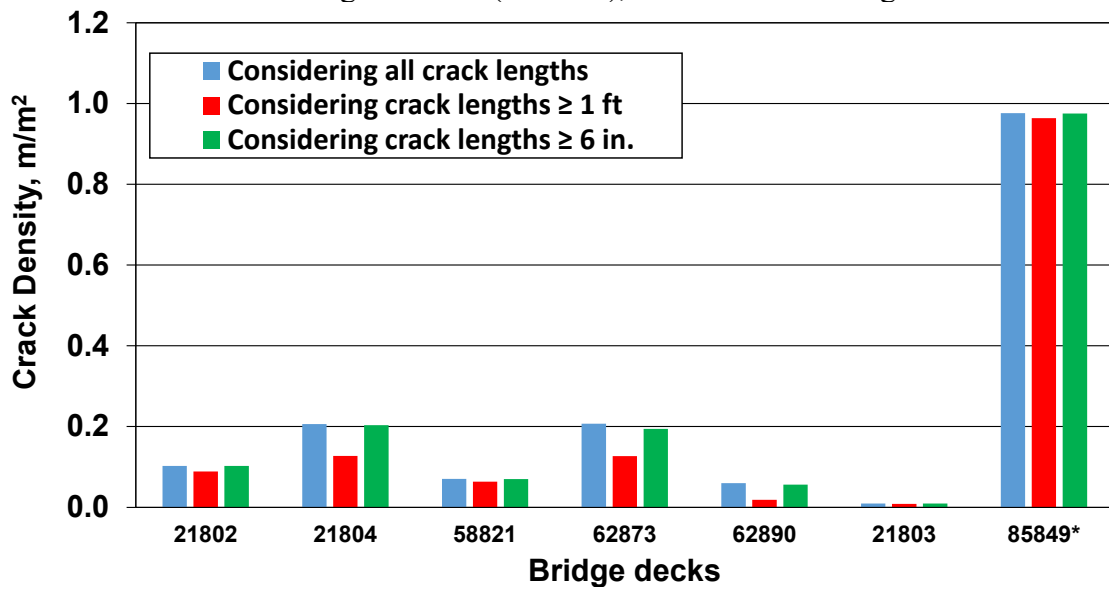
Figure 3.25: Comparison of crack densities, total, cracks with lengths ≥ 1 ft (305 mm), and cracks with lengths ≥ 6 in. (150 mm), for decks not containing fibers

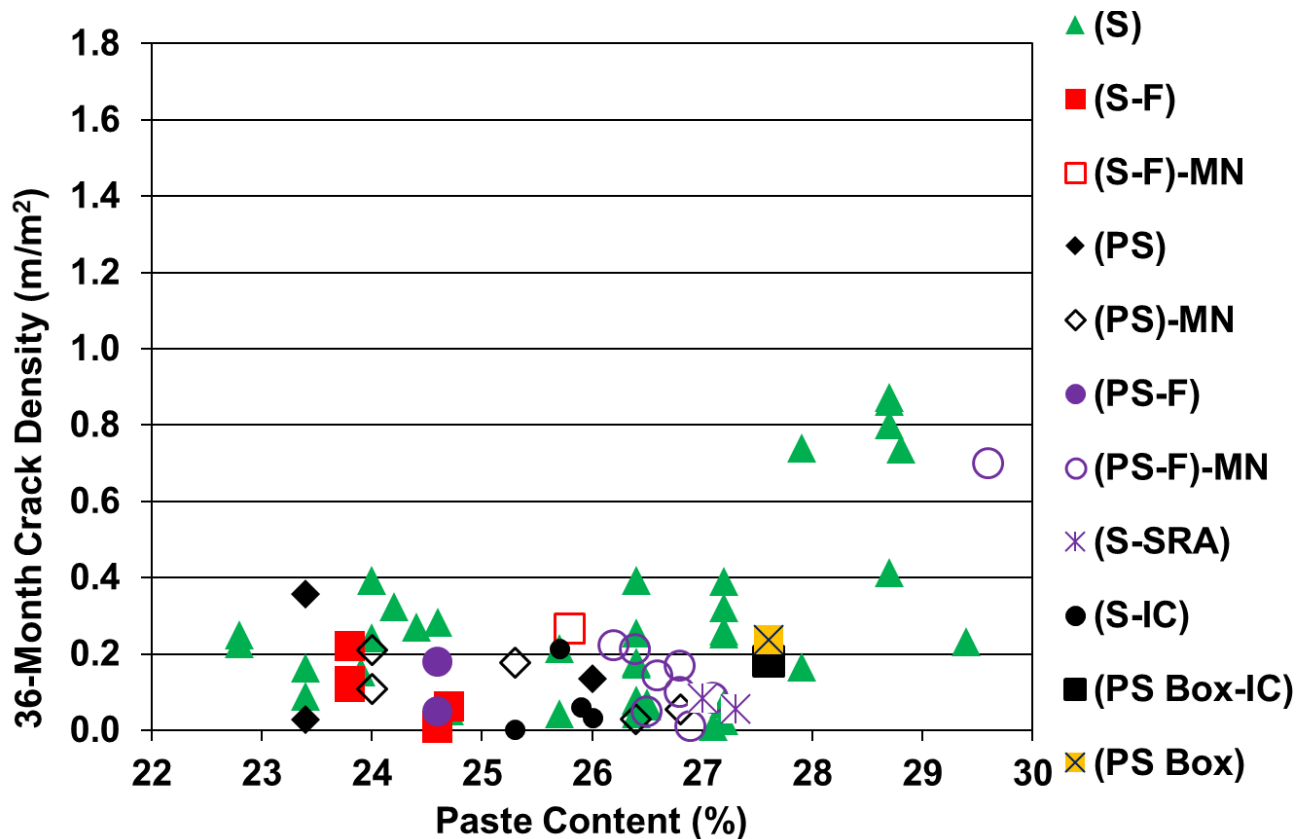
Figure 6.1: Paste content versus 36-month crack density for decks with good construction procedures

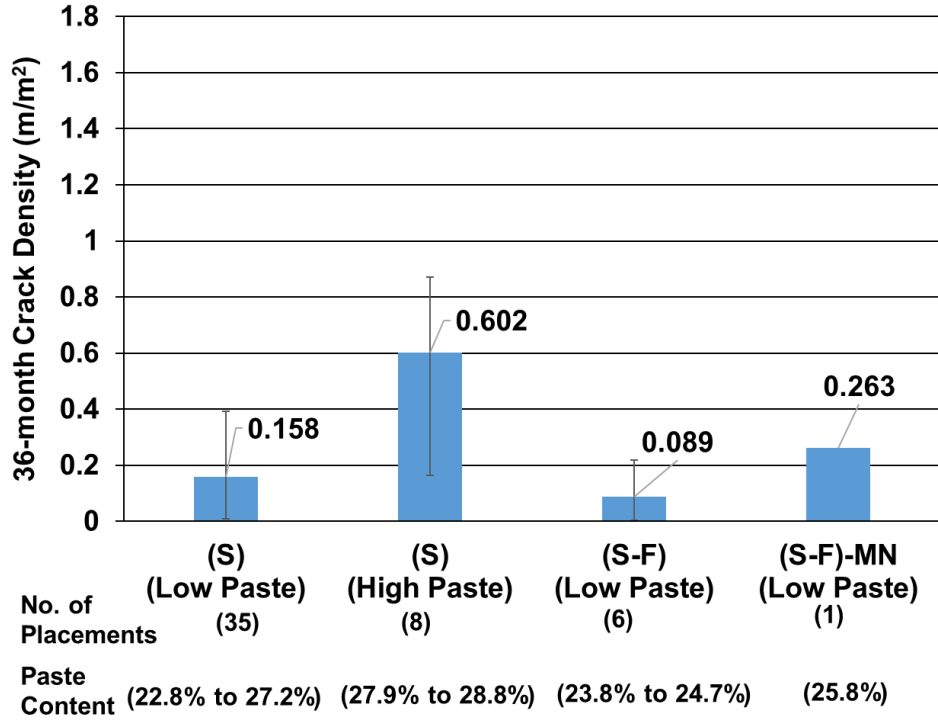
Figure 6.2: 36-month crack densities of decks supported by steel girders with and without fibers

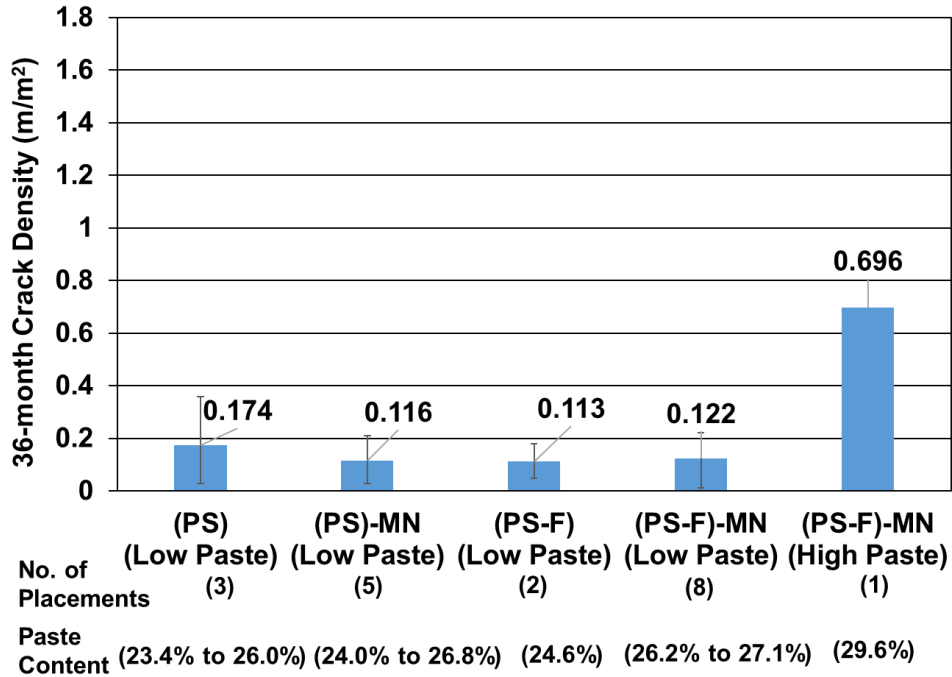
Figure 6.3: 36-month crack densities of decks supported by prestressed concrete girders with and without fibers

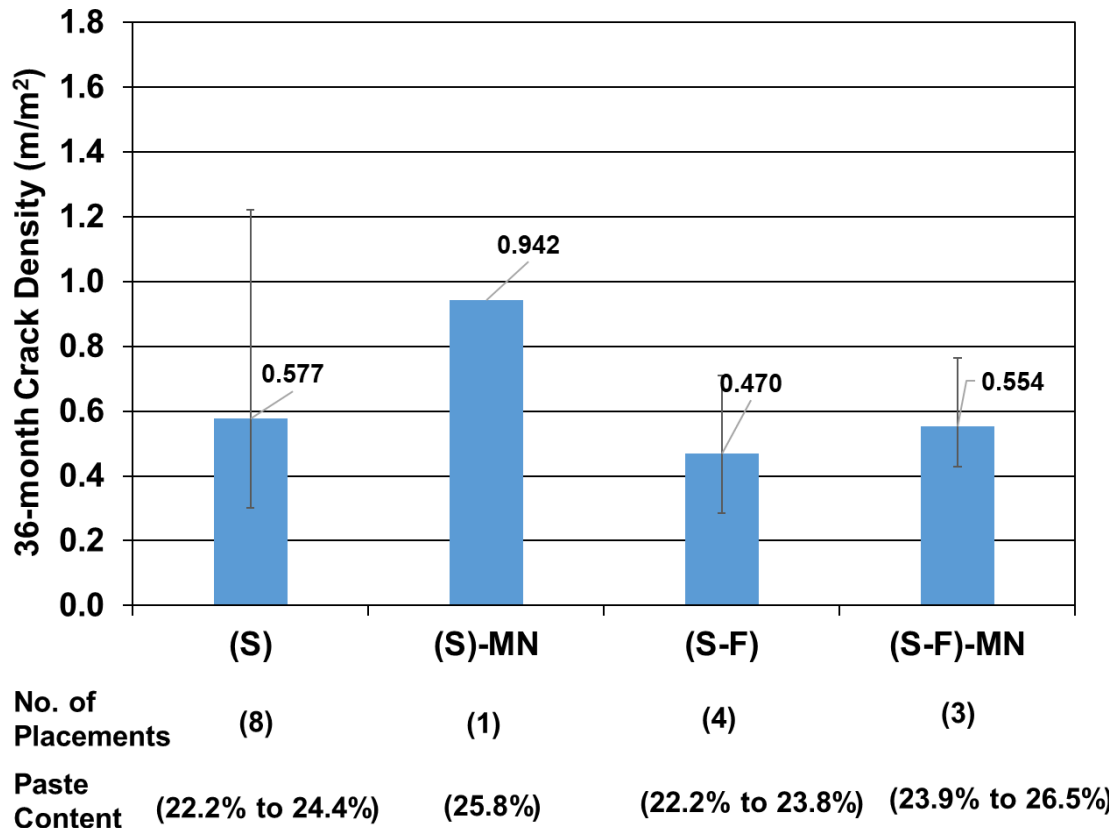
Figure 6.4: Comparing the 36-month crack densities of decks with construction issues

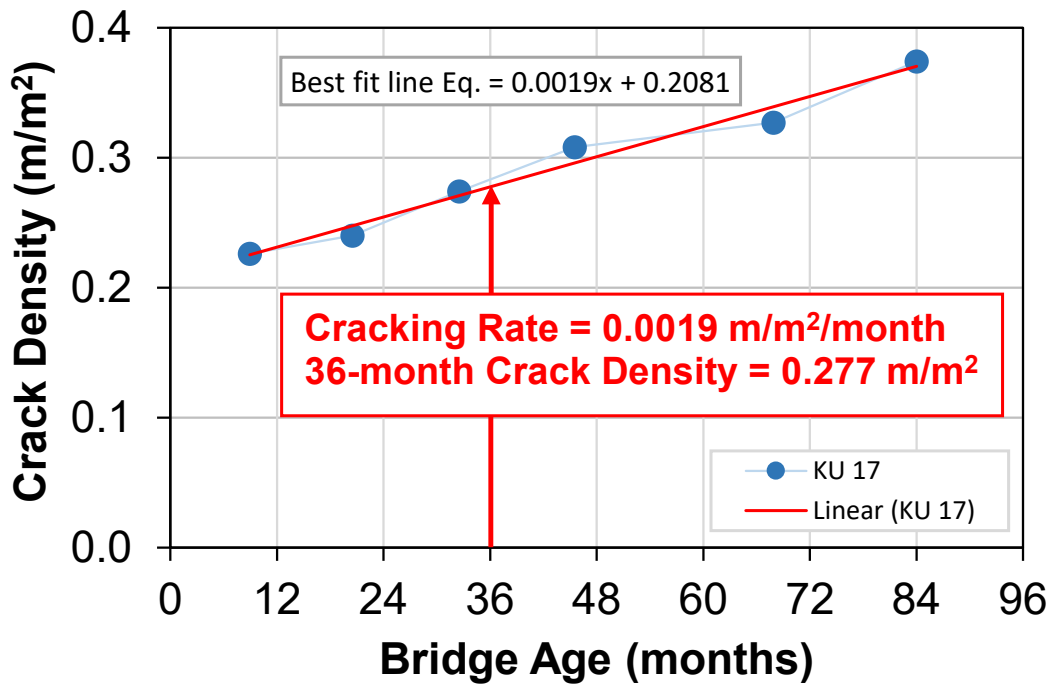
Figure C.1: Cracking Rate and 36-month crack density of LC-HPC 17
