EVALUATION OF CRACKING PERFORMANCE OF BRIDGE DECKS INCORPORATING NONMETALLIC FIBERS

A Report on Research Sponsored by
CONSTRUCTION OF LOW-CRACKING HIGH-
PERFORMANCE BRIDGE DECKS
INCORPORATING NEW TECHNOLOGY
TRANSPORTATION POOLED-FUND PROGRAM
PROJECT NO. TPF-5(392)

Structural Engineering and Engineering Materials
SL Report 22-1
July 2022

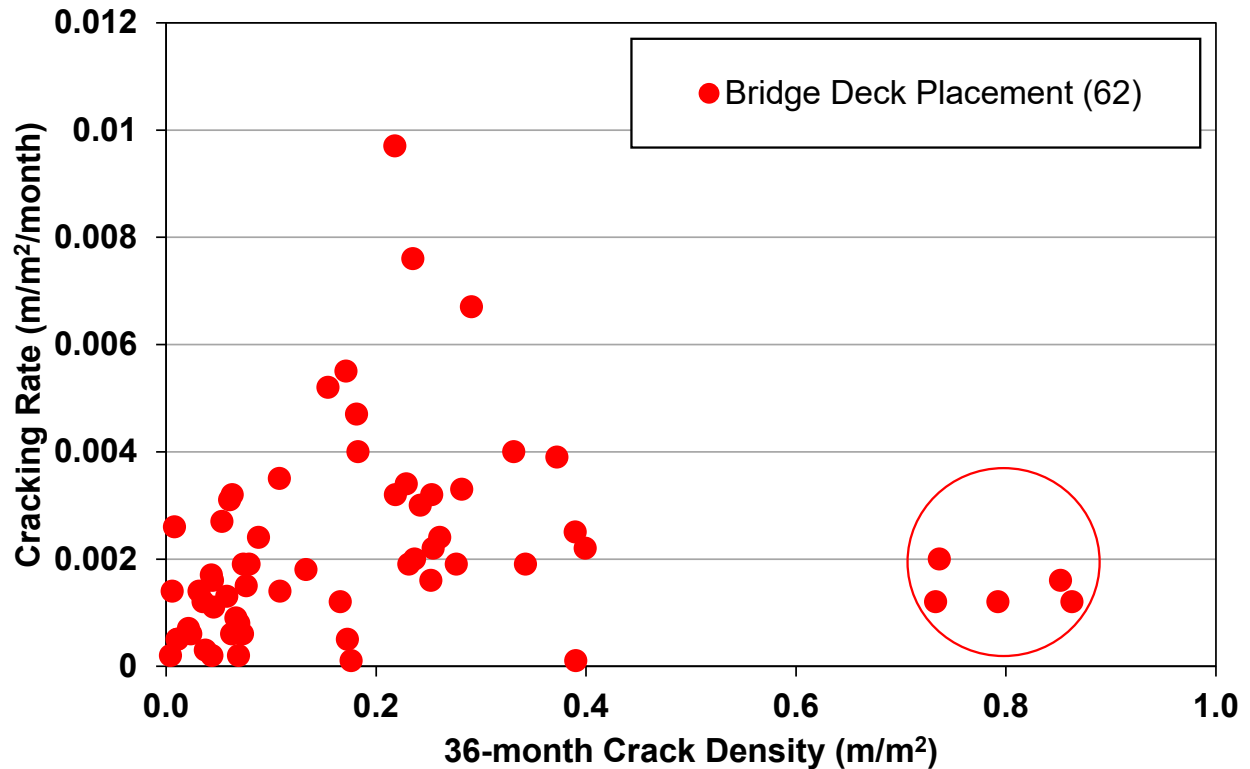
Figure C.2: Cracking rate versus 36-month crack density of 62 deck placements

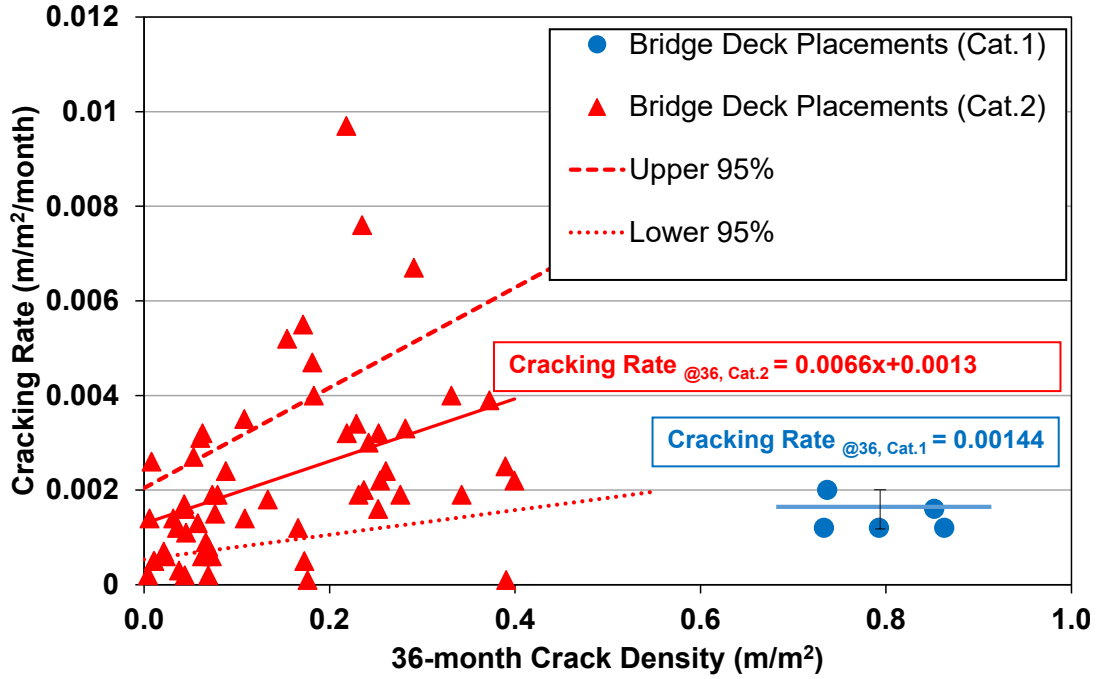
Figure C.3: Cracking rate as a function of 36-month crack density of the decks in Categories of 1 and 2

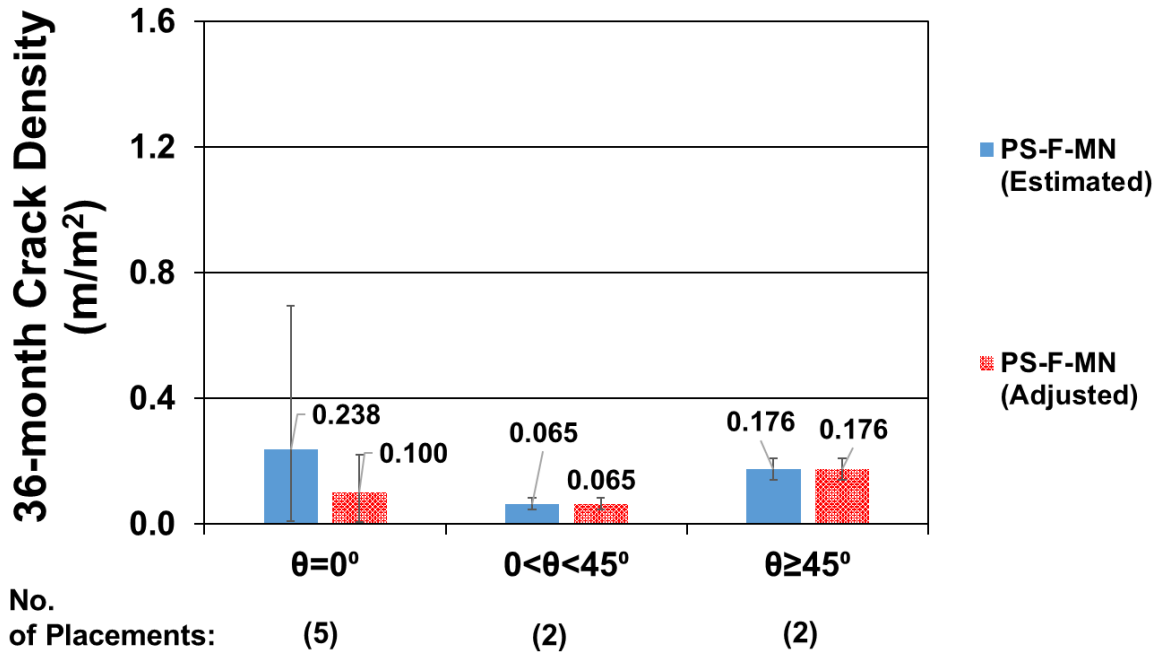
Figure E.1: Average measured/estimated and adjusted 36-month crack densities for Minnesota bridge decks supported by prestressed concrete girders with fibers and different skew

The results show that low cracking can be associated with high or low skew. Figures E.1 to E.3 show the average measured/estimated and adjusted 36-month crack densities for the 15 Minnesota decks surveyed in this study (with good construction). Three categories were defined as decks without skew ($\theta = 0^\circ$), skews greater than 0° and less than 45° , and skews greater than or equal to 45° . As shown in Figure E.1, the average measured/estimated 36-month crack density for prestressed concrete girder decks with fibers decreases from 0.238 to 0.065 m/m^2 when the skew increases from 0 to a greater value but less than 45° ; the average measured/estimated 36-month crack density, however, increases from 0.065 to 0.176 m/m^2 when the skew increases more ($\theta \geq 45^\circ$). Although the standard deviation (σ) for Minnesota decks with fibers supported by prestressed concrete girders without skew ($\sigma = 0.239 \text{ m/m}^2$) was considerably higher than that of the skewed decks ($\sigma = 0.019$ or 0.035 m/m^2), the differences between categories are not statistically significant

(p values ranging from 0.105 to 0.769). Similar observations can be made when the crack densities are adjusted using Eq. (E.1); a decrease from 0.100 to 0.065 m/m^2 when the skew increases from 0 to less than 45° ; and an increase from 0.065 to 0.176 m/m^2 when the skew increases more ($\theta \geq 45^\circ$); these differences, are, again, not statistically significant (p values ranging from 0.105 to 0.639).

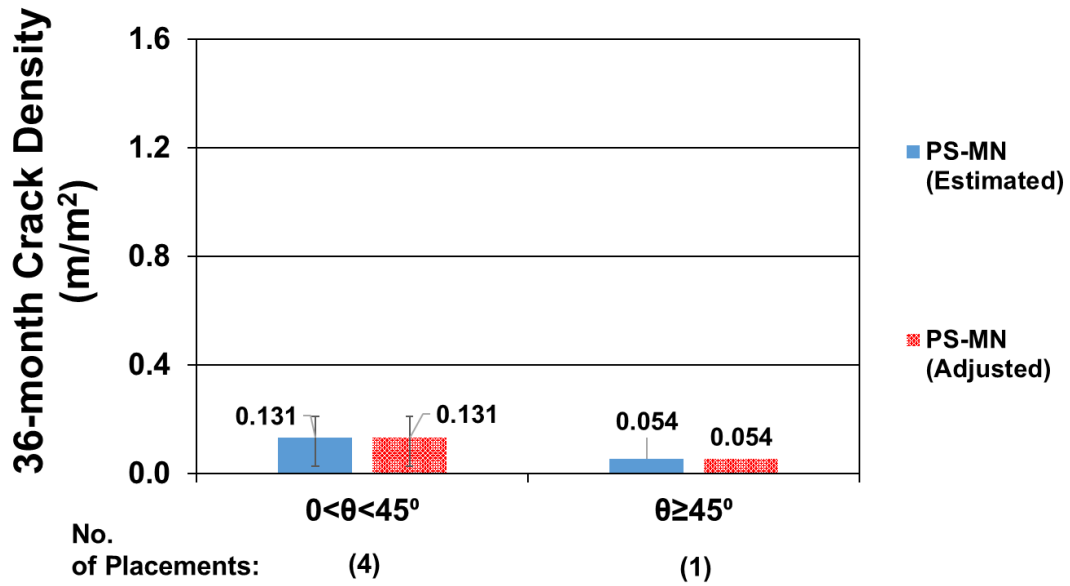
Figure E.2: Average measured/estimated and adjusted 36-month crack densities for Minnesota bridge decks supported by prestressed concrete girders without fibers and different skew

As shown in Figure E.2, the average measured/estimated 36-month crack density for prestressed concrete girder decks without fibers decreases from 0.131 to 0.054 m/m^2 when the skew of the bridge was greater than or equal to 45° . Similar observations can be made when the crack densities are adjusted using Eq. (E.1); these differences, however, are small. The fact that there is no difference between the average measured/estimated and adjusted 36-month crack densities suggests that the paste content alone, regardless of the other variables, has a dominant effect on cracking.

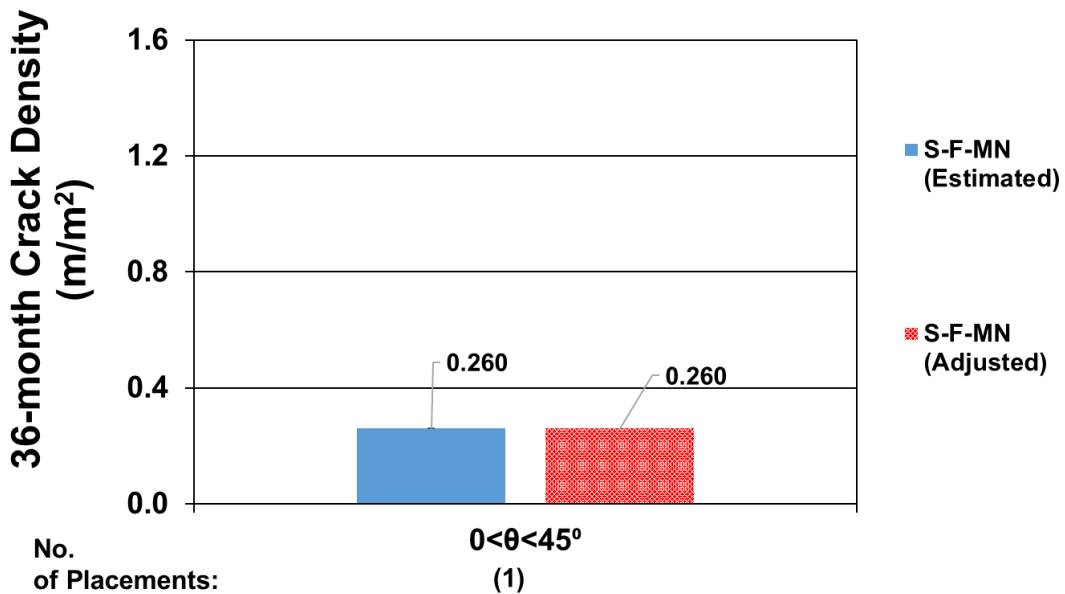
Figure E.3: Average measured/estimated and adjusted 36-month crack densities for a single Minnesota bridge deck supported by steel girders with fibers and a skew less than 45° ($\theta = 14^\circ$)

As shown in Figure E.3, a single steel girder bridge deck with fibers [S-F-MN (Estimated)] exhibited average measured/estimated and adjusted crack density of 0.260 m/m² at 36 months of age.

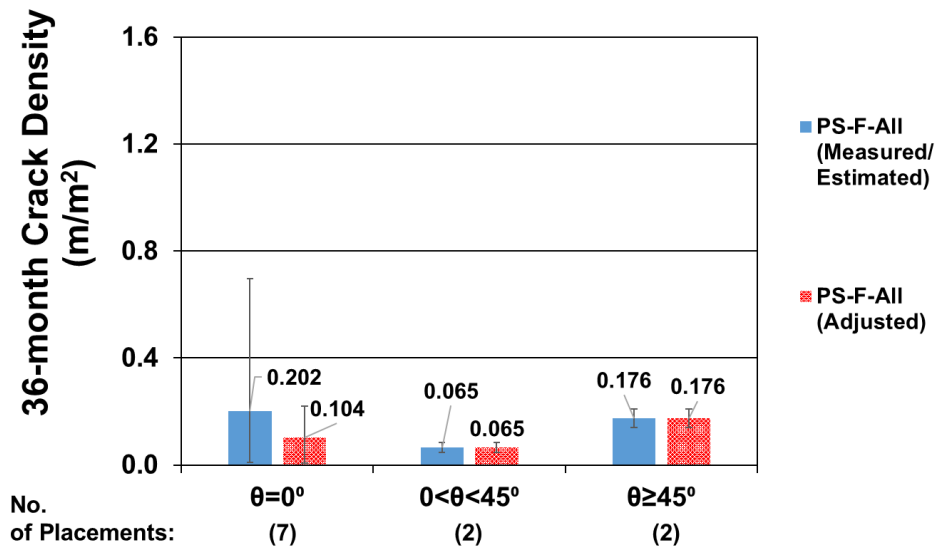
Figure E.4: Average measured/estimated and adjusted 36-month crack densities for all bridge decks supported by prestressed concrete girders with fibers and different skew

Figures E.4 to E.7 show the average measured/estimated and adjusted 36-month crack densities for all of the decks described in Section E.1 (with good construction). As shown in Figure E.4 (all but two of these are Minnesota decks), the average measured/estimated 36-month crack density for prestressed concrete girder decks with fibers decreases from 0.202 to 0.065 m/m² when the skew increases from 0 to a greater value but less than 45°; the average measured/estimated 36-month crack density, however, increases from 0.065 to 0.176 m/m² when the skew increases more ($\theta \geq 45^\circ$). Although the standard deviation for decks supported by prestressed concrete girders and fibers without skew ($\sigma = 0.213$ m/m²) was considerably higher than that of the skewed decks ($\sigma = 0.019$ or 0.035 m/m²), no statistically significant differences were observed between the categories (p values ranging from 0.105 to 0.881). Similar observations can be made when the crack densities are adjusted using Eq. (E.1); a decrease from 0.104 to 0.065 m/m² when the skew increases from 0 to a greater value but less than 45°; and an increase from 0.065 to 0.176 m/m² when the skew increases to $\theta \geq 45^\circ$; these differences, however, are small and not statistically significant (p values ranging from 0.105 to 0.562).

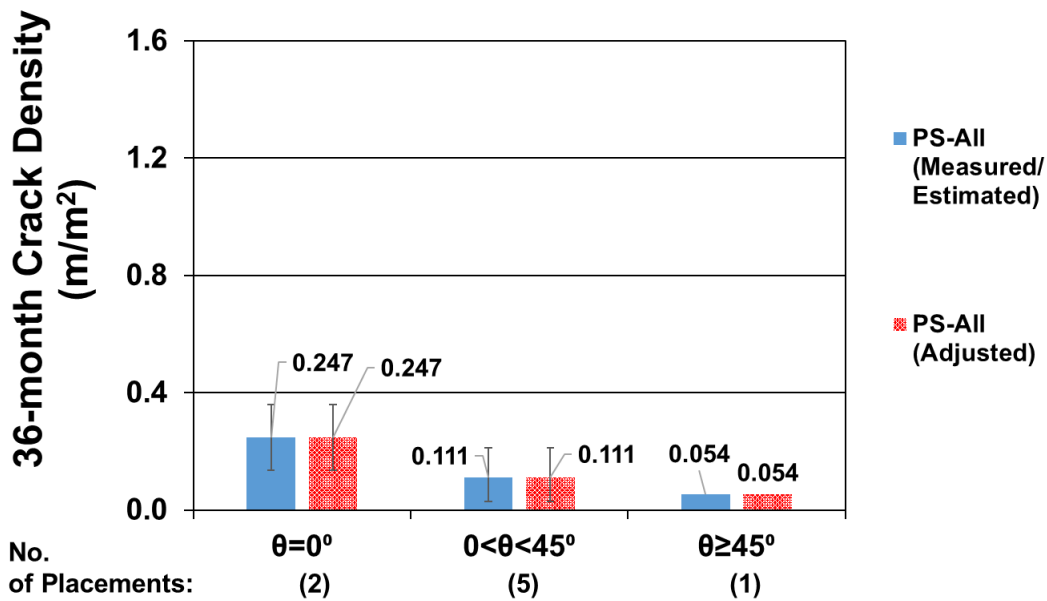
Figure E.5: Average measured/estimated and adjusted 36-month crack densities for all bridge decks supported by prestressed concrete girders without fibers and different skew

As shown in Figure E.5, the average measured/estimated 36-month crack density for prestressed concrete girder decks without fibers decreases from 0.247 to 0.054 m/m² when the skew increases. The lowest 36-month crack density (0.054 m/m²) is observed for a single deck with a skew greater than or equal to 45° ($\theta = 49^\circ$). Similar observations can be made when the crack densities are adjusted using Eq. (E.1); the difference, however, is not statistically significant ($p = 0.173$).

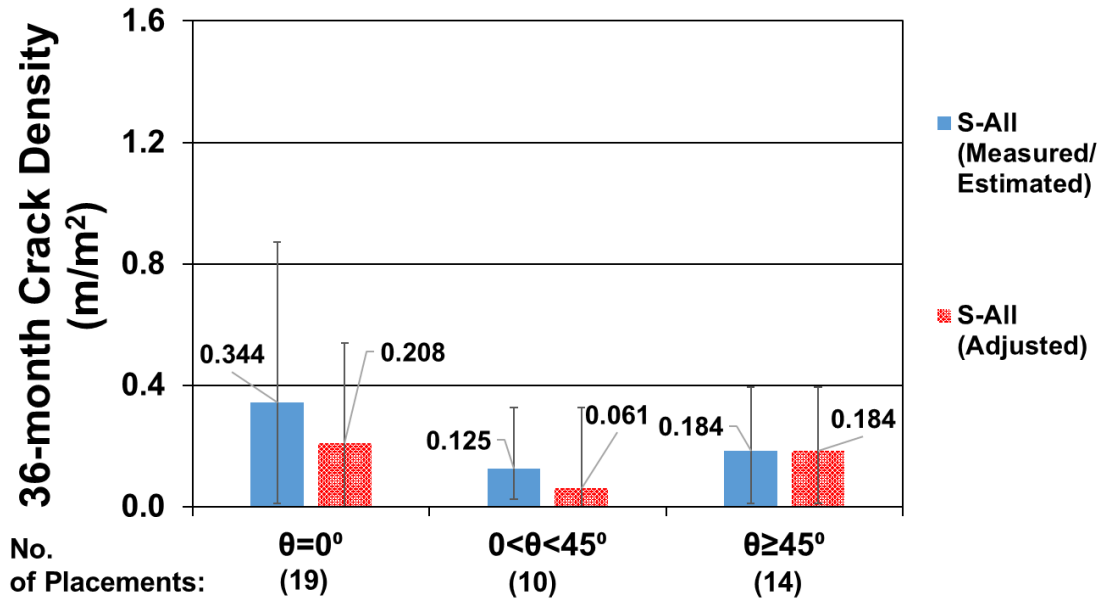
Figure E.7: Average measured/estimated and adjusted 36-month crack densities for all bridge decks supported by steel girders without fibers and different skew

As shown in Figure E.7, the average measured/estimated 36-month crack density for all steel concrete girder decks without fibers decreases from 0.344 to 0.125 m/m² when the skew increases from 0 to less than 45°; the average measured/estimated 36-month crack density, however, increases from 0.125 to 0.184 m/m² when the skew increases more ($\theta \geq 45^\circ$). The standard deviation (σ) for decks supported by steel girders and fibers without skew ($\sigma = 0.294$ m/m²) is considerably higher than that of the skewed decks ($\sigma = 0.097$ or 0.134 m/m²), where a statistically significant difference was observed between decks with $\theta = 0^\circ$ (no skew) and those with $0 \leq \theta < 45^\circ$ ($p = 0.036$). Similar observations can be made when the crack densities are adjusted using Eq. (E.1); a decrease from 0.208 to 0.061 m/m² when the skew increases from 0 to a skew up to 45°; and an increase from 0.061 to 0.184 m/m² when the skew increases more ($\theta \geq 45^\circ$); the difference between the average 36-month crack density of decks with no skew (average of 0.208 m/m²) and that of the decks with $0 < \theta < 45^\circ$ (0.061 m/m²) is statistically significant ($p = 0.044$); the difference between the average 36-month crack density of decks with no skew or with

skews greater than or equal to 45° , however, is not statistically significant ($p = 0.673$); the difference between the 36-month crack density of decks with $0 < \theta < 45^\circ$ or $\theta \geq 45^\circ$, also is not statistically significant ($p = 0.080$).

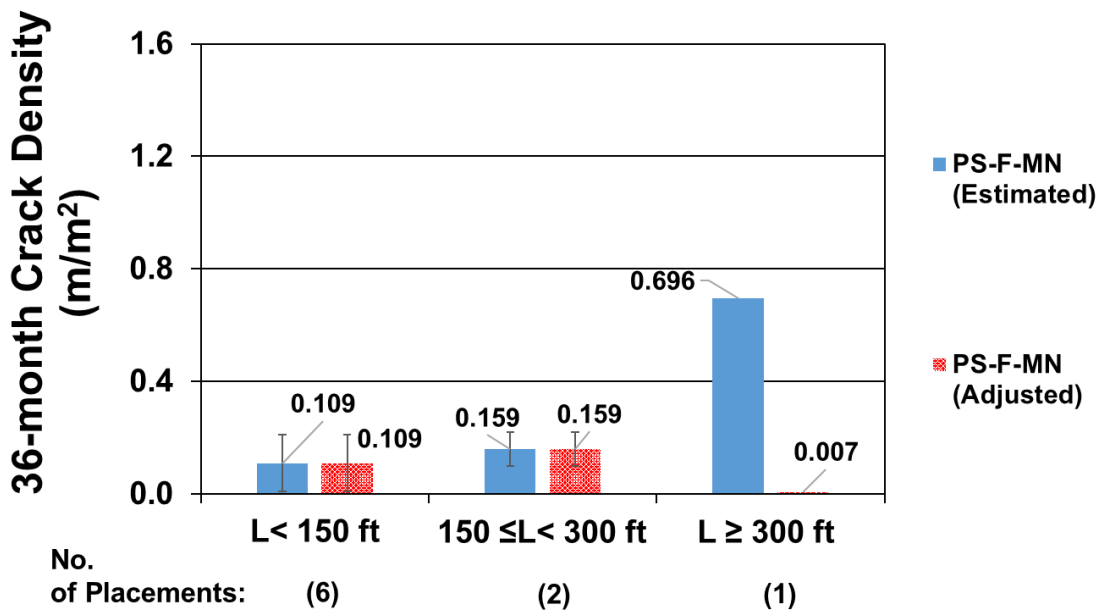
Figure E.8: Average measured/estimated and adjusted 36-month crack densities for Minnesota bridge decks supported by prestressed concrete girders with fibers and different total deck length

ft), greater than or equal to 150 ft but less than 300 ft ($150 \leq L < 300$ ft), and greater than or equal to 300 ft ($L \geq 300$ ft). As shown in Figure E.8, the average measured/estimated 36-month crack density for prestressed concrete girder decks with fibers increases from 0.109 to 0.696 m/m^2 as the total length increases, although the last value is based on a single bridge. Based on both the measured/estimated and adjusted crack densities, the average 36-month crack density increases from 0.109 to 0.159 m/m^2 for total lengths for decks with values less than 150 ft to values between 150 and 300 ft; this difference is not statistically significant ($p = 0.464$). The measured/estimated crack density increases all the way up to 0.696 m/m^2 for the single bridge with a length greater than 300 ft, 1175 ft for bridge 71004. This apparent effect is, however, deceiving because the concrete in the deck had a paste content of 29.6%, a value expected to lead to significant cracking. When adjusted for paste content, the crack density of the deck on bridge 71004 is just 0.007 m/m^2 . Thus, based on these survey results, there is no indication that bridge deck cracking is associated with bridge length.

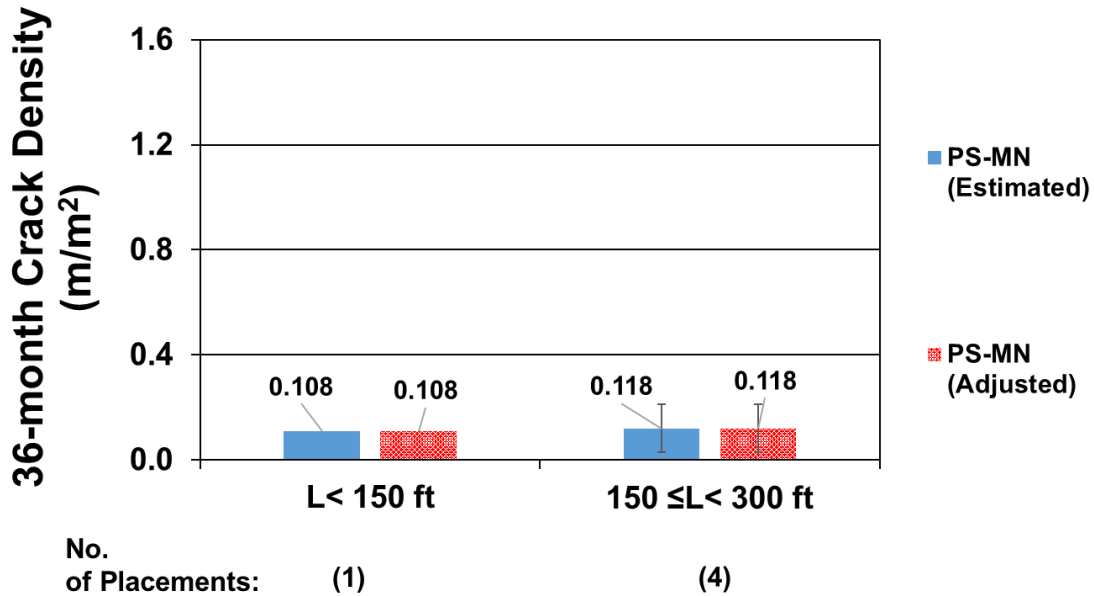
Figure E.9: Average measured/estimated and adjusted 36-month crack densities for Minnesota bridge decks supported by prestressed concrete girders without fibers and different total deck length

As shown in Figure E.9, the average measured/estimated and adjusted 36-month crack density for prestressed concrete girder decks without fibers increases from 0.101 to 0.118 m/m² as the total length increases; these differences, however, were small.

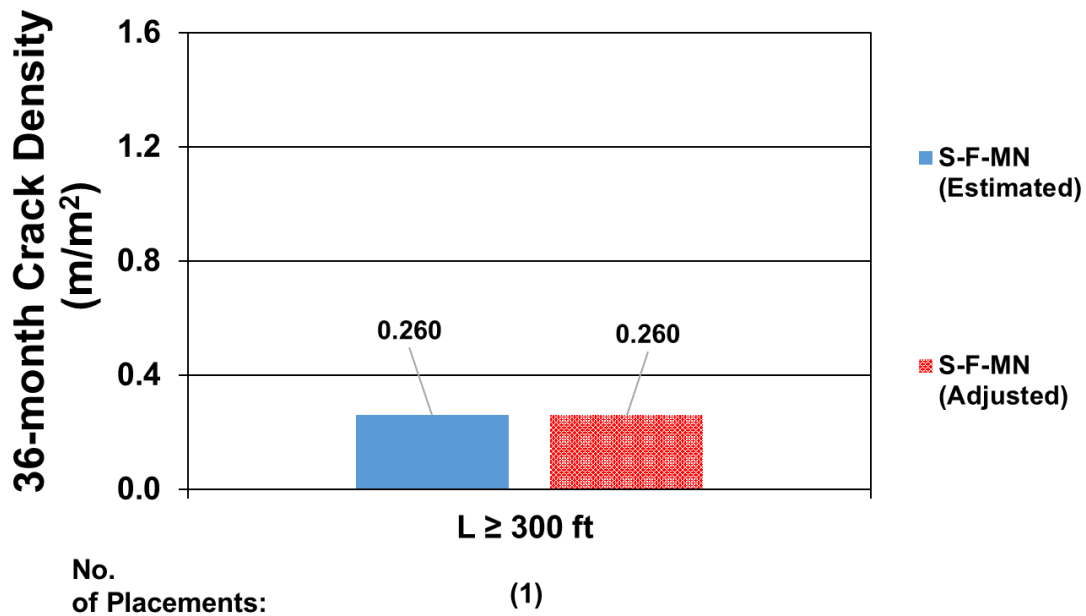
Figure E.10: Average measured/estimated and adjusted 36-month crack densities for a single Minnesota bridge deck supported by steel girders with fibers and a deck length greater than or equal to 300 ft ($L = 301.2$ ft)

As shown in Figure E.10, a single steel girder deck with fibers [S-F-MN (Estimated)] exhibited average measured/estimated and adjusted crack density of 0.260 m/m² at 36 months of age.

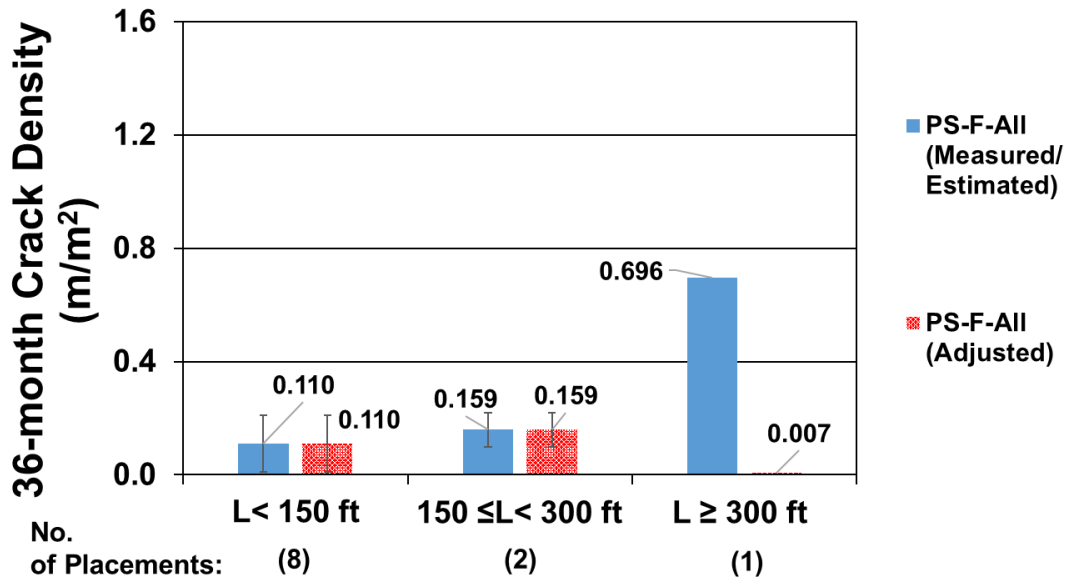
Figure E.11: Average measured/estimated and adjusted 36-month crack densities for all bridge decks supported by prestressed concrete girders with fibers and different total deck length

Figures E.11 to E.14 show the average measured/estimated and adjusted 36-month crack densities for all of the decks. As shown in Figure E.11, the average measured/estimated and adjusted 36-month crack density for prestressed concrete girder decks with fibers increases from 0.110 to 0.696 m/m² as the total length increases, but as discussed in relation to Figure E .8, the later value results from the high paste content of the concrete in the deck. When the crack densities are adjusted using Eq. (E.1), the average 36-month crack density increases from 0.110 to 0.159 m/m² as total deck lengths increase from less than 150 ft increases to values between 150 and 300 ft, with a difference that is not statistically significant ($p = 0.433$) and drops for the single bridge with a length greater than 300 ft to 0.007 m/m².

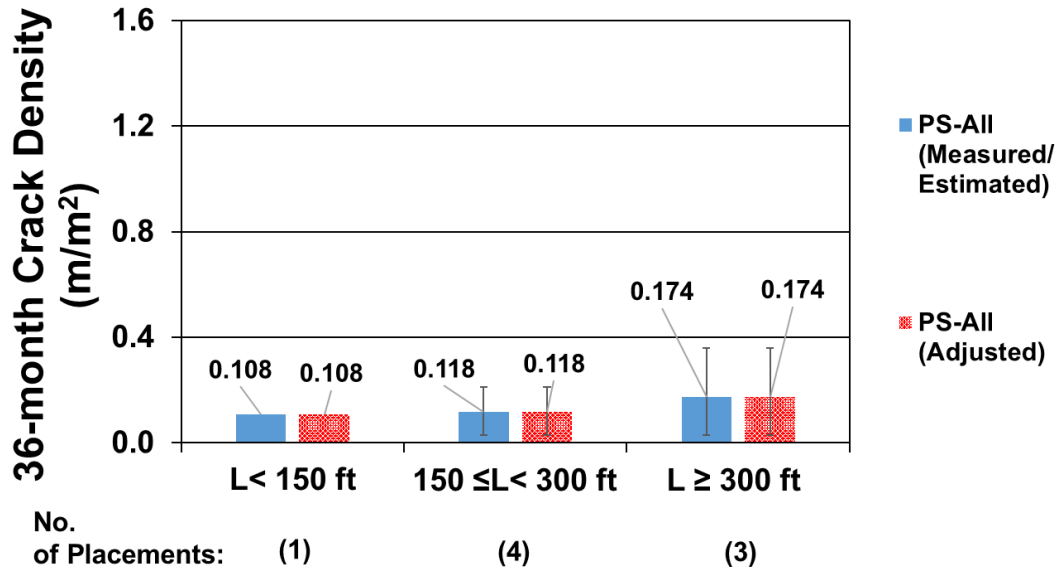
Figure E.12: Average measured/estimated and adjusted 36-month crack densities for all bridge decks supported by prestressed concrete girders without fibers and different total deck length

As shown in Figure E.12, the average measured/estimated and adjusted 36-month crack density for prestressed concrete girder decks without fibers increases from 0.108 to 0.174 m/m² as the total length increases, although the difference between the 36-month crack density of decks with $150 \leq L < 300$ ft and $L \geq 300$ ft is not statistically significant ($p = 0.583$).

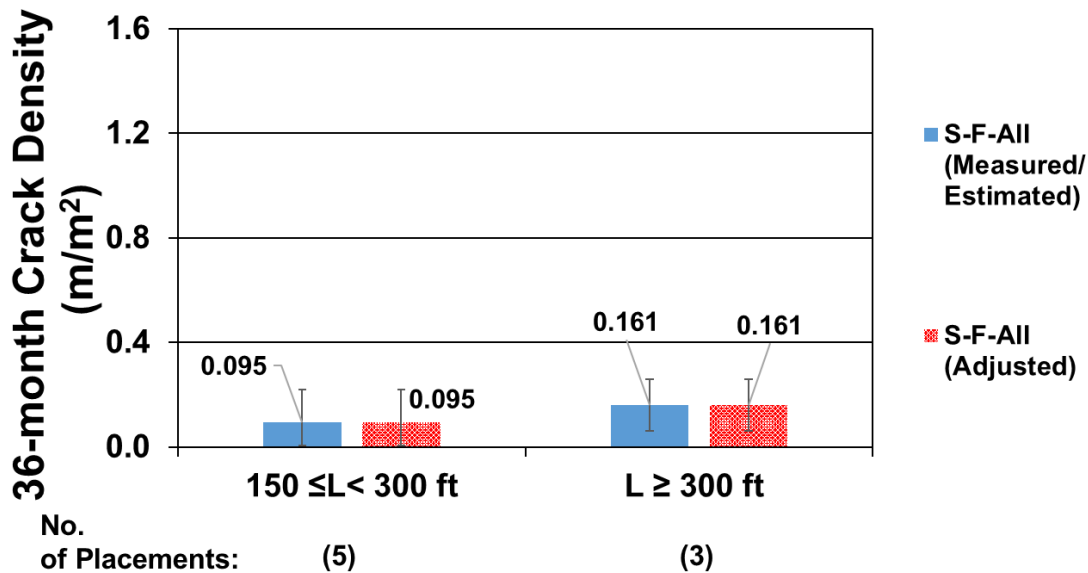
Figure E.13: Average measured/estimated and adjusted 36-month crack densities for all bridge decks supported by steel girders with fibers and different total deck length

Similarly, as shown in Figure E.13, the average measured/estimated and adjusted 36-month crack density for steel girder decks with fibers increases from 0.095 to 0.161 m/m² as the total length increases; the difference, however, is not statistically significant ($p = 0.476$).

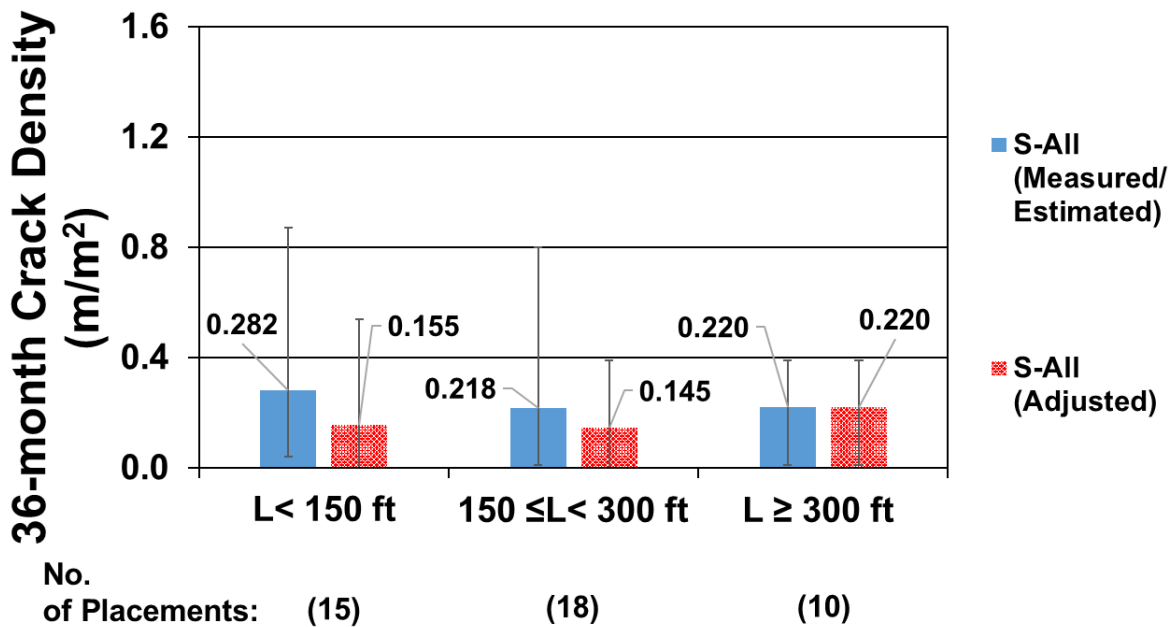
Figure E.14: Average measured/estimated and adjusted 36-month crack densities for all bridge decks supported by steel girders without fibers and different total length

As shown in Figure E.14, the average measured/estimated 36-month crack density for steel concrete girder decks without fibers decreases from 0.282 to 0.218 m/m^2 when the total length increases from $L < 150$ ft to $150 \leq L < 300$ ft and remains essentially unchanged at 0.220 m/m^2 for a total length $L \geq 300$ ft. Although the standard deviation (σ) for decks supported by steel girders without fibers with $L < 150$ ft and $150 \leq L < 300$ ft ($\sigma = 0.287$ and 0.234 m/m^2 , respectively) were considerably higher than that of the decks with $L \geq 300$ ft ($\sigma = 0.112$ m/m^2), none of the differences are statistically significant (p values ranging from 0.500 to 0.976).

Similar observations can be made when the crack densities are adjusted using Eq. (E.1); a decrease from 0.155 to 0.145 m/m^2 when the total length increases from $L < 150$ ft to $150 \leq L < 300$ ft; and an increase from 0.145 to 0.220 m/m^2 when the total length increases from $150 \leq L < 300$ ft to $L \geq 300$ ft. The standard deviations after the adjustment for paste content reduced from 0.226 to 0.111 m/m^2 , where no statistically significant differences were observed between the adjusted 36-month crack density of each category (p values ranging from 0.154 to 0.869).

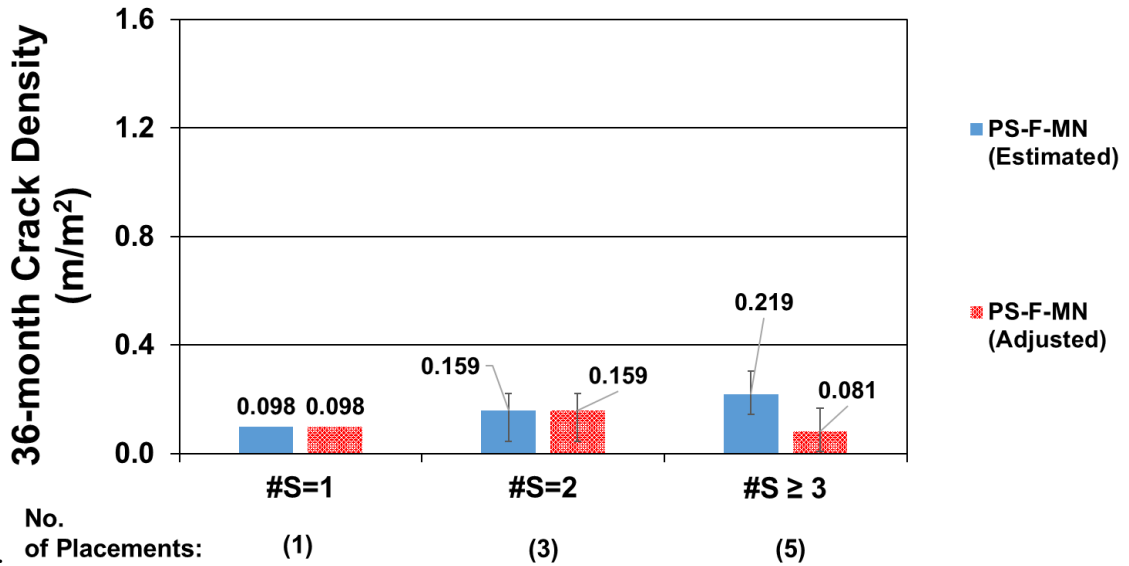
Figure E.15: Average measured/estimated and adjusted 36-month crack densities for Minnesota bridge decks supported by prestressed concrete girders with fibers and different numbers of span

Figures E.15 to E.17 show the average measured/estimated and adjusted 36-month crack densities for the 15 Minnesota decks surveyed in this study. Three categories were defined as decks with only one span ($\#S = 1$), two spans ($\#S = 2$), and three or more spans ($\#S \geq 3$). As shown in Figure E.15, the average measured/estimated 36-month crack density for prestressed concrete girder decks with fibers increases from 0.098 to 0.219 m/m^2 as the number of spans increases (possibly due to appearance of the negative moment regions in decks with more than one span) with a difference that is not statistically significant between decks with two spans and decks with three or more spans ($p = 0.731$). When the crack densities are adjusted using Eq. (E.1), the average 36-month crack density increases from 0.098 for a single deck with one span to 0.159 m/m^2 for decks with two spans. A decrease from 0.159 to 0.081 m/m^2 , however, is observed when the number of spans increases from 2 to values greater than or equal to 3, with a difference that is not statistically significant ($p = 0.245$).

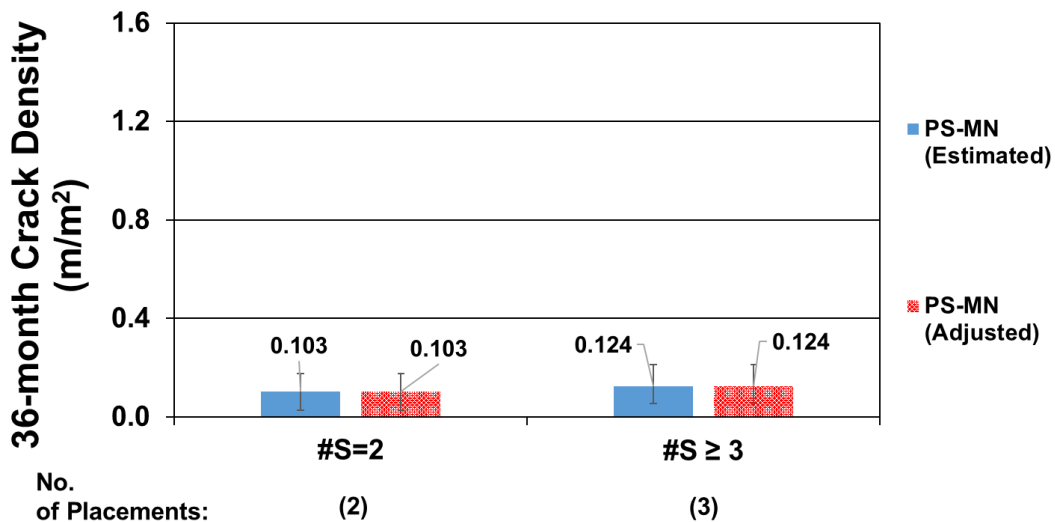
Figure E.16: Average measured/estimated and adjusted 36-month crack densities for Minnesota bridge decks supported by prestressed concrete girders without fibers and different numbers of span

As shown in Figure E.16, the average measured/estimated and adjusted 36-month crack density for prestressed concrete girder decks without fibers increases from 0.103 for decks with two spans to 0.124 m/m² for decks with three and more spans; these differences, however, are not statistically significant ($p = 0.805$).

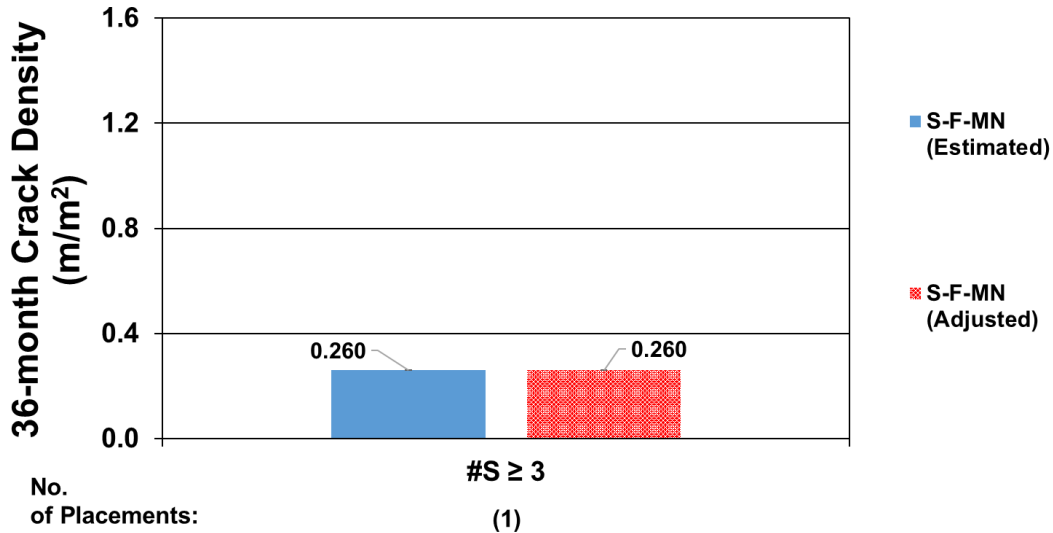
Figure E.17: Average measured/estimated and adjusted 36-month crack densities for a single Minnesota bridge deck supported by steel girders with fibers and four spans ($\#S \geq 3$)

As shown in Figure E.17, a single steel girder bridge deck with fibers [S-F-MN (Estimated)] exhibited an measured/estimated and adjusted crack density of 0.260 m/m² at 36 months of age.

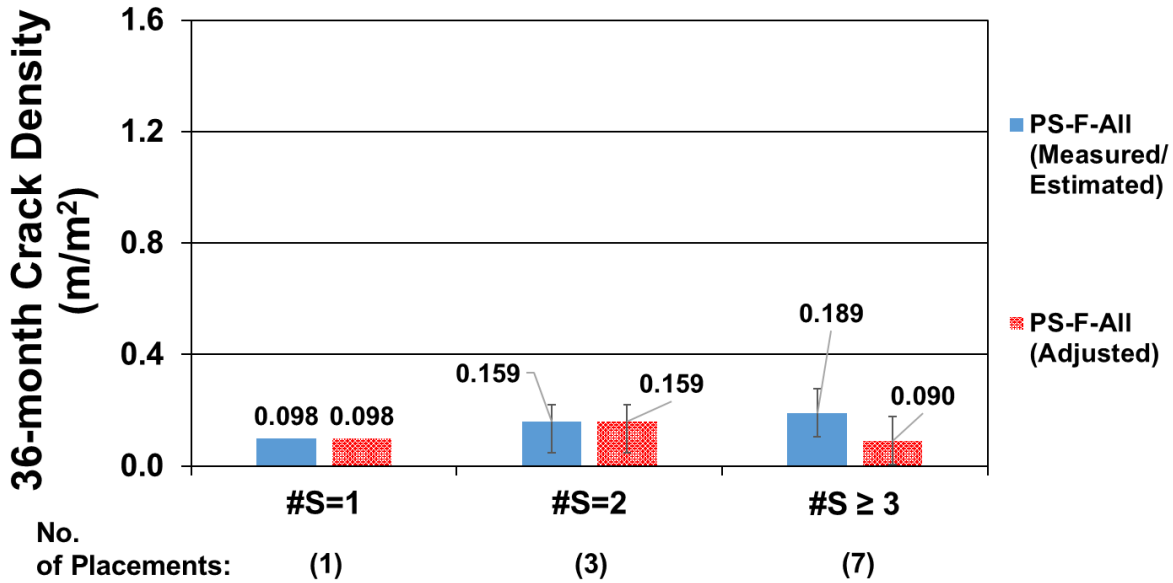
Figure E.18: Average measured/estimated and adjusted 36-month crack densities for all bridge decks supported by prestressed concrete girders with fibers and different numbers of span

Figures E.18 to E.21 show the average measured/estimated and adjusted 36-month crack densities for all of the decks. As shown in Figure E.18, the average measured/estimated 36-month crack density for prestressed concrete girder decks with fibers increases from 0.098 to 0.189 m/m² as the number of spans increases (possibly due to the negative moment regions in decks with more than one span) with a difference that is, however, not statistically significant ($p = 0.838$). When the crack densities are adjusted using Eq. (E.1), the average 36-month crack density increases from 0.098 for a single deck with one span to 0.159 m/m² for decks with two spans and decreases from 0.159 to 0.090 m/m² when the number of spans increases from 2 to 3 or more; the difference is not statistically significant ($p = 0.247$).

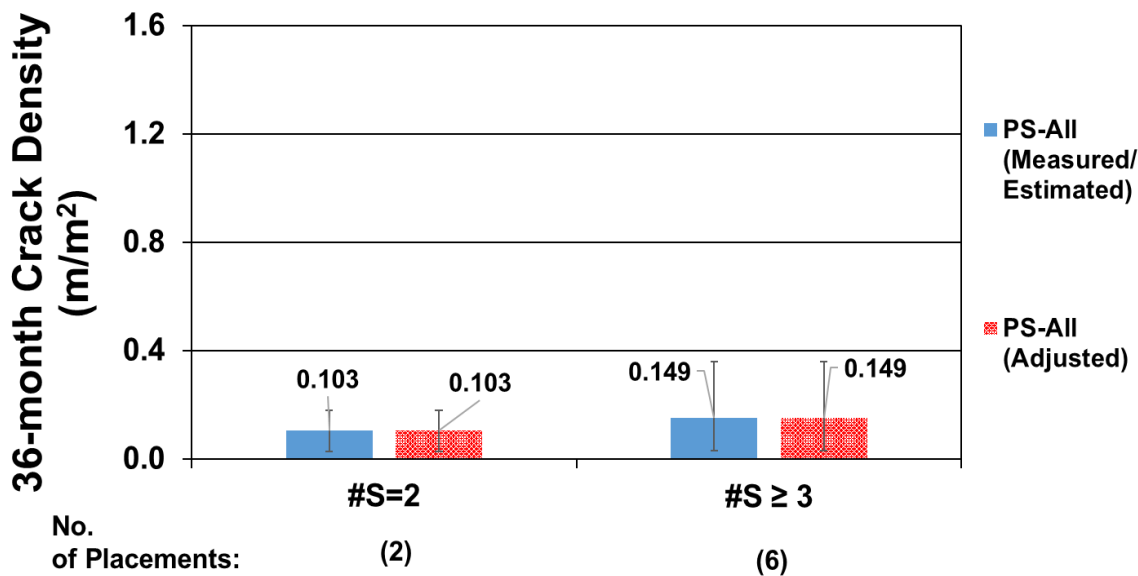
Figure E.19: Average measured/estimated and adjusted 36-month crack densities for all bridge decks supported by prestressed concrete girders without fibers and different numbers of span

As shown in Figure E.19, the average measured/estimated as well as the adjusted 36-month crack density for prestressed concrete girder decks without fibers increases from 0.103 (for decks with two spans) to 0.149 m/m² (for decks with three and more spans); these differences are also not statistically significant ($p = 0.645$).

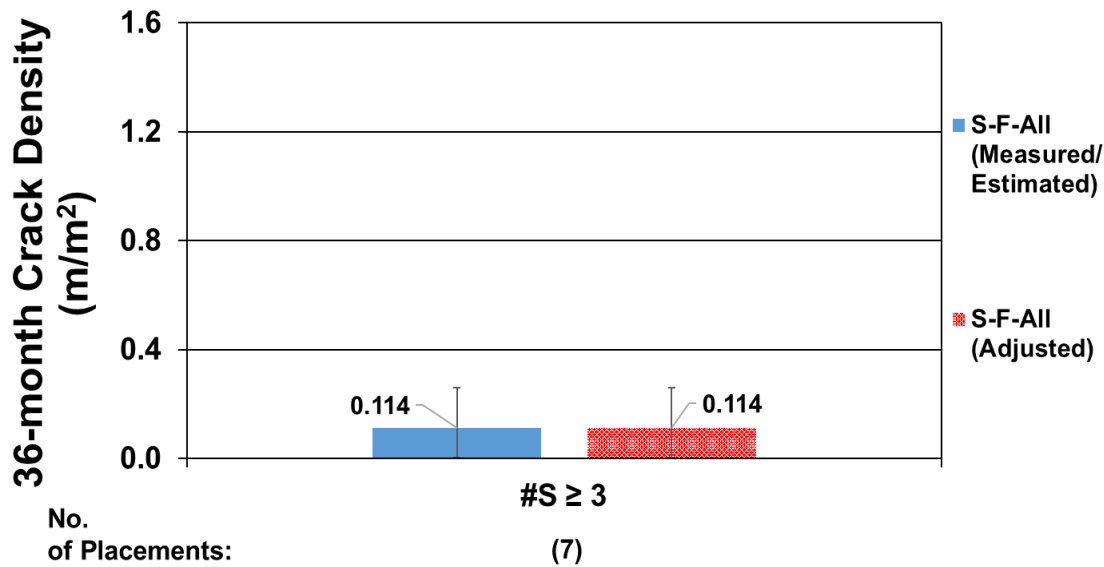
Figure E.20: Average measured/estimated and adjusted 36-month crack densities for all bridge decks supported by steel girders with fibers and different numbers of span (#S ≥ 3)

As shown in Figure E.20, the average measured/estimated and adjusted crack density for steel girder decks with fibers was 0.114 m/m² at 36 months of age.

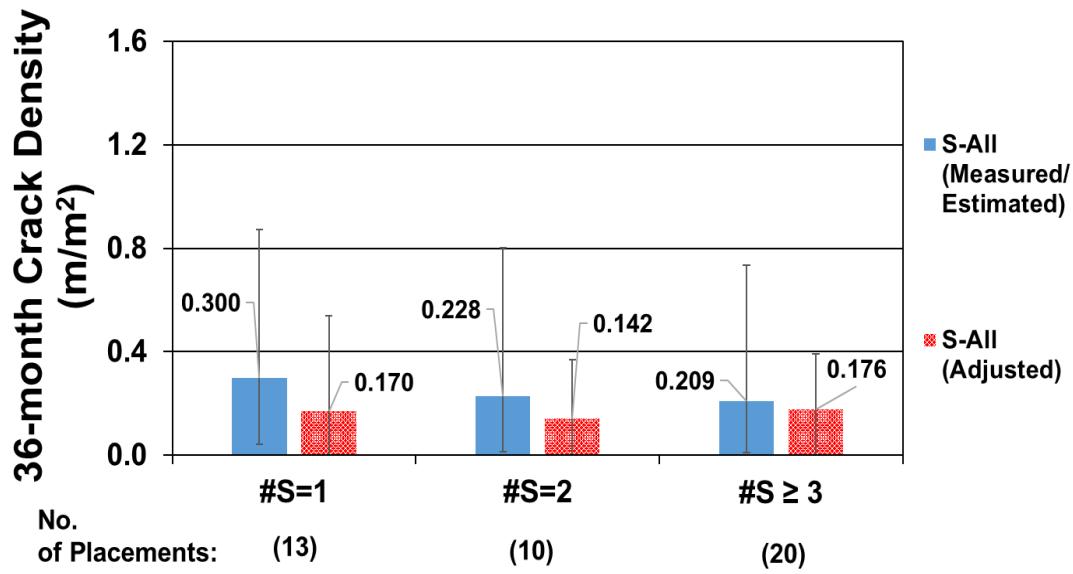
Figure E.21: Average measured/estimated and adjusted 36-month crack densities for all bridge decks supported by steel girders without fibers and different numbers of span

As shown in Figure E.21, the average measured/estimated 36-month crack density for steel girder decks without fibers decreases from 0.300 to 0.209 m/m² as the number of spans decreases; the differences between categories are not statistically significant (*p* values ranging from 0.295 to 0.805). When adjusted for paste content using Eq. (E.1), the average 36-month crack density decreases from 0.170 m/m² for decks with one span to 0.142 m/m² for decks with two spans and increases to 0.176 m/m² for decks with three and more spans; the differences between categories are not statistically significant (*p* values ranging from 0.525 to 0.929).
