REPAIR OF STEEL BRIDGE GIRDERS DAMAGED BY DISTORTION-INDUCED FATIGUE
By

Submitted to the graduate degree program in Civil Engineering and the Graduate Faculty of the
University of Kansas in partial fulfillment of the requirements for the degree of Master of
Science.

EXECUTIVE SUMMARY

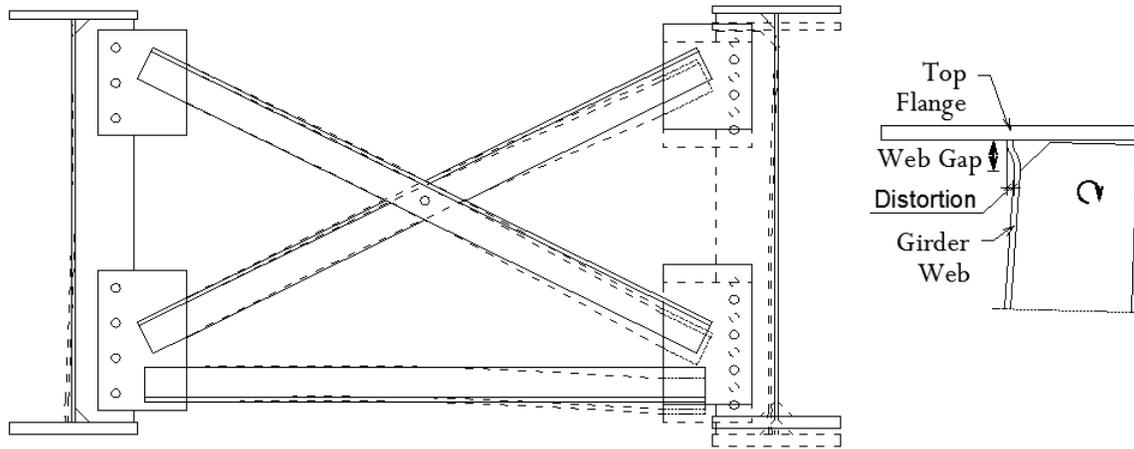
Figure 1-1: Out of plane distortion in bridge girder

A web-gap region is created when a connection plate is clipped at the top or bottom, leaving a gap between the edge of the connection plate and the unconnected girder flange (Fig. 1-1). This type of connection detail was widely used in the United States before the mid-1980s. The connection detail was implemented in this manner because it is very difficult to achieve a good quality weld at the intersection of the web and flange (Castiglioni et al. 1988), and because there were concerns that welding the connection plate to the tension flange would lead to fatigue damage, a problem that was observed in European bridges early in the last century (Roddis and Zhao 2001). Roddis and Zhao (2001) indicate that it was common practice not to weld connection plates to the compression flange also to avoid the introduction of AASHTO fatigue category E connection details.

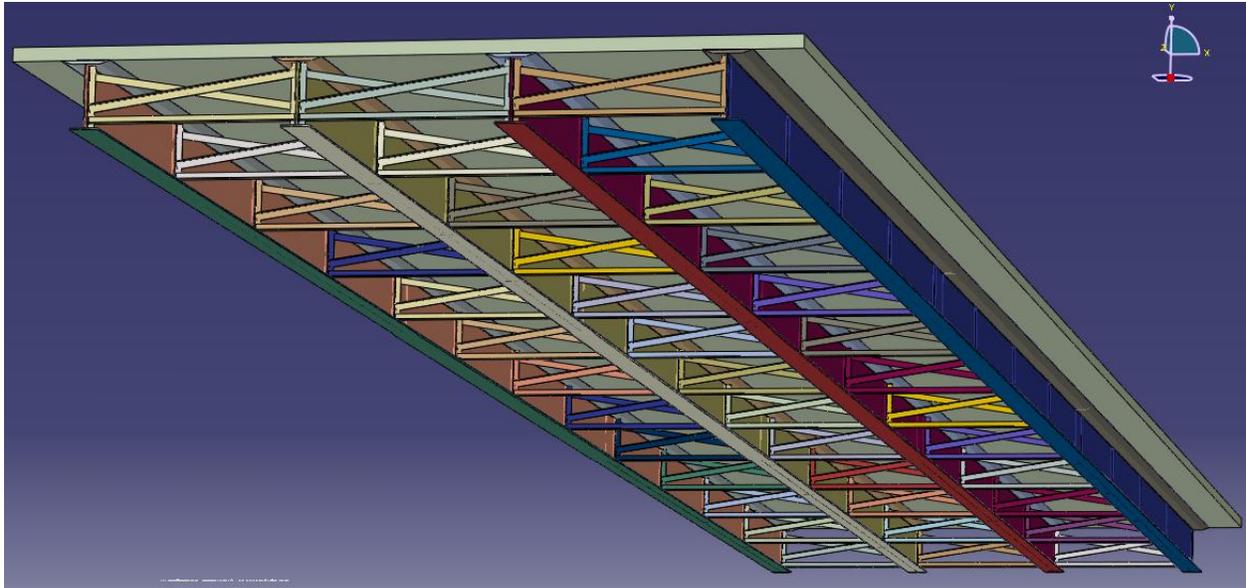
Figure 1-2: Bottom view of simulated bridge model (Hassel 2011)

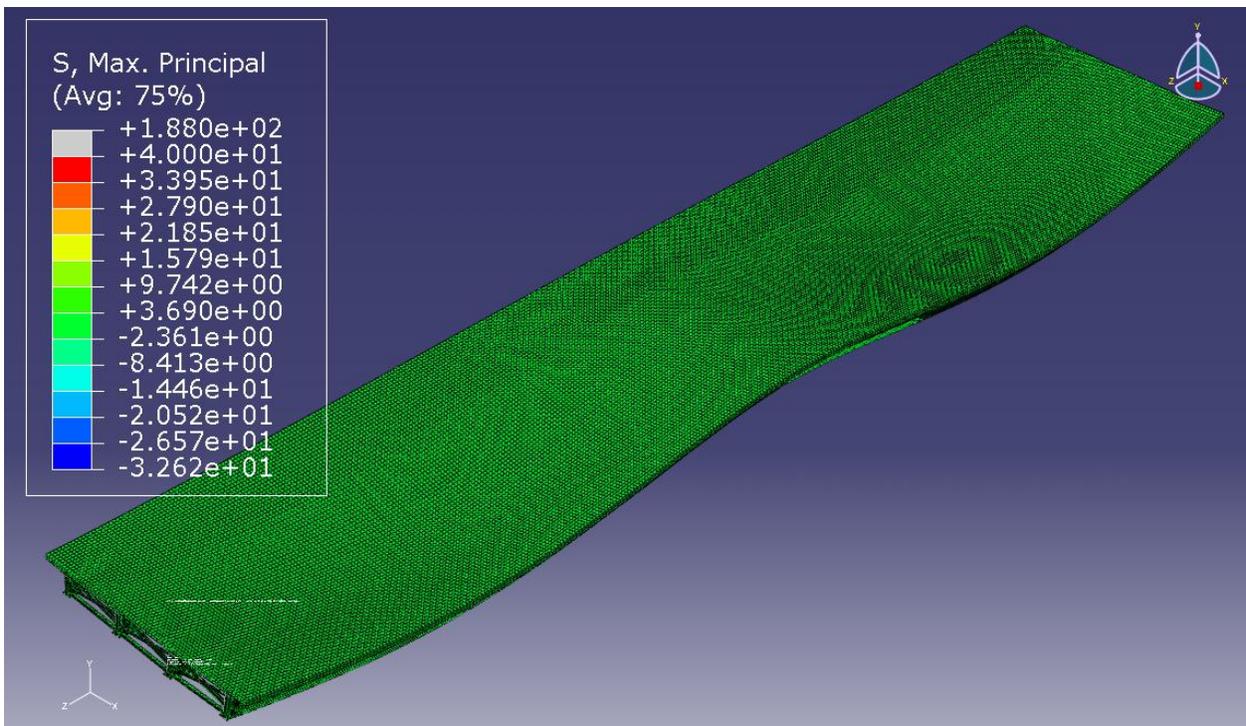
Figure 1-3: Deflected shape of the bridge model under truck load (Hassel 2011)

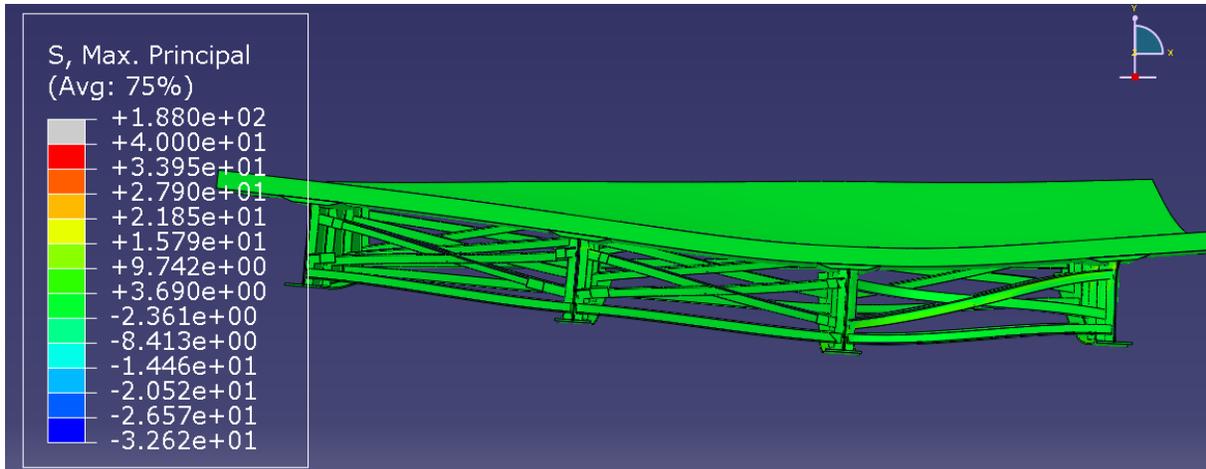
Figure 1-4: Deflected shape of bridge section in a region of positive moment (Hassel 2011)

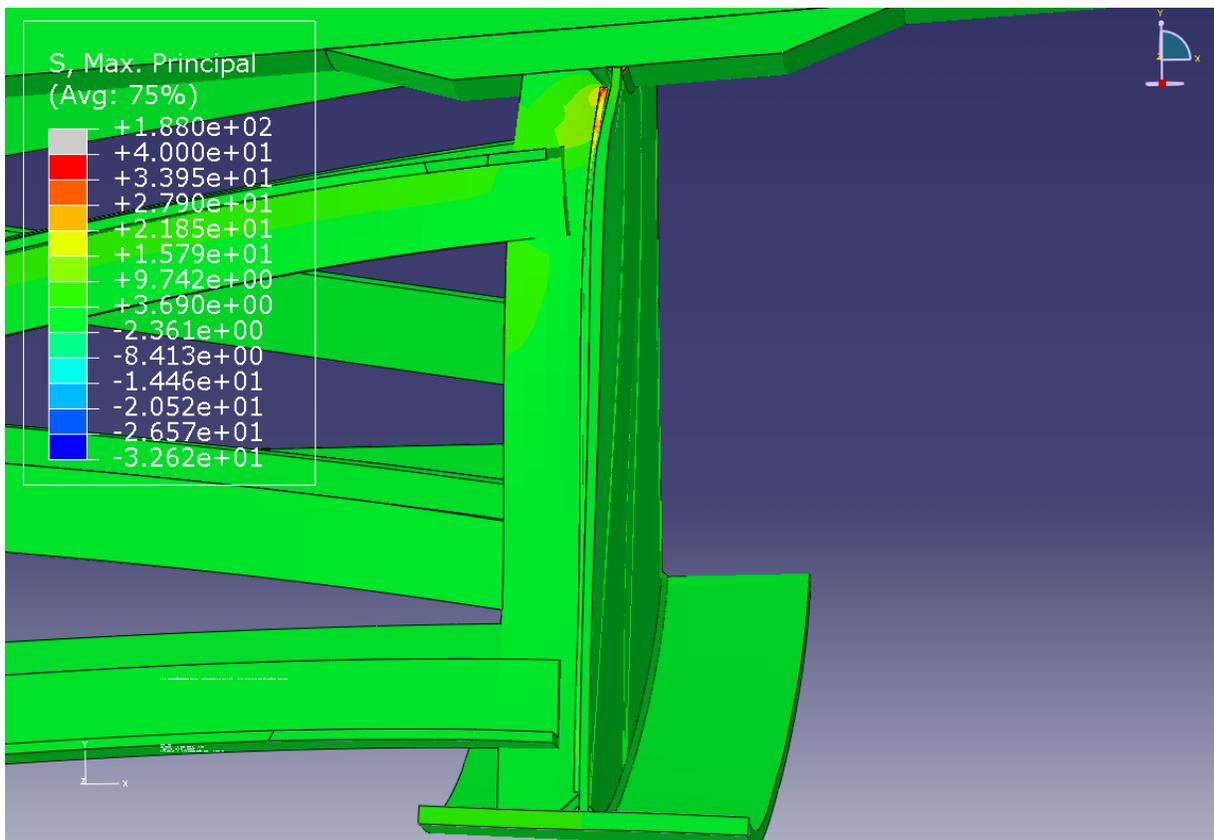
Figure 1-5: Close-up view showing stress demand at the web-gap region of the deflected girder (Hassel 2011)

Given the interactions that exist between primary and secondary actions in a bridge, a complete bridge system provides a far superior means to evaluate the efficacy of retrofit measures than subassemblies. The main advantage of subassemblies is that testing can be performed at a significantly lower cost, allowing multiple simulations at a fraction of the cost of a single simulation of a bridge system. Because the former technique was employed in this study, a comparison was carried out between results from high-resolution computer simulations of subassemblies and complete bridge systems. A large-scale analytical study on distortion-induced fatigue in steel bridges, comprising more than 1000 high-resolution simulations of bridge systems with similar girder dimensions as those used in the subassemblies evaluated in this study, was carried out by Hassel (2011). FE simulation results, illustrated in Figs. 1-2 through 1-6, show that the distribution of stresses in the web-gap region of the subassemblies was similar to that found in the web-gap region of the two-span continuous model bridge employed by Hassel. In both instances the main areas of vulnerability were at the weld between the connection plate and the girder web, and at the weld between the web and the flange (Figs. 1-5 and 1-6).

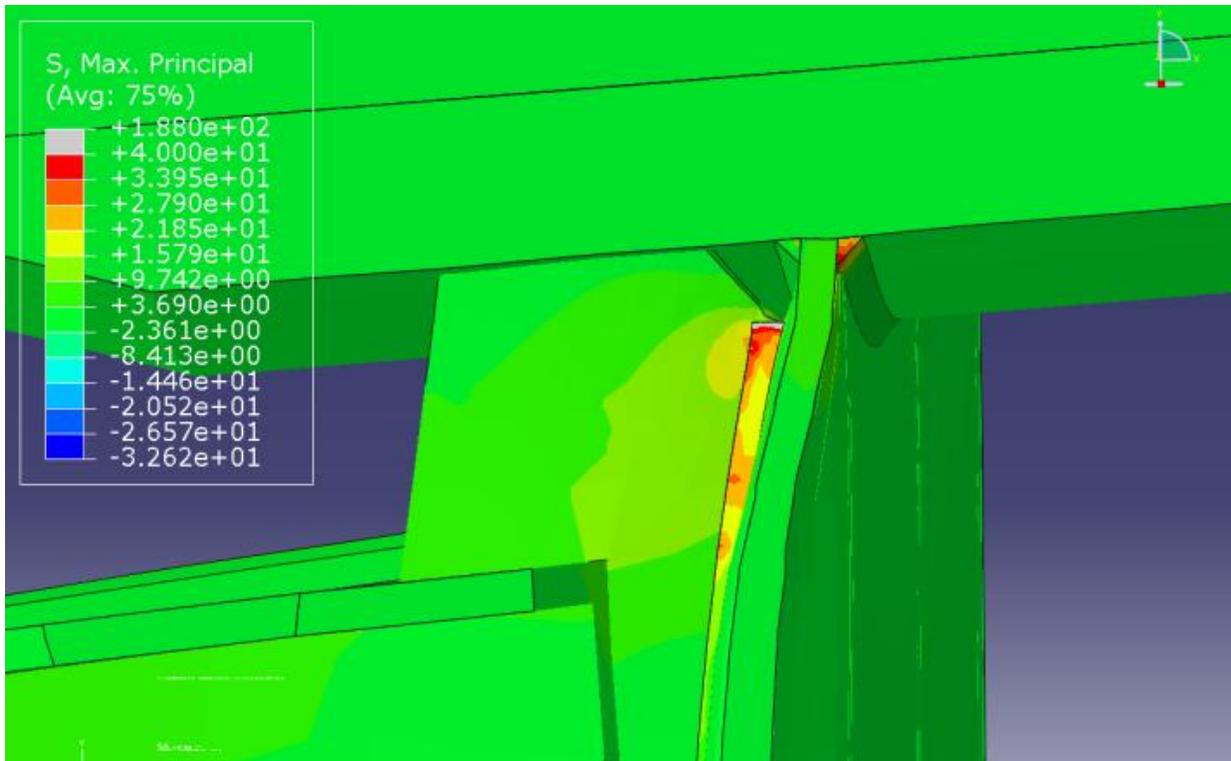
Figure 1-6: Detailed view of the stress demand at the web-gap region of an external bridge girder

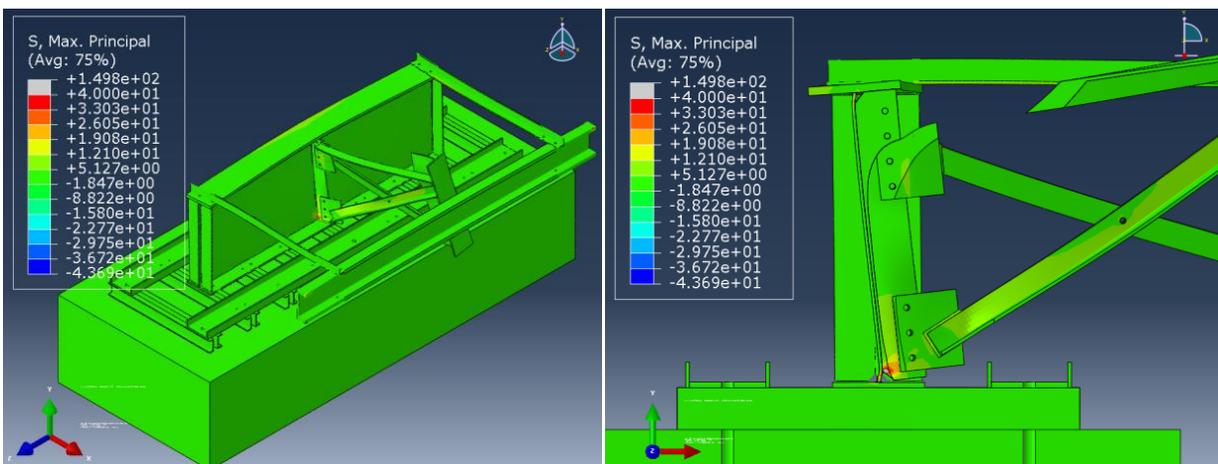
Figure 1-7: Deformed configuration of girder specimen: a) aerial view b) center cut

The computer models were created to resemble as closely as possible the girder-cross frame subassemblies that were tested (Fig. 1-7). Computer simulations of a full bridge with similar girder dimensions carried out for a different study (Hassel 2011) showed good agreement between the stress fields computed at the web-gap region of the model bridge and those computed for the specimens evaluated in this study. The dimensions of the specimens and the measured material properties are described in the experimental program section. Linear-elastic FE models were created using 8-node brick elements, each with 24 degrees of freedom. The number of elements ranged from 1 to 2 million, depending on the retrofit measure that was modeled. An 813-mm (32-in.) wide strip with a reduced mesh size was defined in the girder web, centered on the cross-frame connection plate, spanning from the bottom to the top flange. The size of the elements in this strip was set as 3-mm (0.10-in) to improve the accuracy of the calculated stress field in this region. A 76-mm (3-in.) wide vertical strip of tetrahedral elements was used to transition from the fine mesh to a 10-mm (0.38-in.) coarser mesh used to model the web of the girder in locations away from the cross frame.

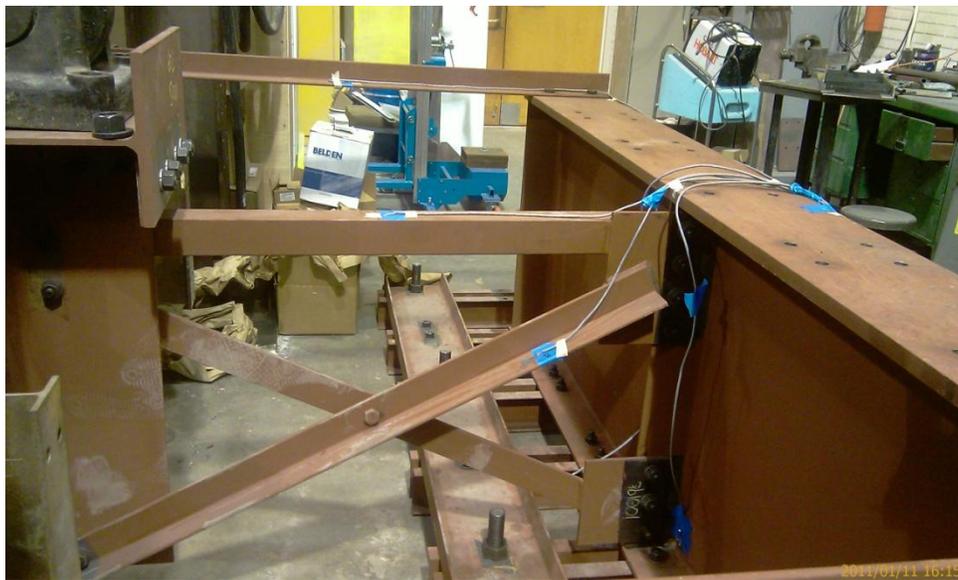
Figure 1-8: Experiment setup.

The computer model was loaded with a single 22,240-N (5-kip) force, applied to a WT section that was used to connect the cross braces to the actuator in the physical model (Fig. 1-8). In the computer model, the bottom of the concrete block below the specimen was modeled as fully fixed, and so were both ends of a channel connecting the two end angles to the reaction frame in the physical model (Fig. 1-8). In the computer model, the WT section where the actuator force was applied was restrained from moving along the direction parallel to the longitudinal axis of the girder. Figures 1-8 and 1-9 show the girder specimen and the experimental setup.

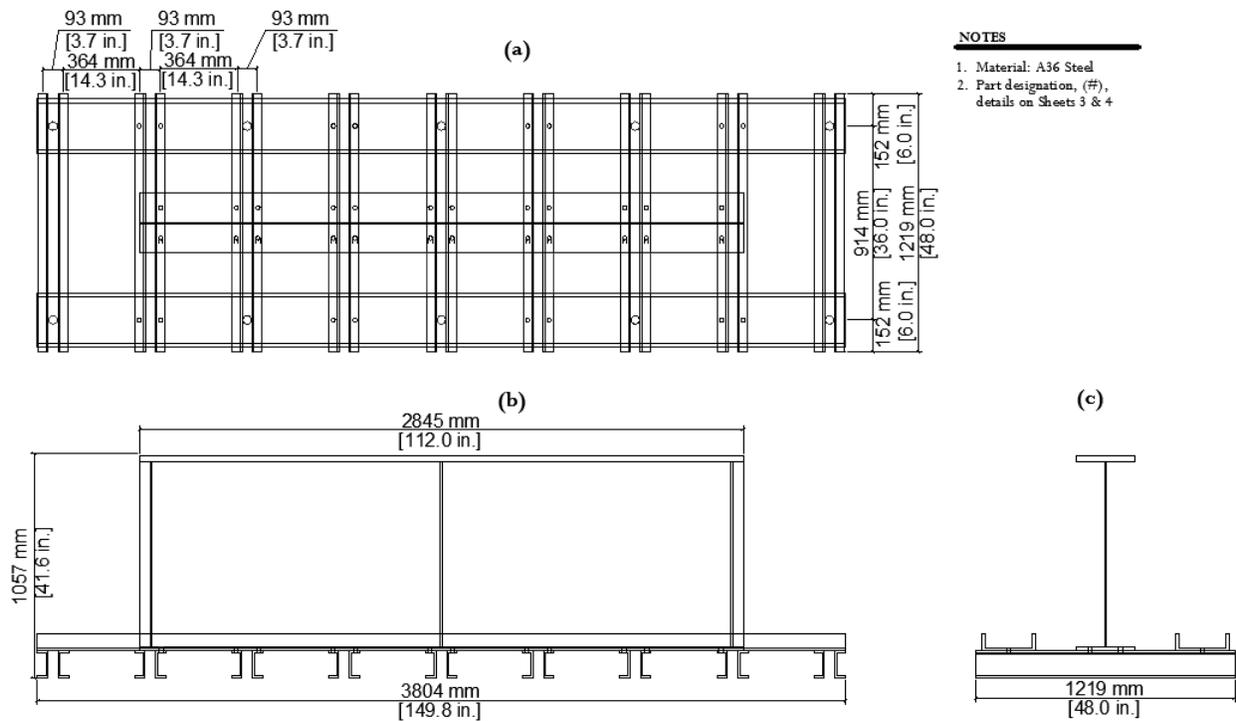
Figure 1-9: Girder specimen a) plan b) elevation c) section

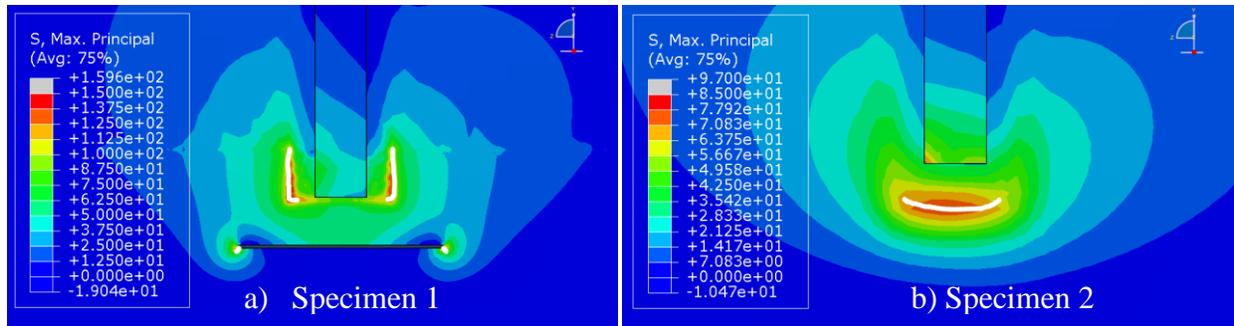
Figure 1-10: Observed crack patterns superimposed on the results from the simulation models for web-gap regions of specimens 1 and 2 (observed cracks shown as white lines).

Computed stresses from models with different retrofit measures were compared using the hot spot stress (HSS) technique. The HSS technique was adopted to obtain a more reliable measure of demand in areas of the web-gap region where there were large stress gradients, such as near welded or bearing connections. Maximum principal stresses were used as a measure of vulnerability to fatigue damage because areas with the largest maximum principal stress demands in the model correlated well with locations where cracks formed in the specimens (Fig. 1-10).

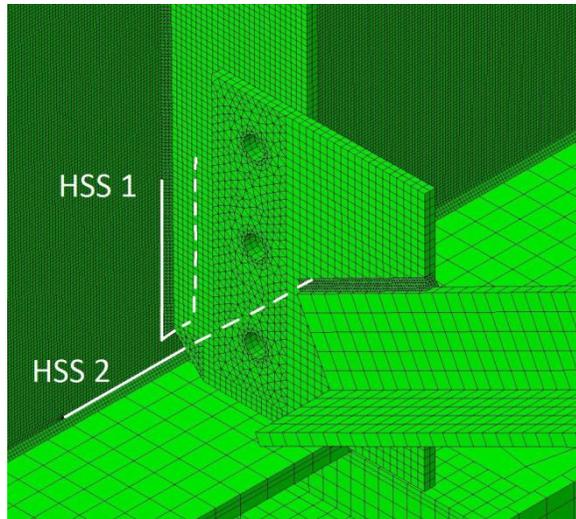
Figure 1-11: Pre-defined paths for sampling of stress demands in the various FE models.

In accordance with the definition of HSS used in this study, paths for sampling the stresses were defined at a distance of 5-mm ($\frac{3}{16}$ -in.) away from the weld, equivalent to half the thickness of the web (10-mm, $\frac{3}{8}$ -in.) (Fig. 1-11). HSS sampling paths were defined only near locations where cracks were observed in the specimens. HSS Path #1 Bottom was defined as a horseshoe-shaped path in the bottom web-gap of the subassembly. HSS Path #2 Bottom was defined as a horizontal path above the crack that formed in the web-to-flange weld in the bottom web-gap of the subassembly. Similar paths were defined and sampled in the top web-gap of the subassembly when cracks were observed in the experiment. The J-Integral and stress intensity factors (SIF) at the tip of simulated cracks were computed as a measure of propensity for crack growth. A total of 5 contours were evaluated in the calculations, at points evenly spaced through the thickness of the web.

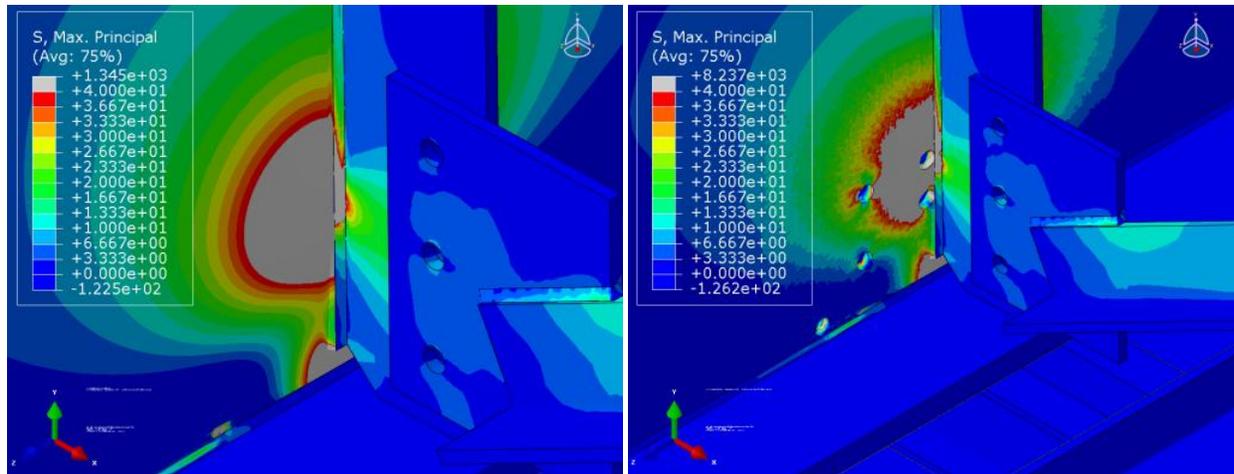
Figure 1-12: Stress field comparison a) No retrofit b) Crack stop hole retrofit

The two HSS sampling paths in the model with crack stop holes were defined at a distance of half the thickness of the web away from the web-to-connection plate weld. Simulations were performed to establish a comparison between an unretrofitted model with two cracks in the bottom web-gap region and a model with the same crack pattern but with crack-stop holes (Fig.

1-12). The maximum HSS value at Path #1 decreased by 27% with the drilling of the crack stop holes, while the maximum HSS along Path #2 decreased by 16%. The stress fields presented in Fig. 1-12 show that the drilling of crack-stop holes did not significantly reduce the stress demand, and that the reduction was not likely sufficient to prevent the existing cracks from propagating.

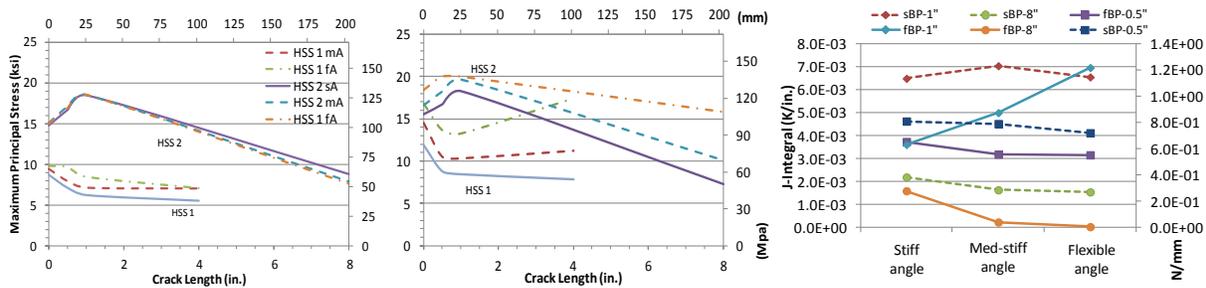
Figure 1-13: Peak demand at web-gap region vs. crack length for retrofitted specimens a) HSS for stiff back plate configurations b) HSS for flexible back plate configurations, c) J-Integral for various back plate configurations.

The peak HSS exhibited different trends with respect to crack length along Path #1 (horseshoe-shaped crack) than it did along Path #2 (horizontal crack). For HSS Path #1 (horseshoe-shaped crack) configurations with the thickest angles and/or back plate (stiff configurations, Fig. 1-13a) the maximum stress demand corresponded to the retrofitted specimen without cracks (shown in the graphs in Fig. 1-13 as zero length). The peak HSS decreased with increasing crack length, stabilizing at approximately 75% of the peak demand computed with the unretrofitted model. The crack length at which the peak stress demand stabilized was lowest for the model with the stiffest angles. For the configuration with the thinnest angles (flexible

configuration, Fig 1-13b) and back plate the HSS values decreased with crack length for very short lengths, approximately less than 12-mm ($\frac{1}{2}$ -in.). For crack lengths longer than 12-mm ($\frac{1}{2}$ -in.), the peak stress demand increased with crack length for the configurations with the two thinnest angles. These results showed that the best alternative to reduce the stress demand near the horseshoe-shaped crack was to use the stiffest angle and back plate combination, and that the effectiveness of the retrofit measure was nearly independent of crack length.

Similar trends were observed for computed J-Integral values from contours surrounding the tip of the horizontal crack, at the tension face of the web (Fig. 1-13c). Calculated J-Integral values for retrofitted models with $\frac{1}{2}$ -in. cracks fell between those calculated for models with 1- and 8-in. cracks, with the highest value corresponding to the models with 1-in. cracks. This trend was similar to that observed in Fig. 1-13a and 13b for the HSS, and suggests that the potential for crack growth increased with crack length for relatively short cracks (less than 25-mm or $\frac{1}{2}$ -in. long). For longer cracks, the computed J-Integral values suggest that the potential for crack growth decreased with increasing crack length, and was lowest for the configuration with the longest crack and thinnest angles and plate. This was an important finding considering that the angles-with-plate retrofit measure does not provide any direct connectivity between the connection plate and the flange. The main driving force for the horizontal crack (HSS Path #2) is induced by bending moments in the girder web, caused by the distortion of the web-gap

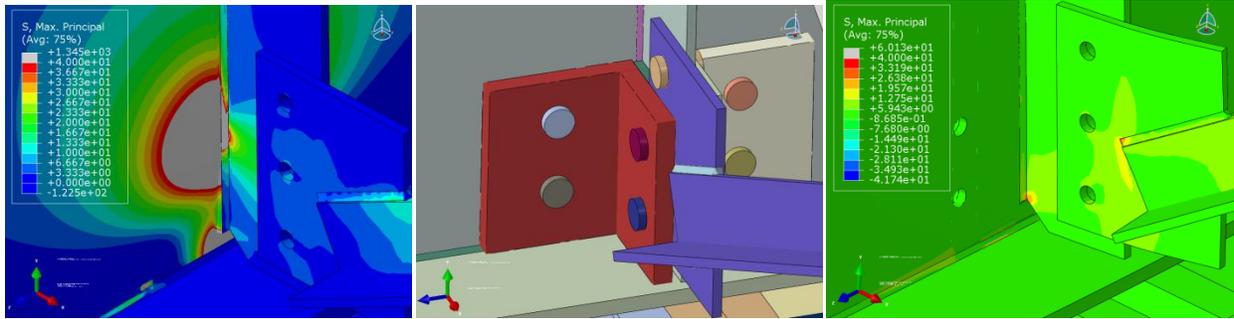
Figure 1-14: a) computed stresses without retrofit b) angle retrofit configuration c) computed stresses with retrofit.

The configuration of this retrofit measure is shown in Fig. 1-14b, Fig. 1-18 and Fig. 1-19. Parametric analyses of the angles-with-plate retrofit measure were performed to determine the optimal back plate and angle dimensions. The first parametric study involved varying the angle and back plate thicknesses, while the other dimensions were kept constant. The crack pattern in the model was the same used to evaluate the performance of the crack-stop hole retrofit, with a 102-mm (4-in.) long horseshoe crack and a 203-mm (8-in.) long horizontal crack in the bottom web-gap of the subassembly. The horseshoe-shaped crack followed the toe of the CP-to-web fillet weld, while the horizontal crack was placed along the web-to-bottom flange weld. The back cover plate and angle thicknesses evaluated were 6-mm ($\frac{1}{4}$ -in.), 13-mm ($\frac{1}{2}$ -in.), and 25-mm (1-in.). Computed stress demands are summarized in Table 1-1. All values in Table 1-1 correspond to reductions in the calculated elastic stress demand with respect to the unretrofitted configuration and ranged between 93 and 98%, which clearly shows that this retrofit measure, regardless of configuration, significantly reduced the computed stress demand in the bottom web-gap region. Although variations in the stress demands were found to be small, some trends that are helpful in choosing an optimum configuration for the retrofit measure could be discerned.

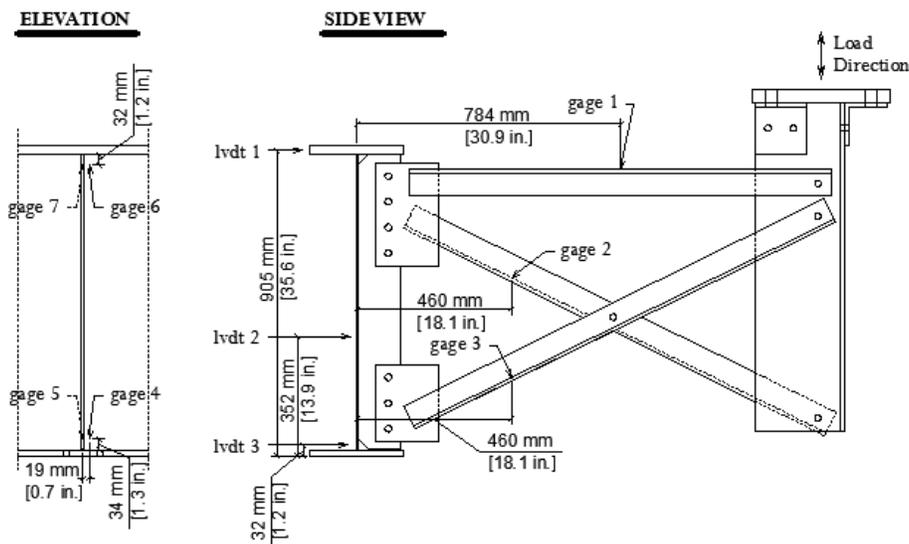
Figure 1-15: Instrumentations on 9-ft girder specimen.

The LVDTs were placed to measure the out-of-plane deflections at three different locations on the center line of the girder. The first LVDT was placed at the top flange, the second at the midsection of the web, and the third directly behind the bottom end of the CP. Good agreement was found between the deflected shapes computed in the simulations and the experimental measurements (Fig. 1-16). As shown in Fig. 1-16, the computed deflections for the nominal force range were lower in magnitude than those measured, but when scaled to match the measured deflection range at the top of the girder the slope of the deflected shape at the center of the girder matched the measured deflected shape very closely.

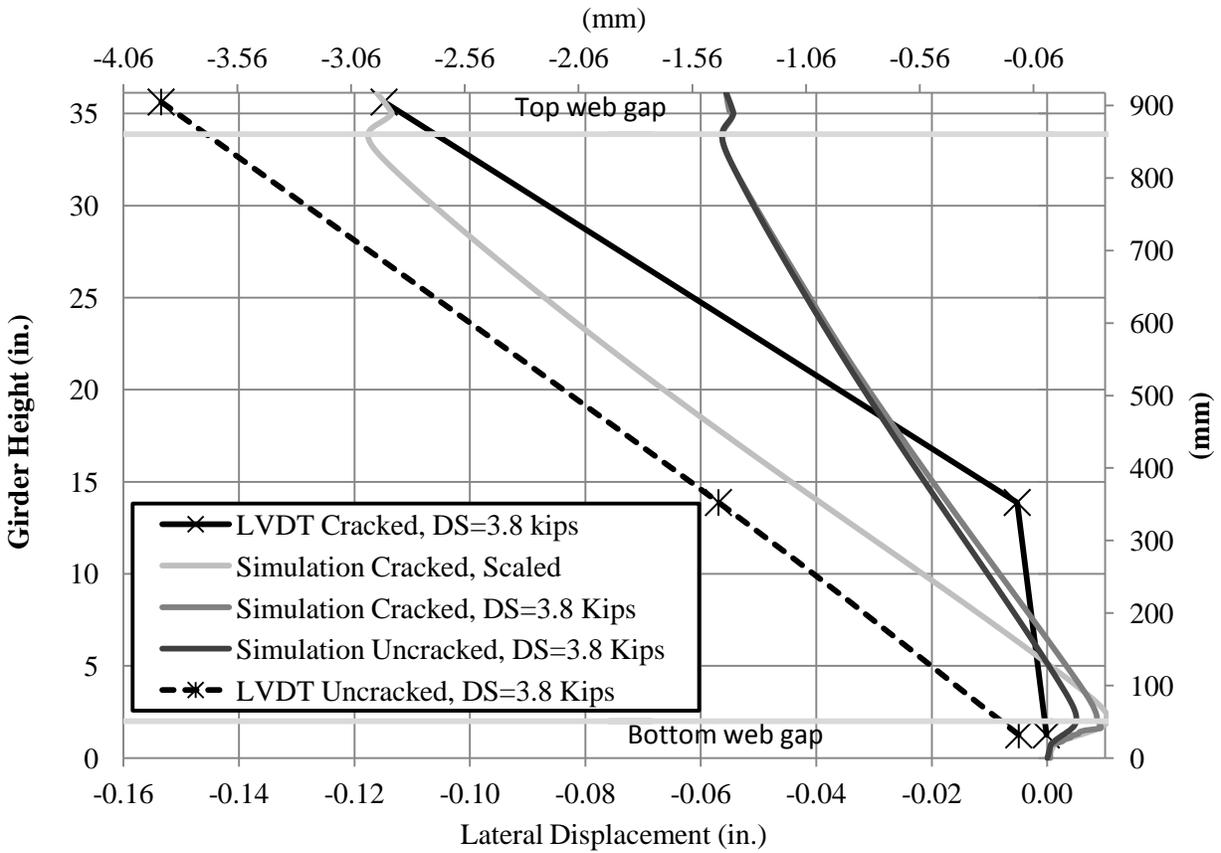
Figure 1-16: Comparison between LVDT readings and computed deformations

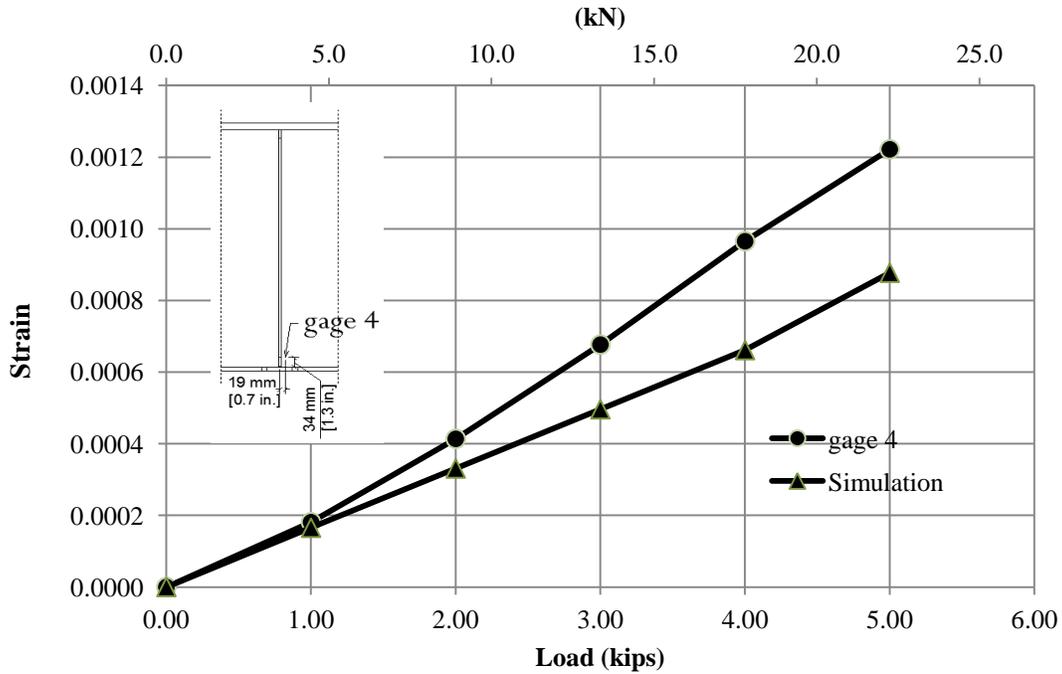
Figure 1-17: Strain gage readings compared with simulation model results.

Figure 1-17 shows a comparison between strain gage readings and simulation results. The computed strains shown in the figure represent average values over the area occupied by the gages. The gage readings were slightly higher than the simulation values, which is consistent with the results for the deflected shapes.

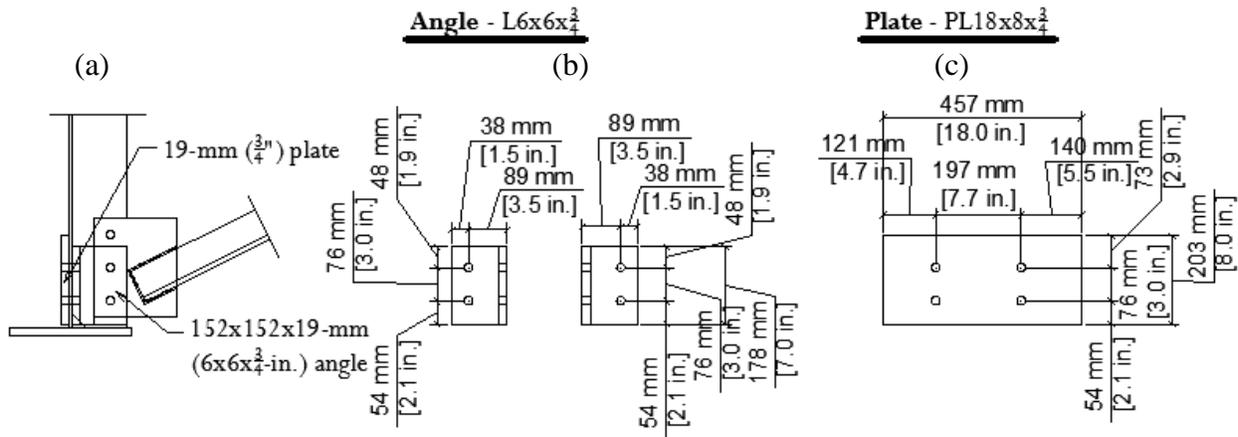
Figure 1-18: Dimensions of angles and plate evaluated experimentally. a) side view, b) angle dimensions, c) plate dimension

The angle and cover plate dimensions evaluated experimentally were L152x152x19-mm (L6x6x³/₄-in.) and 457x457x19-mm (18x8x³/₄-in.), respectively (Fig. 1-18). Angles were connected to the web and the connection plate with two bolts on each leg (Fig. 1-19). A 10-mm (³/₈-in.) thick shim plate was placed between the CP and the angle to prevent any chamfering or grinding of the edge of the angles. The angles and the back plate were removed every 250,000 cycles to inspect the web-gap region and measure crack growth.

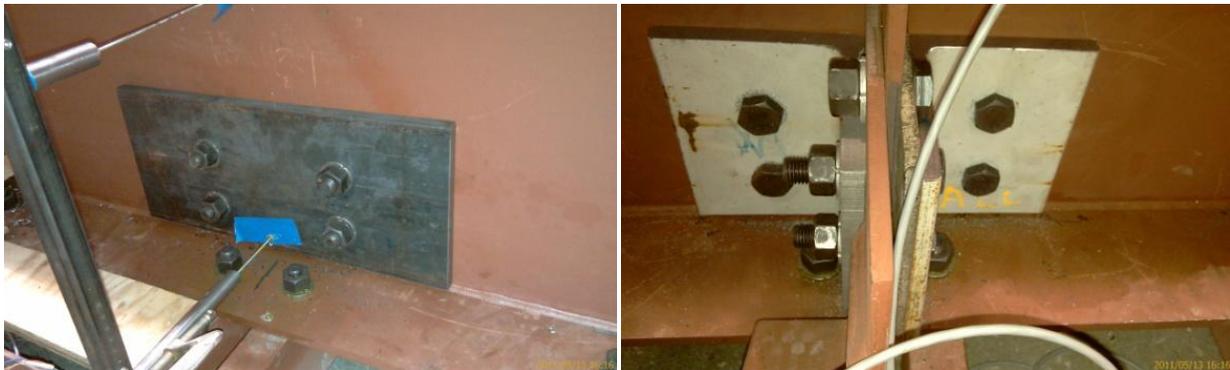
Figure 1-19: Angle retrofit with plate a) back plate, b) angles

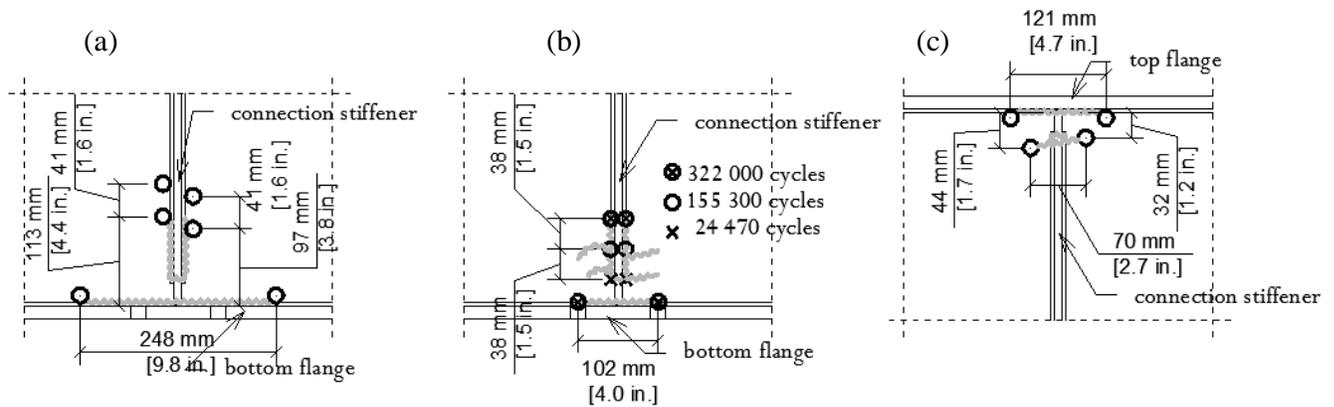
Figure 1-20: a) Crack stop holes in bottom web-gap region specimen 2, b) Crack progression at the bottom web-gap region of specimen 2, un-retrofitted, c) Crack stop holes at the top web-gap region

The crack-stop holes were drilled so that the edge of the hole would coincide with the corresponding crack tip. When two cracks were found closely located to each other a single crack stop hole was drilled to encompass both crack tips. Crack stop holes were not drilled at cracks that had stabilized in the unretrofitted configuration. The hole placement in the bottom and top web-gaps of specimen 2 are shown in Fig. 1-20. As shown in Fig. 1-20 some cracks intersected others; for example, horizontal cracks on the front and back of the web. In that case, crack stop holes were placed on the longer cracks and the smaller diameter holes were drilled at the tips of the shorter cracks. The smaller holes had a diameter of 6-mm ($1/4$ -in.). The diameter of the crack stop holes was 21-mm ($1^{3}/_{16}$ -in.) and they were drilled using a hole saw with guide.

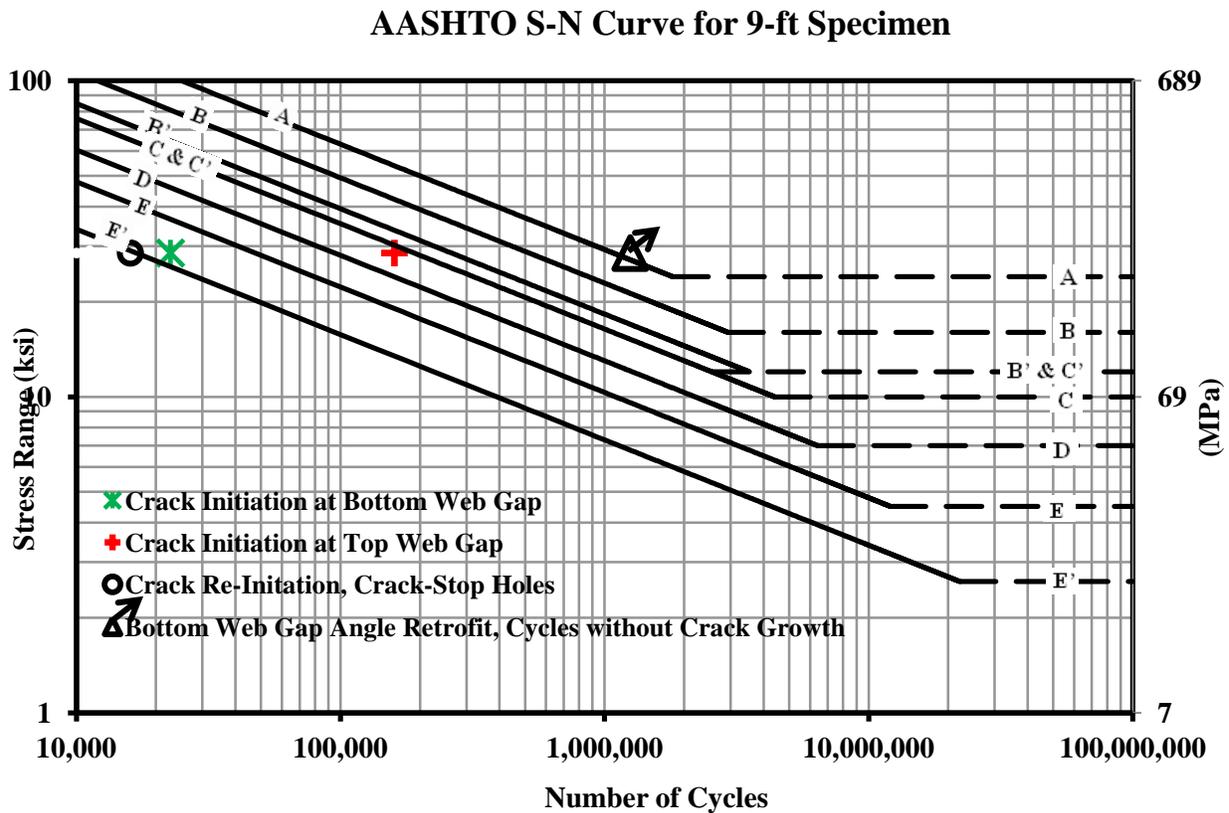
Figure 1-21: Experimental results for specimen 2 trials.

and 4 holes with a diameter of 6-mm ($1/4$ -in.) were drilled. At the end of this test trial, which lasted a total of 39,720 cycles, the bottom horseshoe-shaped crack had grown an additional 70-mm ($2\text{-}3/4$ -in.) and the bottom horizontal crack extended an additional 13-mm ($1/2$ -in.). For the fifth trial, the angles and back plate were again applied to the top and bottom web-gap regions and the specimen was subjected to 1,238,300 cycles. After this test, the specimen was inspected and no crack growth was observed. Experimental results from the various test trials are compared on the basis of the AASTHO S-N Curve in Figure 1-21.

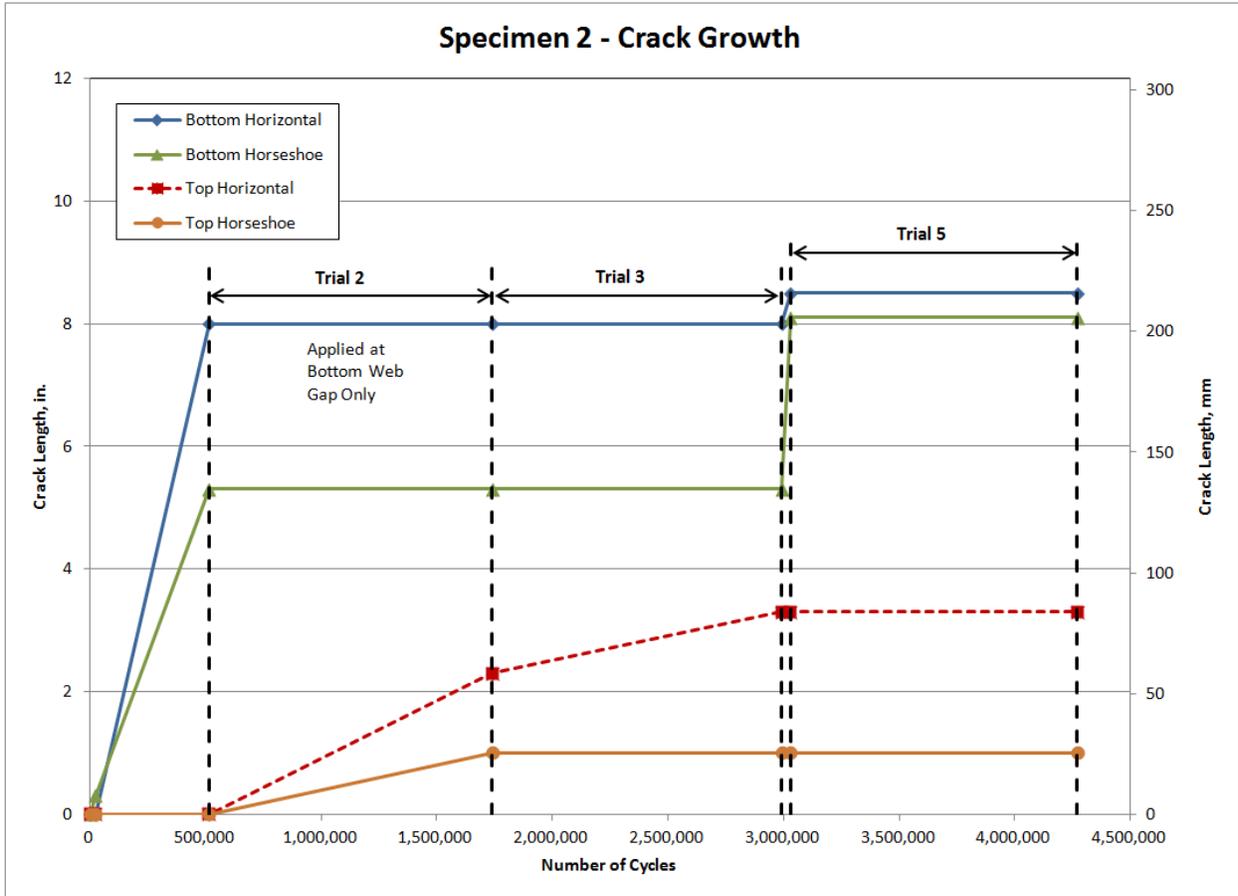
Figure 1-22: Summary of Specimen 2 crack growth

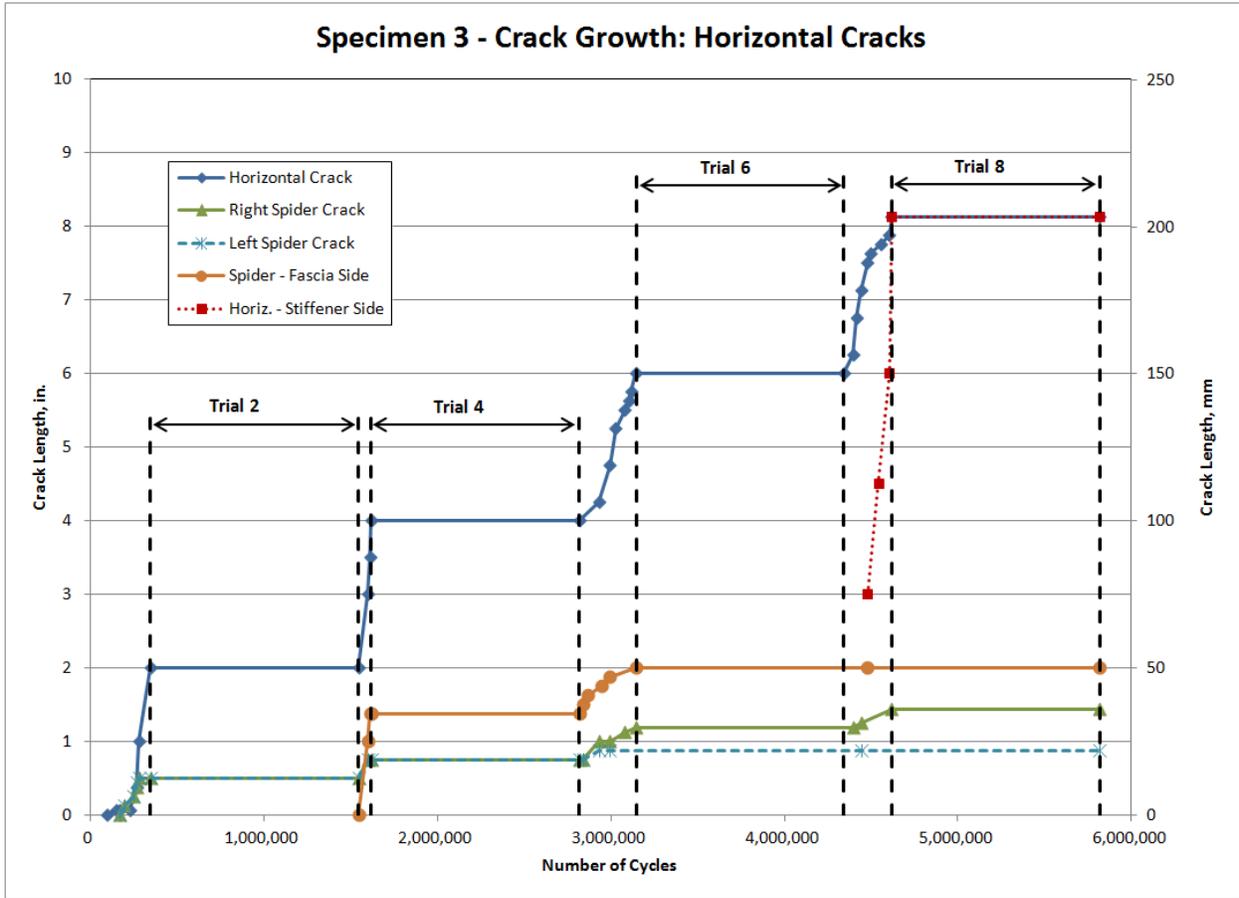
Figure 1-23 Summary of Specimen 3 horizontal crack growth

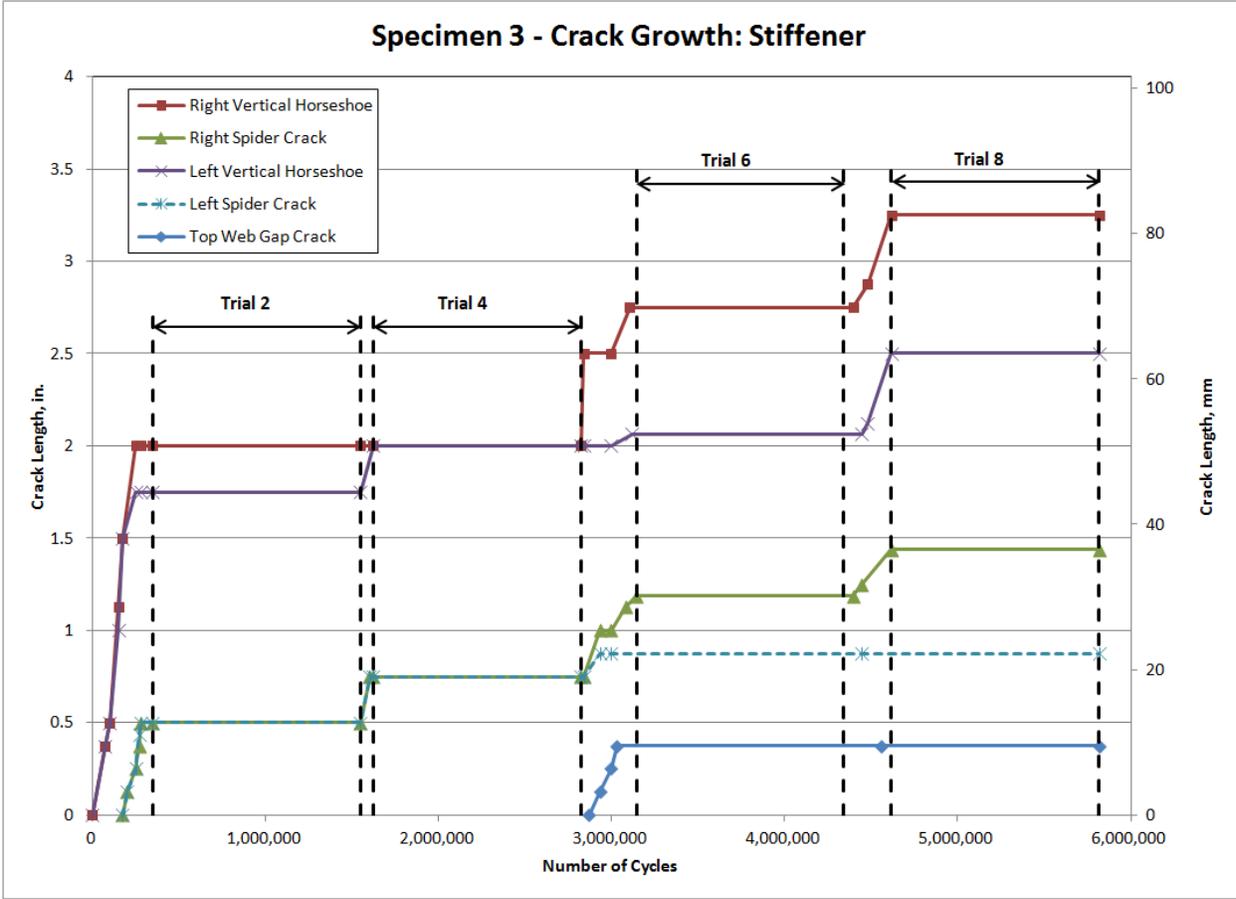
Figure 1-24: Summary of Specimen 3 stiffener crack growth

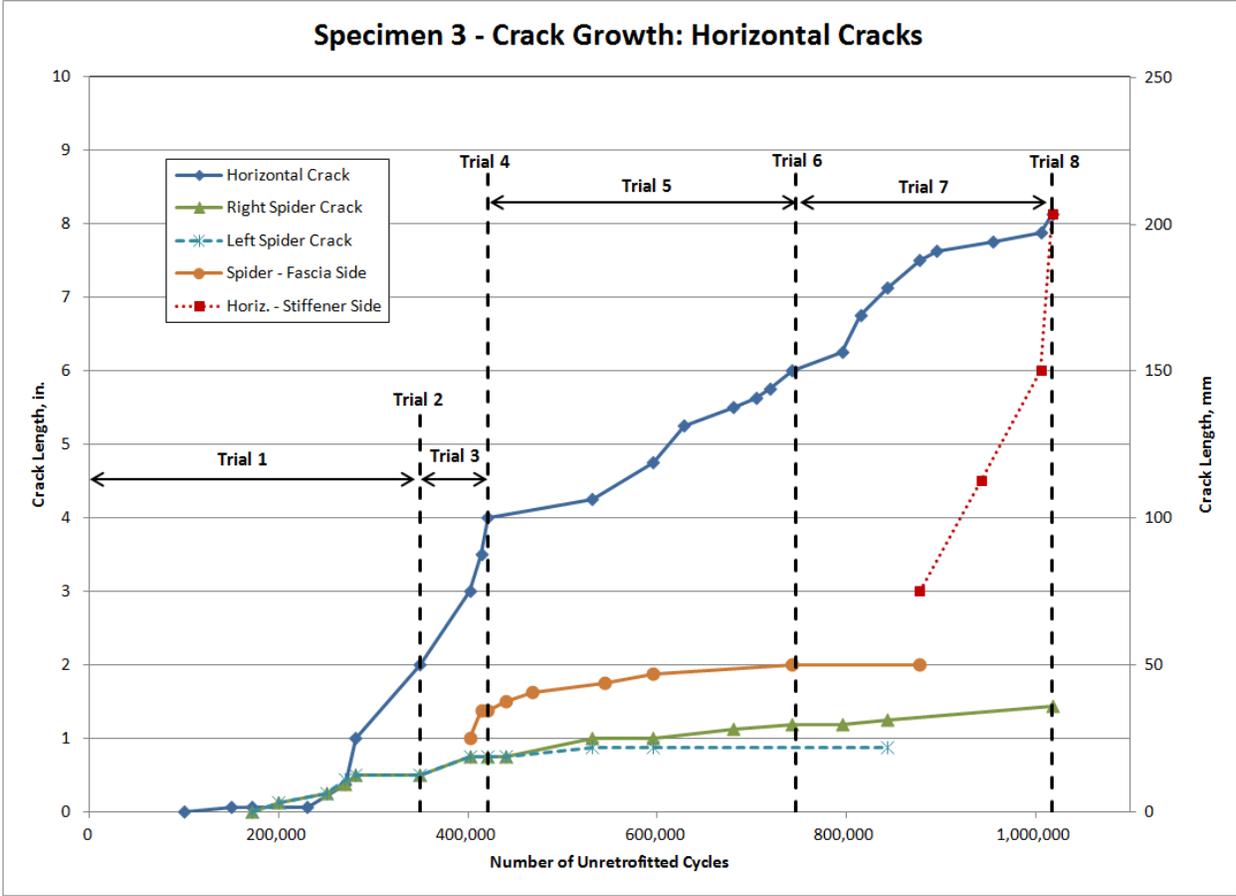
Figure 1-25: Summary of Specimen 3 horizontal crack growth in the unretrofitted configuration
