REPAIR OF STEEL BRIDGE GIRDERS DAMAGED BY DISTORTION-INDUCED FATIGUE
By

Submitted to the graduate degree program in Civil Engineering and the Graduate Faculty of the
University of Kansas in partial fulfillment of the requirements for the degree of Master of
Science.

EXECUTIVE SUMMARY

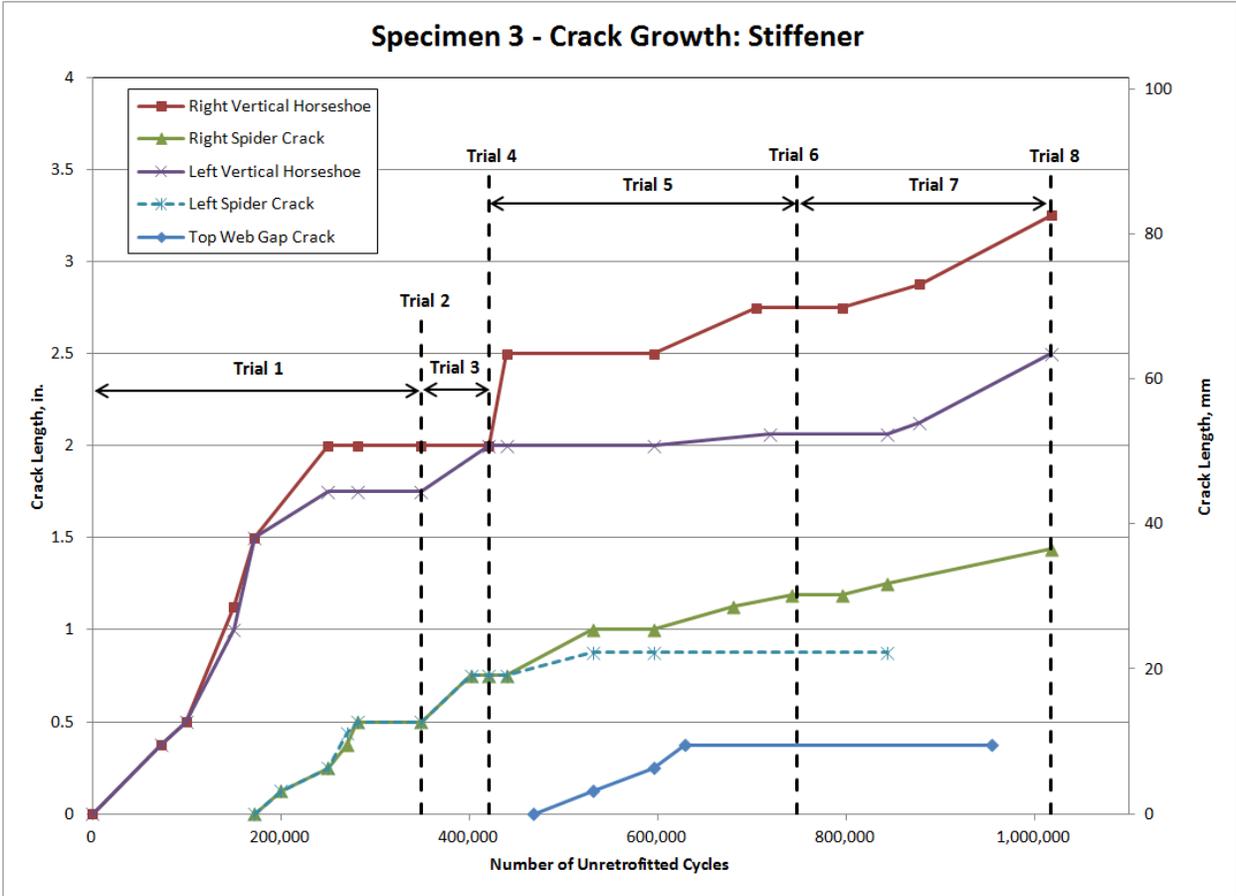
Figure 1-26 Summary of Specimen 3 stiffener crack growth in the unretrofitted configuration

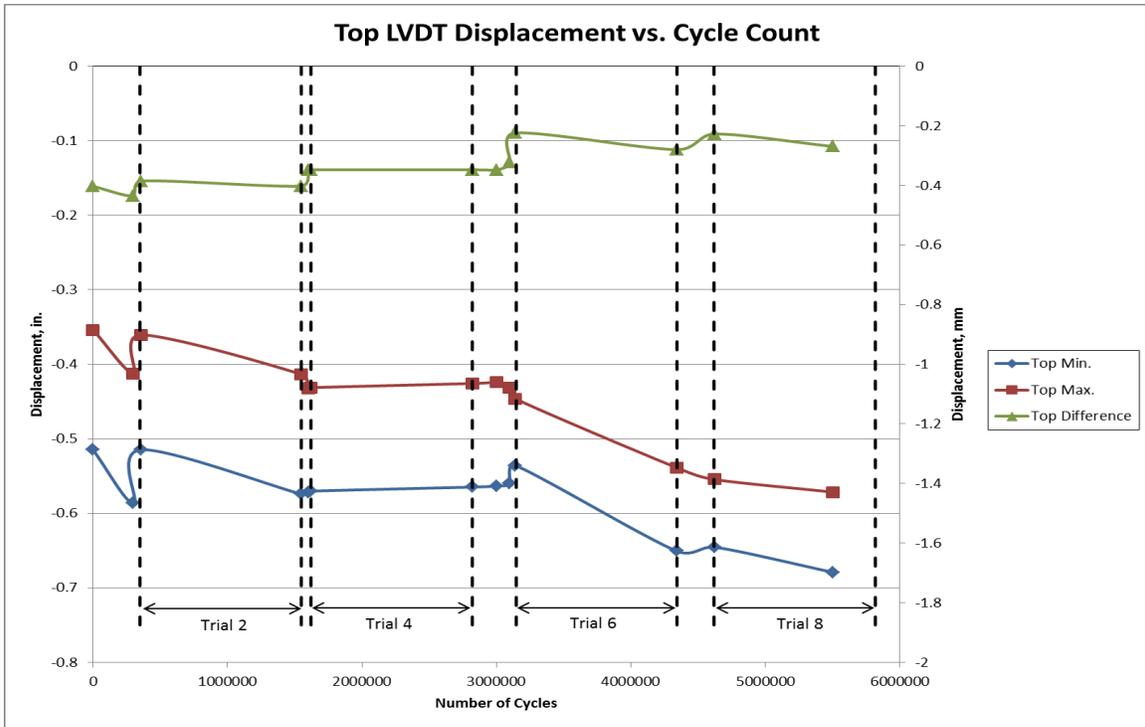
Figure 1-27: Top LVDT displacement minima and maxima

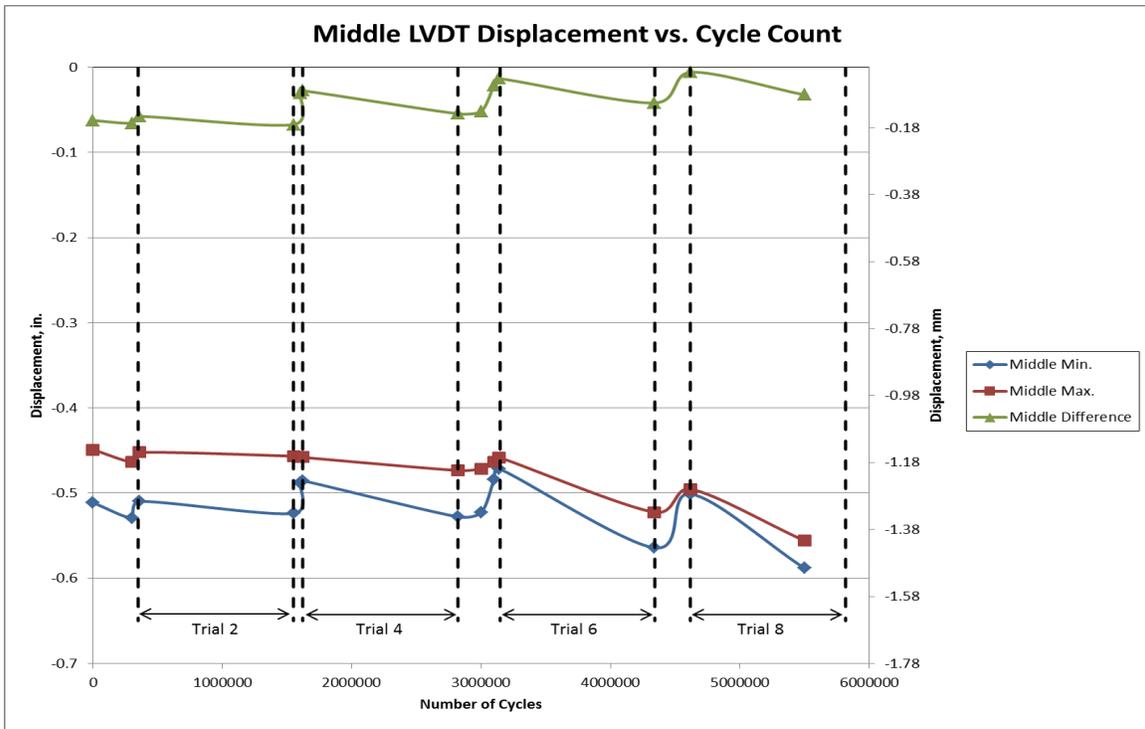
Figure 1-28: Middle LVDT displacement minima and maxima

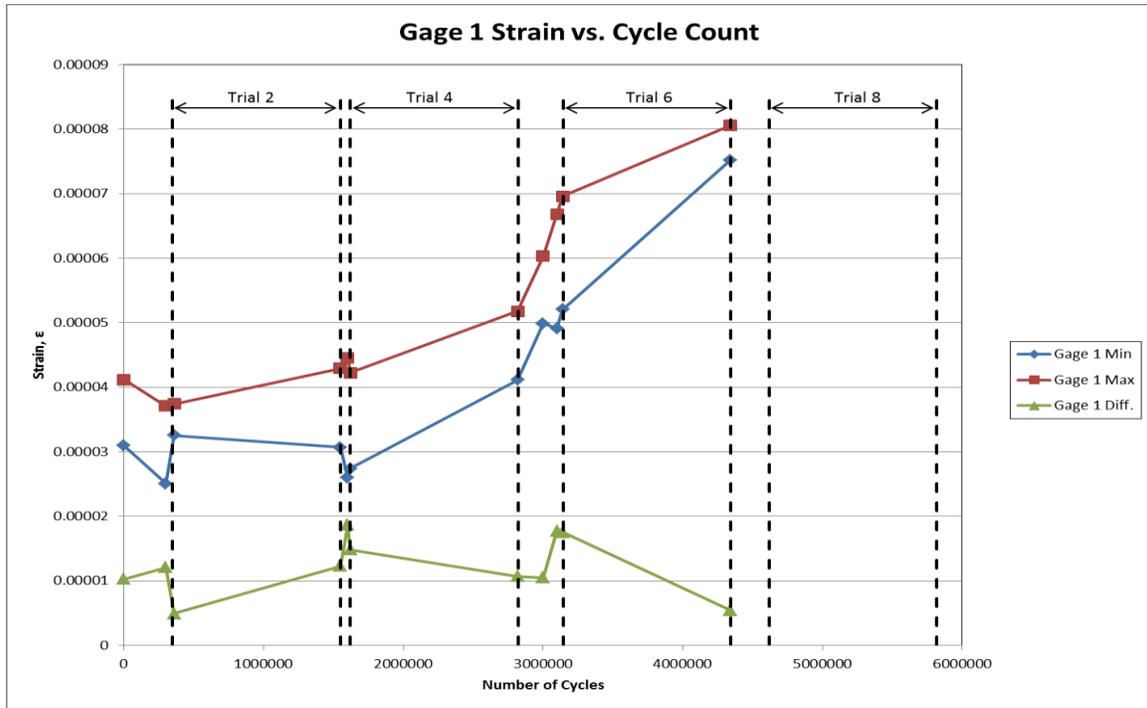
Figure 1-29: Specimen 3 strain maxima and minima

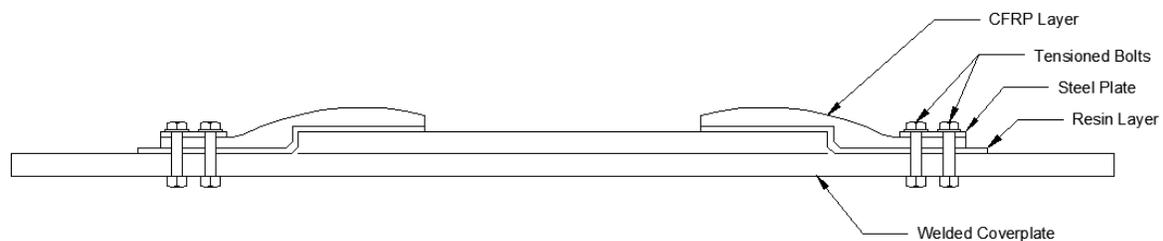
Figure 2-1: Welded cover plate with proposed bolted CFRP retrofit

between the composite and the steel under fatigue loading is investigated in this study. The method consists of adding tensioned bolts and a steel plate to a CFRP-resin-steel assembly (Fig. 2-1). The bolts are beneficial to improve the durability of the bond because they reduce the demand on the steel-composite interface due to force transmitted directly through them, and because the tension force in the bolts maintains the steel composite interface under compression, arresting any cracks that develop due to fatigue.

This retrofit measure investigated in this study is an extension of work done by Kaan (2012) and Alemdar (2012) investigating the use of CFRP overlays on welded connection plates. While the cover plate specimens used by Kaan (2012) and Alemdar (2012) are identical to the configuration used in this study, the profile of the composite overlay is significantly different to allow for the inclusion of the bolted plates. Figure 2-3 shows the loading apparatus and specimens used by Kaan (2012) with the CFRP overlays attached to the cover plate. This specimen configuration constitutes the basis of the FE models evaluated in this study, as well as a future experimental program to validate the computer simulation findings. Like other researchers (Kim 2011), Kaan (2012) found that propagation occurred quickly after debonding of the overlay was first observed. Kaan (2012) observed that debonding initiated at the edge of the overlay closest to the support and propagated towards the weld toe. Because that part of the specimen has only one plate, it is the most flexible and experiences the largest change in vertical deformations, which leads to significant peel stresses at the interface. For these reasons, this location was chosen for the placement of the bolted steel plate (Fig. 2-1).

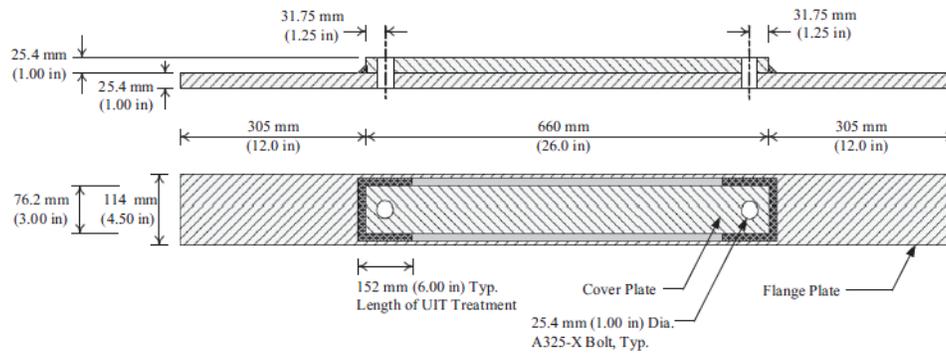
Figure 2-2: Schematic Category E' fatigue specimen (Villhauer 2011)

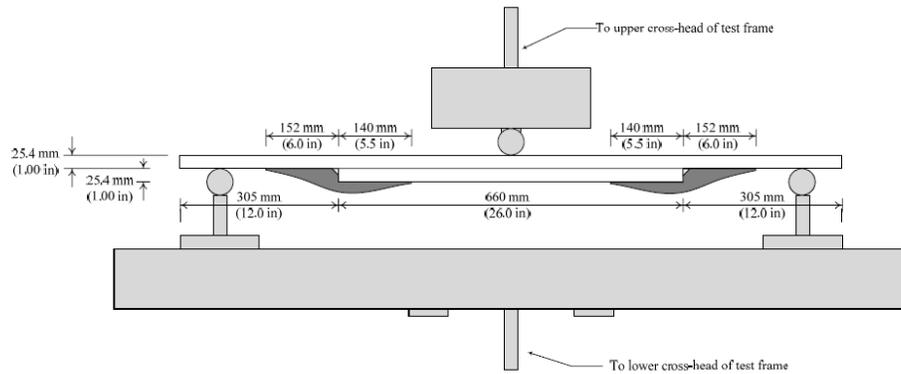
Figure 2-3: Schematic of Three-Point Bending Fixture with CFRP-Stiffened Specimen (Kaan 2012)

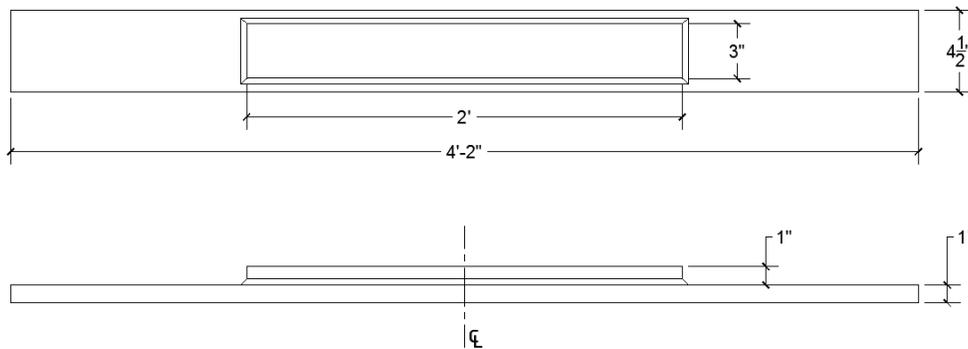
Figure 2-4: Welded cover plate plan and elevation

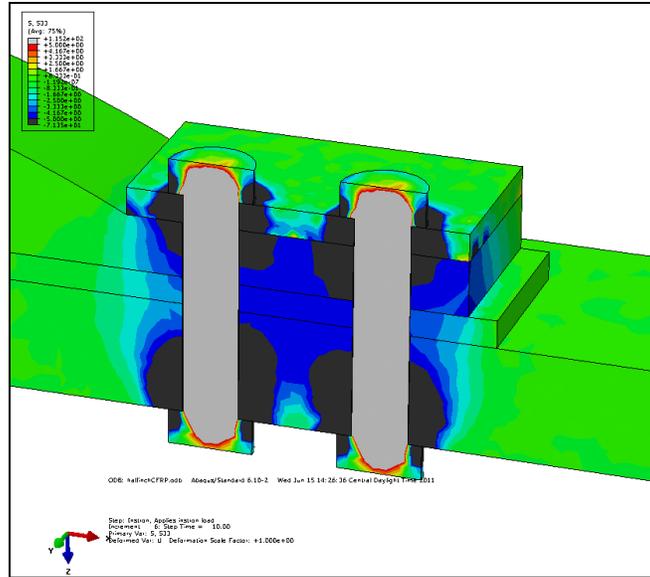
Figure 2-8: Section cut of 1/2-in. overlay showing S33 stresses

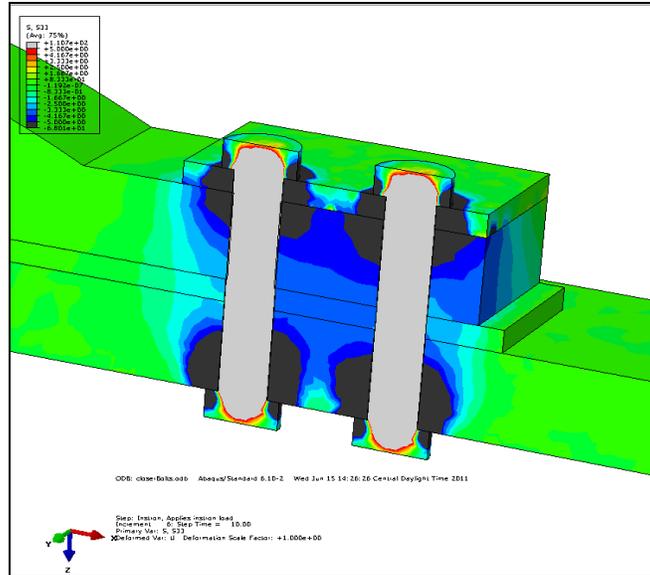
Figure 2-9: Section cut of overlay with closer bolt spacing showing S33 stresses

Another parameter that was analyzed was the spacing between the two bolts used to attach the overlay. The gage length and edge distance were taken as the minimum allowable values as allowed in the AISC specification (AISC 16.1-106/107). The bolt spacing was reduced to 38-mm (1-1/2-in.) and the edge distance was reduced to 19-mm (3/4-in.). The length of the steel plate was reduced to 76-mm (3-in.) to accommodate the change in the spacing. All other model and material properties were kept the same as the curved overlay model. Results showed that the calculated stress was -26.9 MPa (-3.9 ksi) in the composite-resin interface and 4.1 MPa (0.6 ksi) in the resin-steel interface (Fig. 2-2). The effect of reducing the bolt spacing was a significant increase in compressive stress and a decrease in tensile stress.

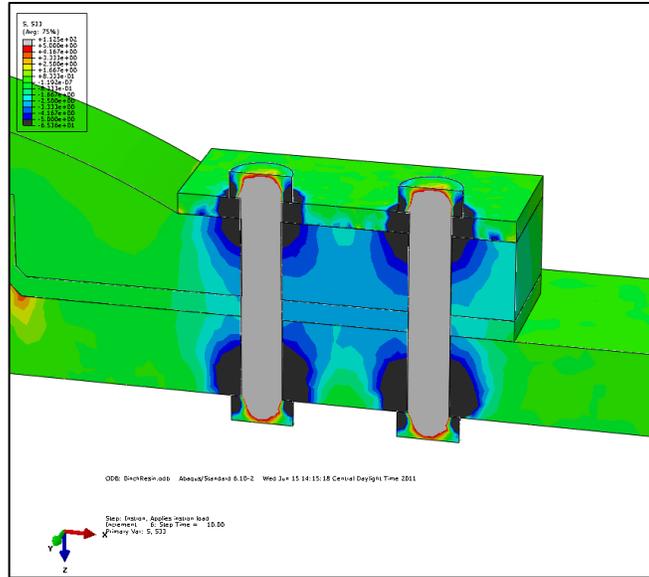
Figure 2-10: Section cut of specimen without a resin pool showing S33 stresses

Two more parameters were analyzed to investigate other alternatives to reduce the tensile stress demand at the resin-steel interface. The effect of increasing the length of the resin pool (the length of resin that extended beyond the overlay) was investigated by analyzing models without a resin pool and with a 25-mm (1-in.) resin pool. The curved overlay model was used with the only variation being the length of the resin pool. The model without a resin pool, had computed stresses in the composite-resin and resin-steel interfaces of -11.7 MPa (-1.7 ksi) and 4.1 MPa (0.6 ksi), respectively (Fig. 2-7). The model with a 25-mm (1-in.) resin pool had computed stresses of -11.7 MPa (-1.7 ksi) and 0.5 MPa (0.07 ksi), respectively (Fig. 2-8). As was expected, the presence of the resin pool had a negligible effect on the stress in the composite-resin interface. However, the model with the 25-mm (1-in.) resin pool showed a significant decrease in the tensile stress demand at the resin-steel interface.

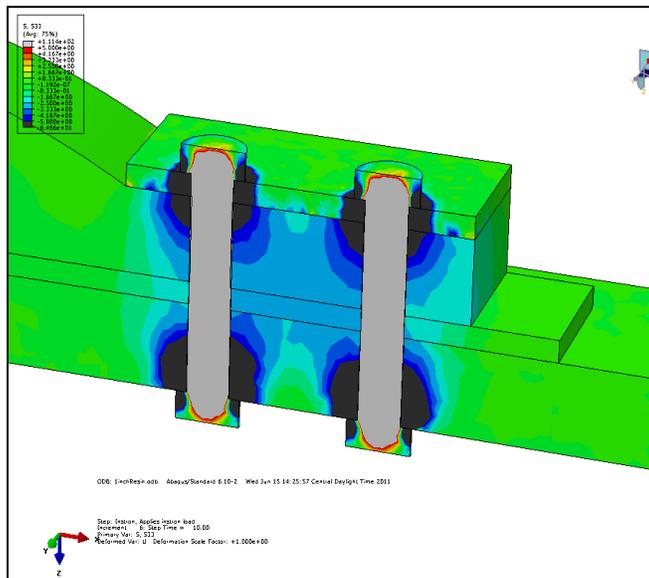
Figure 2-11: Section cut of specimen with 1-in. resin pool showing S33 stresses

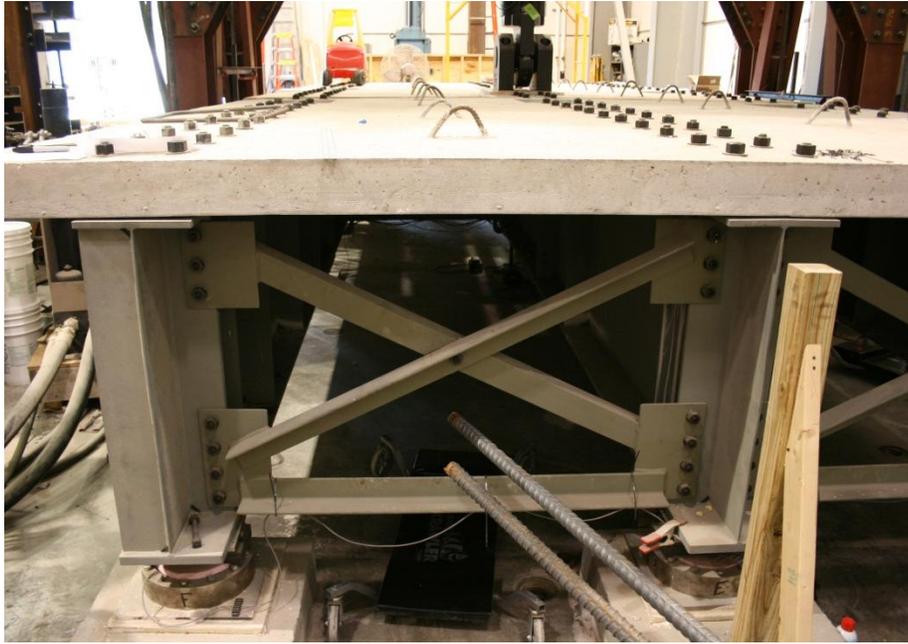
Figure 3-1: View of end of bridge setup with load cells in place

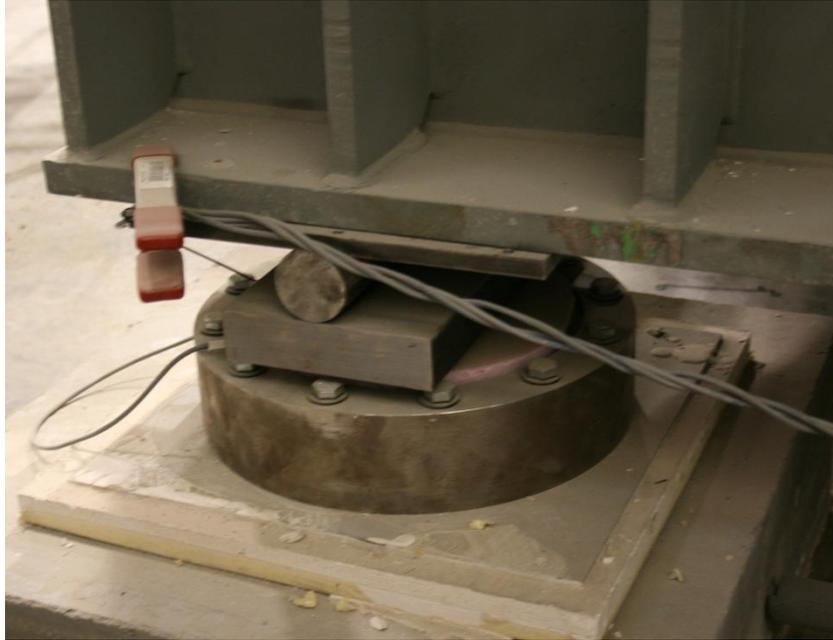
Figure 3-2: Load cell at girder support

The basic configuration had a diameter of 330-mm (13-in.) with eight cutouts with diameters of 51-mm (2-in.). Each pair of cutouts was joined by the removal of the material in between (Fig. 3-3). These interior cutouts essentially created four web portions of material that connected the interior of the load cell to the exterior. There was a raised ridge around the perimeter of the cells that provided the support, such that when load was applied, the four connecting webs experienced most of the deformation and stress demand (Fig. 3-6). Figure 3-2 shows the load cells in use at a girder end of the reduced-scale bridge model.

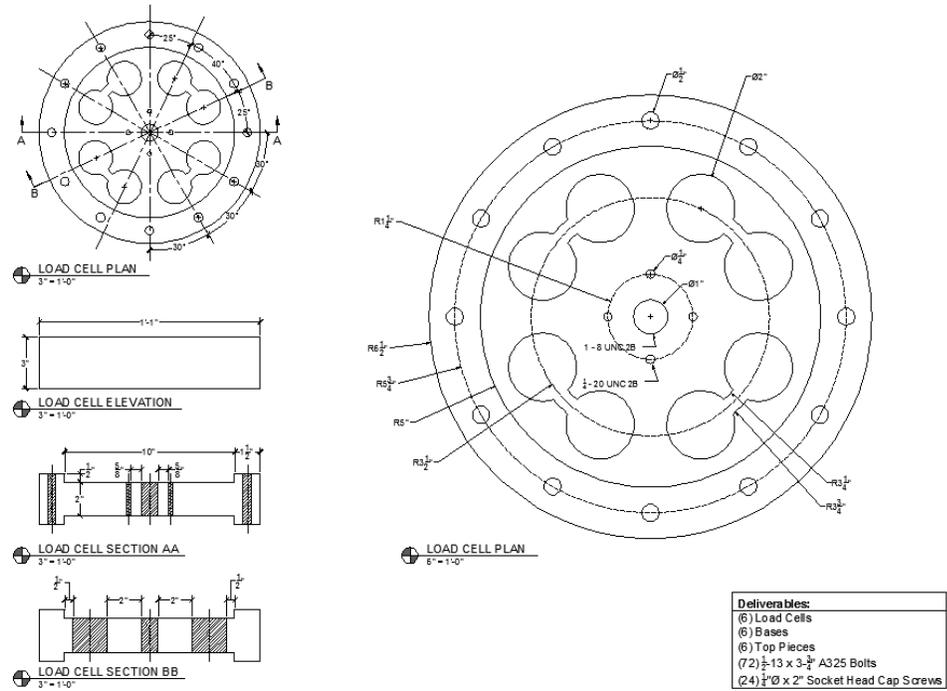
Figure 3-3: Load cell schematic

The shop drawings sent out for fabrication are shown in Figs. 3-3 and 3-4. The fabricator provided steel with a yield strength of 930 MPa (135 ksi); there was no heat-treating or plating, and the surfaces were machine finished. Figure 3-7 shows the load cell assemblies in the condition that they were received from the fabricator.

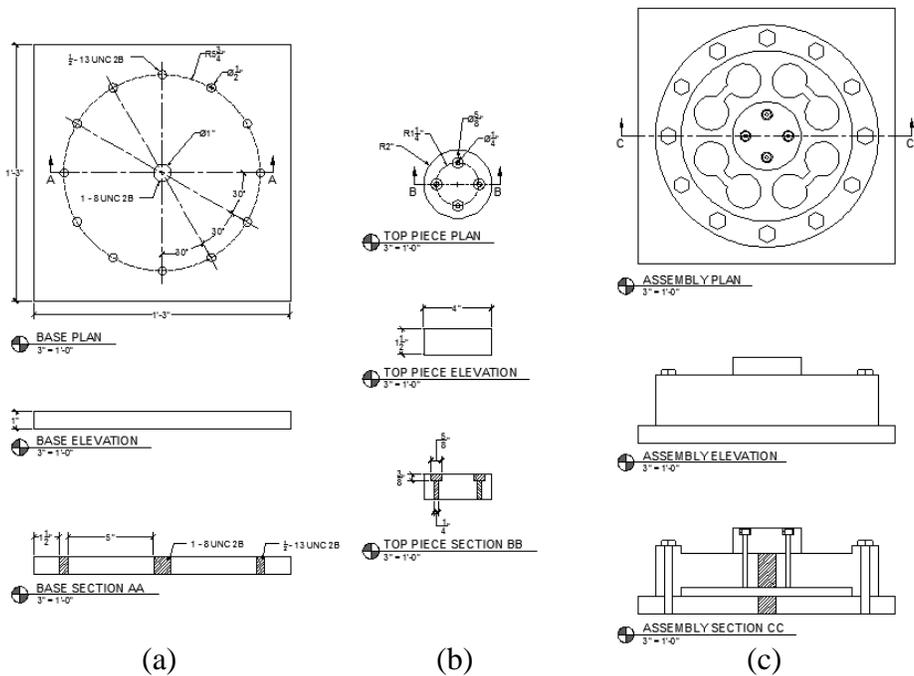
Figure 3-4: Load cell schematics: a) tension base b) compression piece c) assembly

A base was also included in the drawings in Fig. 3-4a, and it is connected to the load cell with twelve structural bolts. Additionally, both the load cell and the base have 25-mm (1-in.) diameter threaded holes in their centers so that two threaded rods can be inserted at each end for the purpose of tension testing. However, the base is designed to be used in both tension and compression testing, as it provides a level support for the load cell. Figure 3-4b shows the compression component which is attached during compressive load testing. This piece transfers the applied load to the inner core of the load cell. It was designed as a separate piece to avoid additional reentrant corners in the load cell, which would create areas of high stress demand, and the fact that it is a separate piece makes fabrication much easier. Finally, a schematic of the completed assembly is shown in Fig. 3-4c in the configuration that will be used in the scale bridge test.

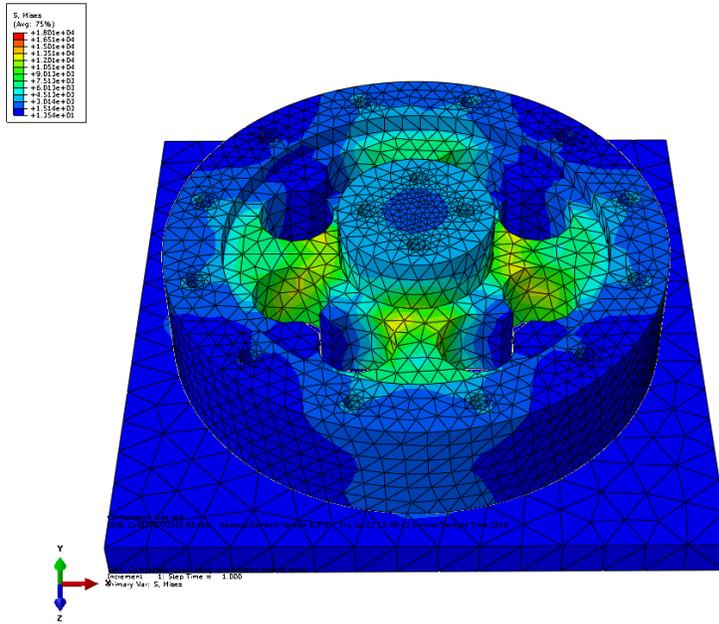
Figure 3-5: Computed stresses in load cell assembly

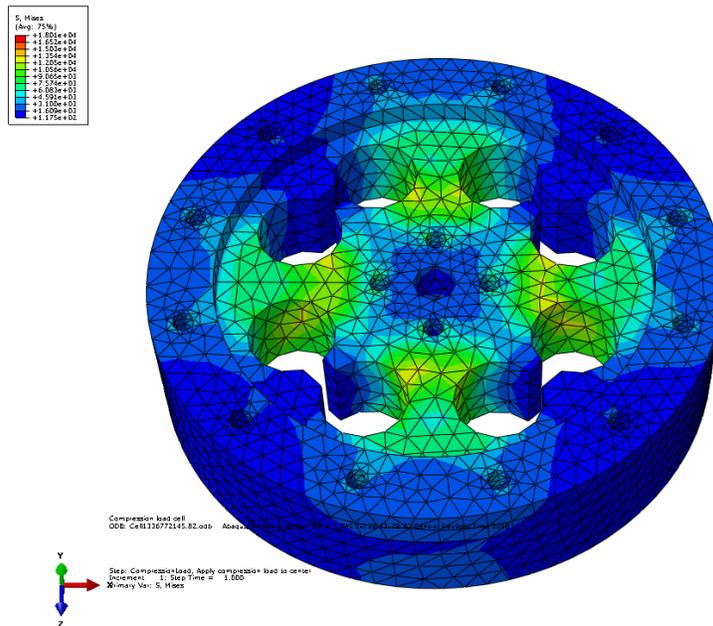
Figure 3-6: Computed stresses in load cell alone

Figure 3-6 shows the von Mises stresses on the load cell alone; the maximum stress at the center of the connecting web portions (the interior surface of the 51-mm, 2-in. diameter cutouts) was computed to be 90 MPa (13 ksi). The maximum principal stress at this location was computed to be approximately 45 MPa (6.5 ksi). Additionally, the maximum principal strain at this point was found to be 310 $\mu\epsilon$. These stress and strain values are important for determining the load capacity of the cells and the kind of strain gages best suited for the expected strain range. Near the point of application of the 222-kN (50-kip) load, the maximum von Mises stress in the models was 124 MPa (18 ksi). Based on the yield strength of the steel used, a ratio of load to stress can be used to determine the maximum allowable load. Additionally, because the maximum principal strain for the gages selected was on the order of 1000 to 1200 $\mu\epsilon$, fatigue on the strain gages is not expected to be a significant problem (Vishay 2012).

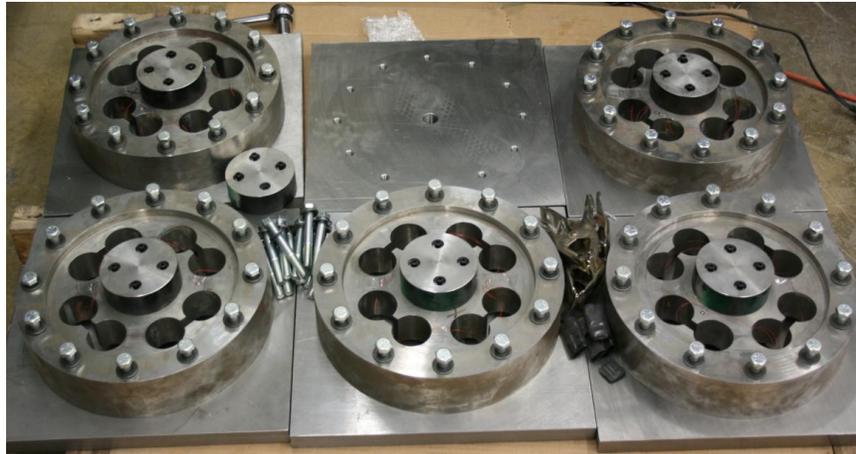
Figure 3-7: Fabricated load cells

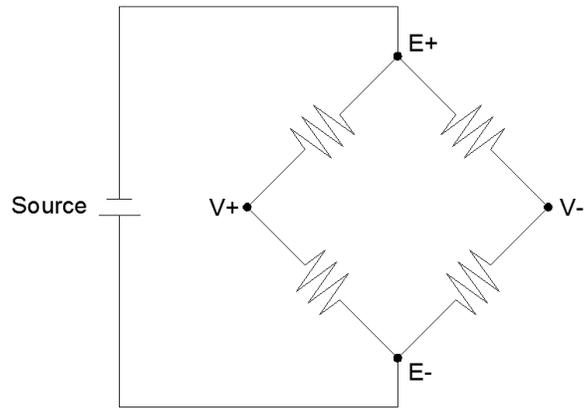
Figure 3-9: Load cell wiring diagram

After cooling, the load cells were wired in a full Wheatstone bridge configuration (Fig. 3-9). Figure 3-10 shows a strain gage in place after being wired. The conductor used in the wiring was single-strand copper wire with a polyurethane enamel coating. The enamel was removed by applying heat from a soldering iron where it was necessary for connection. Four gages were attached to each of the four web portions of the load cells and wired as described (Fig. 3-11).

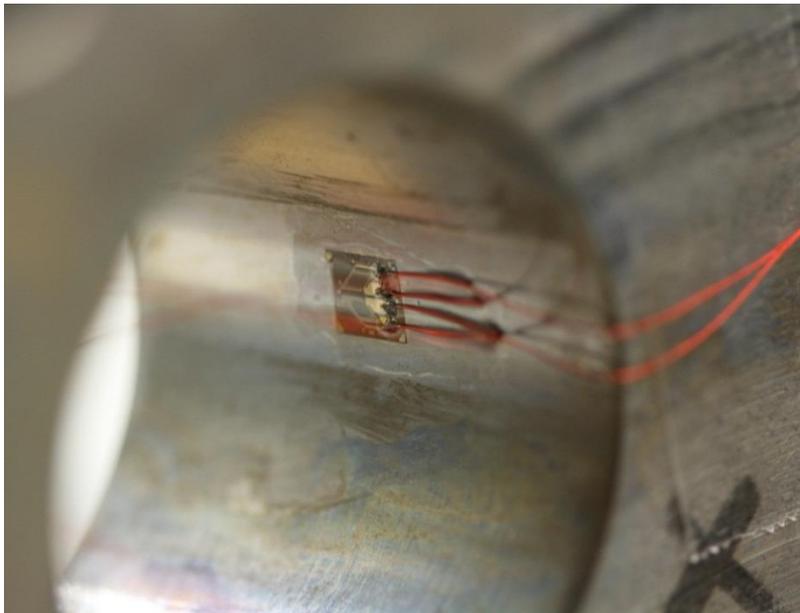
Figure 3-10: Dual-grid gage after wiring

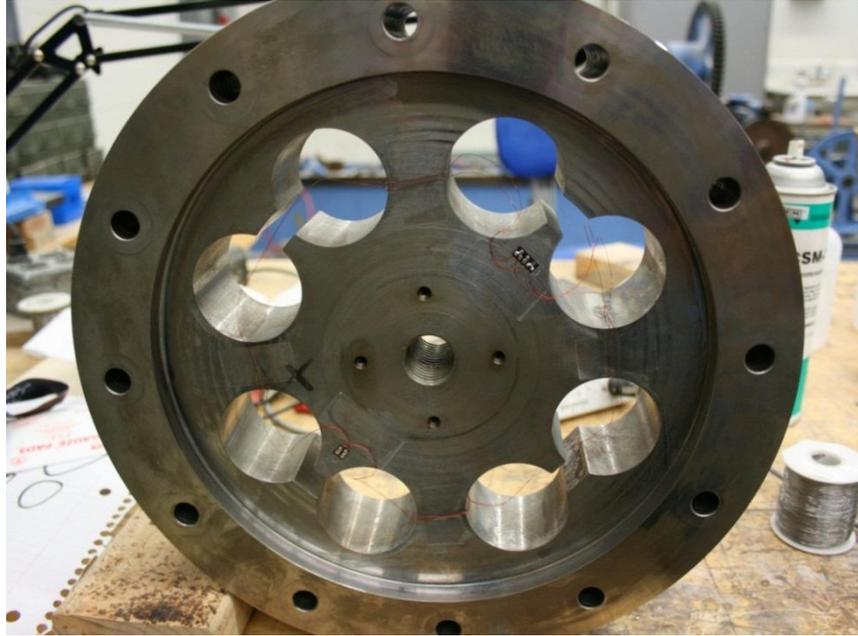
Figure 3-11: Load cell after gaging and wiring

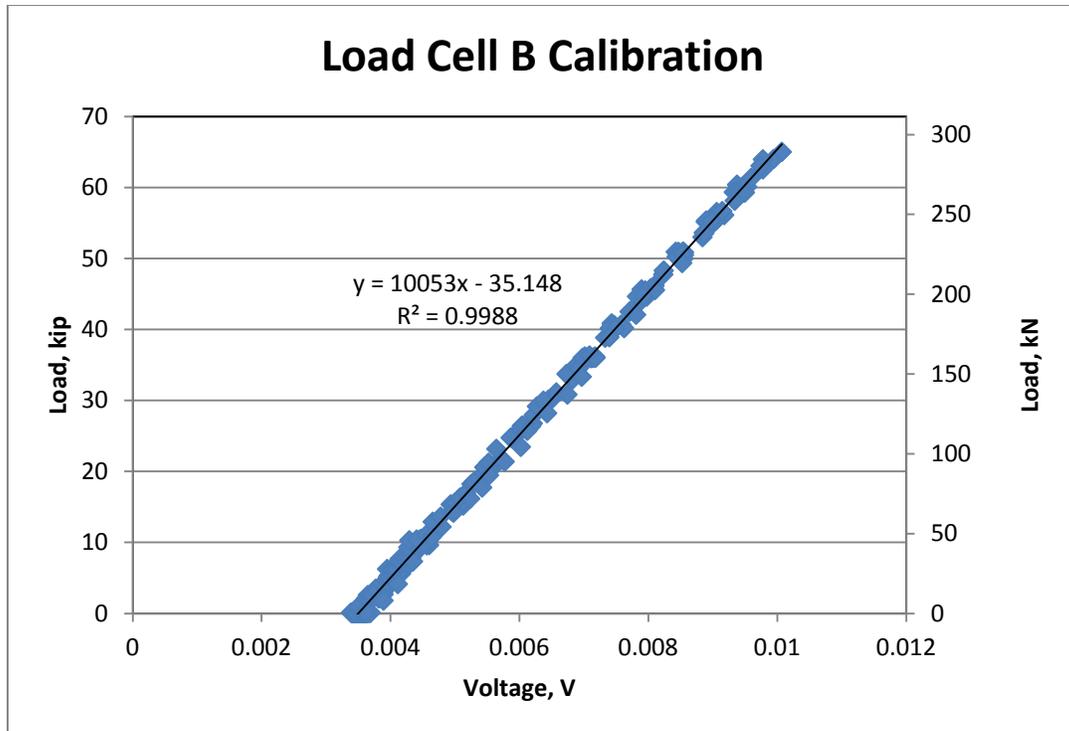
Figure 3-12: Load cell calibration plot

The final step in preparing the load cells for testing was to calibrate them. A Baldwin universal test frame, periodically calibrated using NIST-traceable standards, was used for calibration of the load cells. The load cell assemblies were loaded in compression from 0 to 267-kN (0 to 60-kip); the corresponding output voltage was recorded. The plotted data for Load Cell B is shown in Figure 3-12, and the slope and intercept are calculated therein. This calibration was carried out for all six load cells, labeled A through F and will be used for data collection in the scale bridge test. The curve in Fig. 3-12 shows the high linearity of the relationship between the output voltage and the load, and the coefficient of correlation r^2 of approximately 1.0 shows that the load cell configuration was very effective.
