SUBSTANTIAL MAINTENANCE PRACTICE FOR BRIDGES ON THE KANSAS STATE  
HIGHWAY SYSTEM

Submitted to the graduate degree program in Civil, Environmental, and Architectural  
Engineering and the Graduate Faculty of the University of Kansas in partial fulfillment of the  
requirements for the degree of Doctor of Engineering.

### **Abstract**

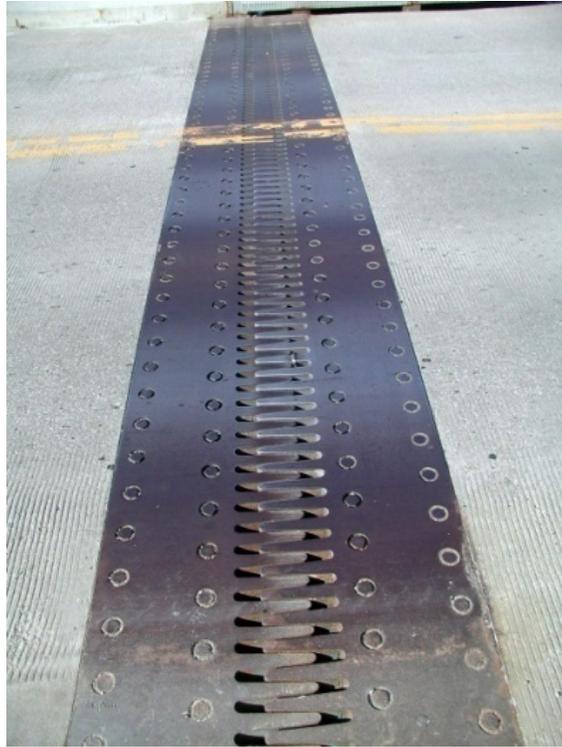
**Figure 3.2—Typical finger joint expansion device.**

The next most common scope for a span bridge is replacement of the deck expansion joints. All bridges are subject to thermal expansion and contraction. A bridge with a steel girder superstructure will expand approximately 0.08 in. per 100 ft. of girder per 10° F increase in temperature. A 400 ft. bridge will expand 1.27 in. at each end with a change in temperature of 60° to 100° F. It will contract 3.18 in. at each end in the drop from 100° to 0° F. This movement is accommodated with joints in the deck. For relatively large movements as described, a finger joint, as shown in Figure 3.2, is used. For smaller movements, where the largest gap at -30° F will not result in a gap larger than 4 in., a strip seal, as shown in Figure 3.3 is used. A strip seal consists of a neoprene gland held into place by two cast steel extrusions which clamp the gland. Joints have the shortest life of any element on the bridge because they see impact from traffic wheel loads (and the occasional snow plow) and drainage and debris washing off the wearing surface of the bridge deck.

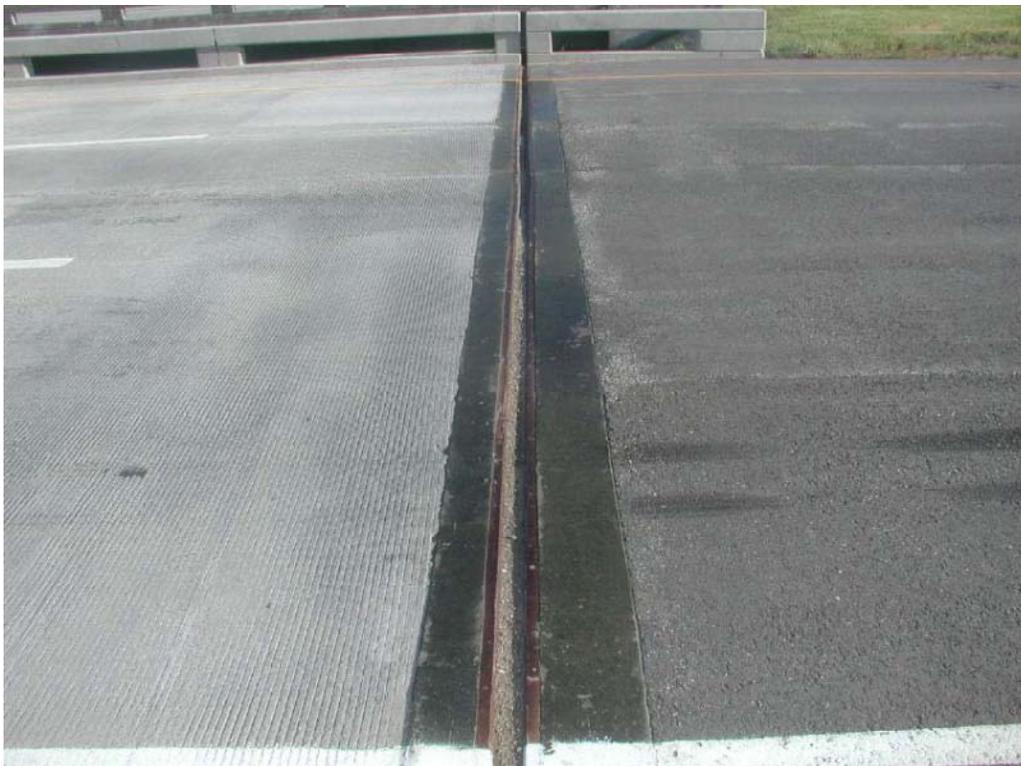
**Figure 3.3—Strip seal expansion device on Br. 10-46-176.**

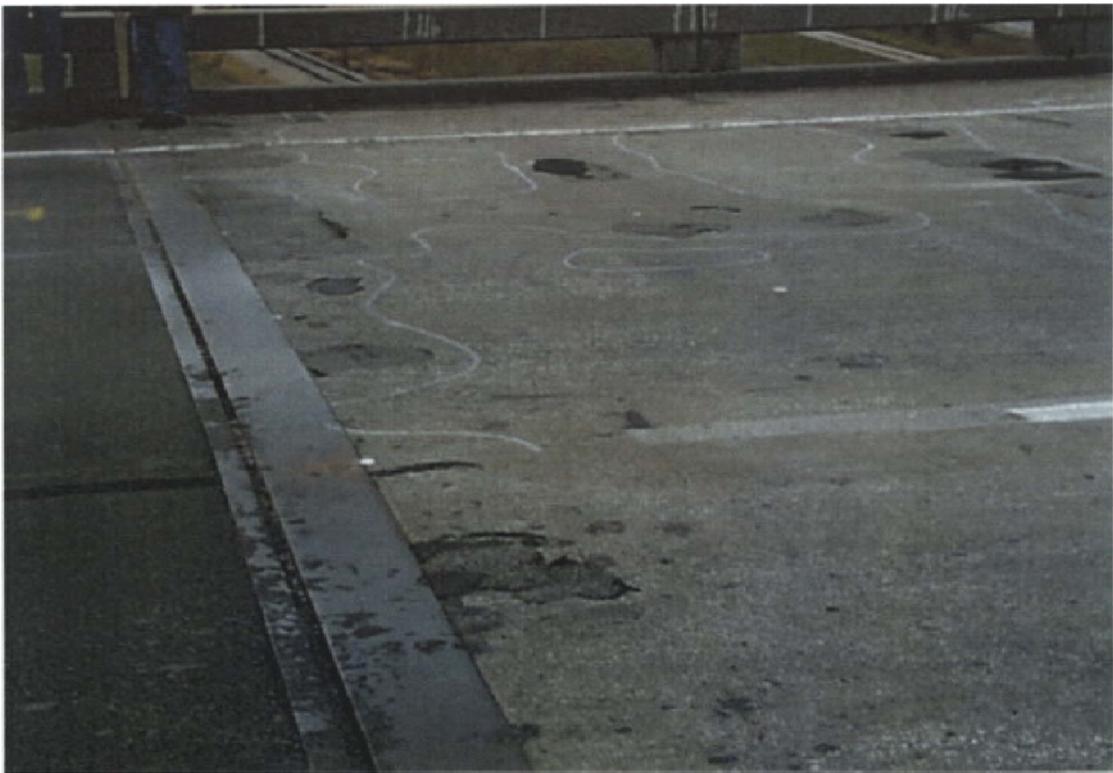
**Figure 3.5—East sliding plate expansion joint and deteriorated deck concrete on Br. 10-46-176.**

Bridges<sup>2</sup> 46-176 and 46-177, carrying K-10 over lines of the BNSF Railway and bridges 46-178 and 46-179, carrying K-10 over Kill Creek near DeSoto, were field checked on November 26, 2011 by the District Engineer, District Construction Engineer, BME, and the author as the BMP Engineer. These four bridges were District One's top priority on their candidate list and all, but bridge, 46-176 were on the bridge inspection A-list at the time and recommended for maintenance work. Photos taken at the time documented the spalled condition of the deck and corrosion at the bearings caused by drainage through the sliding plate expansion device in the deck. Spalling and deterioration of the deck concrete on two of the bridges are shown in Figures 3.5 and 3.7. Figure 3.6 shows the excessive tip of the rockers at the west abutment on bridge 46-177.

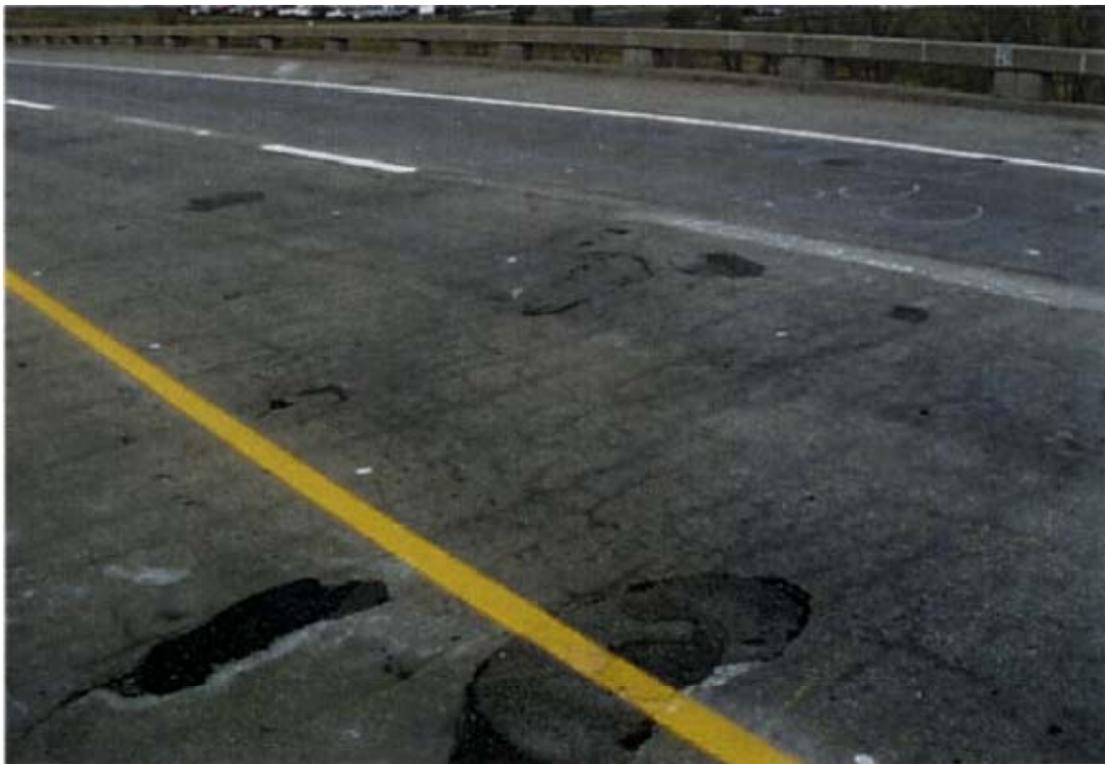
**Figure 3.7—Deteriorated deck concrete on Br. 10-46-179.**

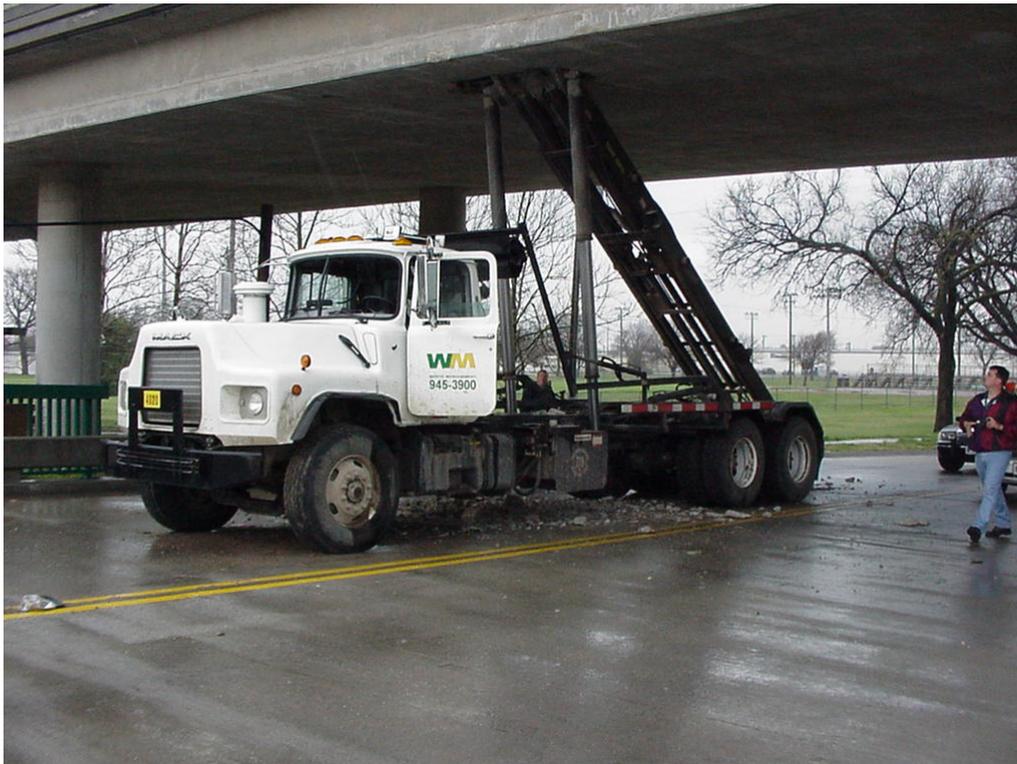
**Figure 3.8—Truck on 17th St. impacting I-135 bridge in Wichita.**

On March 23, 2000, a container delivery truck was driving on 17<sup>th</sup> Street in Wichita with (unbeknownst to the driver) its hydraulic hoist upright. The hoist struck the bottom of a multi-cell concrete box girder bridge at speed. The floor of the east exterior cell was struck and damaged, resulting in a 3 ft. 6 in. x 6 ft. hole and a total damaged area of concrete measuring 6 ft. x 20 ft. (see Figures 3.8 and 3.9).

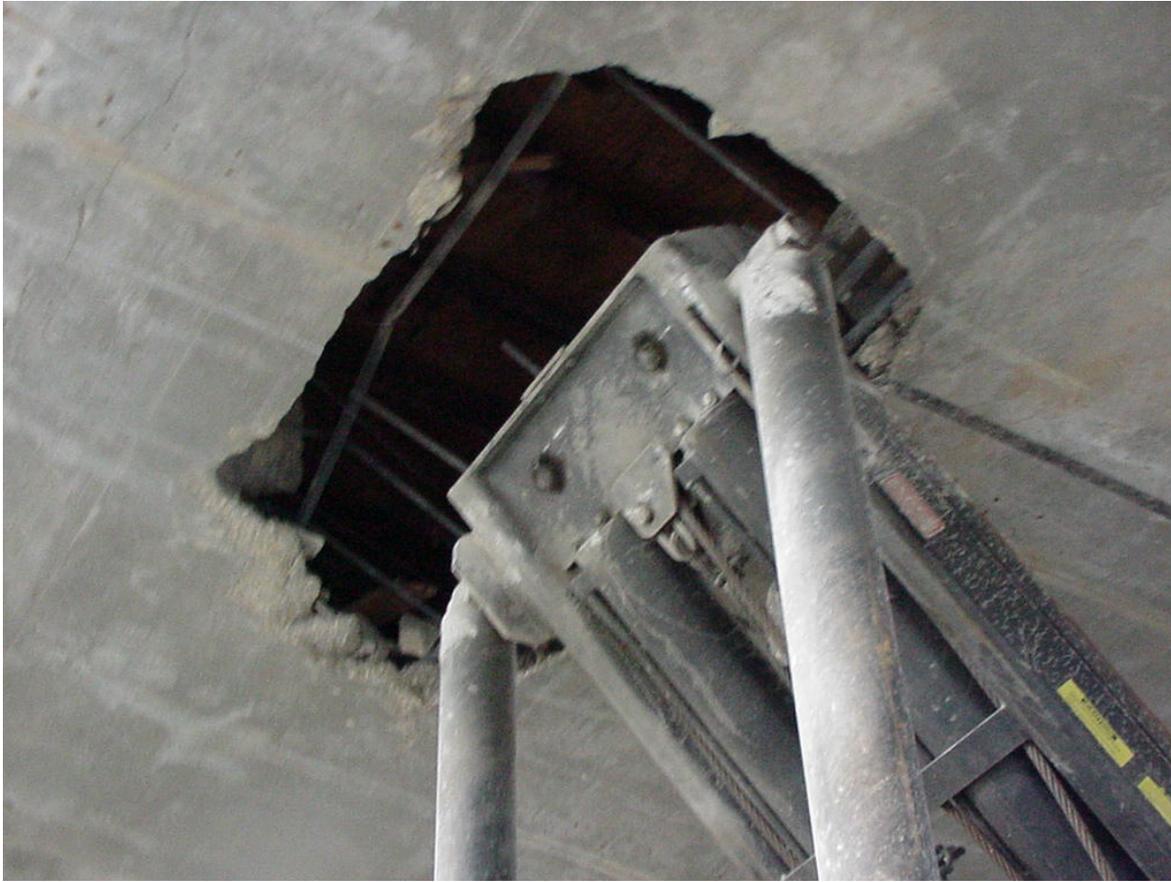
**Figure 3.9—Impact damage on Br. 135-87-290.**

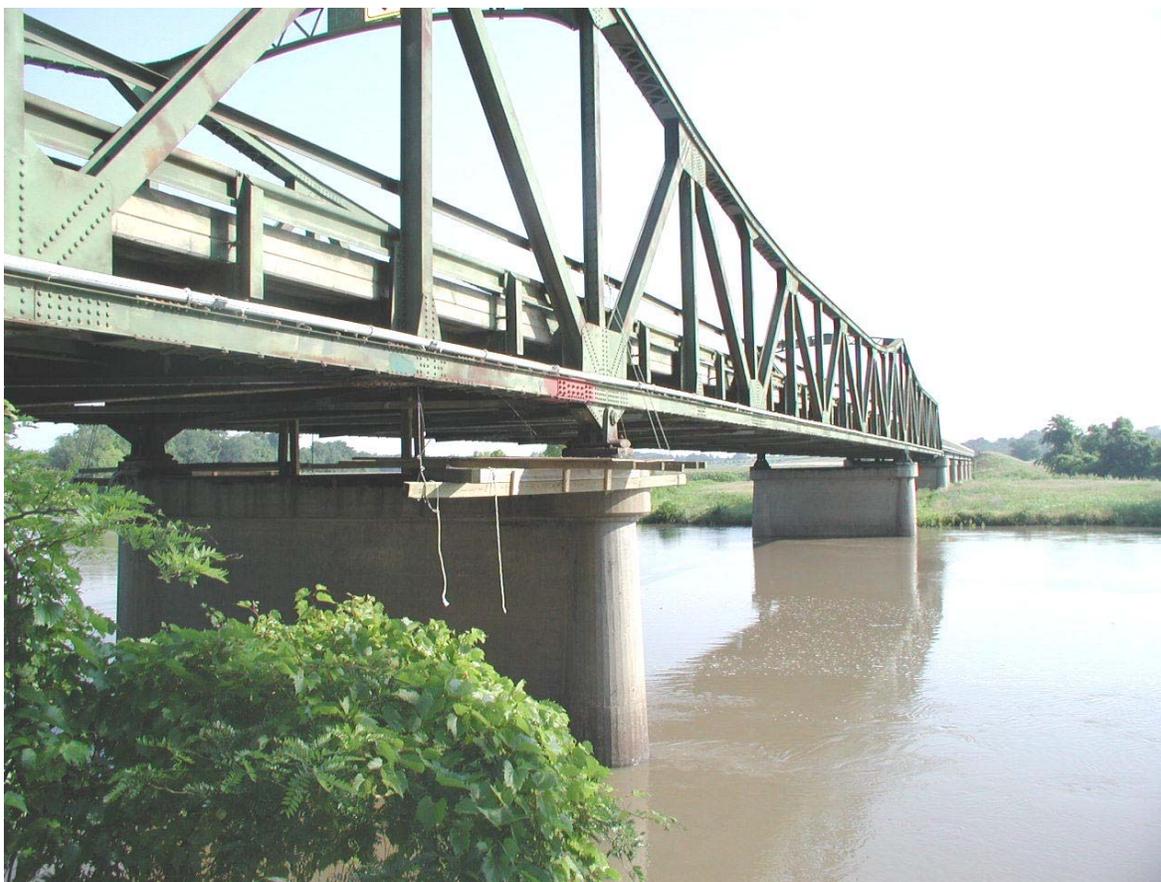
**Figure 3.10—Repaired chord of US-75 bridge over the Neosho River.**

On March 1, 2001 the Bridge Office recommended to the State Signing Engineer that the truss carrying US-75 over the Neosho River north of Burlington (Br. 75-16-21) be posted to 25-35-40 tons<sup>3</sup> (see Figure 3.10). The cause for reduction in rated load capacity was a section of significant deterioration through the bottom chord on the east truss. Deterioration through over half the height of the channels forming the webs of the chord occurred at the batten plates<sup>4</sup> south of pier #2. The posting led to a letter dated March 20, 2000 from the Coffey County Commission to the Secretary of Transportation asking that a bridge replacement project at the site, scheduled for completion in October 2005, be accelerated out of concerns for truck traffic through the city of Burlington. On April 13, the Secretary responded to the county commission in writing; repair options that would allow the posting to be removed began to be evaluated.

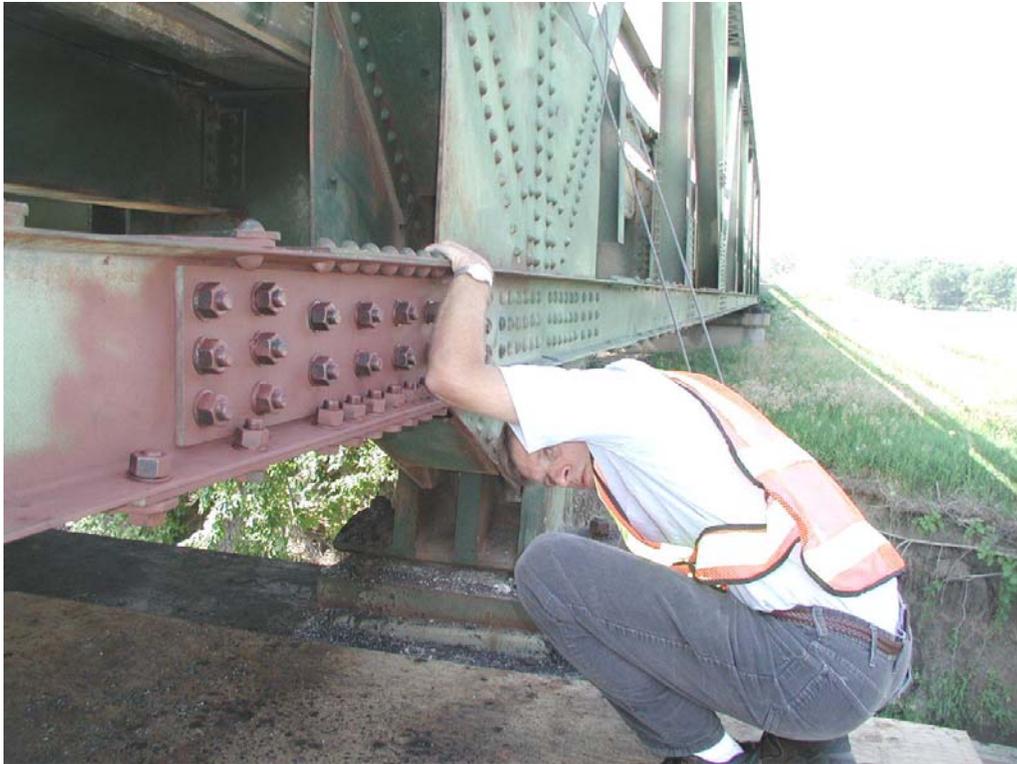
**Figure 3.11—Close up of the repaired chord.**

<sup>4</sup> Batten plates are the horizontal plates in the plane of the lacing between the channels forming the built-up chord section.

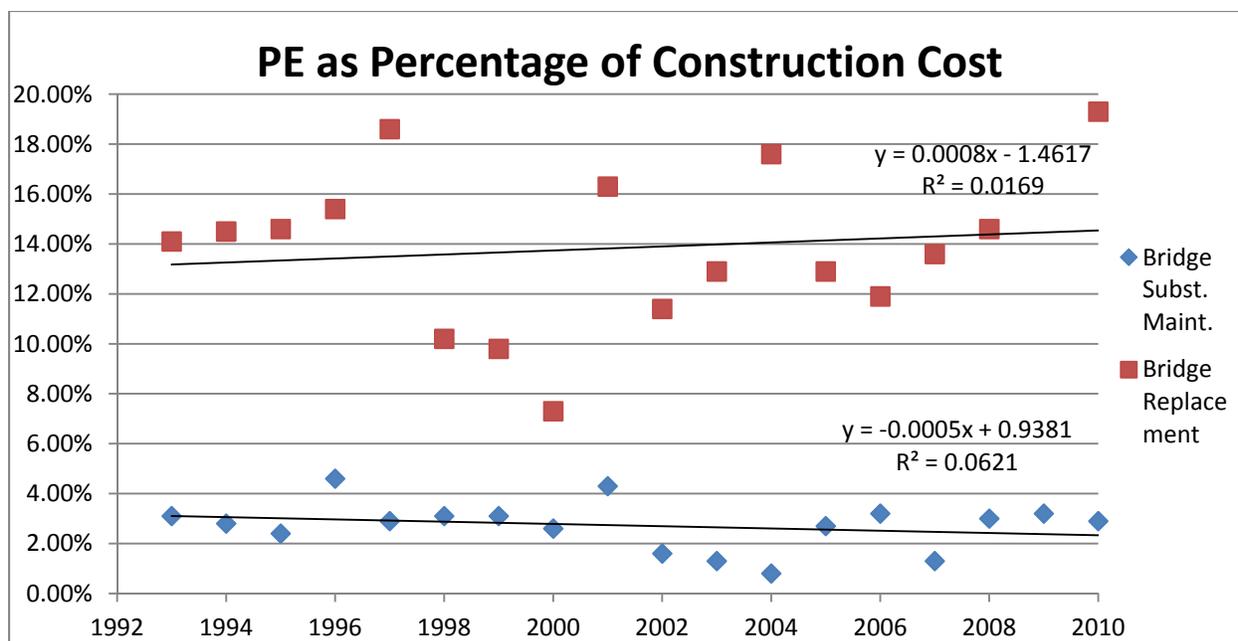
Plotting the PE percentages, although there is considerable scatter, a slight upward trend is noted for bridge replacement projects, while a slight downward trend is noticed for Bridge Substantial Maintenance projects .

**Figure 4.3—Preliminary Engineering as a percent of construction for FY 1993 – 2010.**

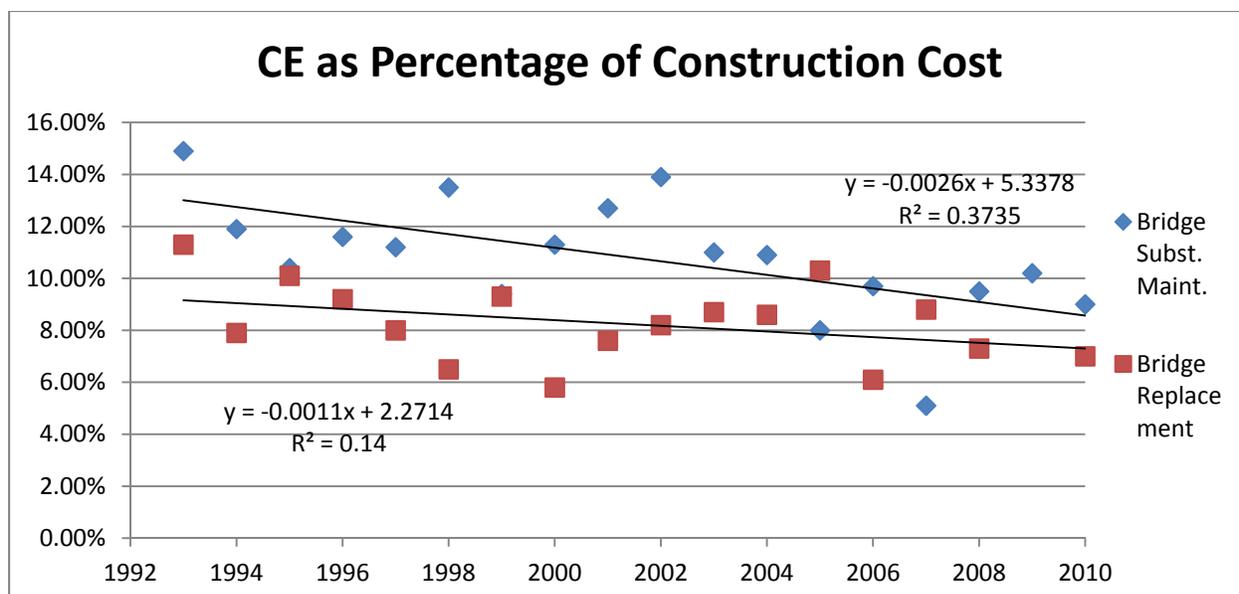
As with the review of PE costs in the previous section, CE costs as a percentage of construction costs were obtained over the years 1993 through 2010 for Bridge Substantial Maintenance projects and, as a comparison, for bridge replacement projects. The fiscal year averages may be found in Table 4.1 with the Preliminary Engineering percentages. Plotting the years 1993 through 2010 in Figure 4.4 shows that CE percentages have decrease over the years for both types of projects.

**Figure 4.4—Construction Engineering as a percent of construction for FY 1993 – 2010.**

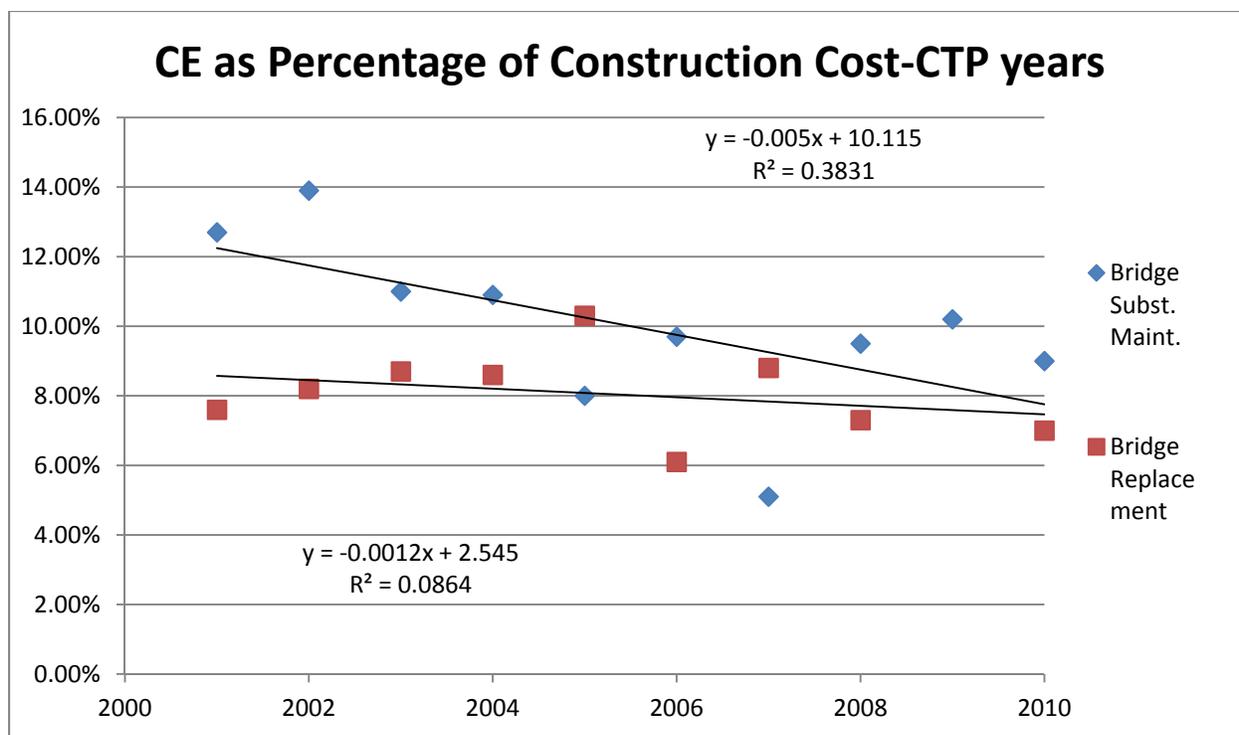
To test for serial correlation errors common to time series data, Durbin-Watson statistics were calculated for CE over the FY 1993-2010 periods reviewed. For CE for Bridge Substantial Maintenance projects  $d = 1.57$ , while for bridge replacement projects  $d = 2.19$ , given that the statistic was near 2.0 serial correlation of the residuals is not an issue for these data.

**Figure 4.5—Construction Engineering as a percent of construction for FY 2001 – 2010.**

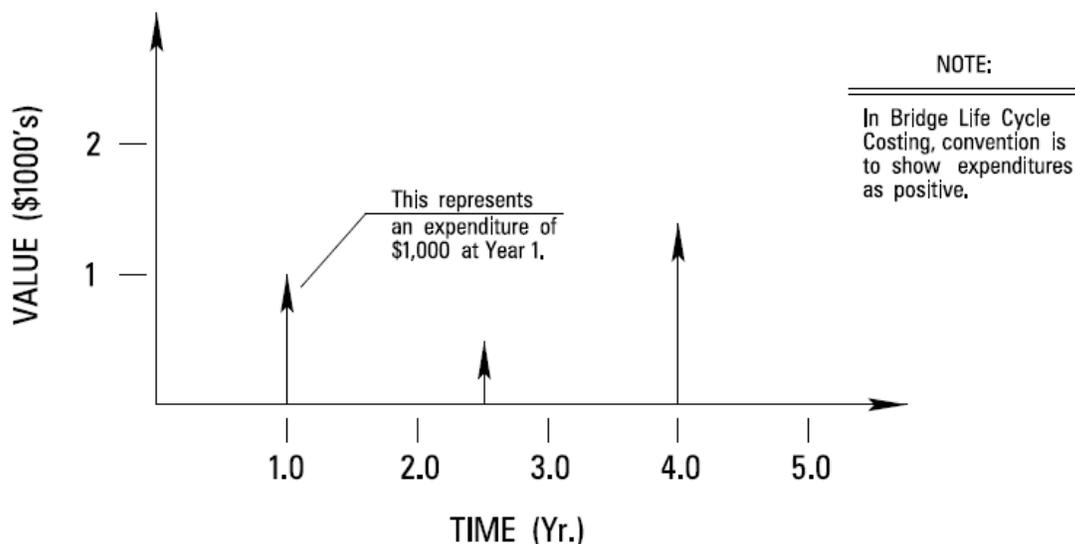
This can be illustrated in a cash flow diagram as shown in Figure 6.1. The vertical lines represent expenditures whose magnitude (in base year dollars) is indicated by the y-axis scale. These expenditures take place at discrete times indicated by their location on the x-axis.

**Figure 6.1—Example cash flow diagram.**

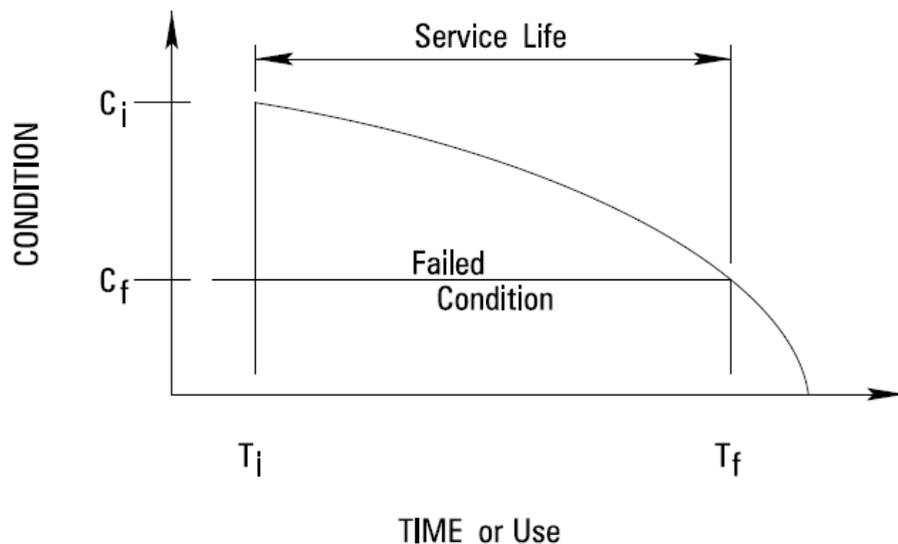
Figure 6.2 below illustrates the typical change in condition of elements (or of the entire bridge) over time. Elements start at an initial time in good condition, and then deteriorate to some level of condition that is not acceptable. The service life is the time it takes to reach an unacceptable condition.

**Figure 6.2—Element condition vs. time.**

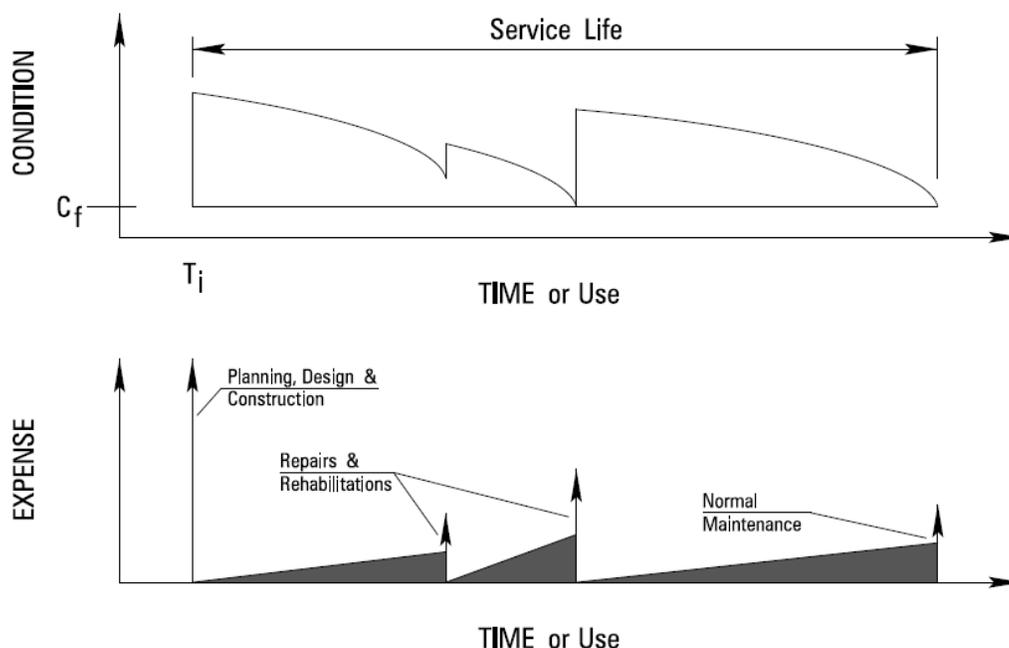
Activities to repair or rehabilitate deficient elements restore the element (and the bridge) to a higher condition level. The relation between these activities and expenditures over time can be illustrated as shown below in Figure 6.3.

**Figure 6.3- Condition and cash flow diagram over service life.**

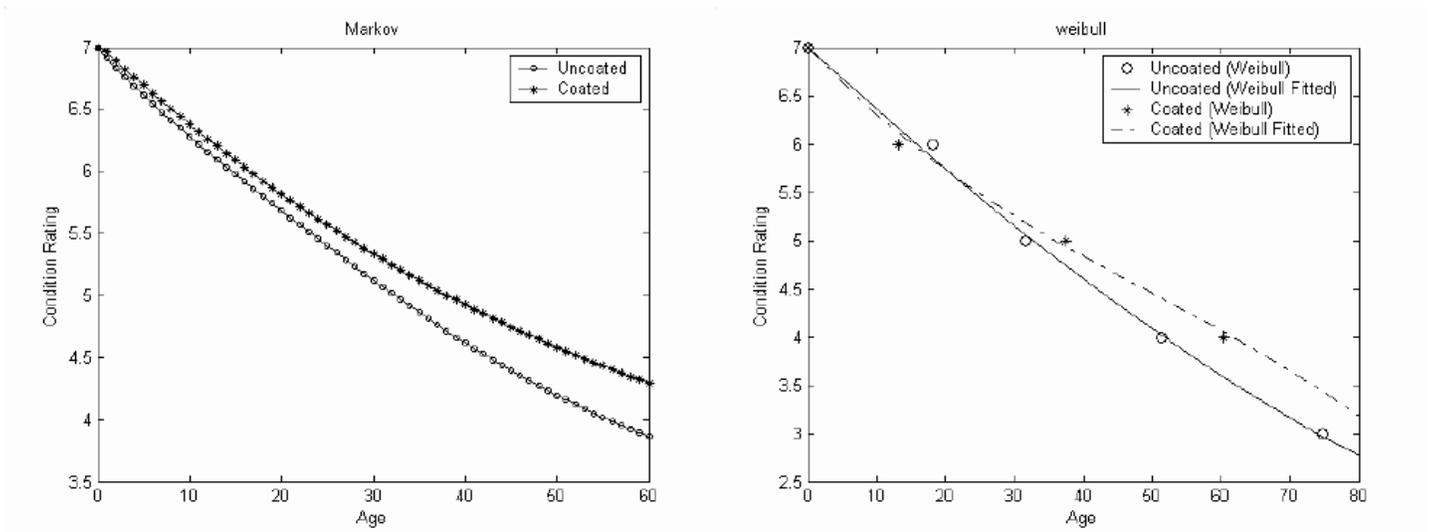
For structural decks with uncoated reinforcing, the researchers reported that the time for a drop in condition rating from 7 to 4 was 49 years according to a Markov chain analysis and 43 years with a Weibull-distribution analysis. For structural decks with epoxy-coated reinforcing, the numbers were 62 and 60 years, respectively. One item of interest noted by this author in the review of the various deterioration rates was how linear the rates of deterioration were with respect to time, as seen in Figure 6.6, which was Figure 4-21 in the NYSDOT report.

**Figure 6.6—Deterioration plots for structural decks owned by NYSDOT.**

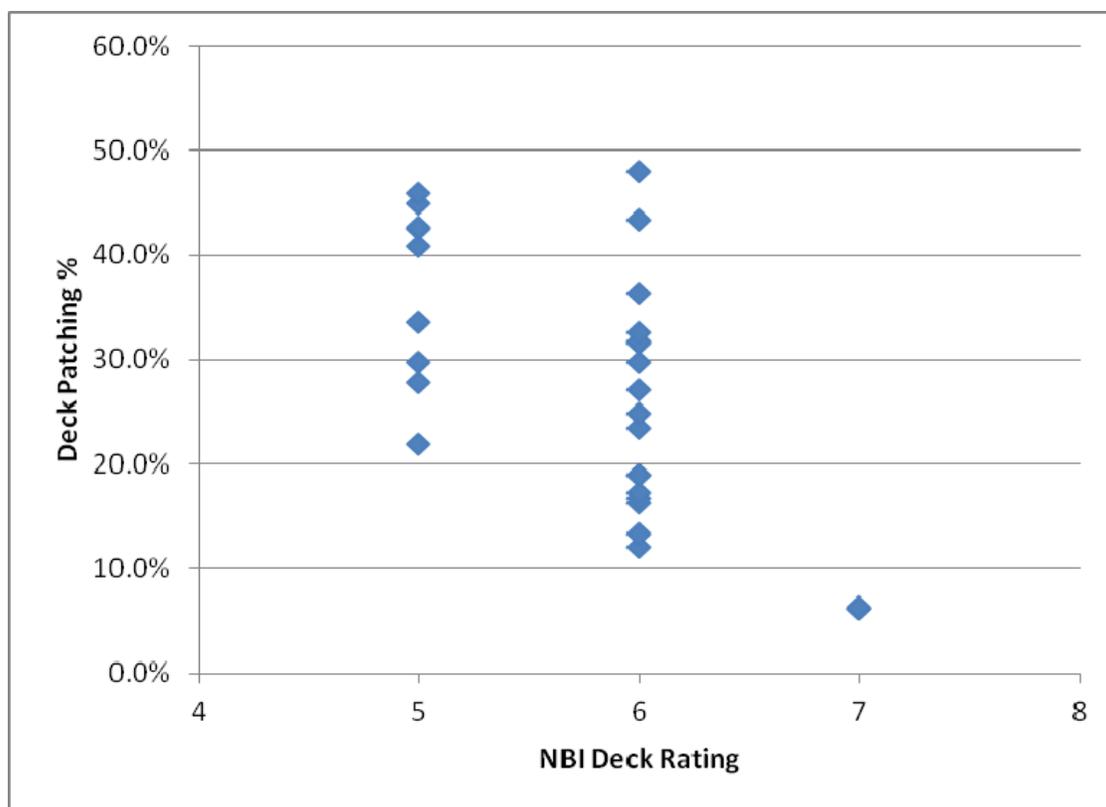
With a program year selected, it is also possible to calibrate the increased costs of repairs based on real construction data. A minimal maintenance scenario does not eliminate the need for contracted deck work to patch and overlay, it simply defers it until the condition of the deck is worse. With a worse condition, there is a higher patching quantity needed and more working days required, requiring higher traffic control cost. To project the cost of a deferred patching and overlay job, construction bid tabs for the FY 2003 overlay project were obtained and the patching as a percentage of deck area was determined for each bridge. For each bridge, the percentage of deck patching costs in regard to total construction costs was also calculated. The bridges were then grouped by NBI deck rating prior to the repair. The percent of deck patching vs. NBI deck rating is shown in Figure 6.9.

**Figure 6.9—Percent of deck area patched vs. NBI deck rating for FY 2003 deck repairs.**

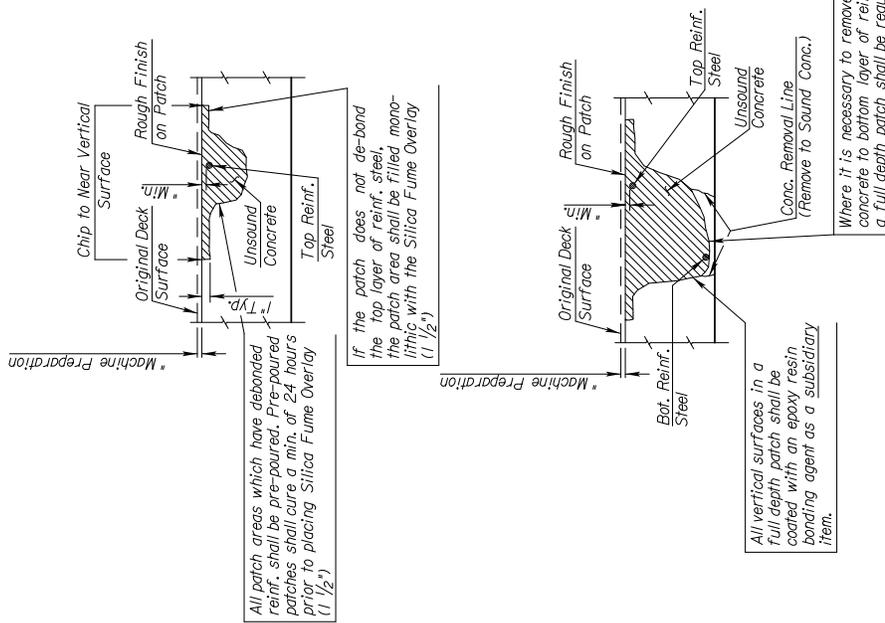
**REPAIR OF EPOXY COATED REINFORCING STEEL:** Replace any epoxy coating that is removed from the reinforcing steel during the concrete removal process. Thoroughly clean damaged areas with a stiff wire brush to remove dirt and damaged coating. Apply an approved patching material in accordance with manufacturer's recommendations. Avoid dripping any patching material onto existing concrete that will have new concrete placed against it. See KDOT Specifications.

**DECK PATCHING DETAILS**

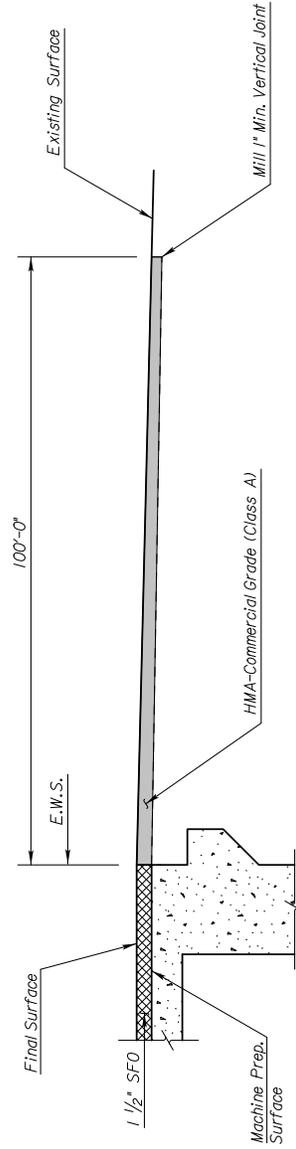
*HMA APPROACH OVERLAY: The approach and exit overlays shall be HMA-Commercial Grade (Class A) paid by the bid item designated. The overlay shall taper from the new Silica Fume Overlay in a manner that will provide a smooth transition in grade as shown. Contract quantity includes 10% for contingencies. Additional material may be required due to soft or unstable areas in the existing surface. These areas shall be repaired as needed and as directed by the Engineer. Milled material shall be disposed of in a manner and at a location approved by the Engineer.*

TRANSITION AT BRIDGE ENDS

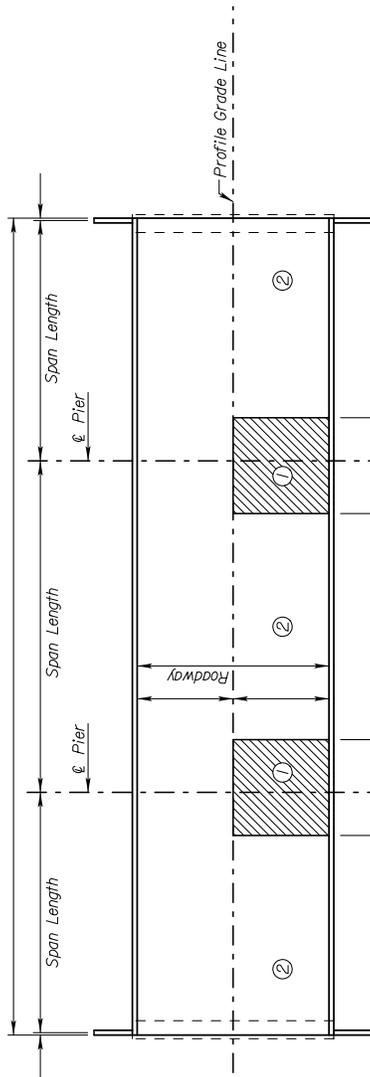
**DECK PATCHING SEQUENCE**  
(Showing sequence for one lane only, other lane similar)

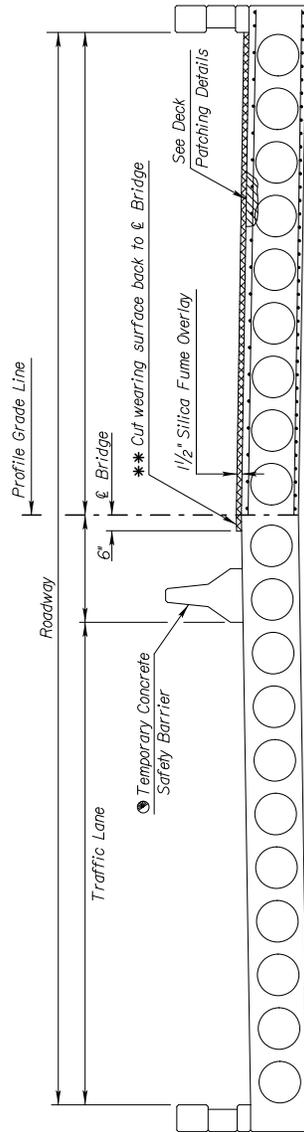
TYPICAL SECTION SHOWING  
FIRST STAGE OF REPAIR

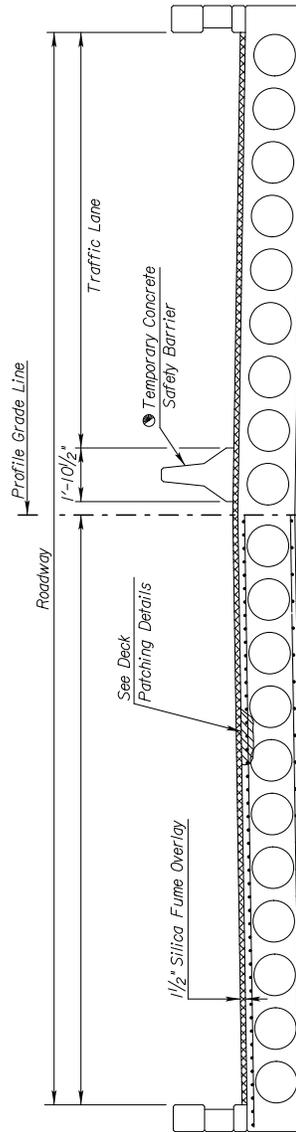
TYPICAL SECTION SHOWING  
SECOND STAGE OF REPAIR

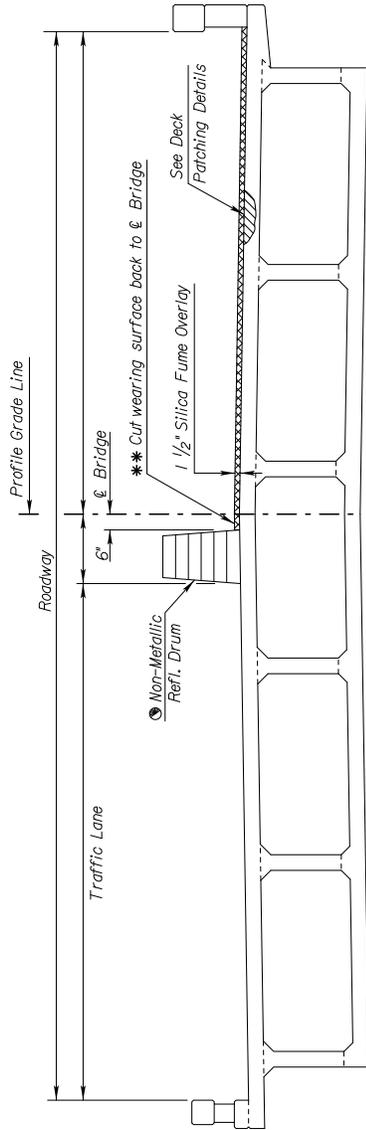
TYPICAL SECTION SHOWING  
FIRST STAGE OF REPAIR

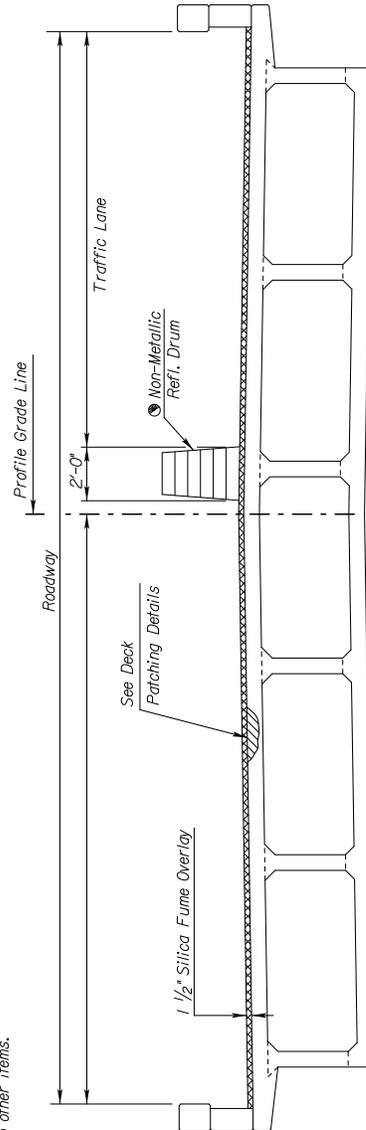
TYPICAL SECTION SHOWING  
SECOND STAGE OF REPAIR

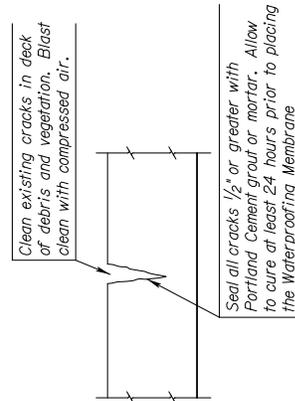
**CRACK SEALING DETAIL**

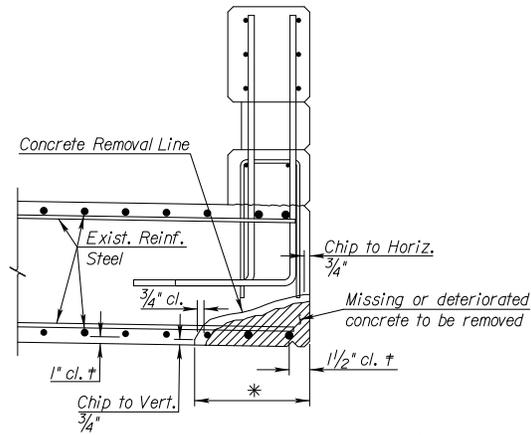
**TYPICAL DRIP LINE REPAIR**

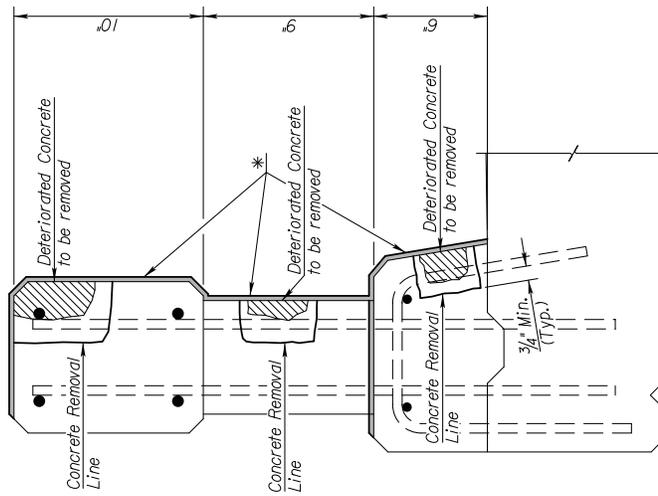
**TYPICAL CURB REPAIR**

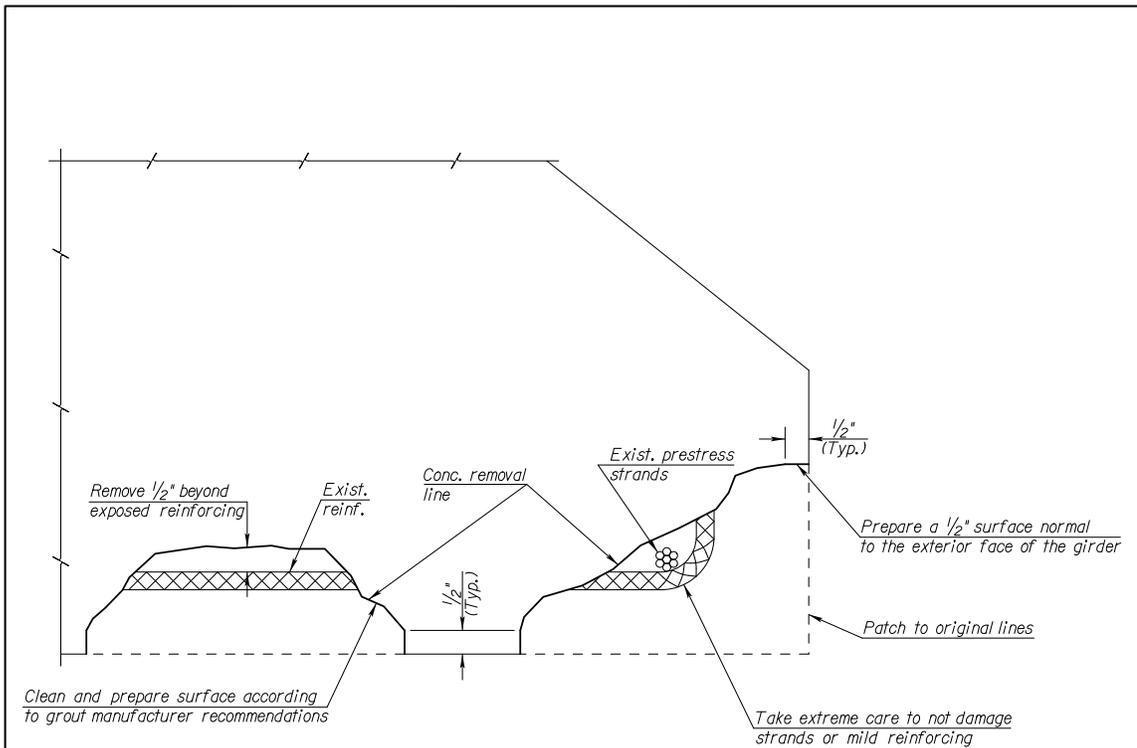
**TYPICAL GIRDER SURFACE REPAIR**

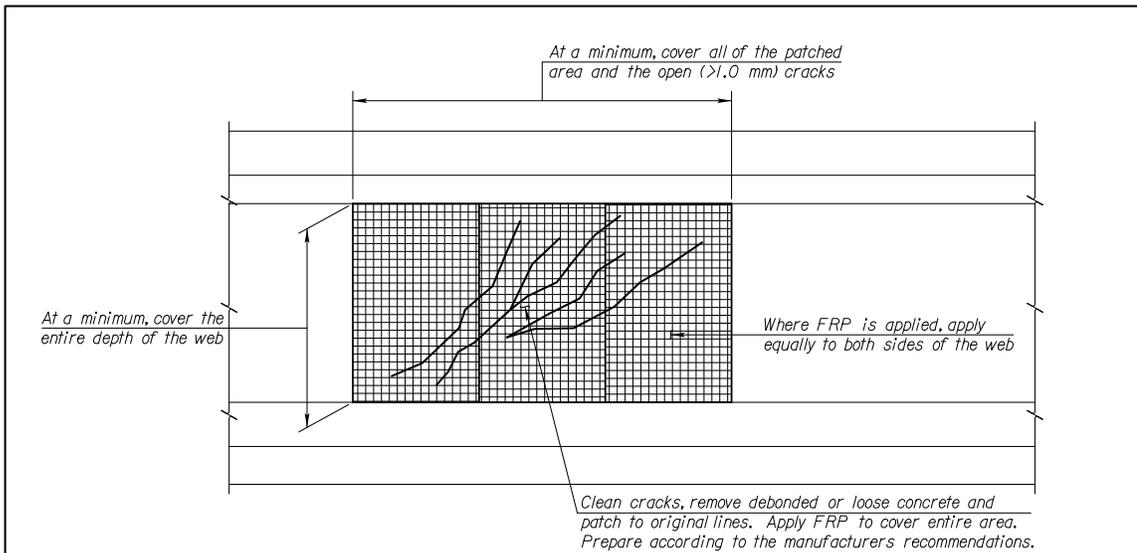
**TYPICAL FRP SHEAR STRENGTHENING OF PRESTRESSED CONCRETE GIRDERS**

Required Shear Capacity from FRP = 55 kips

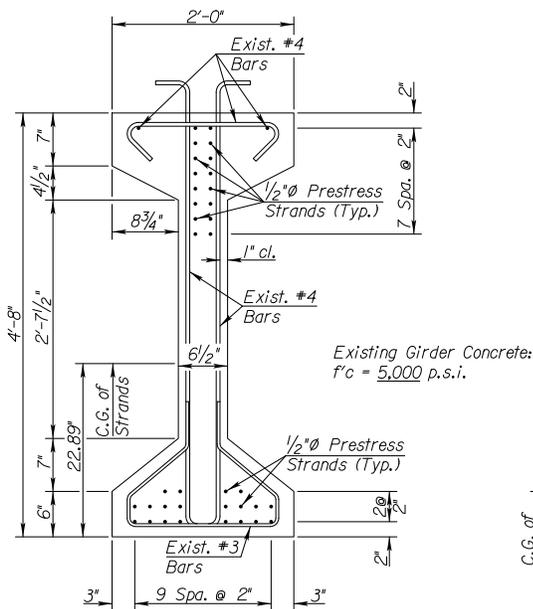
**TYPICAL PRESTRESSED BEAM SECTION AT BEARING**

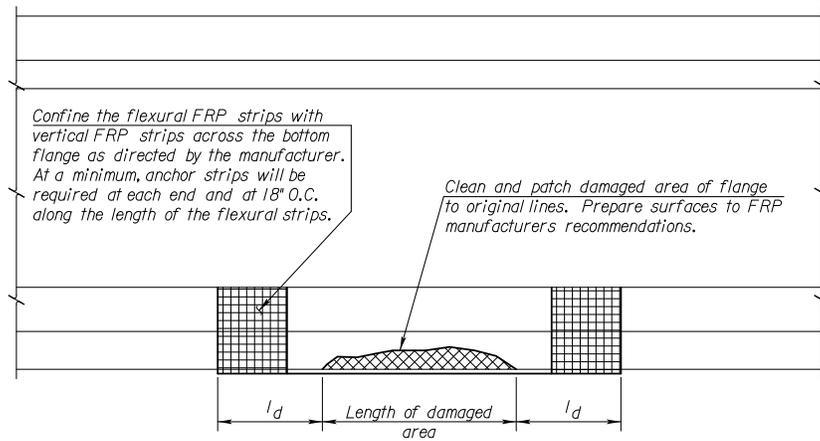
**TYPICAL FRP FLEXURAL STRENGTHENING OF PRESTRESSED CONCRETE GIRDERS**

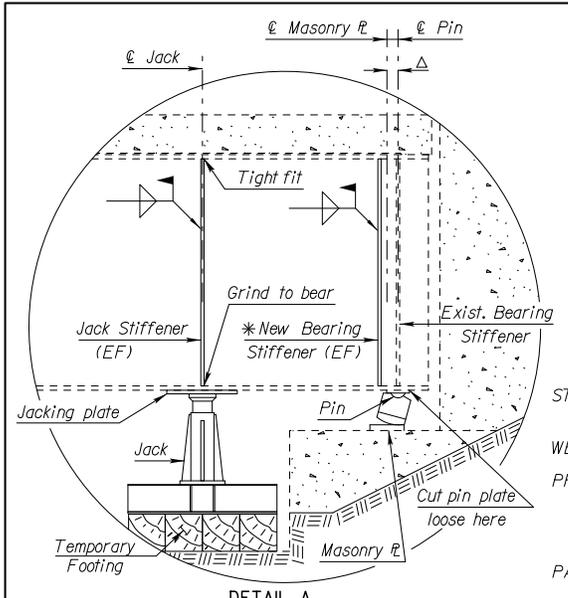
**DETAIL A**  
(Showing Preparatory Work)

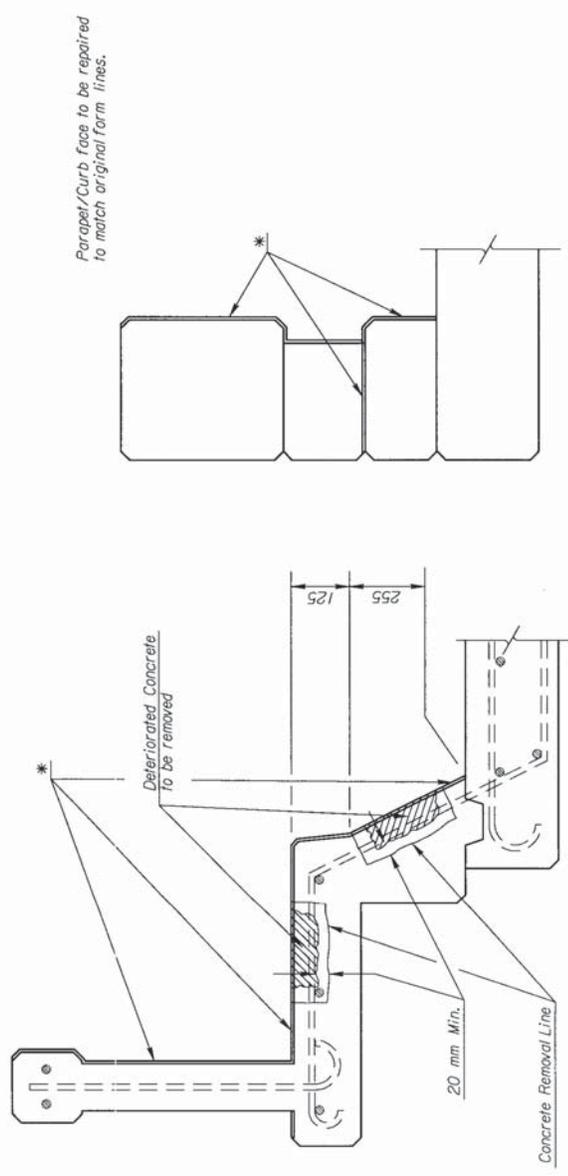
**TYPICAL CURB REPAIR**

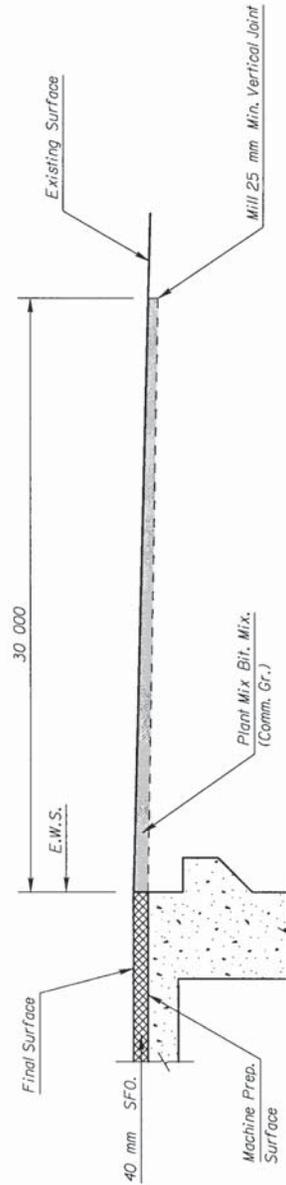
TRANSITION AT BRIDGE ENDS
