Evaluation of Advanced Safety Perimeter Systems for Kansas Temporary Work Zones

Submitted to the graduate degree program in Civil, Environmental, and Architectural Engineering and the Graduate Faculty of the University of Kansas in partial fulfillment of the requirements for the degree of Master of Science.

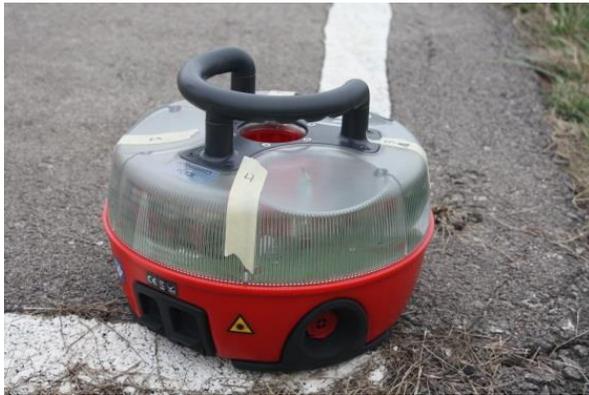
**Figure 1. Intellicone Alarm Unit**

An electronic safety perimeter system has been developed in the United Kingdom (UK), taking advantage of recent technology, and has had some success in the UK. The Intellicone system (Figure 1) is a safety perimeter system that uses already-present plastic channelizers and cones with sensors. Work crews are alerted with both a visual and auditory alarm from a separate alarm unit which is placed near the work crew. The alarm activates when a channelizer or cone equipped with a sensor is knocked over, whether that be in the taper area, before the work zone, or adjacent to the work zone. The use of sensors on multiple channelizers increases the likelihood for an intruding vehicle to strike an equipped channelizer and activate the alarm. The placement of a separate alarm unit near the workers increases the likelihood for workers to hear and recognize the alarm.

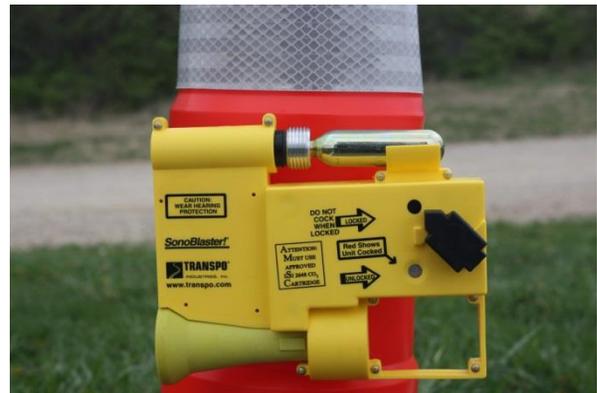
**Figure 2. SonoBlaster with Channelizer**

In order to activate the unit, the nozzle/CO<sub>2</sub> canister cover is removed and the firing pin inside the nozzle cocked by inserting the provided plastic arming tool. The front knob is turned to 'Locked' (the knob must be in the 'Unlocked' position to cock), and a single-use small CO<sub>2</sub> cartridge is inserted into the nozzle. The cover is replaced, covering the nozzle and CO<sub>2</sub> cartridge

completely. The channelizer should then be positioned as desired, and the knob turned back to 'Unlocked.' Once the CO<sub>2</sub> cartridge is inserted and the knob in the 'Unlocked' position, the alarm is armed. The alarm activates when tipped, using a small weight inside the device. The internal firing pin then punctures the CO<sub>2</sub> cartridge, and the escaping gas is routed to a horn, emitting an air horn-like sound. Once fired, the CO<sub>2</sub> cartridge is spent and must be removed and replaced.

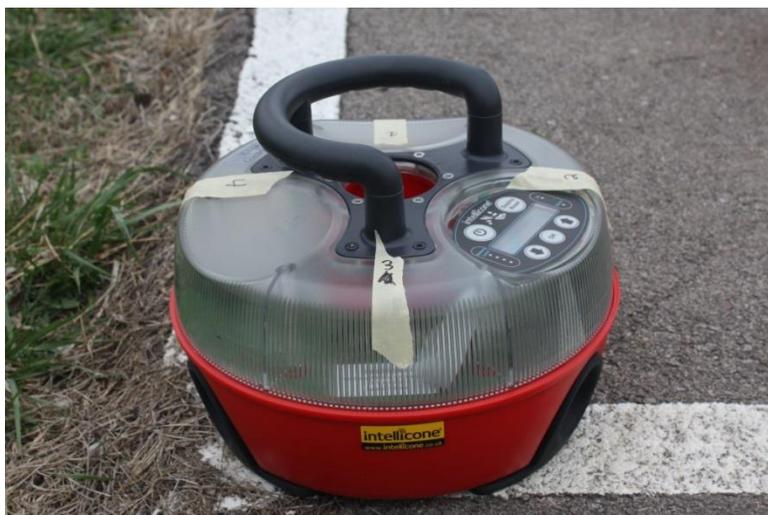
**Figure 3. Intellicone Alarm Unit with Marked Directions**

To test the sound level of the Intellicone alarm, the PSA unit (Figure 3) was set up in the corner of an outdoor test area, along with the sensor attached to a channelizer. The outside test area consisted of the University of Kansas band practice facility, which had the advantage of being in a relatively remote part of campus and had permanent yard line markers for ease of measurement. The sensor was activated along with the alarm unit, and the sensor was tipped by pushing the cone completely over, activating the PSA unit auditory alarm for 10 seconds.

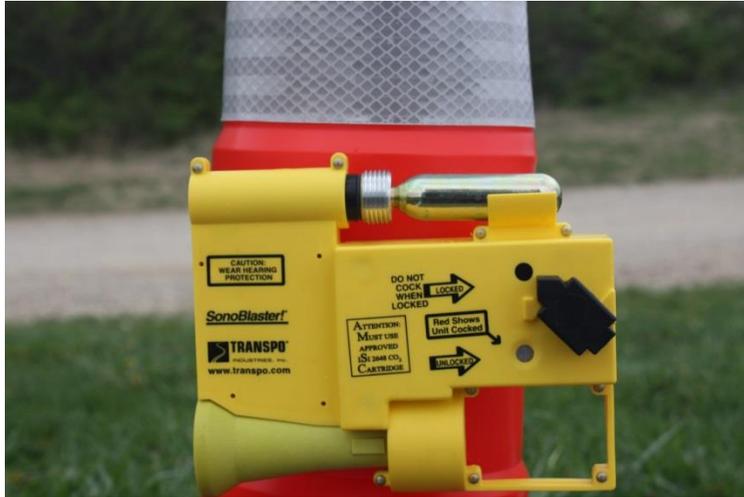
**Figure 6. SonoBlaster Attached to Channelizer**

To test the sound level of the SonoBlaster, it was attached to a traffic delineator cone according to instructions from the manufacturer (Figure 6). The SonoBlaster and cone were then set up in the corner of the outdoor test area. The SonoBlaster was cocked with the cocking pin and the unit was turned to the 'Locked' position. It was loaded with an approved CO<sub>2</sub> cartridge, oriented properly, and then turned to the 'Unlocked' position. The cone was then tipped by pushing the cone completely over, activating the SonoBlaster alarm.

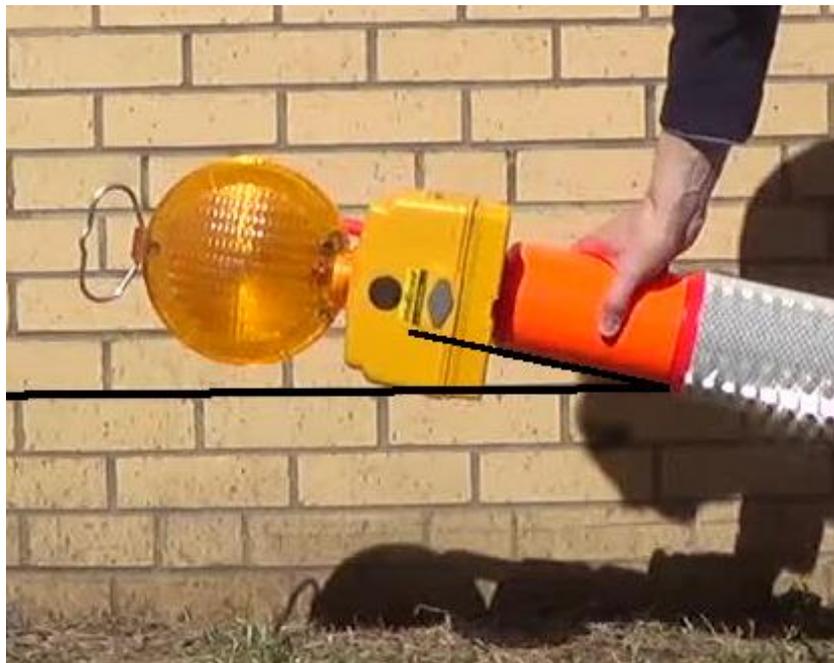
**Figure 8. Intellicone Alarm Activation Angle Measurement**

For the Intellicone system, the sensor unit was attached to the top of a channelizer with the alarm unit on the ground next to the cone. The assembly was then slowly tipped by hand, just as the SonoBlaster was, until the alarm unit was activated, and the angle was measured from a photograph extracted from the video recording. This was also repeated ten times and for both axes.

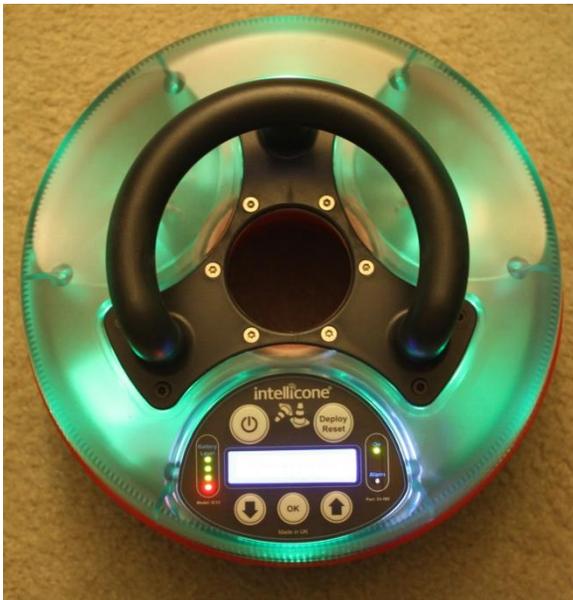
Figure 9. Intellicone with Green LED Activated

Battery life for the portable site alarm unit was measured by fully charging the unit, and then allowing it to run continuously until it was no longer on. The battery life of the alarm was tested both with the green LED status lights on (Figure 9) for the duration of the test and with the green LED status lights off (Figure 10) for the duration of the test. Whether the green LED lights were on or off had no effect on the ability of the alarm unit to receive and display alarms. The alarm unit was tested three times with the LEDs on and three times with the LEDs off in an indoor environment.

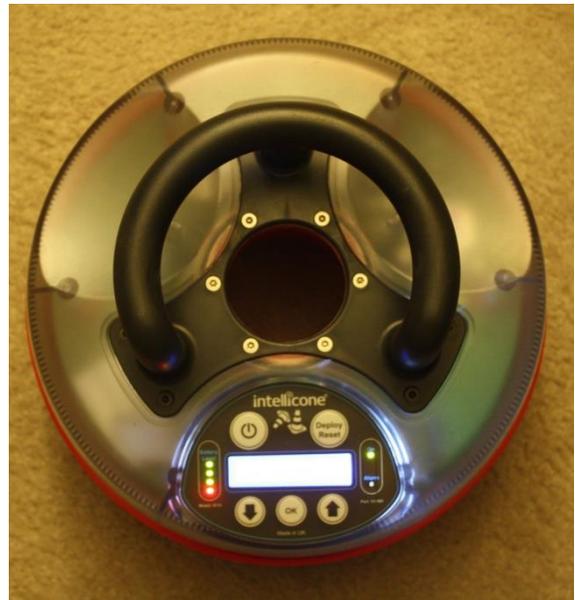
Figure 10. Intellicone with Green LED Deactivated

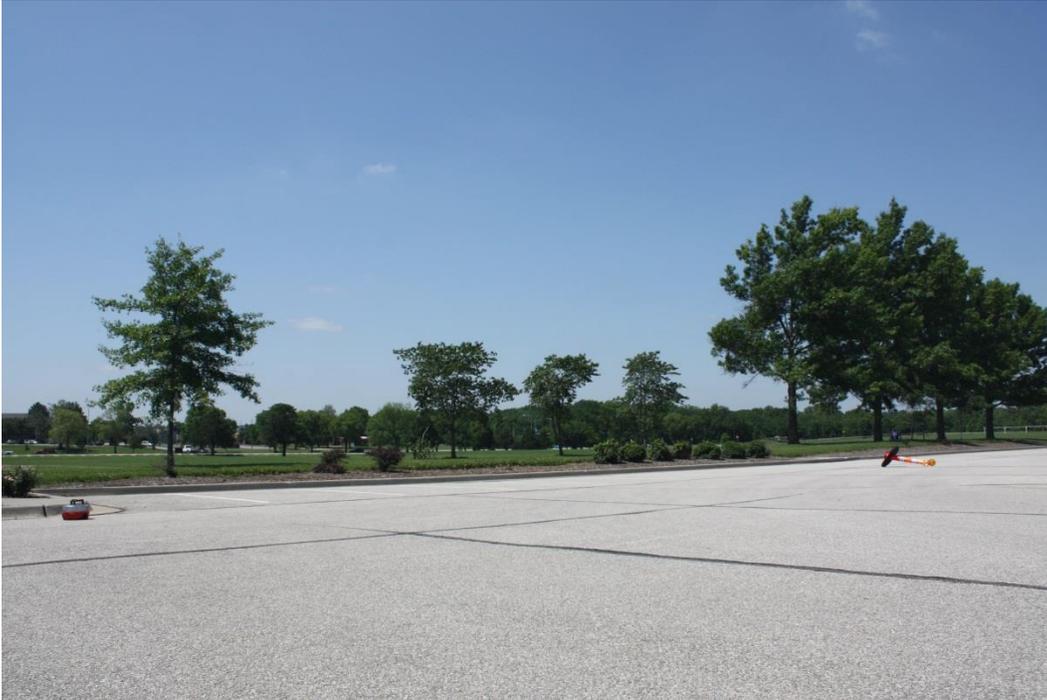
**Figure 11. Intellicone Transmission Distance Testing**

The first transmission distance determined was between the PSA unit and the sensor unit (Figure 11). First, a sensor was activated 50 feet from the PSA unit. It was assumed that at this distance, there would be 100 percent transmission. The sensor was activated by quickly tipping the channelizer and attached sensor completely over to a 90° angle, which was found to be most reliable.

This was repeated 10 times and a transmission percentage was established. If the transmission percentage was not 100 percent, the distance was decreased in 10-foot increments until 100 percent transmission was achieved. The distance was then increased in 50-foot increments until the longest distance with 100 percent transmission and the distance with 0 percent transmission were found.

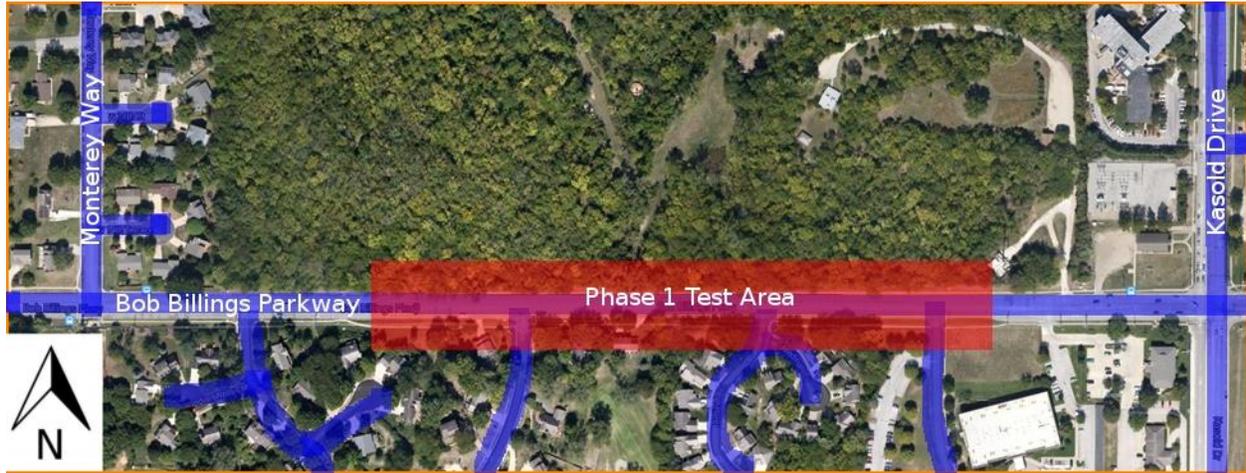
**Figure 12. Phase 1 Test Area**

Working with the City of Lawrence Public Work Department, a suitable work zone was selected on Bob Billings Parkway between Kasold Drive and Monterey Way (Figure 12). Bob Billings Parkway is a four-lane principal arterial road (KDOT June 2013) with an ADT of approximately 11,500 vehicles on the portion under construction (KDOT August 2013). The posted speed limit is 40mph.

Asphalt was being patched in the eastbound lanes by a seven person crew. Diesel trucks, a skid steer loader, jackhammers, an asphalt roller, and a vibratory plate compactor were all in use. Both eastbound lanes were closed and traffic was diverted to the westbound lanes, with one lane open in each direction. Traffic control consisted of standard 42” vertical channelizers to separate both the opposing traffic as well as the work zone from the flow of traffic (Figure 13). Two arrow boards were used upstream of the work zone in both directions in order to indicate

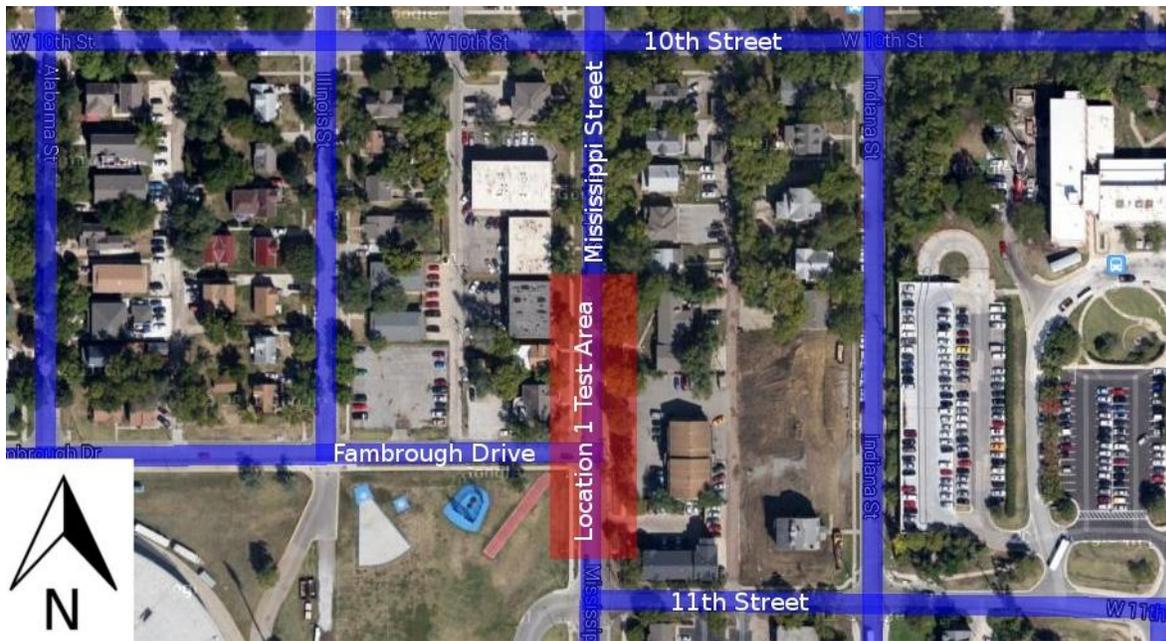
**Figure 14. Location 1 Test Area**

Working with the City of Lawrence Public Works Department, a suitable work zone was selected for the first of four locations. The work zone was on Mississippi Street between 10<sup>th</sup> Street and 11<sup>th</sup> Street, at the intersection of Mississippi Street and Fambrough Drive (Figure 14). Mississippi Street north of Fambrough Drive is a two lane major collector (KDOT June 2013) with an ADT of approximately 4,000 vehicles on the portion under construction (KDOT August 2013). The speed limit is 30mph.

A storm sewer was being laid by an eight person crew, with the centerline of the storm sewer approximately 4 feet into the travelled way from the curb. Once the storm sewer was laid, concrete was poured over it, and then an asphalt wearing surface was placed. Diesel dump trucks, a skid steer loader, a backhoe, concrete trucks, an asphalt roller, and a vibratory plate compactor were all in use. The northbound lane and shoulder were closed, necessitating one-lane, two-way operation along the length of the operation. A single flagger was used to control traffic along the work zone as well as the intersection of Fambrough Drive and Mississippi Street, which is normally STOP-controlled along Fambrough Drive. Traffic control consisted of standard 42" vertical channelizers to separate the work zone from the flow of traffic (Figure 15). The work zone was approximately 350 feet long.

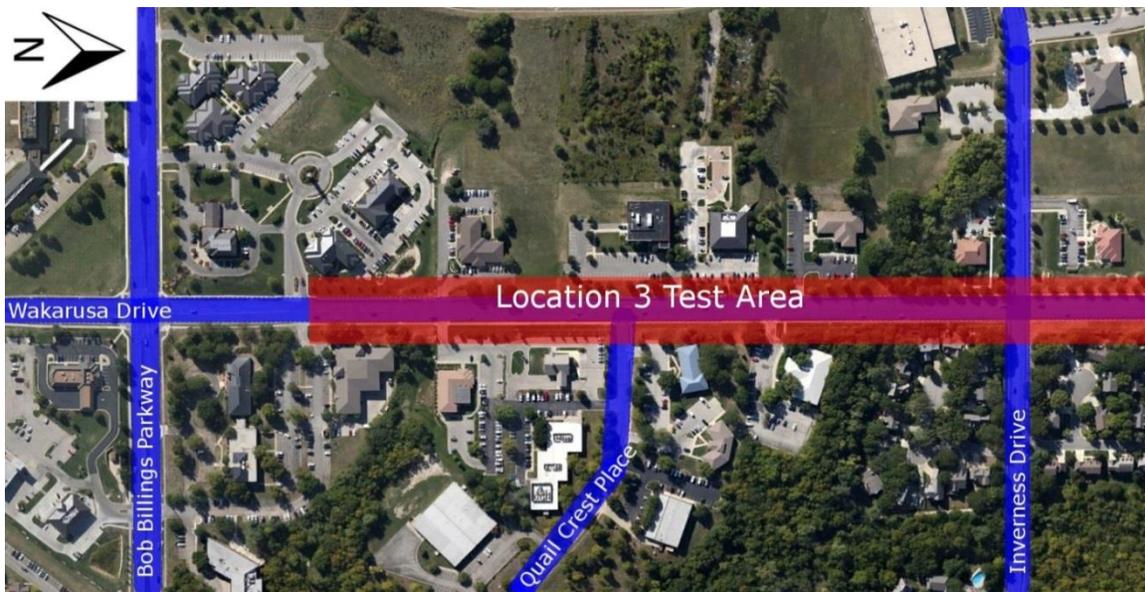
Figure 18. Location 3 Test Area

Working with the City of Lawrence Public Works Department, a suitable work zone was selected for the third of the four locations. The work zone was on Wakarusa Drive between Bob Billings Parkway and north of Inverness Drive (Figure 18). Wakarusa Drive is a four-lane principal arterial (KDOT June 2013) with an ADT of approximately 14,000 vehicles on the portion under construction (KDOT August 2013). The speed limit is 45mph, though it had a posted speed limit of 20mph while under construction.

Complete pavement reconstruction as well as the addition of bike lanes was being completed. Diesel dump trucks, a skid steer loader and a backhoe were all in use. The northbound lanes and shoulder were closed, with both directions of traffic shifted to the

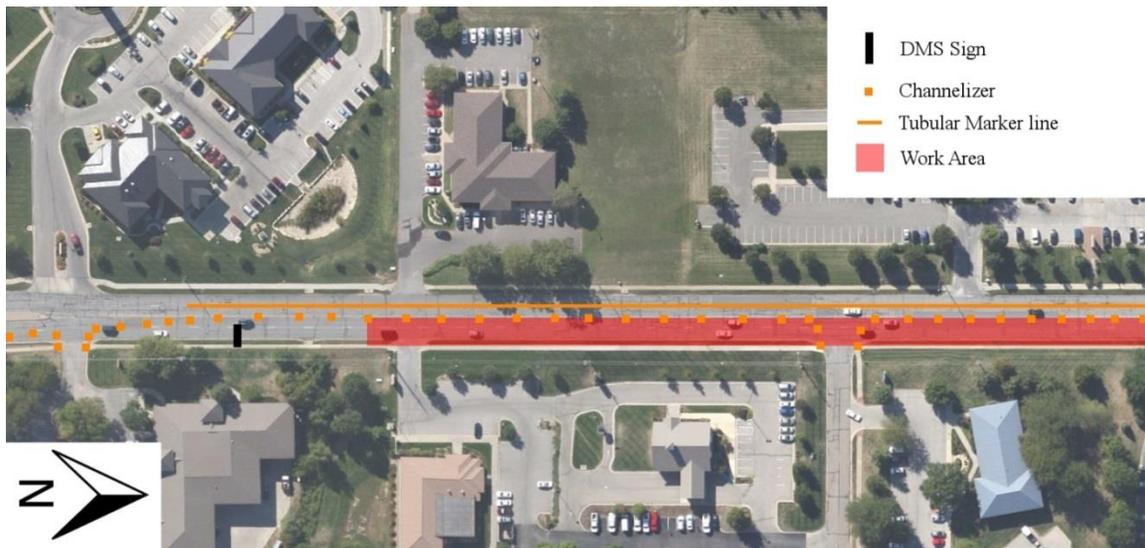
Figure 19. Location 3 Test Area Traffic Control

southbound lanes, necessitating a single lane of traffic in each direction. Traffic control consisted of standard 42” vertical channelizers to separate the work zone from the flow of traffic and 28” tubular markers were used to separate opposing streams of traffic (Figure 19). A DMS sign was located in the taper section to direct northbound traffic to the proper access for nearby businesses. Several Type 3 barricades were also used in the taper section to block the lanes of traffic. The work zone was approximately 2500 feet long, with the southern half of the work zone being used for this research.

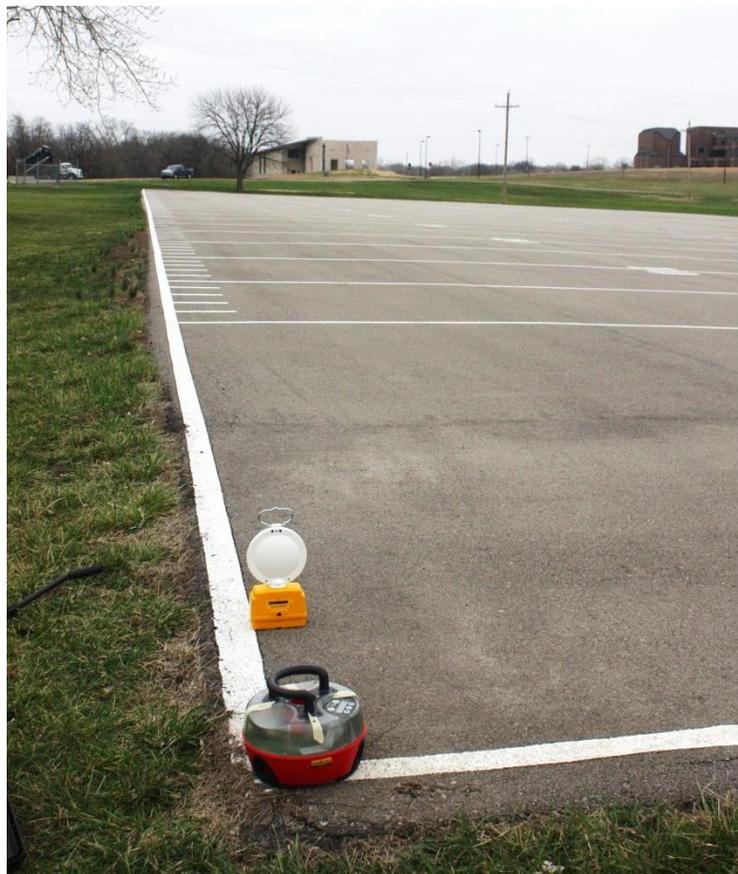
Figure 22. Intellicone Alarm at Sound Level Testing Area

Sound levels were tested in an outdoor environment with the units set up on the ground in the corner of a level 360 foot by 160 foot asphalt test area (Figure 22). Sound levels were tested on a windy day using a sound meter with attached wind shield. The weather was cloudy and the temperature was approximately 50°F. Observations of sound levels indicated that wind did not affect the sound levels recorded due to the substantial difference in sound levels between the wind and the alarm.

While the sound level tests were being conducted, there were several construction vehicles in the area when the close distance tests were being conducted. Monitoring the sound meter as levels were being read indicated that this did not affect the sound level readings of the alarm at all. However, the construction vehicles returned while the 400 foot tests were being conducted and engine and mechanical noises from the vehicles were observed to be louder than the alarm levels, so the tests were ended after all 400 foot tests were completed, without testing sound levels at 500 feet. It was noted, however, that even though noise from the construction vehicles was louder, the alarm could still be clearly perceived due to its unique high-frequency noise, which was qualitatively different than the mechanical noises from the equipment. It was also observed that the alarm sound level is fairly consistent while it is playing. A graph of a typical alarm sound level profile is displayed in Figure 23.

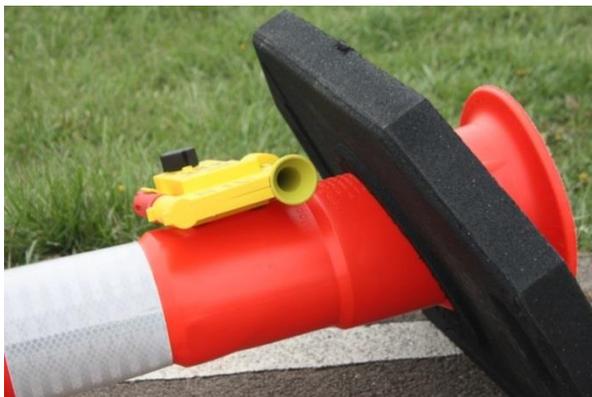
**Figure 24. SonoBlaster Oriented Towards Sound Meter**

From the SonoBlaster orientation measurements, it was determined that directly towards the sound meter (Figure 24) resulted in the loudest alarm and towards the ground (Figure 25) resulted in the quietest alarm. These orientations were then measured at distances of 10 feet, 20 feet, 30 feet, 40 feet, 50 feet, 100 feet, 200 feet, 300 feet, and 400 feet and 500 feet.

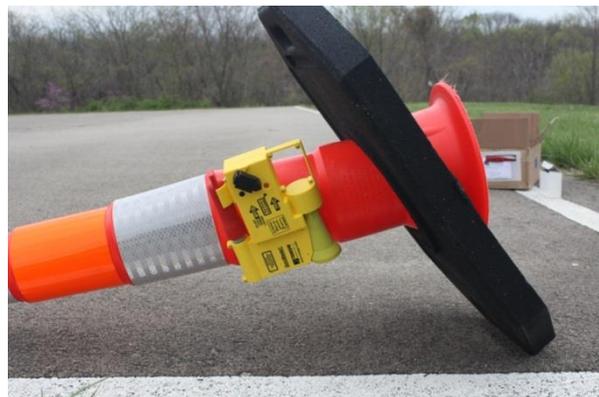
**Figure 25. SonoBlaster Oriented Downward**

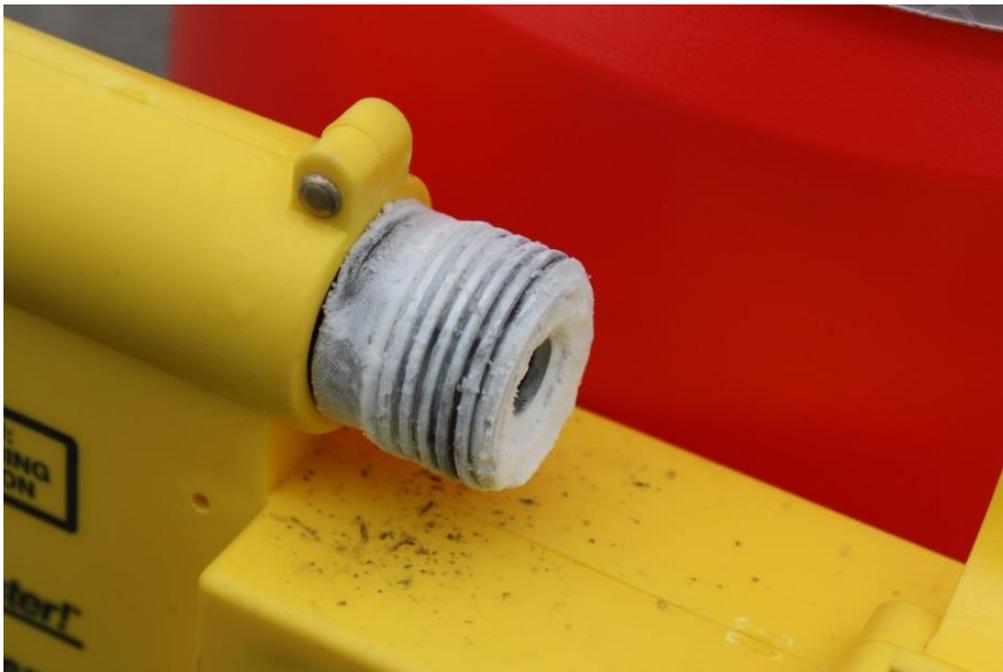
**Figure 26. Ice Accumulation on SonoBlaster Nozzle**

During the testing several phenomena were observed. First, as the SonoBlaster uses compressed CO<sub>2</sub> to generate an air horn like alarm, the compressed CO<sub>2</sub> cartridges can become quite cold during firing, to the point where ice begins to condense on the cartridges – even though the test was conducted in approximately 55°F temperatures. This did not appear to be an issue. However, as the socket for the cartridges is also metallic and the cold, compressed CO<sub>2</sub> was pushed through it, the nozzle became very cold and condensed water and then created ice. During the testing, which took place over a two-hour window, larger amounts of frost gradually accumulated on the exterior of the nozzle (Figure 26).

This is unlikely to be an issue when used in the field as an individual unit will not be fired so many times in such a short period. It could be an issue in already cold or wet weather conditions if water were to get into the nozzle, or if the unit were fired, either as part of a test, accidentally, or legitimately, and then the cartridge was replaced. In that situation, it is possible for the ice buildup to occur suddenly and this could result in false negatives. In order to fix the problem, the research team simply cocked the unit twice, and the plastic cocking mechanism was sufficient to puncture the ice, allowing the firing pin to puncture the CO<sub>2</sub> cartridge properly upon alarm activation.

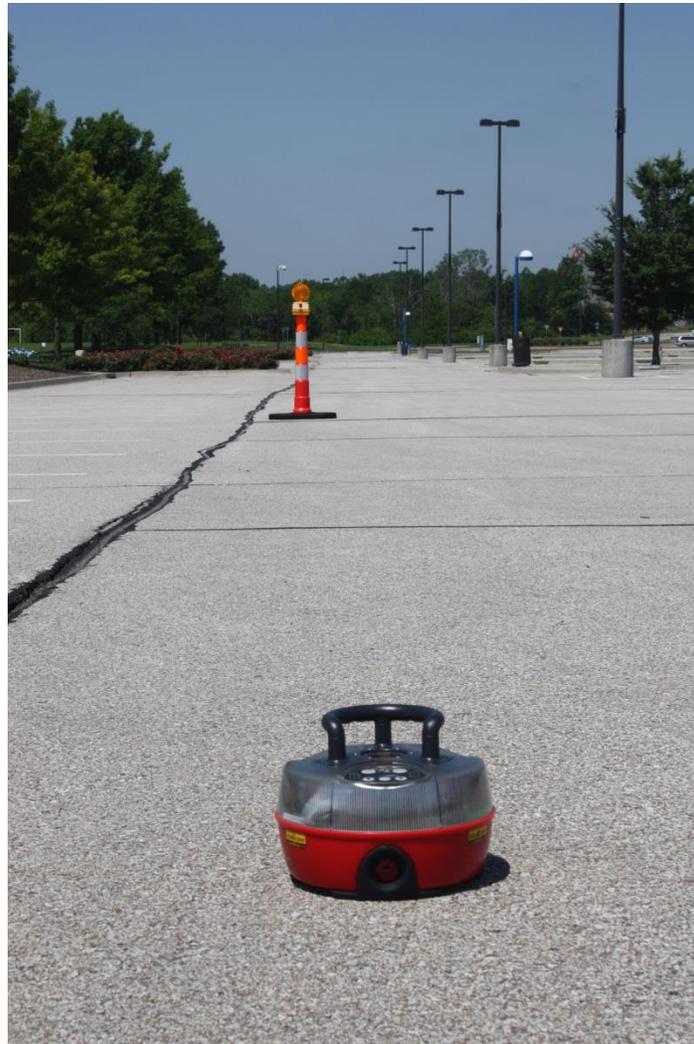
**Figure 29. Intellicone Transmission Distance Test Area**

Transmission testing for both between the PSA unit and the sensor unit and between the two sensor units was performed in an empty asphalt parking lot (Figure 29) approximately 825 feet long on Wednesday, June 11, 2014 at 10:00 a.m. The weather was sunny, and a temperature of approximately 90°F. The cone was sitting on level ground.

For testing between the PSA and a single sensor, the beginning distance used was 50 feet. This distance resulted in 100 percent transmission and the distance was increased in 50 foot increments until 100 percent transmission was not achieved at 400 feet. The distance was

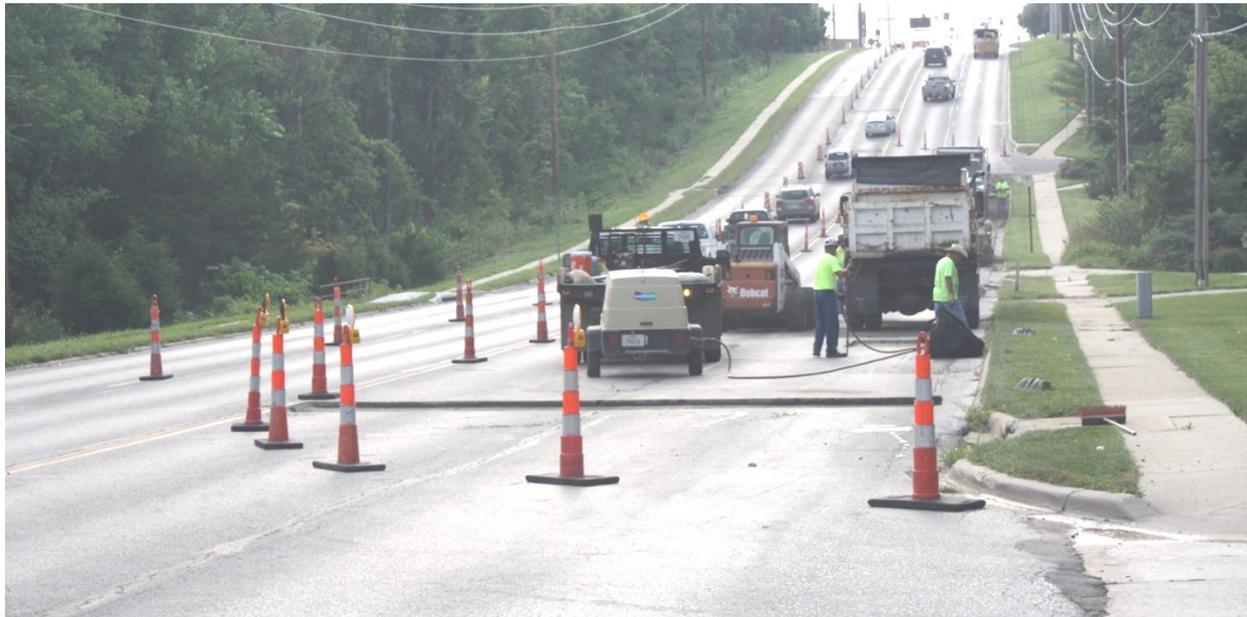
**Figure 32. Phase 1 Intellicone Sensor Deployment**

The sensors were deployed along the downstream edge of the intersection on channelizers (Figure 32). The video camera was deployed on a tripod approximately one foot above the ground on the upstream edge of the intersection behind the arrow board, with the PSA

unit set up several feet downstream of the camera. The video camera had a view of the PSA unit, all four sensors and both streams of traffic.

There were no false alarms, actual alarms, or false negatives during the testing period. While the proper activation of the alarm was not tested, the system otherwise performed as expected.

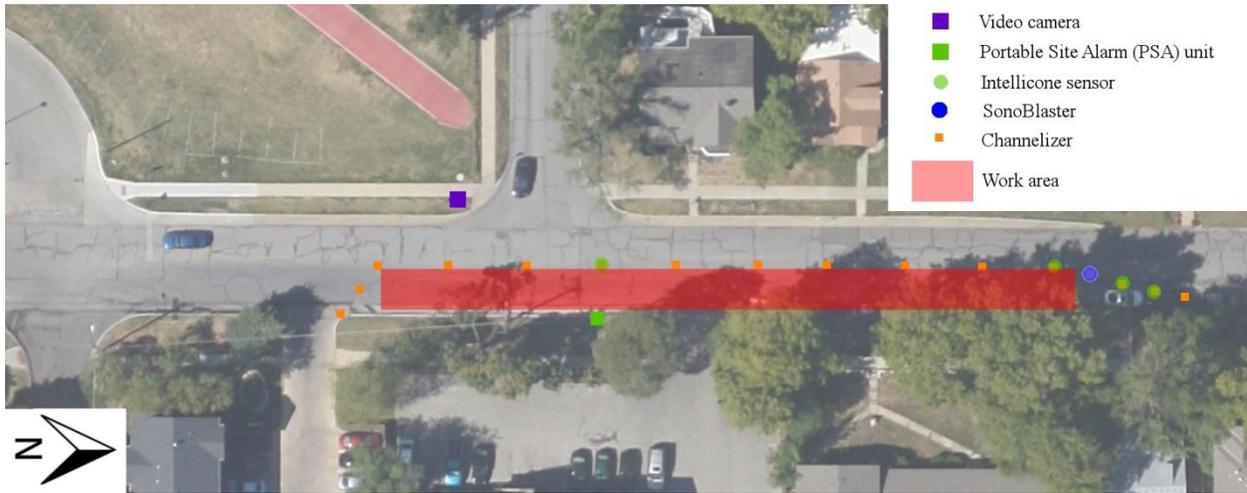
**Figure 33. Location 1 Test Area Equipment Setup**

33). Three of the four Intellicone sensors and the SonoBlaster alarm were deployed at the north, downstream end of the work zone. This was determined to be the most useful location for deployment as a flagger was controlling traffic at the intersection of Mississippi Street and Fambrough Drive, very near the south, upstream end of the work zone.

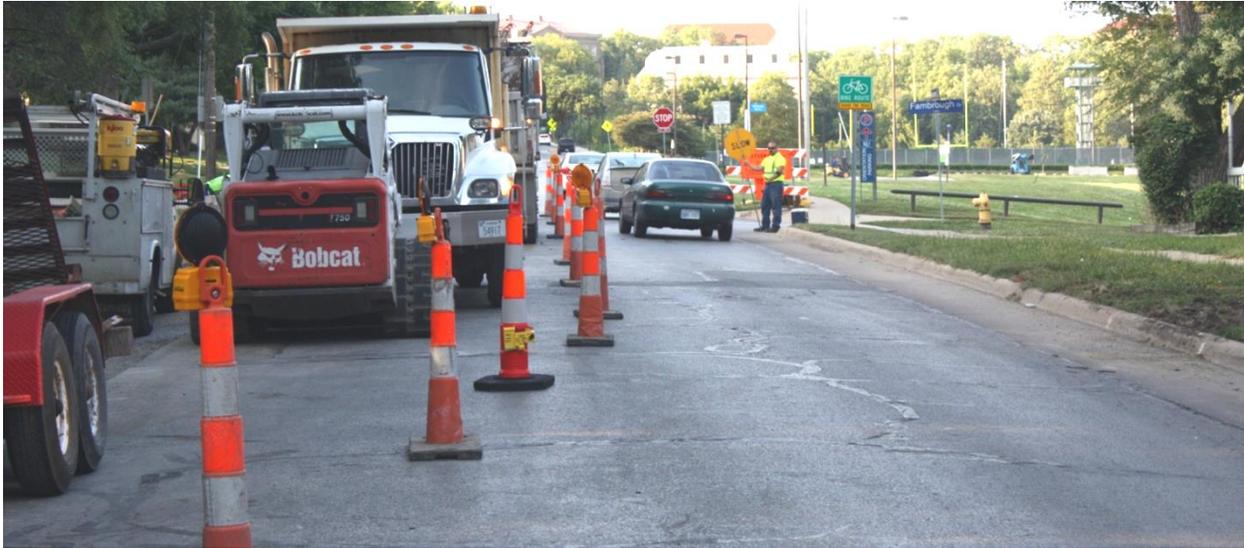
**Figure 34. Location 1 Taper with Equipment**

The sensors were deployed on the channelizers in the taper section, with the SonoBlaster alarm also deployed in the taper (Figure 34). The final fourth and final Intellicone sensor was deployed on a channelizer nearest the active work in the work zone, which was directly in line with the intersection of Mississippi Street and Fambrough Drive (Figure 35). The PSA unit was set up approximately three feet from the curb off the road, near to the center of the work activity. The video camera was deployed on a tripod approximately one foot above the ground on the upstream side of the work zone, on the southwest corner of the Mississippi Street and Fambrough Drive intersection. The video camera had a view of the PSA unit, all four sensors and the traffic.

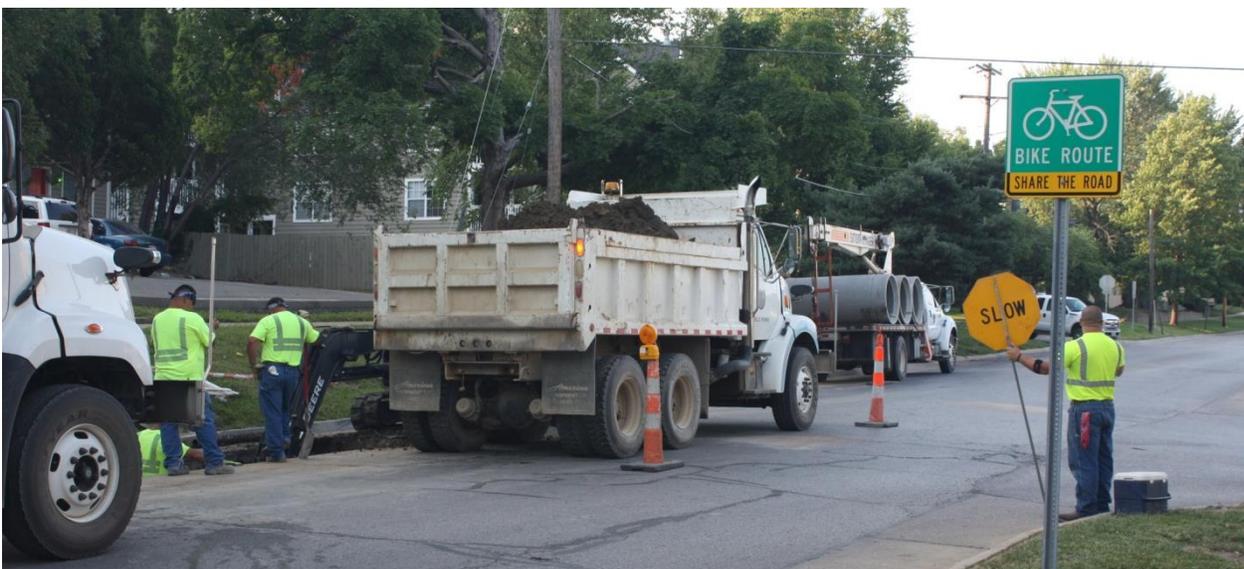
**Figure 35. Location 1 Intersection and Work Area with Equipment**

During testing, both the Intellicone alarm and the SonoBlaster were activated. On the first day of testing the Intellicone alarm was set off at approximately 10:30 a.m. when a channelizer and attached sensor were backed over by a truck exiting the work zone. The Intellicone alarm was set off a second time at 11:10 a.m. when the site foreman intentionally tipped a channelizer and attached sensor to demonstrate the system to utility workers who were present. The SonoBlaster alarm was intentionally activated at 1:30 p.m.

On the second day, the Intellicone alarm was activated at approximately 10:00 a.m. as a channelizer and the attached sensor were dragged out of the way of a front loader entering the work zone. No activations occurred on the third day of testing.

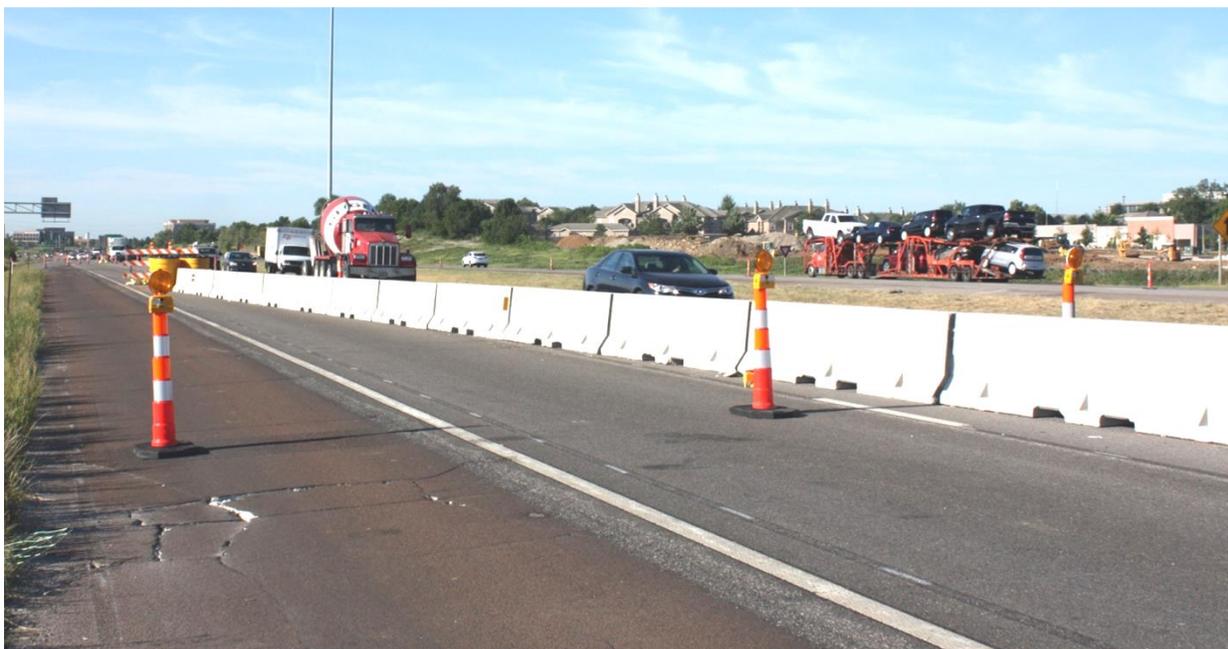
**Figure 37. Location 2 Sensor Line**

The sensors were deployed on channelizers at the end of the concrete barrier taper section. One sensor was deployed on the traffic side of the concrete barrier, about two feet from traffic. The other two sensors were deployed on the work zone side of the concrete barrier, about 11 feet apart, parallel with the first sensors, forming a line across the roadway (Figure 37). The SonoBlaster alarm was deployed on the work zone side channelizer nearest traffic which also had the Intellicone sensors on it. The final fourth and final Intellicone sensor was deployed as a relay on the ground next to the concrete barrier, approximately halfway between the sensor line and the PSA unit, as the distance between the sensor line and the PSA unit was approximately 400 feet, which is greater than the distance of 100 percent transmission for the Intellicone system. The PSA unit was set up next to the concrete barrier, near to the center of the work activity (Figure 38). The video camera was deployed on a tripod approximately five feet above the ground on the downstream side of the work zone behind the metal railing. The video camera had a view of the sensor line and the SonoBlaster alarm, as well as the traffic, but not the PSA unit or the relay sensor.

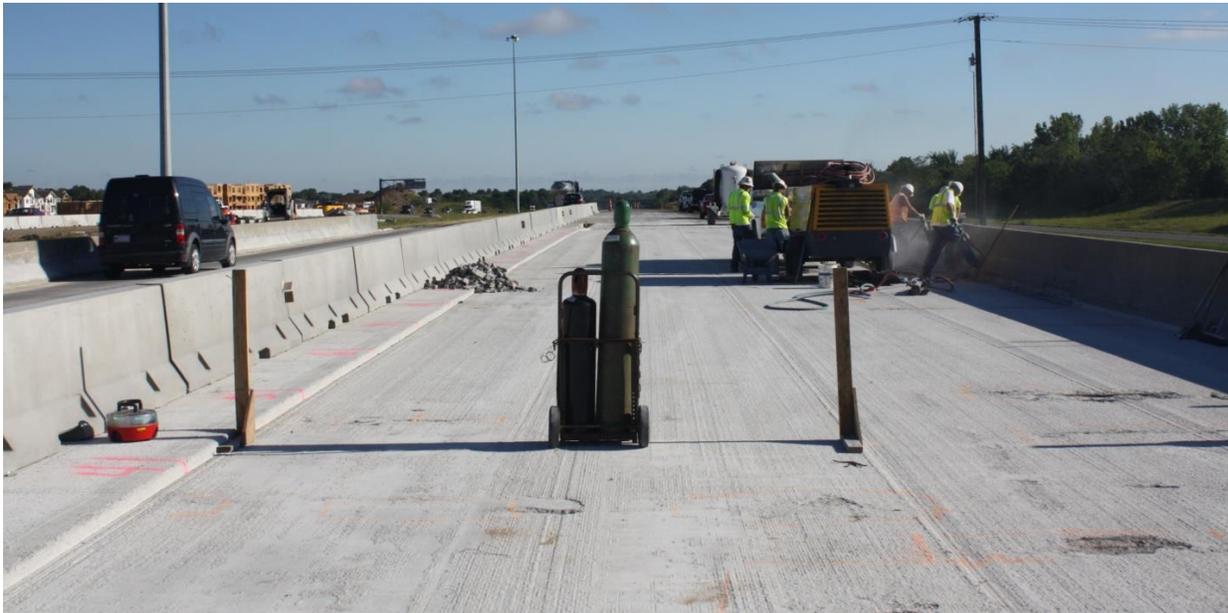
**Figure 38. Location 2 Intellicone Portable Site Alarm Deployment near Work Activity**

During testing, the Intellicone alarm was successfully intentionally activated several times. On the first day of testing, the Intellicone alarm was intentionally activated at 1:15 p.m. At the time, the workers were approximately 150 feet away, using jackhammers and wearing in-ear hearing protection. On the second day of testing, the Intellicone alarm was activated four times. At 10:10 a.m., the alarm was activated while the workers were using jackhammers and wearing in-ear hearing protection, approximately 100 feet away. At 11:10 a.m., the alarm was activated while the workers were approximately 200 feet away using jackhammers and wearing in-ear hearing protection. One worker was approximately 150 feet away and using a chipping hammer, also while wearing in-ear hearing protection. At 12:45 p.m., the alarm was activated while three workers were using jackhammers 150 feet away, one was using a concrete saw 100 feet away, and one was using a chipping hammer 50 feet away. All the workers were wearing hearing protection. At 1:30 p.m., the alarm was activated while one worker was using a concrete saw

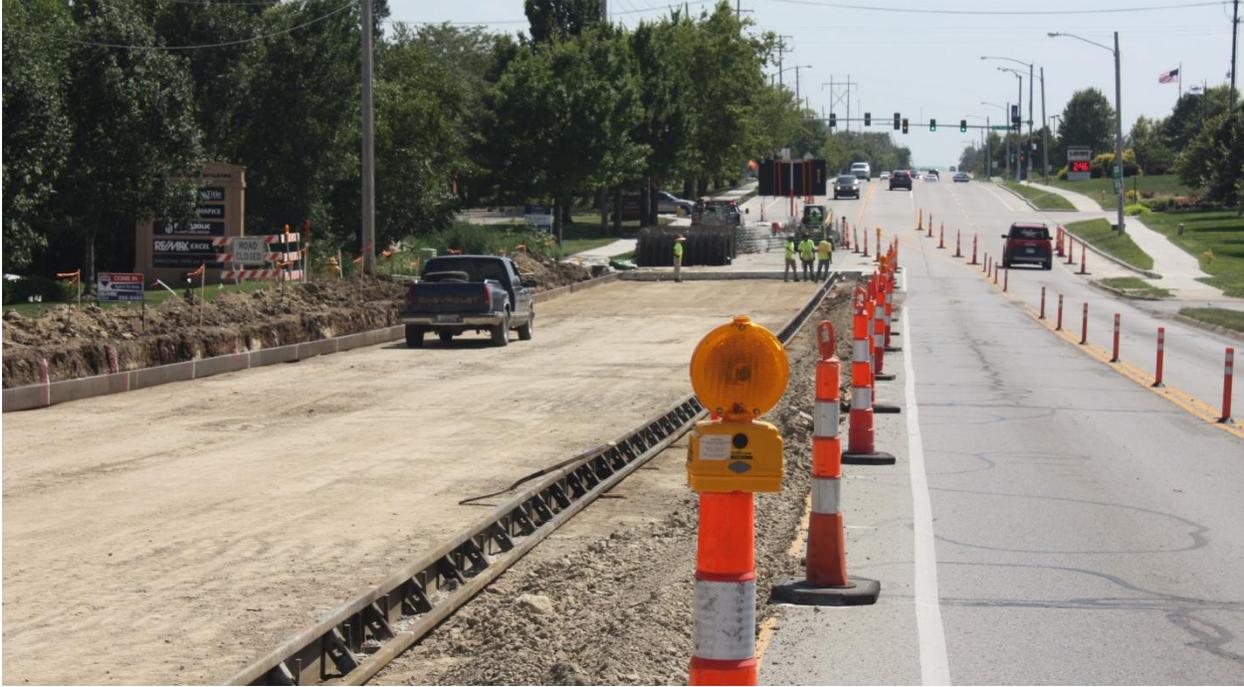
**Figure 40. Location 3 Sensor Line**

The sensors were deployed on channelizers. One sensor was deployed on a channelizer in the taper section. The other three sensors were deployed on channelizers along the work zone (Figure 40), approximately 200 feet apart, which is within the 100 percent transmission distance for the sensors. The SonoBlaster alarm was deployed with the Intellicone alarm in the taper section. The PSA unit was set up on the ground just outside the work limits, near to the center of the work activity (Figure 41). The video camera was deployed on a tripod approximately three feet above the ground on the downstream side of the work zone behind Type 3 barricade. The video camera had a view of three of the four Intellicone sensors, as well as the traffic, but not the PSA unit or the taper section. There was no location where all of the equipment could be recorded simultaneously.

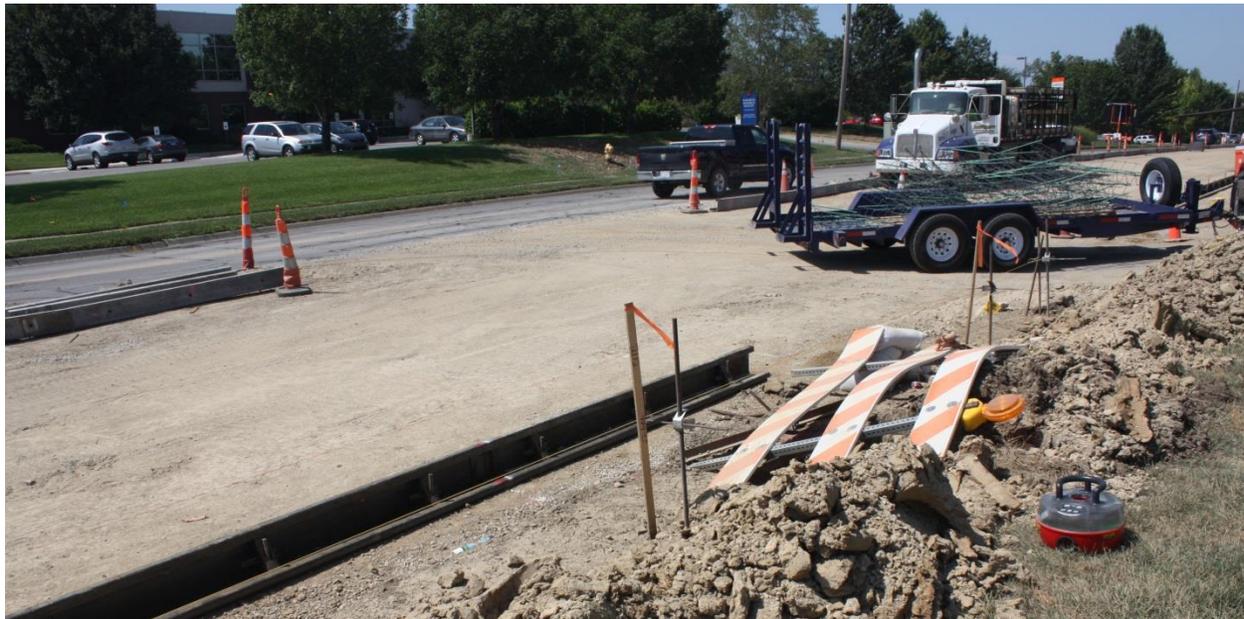
**Figure 41. Location 3 Intellicone Portable Site Alarm Deployment near Work Activity**

During the first day of testing, only two workers were present in the work zone and not in the area being studied; therefore neither of the alarms were intentionally activated. However, the systems were still active and the Intellicone system experienced a false negative during the

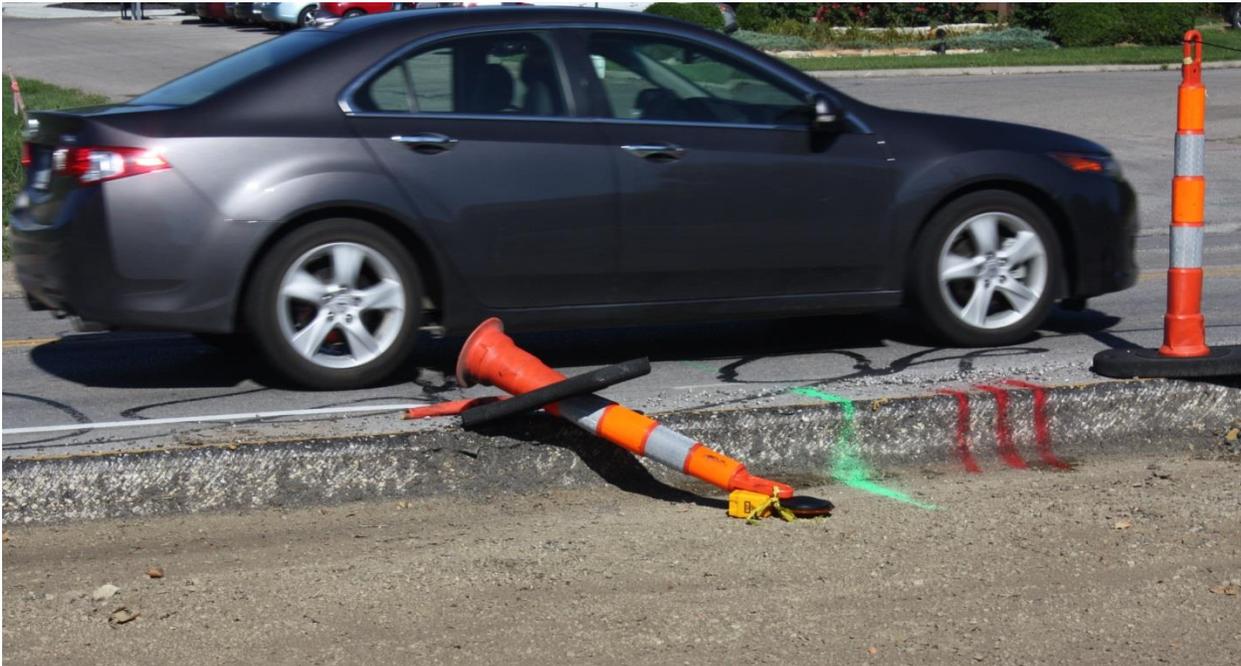
**Figure 42. Location 3 Intellicone Sensor on Ground**

testing period. At approximately 10:00 a.m., one of the cones with attached sensor deployed along the length of the work zone was knocked over as a result of a car hitting the base of the channelizer, tipping the channelizer over (Figure 42). However, the Intellicone alarm did not activate.

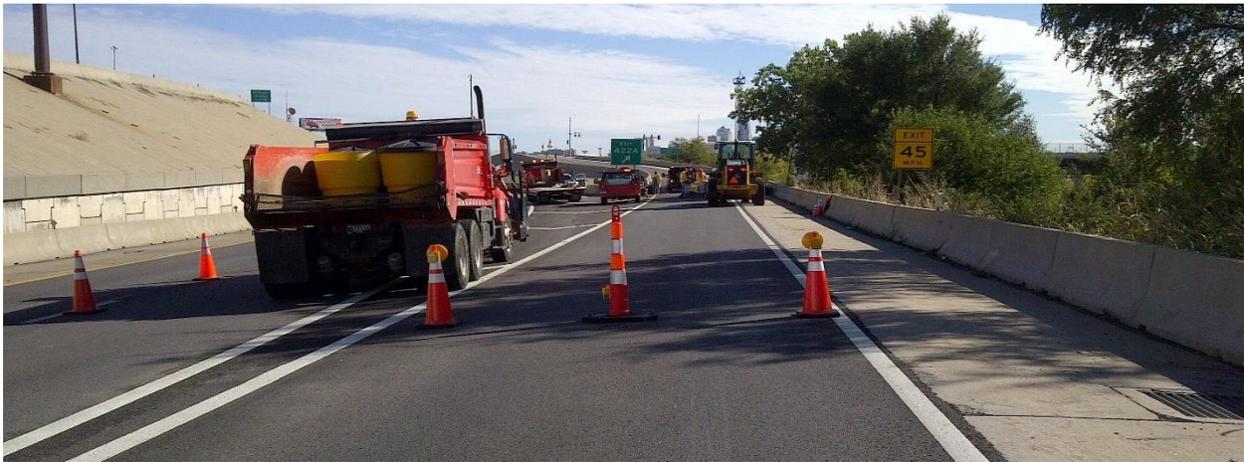
**Figure 44. Location 4 Sensor Line**

The sensors were deployed on cones approximately 250 feet upstream from the gore area. The sensors were placed in a line approximately six feet apart across the closed right-hand through lane, with the SonoBlaster alarm set up in between the two Intellicone sensors (Figure 44). The PSA unit was set up on the ground about 12 feet away from the work activity (Figure 45). The video camera was deployed on a tripod approximately three feet above the ground on the downstream side of the work zone behind a concrete barricade. The video camera had a view of the sensor line, the SonoBlaster alarm, and the traffic, but not the PSA unit. There was no location where all of the equipment could be recorded simultaneously by a single video camera.

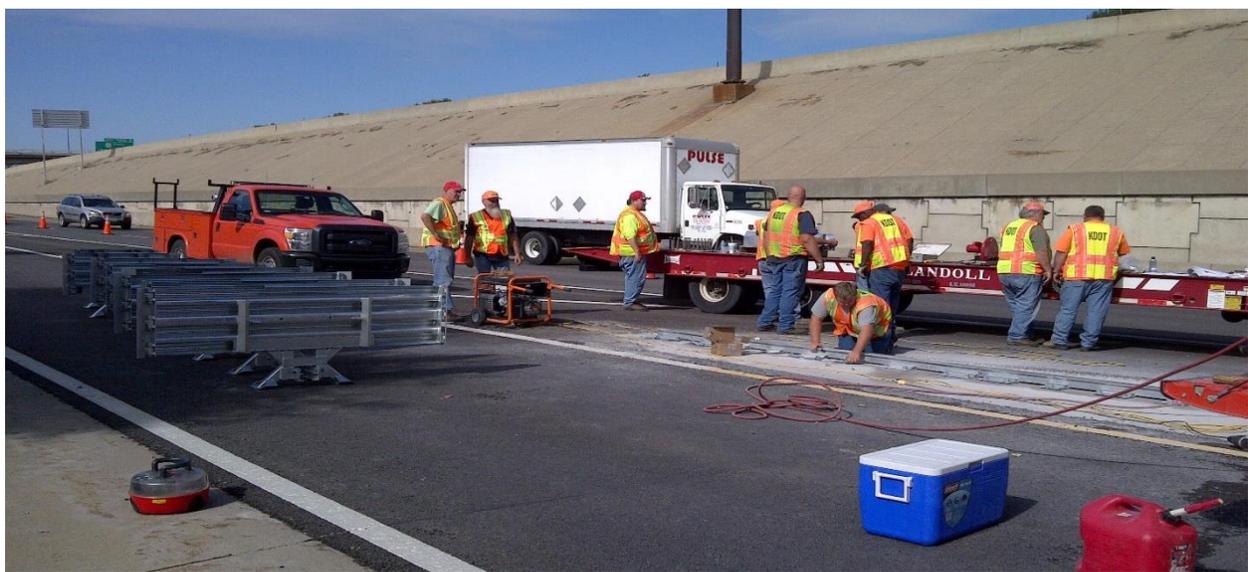
**Figure 45. Location 4 Intellicone Portable Site Alarm Deployment near Work Activity**

During testing, the Intellicone alarm experienced a single false positive. At approximately 10:15 a.m., a fast moving truck passed close to one of the traffic cones, causing it to move, resulting in activation of the alarm. While this does not represent an actual intrusion, the sensor did correctly activate upon movement.
