Evaluation of Advanced Safety Perimeter Systems for Kansas Temporary Work Zones

Submitted to the graduate degree program in Civil, Environmental, and Architectural Engineering and the Graduate Faculty of the University of Kansas in partial fulfillment of the requirements for the degree of Master of Science.

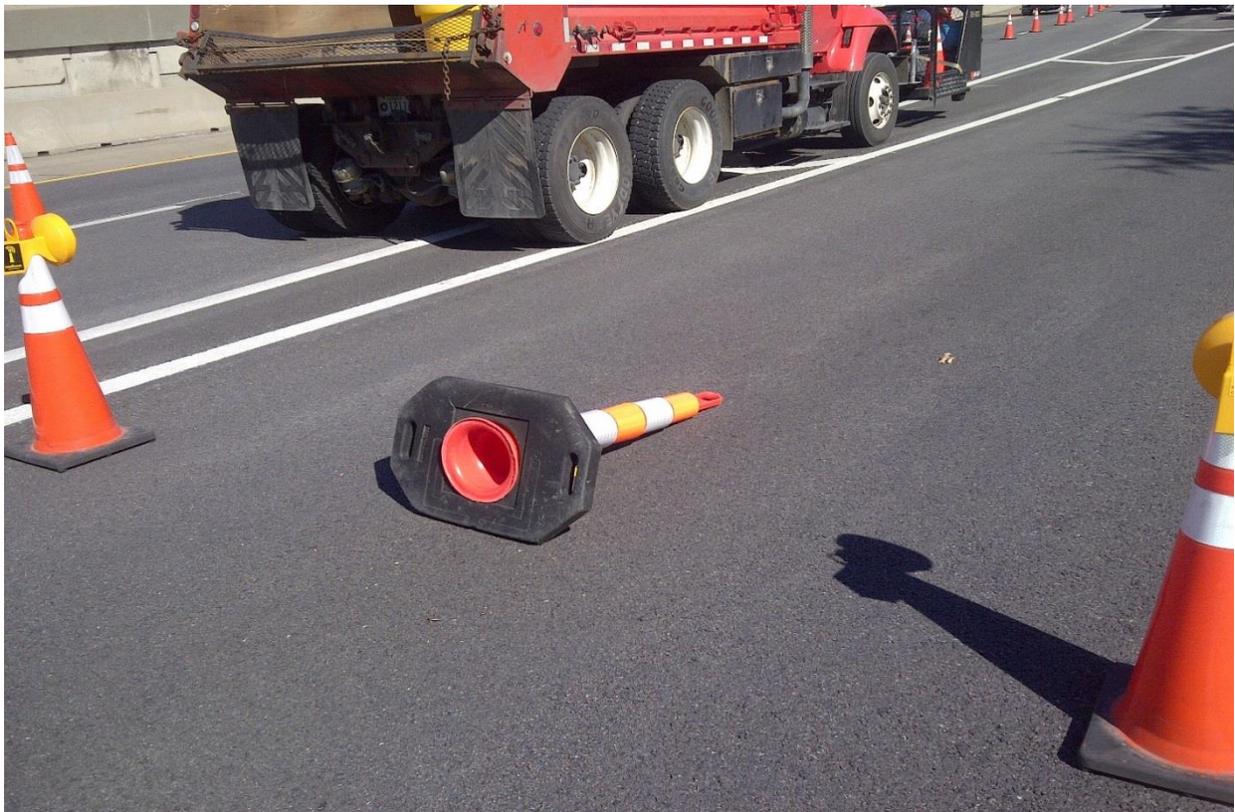
**Figure 46. Location 4 Intentional Activation of SonoBlaster Alarm**

In addition to the false positive, the Intellicone alarm was intentionally activated at 11:30 a.m. At the time, workers were approximately 15 feet away, using drilling machinery. The SonoBlaster alarm was also intentionally activated at 12:45 p.m. (Figure 46). Workers were approximately 250 feet away from the alarm and not using any powered machinery.
