**The Effects of PET-Lined and Epoxy-Coated Lead and Copper
Service Lines on Metals Leaching, Total Organic Carbon,
and Chlorine Residual in Drinking Water**

Submitted to the graduate degree program in Environmental Engineering and Science and the Graduate Faculty of the University of Kansas in partial fulfillment of the requirements for the degree of Master of Science in Environmental Engineering

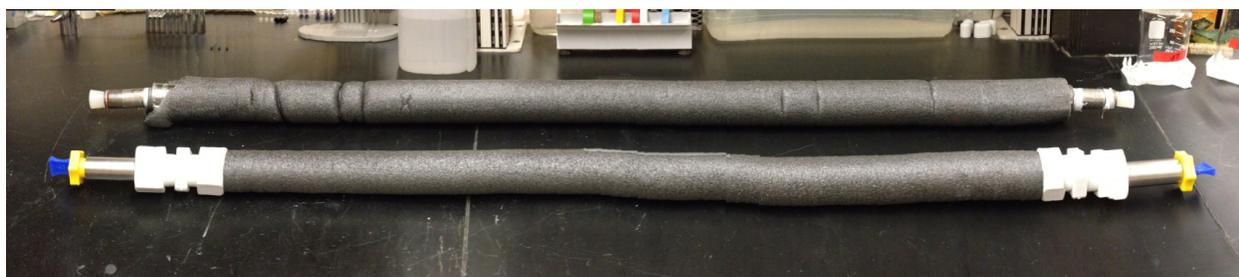
Figure 1: Image of fully prepared pipe specimens. On the top, a LSL with threaded SS nipples and silicone stoppers. On the bottom, a CSL with unthreaded SS pipe nipples connected with polypropylene compression fittings and fitted with HDPE stoppers.

Approximately 100 year old lead pipe sections, 3.5 to 4 ft. long with 5/8 in. inner diameter (ID), with the exception of two having a 1/2 in. ID, were procured from a water utility (the Rochester, N.Y. Water Bureau) that had recently removed them from service. Some pipes were excavated, but most were pulled from the ground by inserting a chain through the pipe's length and securing it on the end. This process has the potential to damage the inner pipe as the chain rubs against it. The whole pipe can also be damaged due to the compressive and tensile stresses that pulling the pipe through a resistant soil can place on the ductile lead. Consequently, the pipes were inspected for damage once received, and those showing signs of damage were set aside and not used. The external surfaces of the pipes were then cleaned using tap water to remove excess dirt. After drying, the pipes were wrapped with duct tape to minimize potential contamination from handling the outer surfaces. To prevent extraction water from coming into contact with the end of the lead pipe while being poured out over the lip of the pipe, stainless steel (SS) end fittings were installed on both ends of each pipe, as shown in Figure 1.

The ends of each LSL pipe specimen were reamed and then threaded with a ½ in. nominal die. After wrapping three times with PTFE tape (Poly-Temp® XHD, Anti-Seize Technology, Inc., Franklin Park, Ill., meeting C.I.D. Spec A-A-58092), ½ in. ID (nom., about 5/8 in. actual ID) by 2-½ in.-long 316 SS threaded pipe nipples (Part No. 1XAB2, Grainger, www.grainger.com, meeting ASTM Standard A733) were installed on both ends of each LSL pipe specimen. Before installation, the nipples were scrubbed with a stiff brush to remove any remaining grease residue from the manufacturing process, rinsed with warm tap water, then agitated and soaked in hexane for at least 5 minutes. SS hose clamps (Breeze Aero-Seal® Model 200 12H, Norma Group, Auburn Hills, Mich.) were installed over the pipe ends and nipples to tightly secure the nipples and decrease leakage. The pipes were then wrapped in foam insulation to minimize any damage from shipping and handling and to provide an extra layer of protection from surface lead contamination.

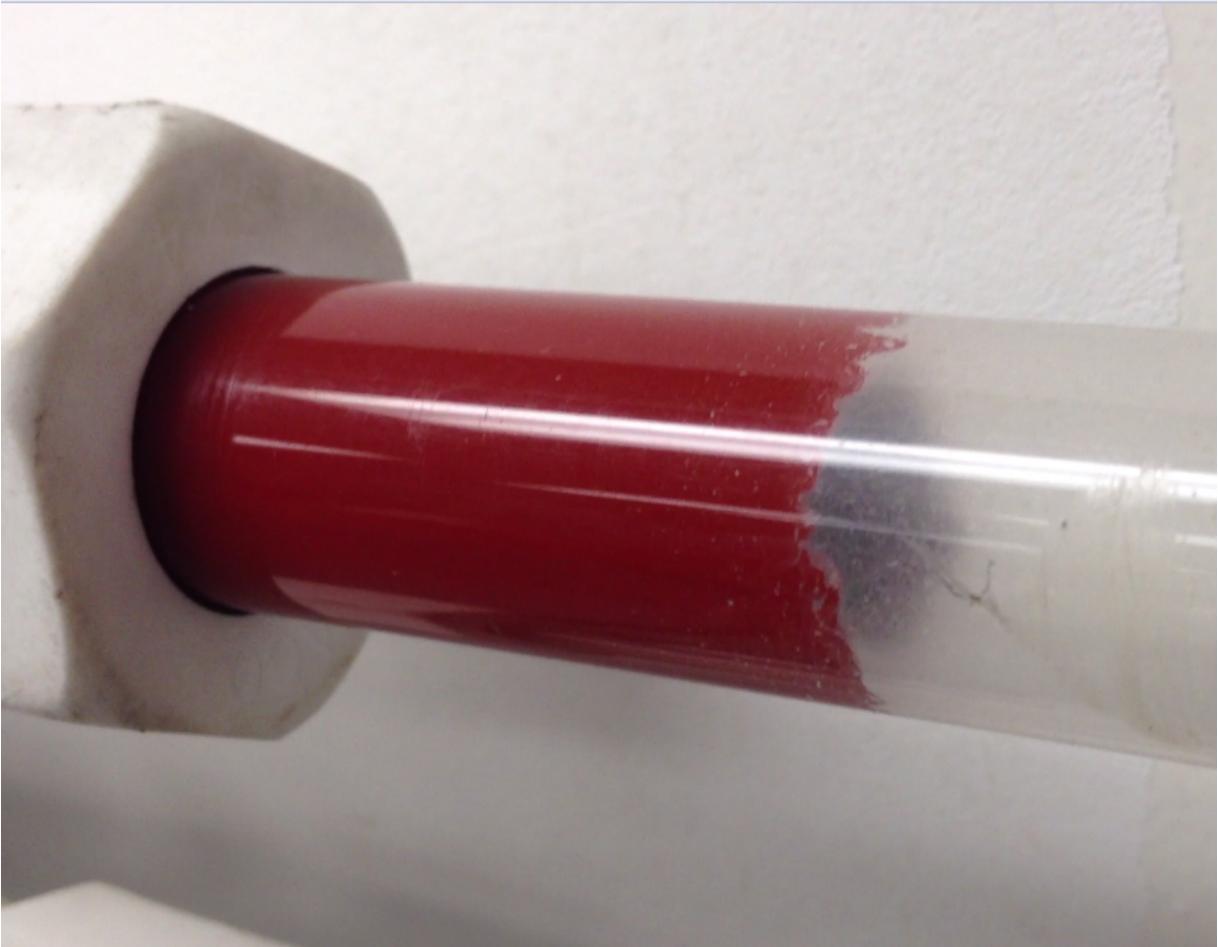
Figure 2: Image of epoxy coating as it is being installed through transparent acrylic pipe

loop that allowed the epoxy to pool at the bottom as it was connected to the pipe. The other end of the epoxy filled loop was connected to the air flow system. Air pressure and flow were applied to spread the epoxy along the inner walls of the pipe. The amount of air pressure and flow were determined by the inner diameter and length of the pipe. Looking through the acrylic pipe makes the coating process easy to see, as shown in Figure 2. The epoxy is not a slug of liquid being pushed through the pipe. Instead, a channel of air flows through the liquid, creating a vortex. The epoxy is then spun into the wall of the pipe as a uniform leading edge moves along the length of the pipe.

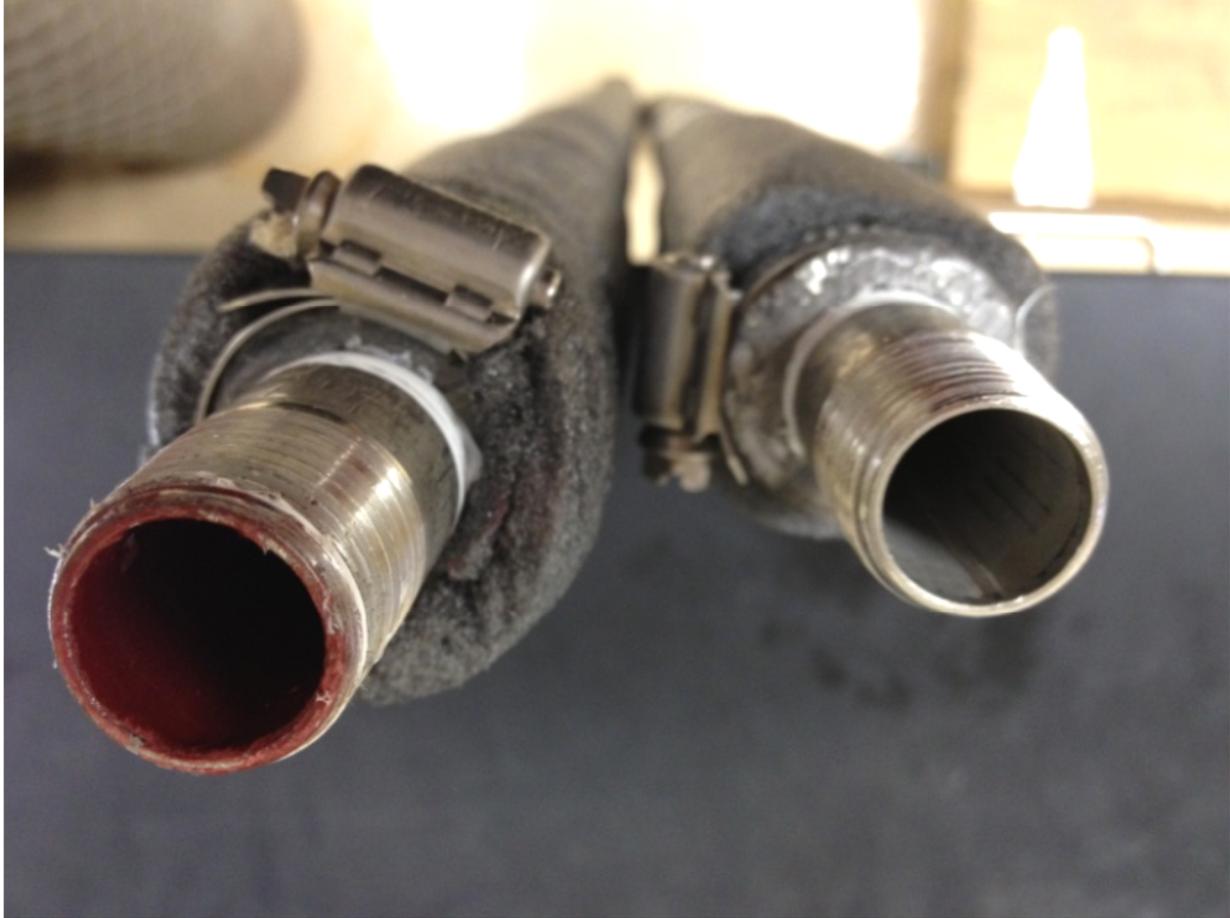
Figure 3: Image comparing an epoxy-coated LSL (left) to an uncoated LSL (right)

Once the epoxy was installed, all connections from the Nu Flow equipment were unhooked, which must be done before the epoxy dries. The unthreaded SS nipples were re-attached to the copper pipes. In the field, air would be blown through the pipes for an additional 2 – 3 hours, expediting curing and minimizing pooling effects. As this demonstration involved 9 separate connections (one for each pair of pipes), the air flow could not be reasonably continued for that long. Therefore, the pipes were hung vertically on a rack and allowed to cure. One coated and one uncoated LSL (used as a control) are depicted in Figure 3 to compare the pipes before and after epoxy coating.

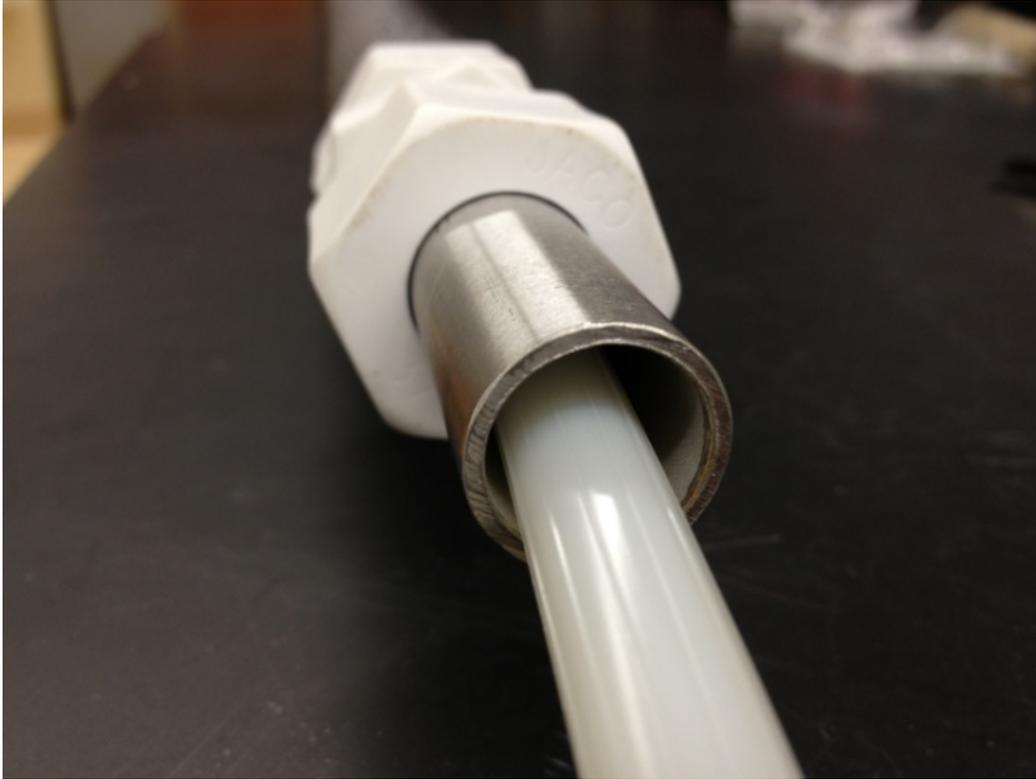
Figure 4: Image of an unexpanded PET liner being inserted into an unthreaded SS nipple attached to a CSL specimen

The PET liner installation was not witnessed in person, but consists of inserting an unexpanded liner into the pipe then applying pressure in the form of hot water or air to expand the liner until it fits tightly against the inner wall of the pipe, as explained in further detail in Chapter 2. A sample of unexpanded PET liner, acquired from Flow-Liner Systems, can be seen in Figure 4 protruding from an unthreaded SS pipe nipple attached to a CSL specimen. One lined and one unlined LSL (used as a control) are depicted in Figure 5 to compare the pipes before and after the PET liner installation.

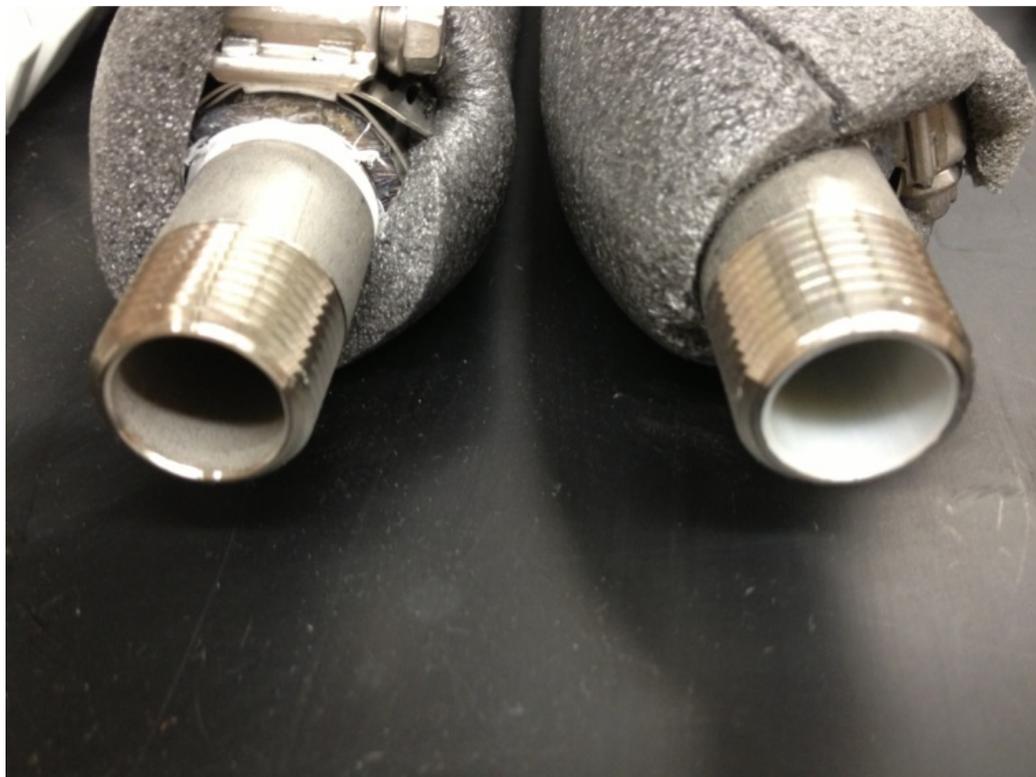
Figure 5: Image comparing an unlined LSL (left) to a PET-lined LSL (right)

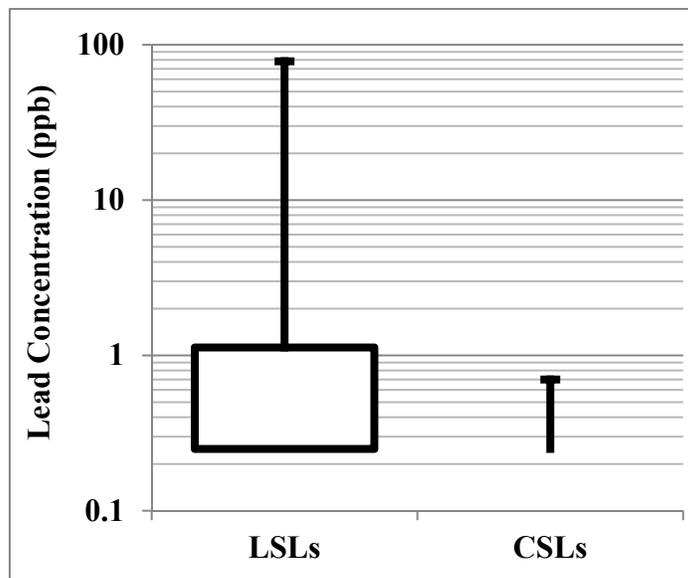
Figure 6: Lead concentrations in samples collected from epoxy-coated pipe specimens

Of the 27 samples collected from coated LSLs, only one had a lead concentration (78 $\mu\text{g/L}$) exceeding the AL of 15 $\mu\text{g/L}$. Another sample contained 6.2 $\mu\text{g/L}$ Pb. The remaining 25 samples contained ≤ 3.8 $\mu\text{g/L}$ Pb, which is within the range reported for Lawrence tap water (ND - 9.9 $\mu\text{g/L}$) in 2011. Lead concentrations in sixteen of the samples were at the detection level (0.5 $\mu\text{g/L}$) or lower. Of the 11 samples with a detectable lead level, 7 were collected from the same pipe specimen, Pb05, which contains a large joint. The pipe specimen that held the sample that contained 78 $\mu\text{g/L}$ (Pb01) was reused twice to hold both pH 6.5 and chlorinated pH 8.0 extraction waters. In both cases, the lead levels measured were below the MDL. If the epoxy was unsuccessful at blocking lead release in pipe specimen Pb01, lead should have been detectable in subsequent tests. Furthermore, since lead is seen in significantly lower levels in all other samples from all other pipe specimens, it is reasonable to conclude that the 78 $\mu\text{g/L}$ Pb measured in one sample was the result of contamination.

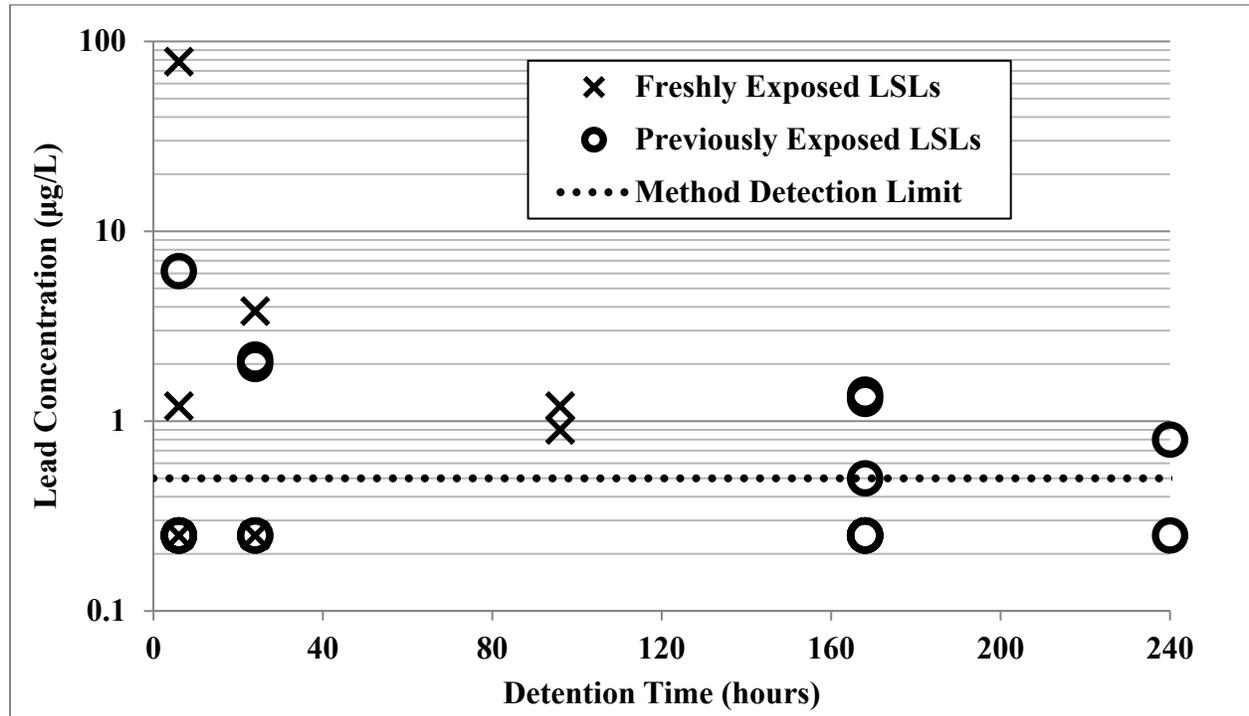
Figure 7: Lead concentrations in samples collected from coated LSLs

Figure 7 displays lead concentrations in samples collected from just the epoxy-coated LSLs (excluding the CSLs), separated into two groups: those exposed for the first time and those exposed in a previous test. Excluding the first sample collected from Pb01 (78 $\mu\text{g/L}$) as an outlier and all samples collected from Pb05 (discussed in more detail below), only 3 of remaining 6 samples collected from LSLs extracted for the first time contained detectable levels of lead, and the concentrations were quite low (1.2, 0.9, and 1.2 $\mu\text{g/L}$). These very low concentrations did not necessarily leach from or through the epoxy coating but could have resulted from surface contamination during the coating process that was not completely removed by flushing or from contamination introduced as the pipes and samples were handled in the laboratory. All 14 samples collected from previously exposed epoxy-coated LSLs, excluding samples collected from Pb05, contained lead below the MDL (0.5 $\mu\text{g/L}$). Thus, if leachable lead was initially present in any of the epoxy-coated LSLs, it was either removed by the 15-min. flushing or removed or passivated the first time the LSLs were extracted. Similar results would

LSL specimen Pb05 is the only specimen that consistently produced samples containing detectable levels of lead (3.8, 0.8, 2.1, 1.4, 6.2, 2.0, and 1.3 µg/L), which is why this specimen was repeatedly sampled. As with all coatings, the application of epoxy carries a potential for defects. These defects can potentially propagate larger breaches in the coating surface, allowing water to contact lead surface and contribute to further corrosion of lead. There is a possibility that the epoxy never fully coated a portion of pipe Pb05, perhaps at the large solder joint (having a diameter approximately twice that of the rest of the pipe) located approximately half-way down its length. However, the pipe was carefully inspected with a pipe camera, both initially by the manufacturer (at the time the pipe was coated) and later by the author, and no defects were visible near the joint. A possible defect was visible (in the post-experiment inspection) at one end of the pipe where there appeared to be a very thin line of exposed metal that travelled the circumference of the SS nipple/lead pipe junction. This could explain the continued occurrences of detectable lead levels seen in samples collected from Pb05. Disturbing the SS nipple with enough shear force or torsion could compromise the epoxy in such a manner as to crack along the nipple/pipe junction. This could have occurred during the flushing procedure. In order to create a water-tight manifold to flush multiple pipe specimens at a time, female-to-female threaded fittings were installed to connect the SS nipples of two LSLs. Excessive twisting of the connecting fitting could have transferred enough torsion to the coated epoxy via the SS nipples to cause a crack. If the epoxy did not fully coat the inner pipe wall or was compromised, it was still effective at significantly reducing lead levels compared to the uncoated lead pipe. However,

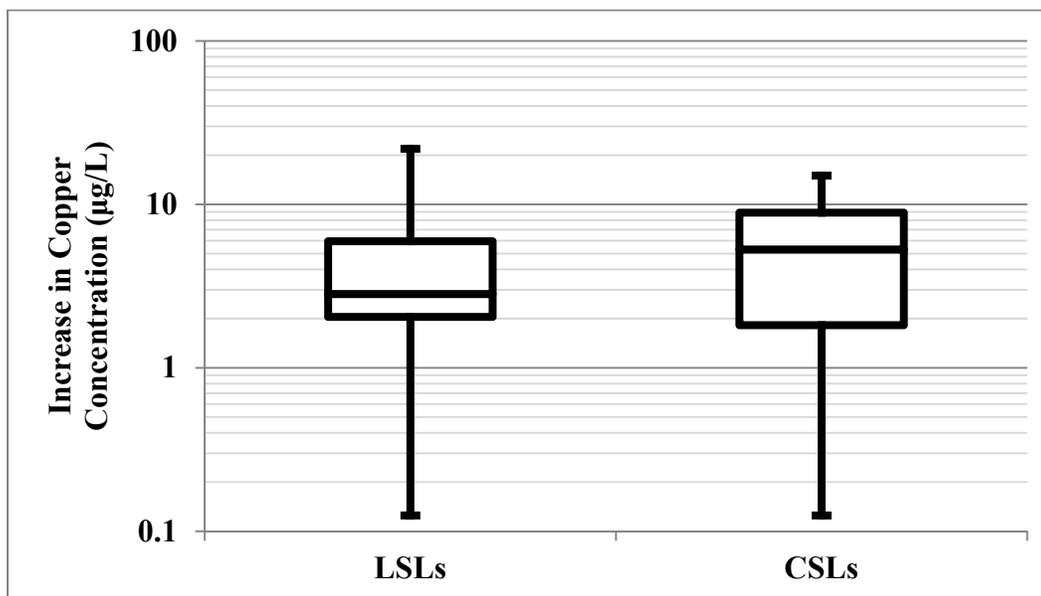
Figure 8: Increase in copper concentrations in samples collected from epoxy-coated pipe specimens

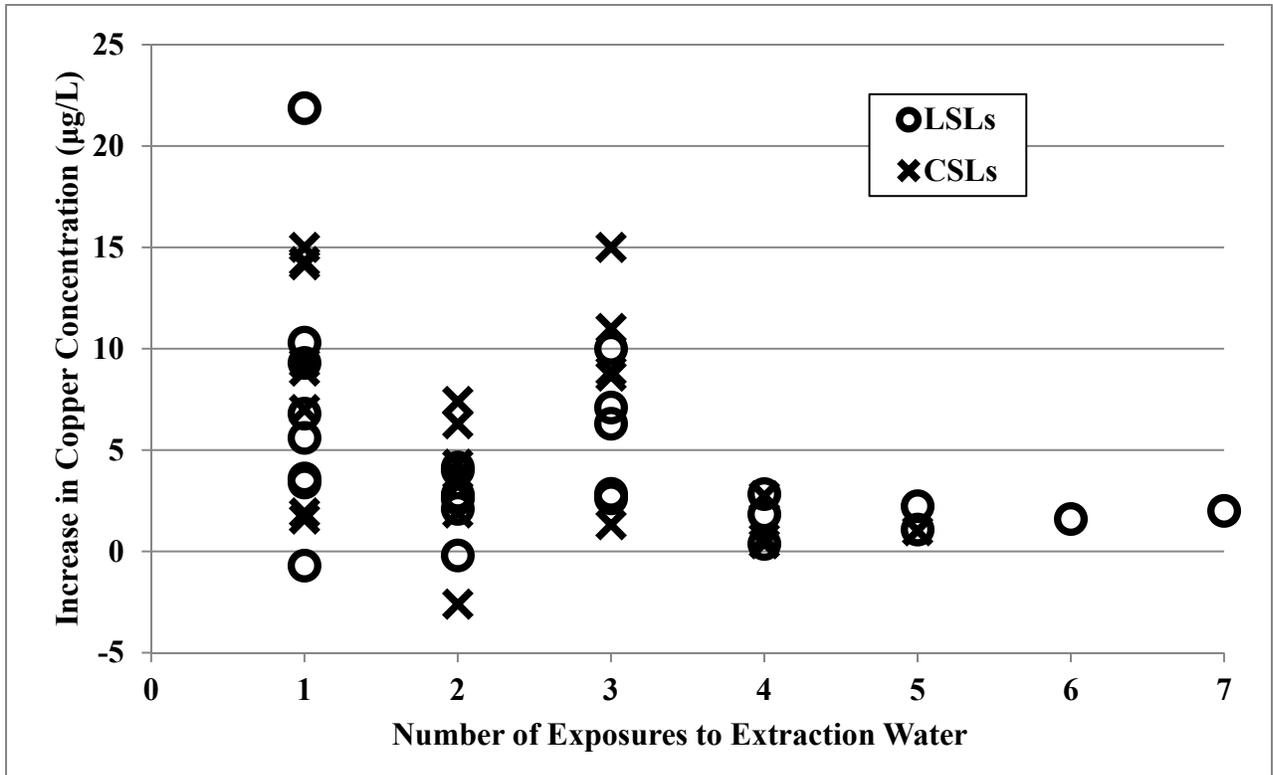
Figure 9: Increase in copper concentrations in epoxy-coated pipe specimens after sequential fill-and-dump tests

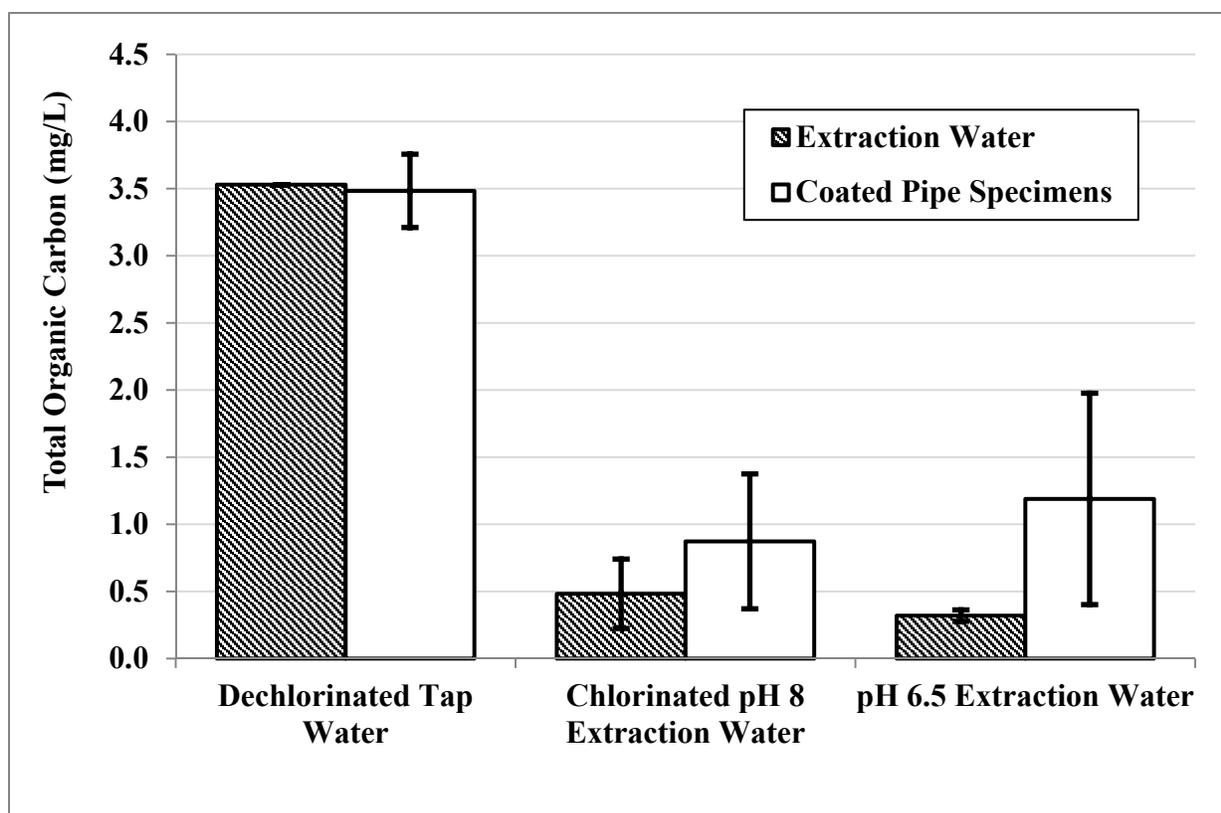
Figure 10: TOC concentrations in samples collected from epoxy-coated pipe specimens and reservoirs (Error bars represent SD)

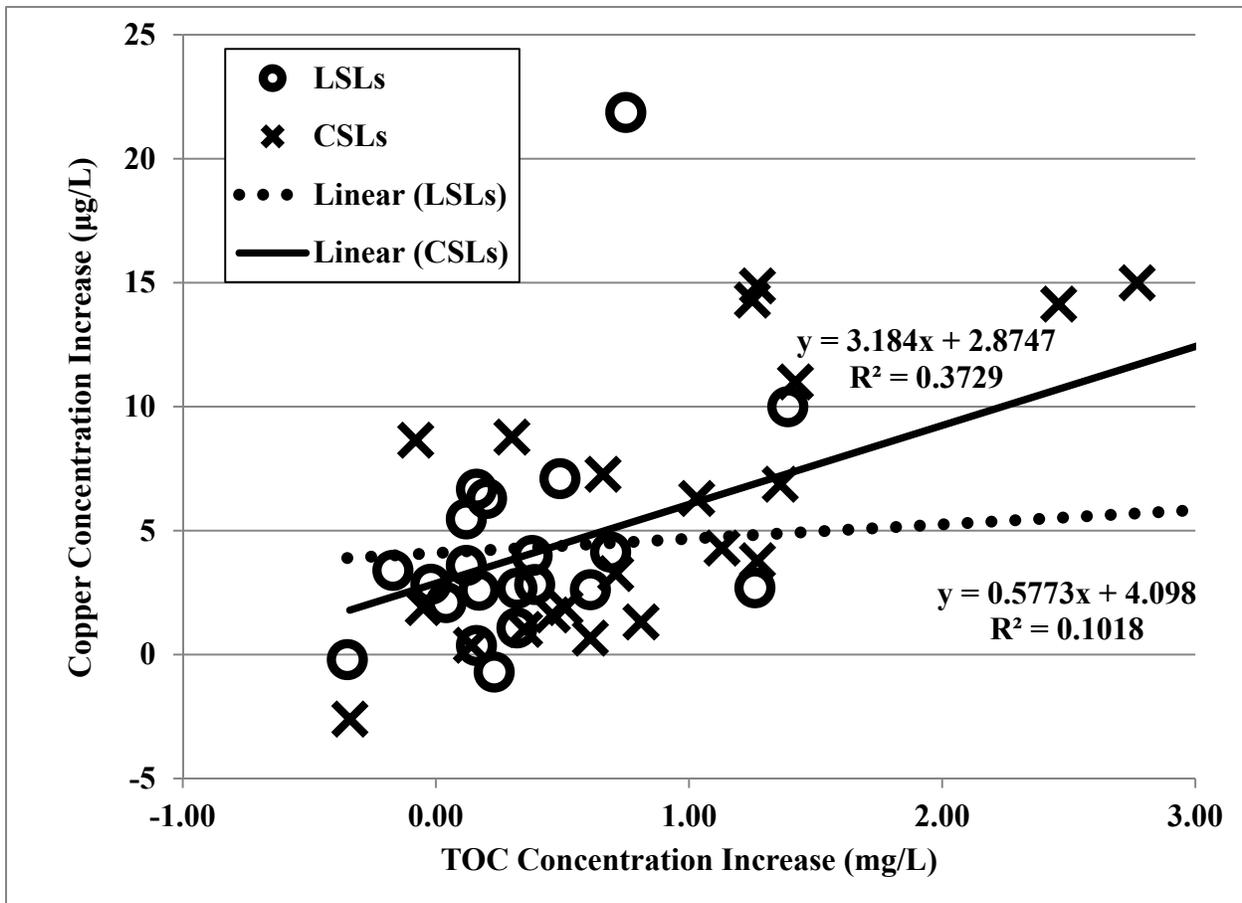
Figure 11: Relationship between TOC concentration increase and copper concentration increase in samples collected from epoxy-coated pipe specimens

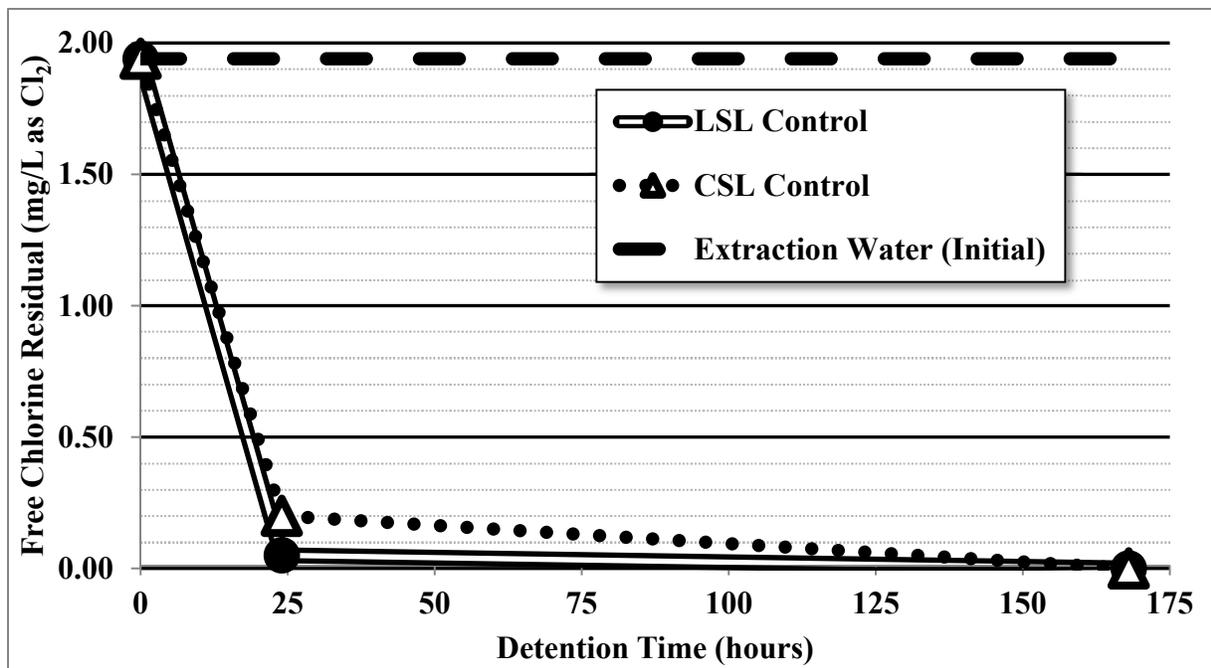
Figure 12: Free chlorine remaining in uncoated control pipes over time after exposure to chlorinated pH 8.0 extraction water dosed with sodium hypochlorite to an initial concentration of 1.94 mg/L free chlorine as Cl₂

from the epoxy-coated pipe specimens, the data for which can be found in Table 23 in Appendix D. The coated pipes consumed nearly all the free chlorine after 6 hours. The uncoated control pipes were not exposed to free chlorine for a 6 hour detention time, but consumed nearly all the free chlorine after 24 hours.

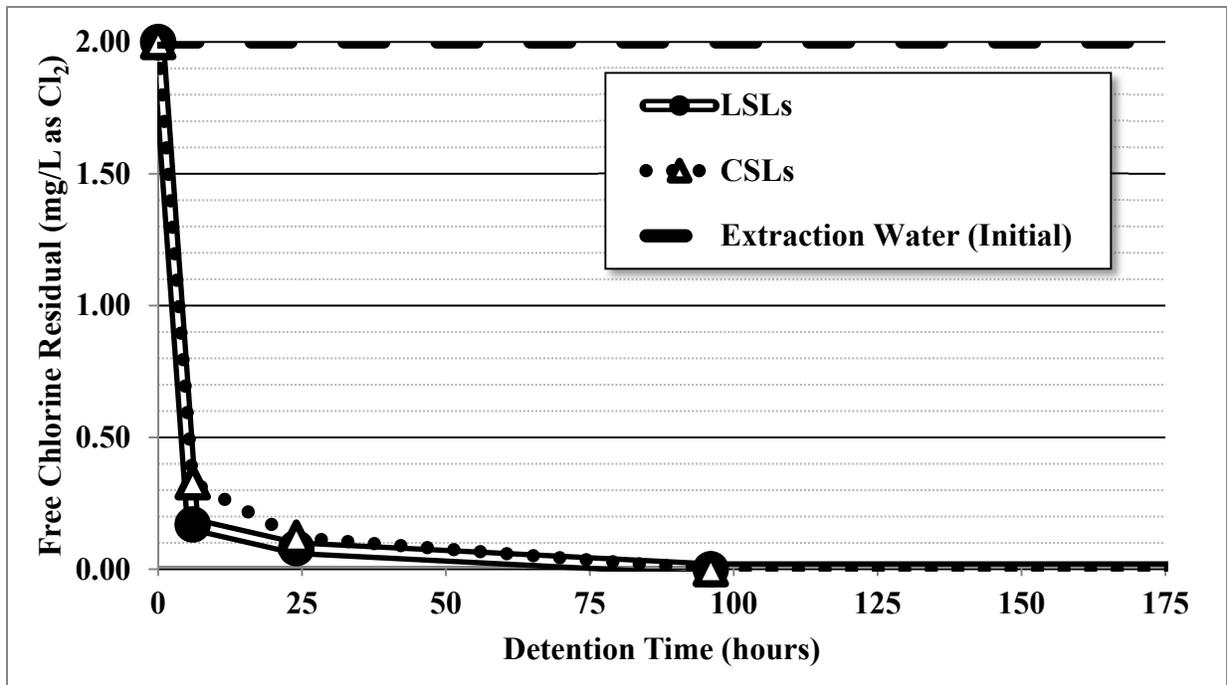
Figure 13: Free chlorine remaining in epoxy-coated control pipes over time after exposure to chlorinated pH 8.0 extraction water dosed with sodium hypochlorite to an initial concentration of 2.00 mg/L free chlorine as Cl₂

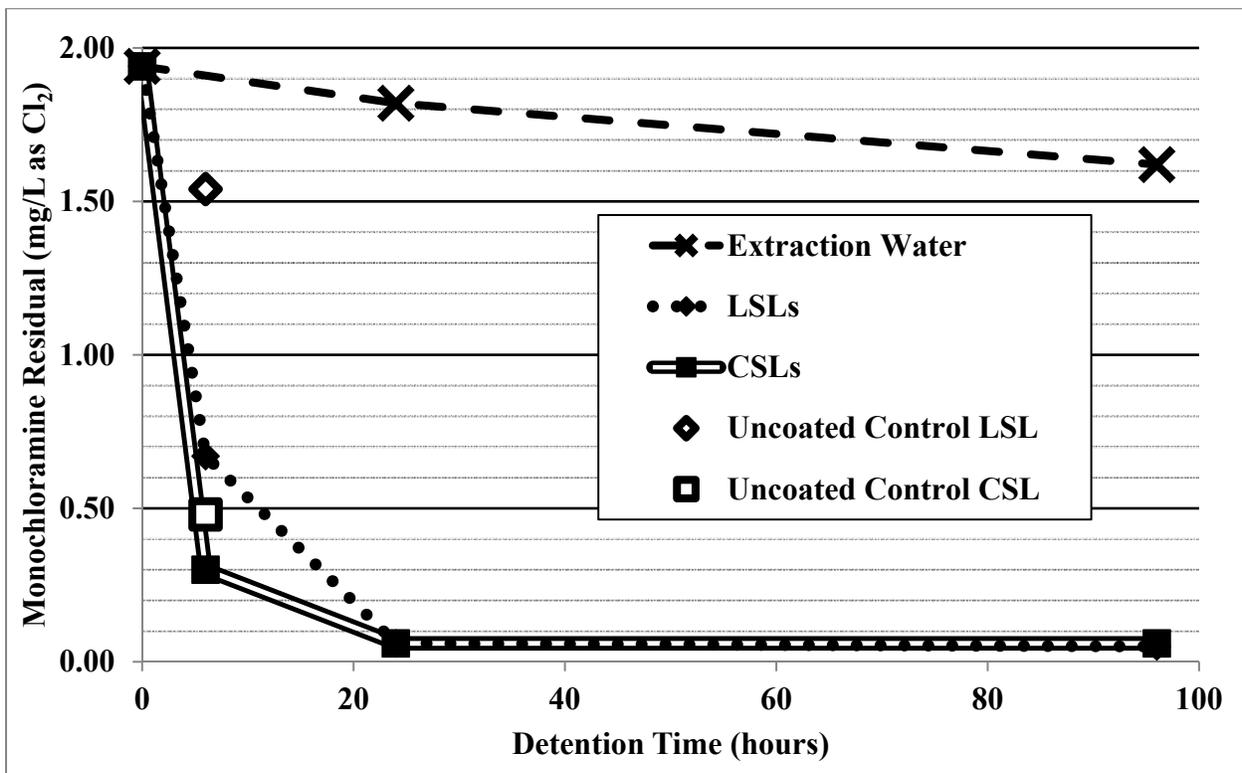
Figure 14: Monochloramine remaining in samples collected from epoxy-coated pipe specimens over time after exposure to pH 8.0 extraction water containing 1.94 mg/L combined chlorine as Cl₂

Remaining monochloramine concentrations in samples collected from epoxy-coated pipe specimens are displayed in Figure 14, the data for which can be found in Table 24 in Appendix D. The monochloramine concentration in the control sample (chlorinated pH 8 extraction water stored in a 4 L amber glass bottle) decreased 0.34 mg/L as Cl₂ after 4 days. The epoxy-coated pipes consume chlorine at a much faster rate, 1.3 mg/L as Cl₂ and 1.6 mg/L as Cl₂ after 6 hours in the epoxy-coated LSLs and CSLs, respectively. Comparatively, the uncoated control LSL consumed only 0.4 mg/L as Cl₂ after 6 hours. The uncoated control CSL consumed approximately the same amount of monochloramine as the coated CSL after 6 hours, 1.5 mg/L as Cl₂. The epoxy-coated pipe specimens' combined chlorine demand was much like their free chlorine demand, with nearly all the combined chlorine being consumed after 24 hours. The results indicate a reactive epoxy surface that initially consumes substantial amounts of chlorine.

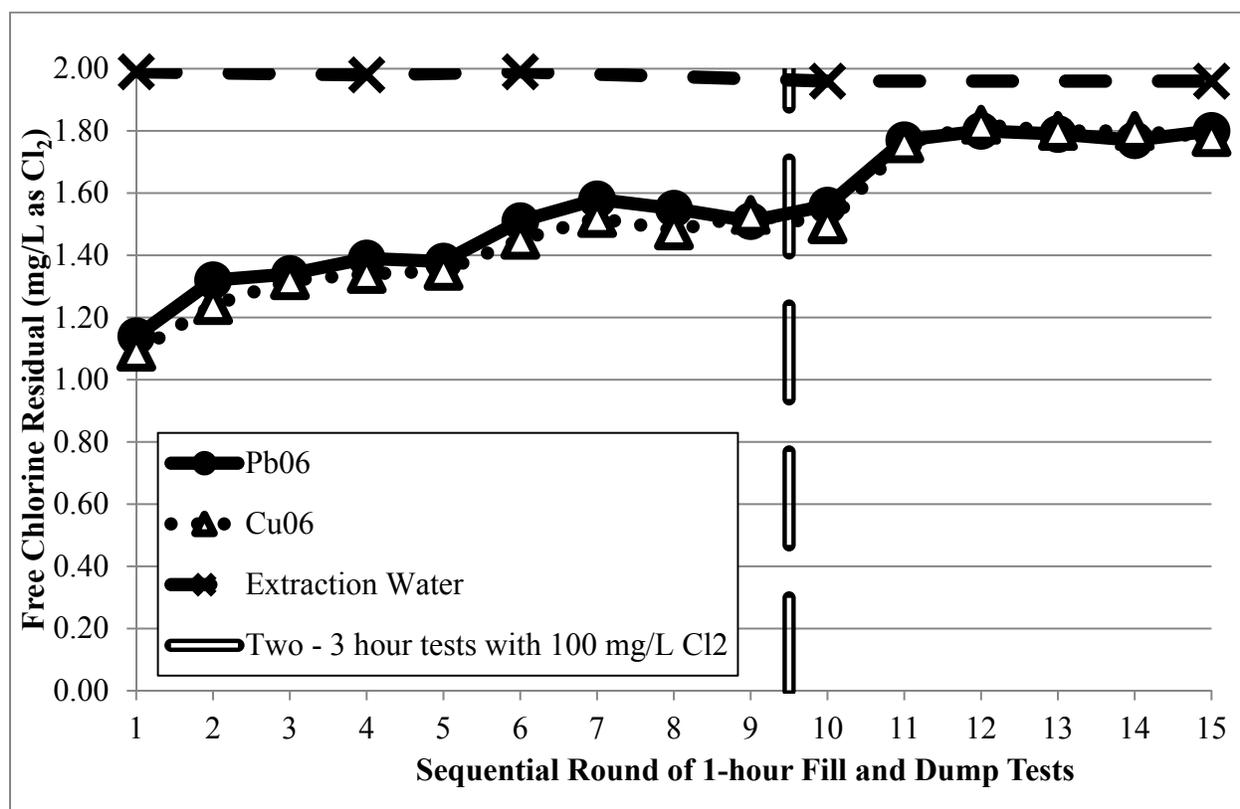
Figure 15: Free chlorine remaining after sequential 1-hour fill-and-dump experiments with chlorinated pH 8.0 extraction water dosed with sodium hypochlorite to an initial concentration of 2.00 mg/L free chlorine as Cl_2

In a series of 1-hour fill-and-dump tests sequentially exposing the same epoxy-coated LSL and CSL specimens (Pb06 and Cu06, respectively) to chlorinated pH 8 extraction water, the remaining free chlorine gradually increased with the number of tests conducted, as seen in Figure 15 (the values for which are listed in Table 25 in Appendix D). After nine 1-hour tests with 2 mg/L free chlorine as Cl_2 , two 3-hour tests were performed with 100 mg/L free chlorine as Cl_2 (Figure 16, the data for which are shown in Table 26 in Appendix D). The pipes were then subjected to 6 more sequential 1-hour tests with chlorinated pH 8 extraction water dosed with 2 mg/L as Cl_2 and then 3 more sequential 3-hour tests exposed to 100 mg/L as Cl_2 . After repeated exposure, the free chlorine demand stabilized at approximately 10% of the initial free chlorine concentration when exposed to either 2 mg/L as Cl_2 for 1 hour or 100 mg/L as Cl_2 for 3 hours.

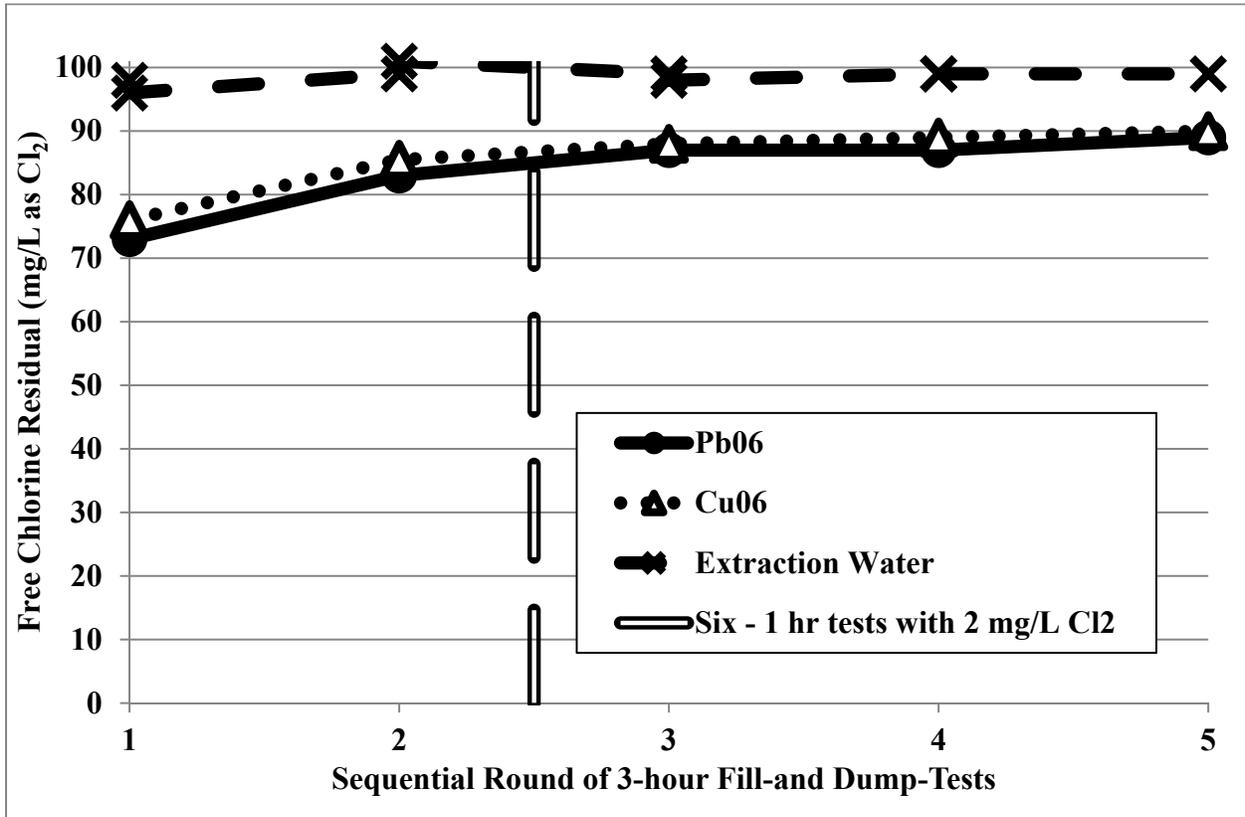
Figure 16: Free chlorine remaining after sequential 3-hour fill-and-dump experiments with chlorinated pH 8.0 extraction water dosed with sodium hypochlorite to an initial concentration of 100 mg/L free chlorine as Cl₂

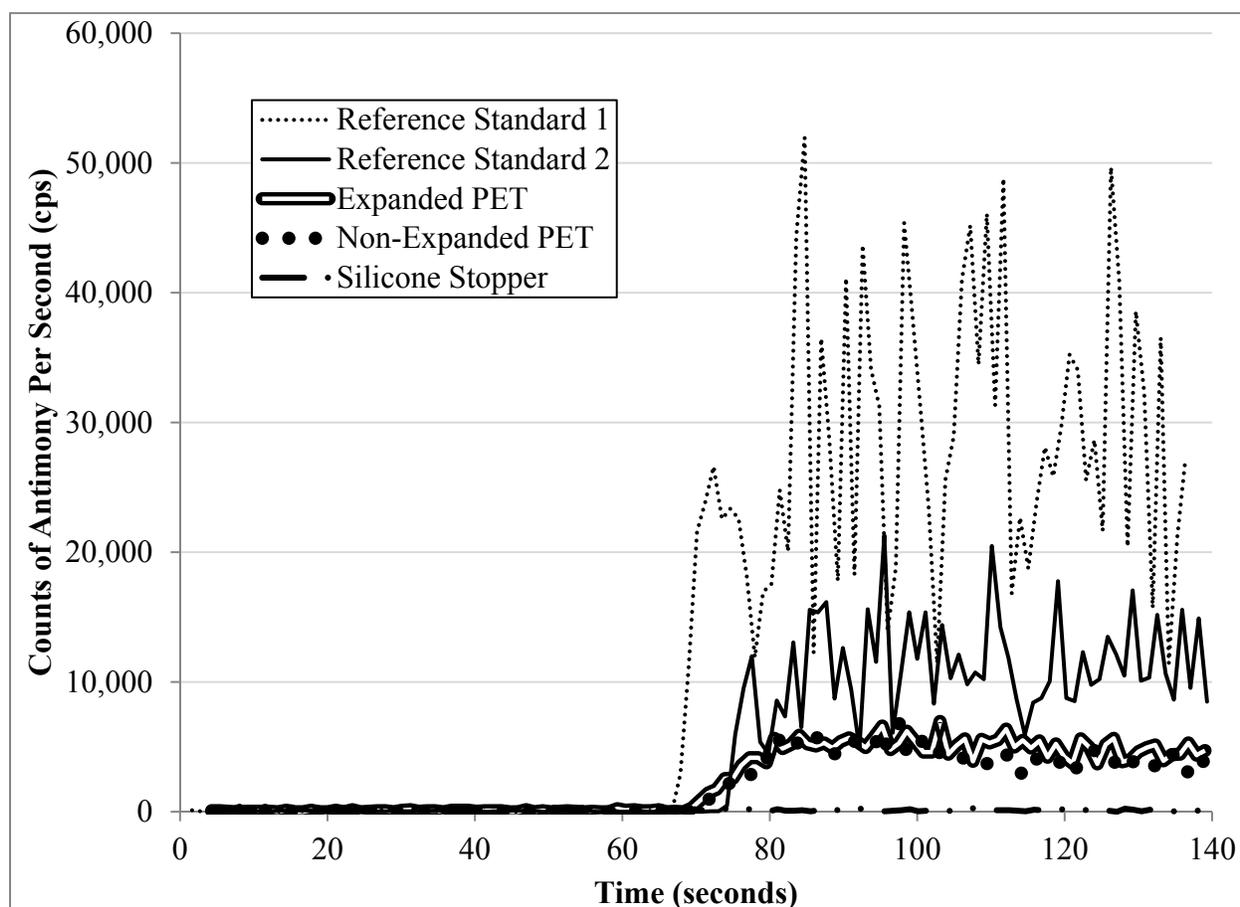
Figure 17: ICP-MS results for antimony in PET liner and silicone stopper using laser ablation

Analysis of the PET liner using ICP-MS and ablating the liner surface with a laser indicated the presence of antimony, as shown in Figure 17. However, the amount of antimony was not quantifiable using the ablation technique since the amount of liner drawn from the solid by the laser is itself unknown. Therefore, a digestion was performed on a known mass of liner to provide a sample from which could produce quantitative results. ICP-MS analysis quantified the average antimony concentration in the PET liner at 130 mg Sb/kg PET. This result is only slightly below the range of 190 – 300 mg/kg reported by Duh (2002), and represents a quantity that could potentially pose health risks if extensive leaching into drinking water were to occur.

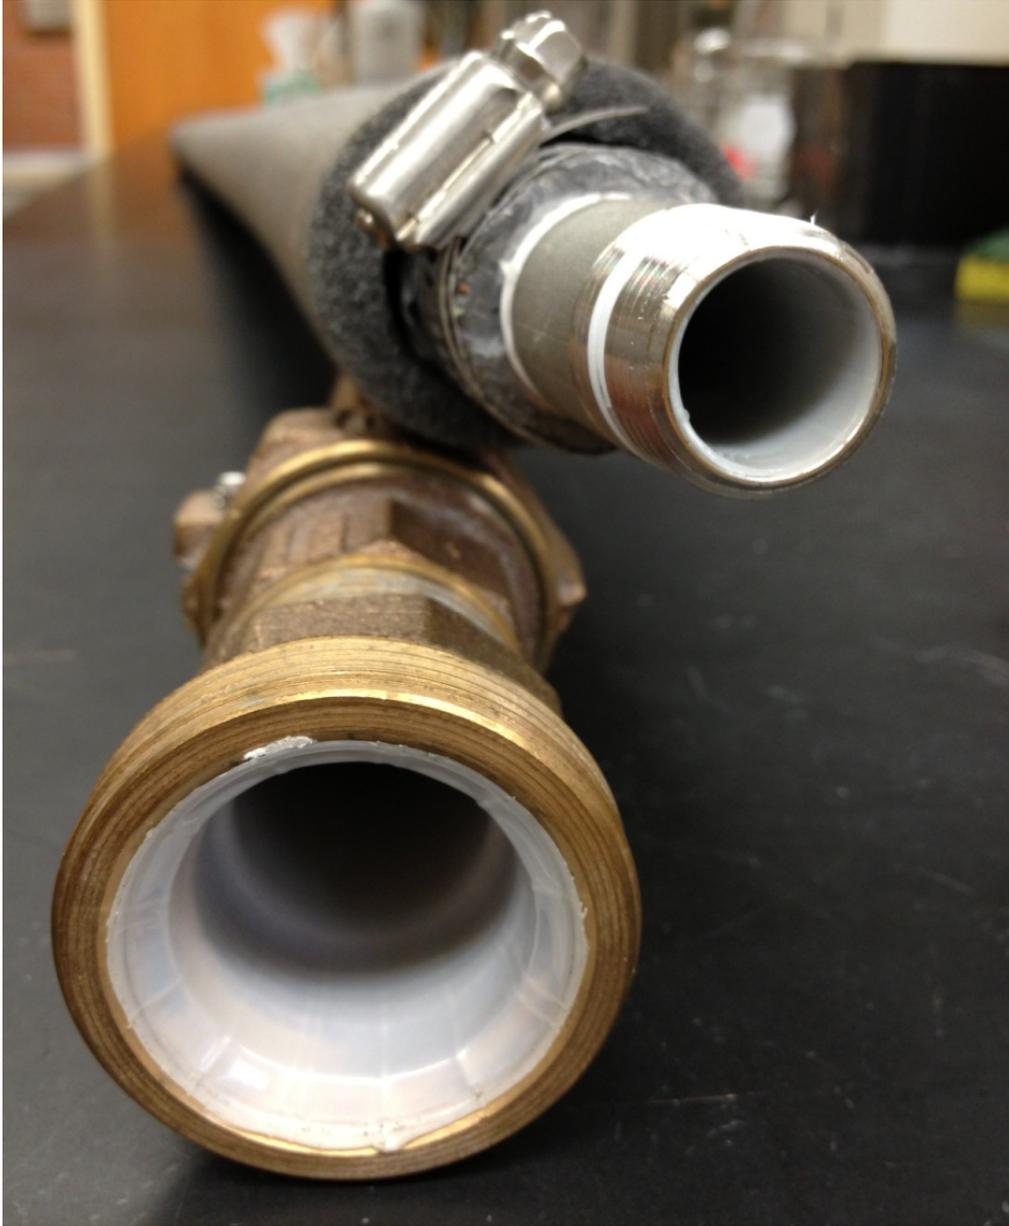
Figure 18: Image depicting the difference in PET-lined pipes with: SS nipple used in the fill-and-dump experiments (top) and flanged fitting properly designed to seal liner after expansion (bottom)

After investigation and discussions with the manufacturer, it became clear that the end fittings used in these experiments (the SS nipples) were incompatible with proper installation of PET liners. With SS nipples, the liner and pipe wall are parallel throughout the length of the pipe with no barrier to seal the liner. When water is flowing through the pipe, as was the case during the flushing procedure, there is nothing keeping the water from flowing behind the liner. When liners are installed in the field, a flanged end fitting is used, and the expanded liner is molded onto it (Figure 18), creating a physical barrier to stop water from flowing between the liner and pipe wall. Therefore, any lead and copper seen in the samples collected from the PET-lined pipe specimens could simply have circumvented the liner, so the results cannot be used as a measure of the PET liner's effectiveness to block lead and copper leaching. Therefore, the lead and copper data were deemed to have been compromised and were discarded. They will be replaced (in the on-going project this work is one part of) with data obtained using PET-lined specimens having proper end fittings that do not allow water to pass behind the liners.

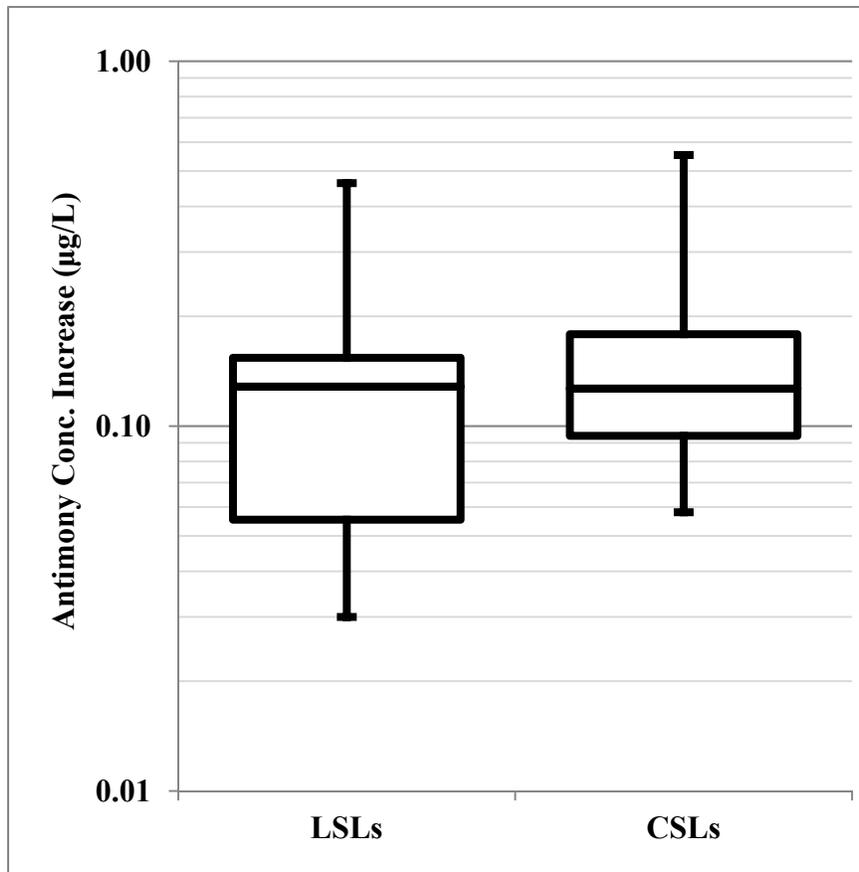
Figure 19: Antimony concentration increases in extraction water samples exposed to PET-lined LSL (n = 13) and CSL (n = 13) pipe specimens

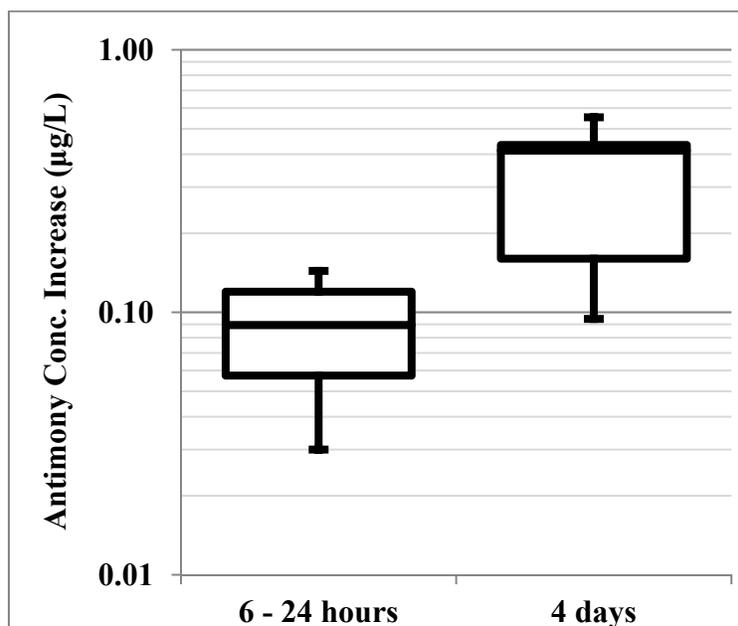
Figure 20: Antimony concentration increases in extraction water samples exposed to PET-lined pipe specimens for 6 – 24 hours (n = 16) and 4 days (n = 10)

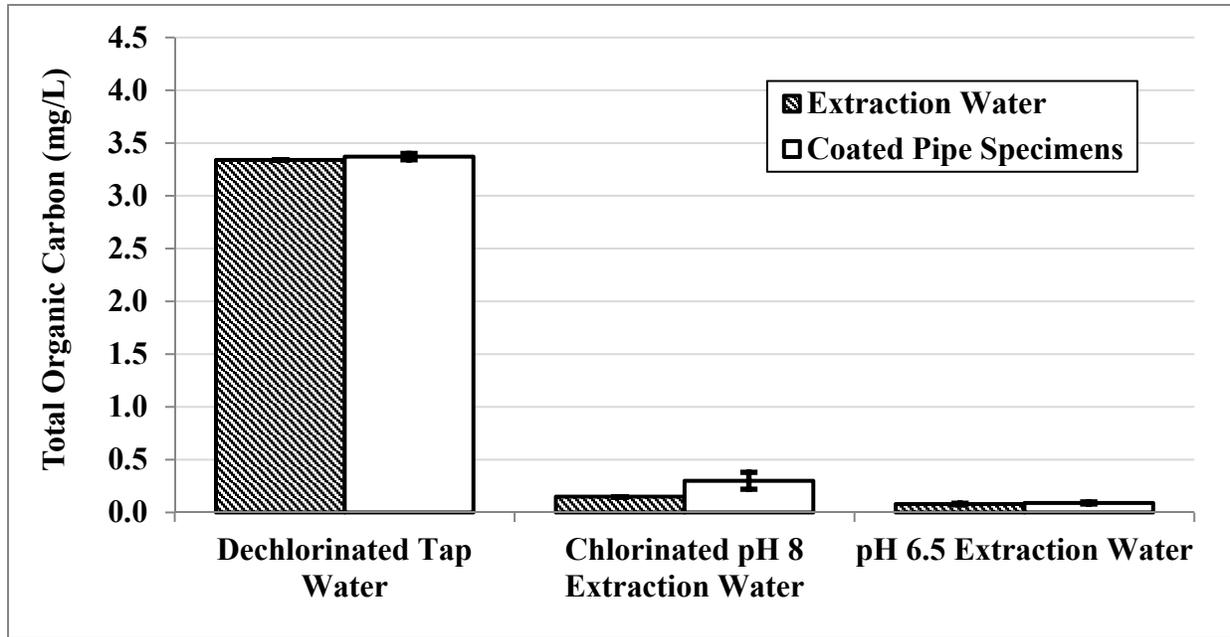
Figure 21: TOC concentrations in extraction waters and in samples collected from PET-lined pipe specimens (Error bars represent SD)
