**The Effects of PET-Lined and Epoxy-Coated Lead and Copper
Service Lines on Metals Leaching, Total Organic Carbon,
and Chlorine Residual in Drinking Water**

Submitted to the graduate degree program in Environmental Engineering and Science and the Graduate Faculty of the University of Kansas in partial fulfillment of the requirements for the degree of Master of Science in Environmental Engineering

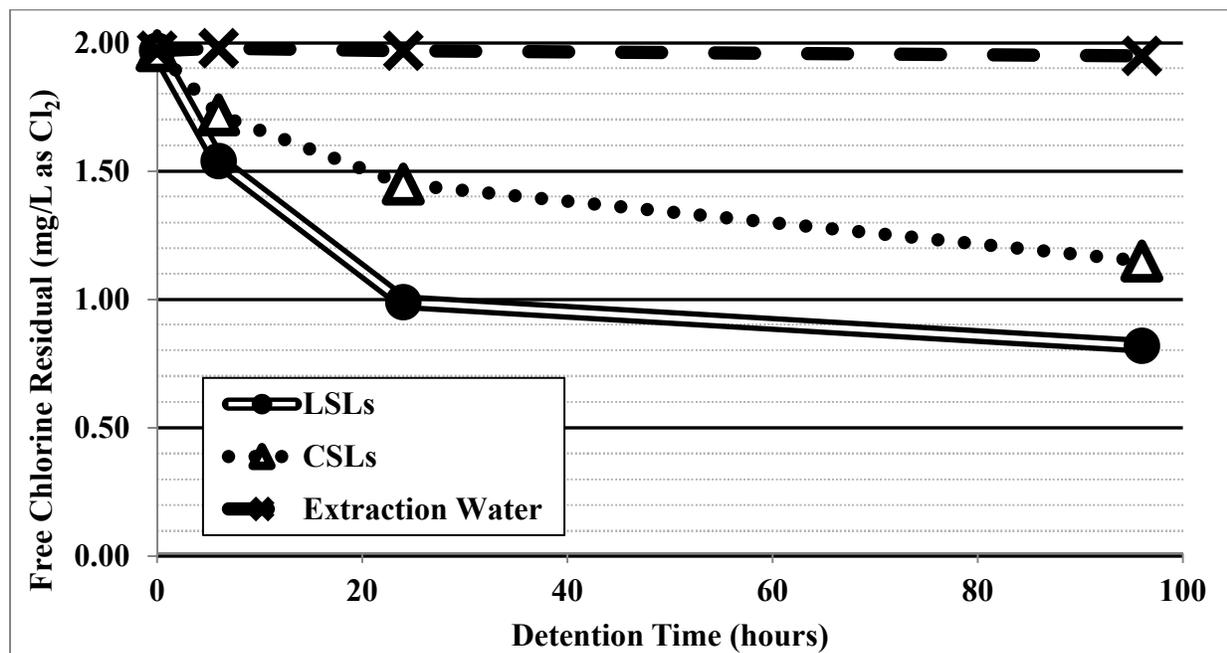
Figure 22: Free chlorine remaining over time in PET-lined pipe specimens exposed to chlorinated pH 8.0 extraction water dosed with sodium hypochlorite to an initial concentration of 1.97 mg/L free chlorine as Cl_2

Substantially less free chlorine was consumed in PET-lined pipe specimens than in unlined control pipe specimens when exposed to chlorinated pH 8.0 extraction water, as displayed in Figure 12 (control specimens) and in Figure 22 (PET-lined specimens), the data for which can be found in Table 30 in Appendix E. In the PET-lined pipe specimens, approximately half of the initial free chlorine of 2 mg/L as Cl_2 was consumed in 96 hours.

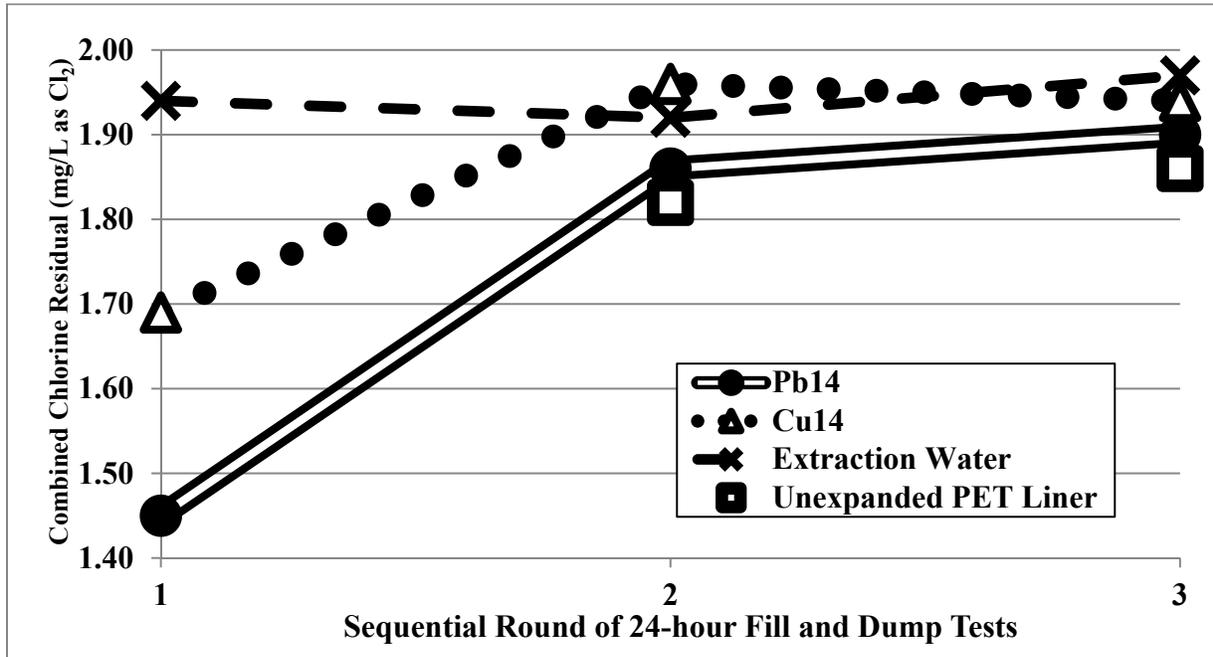
Figure 23: Free chlorine demand of PET-lined pipe specimens and extraction water after sequential 24-hour fill-and-dump experiments with chlorinated pH 8.0 extraction water dosed with sodium hypochlorite to an initial concentration of approximately 2.00 mg/L as Cl₂

Free chlorine demand diminished after repeated exposure to chlorinated extraction water, as seen in Figure 23. After three 24-hour fill-and-dump experiments with chlorinated pH 8.0 extraction water dosed with 2 mg/L free chlorine as Cl_2 , approximately 0.1 mg/L Cl_2 , or 5% of the initial free chlorine, was consumed in the PET-lined pipe specimens.
