LONG-TERM EFFECTS OF CONFIRMATION LIGHTS AND FACTORS THAT LEAD TO
RED LIGHT RUNNING

Submitted to the graduate degree program in Civil, Environmental and Architectural Engineering
and the Graduate Faculty of the University of Kansas in partial fulfillment of the requirements for
the degree of Doctor of Philosophy.

LONG-TERM EFFECTS OF THE RED-SIGNAL INDICATION LIGHT AND FACTORS
THAT LEAD TO RED LIGHT RUNNING

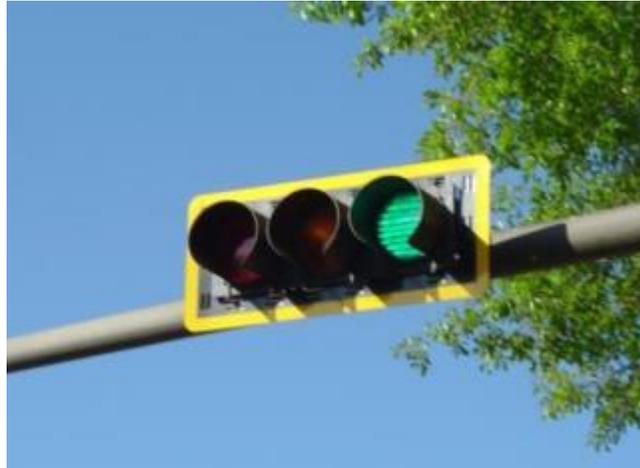
Another technique of making signal head conspicuous is to use retroreflective materials on the borders of backplates as shown in Figure 1.

Figure 1. Retroreflective backplate border (FDOT, 2014)

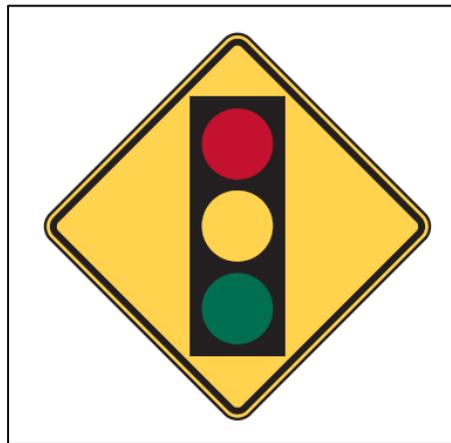
Advance warning signs gain the attention of road users to unexpected roadway conditions that might be not readily apparent to them. According to the MUTCD (2009), the “Signal Ahead” sign (W3-3) shown in Figure 5 can be used to alert drivers of the presence of a signalized intersection ahead.

Figure 5. W3-3 Signal Ahead sign (MUTCD, 2009)

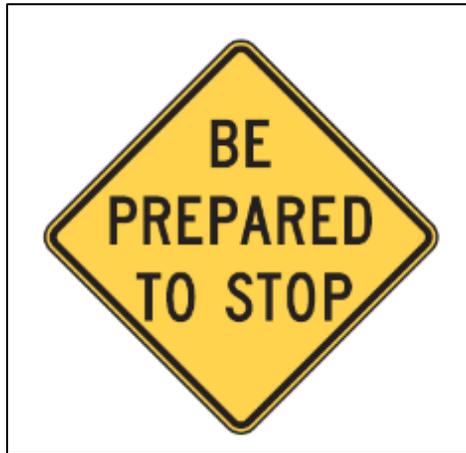
Another type of advance warning sign is the “Be Prepared To Stop” sign (W3-4) as shown in Figure 6.

Figure 6. W3-4 Be Prepared to Stop sign (MUTCD, 2009)

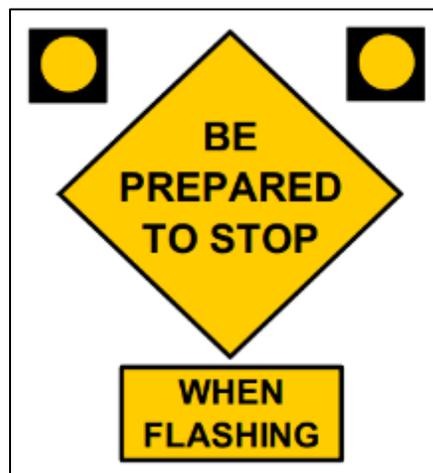
Flashing beacons and “When flashing” plaques (W16-13P) shown in Figure 7 can be added to this sign to alert drivers that the green light is about to change to red in few seconds (MUTCD 2009).

Figure 7 Be Prepared to Stop sign supplemented with flashing beacons (MUTCD, 2009)

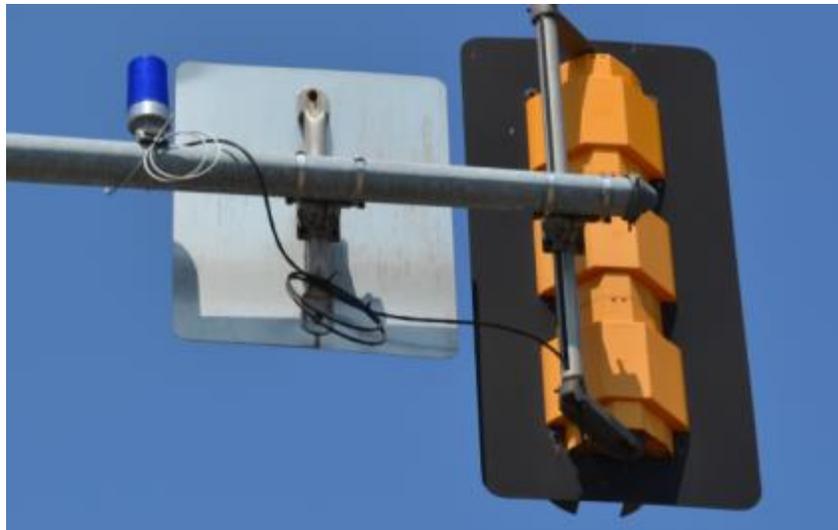
(a)

Confirmation lights are a relatively small, low-cost light mounted on the top or the bottom of a traffic signal head or mast arm. This light is sometimes referred to as “Red-Signal Enforcement Lights” or “Red Indication Lights” or “Rat Boxes” or “Tattletale Lights” (Hsu et al., 2009). The confirmation light activates simultaneously during the red signal phase to aid a police officer located downstream of the intersection in observing a RLR violation. After the confirmation light turns on, it is visible 360 degrees from any intersection approach. The confirmation light is wired directly into the red signal aspect and only activates when the red light is indicated as shown in Figure 8 a, b and c which shows confirmation lights in operation during the day and night times respectively.

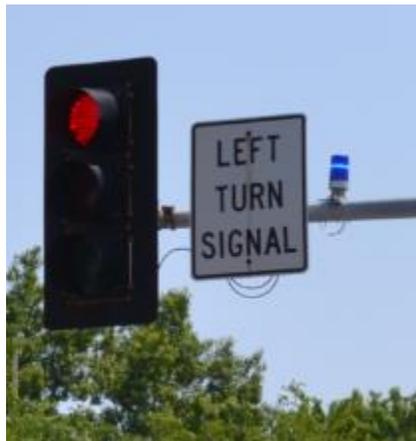
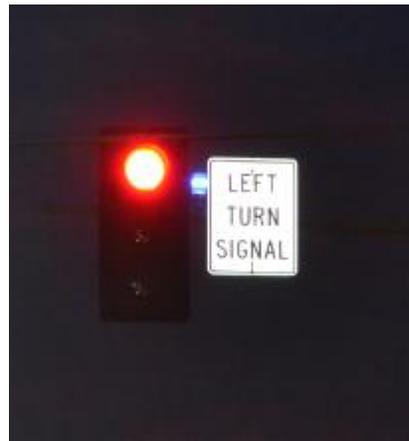
Figure 8. Blue confirmation light wiring (a), daytime operations (b), and nighttime operations (c)

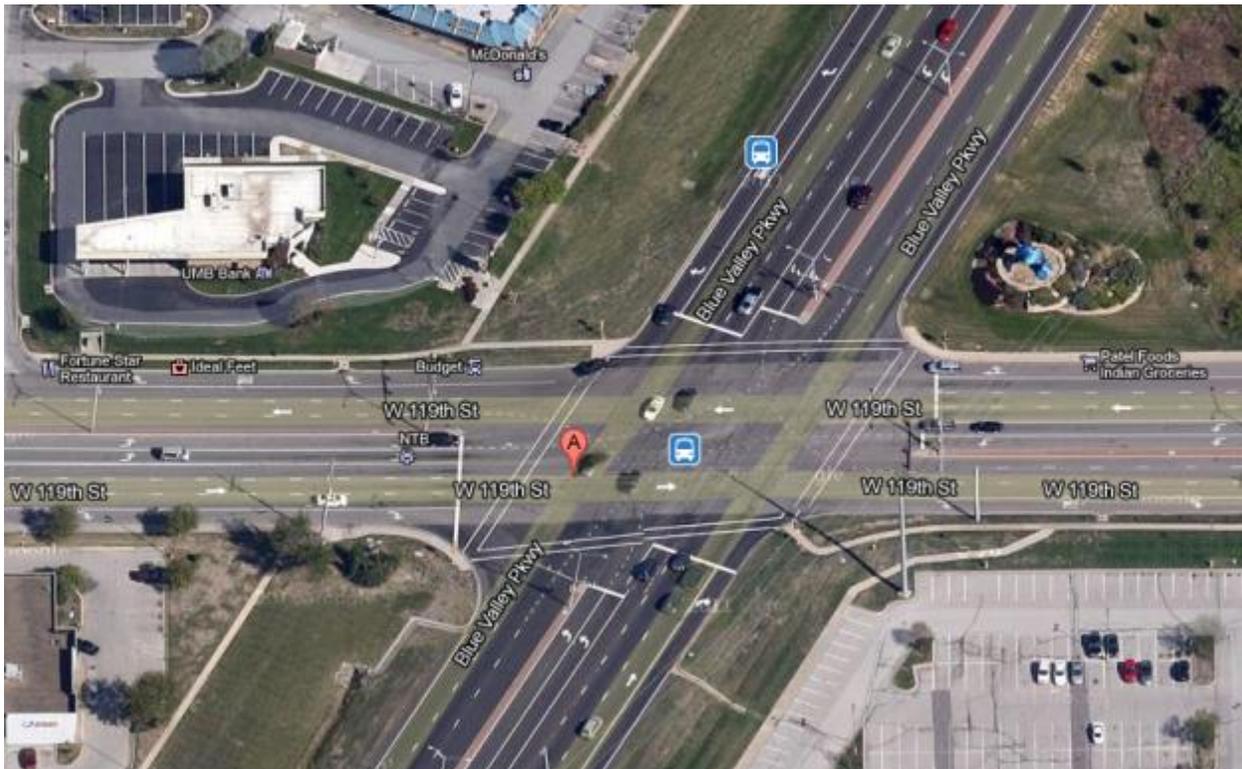
Figure 10. 119th and Blue Valley Parkway (aerial image, Google Earth, 2013)

The intersection at Blue Valley Parkway and West 119th Street accommodated heavy volumes of traffic during peak hours. For the northbound and southbound approach there were two left-turning lanes, three lanes for thru-traffic, and one right turn lane. For eastbound and westbound approaches there were two left-turn lanes, three through-traffic lanes and one right-turn lane. The intersection is shown in Figure 10.

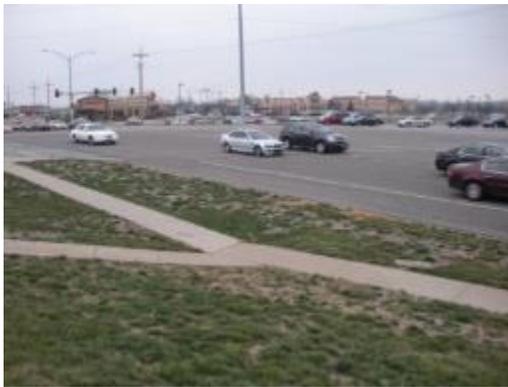
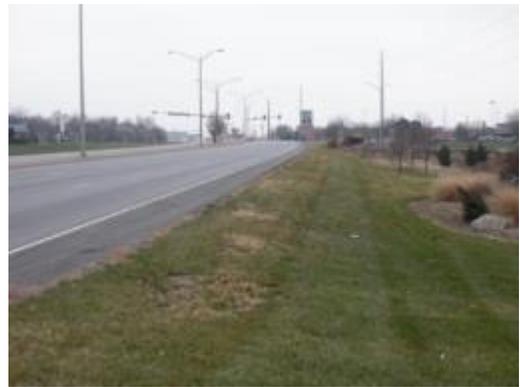
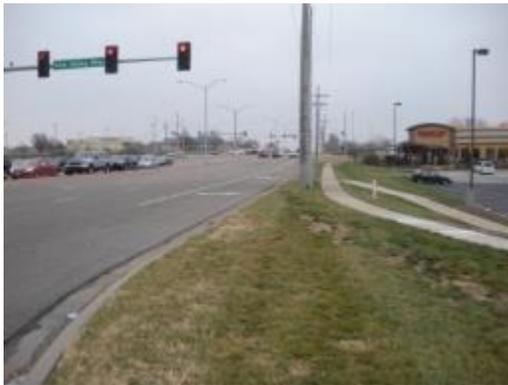
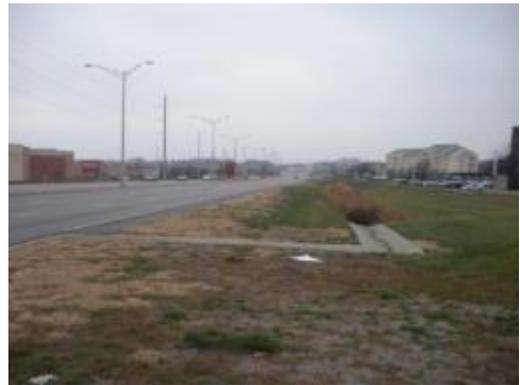
For northbound and southbound approaches there was a two-foot shoulder, some turf, and then a ditch. For the eastbound approach there were no shoulders or driveways. The street became a four lane road, with the right lane designated as a right turn only for people turning onto Metcalf Avenue. For westbound traffic, there was a driveway, however it was too narrow for a patrol car

to sit, therefore blocking the entrance to the bank and a restaurant. The shoulders of each approach are shown in Figure 11.

Figure 11. Shoulder for (a) westbound (b) northbound (c) eastbound (d) southbound approach at 119th Street and Blue Valley Parkway

Figure 11 (a) shows an area recommended by the police officer to monitor traffic if the confirmation lights were to be installed. The police car would be located exactly where the mast arm for westbound approach is located. This means that the officer could only enforce left-turning traffic, since the northbound mast arm is visible through the rear-view mirror, but not the westbound traffic. What could make enforcement more complicated is that the intersection

stop line was not visible, and the left-turning traffic was located approximately 10 feet behind the stop line for through movement traffic. Even if a delineator outlining the location of the stop line was to be placed on the street, the officer would have to multi-task and view three different locations in order to view a RLR violation. Figures 11 (b) and (d) show the shoulder for northbound and southbound traffic, respectively. There was approximately two feet of paved shoulder and then a slope. A concern raised by the officer was that most police officers are reluctant to sit on shoulders for enforcement. Figure 11 (c) shows the stretch of roadway for eastbound traffic, where there was no spot for the officer to sit far enough to watch the light, and watch traffic. Because of the limited areas for an officer to pull over and watch for violators this site was not chosen as a deployment site.

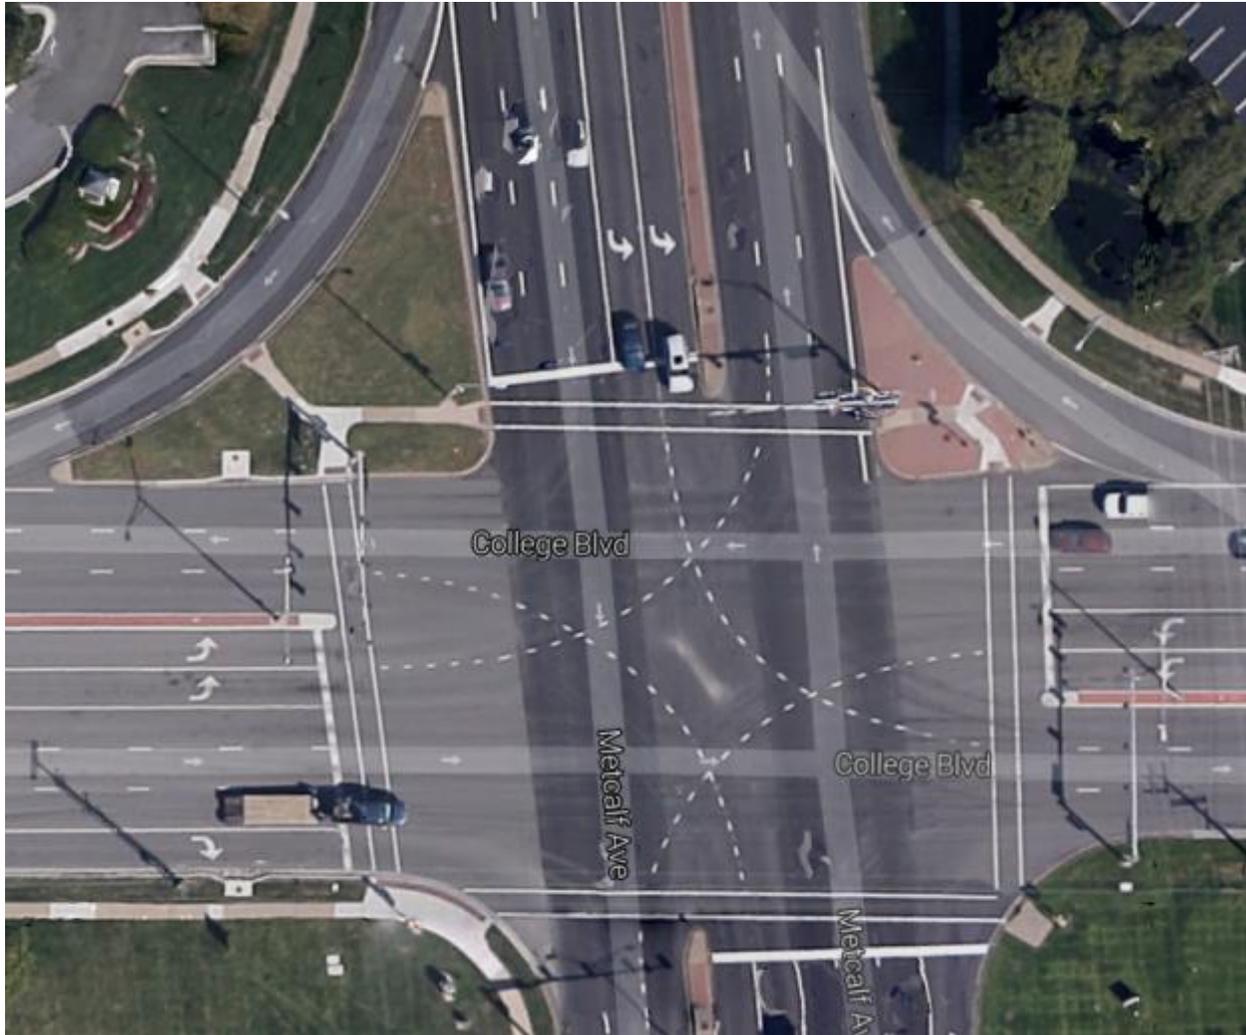
Figure 12. College Boulevard and Metcalf Avenue aerial view (Google images, 2013)

At College Boulevard and Metcalf Avenue the northbound and southbound were identified in the field as the approaches with the most RLR violations. The police officer pointed out that this was because of the long queues that form during rush hours. At rush hour, the southbound approach could be backed up all the way to 105th Street. There was also another traffic signal less than a quarter mile away, which made enforcement difficult because of the short proximity between signals. According to the police officer the westbound and eastbound approaches were a problem in the evening rush hour. Also, the proximity of adjacent traffic signals may affect driver behavior and promote RLR.

As was the case at 119th Street and Blue Valley Parkway, there were no convenient spots for a police officer to pull-over and enforce RLR with the use of confirmation lights. The lack of shoulders and the long queues during peak hours would also make it hard for officers to make violators safely pull over.

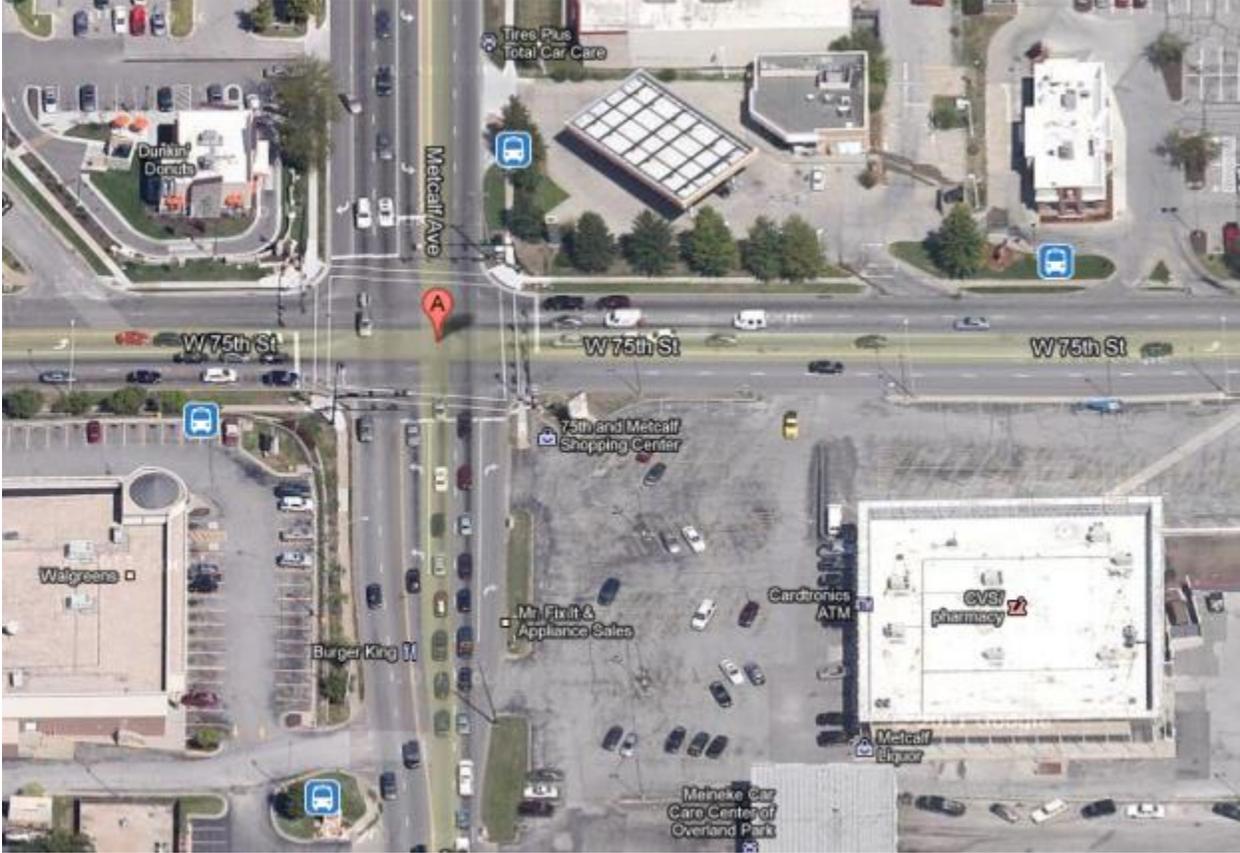
Figure 15. 75th Street and Metcalf Avenue (aerial image, Google Earth, 2013)

Metcalf Avenue is the north/south approach, and there was a designated left turn lane, a right turn lane, and two through lanes for both approaches. The speed limit at the south corridor of the intersection was 35 mph. The north end of Metcalf Avenue had a posted speed limit of 40 mph. The clearance path for traffic along Metcalf Avenue was 106 feet. Along 75th Street the posted

speed limit was 35 mph, and the clearance path was 110 feet. For the approaches along 75th Street there was one left turn lane, a through lane, and a shared through/right turn lane for each approach. Figure 15 shows an aerial view of 75th Street and Metcalf Avenue.

As shown in Figure 15, this intersection was located in a dense commercial district. There were convenience stores at the south end of the intersection, a gas station on the northeast corner, and a restaurant in the northwest corner. Left turns were protected on all approaches and right turns were protected for the northbound and southbound approaches. No U-turns were allowed for eastbound and westbound traffic. Figure 16 shows the signal heads on all approaches at the intersection.

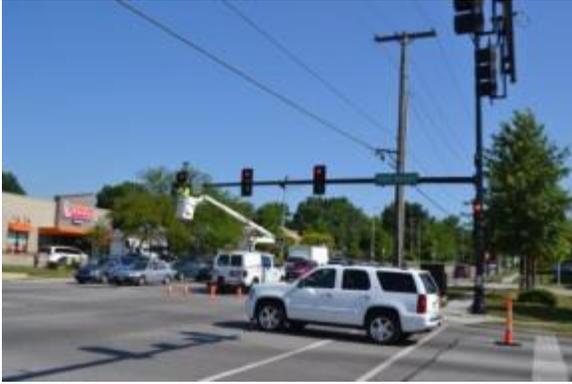
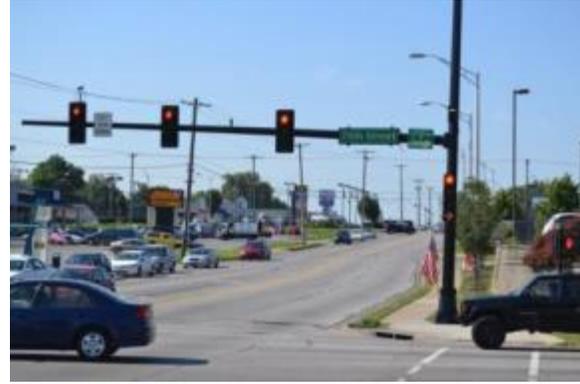
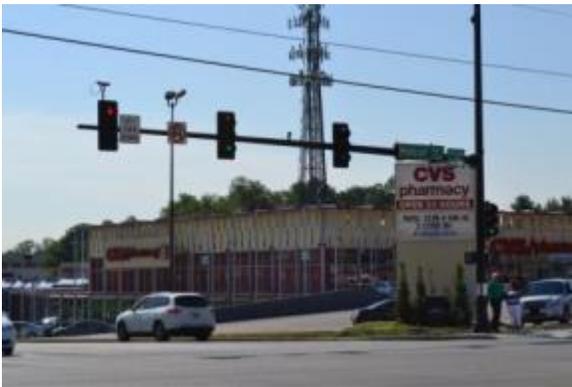
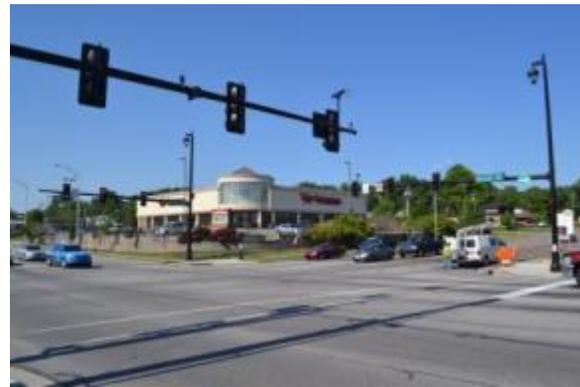
Figure 16. Signal mounting for 75th Street and Metcalf Avenue for (a) northbound (b) southbound (c) eastbound and (d) westbound approaches

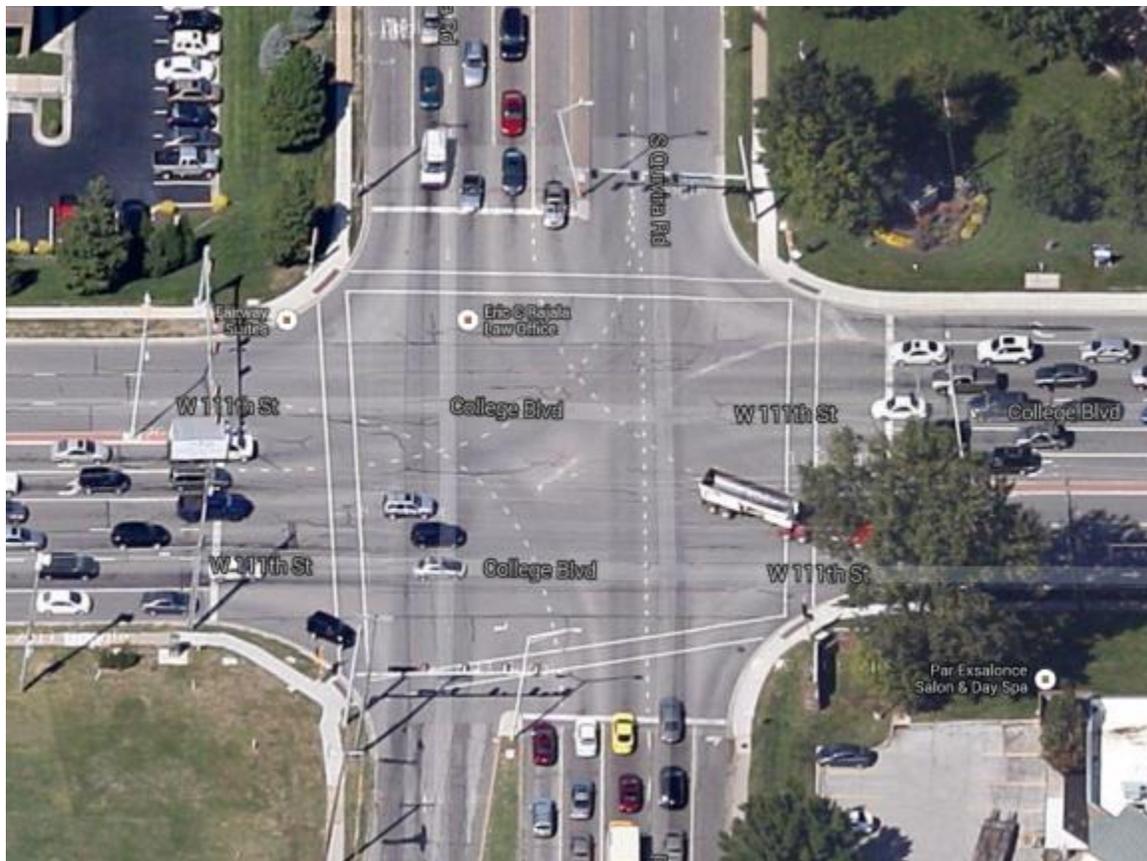
Figure 19. College and Quivira aerial view (Google images, 2013)

The posted speed limit on College Boulevard and Quivira Road was 45 mph. On the northbound and southbound approaches of the intersection, there were three through lanes, two left turn lanes, and one right turn lane. This intersection was located in a commercial area.

The northbound approach had a restriction on U-turns, while in the southbound direction U-turns were allowed. In the eastbound and westbound approaches there were three through lanes, two left turn lanes, and one right turn lane. The intersection is shown in Figure 19.

As shown in Figure 19, downstream of the northbound and southbound approaches there were three through lanes. For the northbound and southbound movements vehicles had to travel

approximately 182 feet. The clearance distance for westbound and eastbound approaches was 183 feet. Johnson County Community College is located at the southwest corner of the intersection. There was a bank on the northwest corner, an office building on the northeast corner, and restaurants in the southeast corner of the intersection. Figure 20 shows the traffic signal set-up at the intersection.

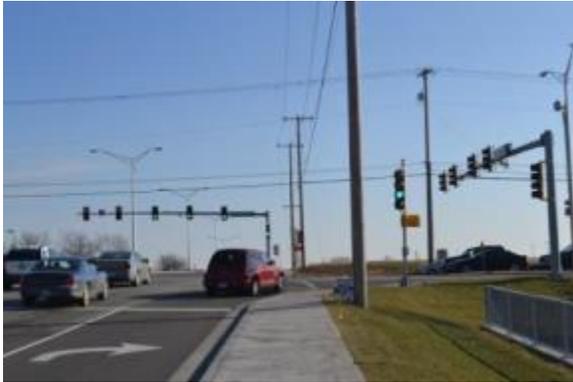
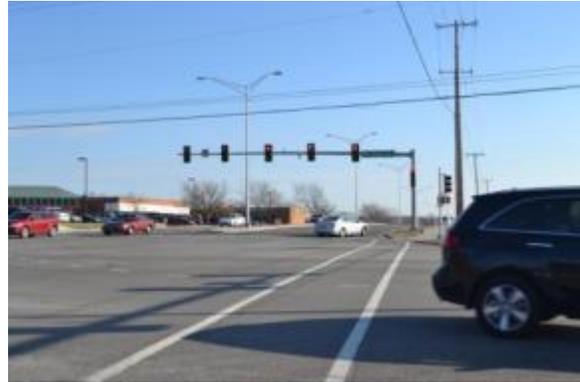
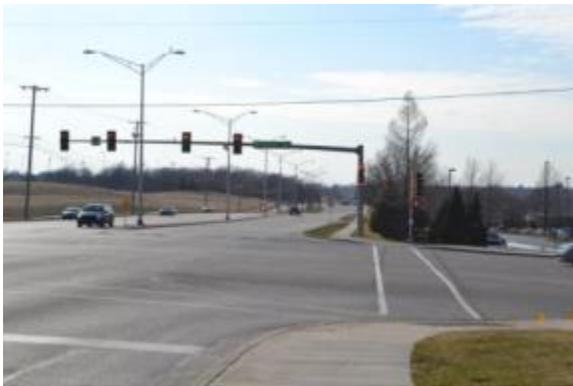
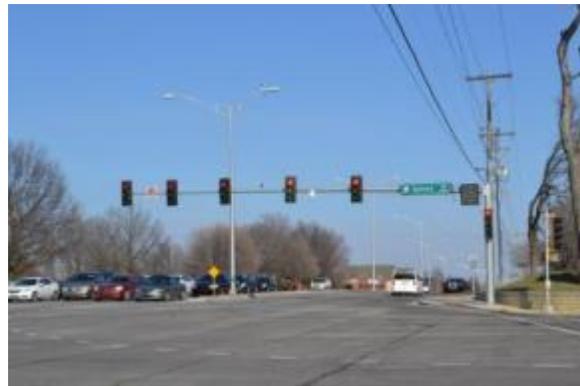
Figure 20. College and Quivira signal system for (a) northbound approach (b) southbound approach (c) eastbound approach and (d) westbound approach

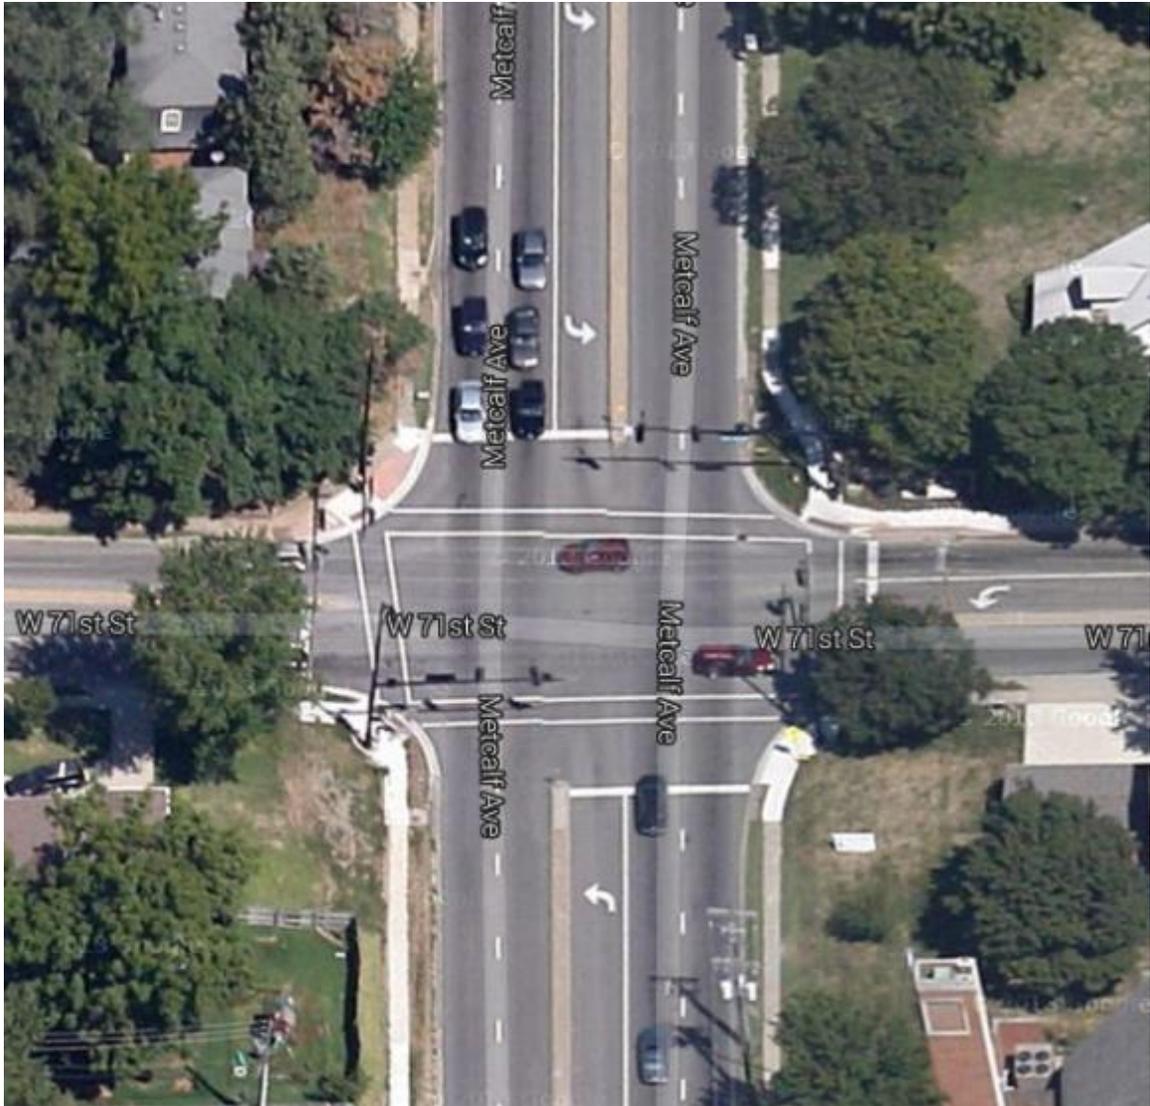
Figure 25. 71st Street and Metcalf Avenue (aerial image, Google Earth, 2013)

The intersection of 71st Street and Metcalf Avenue was chosen as a spillover site for the treatment intersection for 75th Street and Metcalf Avenue. This intersection was located in a residential area. There were private residences at all corners of the intersection, except for the southeast corner where there was a church. The posted speed limit for northbound and southbound traffic was 40 mph, for eastbound it was 30 mph, and westbound was 25 mph. The clearance path for cars traversing the intersection in the northbound or southbound direction was approximately 100 feet, and 114 feet for westbound and eastbound traffic. Figure 25 shows an aerial view of the intersection.

For traffic along Metcalf Avenue (North/South) there was a left turn lane, a through lane and a shared through/right turn lane. There was no protected right turn signal, the left turn signal was protected/permitted, and there were no restrictions on left turns. There were three signal heads per approach, two on the mast and one on the post. For traffic along 71st Street, there was a left turn lane and a shared through/right turn lane. The left turn movements were protected/permitted, and there were two signal heads per approach. There was one signal head

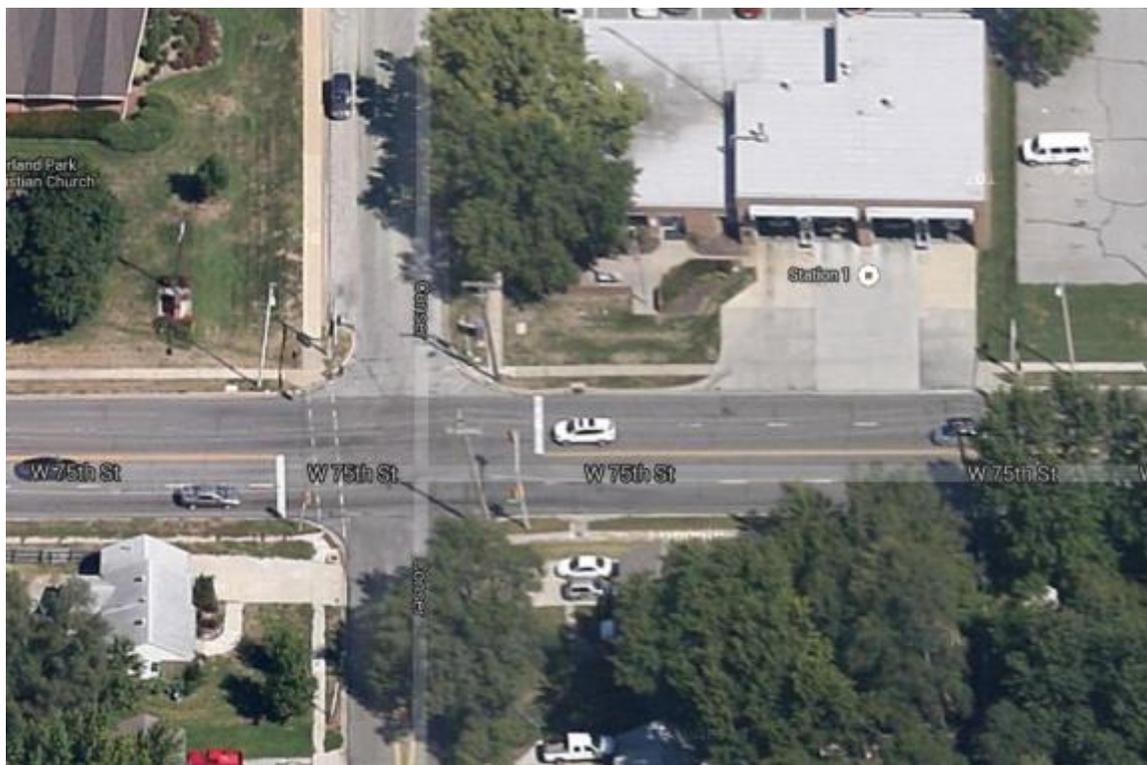
Figure 28. 75th Street and Conser Street (aerial image, Google Earth, 2013)

The intersection of 75th Street and Conser Street was also selected as a spill-over effect because its proximity to the signalized intersection of 75th Street and Metcalf Avenue. This intersection was located on a residential area. The posted speed limit along 75th Street (eastbound and westbound) was 35 mph, and the speed limit for Conser Street (northbound and southbound) was 25 mph. The clearance path for vehicles along 75th Street was 70 feet, while for traffic along Conser Street it was 73 feet. Figure 28 shows an aerial view of the intersection.

In the northeast corner of the intersection there was a city fire station. To avoid westbound traffic from blocking the entrance and exit of the station, an emergency traffic signal was placed approximately 129 feet downstream from the stop line and cars were required to stop at this location when the signal shows red. Along 75th Street, there were two lanes that share turning movement traffic. Conser Street gives access to the residential neighborhoods adjacent to the intersection and there was one lane per approach. There were two signals for the southbound traffic, one overhead and one on a pole, and only one signal on a pole for northbound movement traffic. Left turn movements were permitted only and along the eastbound approach there were two overhead signals and one on the pole. This configuration was the same for the westbound signals at the intersection and prior to the fire station driveway. There were pedestrian countdown signals at each corner, and backplates installed on all overhead signal lights. There were no protected turning movements at this intersection. The traffic signal timing along 75th Street was coordinated, and the morning and evening peak hour cycles were approximately 70 seconds. Table 7 shows the yellow and all-red phasing in seconds.

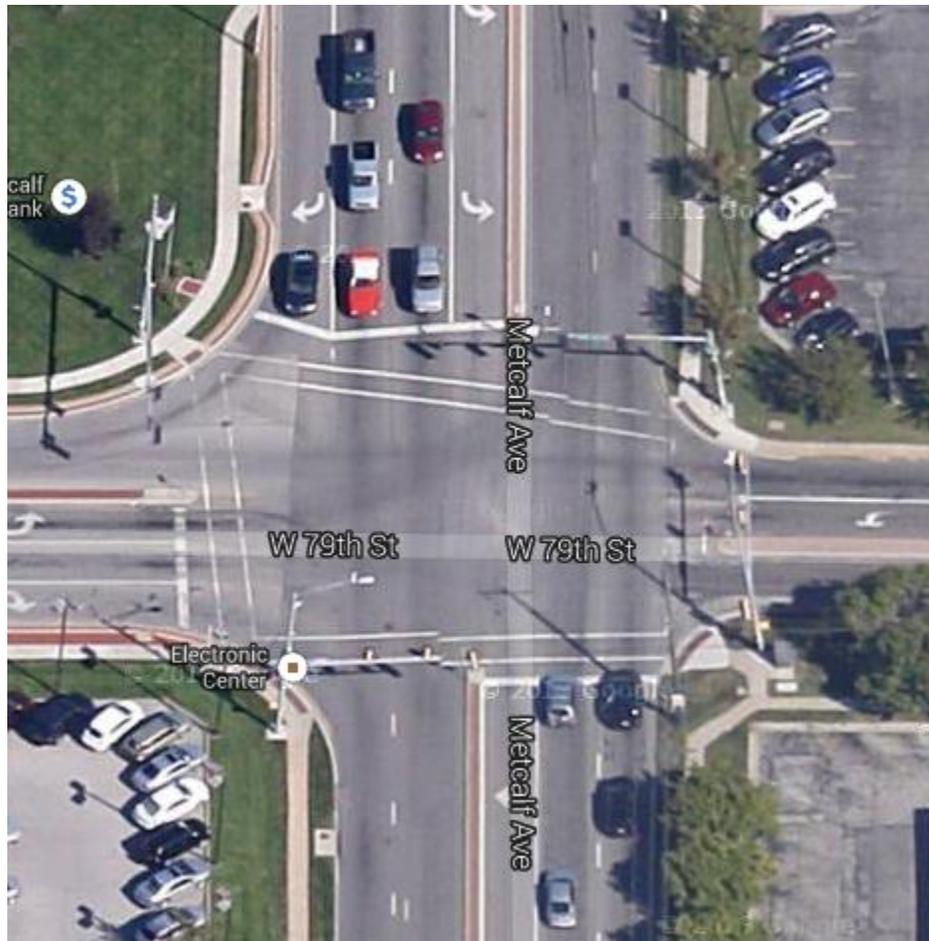
Figure 31. 79th Street and Metcalf Avenue (aerial image, Google Earth, 2013)

The intersection of 79th Street and Metcalf Avenue was chosen as a spillover site for the treatment intersections of 75th Street and Metcalf Avenue. This intersection was located in a commercial area. There was a bank at the northwest corner and commercial businesses at all the other corners of the intersection. Figure 31 shows an aerial view of the intersection.

As shown in Figure 31, it was found that for northbound traffic along Metcalf Avenue there was a left turn lane, a through lane, and a shared right turn/through lane. For the southbound approach there was a left turn lane, a right turn lane, and two through lanes. The posted speed

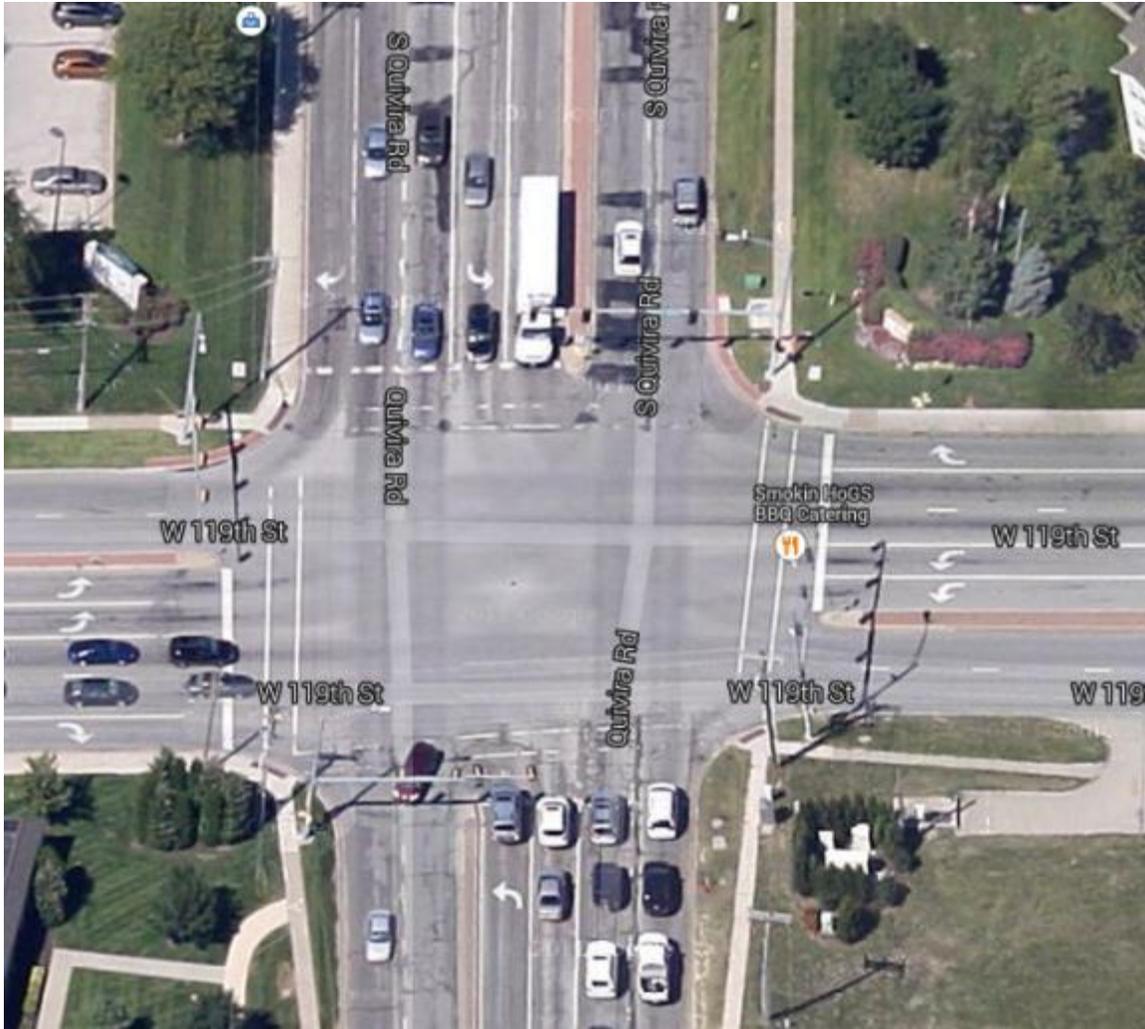
Figure 34. 119th Street and Quivira Road (aerial image, Google Earth, 2013)

The intersection of 119th Street and Quivira Road was chosen as a spill-over site for the intersection of College Boulevard and Quivira Road. The land use around the intersection was mixed. There were apartment buildings at the northeast corner, and commercial businesses at the west side of the intersection. There was no development on the southeast corner. The posted speed limit for 119th Street and Quivira Road was 45 mph. The eastbound, westbound and southbound approaches had two left turn lanes, two through lanes, and one right turn lane. The northbound approach had one left turn lane, two through lanes, and a shared through/right turn movement lane. Figure 34 shows an aerial picture of this intersection.

As show in Figure 34, the clearance path was 135 feet for traffic on Quivira Road and 130 feet for traffic on 119th Street. The intersection had a signal head per travel lane for all approaches. Additionally, all overhead signal heads have backplates. There were protected right turns for the southbound and eastbound approaches, and all left turn movements were protected only. Table 9 shows the yellow and all-red phase signal timing in seconds.

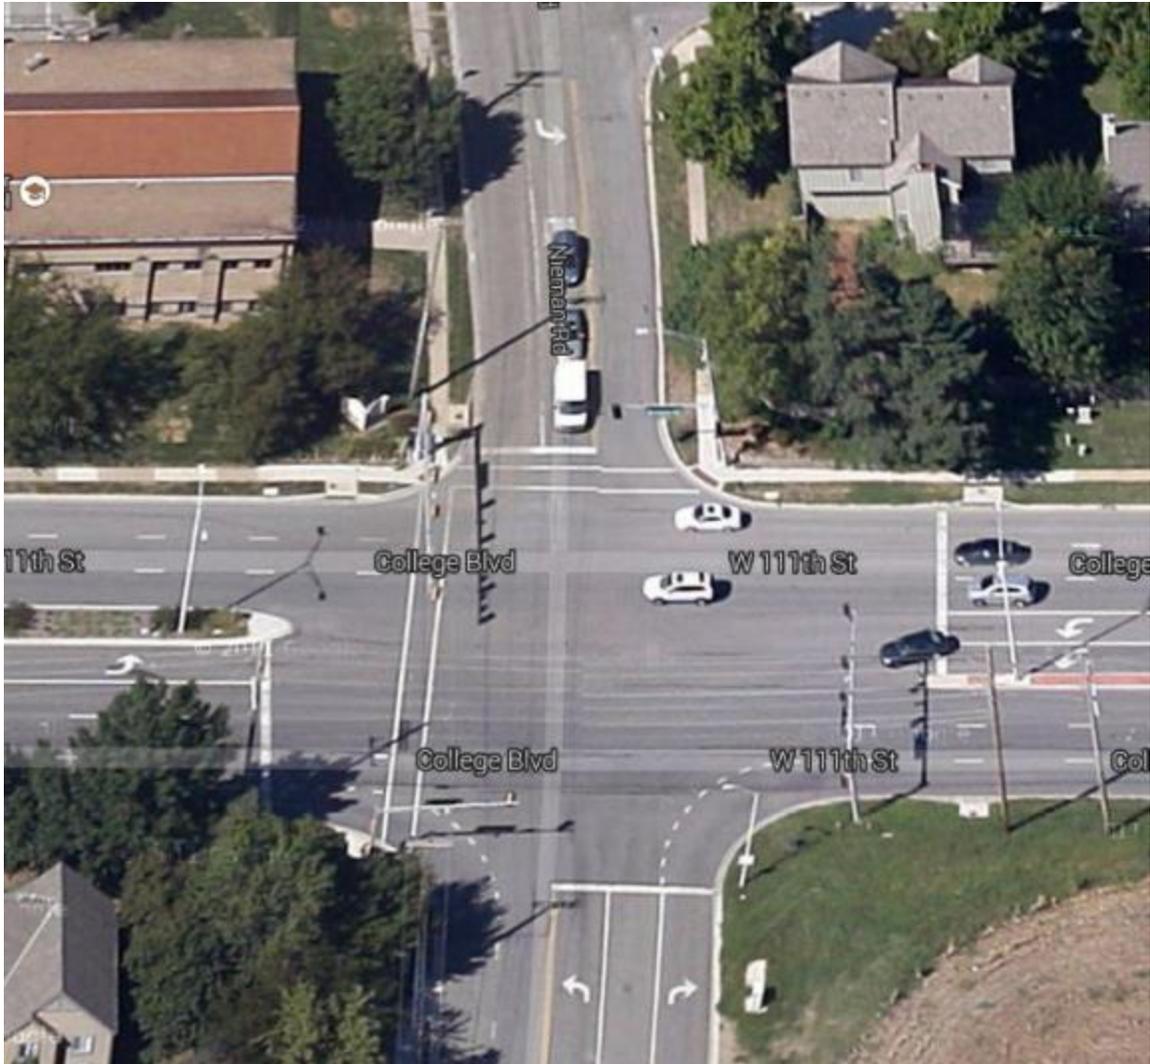
Figure 37. College Boulevard and Nieman Road (aerial image, Google Earth, 2013)

There was a church and a preschool at the northwest corner. There was no development at the southeast corner. The posted speed limit along Nieman Road was 30 mph while the posted speed limit along College Boulevard was 45 mph. Figure 37 shows an aerial photo of the intersection.

As shown in Figure 37, the northbound traffic along Nieman Road has one lane per movement. For southbound traffic there was one left turn lane, and one right turn/through movement lane. Along College Boulevard the eastbound approach had three through lanes, one right turn lane, and one left turn lane. The clearance path for traffic along Nieman Road was 138 feet, and 145 feet for traffic on College Boulevard. The northbound movement had a protected right turn and the left turns for northbound and southbound were permitted. Left turns lanes for eastbound

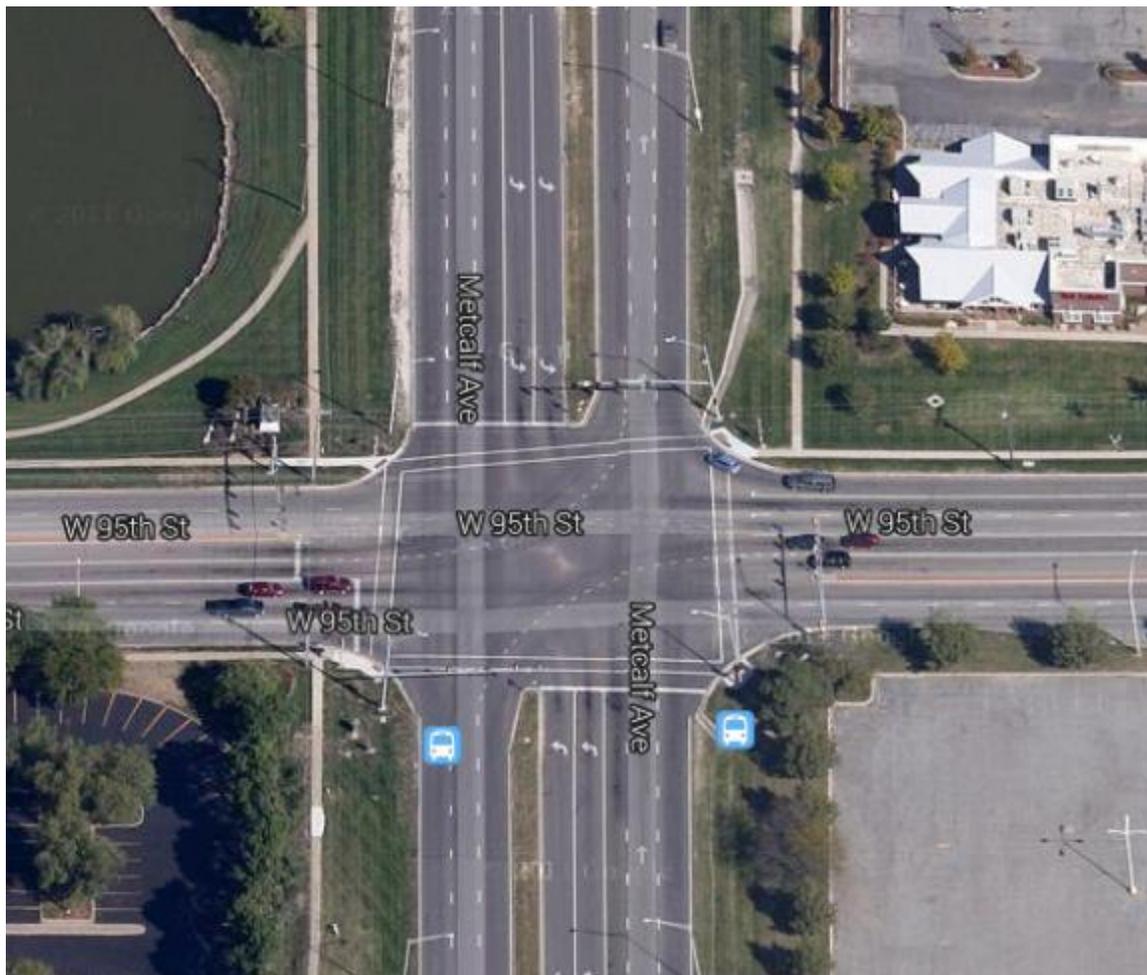
Figure 43. 95th Street and Metcalf Avenue (aerial image, Google Earth, 2013)

The northbound and southbound approaches of Metcalf Avenue had three through lanes, and two left lanes, there was no right-turning lanes. The eastbound and westbound approaches of 95th Street had two left turn lanes, two through lanes, and one right-turning lane. Figure 43 shows an aerial view of the intersection.

The clearance path for the northbound and southbound approaches was 145 feet. For the eastbound and westbound approaches the clearance path was 150 feet. For the eastbound and westbound approaches there was one signal head per lane. There was a total of 12 signal heads, six per approach, a signal head mounted on the pole, and there was a signal head on the southeast corner and the northwest corners for the right-turning vehicles. Figure 44 shows the signal lights for all approaches.

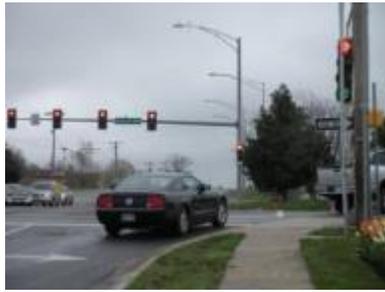
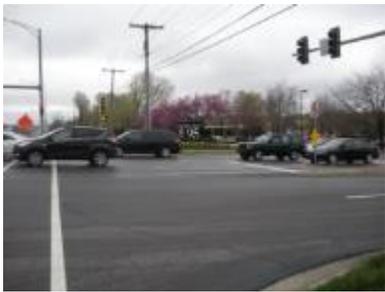
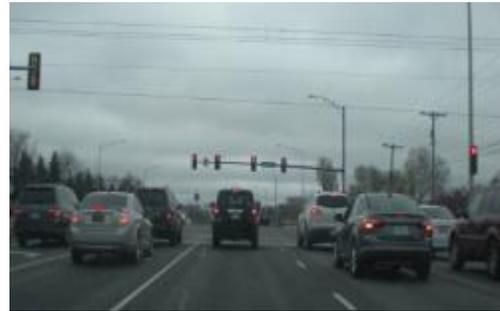
Figure 44. 95th and Metcalf (a) eastbound (b) westbound (c) eastbound stop line alignment (d) southbound

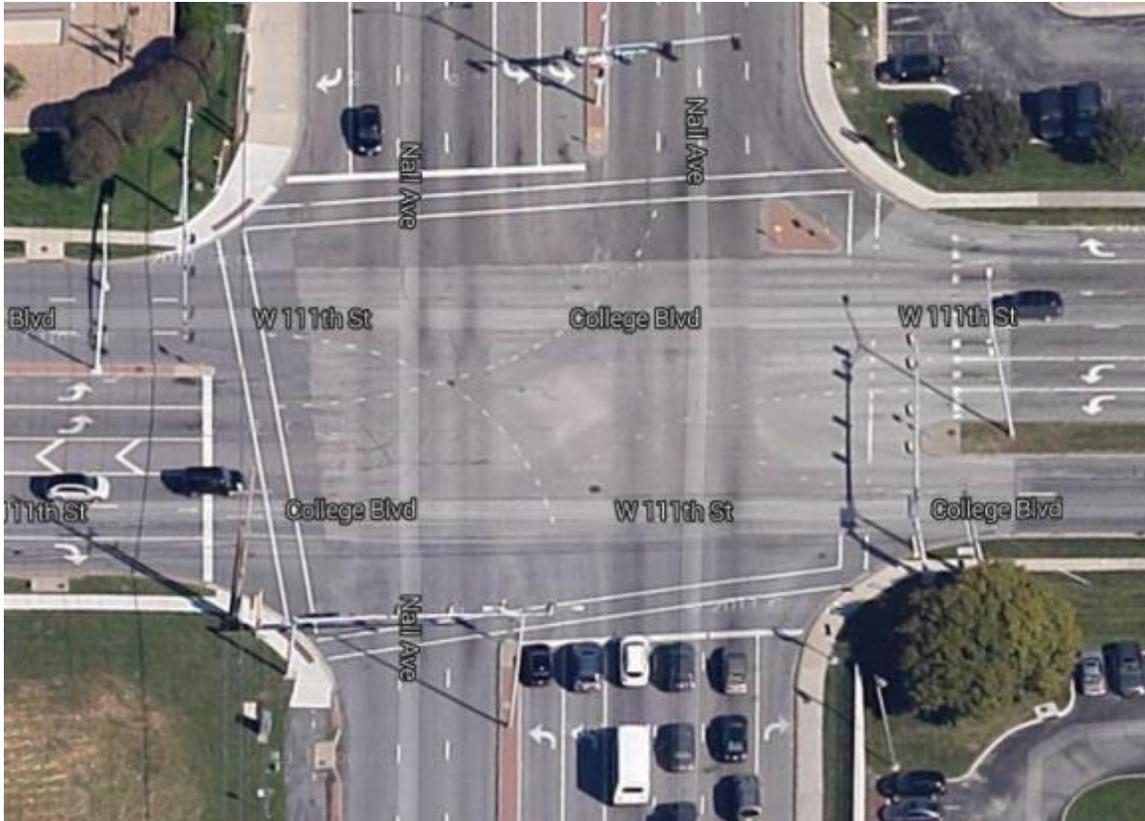
Figure 47. College Boulevard and Nall Avenue (aerial image, Google Earth, 2013)

Figure 47 shows an aerial view of the intersection.

The eastbound and westbound approaches of College Boulevard had two left-turning lanes, two through lanes and a right-turning lane. The northbound and southbound approaches of Nall Avenue had three through lanes, two left-turning lanes, and a right-turning lane. All approaches had protected left-turning and protected right-turning movements. The clearance path for traffic on Nall Avenue was 155 feet and 175 feet for traffic on College Boulevard. The morning peak cycle length was 120 seconds, and the evening peak hour cycle length was 140 seconds. The northbound and the southbound approaches were coordinated. Table 13 shows the phase time in seconds for yellow and all-red.

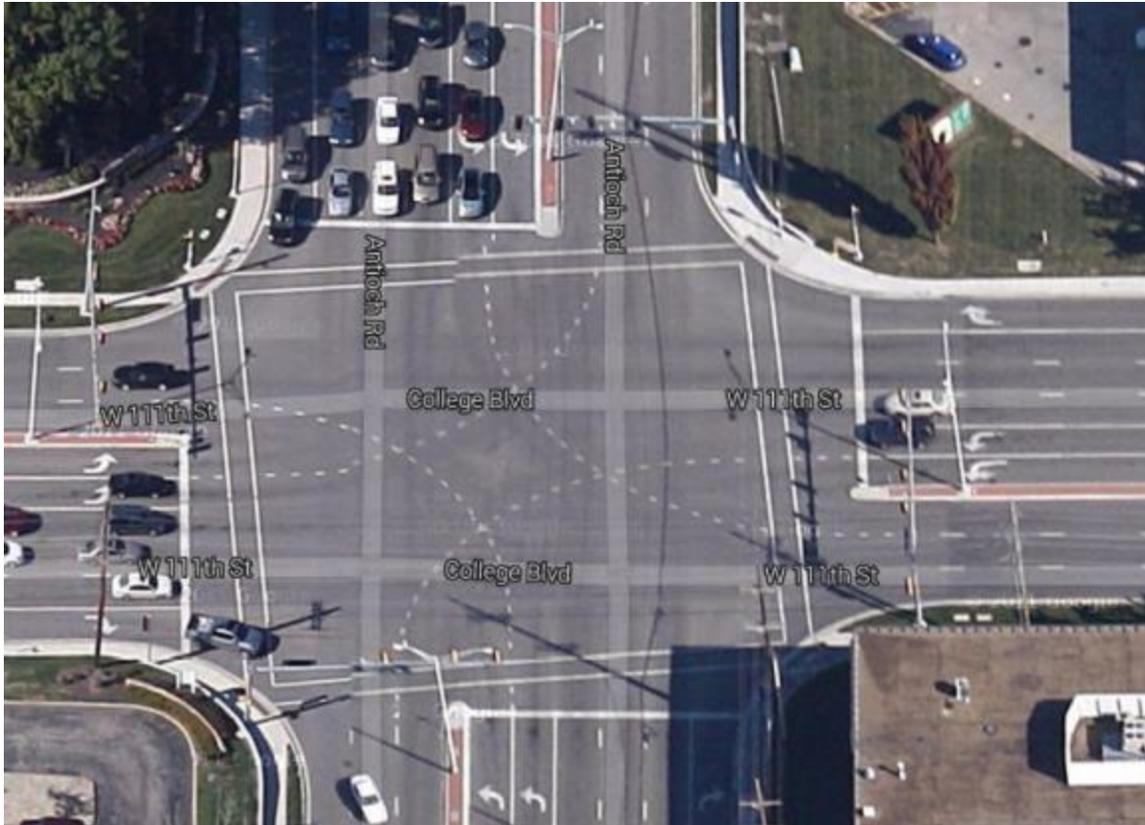
Figure 50. College Boulevard and Antioch Road (aerial image, Google Earth, 2013)

College Boulevard and Antioch Road was selected as a control site. This intersection was located in a commercial area of town. The Corporate Woods Office Park was at the northwest corner, and commercial businesses were located at all other corners of the intersection. All intersection approaches had two left-turning lanes, three through lanes, and a right-turning lane. The posted speed limit for all approaches was 45 mph. Figure 50 shows an aerial view of the intersection.

It was found that the clearance path for the approaches on Antioch Road and College Boulevard was 164 feet. All approaches had four overhead signal heads and one on the pole, and a signal located on the nearside of the intersection for the right turn movement. Two signal heads were for left-turning traffic and the other three were for through and right turn movements. All approaches had protected right-turning and protected left-turning movements. Table 14 shows the time in seconds for yellow and all-red phase.
