LONG-TERM EFFECTS OF CONFIRMATION LIGHTS AND FACTORS THAT LEAD TO
RED LIGHT RUNNING

Submitted to the graduate degree program in Civil, Environmental and Architectural Engineering
and the Graduate Faculty of the University of Kansas in partial fulfillment of the requirements for
the degree of Doctor of Philosophy.

LONG-TERM EFFECTS OF THE RED-SIGNAL INDICATION LIGHT AND FACTORS
THAT LEAD TO RED LIGHT RUNNING

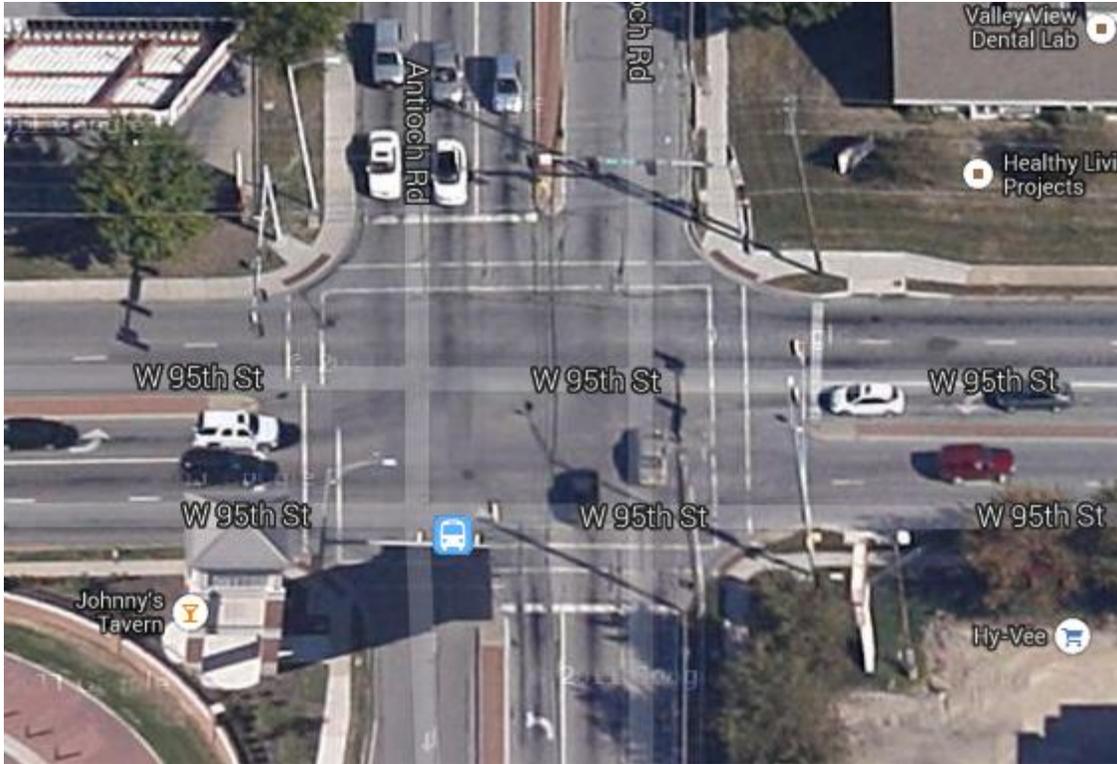
Figure 53. 95th Street and Antioch Road (aerial image, Google Earth, 2013)

The intersection of 95th Street and Antioch Road was selected as a control site. The posted speed limit on 95th Street was recorded as 35 mph and the posted speed limit on Antioch road was recorded as 35 mph. There were no right-turning lanes at any of the approaches at this intersection. However, each approach had a left turn lane, a through lanes and a shared through/right turn lane. This intersection was located on a dense commercial area. At the south end of the intersection there were many commercial businesses, including Walgreens and another grocery store. At the time of data collection there was construction for a bank and other shops at the south end of the intersection. There was a gas station on the northwest corner, and a dentist office on the northeast corner of the intersection. Figure 53 shows an aerial view of the intersection.

It was found that clearance path for the northbound and southbound approaches were approximately 105 feet and for the eastbound and westbound approaches was about 107 feet. For the northbound approach the left-turning movement was protected only, there were four signal heads, and no restrictions on U-turns. For the southbound approach, the left-turning movement was protected only. For eastbound approach there were four signal heads, protected left-turning movement, and no restrictions on U-turns. For the westbound approach the left-turning movement was protected, there were four signal heads and no restrictions on U-turns. The signal phases on Antioch Road were coordinated, and the cycle length for the morning peak hour was 120 seconds, and 140 seconds for the evening peak. Table 15 shows the yellow and all-red phase times in seconds for the intersection.

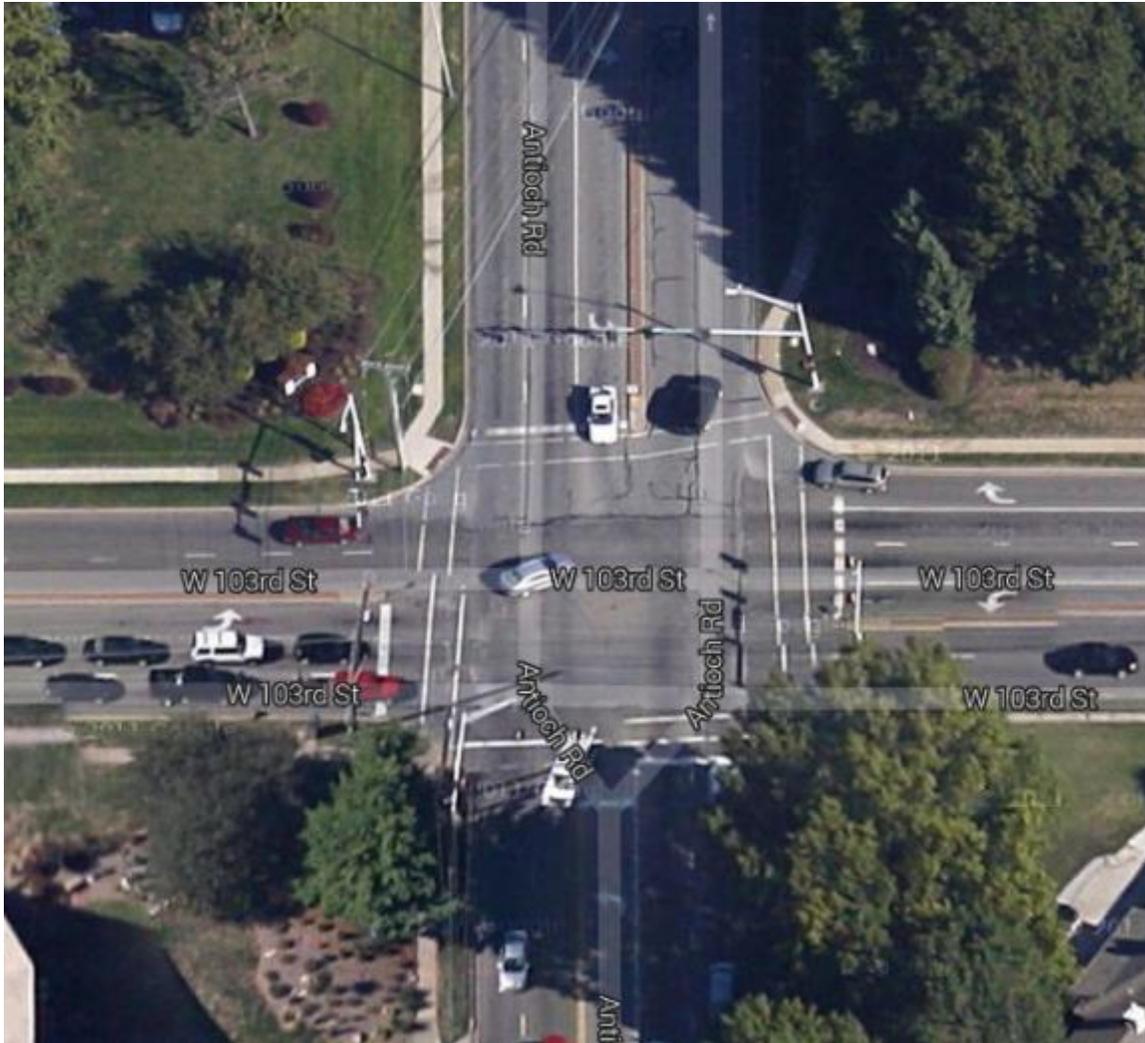
Figure 56. 103rd Street and Antioch Road (aerial image, Google Earth, 2013)

The intersection was located in a residential area of town. There was a church in the southwest corner of the intersection, and housing in all other corners. As shown in Figure 56, the clearance path for vehicles on Antioch Road was approximately 100 feet, while for the eastbound and westbound approaches of 103rd Street the clearance path was 94 feet. For the westbound approach there was a protected right-turning signal, protected left-turning signal, and two through signals for a total four signals for this approach. All signal heads that were mounted on

The intersection of 103rd Street and Antioch Road was selected as a control site. For and southbound traffic on Antioch Road, the posted speed limit was 35 mph and for eastbound and westbound traffic on 103rd Street the posted speed limit was 40 mph. For the northbound and southbound approaches, there were two through lanes, one left-turning lane, and no right turn lanes. There were no U-turns allowed for the southbound traffic. The westbound approach had a right-turning lane, a left-turning lane, and two through lanes. There were no restrictions of movement for U-turns. The eastbound approach had one through lane, a shared through/right-turning lane, and one left-turning lane. There were no prohibited movements (e.g. U-turns) for eastbound traffic. Figure 56 shows an aerial view of the intersection.

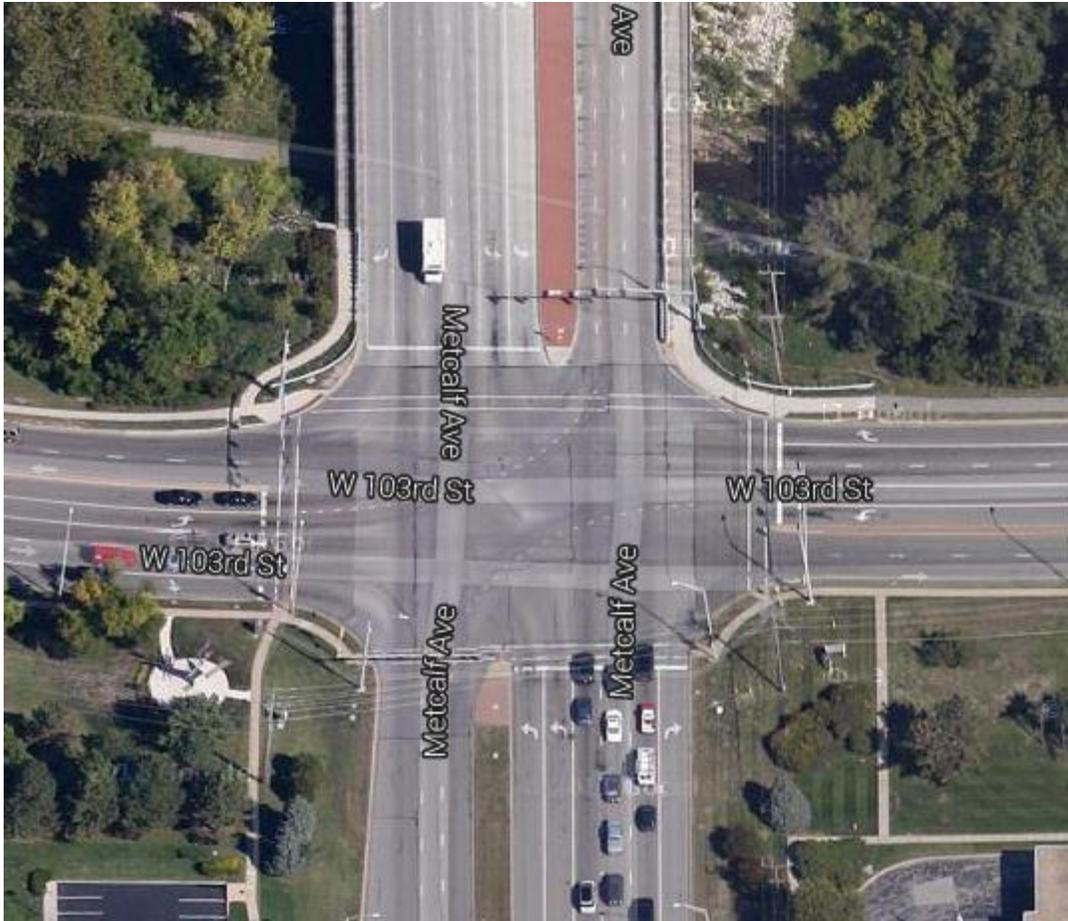
Figure 59. 103rd Street and Metcalf Avenue (aerial image, Google Earth, 2013)

As shown in Figure 59, the clearance path for northbound and southbound movements was approximately 165 feet. For the eastbound and westbound movements the clearance path distance was 196 feet. There were six signal heads for each approach at the intersection. For the eastbound and westbound approach there was one signal head per travel and movement lane. There was also a signal head placed on the nearside of the intersection. For the northbound and southbound approaches there were two signal heads for the left turn, two for the through movements, and two for the through and right-turning movements with one of the signal heads placed on the nearside of the approach. Figure 60 shows the signal mountings for all approaches.

The intersection of 103rd Street and Metcalf Avenue was selected as a control site. The surrounding land use was a mixed commercial and recreational. There were commercial businesses south of 103rd Street, and Pinehurst Park was located north of 103rd Street. For the southbound approach there were three through lanes, two left-turning lanes, and one right-turning lane. The northbound approach had three through lanes, two left-turning lanes, and one right-turning lane. For both the westbound and eastbound approaches there were two through lanes, two left-turning lanes, and one right-turning lane. The posted speed limit for Metcalf Avenue was 45 mph; posted speed limit for 103rd Street was 40 mph. There were no U-turns allowed for both northbound and westbound traffic. Southbound and eastbound traffic were allowed to make U-turns. Figure 59 shows an aerial view of the intersection.

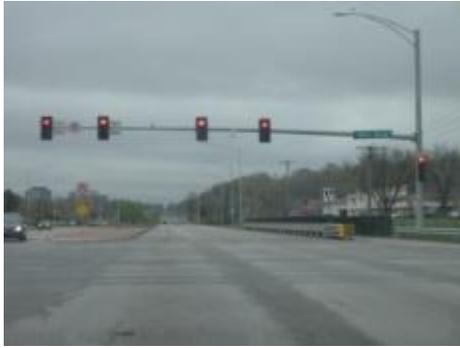
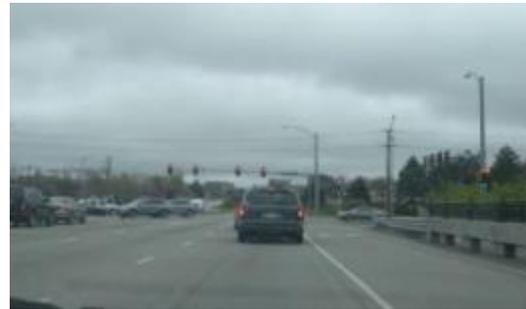
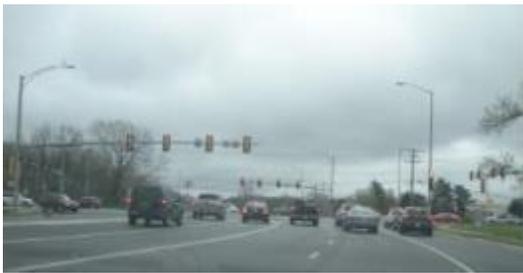
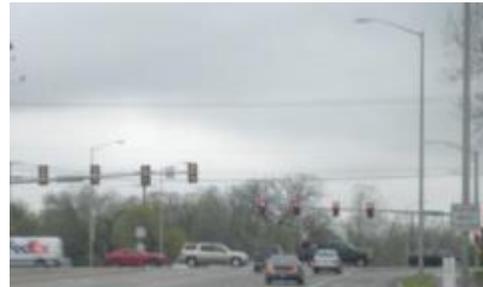
Figure 60. 103rd and Metcalf signals at (a) northbound (b) southbound (c) eastbound (d) westbound

As shown in Figure 60, all overhead signals had back plates. It was found that the only approach that did not have a protected right turn was the westbound approach. All left-turning movements were protected at the intersection. Only the north and south phases were coordinated, and the peak hour cycle length for morning and evening was 140 seconds. The yellow and the all-red intervals in seconds are in Table 17.

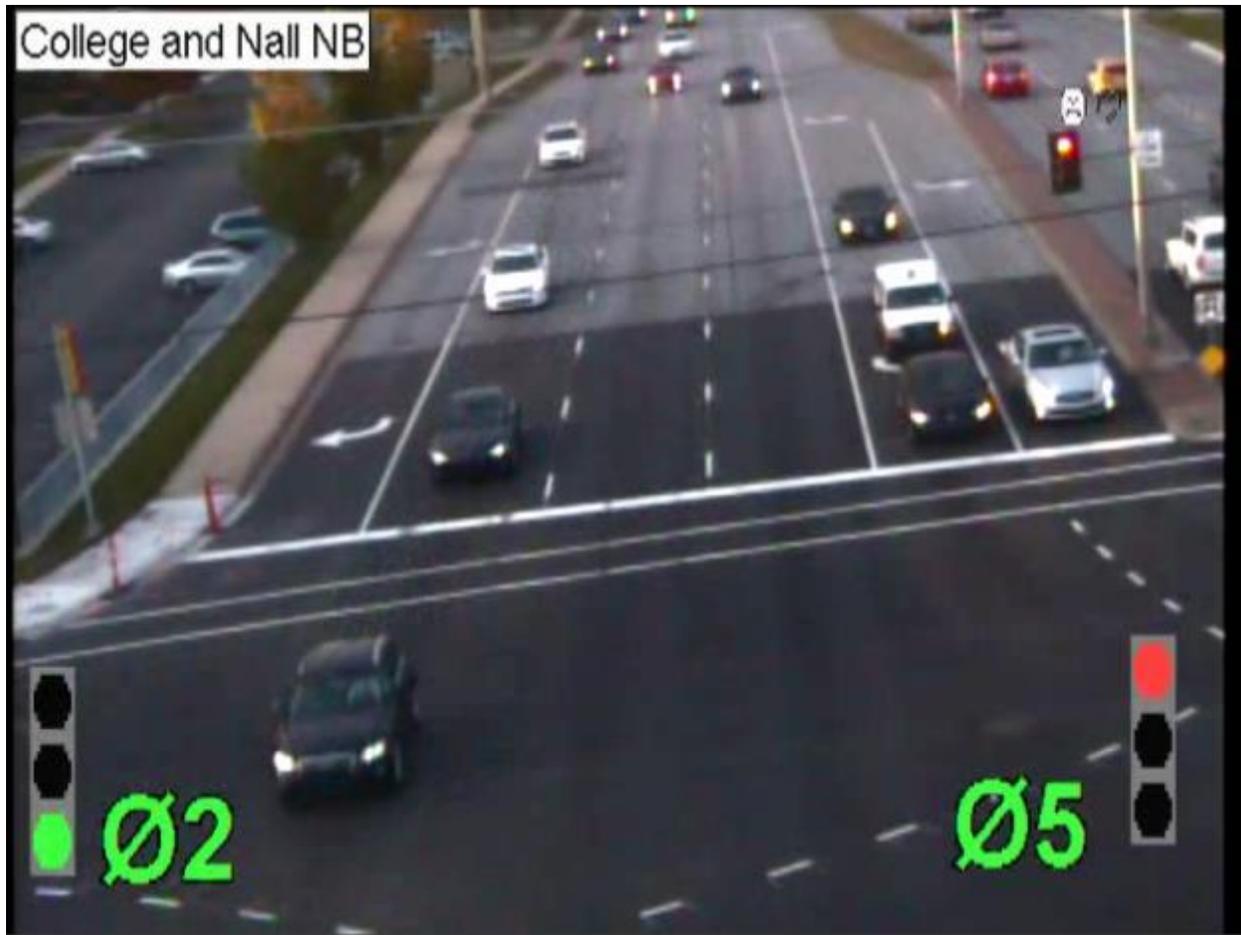
Figure 64. Overhead camera view of an intersection approach

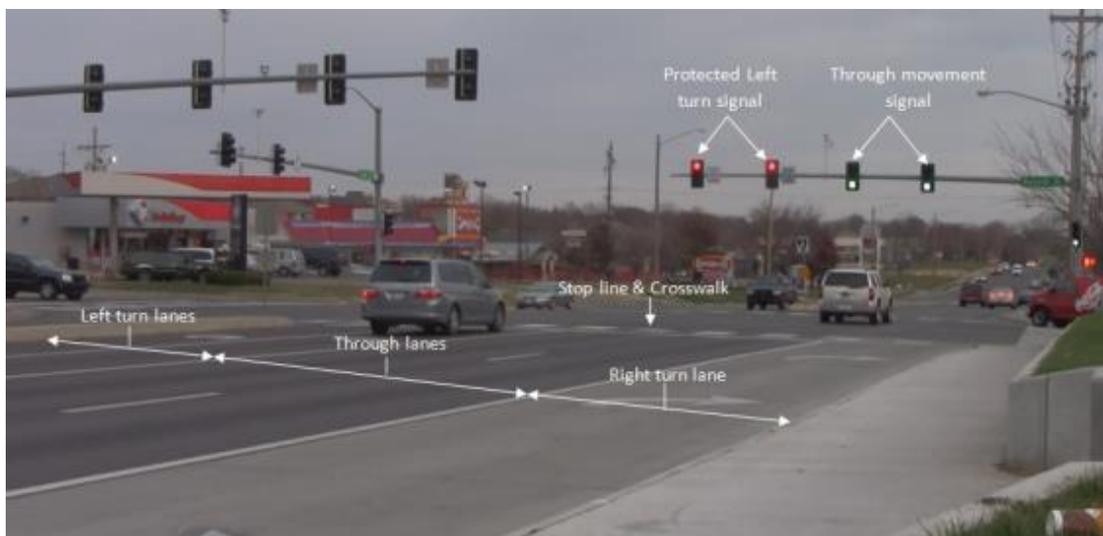
Figure 65. Camera view of an intersection approach

As shown in Figure 65, the camera setup had to be deployed close to the intersection so that the stop line could be visible, and far enough away so the field of view could capture all of the approach lanes. Additionally, all signal heads had to be clearly visible in the field of view. This was complicated at some locations due to the rising sun in the morning and early nighttime

either a protected, or permitted left turn. It was assumed that if an intersection had a protected/permitted left turn, the signal display would indicate red for left turns, but the through movement would remain green. In order to avoid confusion when the data were reduced, student researchers were required to become familiar with the intersection signal operations prior to reducing the video data. A total of five intersections were found to not have the capabilities of utilizing vehicle detection cameras to collect data. Therefore, a student researcher setup multiple video cameras at these intersections and recorded the data. When data were collected using ground-based cameras, the field of view that was required of the student researcher was shown in Figure 65.

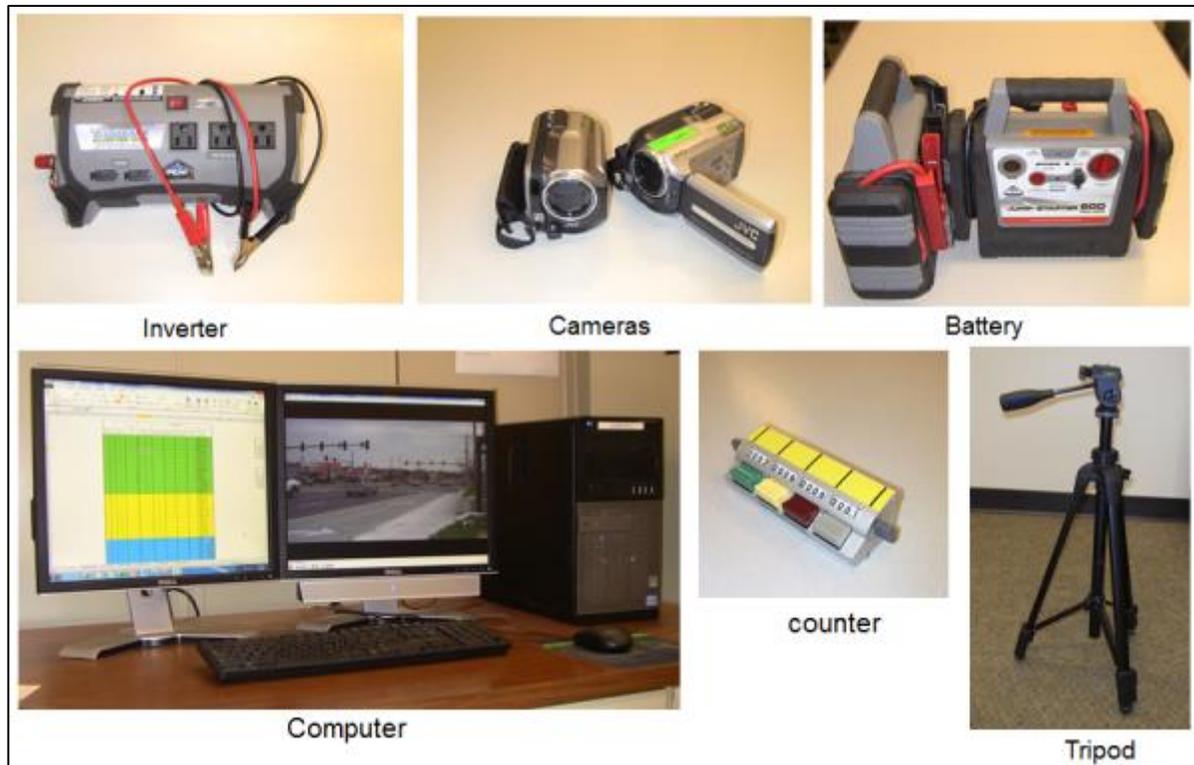
Figure 66. Equipment used for field data collection effort

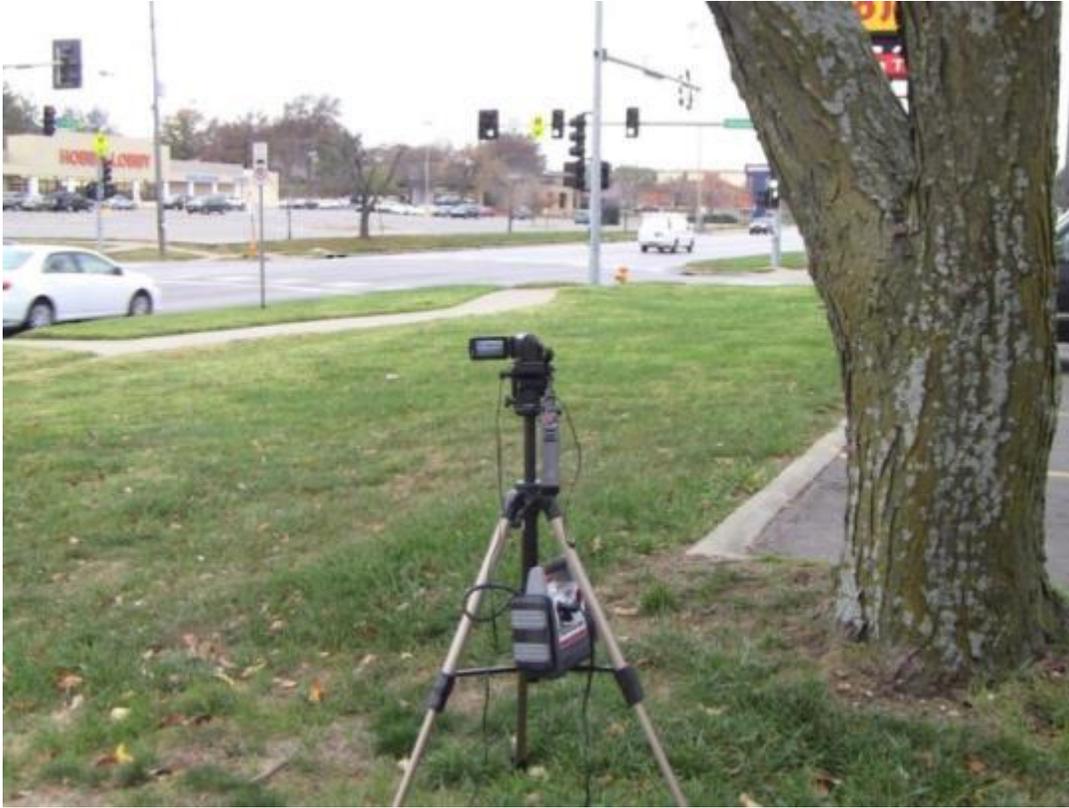
Figure 67. Camera setup at an intersection

Student researchers in the field were instructed to setup the video equipment in a safety vest and would then monitor the cameras at the intersection during both peak hours from a vehicle parked nearby. Video data were collected on weekdays that were non-holidays or when there would be no a special events on a Tuesday, Wednesday, or Thursday. Data were also collected during the identified morning peak hour (7 a.m. to 9 a.m.) and evening peak hour (4 p.m. to 6 p.m.). The data collection methodology described was used for all study periods of the project. The dates which video data were collected in the Overland Park included the following:

As shown in Figure 66, high definition video cameras were used in conjunction with an extended battery and inverter. An important aspect to the data collection effort was deploying and monitoring the video camera equipment at all four intersection approaches while not affecting driver behavior with the presence of the student researchers or equipment. Prior to any video data collection effort, the City of Overland Park Police Department dispatch center was notified to facilitate driver or business curiosity. A common setup of the ground-level video equipment is illustrated in Figure 67.

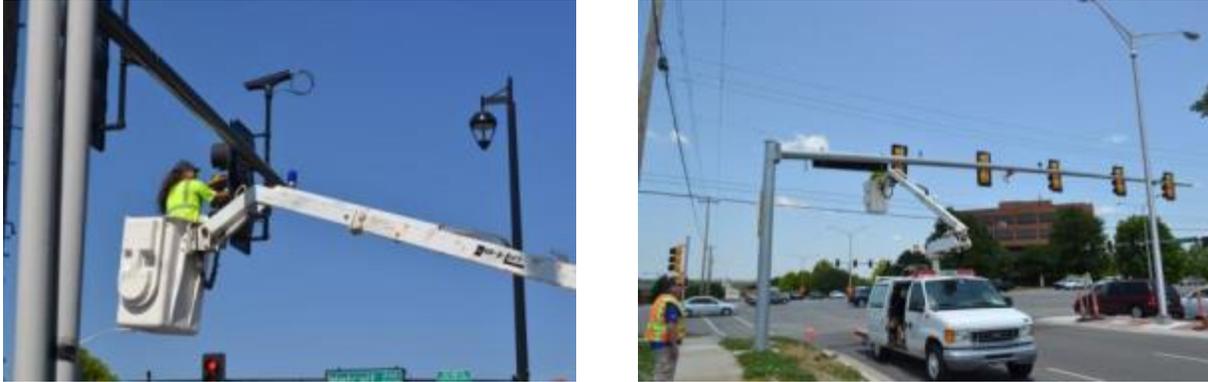
Figure 69. Field installation of the confirmation light

On the July 2, 2013 at approximately 9 a.m., the City of Overland Park Traffic Engineering Department installed the confirmation lights at 75th Street and Metcalf Avenue intersection and then College Boulevard and Quivira Road. Figure 69 shows how the city installed the lights using a boom truck.

The light elected was a Pelco confirmation light which ranges from \$110-\$140 depending on the mounting bracket. As shown in Figure 69, the City of Overland Park specified that they wanted

the light to be mounted by a cable Pelco Astro-Brac. Also shown in Figure 69, excess cable and wire were zip-cord strapped to the mast arm and sign bracket. The Pelco confirmation light came in multiple colors including blue, red, and clear. A standard Edison light bulb was used and the plastic dome was sealed by a rubber weather strip. The confirmation light came with a short three strand wire which included a ground wire. The Overland Park traffic signal technicians removed the provided wire and attached a standard two-wire hookup.

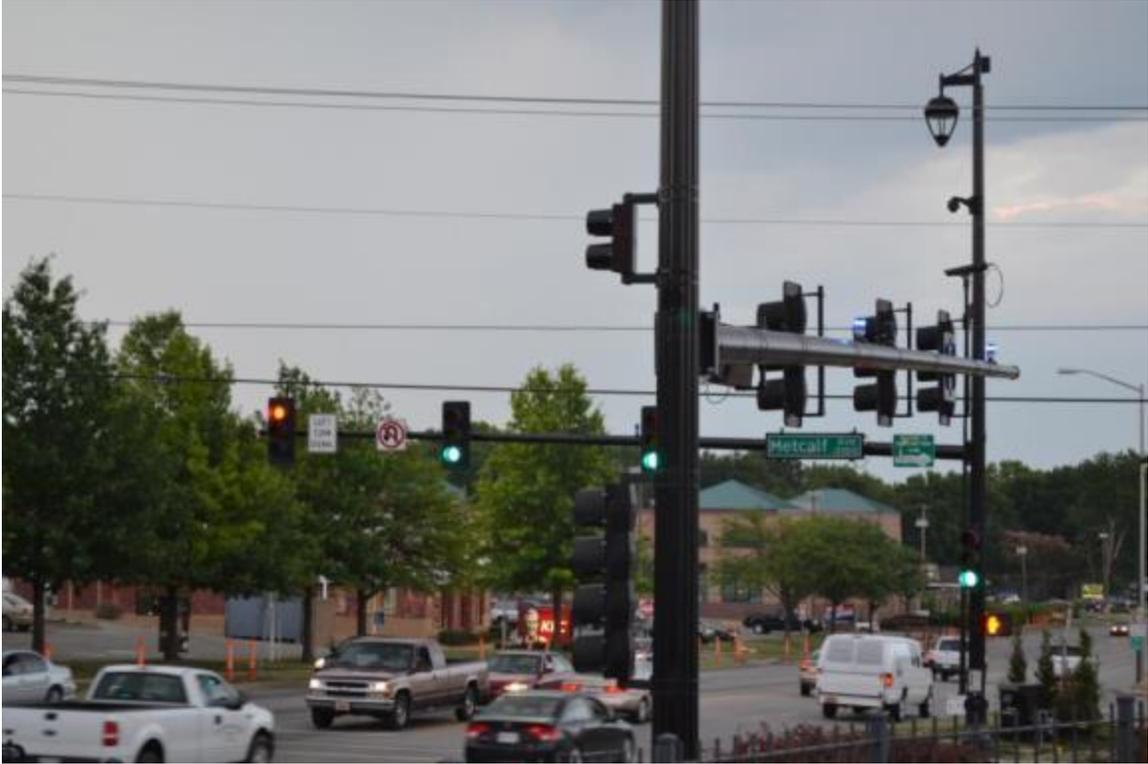
Figure 70. Confirmation Lights at 75th Street and Metcalf Avenue

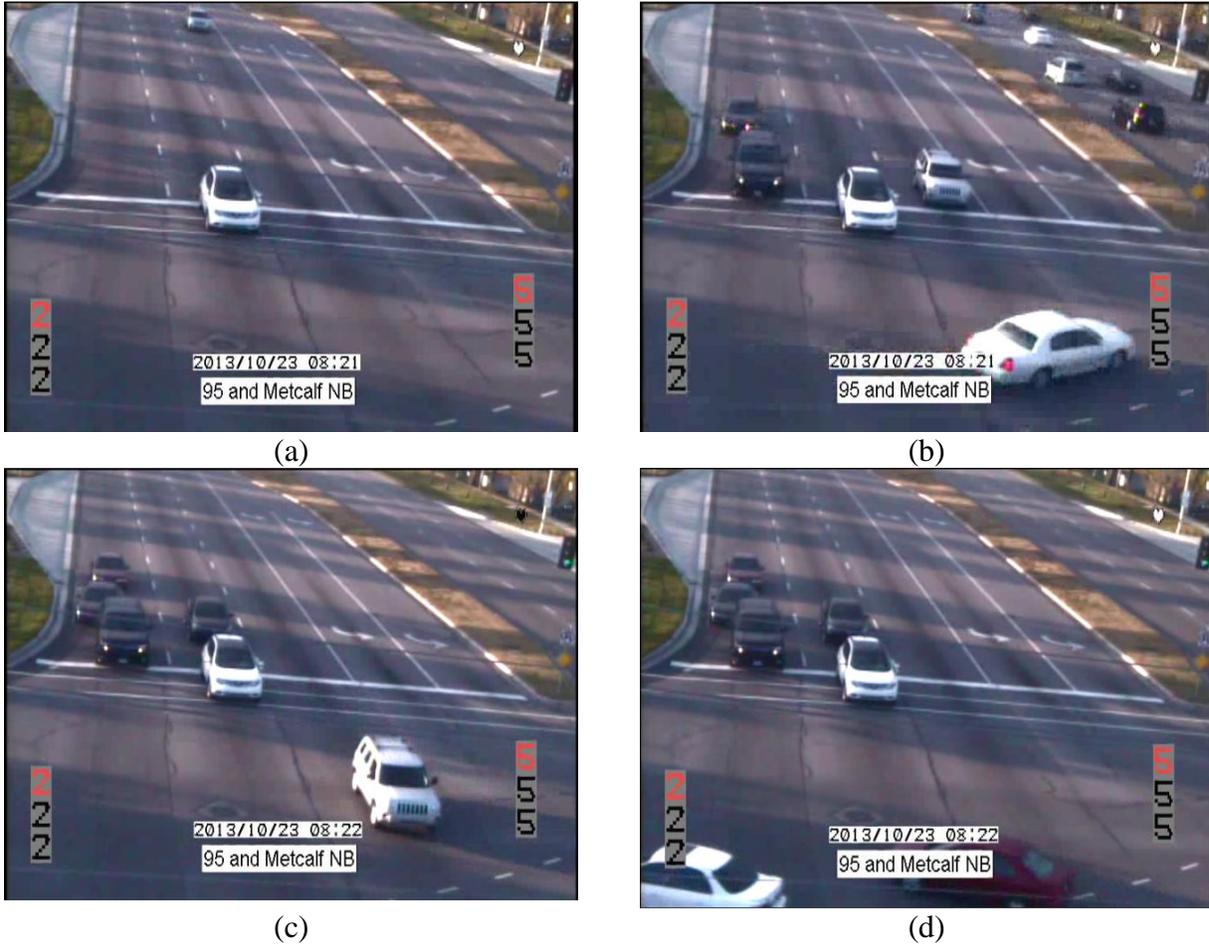
Figure 79. Through movement violation at 95th Street and Metcalf Avenue

At 95th Street and Metcalf Avenue a northbound vehicle crossed the intersection 51 seconds into the red. Figure 79 (a) shows a car already stopped past the stop line and another car approaching the intersection. The grey car that was pulling up on the through lane next to the dual left turn lanes was the driver that committed the violation. As shown in Figure 79 (b) all vehicles at the northbound approach were stopped as traffic along 95th Street travel through the intersection. After there was no more traffic traveling along 95th Street the driver crossed the intersection during the all-red interval, before southbound left-turning started crossing the intersection as

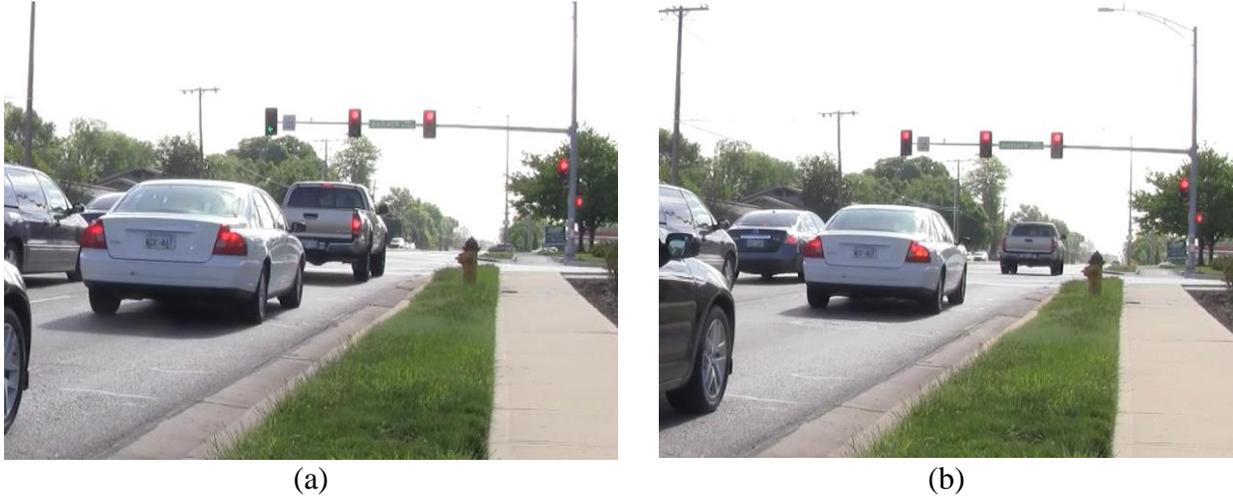
Figure 83. Violation 66 seconds into the red at 95th Street and Antioch Road

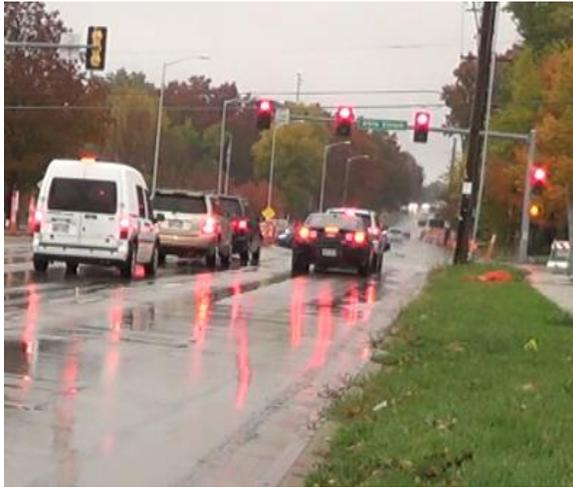
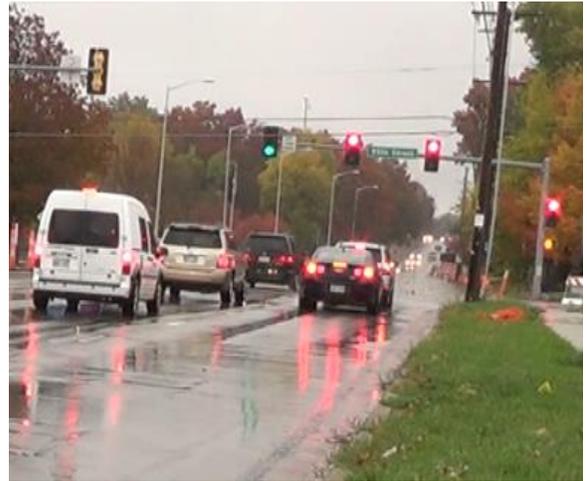
Figure 84. Violation at 95th Street and Antioch Road 57 seconds into the red

At 95th Street and Antioch Road a driver crossed the intersection 57 seconds into the red. As shown in Figure 84 (a) the all movements for the northbound approach were on the red phase. The vehicle on the left through lane traveled through the intersection as soon as the left turn arrow was green as seen in Figure 84 (b). This situation could be attributed in part to driver inattention.

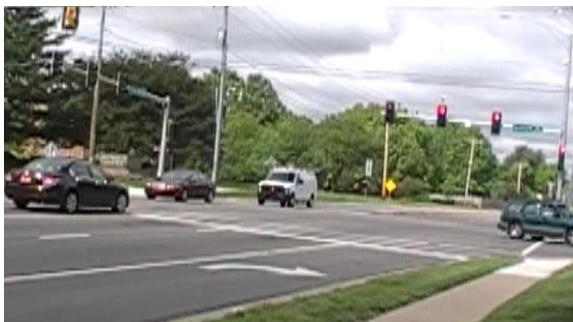
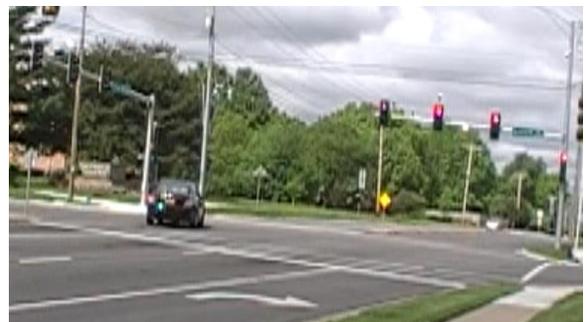
Figure 85. Violation at 103rd Street and Antioch Road 82 seconds into the red

At 103rd Street and Antioch there was another driver that made a left turn 82 seconds into the red. The eastbound approach traveling along 103rd Street was on the green phase for all movements, while the westbound approach was in all-red for all movements. Figure 85 (a) shows that the vehicle arrived at the intersection and it was the only vehicle on the approach. After oncoming traffic crossed the intersection and there were no more oncoming vehicles, the driver made a left turn onto southbound Antioch Road. This case could be due to driver inattention, since the driver could have assumed that the lights were green for all approaches. It could also be due to a blatant disregard of the traffic signal.
