Inferior Vena Cava Filter Erosion Causing Symptomatic Obstructive Hydronephrosis

Nathan Locke, MD, David Duchene, MD and Priya Padmanabhan, MD, MPH

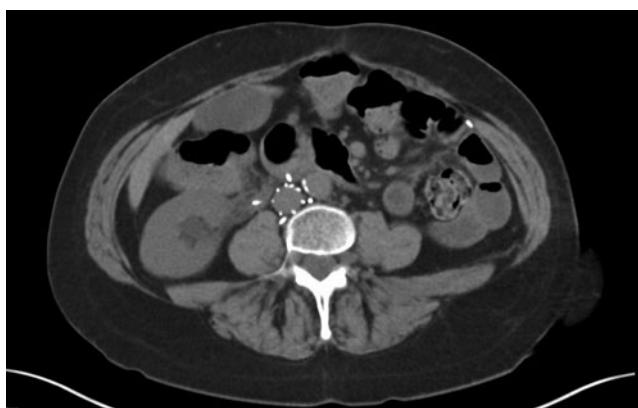
FIG. 1. Axial cut CT showing erosion of multiple IVC filter limbs, including limb projecting into lumen of right ureter with proximal hydronephrosis.

A CT of the abdomen and pelvis was obtained in the emergency room, which revealed moderate right hydronephrosis secondary to an eroded IVC filter limb projecting in the right proximal ureteral lumen (Figs. 1 and 2). Her complicated history had led to multiple previous CT scans, allowing for radiographic tracking of gradual migration of the filter limb into the ureter on sequential scans.

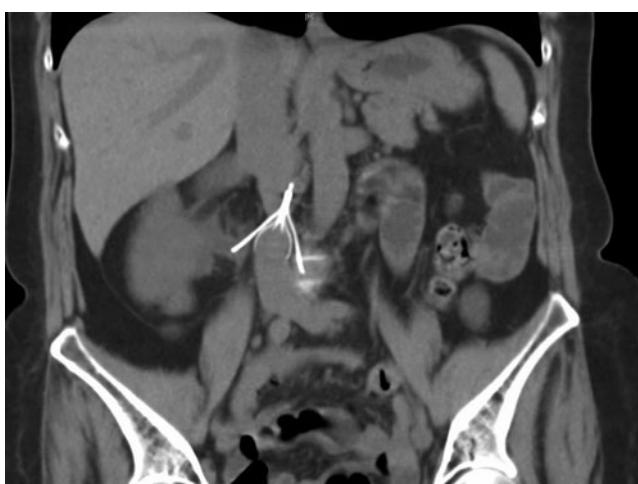
FIG. 2. Coronal cut CT with additional demonstration of filter limb penetrating right ureter.

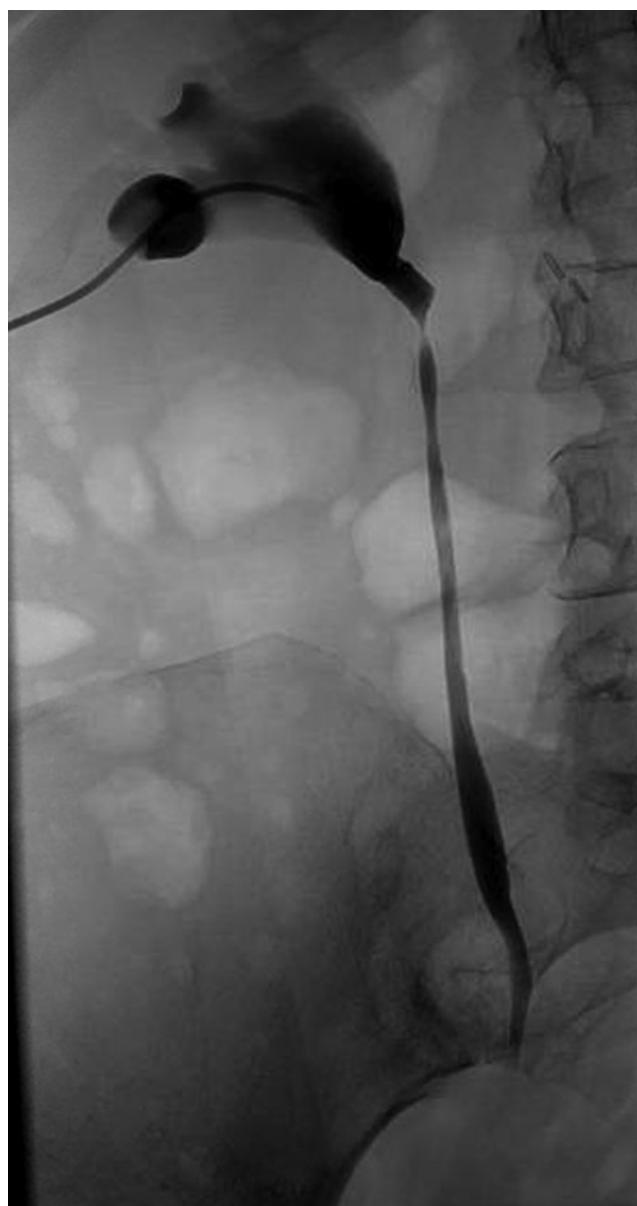
FIG. 3. Antegrade nephrostogram immediately after filter retrieval showing luminal narrowing at site of limb penetration, without evidence of extravasation.

embedded in the caval wall, which allowed it to be snared easily with a filter retrieval device. After this, the entire filter was withdrawn back into a sheath and removed. Concomitantly, percutaneous access for antegrade nephrostogram was performed (Fig. 3), which revealed some narrowing at the site of penetration but no contrast extravasation. A nephroureteral stent was effectively placed. Postprocedure course was uneventful and the patient was discharged home.
