Title No. 114-M73

Corrosion Performance of Poorly Pickled Stainless Steel Reinforcement

by M. O'Reilly, J. Sperry, D. Darwin, J. Lafikes, I. Somogie, S. Storm, and J. Browning

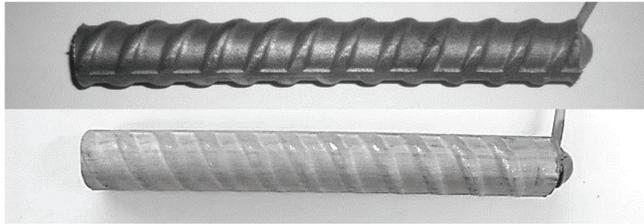
Fig. 1—XM-28(1) first heat (top) and XM-28(2) second heat (bottom). No. 16 (No. 5) bars.

Both steels were pickled by the producers. The samples from the two heats of XM-28 steel are shown in Fig. 1. The first heat, identified as XM-28(1), had a dark, mottled appearance, while the second heat had a uniformly light surface finish. The single heat of 2304 stainless steel was tested in two conditions: as received and re-pickled by the authors. The re-pickling process consisted of submerging the bars in a solution of 25% nitric acid and 5% hydrofluoric acid at room temperature (22°C [72°F]) for 30 minutes, followed by rinsing the bars with distilled water. The 2304 bars before and after re-pickling is shown in Fig. 2. In the two heats of XM-28 steel shown in Fig. 1, the as-received 2304 had a dark, mottled appearance and the re-pickled 2304 had a bright, shiny appearance.

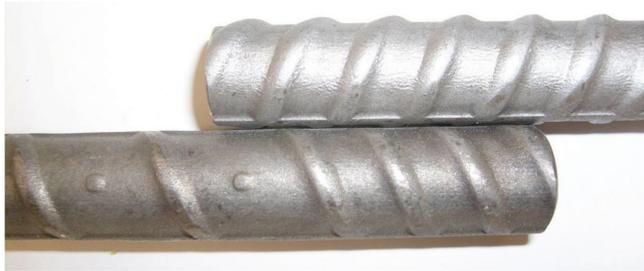
Fig. 2—2304 as-received (left) and re-pickled (right). No. 16 (No. 5) bars.

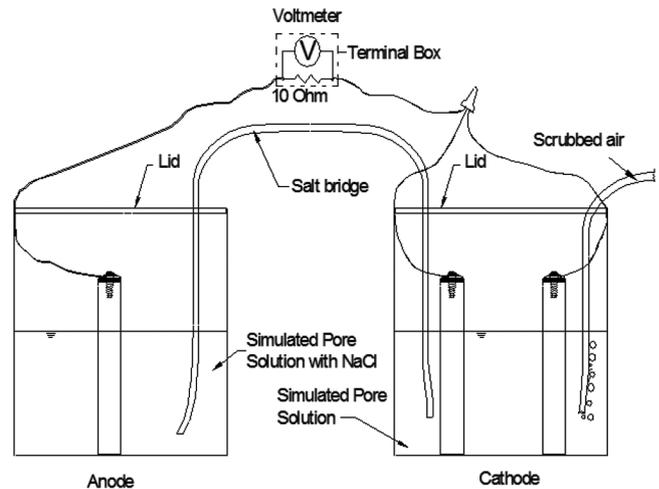
Fig. 3—Rapid macrocell test specimen.

Rapid macrocell test—Rapid macrocell specimens (Fig. 3) consist of a single 127 mm (5 in.) long No. 16 (No. 5) reinforcing bar in a container with simulated concrete pore solution containing salt and two 127 mm (5 in.) long No. 16 (No. 5) reinforcing bars in a second container with simulated pore solution not containing salt. One liter of pore solution contained 18.81 g potassium hydroxide, 17.87 g sodium hydroxide, and 974.8 g distilled water. 174.1 g sodium chloride was added to 1 L of pore solution to create the salt solution at the anode. The containers are filled to a depth of 76 mm (3 in.) with their respective pore solutions, and air scrubbed to remove CO₂ is bubbled to the pore solution in the second container to provide oxygen. The bars in the two containers are connected ionically via a potassium chloride salt bridge, and electrically across a 10-ohm resistor to allow for corrosion rate measurements to be taken. By measuring the voltage drop across the 10-ohm resistor, the current flow to the anode may be determined, which in turn can be expressed as a current density i in microamps per square centimeter ($\mu\text{A}/\text{cm}^2$) based on the anode surface area. Faraday's law can be used to convert current density i to the rate of metal loss R ($\mu\text{m}/\text{y}$) based on the atomic weight of the metal a (55.8 g/mole for iron), the number of electrons transferred n (2 for iron), Faraday's constant F (96,500 Coulombs/equivalent) and the metal density ρ (7.87 g/cm³ for iron) (Jones 1996).

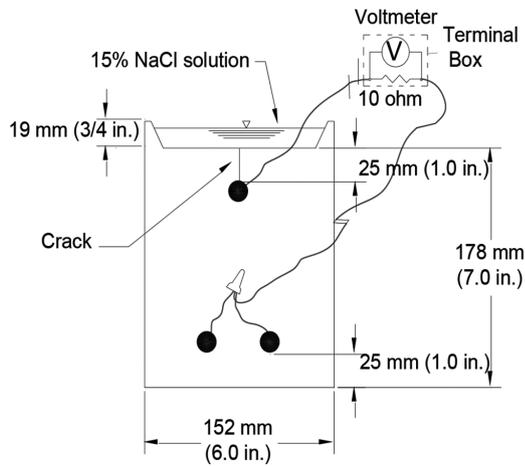
Fig. 4—Cracked beam specimen.

Cracked beam test—Cracked beam specimens (Fig. 4) consist of two mats of No. 16 (No. 5) reinforcement with 25 mm (1 in.) clear cover, cast in a 152 x 305 x 178 mm (6 x 12 x 7 in.) concrete block. The top mat contains a single No. 16 (No. 5) bar; the bottom mat contains two bars. The bars in the top and bottom mats are electrically connected via external wiring to a terminal box across a 10-ohm resistor to allow for corrosion rate measurements. The specimens are cast upside down with a 0.3 mm (12 mil) x 152 mm (6 in.) stainless steel shim placed in the mold in contact with the top bar prior to casting. This shim is removed 12 hours after casting, leaving a 152 mm (6 in.) long crack in the concrete over the top bar. A 19 mm (0.75 in.) concrete dam is cast integrally with the top of the specimen to allow for ponding of saltwater.

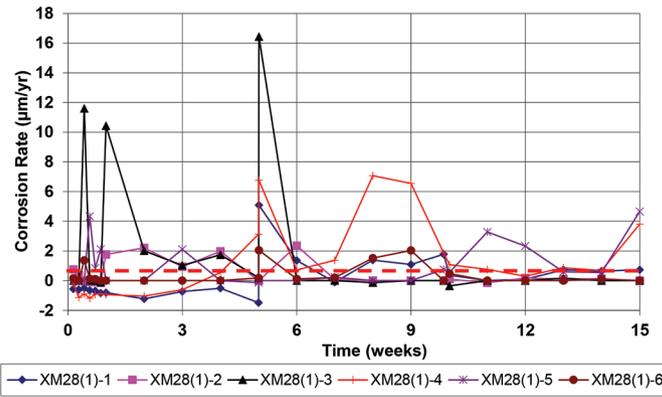
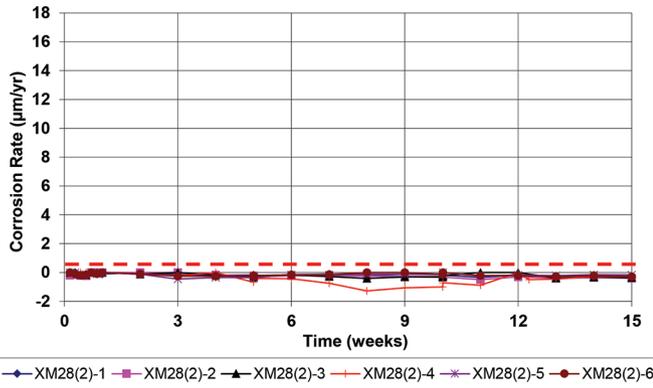
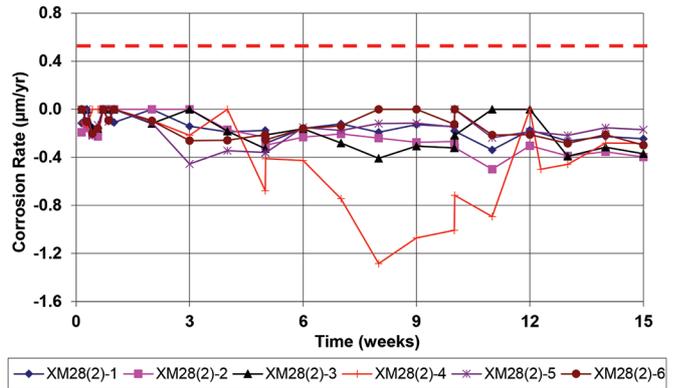
Fig. 5—(a) Rapid macrocell test—individual corrosion rate versus time for first heat of XM-28 stainless steel; (b) rapid macrocell test—individual corrosion rate versus time for second heat of XM-28 stainless steel; and (c) rapid macrocell test—individual corrosion rate versus time for second heat of XM-28 stainless steel (different scale).

Rapid macrocell test—Individual corrosion rates from the rapid macrocell test for specimens from XM-28(1) (poorly pickled) and XM(2) (properly pickled) are shown in Fig. 5(a) and (b), respectively. Figure 5(c) shows individual corrosion rates for XM-28(1) with an expanded scale. The dashed horizontal line represents the ASTM A955 corrosion rate limit for individual specimens of 0.5 μ m/y. For the poorly pickled XM-28(1) (Fig. 5(a)), all six specimens exceeded the 0.5 μ m/y limit, with a peak corrosion rate of 16.4 μ m/y observed for Specimen XM28(1)-3 at week 5. No specimen of XM-28(2) exhibited a measurable positive corrosion rate at any point during the test (Fig. 5(b)). The “negative” corrosion rates observed in the figures are the result of a slight current drift between anode and cathode and are not indicative of corrosion, nor are they a cause to disqualify stainless steel under ASTM A955.

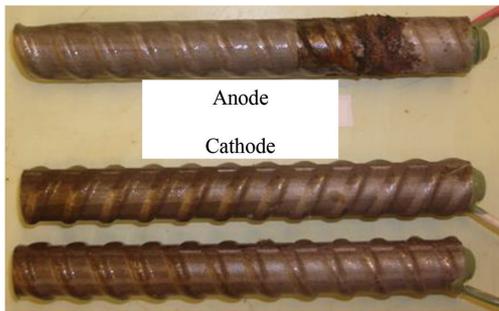
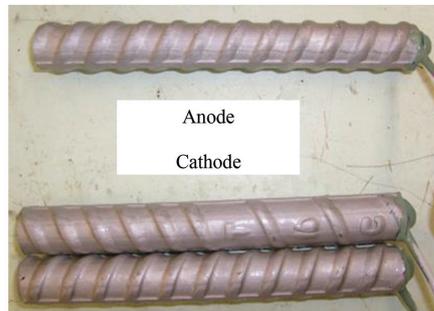
Fig. 6—(a) Rapid macrocell test—first heat specimen XM28(1)-6 after testing. Anode bar (top) and cathode bars (bottom). No. 16 (No. 5) bars; and (b) rapid macrocell test—second heat specimen XM28(2)-4 after testing. Anode bar (top) and cathode bars (bottom). No. 16 (No. 5) bars.

Photos of the poorly and properly pickled XM-28 steel after testing are shown in Fig. 6(a) and (b), respectively. The top bar in each photo is the anode bar; the two bottom bars are cathode bars. After testing, all anode bars from the poorly pickled steel showed visible signs of corrosion, particularly at and above the level of pore solution in the container (Fig. 6(a)). The cathode bars showed no visible corrosion. For the properly pickled steel, no corrosion products were visible on any of the anode or cathode bars (Fig. 6(b)).

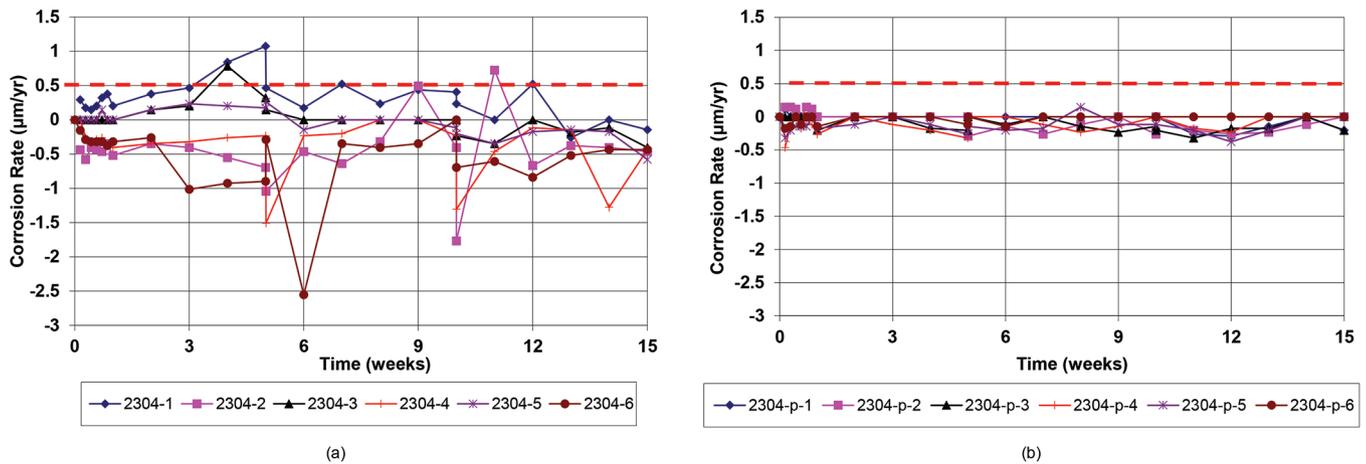
Fig. 7—(a) Rapid macrocell test—individual corrosion rate versus time for 2304 stainless steel in the as-received condition; and (b) rapid macrocell test—individual corrosion rate versus time for 2304 stainless steel in the re-pickled condition.

Rapid macrocell test—Figures 7(a) and (b) show individual corrosion rates from the rapid macrocell test for the 2304 stainless steel in, respectively, the as-received and re-pickled conditions. For the as-received 2304 (Fig. 7(a)), three out of the six specimens exceeded the 0.5 μ m/y corrosion rate limit: Specimen 2304-1 at weeks 4 and 5, Specimen 2304-2 at week 11, and Specimen 2304-3 at week 4. The maximum individual corrosion rate, 1.07 μ m/y, was observed for Specimen 2304-1 at week 5. For the re-pickled 2304 (Fig. 7(b)), no specimen exceeded the 0.5 μ m/y limit. The maximum individual corrosion rate, 0.145 μ m/y, was observed on Specimen 2304-p-2 during the first week of testing.

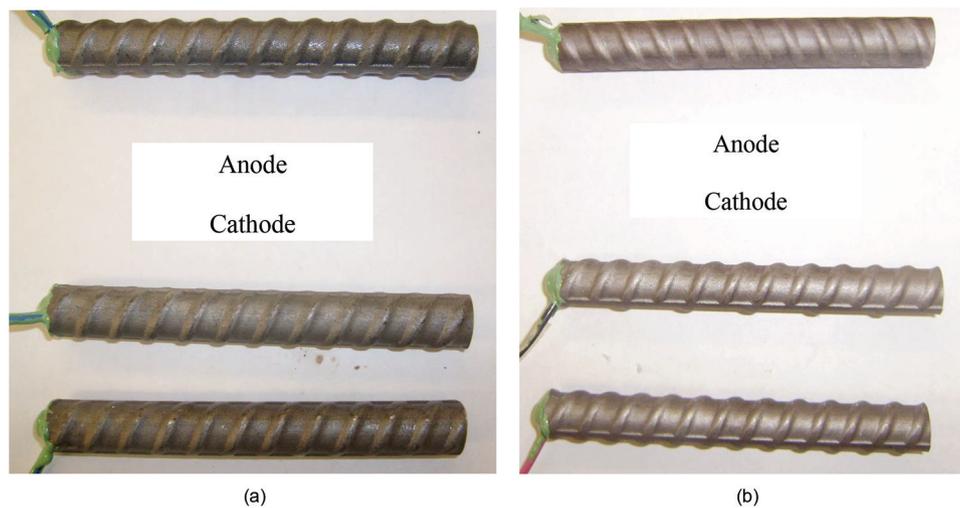
Fig. 8—(a) Rapid macrocell test of as-received Specimen 2304-1 after testing. Anode bar (top) and cathode bars (bottom). No. 16 (No. 5) bars; and (b) rapid macrocell test of re-pickled Specimen 2304-p-4 after testing. Anode bar (top) and cathode bars (bottom). No. 16 (No. 5) bars.

Photos of the as-received and re-pickled 2304 specimens after testing are shown in Fig. 8(a) and (b), respectively. The top bar in each photo is the anode bar; the two bottom bars are cathode bars. No corrosion products were visible on any of the anode or cathode bars in either condition, although the as-received bars (Fig. 8(a)) generally had a darker appearance than the re-pickled bars (Fig. 8(b)).

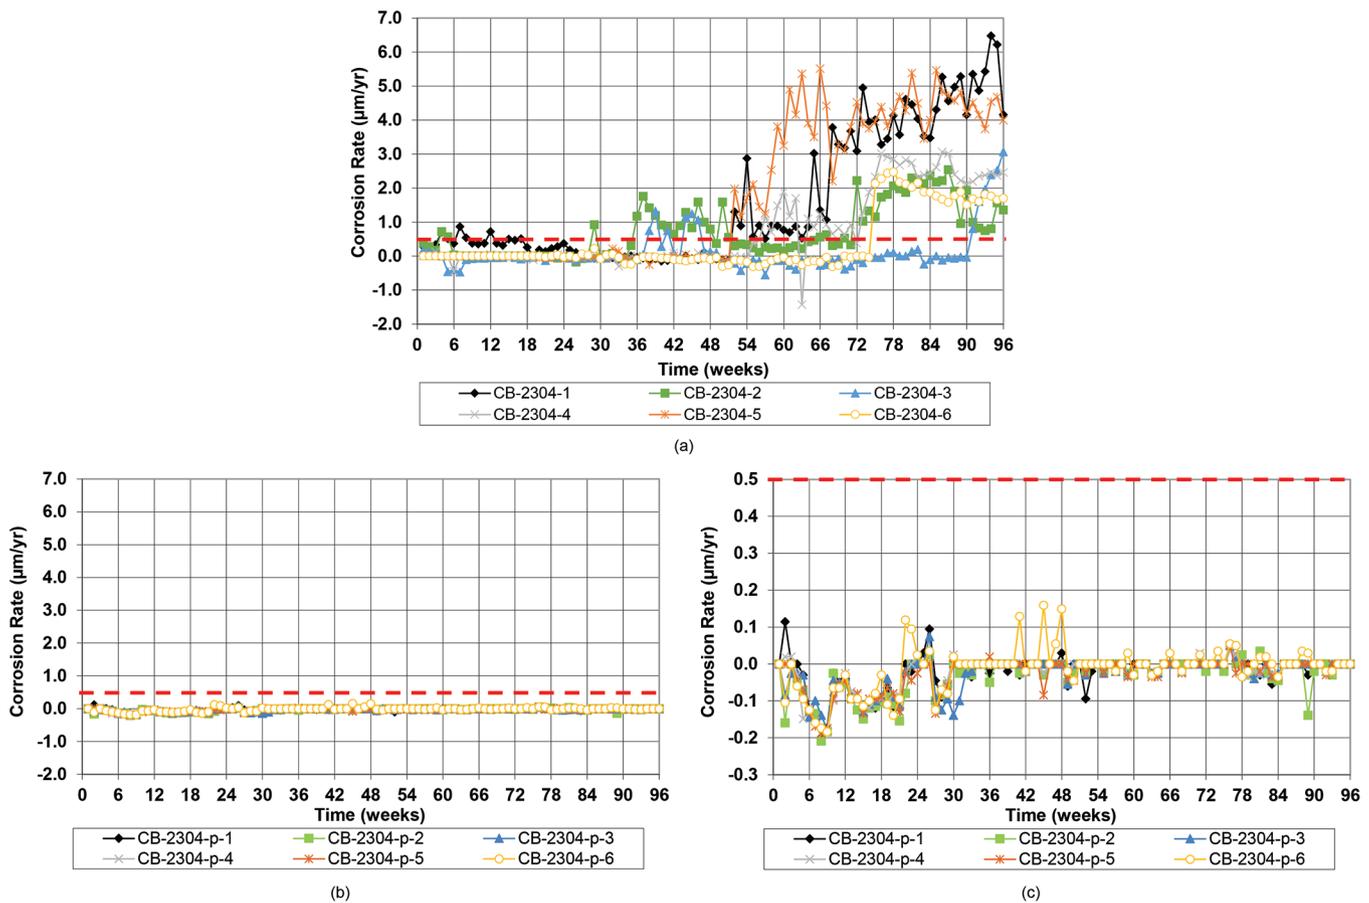
Fig. 9—(a) Cracked beam test—individual corrosion rate versus time for 2304 stainless steel in the as-received condition; (b) cracked beam test—individual corrosion rate versus time for 2304 stainless steel in the re-pickled condition; and (c) cracked beam test—individual corrosion rate versus time for 2304 stainless steel in the re-pickled condition (different scale).

Cracked beam test—The individual corrosion rates from the cracked beam test for the 2304 stainless steel are shown in Fig. 9(a) and (b) for the as-received and re-pickled conditions, respectively. Figure 9(c) shows individual corrosion

rates for the re-pickled 2304 on an expanded scale. For the as-received 2304 (Fig. 9(a)), Specimen CB-2304-2 exceeded the 0.5 $\mu\text{m}/\text{y}$ limit at week 4, and Specimen CB-2304-1 exceeded the limit at week 12. The corrosion rate for all specimens remained below 1.0 $\mu\text{m}/\text{y}$ through week 36, when the corrosion rate began to increase for Specimens CB-2304-2 and CB-2304-3. By week 75, all six specimens had exceeded the 0.5 $\mu\text{m}/\text{y}$ limit. The peak corrosion rate during the first 75 weeks was 5.51 $\mu\text{m}/\text{y}$ for Specimen 2304-5 at week 66; through 96 weeks, the peak rate was 6.48 $\mu\text{m}/\text{y}$ for Specimen 2304-1 at week 94. For the re-pickled 2304 (Fig. 9(b)), specimens had corrosion rates less than 0.1 $\mu\text{m}/\text{y}$ for most of the test, with a few isolated spikes above 0.1 $\mu\text{m}/\text{y}$. The peak

corrosion rate was 0.159 $\mu\text{m}/\text{y}$ for Specimen CB-2304-p-6 at week 45; no specimen exceeded the 0.5 $\mu\text{m}/\text{y}$ limit.

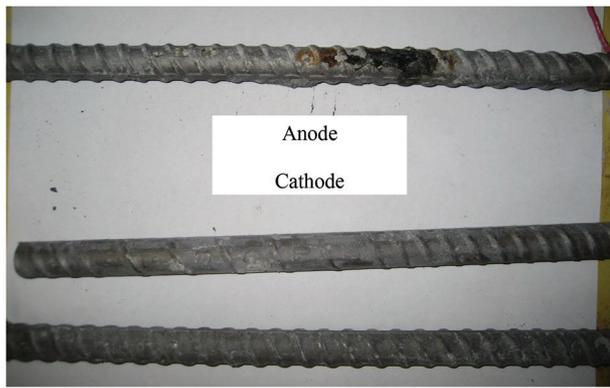
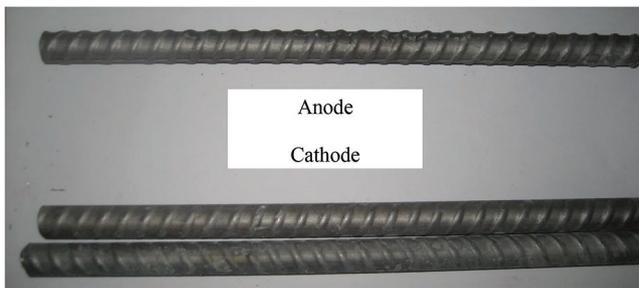
Fig. 10—(a) Cracked beam test of as-received Specimen CB-2304-1 after testing. Anode bar (top) and cathode bars (bottom). No. 16 (No. 5) bars; (b) cracked beam test of as-received Specimen CB-2304-1 after testing. Closeup of corrosion on anode bar. No. 16 (No. 5) bar; and (c) cracked beam test of re-pickled Specimen CB-2304-p-1 after testing. Anode bar (top) and cathode bars (bottom). No. 16 (No. 5) bars.

Photos of the as-received 2304, a closeup of the corrosion on the top bar of the as-received 2304, and the re-pickled 2304 after testing are shown in Fig. 10(a) through (c), respectively. The top bars in Fig. 10(a) and (c) are the anode bars (as is the bar shown in Fig. 10(b)); the bottom two bars are cathode bars. All the as-received bars showed moderate corrosion in the area of the bar under the crack, as shown in Fig. 10(a) and (b), with no corrosion on the bottom bars. No corrosion was observed on any of the re-pickled 2304 bars (Fig. 10(c)).
