e-ISSN 1941-5923
© Am J Case Rep, 2018; 19: 382-385
DOI: 10.12659/AJCR.908508

Hemoptysis After CardioMEMS Implantation: Case Report and Review

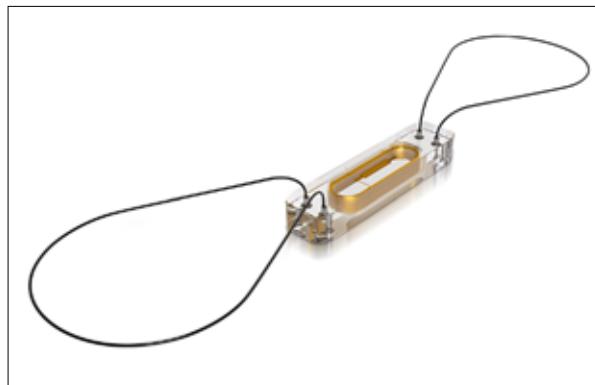
Figure 1. CardioMEMS sensor.

The CardioMEMS heart failure system (Figure 1) is a small sensor that is placed in a branch pulmonary artery for ambulatory monitoring of pulmonary artery pressures. CardioMEMS has been approved for use in the United States in patients with New York Heart Association (NYHA) class III heart failure and frequent hospitalizations [1–3]. Overall, it has been shown to be safe with a very low rate of adverse events. The occurrence of hemoptysis post implantation is rare, though it has been described both in the CHAMPION trial and a recent analysis of the MAUDE Database [1,4]. With the growing use of the device, this is likely to increase.

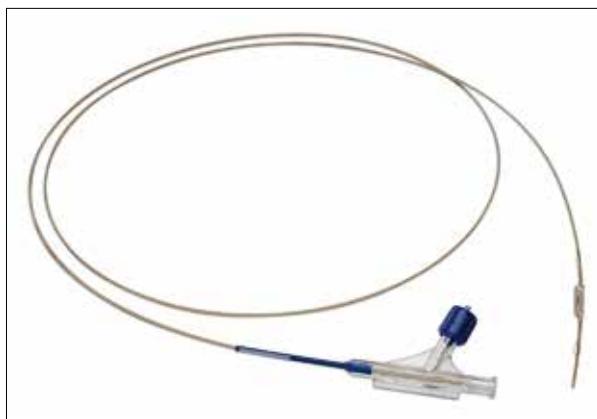
There are several possible mechanisms for the occurrence of hemoptysis. The most likely cause is injury from the catheter nose cone or wire. The delivery catheter has a significant leading edge beyond the sensor to accommodate the distal nitinol loop that is wrapped on the catheter. Even beyond this there is a significant nose cone (Figure 2). Considering that many pulmonary artery branches have rapid tapers, this can result in the nose cone being pushed into an artery whose diameter is smaller than the catheter tip causing arterial injury. The device is delivered over a 0.018-inch exchange length wire. Even these relatively soft tip wires can cause injury and perforation of the small branches of the pulmonary artery.

Figure 2. Prominent nose cone of the delivery system that extends beyond the distal nitinol loop.

especially if they are pushed in deeper to accommodate the long delivery catheter nose cone. Another cause of hemoptysis could be from implantation of the sensor body into an artery of a smaller than recommended diameter. The recommended diameter is 5–10 mm for the sensor body, and if implanted into a smaller artery there could be frictional injury. This may happen if there are overlapping branches on angiography and if the wire is inadvertently advanced into an unintended branch of smaller diameter. This mechanism was reported in at least one case in a recent publication from the MAUDE database [4]. Alternatively, this may happen if the wire comes back during advancement of the sensor and then goes into a wrong branch when re-advanced. Finally, peri-procedural anti-coagulation may exacerbate hemoptysis caused by any of the aforementioned etiologies.

Several simple strategies can minimize the risk of hemoptysis during an implant procedure. First, caution must be taken to identify an appropriately sized artery that would not only be able to receive the sensory but also has sufficient length distally to accommodate the long nose cone of the delivery catheter. Multiple angiographic views may be useful to remove vessel overlap and definitively identify the target vessel. In some instances, a non-balloon tipped wider lumen catheter (a multi-purpose or JR4) might be better than a Swan-Ganz catheter. This would allow one to inject contrast using a Tuohy-Borst connector while simultaneously advancing the wire to ensure that it is indeed advancing into the intended branch (Figure 3). Second, care must be taken to ensure that the wire is not inadvertently pulled back while advancing the sensor. For new implanters, a more liberal use of fluoroscopy might be especially useful during this exchange. Finally, the use of intra-procedural

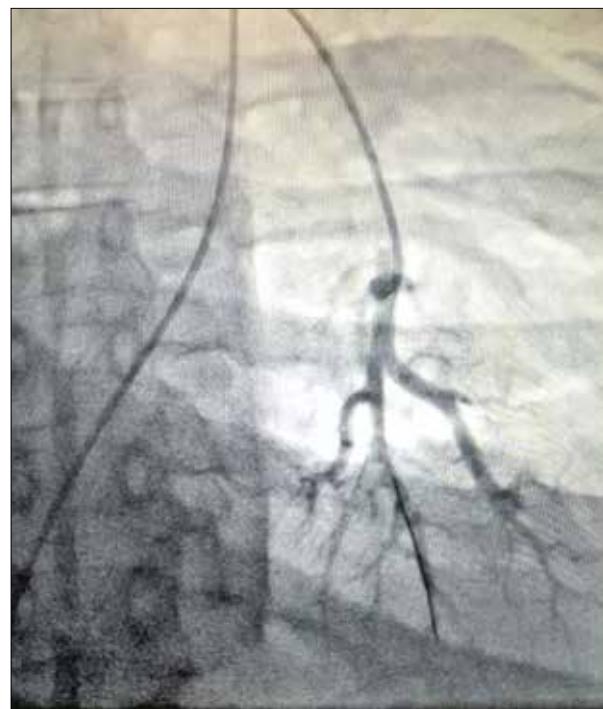
Figure 3. Contrast injected into the intended branch pulmonary artery simultaneously advancing the wire using a Tuohy-Borst connector.
