# An Approach to Bridge Inspection Using 3D Laser Scanners and Digital Photographs

Submitted to the graduate degree program in Civil Engineering and the Graduate Faculty of the University of Kansas in partial fulfillment of the requirements for the degree of Master of Science.

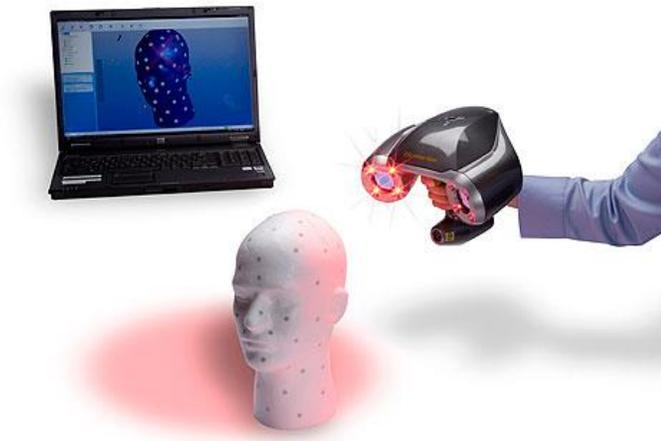
**Figure 3.1: Hand-held laser scanner (makepartsfast.com)**

Depending on the host, laser scanners can be classified as either hand-held, aerial or terrestrial laser scanner. Each type can serve a unique need and help capture data more effectively. Hand-held scanners are small and easy to carry, they are commonly used in the business world to scan bar codes and product detail tags. More powerful hand-held scanners have applications in mining, concept prototyping and in labs to scan irregular objects with great detail. These scanners provide great mobility and ease while operating. Hand-held scanners use an internal coordinate system to map a surface.

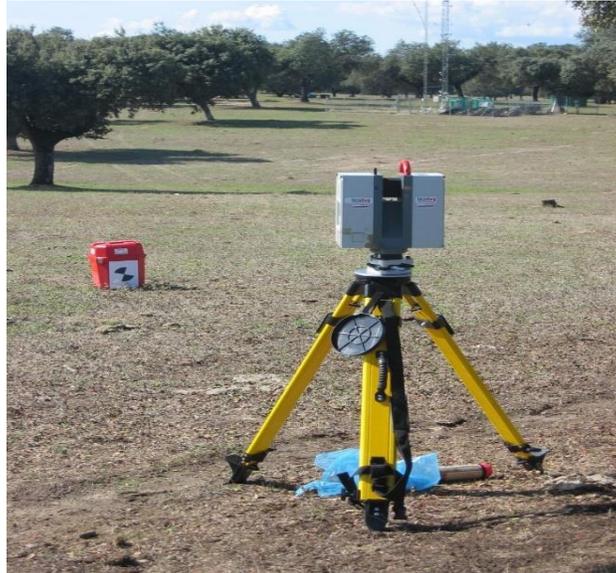
are mounted on a tripod stand while in use. Terrestrial laser scanners use the concept of triangulation and time-of-flight method to map its surroundings and store data in a point cloud format. For this research, a Trimble TX5 terrestrial laser scanner was used.

**Figure 3.3: Terrestrial laser scanner (Source: google images)**

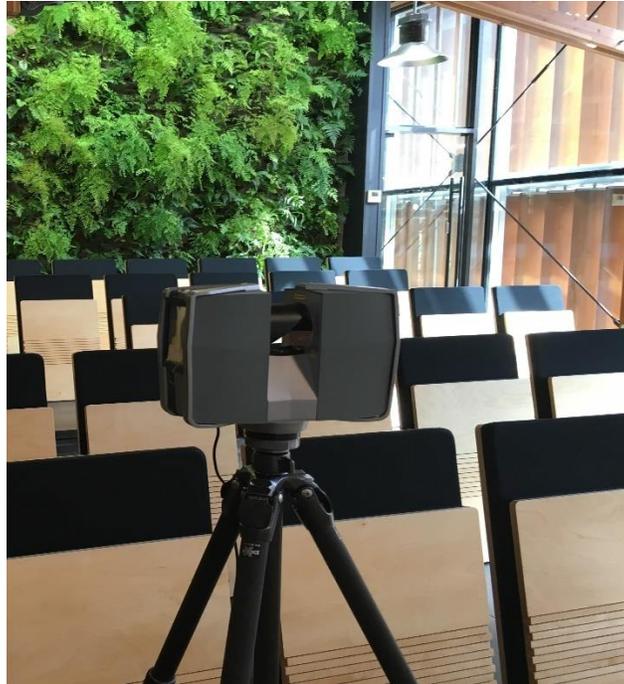
TX5 also includes an integrated color camera featuring an automatic 70 megapixels' parallax-free color overlay. It has a size of only 240 mm x 200 mm x 100mm (9.5 in x 8 in x 4 in) and weight of just 5.0 kg (11 lb), it is easy to move and set up in complex environments. The scanner also comes with a lithium-ion battery that provides up to five hours of battery life and can be charged during operation. The option to operate via WLAN to remotely start, stop, view or download scans from a distance is also available.

**Figure 4.2: Trimble TX5**

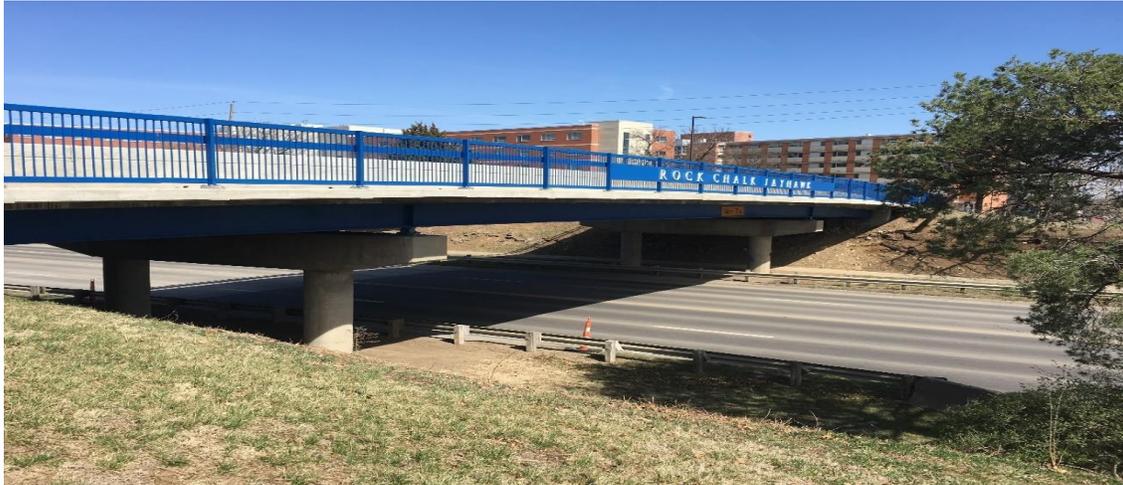
**Figure 5.1: Irving hill bridge**

Irving Hill Bridge (Figure 5.1) near Daisy Hill in the city of Lawrence was identified to be a suitable site for data collection. This site is on KU campus and is easily accessible from both sides of U.S. route 59. As-built plans for the bridge are available at KU Design & Construction

Management office. As-built drawings for the bridge were acquired by submitting a formal request to Design & Construction Management office. These drawings were used to validate point cloud data collected using a 3D laser scanner.

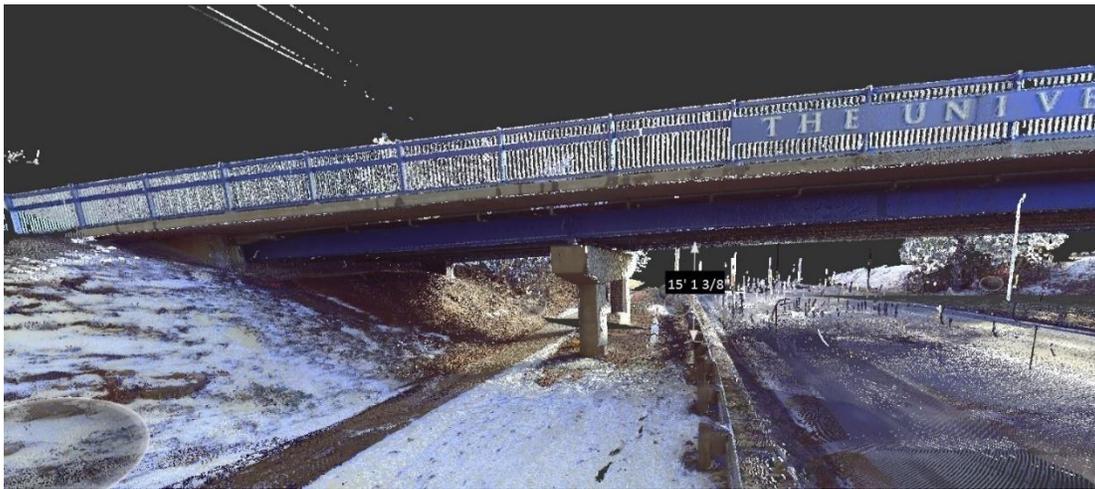
Minimum vertical clearance was measured near north-eastern pier instead of center as the same measurement was given in drawings. Minimum inventory route vertical clearance was also measured at the same point. This point lies at the edge of the roadway on the west side of the bridge. This point represents the minimum vertical clearance for roadway and shoulders. Figure 5.6a shows the bridge plan and minimum clearance as shown in drawings and Figure 5.6b shows the same measurement from scan data. Minimum navigational vertical clearance was measured at the center of the underlying road (Figure 5.6c).

**Figure 5.6a: Minimum vertical clearance as given in drawings**

**Figure 5.6b: Minimum vertical clearance from scan data**

**Figure 5.6c: Navigational vertical clearance**

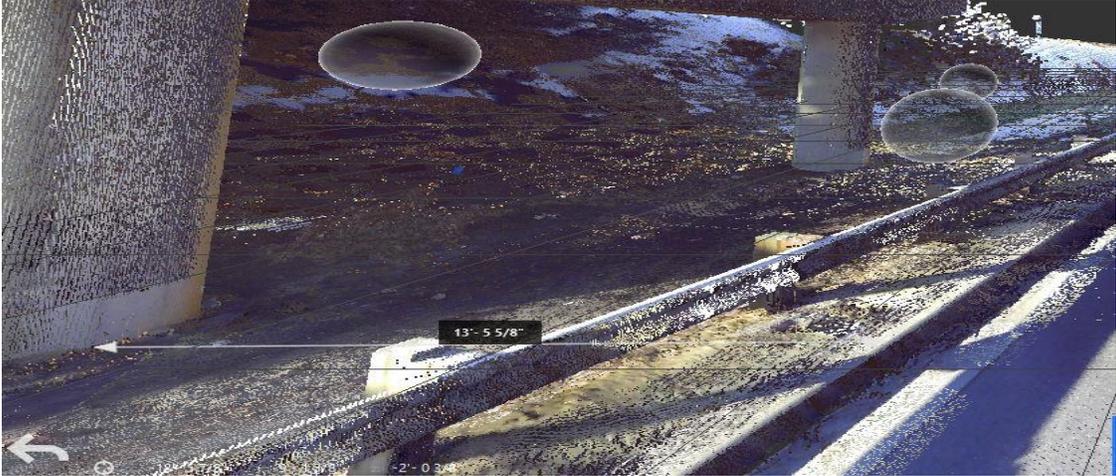
Minimum lateral clearance under the bridge was measured from the edge of curb to the first restrictive structure i.e. piers. Figure 5.7 shows the measurement obtained from scan data for minimum lateral under clearance.

**Figure 5.7: Minimum lateral under clearance on west side**

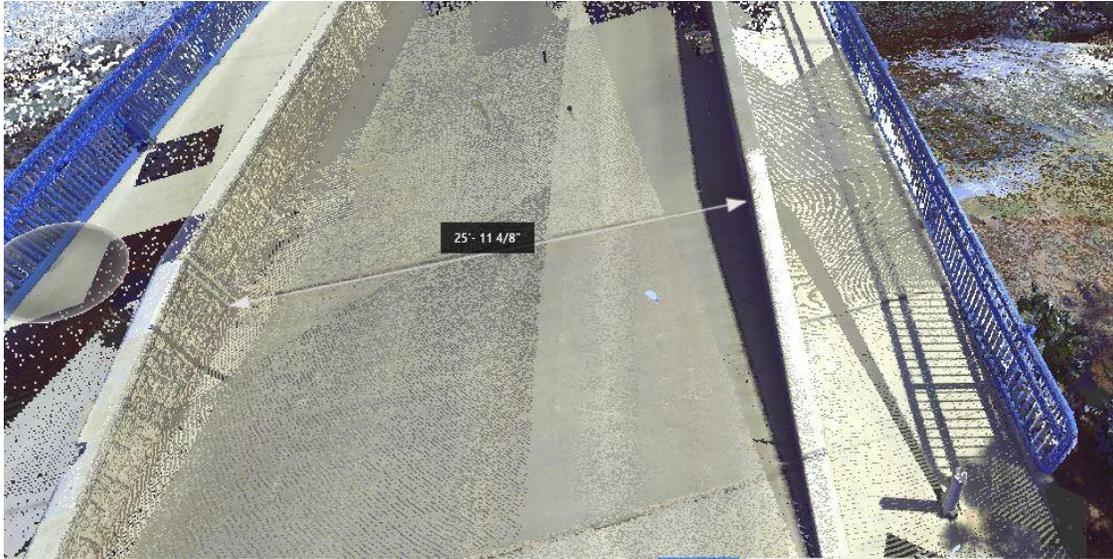
Next item on the list was the width of bridge roadway. Measuring the roadway width was tricky in true colors as the shadow of sidewalk medians hindered in capturing the desired points. The measurement was taken along an expansion joint to assist in capturing the desired points. Figure 5.14a shows the measurement.

**Figure 5.14a: Bridge roadway width from scan data**

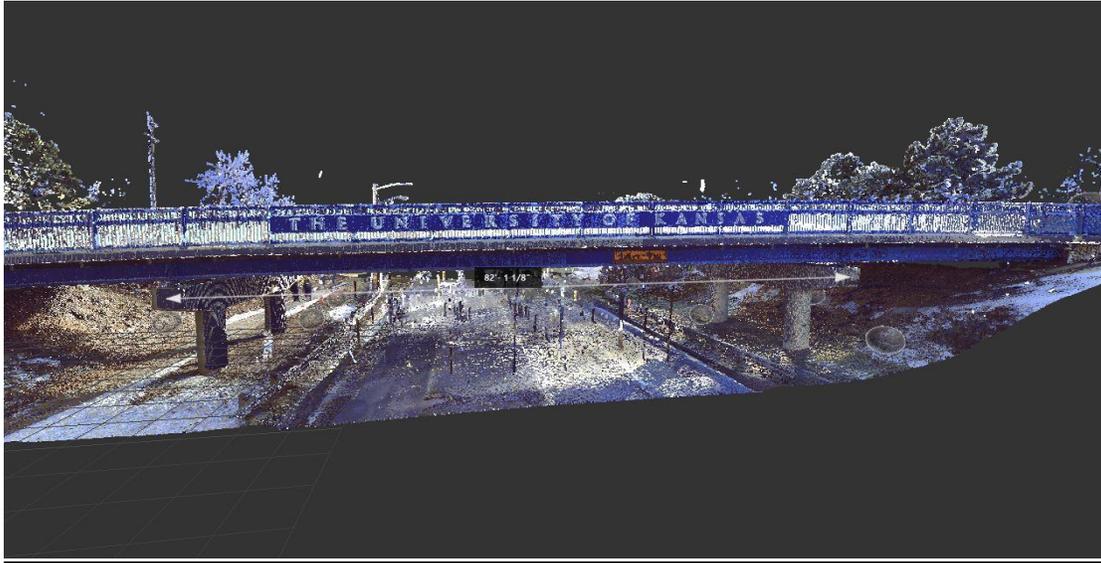
Figure 5.15 shows the measurement for the length of the maximum span as obtained from scan data. The length was measured using the center of the pier as a reference. The measurement from plan drawings is evident in Figure 5.12b.

**Figure 5.15: Maximum span length**

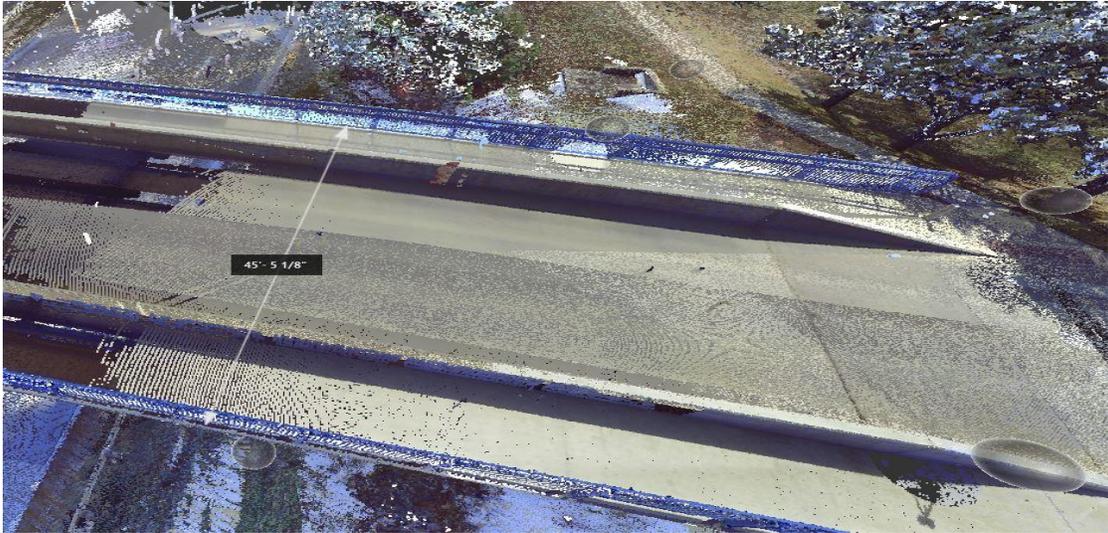
There are three set of drawings for this bridge. Originally, the bridge was constructed in 1965 and rehabilitated in 2005. In 2015, an improvement was conducted to increase the width of the bridge deck. After improvements, the bridge deck width was increased from 39 feet to 45.5 feet. Sidewalks on both sides of the bridge were widened from 5 feet in the original plan to 8 feet (Figure 5.14b). Figure 5.15 shows the measurement from scans for deck width.

**Figure 5.16: Deck width, out-to-out**

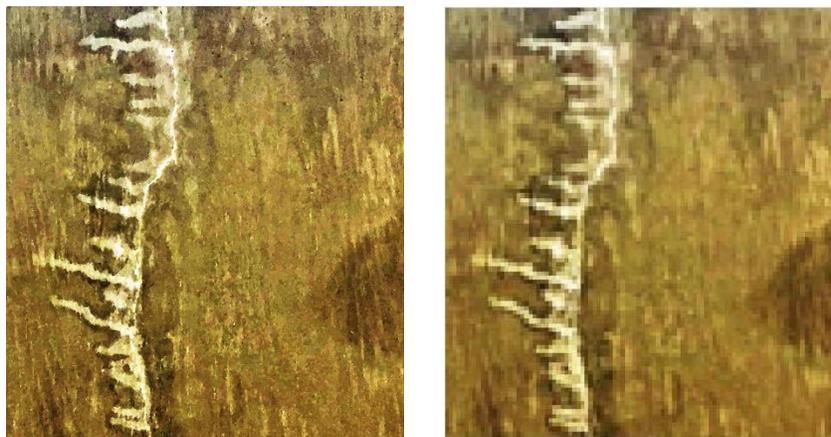
Figure 5.18 shows the true image as taken using a high-resolution camera. The size of the image was reduced to 100x100 pixels for simplification. Large images can make computation difficult and increase the error probability due to lighting conditions. The image was resized using MATLAB command `imresize(I, [100 100])`, where I represent said image.

**Figure 5.18: Raw image(left) vs resized image(right)**

green blue(RGB) format. MATLAB command **rgb2gray()** is used to convert the image in Figure 5.18(right) into a grayscale image. Figure 5.19 shows the resulting image.

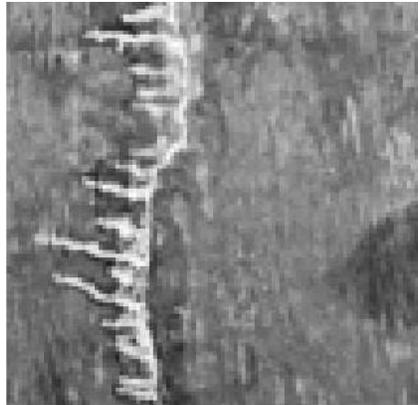
**Figure 5.19: Grayscale image**

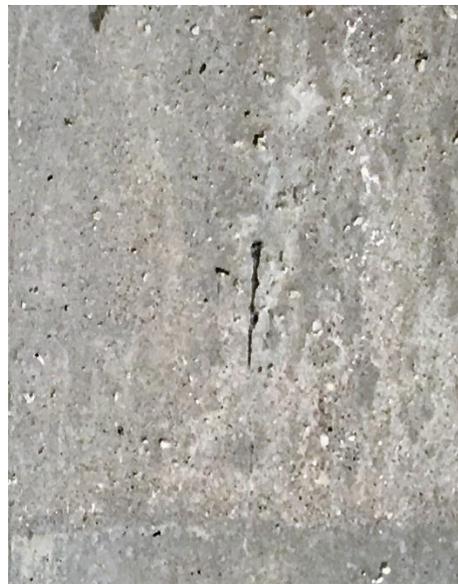
After detection of the crack segment, average crack width was computed to determine the severity of crack. For this purpose, a different image is used. Test image used during crack detection process shows a sealed crack. Due to the applied repairs, it is not possible to determine the actual width of crack. For this reason, a different image showing an open crack was used to demonstrate crack width computation. Image used shows a crack on the southwest pier of the bridge. Before photographing the crack, a rectangle of known parameters was created around the crack using tape. This was done to determine the width of the area visible in the photograph. The width of the image is 12". Test image for crack width computation is shown in Figure 5.24.

**Figure 5.24: Test image for crack width computation**

In order to compute crack width, it is necessary to detect and extract the crack component using methodology discussed in the previous section. Figure 5.25 shows the histograms for the image shown in Figure 5.24.
