AN INVESTIGATION OF DISTORTION-INDUCED FATIGUE
CRACKS IN STEEL HIGHWAY BRIDGES: FROM CRACK
DETECTION TO FATIGUE RETROFIT

Submitted to the graduate degree program in Department of Civil, Environmental, and
Architectural Engineering and the Graduate Faculty of the University of Kansas in partial
fulfillment of the requirements for the degree of Doctor of Philosophy.

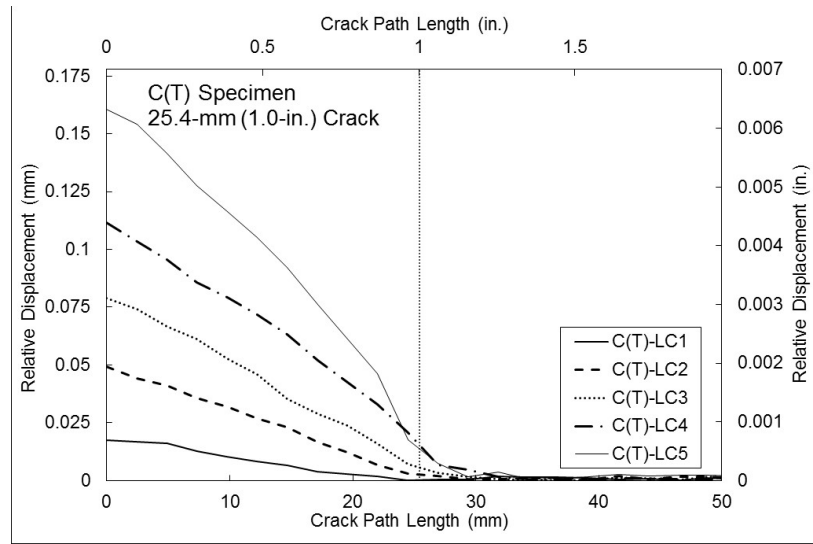
Figure 2-6. Relative displacement along crack path for an in-plane specimen with a 25.4-mm (1.0-in.) long crack

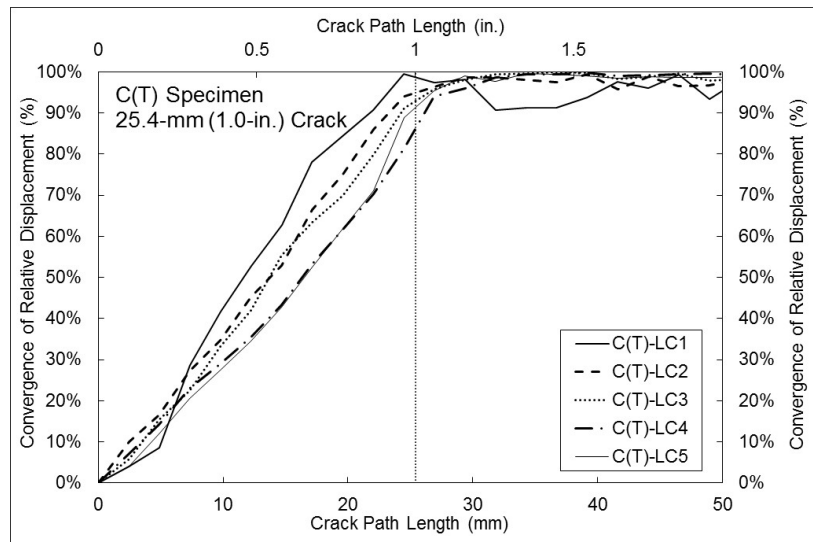
Figure 2-7. Convergence of relative displacement for an in-plane specimen with a 25.4-mm (1.0-in.) long crack

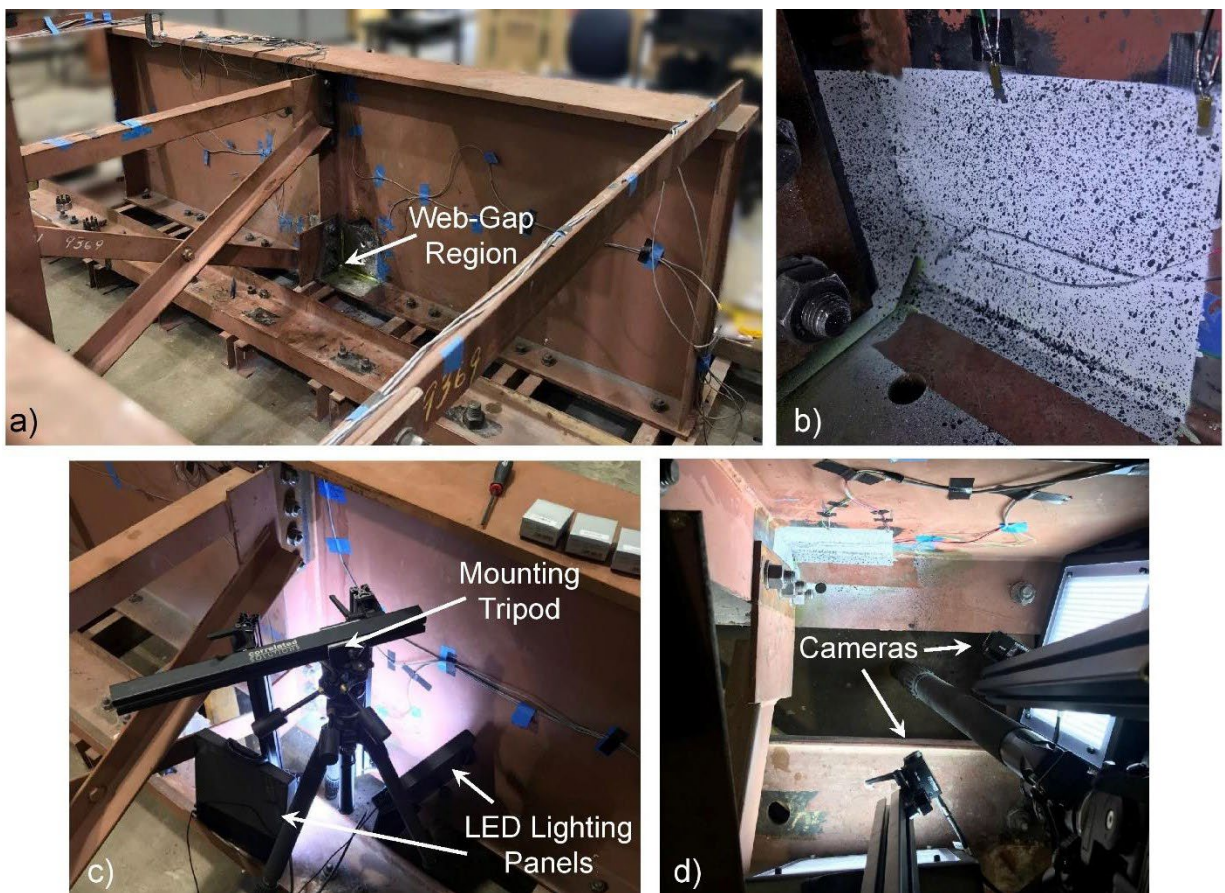
Figure 2-10. a) Distortion-induced fatigue test frame, b) Applied high-contrast surface pattern, c) DIC hardware placement, and d) Detailed orientation of DIC hardware seen from above

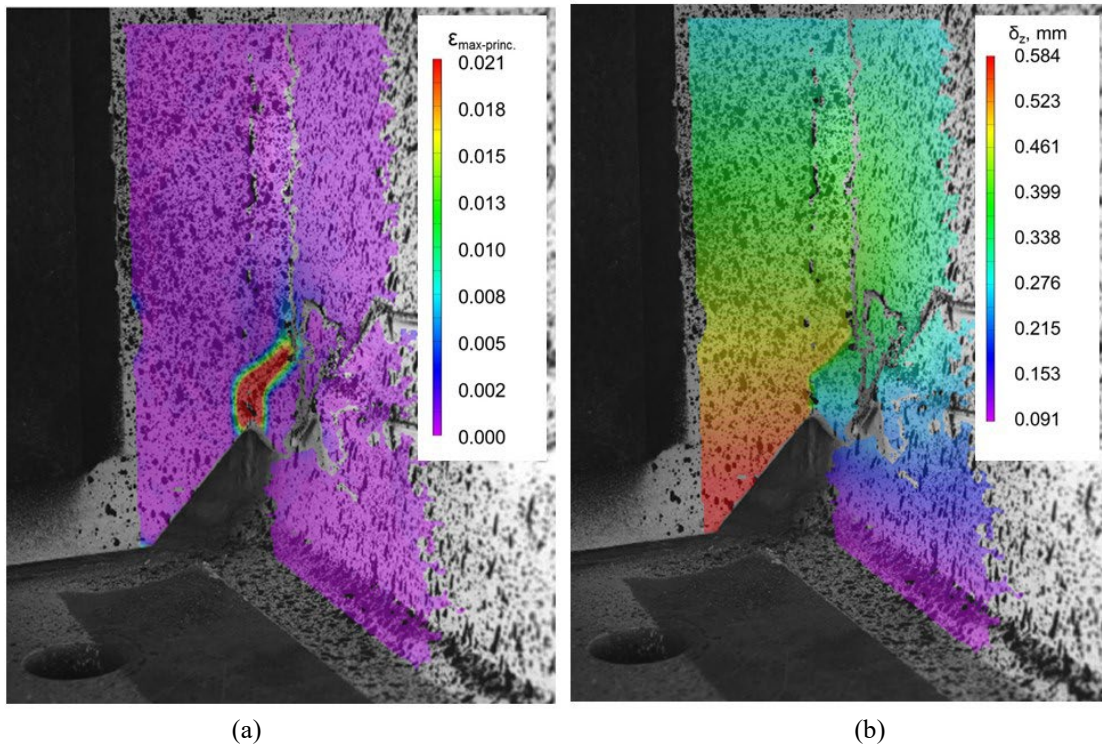
Figure 2-11. Typical visualized DIC results of distortion-induced fatigue specimen in terms of a) maximum principal strain and b) z-direction displacement

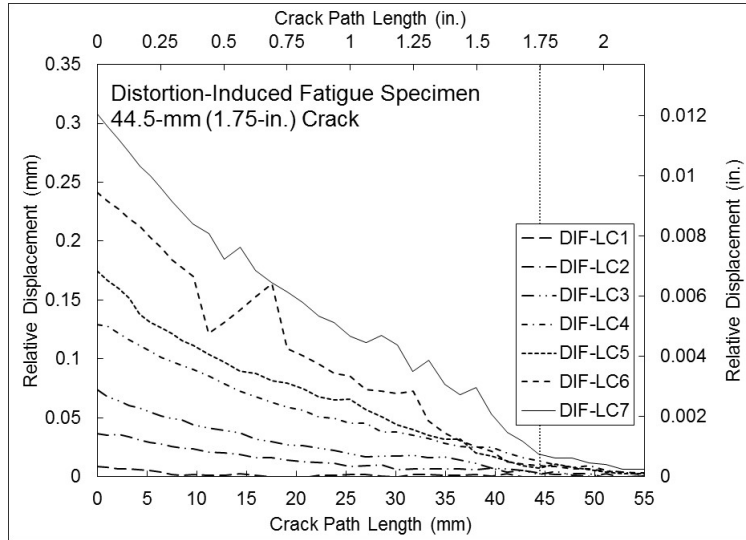
Figure 2-12. Relative displacement along crack path length for distortion-induced fatigue specimen

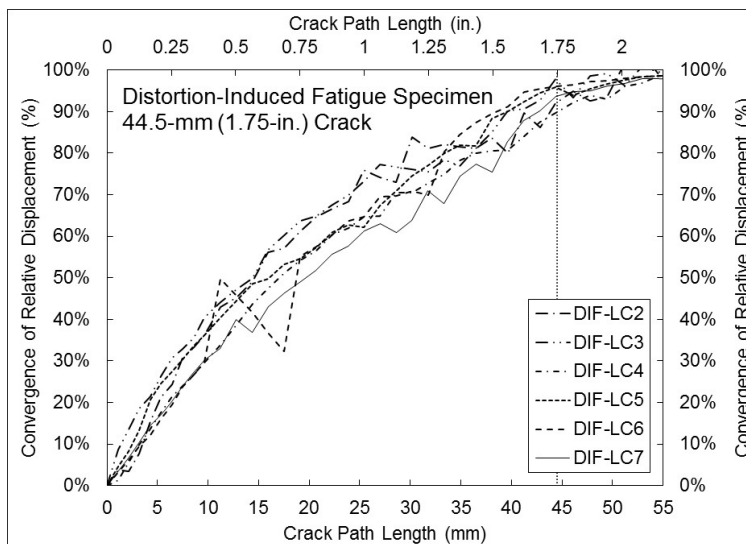
Figure 2-13. Convergence of relative displacement for distortion-induced fatigue specimen

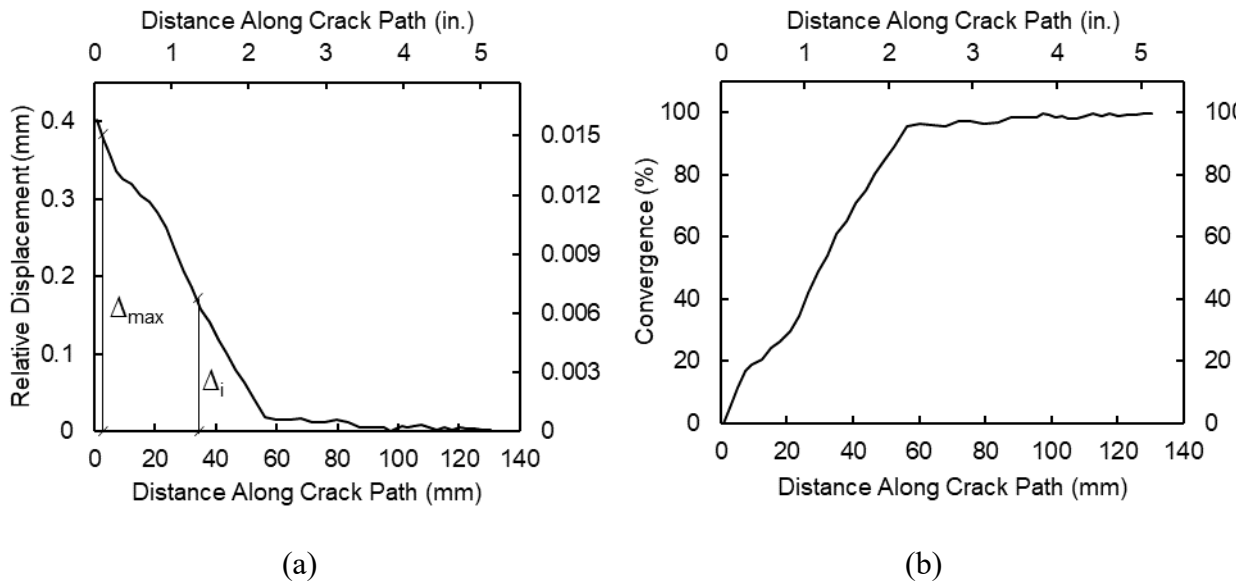
Figure 3-1. (a) Relative displacement and (b) Convergence along length of the crack path

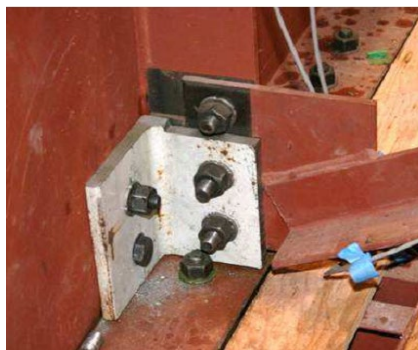
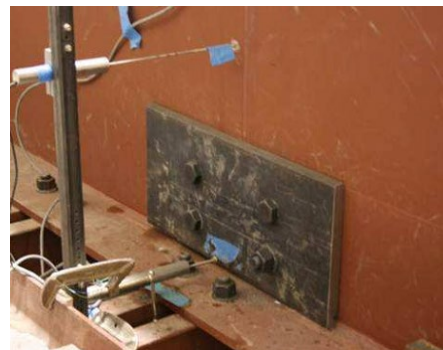
Figure 4-4: Angles-with-plate retrofit: (a) Angles layout; (b) Back plate layout

thicknesses were modeled to bound the behavior of the tested retrofit. Models with each combination of cracks but no retrofit (noted as UR) were also examined, as well as one model representing the uncracked, unretrofitted configuration of the girder, noted as UR-UC. Therefore, a total of 33 models were examined, one uncracked model and 32 cracked models (8 of them unretrofitted and 24 retrofitted), the cracked models divided into two groups, one has $a_1=2a_2$ and the other has $a_1=a_2$. Results from these simulations were compared with the experimental observations. Figure 4-4 shows the angles and back plate layout

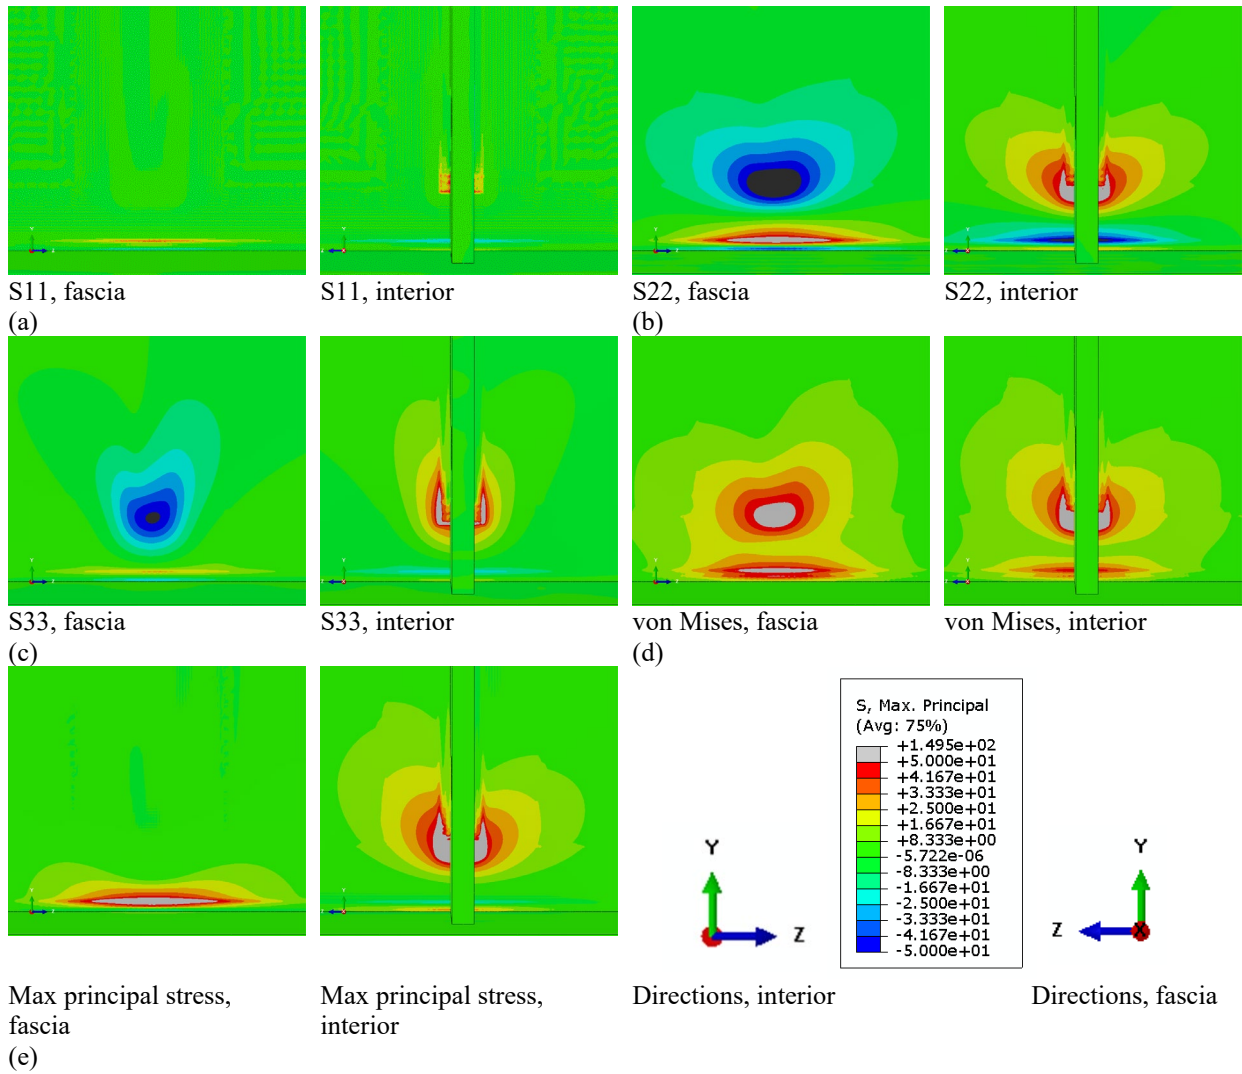
Figure 4-5: Different stresses on the web gap region on the fascia side and interior, (a)S11, (b) S22, (c) S33, (d) von Mises, (e) Max principal stress

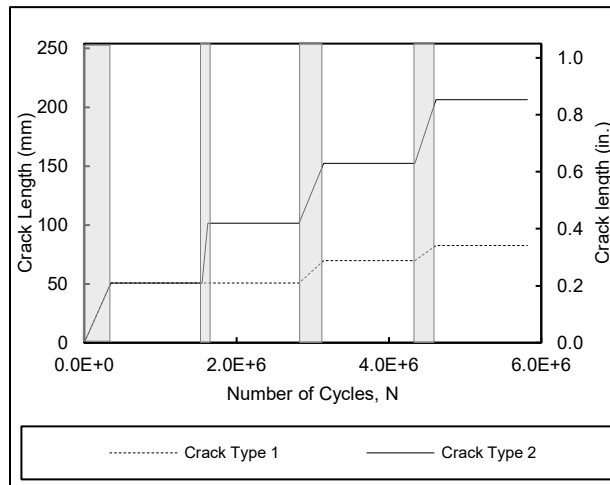
Figure 4-7: Crack propagation data for specimen 3 in both retrofitted and unretrofitted conditions (Alemdar et al. 2014a)

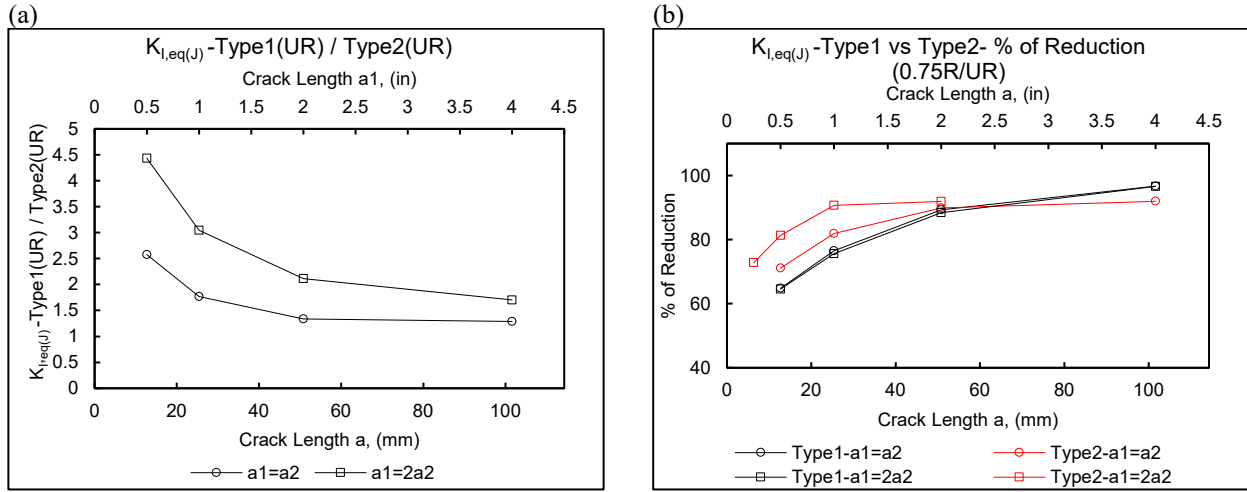
(c) Figure 4-13: (a) $K_{I,eq(J)}$ - Type1 vs Type 2- $a1=a2$; (b) $K_{I,eq(J)}$ - Type1 vs Type 2- $a1=2a2$; (c) $K_{I,eq(J)}$ -Type1(UR) / Type2(UR); (d) $K_{I,eq(J)}$ -Type1 vs Type2- % of Reduction (0.75R/UR)

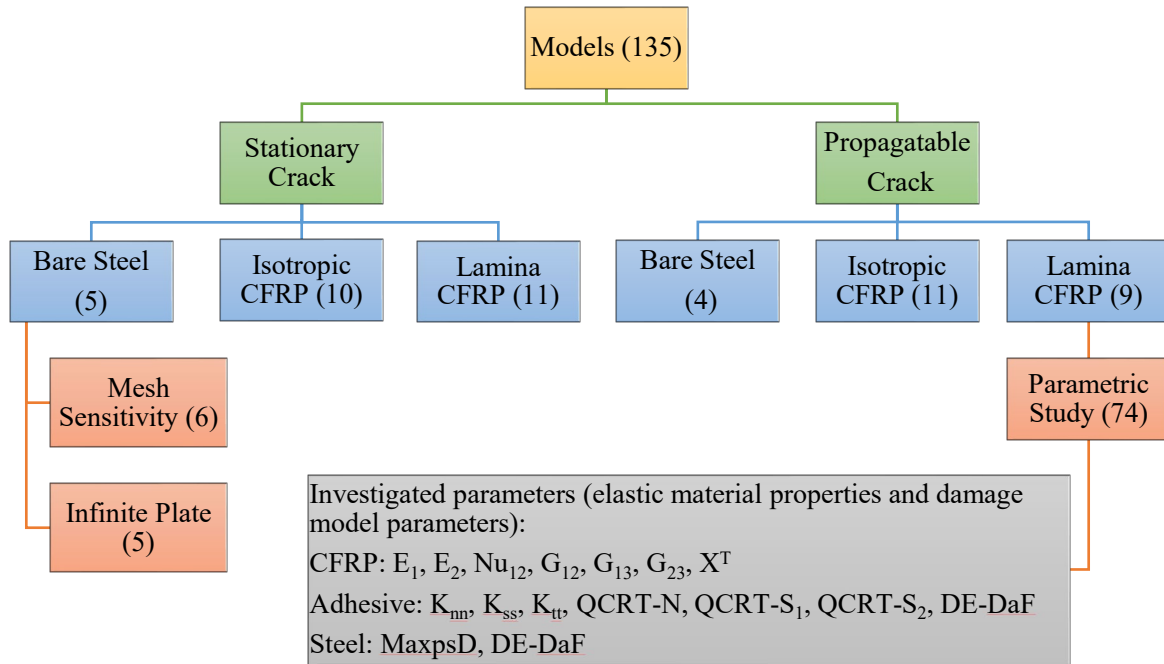
Figure 5-2 FE modelling suite, number between parentheses represent the number of models

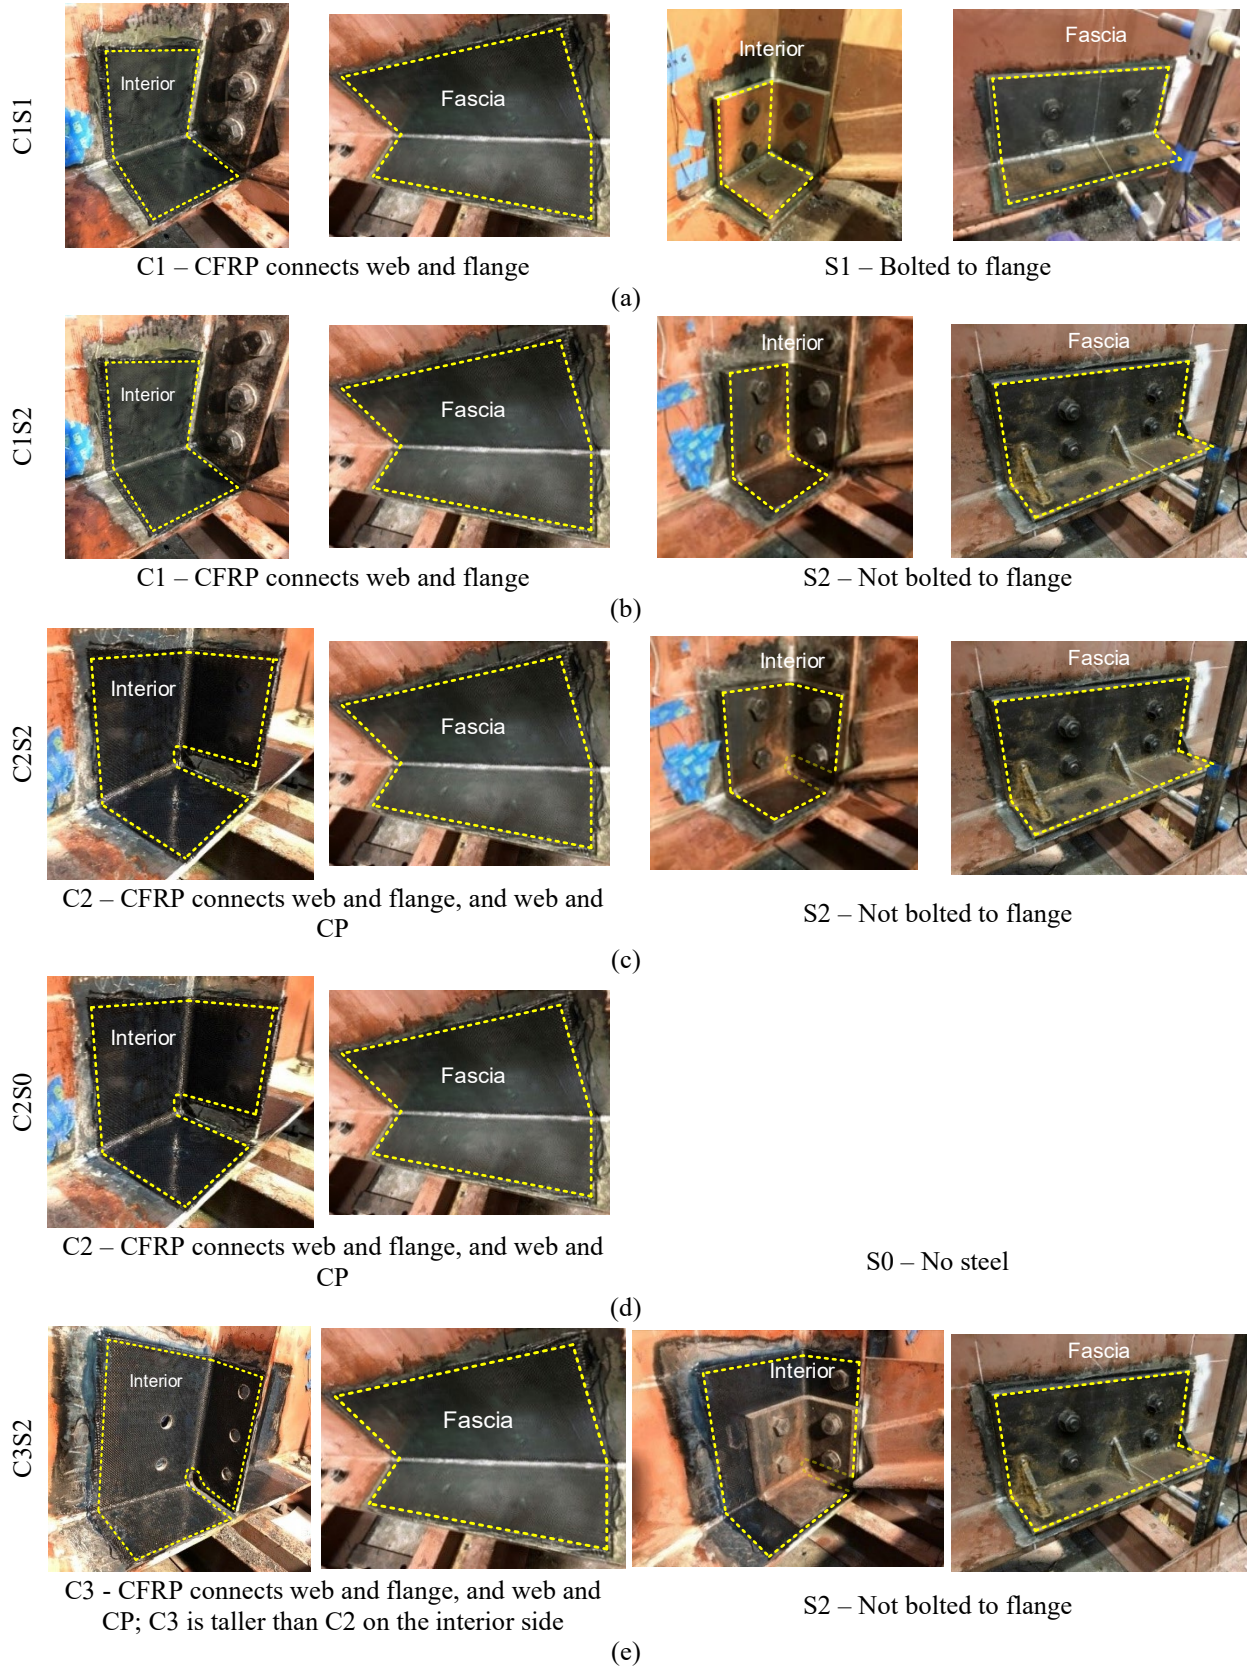
Figure 6-6 Description of repair configurations; the extents of the CFRP are shown in dashed lines

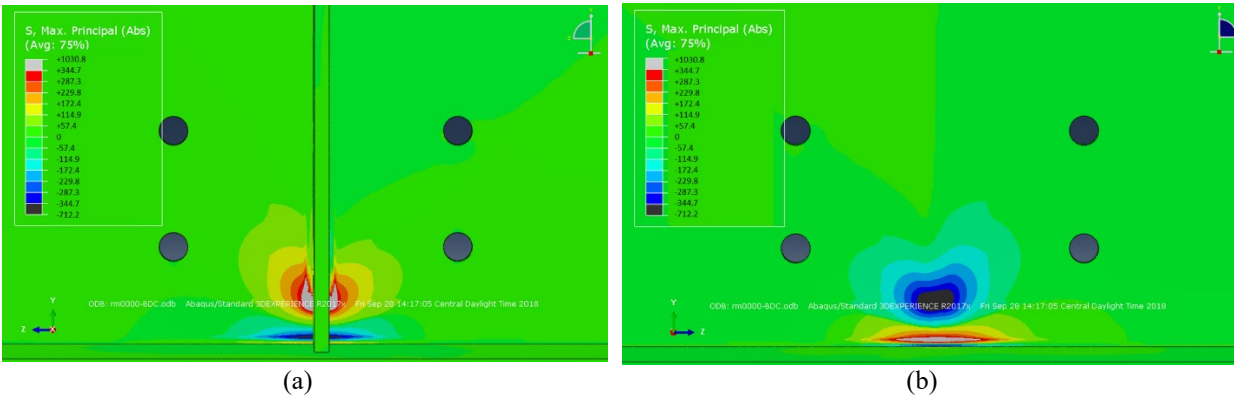
Figure 6-17: Absolute maximum principal stress [MPa] contours of the web gap region of the uncracked unretrofitted girder: (a) on the interior side; (b) on the fascia side

These observations indicate that stresses computed from strain gauge readings can be used as indicators of crack growth and confirm that complex changes took place in the stress field at the web gap region as cracks propagated, consistent with crack propagation measurements. The spatial variation of stress in the web gap region from finite element analysis of the test configuration performed by (Liu 2015) for an uncracked unretrofitted girder is shown in Figure 6-17.

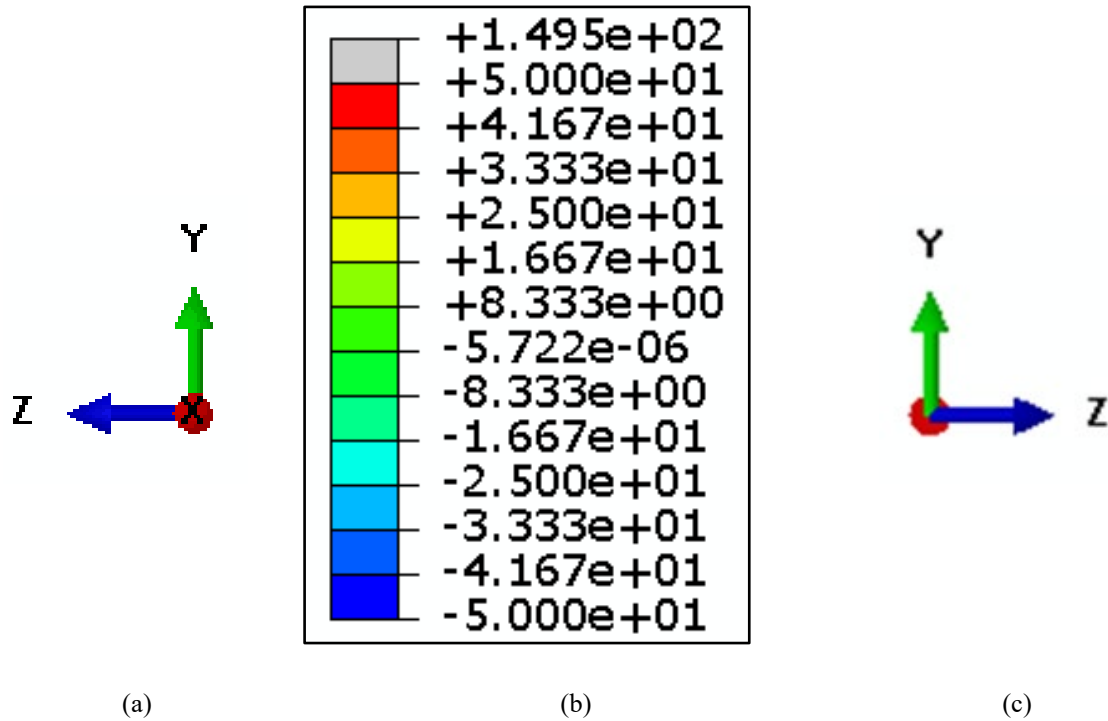
Figure A-1 Stress limits and coordinates directions convention for all figures in this Appendix: (a) Coordinate direction on the interior side of the girder; (b) Stress limits (-50 ksi to +50 ksi); (c) Coordinate direction on the fascia side of the girder
