Seismic performance characterization of Nepali school buildings using a novel micro-modeling approach

Submitted to the graduate degree program in Civil, Environmental and Architectural Engineering and the Graduate Faculty of the University of Kansas in partial fulfillment of the requirements for the degree of Master of Science in Civil Engineering

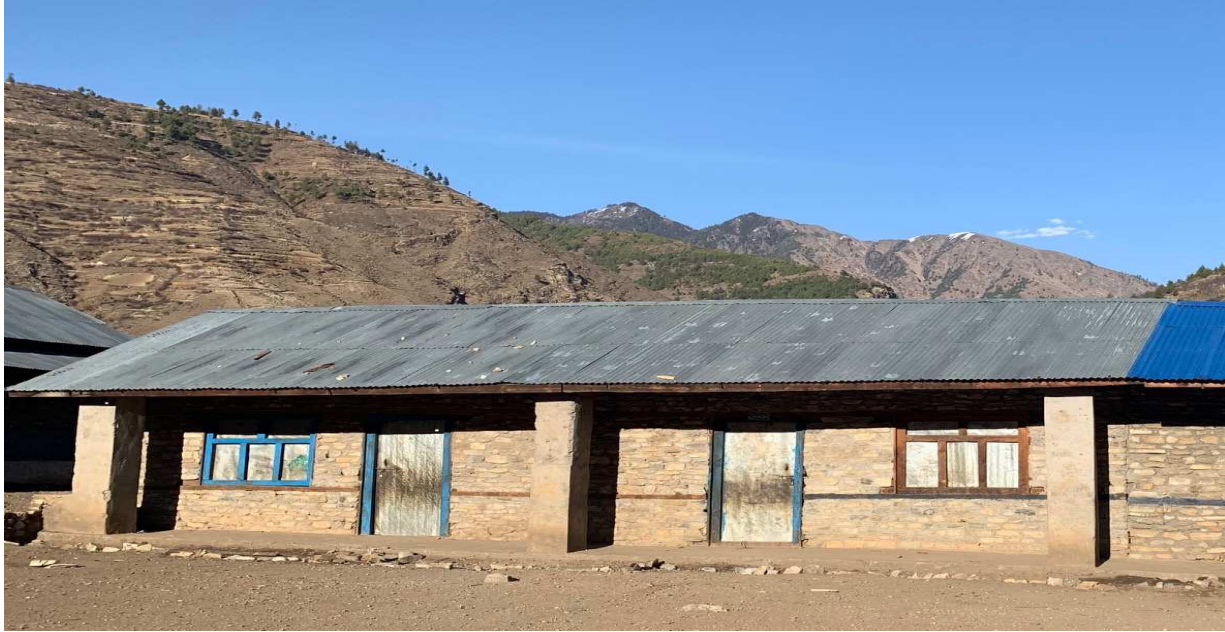
Fig. 2. Typical school building built with stone masonry walls in cement mortar with metal roof (Image credit: Dr. Elaina J. Sutley)

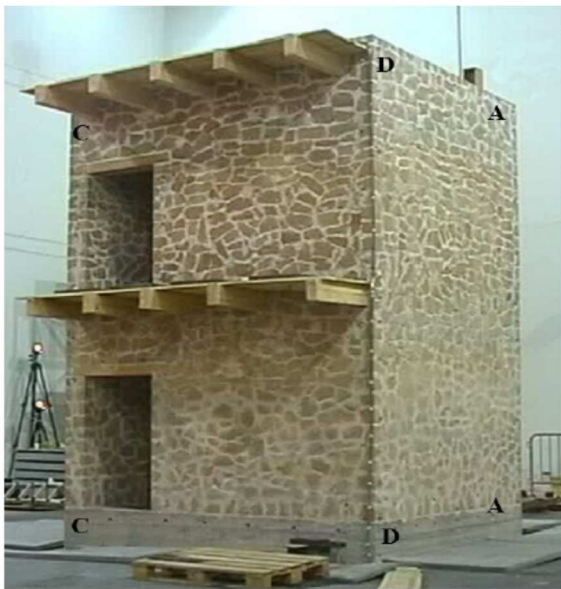
Fig. 5. Shake table test of stone masonry building in lime mortar test specimen (from Betti et al., 2015)

While static loading tests are indispensable to obtain material properties of building components, shake table tests using dynamic loading are needed to exhibit the full behavior of a URM school building. The damage modes that propagate at different intervals of dynamic loading can be observed through these tests to better understand the structural performance of the URM-type buildings. Betti et al. (2014) conducted a shake table test with an unreinforced masonry prototype with flexible diaphragms until collapse. The masonry walls were constructed with calcareous tuff stones and lime-cement mortar with weight ratios of the components of 10.5 (sand), 11 (lime) to 1 (cement). The prototype house was a 1:1.5-scaled two-story building (Figure 8), aimed at reproducing the typical ancient masonry buildings based in Central Italy. The plan layout is made of a single cell with outer dimensions of 3.5 m × 3 m, while the inter-

story heights measure approximately 2.2 m. The masonry walls have a constant thickness of 0.25 m and are composed of vertical faces without any transversal connection with flexible timber floors. Each floor was built using five wooden joists with a section of 0.10 m × 0.18 m and wooden boards with a thickness of about 20 mm nailed to the wooden beams. The tests were carried out through the application of a normalized natural seismic input scaled at increasing intensity. The reference input was from the Umbria-Marche earthquake of 26 September 1997 (Richter magnitude of 6.1, epicenter in Annifo-Colfiorito). The compressive strength of the masonry was in the range of 2.0 to 3.5 N/mm². The unit weight of the stone units was observed to be 1700 kg/m³. The tensile strength for diagonal shear was in the range of 0.06-0.07 Mpa.

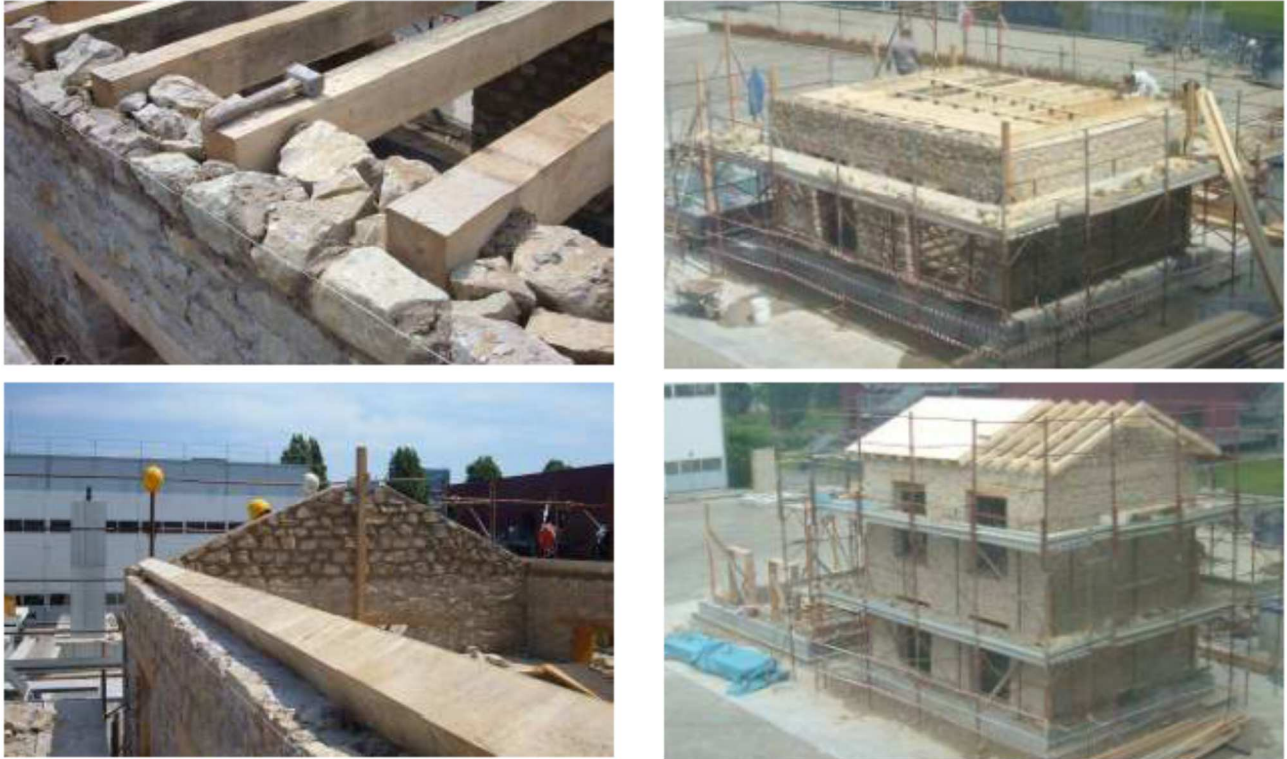
Fig. 6. Floor and roof details with details of wall connection (from Magenes et al. 2010)

Magenes et al. (2010) conducted a full-scale shake table experiment for stone masonry in cement mortar, to extract mechanical properties and test the effectiveness of improving the connection of the ridge beam to the wall using an external steel anchorage through full-scale shake table tests, as seen in Fig. 6. The model was built with URM walls of a nominal thickness of 32 cm, which had two wythes of undressed stones (not cut or rendered smooth) built one close to the other with some smaller stones and mortar filling the gaps in between. The floor structure was made of 12cm wide and 16cm high pinewood joists placed every 50 cm with 30 mm thick planks simply nailed on top. The roof structure included one 20 cm x 32 cm ridge beam, two-segmented 32 cm x 12cm rafter beams on top of the longitudinal walls, and 8 cm x 12 cm purlins every 50 cm forming the two pitches with 3cm thick planks. The mean values of modulus of elasticity, compressive strength (f_m), tensile Strength for diagonal shear (f_t), and Shear Modulus (G) was observed to be 2,550 Mpa, 3.28 Mpa, 0.137 Mpa, and 840 Mpa respectively. It was seen from the experiment that prevented out-of-plane mechanism including gable wall failure during the repetition of the test in which the building behavior was mainly governed by the in-plane wall response.

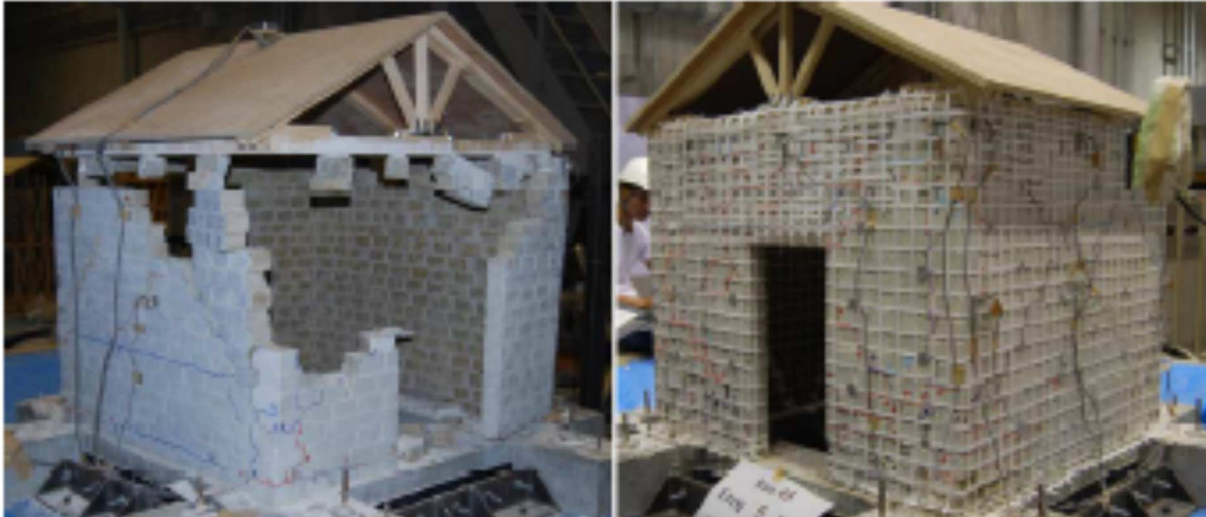
Fig. 7. Level of collapse seen in the non-retrofitted house (left) and pp-band retrofitted masonry specimens (right) (from Meguro et al., 2012).

Meguro et al. (2012) performed shaking table tests on 1:4 scaled stone masonry houses, both with and without retrofitting with polypropylene band meshes. The specimens were a single room, one-story house with a pitched wooden roof but without gable walls. The dimensions of both models were 950 mm x 950 mm x 720 mm with 100 mm thick walls. The wall was constructed using pieces of stone of size 40 mm to 60 mm placed side by side in rows and gaps filled with gravels of size up to 10 mm and cement-lime-sand mortar (1:7:19). The water-cement ratio of the mortar was chosen as 0.15. In the case of a non-retrofitted specimen, cracks were initiated at the top of openings and propagated towards the bottom of the wall. With an increased loading rate, cracks widened further. As a consequence, the connection between walls got separated leading to complete collapse for the non-retrofitted specimen. The nature of crack initiation and propagation in the case of the retrofitted specimen was almost similar to the non-

retrofitted case. However, PP-band mesh prevented the collapse of the structure even when the base displacement was more than four times greater than a non-retrofitted case (Fig. 7).

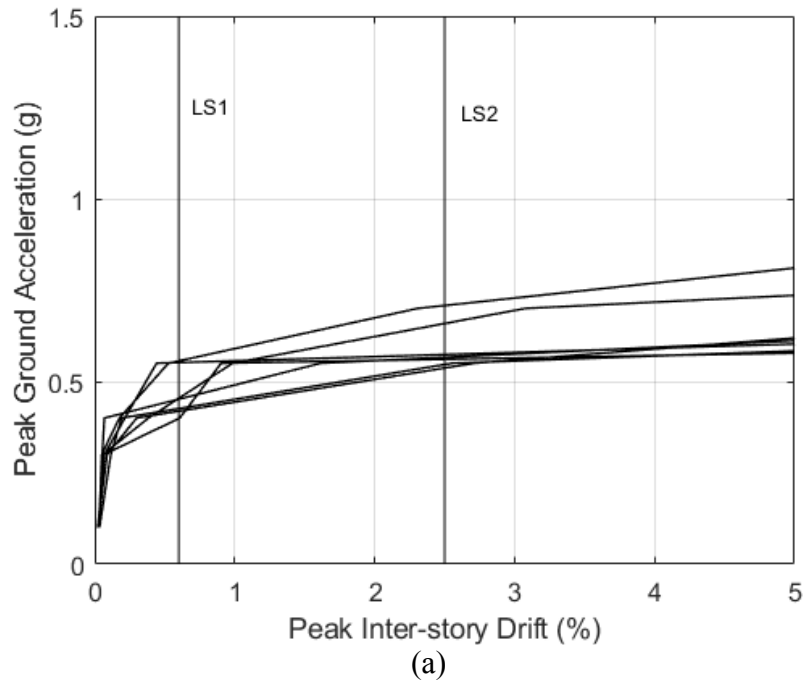
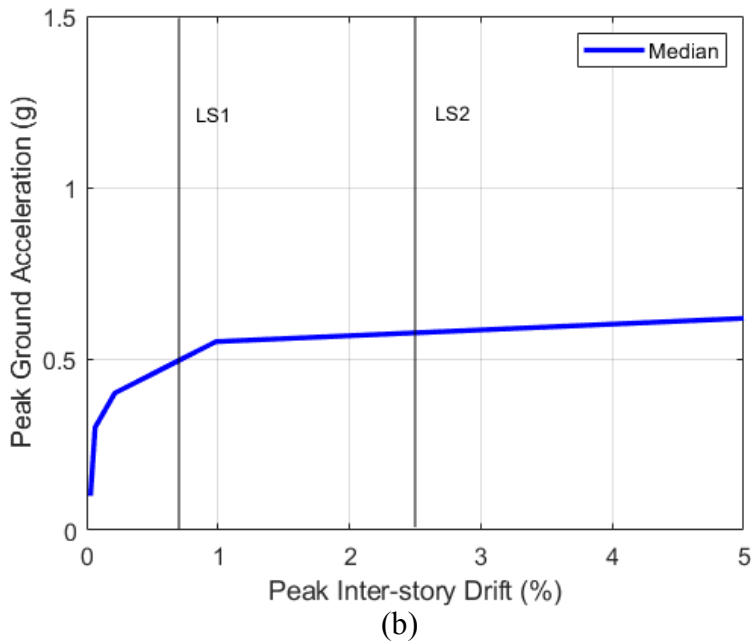
Fig. 14. IDA results: (a) 7 ground motions; (b) median response

The results are expressed in terms of the probability of not exceeding inter-story drifts for three specific PGA values, 0.4g, 0.55g, and 0.7g, in Fig. 14. Although the datasets were generated for seven records, increments lower than 0.3g were too small to generate the first limit state and increments above 0.7g were certain to cause collapse and exceed the second limit state, as evident in Fig. 13. In that regard, the probability of non-exceedance of the limit states against inter-story drifts for specific PGA increments is included in the fragility curve, unlike previous approaches to plot probability of non-exceedance against Intensity Measure (IM) for each limit state.

A high degree of sensitivity of damage scales for lower interval of PGA is observed for the stone masonry building typology considered, which is highly brittle with non-linear deformation initializing as early as 0.3g for some records. The probability of non-exceedance for first limit

state is very high at 0.4g, with almost all the records failing to reach LS1= 0.6%. Comparatively, the probability of non-exceedance for PGA 0.55g at LS1 is 20% whereas for LS2, the probability of non-exceedance is approximately 90%, as seen from Fig. 15. The probability of non-exceedance for a PGA value of 0.7g pushes the building to ultimate limit state with about 95% certainty. Thus, it should be noted that, in the case of strong shaking, most of the stone masonry buildings in Nepal would be heavily damaged that could result in large number of fatalities.
