**MITIGATION OF COLLAPSE RISK IN VULNERABLE  
CONCRETE BUILDINGS**

Submitted to the graduate degree program in Civil Engineering  
and to the Graduate Faculty of the University of Kansas  
in partial fulfillment of the requirements for the degree of  
Master of Science.

The goal of this study is to investigate the collapse risk of reinforced concrete building columns constructed prior to the mid-1970's, subjected to cyclic lateral loading. These columns have reinforcement details deemed inadequate by modern seismic design standards, and as such are vulnerable to collapse. Testing of two full-scale, shear-critical column specimens was carried out at the NEES-MAST facility at the University of Minnesota. The test specimens had nominally identical material and reinforcement properties. The primary test variable was the applied axial load, which was held constant at 500 kips and 340 kips for the first and second specimens, respectively. The specimens were subjected to increasing lateral displacement cycles until axial load carrying capacity was lost. The thesis discusses the observed lateral and axial load resisting behavior, and analyzes the measured responses of the columns up to a

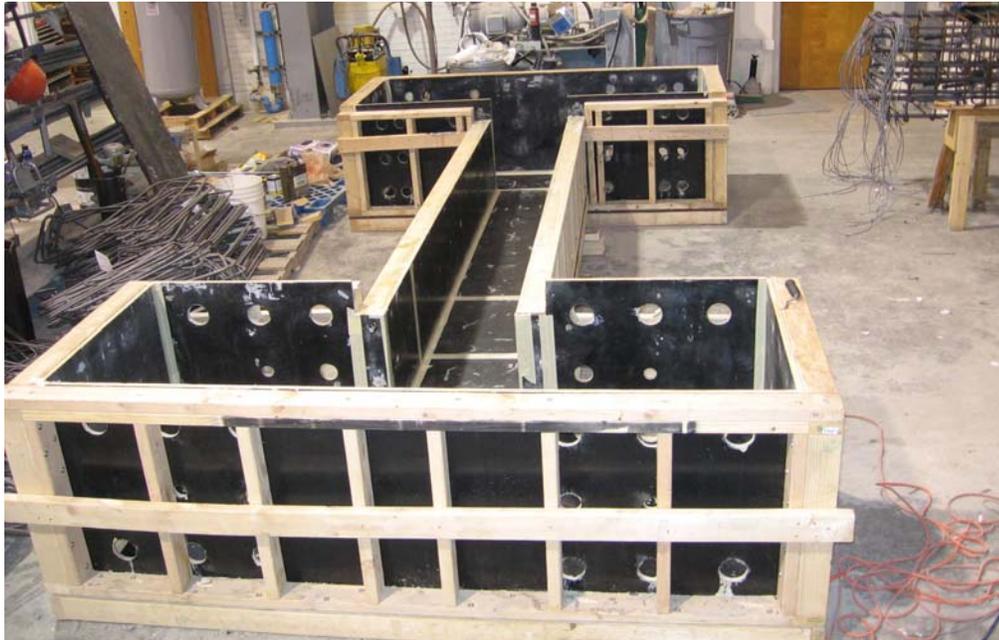
**Figure 2.15:** Specimen formwork

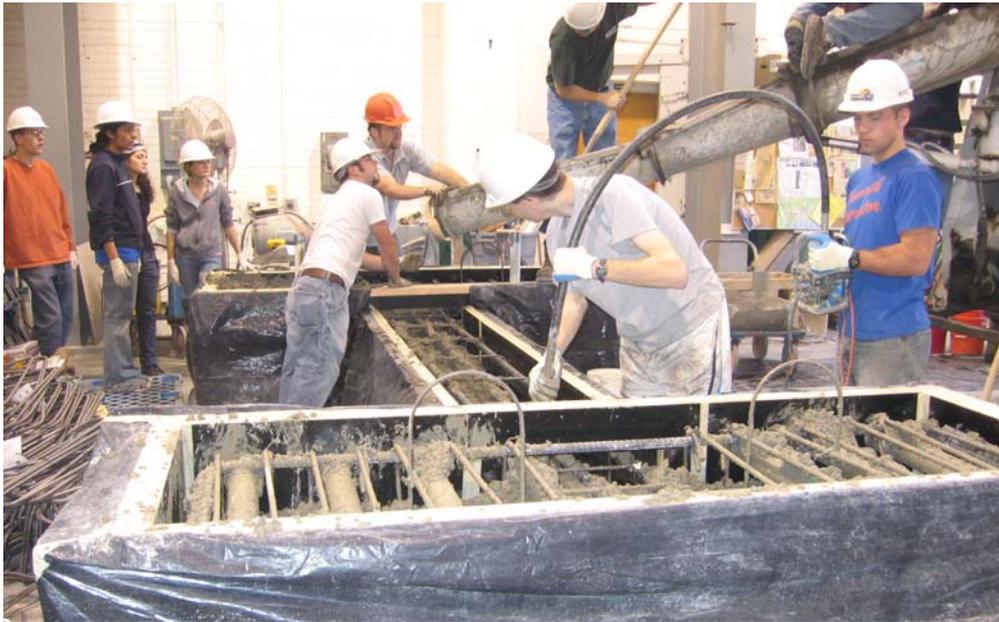
**Figure 2.18:** Internal vibration during concrete placement

The specimens were cast in the horizontal position, using a single batch of five cubic yards of concrete per specimen. The concrete was placed in two lifts, with samples taken for strength specimens between the two lifts. The concrete was consolidated by internal vibration to minimize the presence of voids, as shown in Figure 2.18. Following placement and vibration of the second lift, the top surface of the specimen was struck off and finished using hand trowels. Figure 2.19 shows a photograph of a specimen immediately following finishing procedures. Afterward, the specimen was covered with wet burlap and plastic sheeting. Wood formwork was stripped after four days of moist curing and the specimens were air-dried as they were stored inside the Structural Testing Laboratory until they were ready to be transported to the MAST Laboratory.

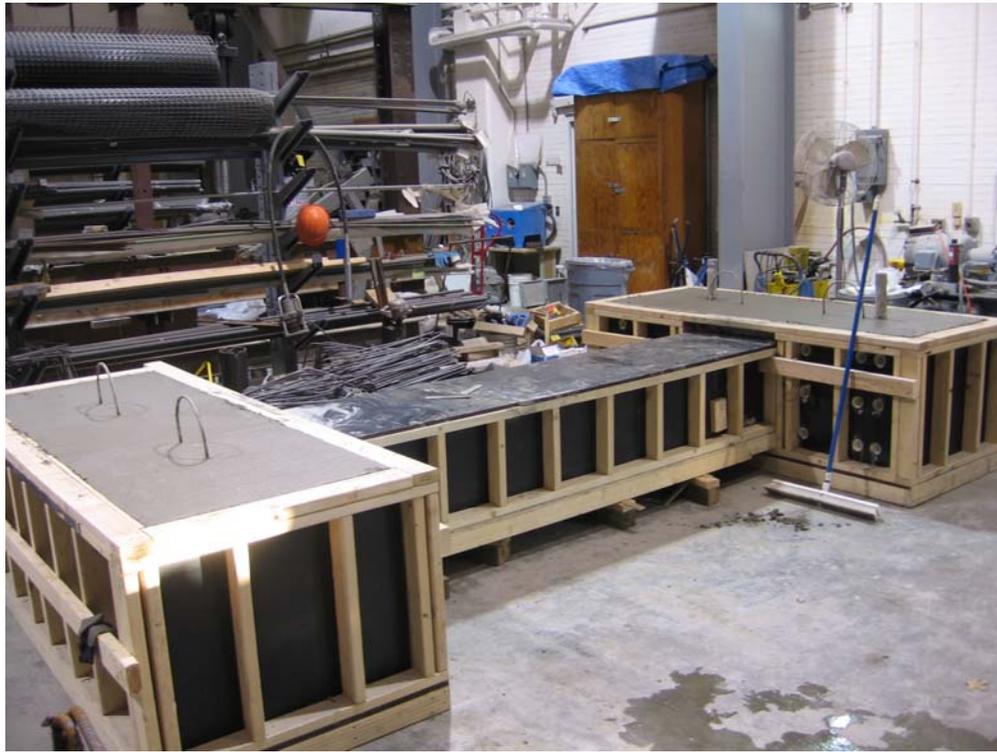
**Figure 2.19:** Finished column test specimen

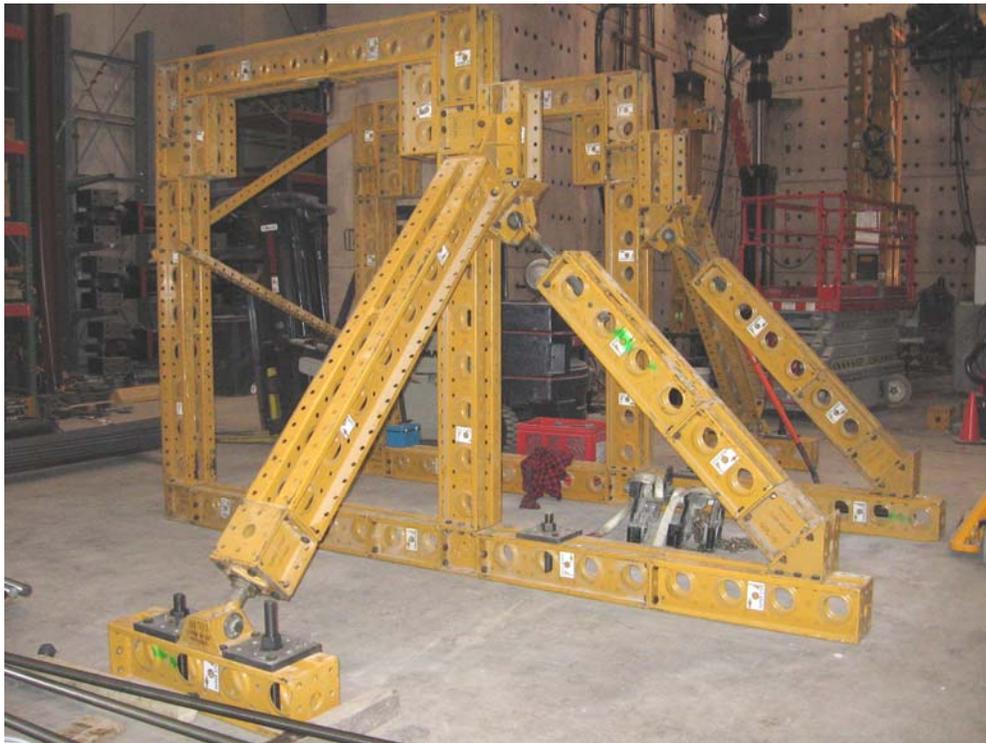
**Figure 2.20:** Tilt-up frame used to rotate specimens into the vertical position

Testing was performed at the MAST (Multi-Axial Subassembly Testing) Laboratory at the University of Minnesota. Following construction and curing, the specimens and base block were shipped to the laboratory on a flatbed truck and unloaded by the laboratory staff. After arrival at the MAST Laboratory, the specimens were tilted up into the vertical position using the frame shown in Figure 2.20. The base block and specimens were then moved from the staging area of the laboratory to the reaction floor using the crane. Final positioning was performed using the crosshead of the multi-axial loading system.

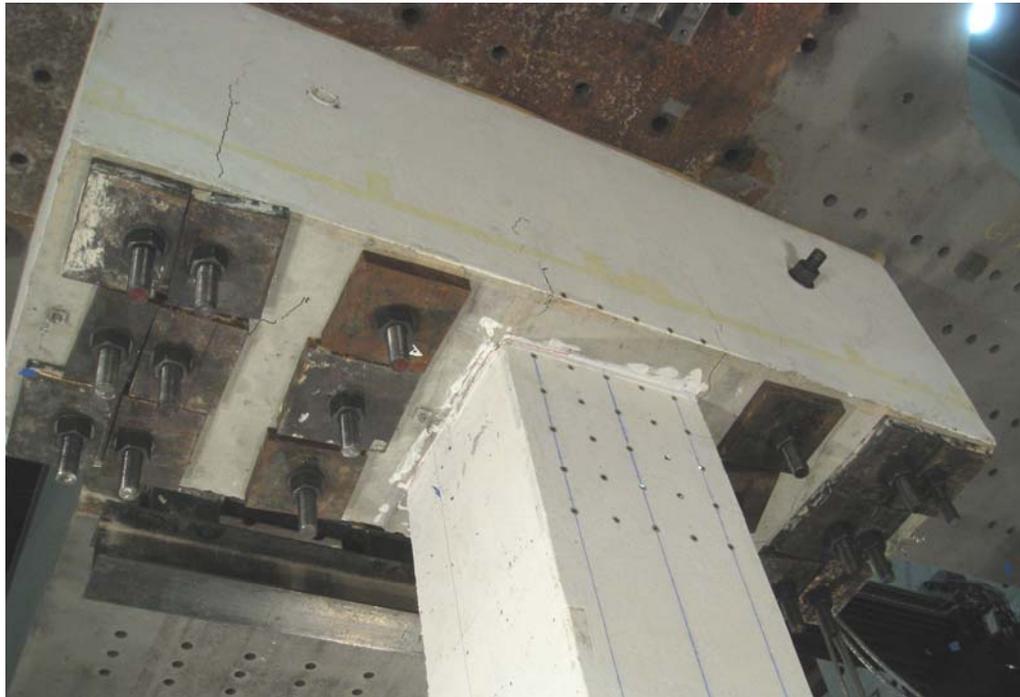
**Figure 2.21:** Top beam connection to the crosshead

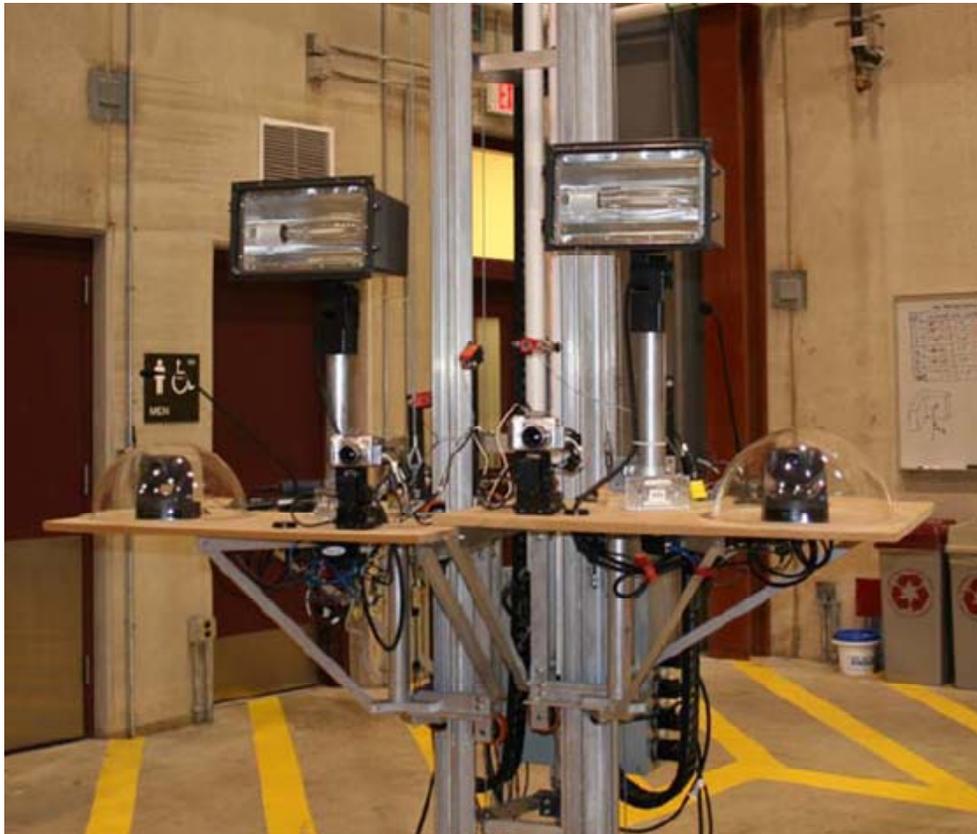
**Figure 2.29:** Telepresence camera tower

Four camera towers were used to obtain a photographic record of each test. Each tower had two shelves, each with one still and one video camera, as shown in Figure 2.29. The layout of the camera towers is shown in Figure 2.30. A set of photographs was taken with all cameras at the peak lateral drift ratio for each cycle. Two additional data collection methods were used to achieve a greater degree of detail and accuracy in the monitoring of deformations in the maximum moment regions of the columns.

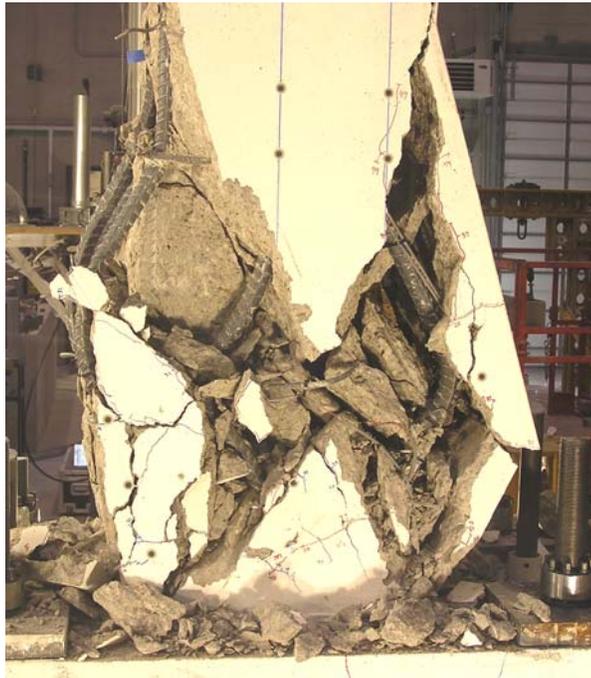
**Figure 3.5:** Specimen 1 condition at the end of the test

(a) Bottom column end, south face, (b) Bottom column end, north face

allowed the longitudinal bars on the west side to buckle outward as well. Anchorage failure was not observed in Hoop 5, which was able to restrain longitudinal bars on all sides. This resulted in a mushroom-shaped deformation pattern of the longitudinal bars.

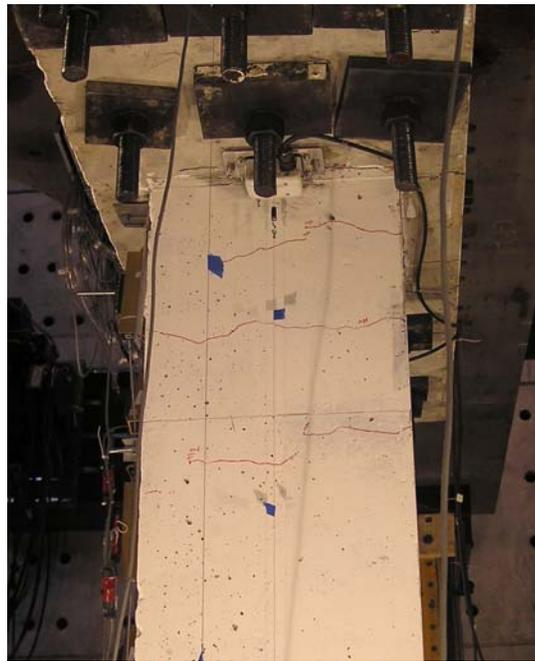
**Figure 3.7:** Specimen 2 crack pattern at a drift ratio of 0.50%

(a) Top column end, north face (b) Top column end, east face

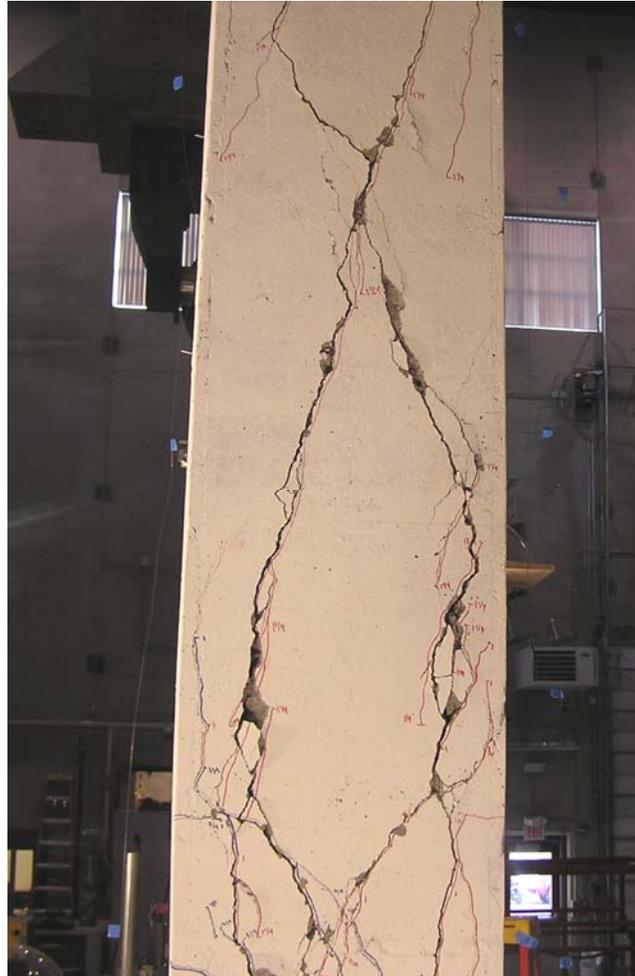
**Figure 3.10:** Specimen 2 crack pattern at a drift ratio of 1.25% (after axial failure)

(a) Center of column, north face

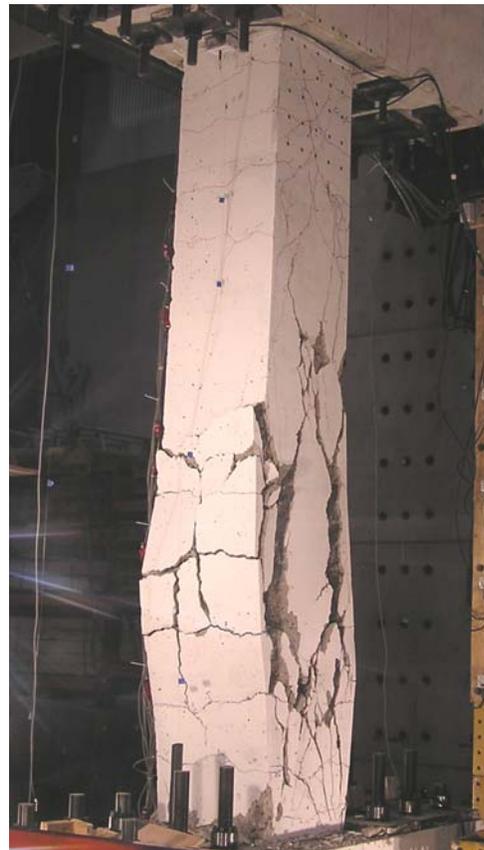
**Figure 3.11:** Specimen 2 condition at the end of the test

(a) Bottom column end, south face, (b) Full column, northeast corner

The condition of the column at the completion of the test is shown in Figure 3.11. At the end of testing, Hoop 6 was still intact, while Hoop 5 had opened at the southeast corner, indicating an anchorage failure. The longitudinal bars on the west face of the column deformed between Hoops 5 and 6. On the east side of the column, the far northeast bar bent outward between Hoops 4 and 5, while the other two bars on the east side deformed outward between Hoop 4 and Hoop 6, as Hoop 5 had opened up. This resulted in an S-shaped deformation pattern of the longitudinal bars.
