**DISPLACEMENT DEMAND EFFECTS IN VULNERABLE
REINFORCED CONCRETE COLUMNS**

Submitted to the graduate degree program in Civil Engineering
and to the Graduate Faculty of the University of Kansas
in partial fulfillment of the requirements for the degree of
Master of Science.

ABSTRACT

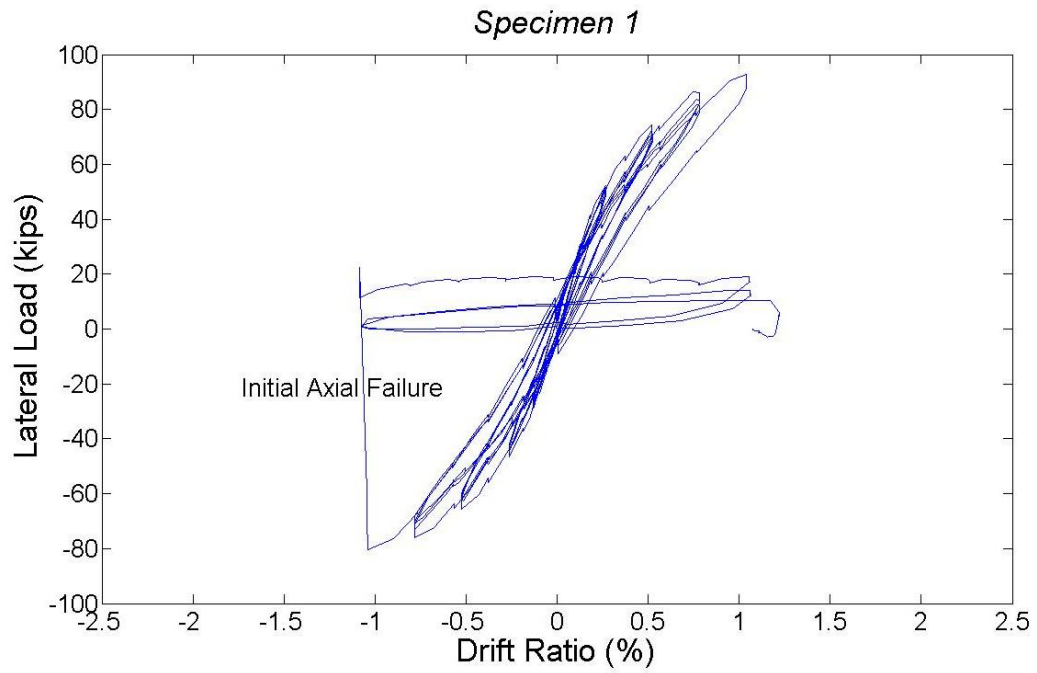
Figure 1.3: Lateral load-deflection response for $0.50A_g f_c$ axial load level.

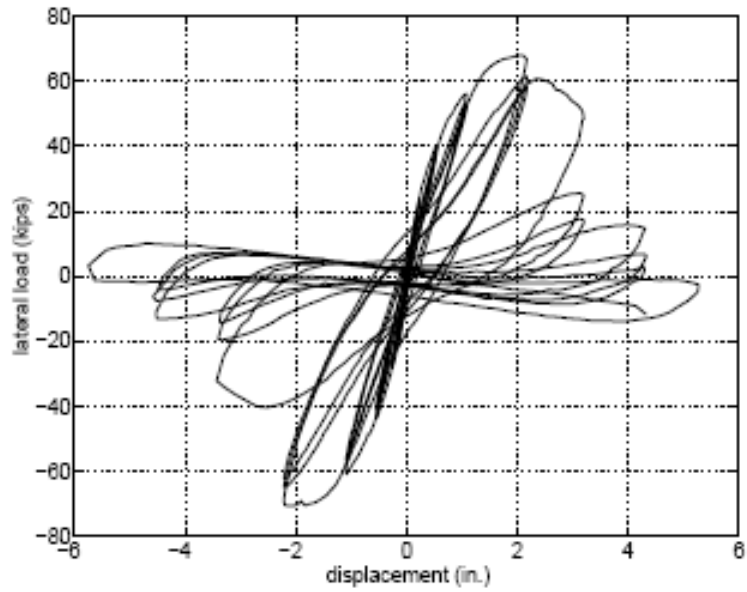
Figure 1.5: Load-displacement interactions for Sezen (2002) specimen 1

Tests conducted by Sezen (2000) evaluated the effect of monotonic and cyclic lateral loading protocols. Sezen (2000) tested two similar specimens with an axial load ratio of 0.15 and varied the displacement protocol between the control and the second specimen. Sezen found that near failure the specimen tested under monotonic loading did not experience the significant increase in deformations related to shear observed in the column subjected to multiple cycles. Additionally, the specimen tested under monotonic loading reached an ultimate lateral deformation (deformation at loss of lateral load capacity) of 3.33 inches versus 2.97 inches recorded for the specimen subjected to cyclic loading, likely the result of increased damage sustained during cycling. Both columns had identical geometries, axial load ratios, transverse reinforcement, and nearly identical material properties. Figures 1.6 and 1.7 show the load-displacement relationships for specimens 1 (cyclic loading) and 4 (monotonic loading) of Sezen, respectively.

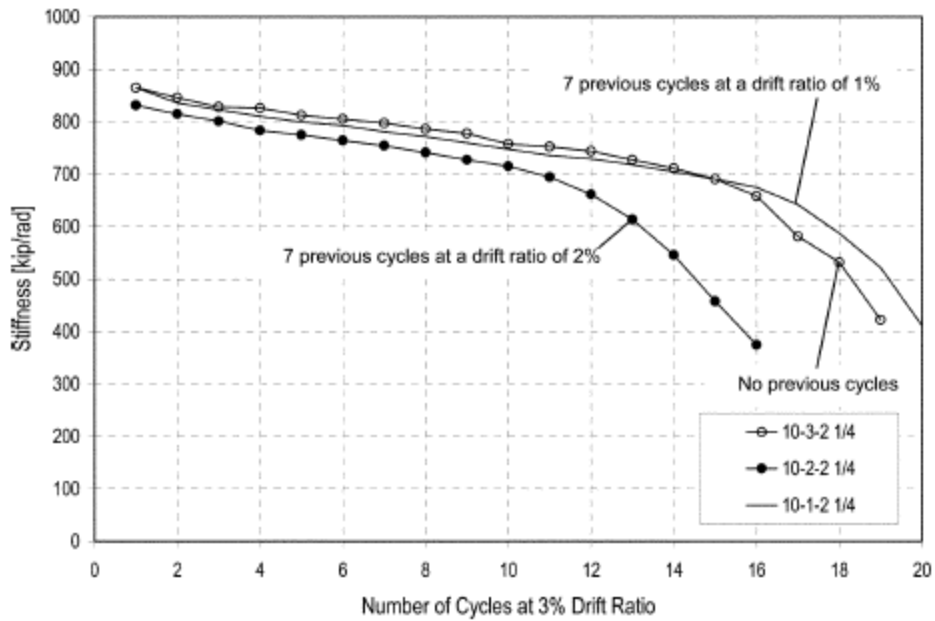
Figure 1.7: Average stiffness during cycles at 3% drift ratio. (Pujol et. al.)

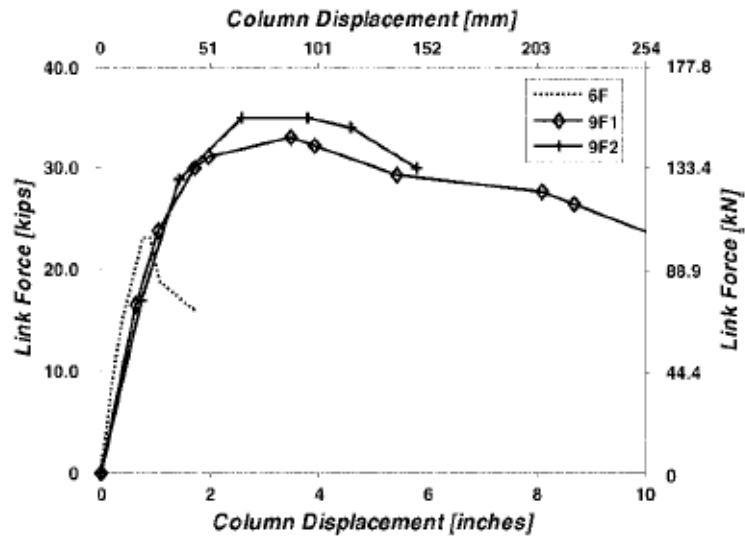
Figure 1.8: Column Response (Laplace et al., 2005)

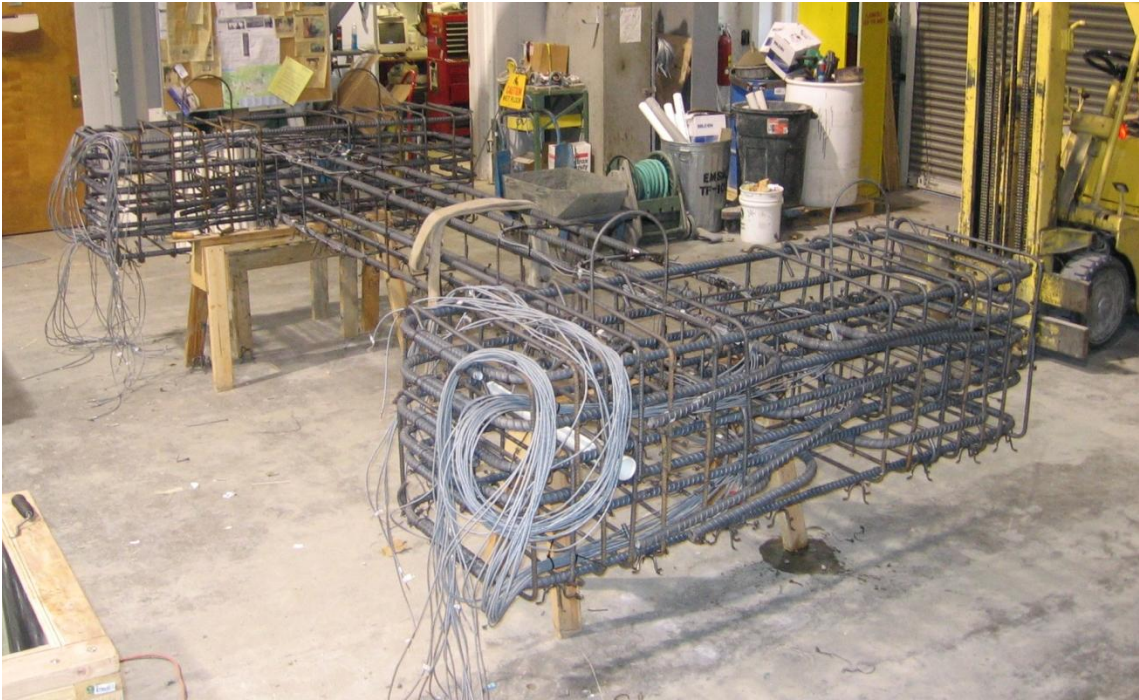
Figure 2.7: Specimen reinforcing cage

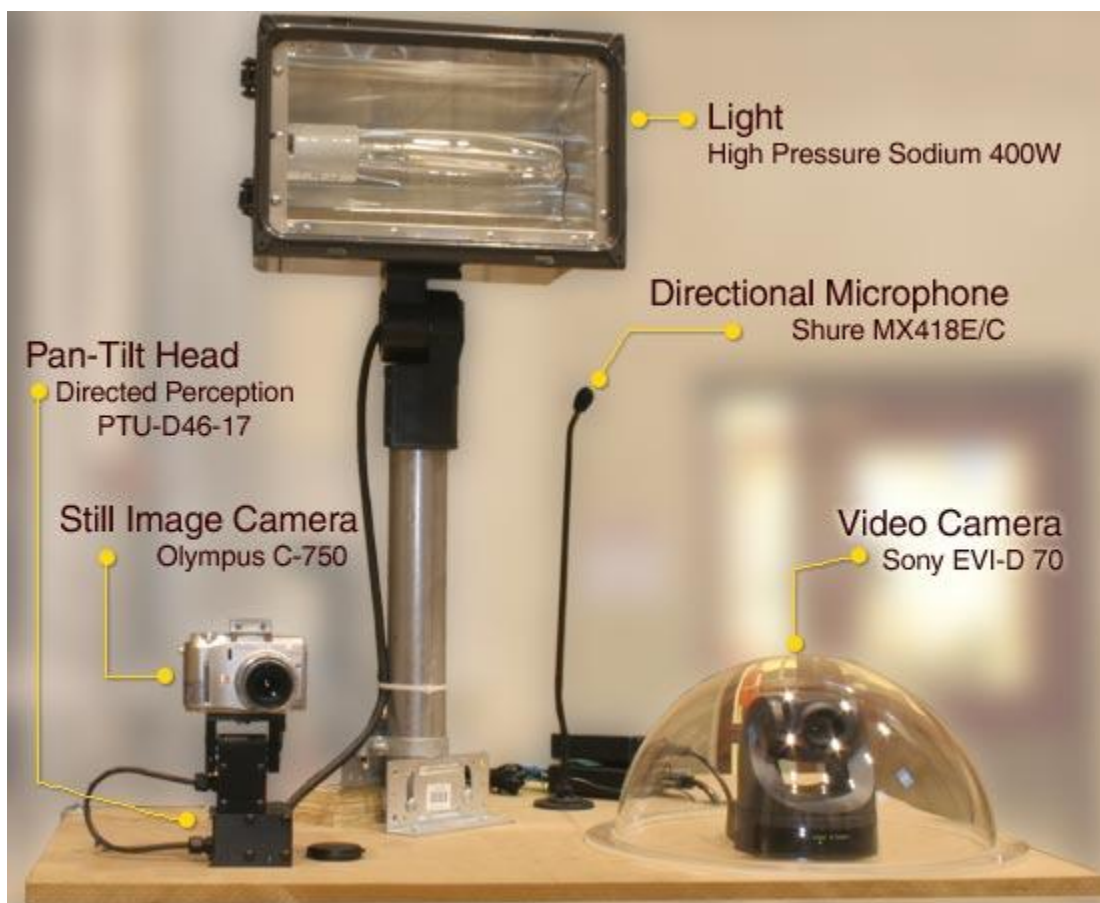
Figure 2.17: Telepresence towers. Image provided by MAST laboratory.

The use of four multi-media towers provided still image and streaming video of both tests. Pictures were taken at each displacement level in order to be used in the analysis of the photogrammetric grid placed on the top, backside of the column, as well as to capture the progression of damage during testing.

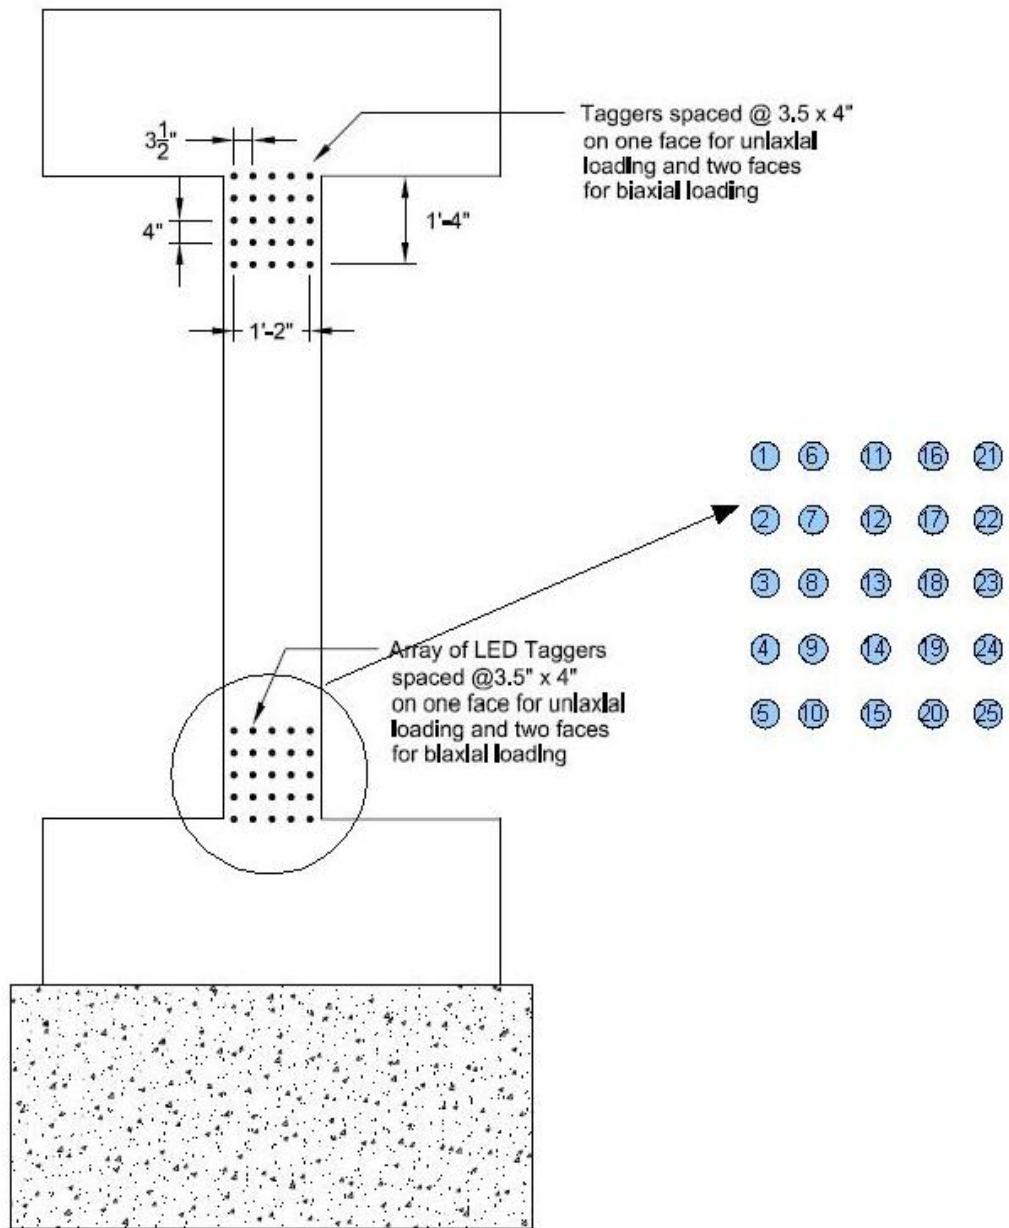
Figure 2.20: Krypton system LED tagger grid layout

In addition to the photo taggers at the top of the column, a 5x5 LED tagger grid was placed on the bottom of the column, also nearest the beam column interface, at the location of maximum moment. A proprietary system called Krypton was used to track the motion of the taggers and convert them to coordinates in three dimensional space. The Krypton system camera was mounted on a support frame located to the side of the column. A reference frame was built to establish a coordinate system by which the grid could be referenced. The Krypton system recorded in three dimensions the location coordinates of each LED tagger during the column displacement cycles. Measurements from the LEDs provided data to calculate deformation components of the column due to shear, flexure, and slip. Figure 2.20 shows the placement and numbering for the LED grid.

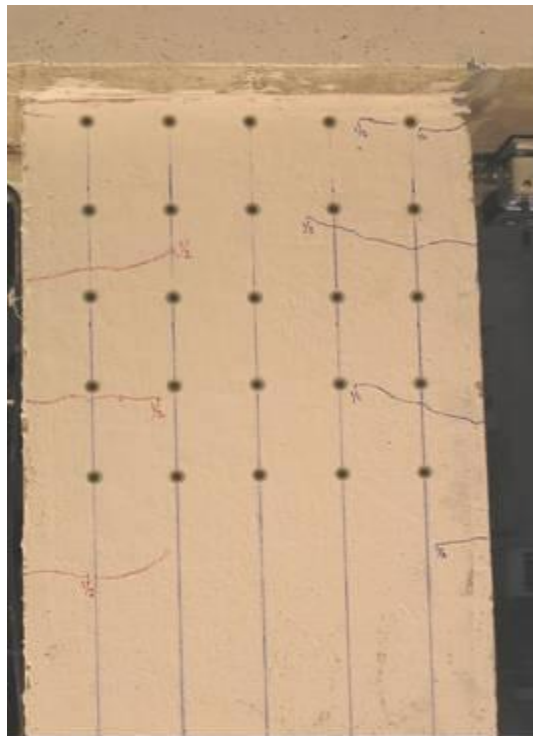
Figure 3.2: Crack pattern at top of Specimen 3 for maximum drift ratio of 0.50%.

Hairline, flexural cracks were noticed at the top of the column following the first positive peak displacement of the 0.25% drift ratio, as shown in Fig. 3.1. The maximum measured shear force was approximately 43 kips. At the first negative and positive peaks of the set of displacement cycles with a maximum drift ratio of 0.5%, the maximum measured shear force was approximately 60 kips. Flexural cracks on the tension face of column continued to spread into the tension zone at the top and base of the column, as can be seen in Figs. 3.2 and 3.3.

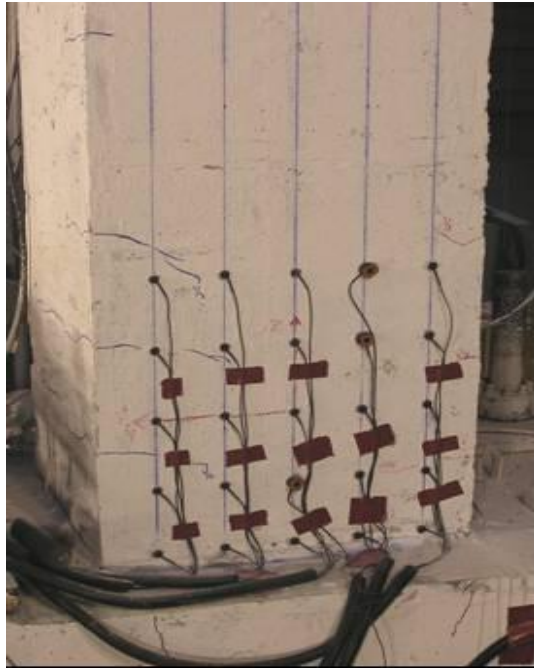
Figure 3.3: Crack pattern at bottom of Specimen 3 for a maximum drift ratio of 0.50%.

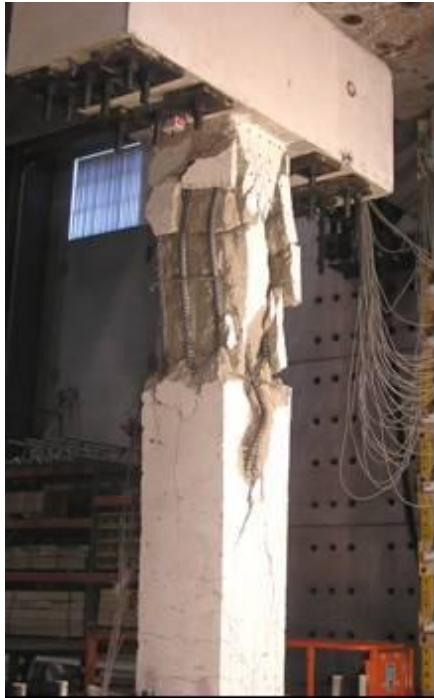
Figure 3.7: Condition of Specimen 3 after a maximum drift ratio of 2%.

Figures 3.7 and 3.8 show the final column state. The most severe damage was observed at the top of the column, in the maximum moment region. Opening of the second hoop from the top allowed unrestrained buckling of the longitudinal bars to occur. Figure 3.8 shows the second hoop from the top just prior to opening, and Fig 3.9 shows the hoop failing at the right-side corner, which removed the lateral restraint of the longitudinal bars. As seen in the figures, a mushroom shaped deformation pattern took place in the longitudinal reinforcement, consistent with previous tests (Matchulat, 2009). This deformation pattern indicates that once the transverse steel experienced anchorage failure and was consequently unrestrained from opening, the axial load acted to “squash” the reinforcing steel.

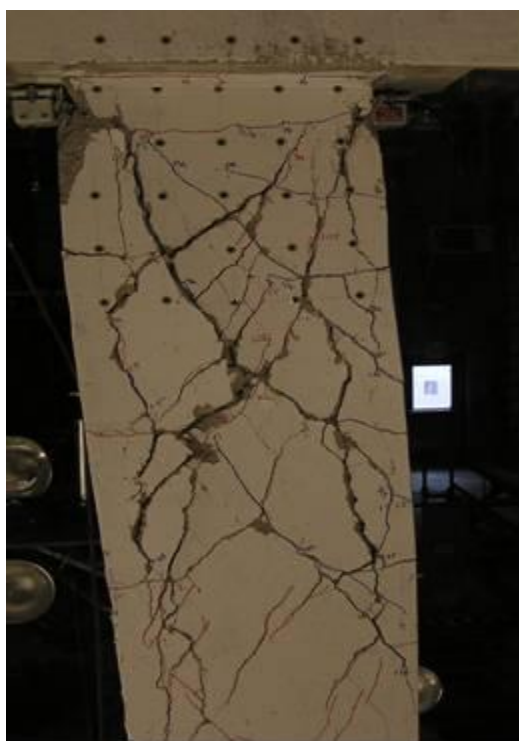
Figure 3.16: Crack pattern at the top of Specimen 4 for a maximum drift ratio of 2%.

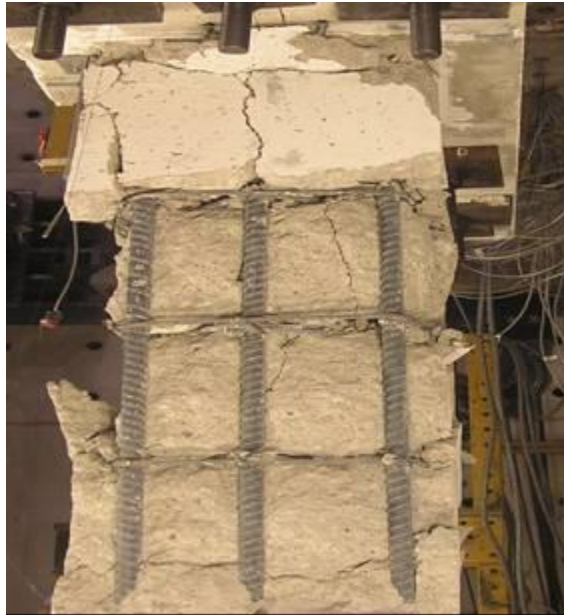
Figure 3.17: Crack pattern at the top of Specimen 4 for a maximum drift ratio of 2.5%.

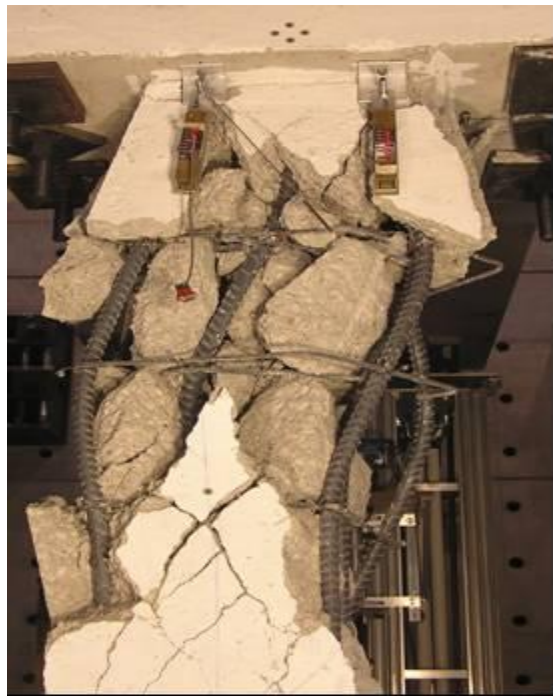
Figure 3.18: Condition of Specimen 4 for a maximum drift ratio of 3%. Damage to the concrete of the core and anchorage failure of the hoop caused buckling of the longitudinal reinforcement.

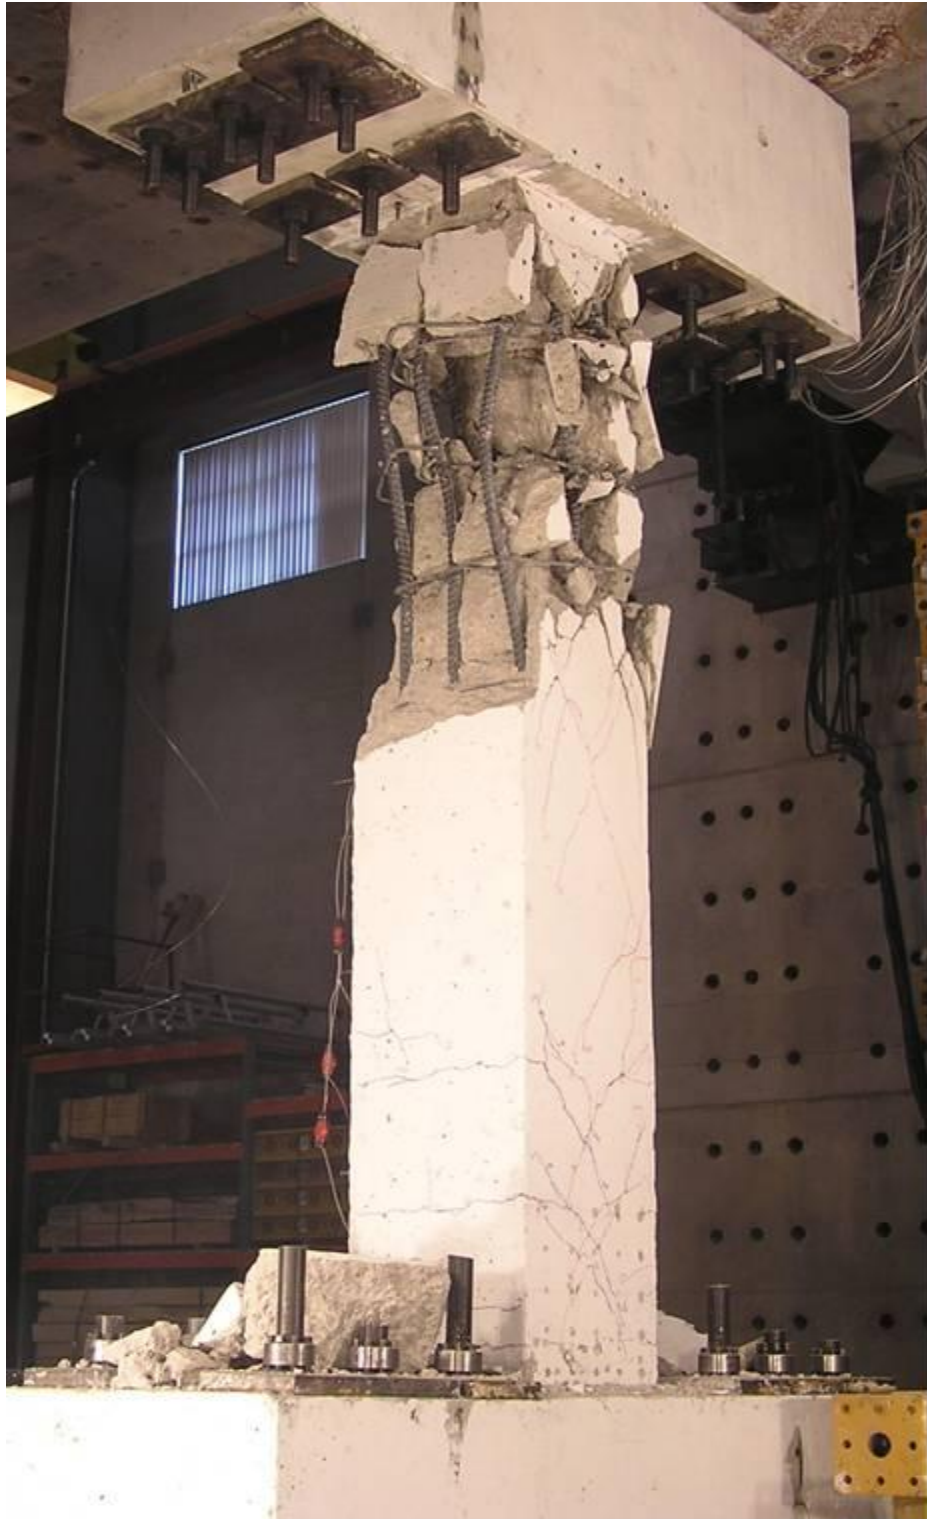
Figure 3.19: Final condition of Specimen 4.

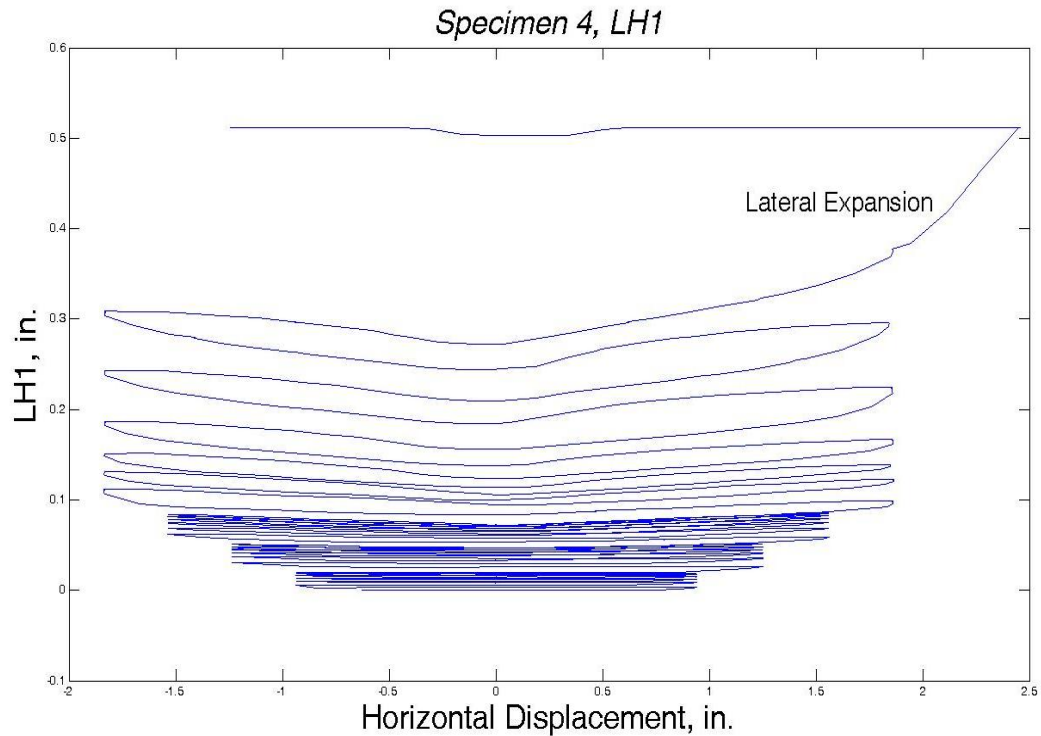
Figure 3.20: Horizontal expansion measured with LVDT LH1.

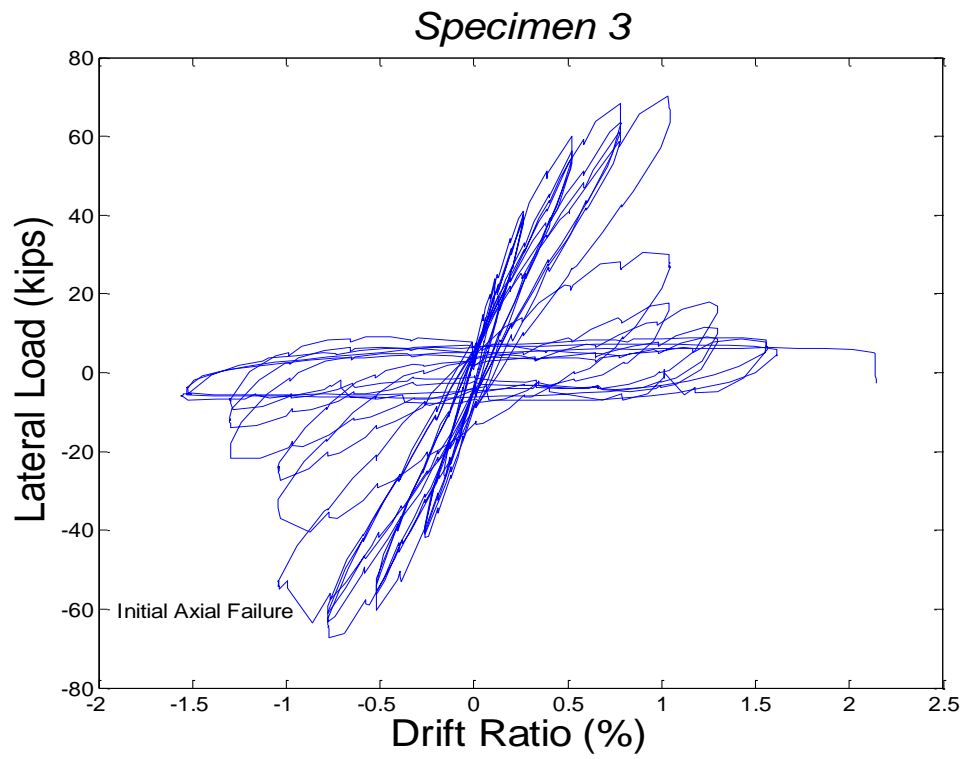
Figure 3.21: Measured lateral-load vs drift ratio. (a) Column 3, (b) Column 4

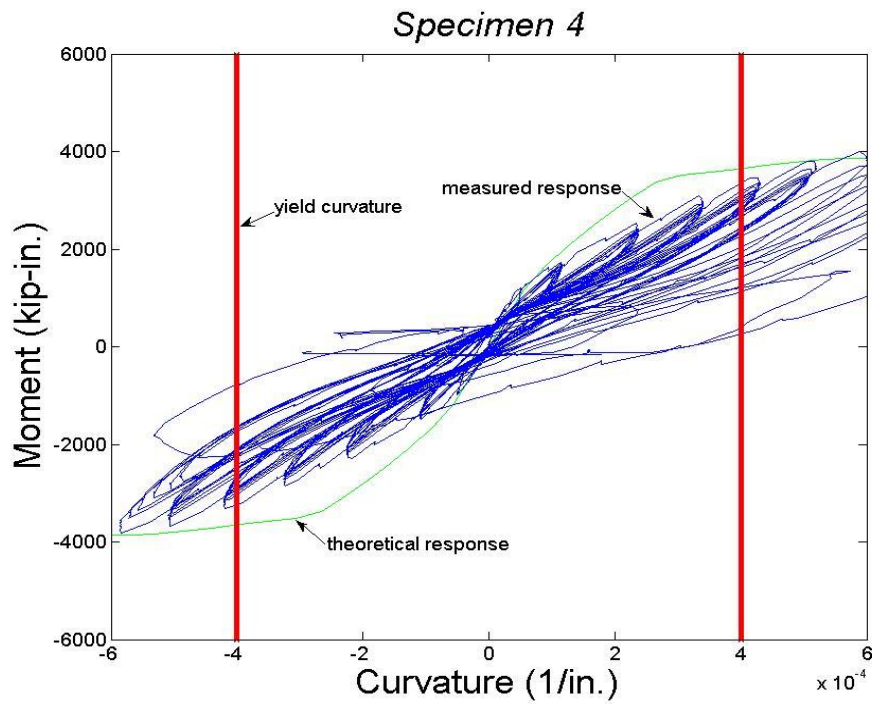
Figure 3.23: Moment-curvature relationship. (a) Specimen 3, (b) Specimen 4

An iterative approach was used to calculate moment and curvature pairs by choosing the neutral axis depth and peak concrete compressive strain and then adjusting the position of the neutral axis to balance the resulting forces. Figure 3.23 shows theoretical moment-curvature results compared with measured moment-curvature response in the maximum moment regions of the columns inferred from LVDT measurements. The vertical lines indicate the calculated curvature at yielding of the longitudinal reinforcement. Figure 3.23 shows that both columns exceeded the calculated curvature at yield prior to axial load collapse. The disparity between the theoretical and measured responses can be attributed to the progressive damage that occurred during cycling.
