RAPID MACROCELL TESTS OF ASTM A775, A615, and A1035 REINFORCING BARS

**Structural Engineering and Engineering Materials
SL Report 10-4**

**THE UNIVERSITY OF KANSAS CENTER FOR RESEARCH, INC.
LAWRENCE, KANSAS
November 2010**

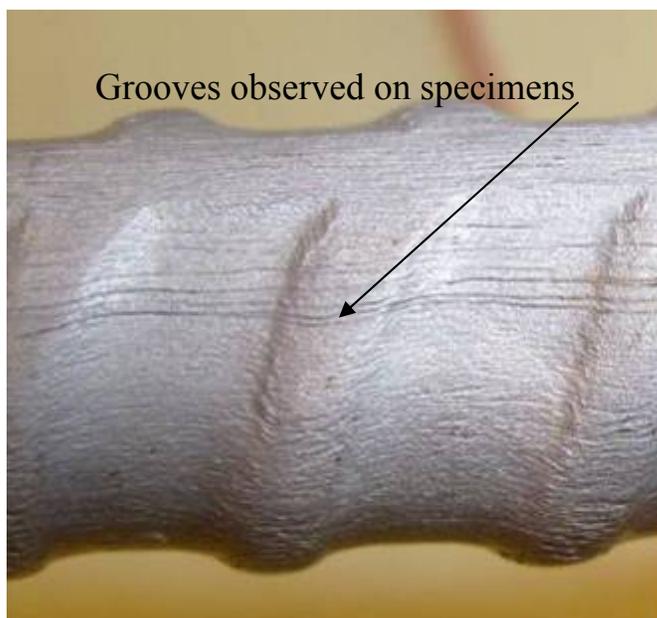
The bars were inspected upon receipt, and the conventional steel and ECR were found to be in good condition. The A1035 exhibited significant corrosion, as shown in Figure 1. As a result, macrocell tests were performed on the A1035 bars after pickling, as well as in the as-received condition.

Figure 1: A1035 steel in the as-received condition exhibit corrosion on the surface of the bars.

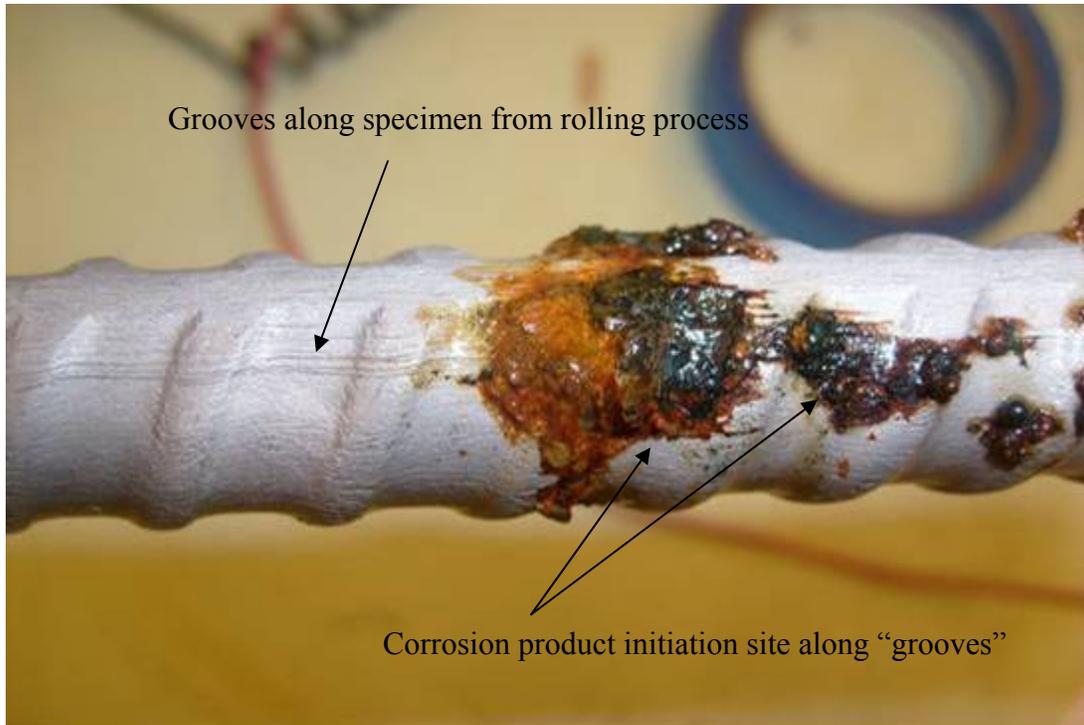
All conventional, as-received A1035, and pickled A1035 steel specimens exhibit corrosion during the test, with the corrosion products forming at or above the liquid level. The conventional and as-received A1035 specimens exhibit significant corrosion products, such as shown for conventional steel in Figures 20 and 21, respectively. The pickled A1035 bars exhibited somewhat more limited corrosion products, as shown in Figures 22 and 23. The "grooves" along the length of the pickled specimens seem to provide a crevice at which corrosion initiates, with the corrosion products distributed along the length of the bar above the liquid level (Figures 22 and 23). This was not observed with the as-received bars, most likely due to the initial, corroded state of those specimens.

Figure 22: Pickled A1035 steel. Specimen 1 after removal from solution and rinsing.

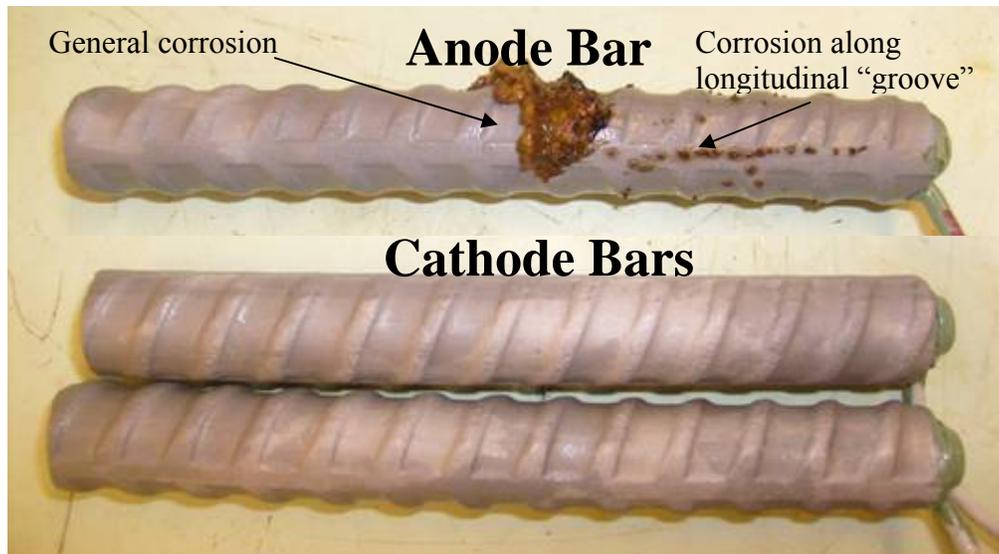
Figure 23: Pickled A1035 steel. Specimen 3, side A after removal from solution and rinsing.

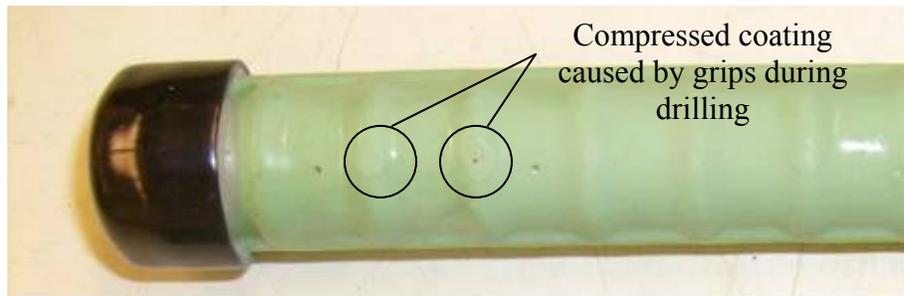
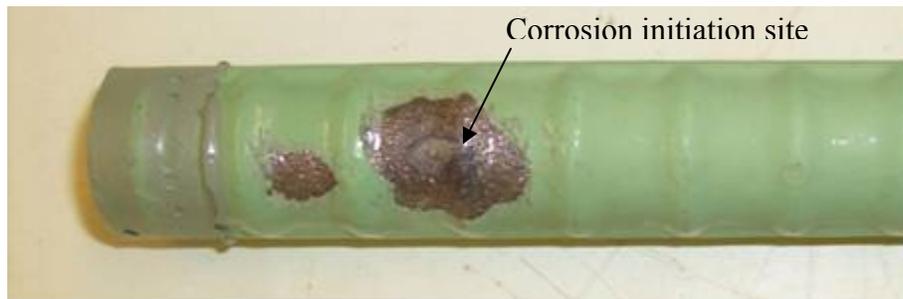
As shown in the Table A1a, the undamaged ECR specimens exhibit disbondment at only one site (site 2 on specimen 6). The disbondment occurred at a previously undetected holiday in the specimen. This also accounts for the negative anode corrosion potential (~ -0.600 V) for that specimen. As mentioned in the report, this specimen is not included in the average corrosion rate and corrosion potential plots, but indicates that the presence of holidays can reduce corrosion performance. As shown in Tables A1b and c, the 0.04% damaged area ECR exhibits more limited disbondment than the 0.83% damaged area ECR, with respective average disbonded areas of 42 mm^2 and 155 mm^2. On both the 0.04% and 0.83% damaged area specimens, unintentional damage to the coating from the drilling process plays a role in the disbondment results. On occasion, the coating that was compressed by the grips during drilling of the anode bars provided additional sites for possible corrosion initiation. In particular, 0.04% damaged ECR specimen 1 (site 3), specimen 2 (site 2), and specimen 5 (site 5) exhibit increased disbondment due to this type of damage. Side 1 of specimen 1 is shown below in Figures A1 and A2. The relatively high disbondment shown in Figure A2 is in contrast to that which is more typical of 0.04% damaged ECR specimens, such as shown in Figure A3 for side 2 of specimen 2.

**Figure A1:** 0.04% ECR, specimen 2, side A. Before attempted disbondment.

Figure A2: 0.04% ECR, specimen 2, side A. After disbondment.

Figure A3: 0.04% ECR, specimen 2, side B. After disbondment. Disbonded areas close to the average (42 mm^2) for 0.04% ECR specimens (see Table A1a).

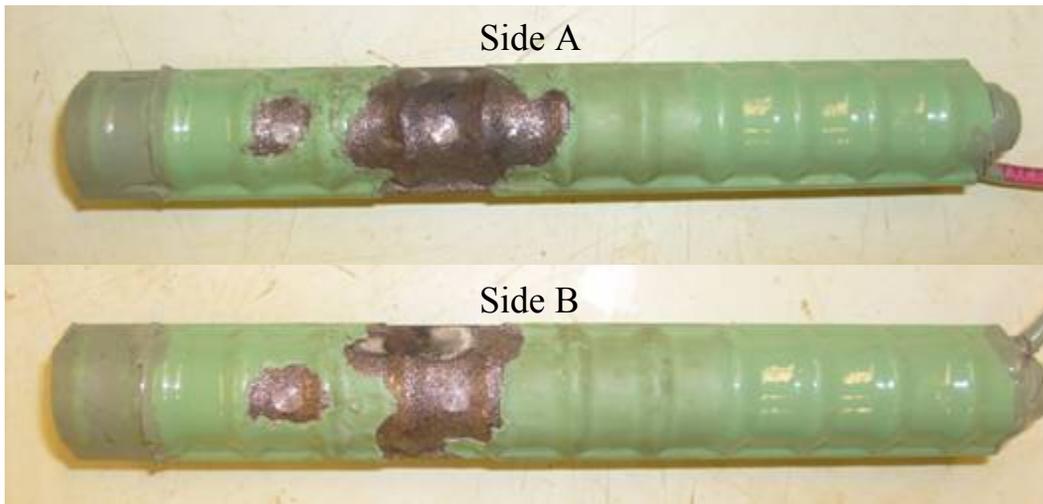
As described above, the 0.83% damaged ECR bars exhibits more disbondment than either the undamaged or 0.04% damaged area bars (about 4 times greater than the latter). At times, disbondment extends to the other side of the bar. This is especially evident for 0.83% damage specimen 2, as shown in Figure A4. Compression of the epoxy coating also affects the disbondment in this case, although it is more difficult to pinpoint since generally more disbondment occurs at the intentional damage sites. The effect of compression of the coating on

disbondment, however, is clear on specimen 6 (site 2), shown in Figure A5, which exhibits significant disbondment away from the intentional damage sites. Other specimens apparently affected by compression of the coating include specimen 2 (sites 2 and 4), specimen 5 (site 1), and specimen 6 (site 4 in addition to site 2).

Figure A4: 0.83% ECR, specimen 2, after attempted disbondment.

Figure A5: 0.83% ECR, specimen 6, after attempted disbondment.

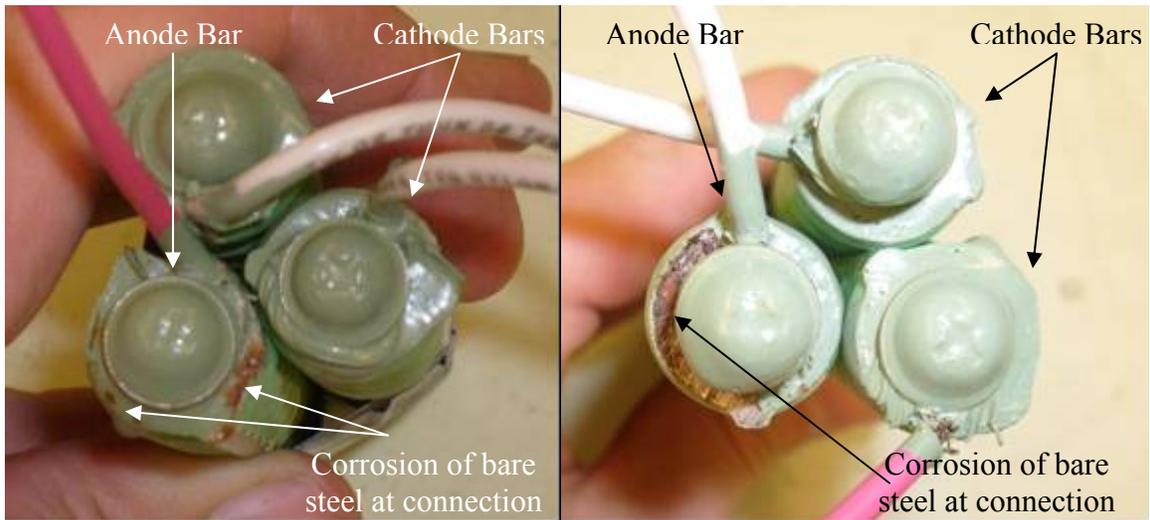
For the undamaged ECR, no apparent corrosion occurs along the length of the specimens. Corrosion does occur, however, on some bars at the electrical connection with the copper wire, which is coated with the two-part epoxy patch material. The corrosion product is indicated by a slight visible surface rust on the steel and not corrosion of the copper wire, as shown in Figure

A6. Despite this local corrosion at the connection, the undamaged ECR performed very well. For example, undamaged ECR specimen 4 exhibits significant corrosion of the steel at the connection due to inadequate epoxy cover (Figure A7), but this corrosion has no appreciable effect on corrosion rate or potential, as shown in Figures 23 and 29.

Figure A6: Undamaged ECR specimens. Left: Specimen 1, corrosion of bare steel occurs under the epoxy patch material. Right: Specimen 5, epoxy patch material is peeled back revealing corrosion of the bare steel.
