**CRACK SURVEYS OF LOW-CRACKING HIGH-PERFORMANCE CONCRETE
BRIDGE DECKS IN KANSAS
2014-2015**

**Structural Engineering and Engineering Materials
SL Report 15-3**

**THE UNIVERSITY OF KANSAS CENTER FOR RESEARCH, INC.
LAWRENCE, KANSAS
September 2015**

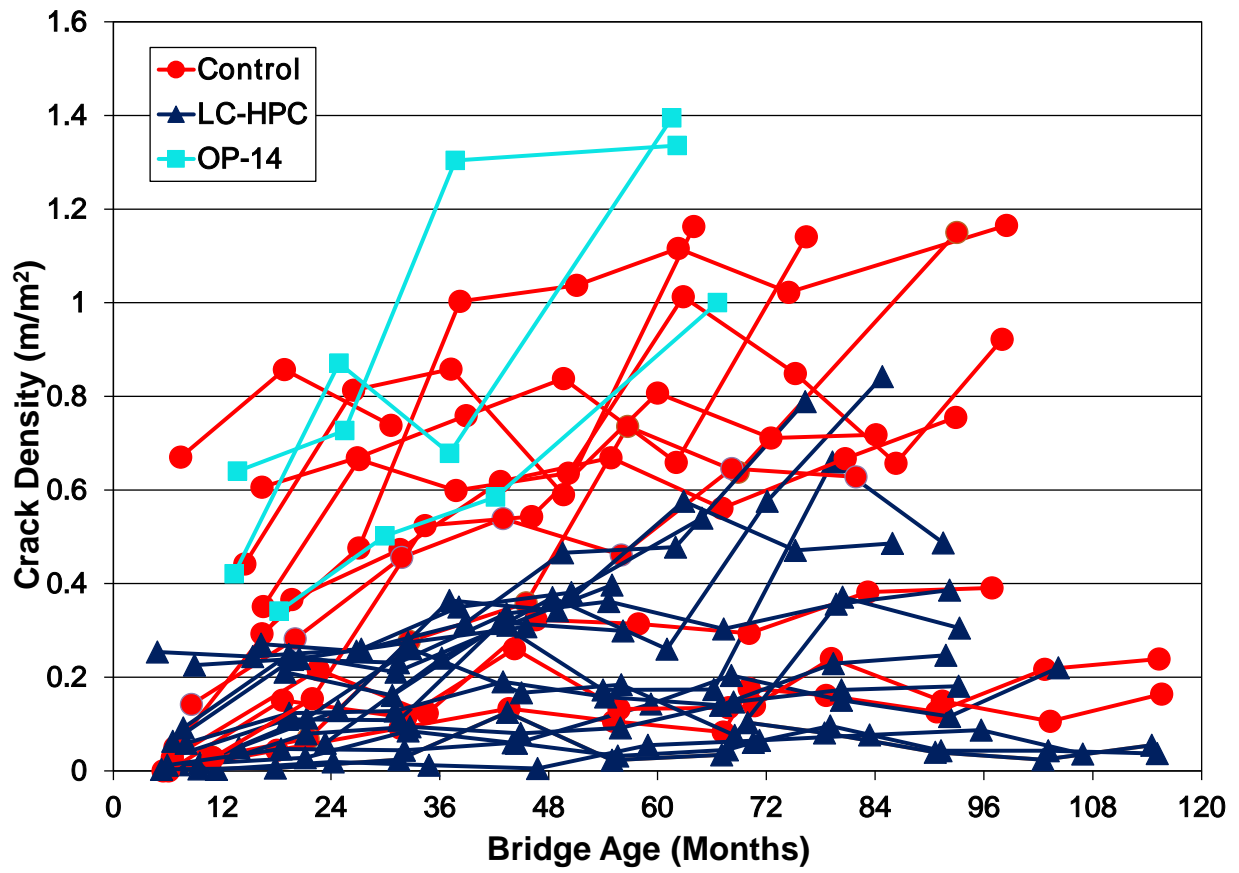
Figure 2: LC-HPC and Control Decks Crack Densities Versus Deck Age

Tables 4 and 5 summarize the crack density for the bridge decks surveyed in 2014 and 2015, respectively. The crack maps for these surveys are included in this section. The results of the surveys performed in 2006, 2007, and 2008 were reported by Gruman, Darwin, and Browning (2009), those performed in 2009 and 2010 were reported by Pendergrass, Darwin, and Browning (2011), and those performed in 2011, 2012, and 2013 were reported by Bohaty, Riedel, and Darwin (2013); the earlier results are summarized in Appendix B. Figure 2 shows crack densities over time for all the bridges included in this study. It can be concluded that the average trend of the LC-HPC decks is lower than the average trend of the control decks. The fact that some LC-HPC decks exhibited greater crack density values than some control decks is because they have experienced different conditions. This report includes individual comparisons for each LC-HPC and control deck pair. In most cases, LC-HPC decks performed better than their controls.

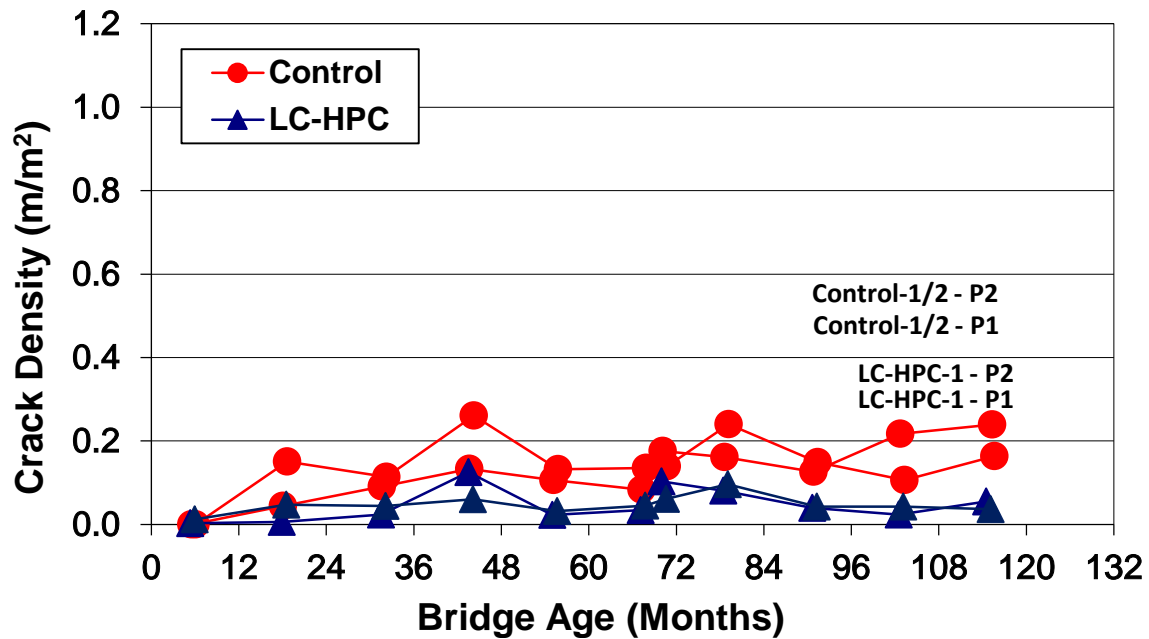
Figure 7: LC-HPC-1 and Control-1/2 Crack Densities Versus Deck Age

The crack densities for LC-HPC-1 and Control-1/2 are compared in Figure 7. The crack densities for both placements of Control-1/2 have been greater than the crack densities for LC-HPC-1. In almost all cases, this has been universally true for the past few surveys.

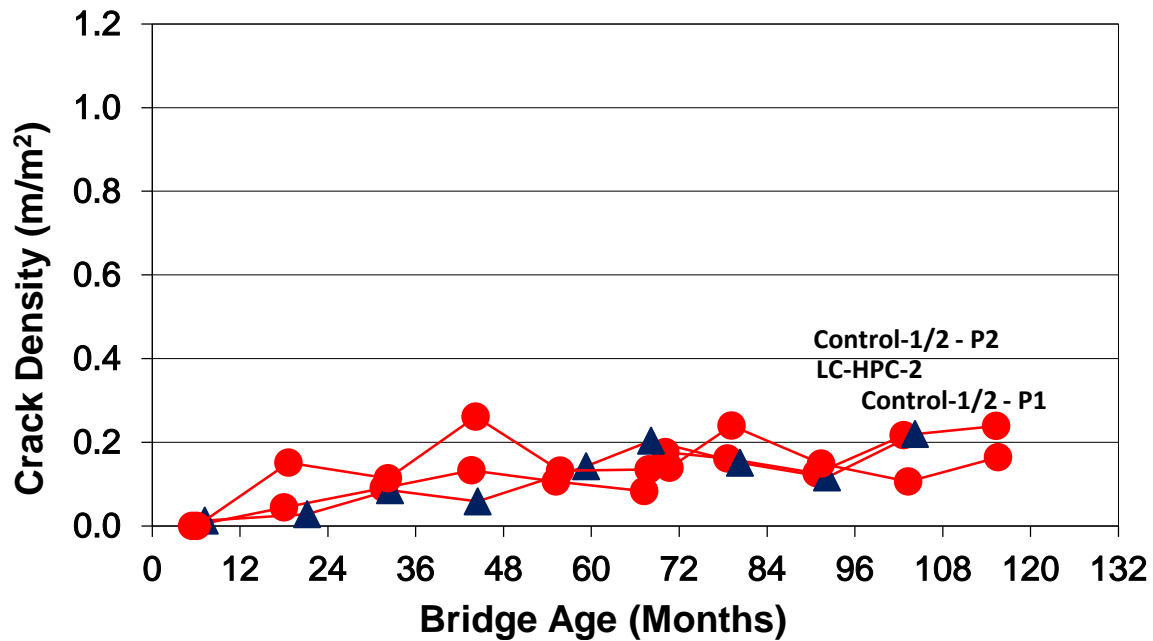
Figure 10: LC-HPC-2 and Control-1/2 Crack Densities Versus Deck Age

As shown in Figure 10, the two decks are exhibiting similar cracking behavior. Placement 2 of Control-1/2 has a higher crack density than LC-HPC-2 and Placement 1 of Control-1/2. Placement 1 of Control-1/2 has a lower crack density than LC-HPC-2. Control-1/2 is the best performing control deck in the study.

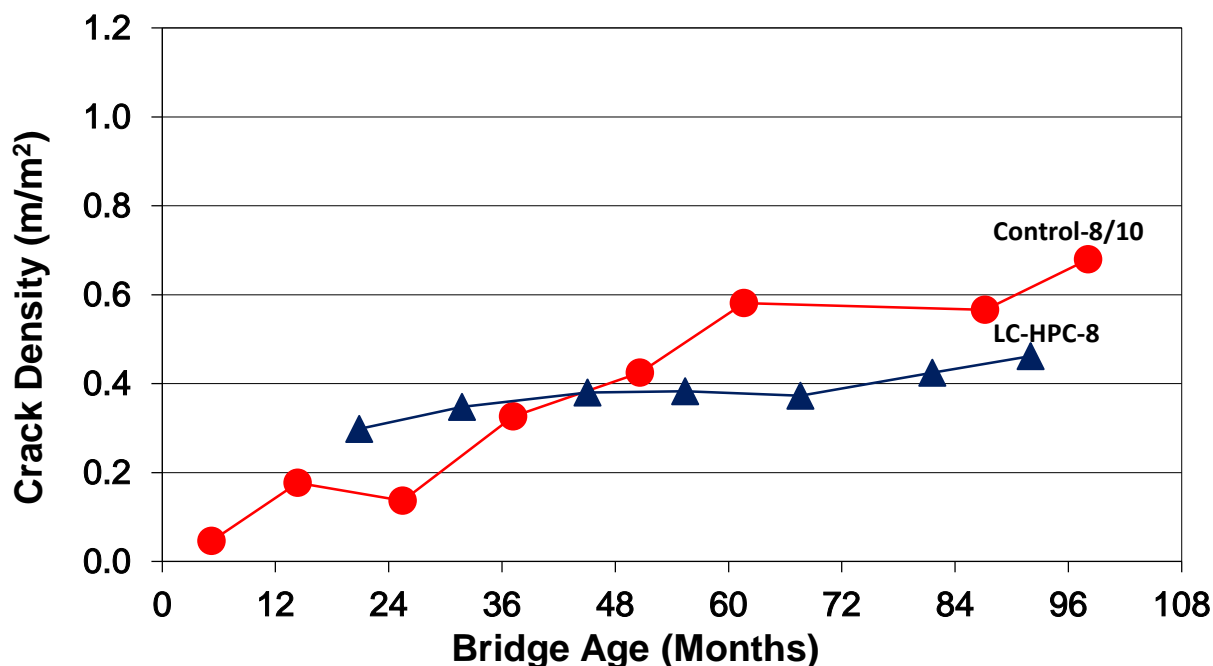
Figure 38: LC-HPC-8 and Control-8/10 Crack Densities Versus Deck Age

Figure 38 compares the crack densities for LC-HPC-8 and Control-8/10 over time. LC-HPC-8 showed higher cracking than Control-8/10 during the early ages of the deck, but has exhibited lower densities since the third survey.

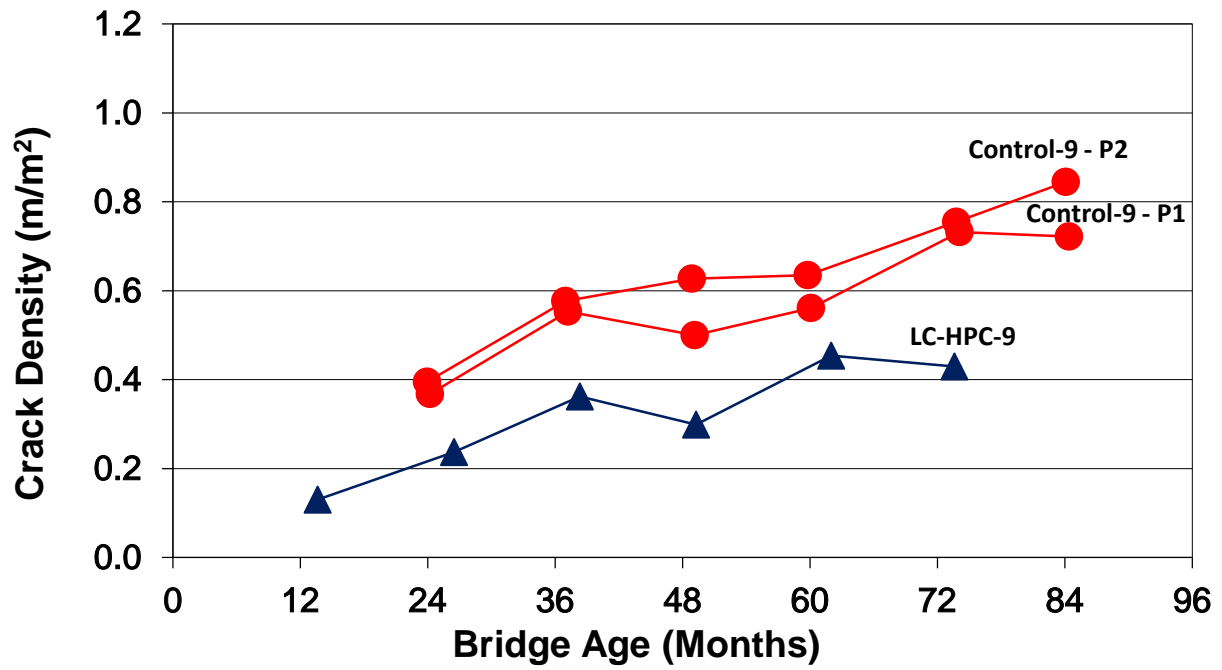
Figure 43: LC-HPC-9 and Control-9 Crack Densities Versus Deck Age

Figure 43 compares the crack densities for LC-HPC-9 and Control-9 over time. LC-HPC-9 has a significantly lower crack density than either placement of Control-9.

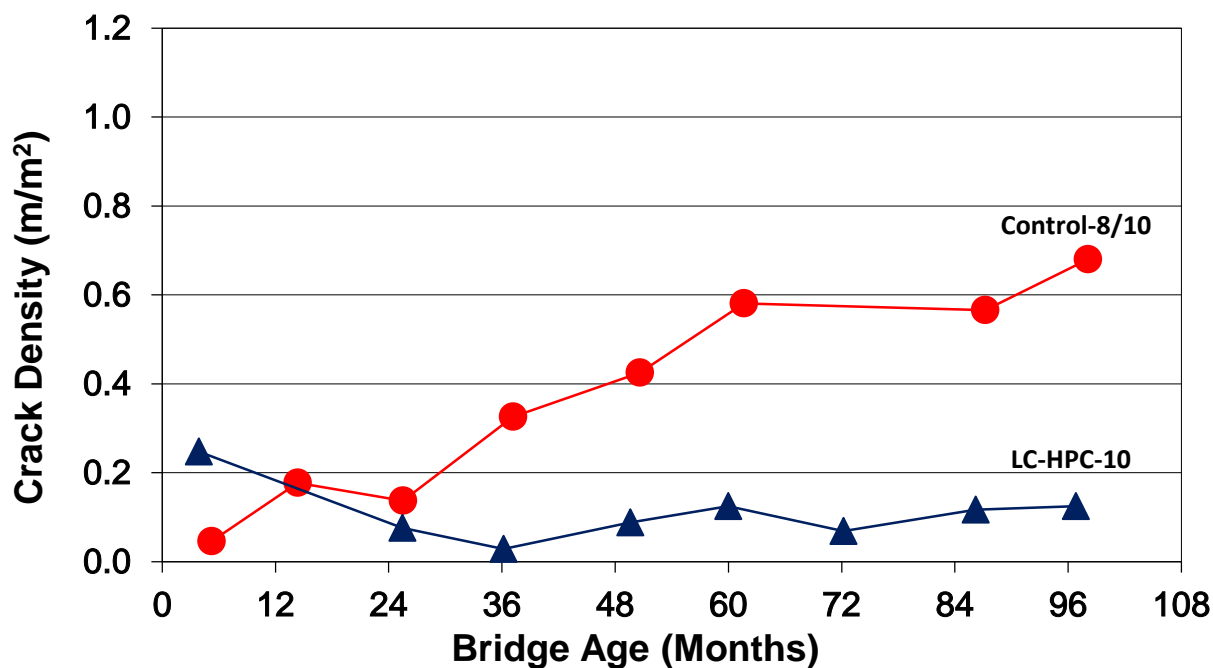
Figure 46: LC-HPC-10 and Control-8/10 Crack Densities Versus Deck Age

Figure 46 compares the crack densities of LC-HPC-10 and Control-8/10 over time. LC-HPC-10 has exhibited much less cracking than Control-8/10 most of the time since the decks were constructed.

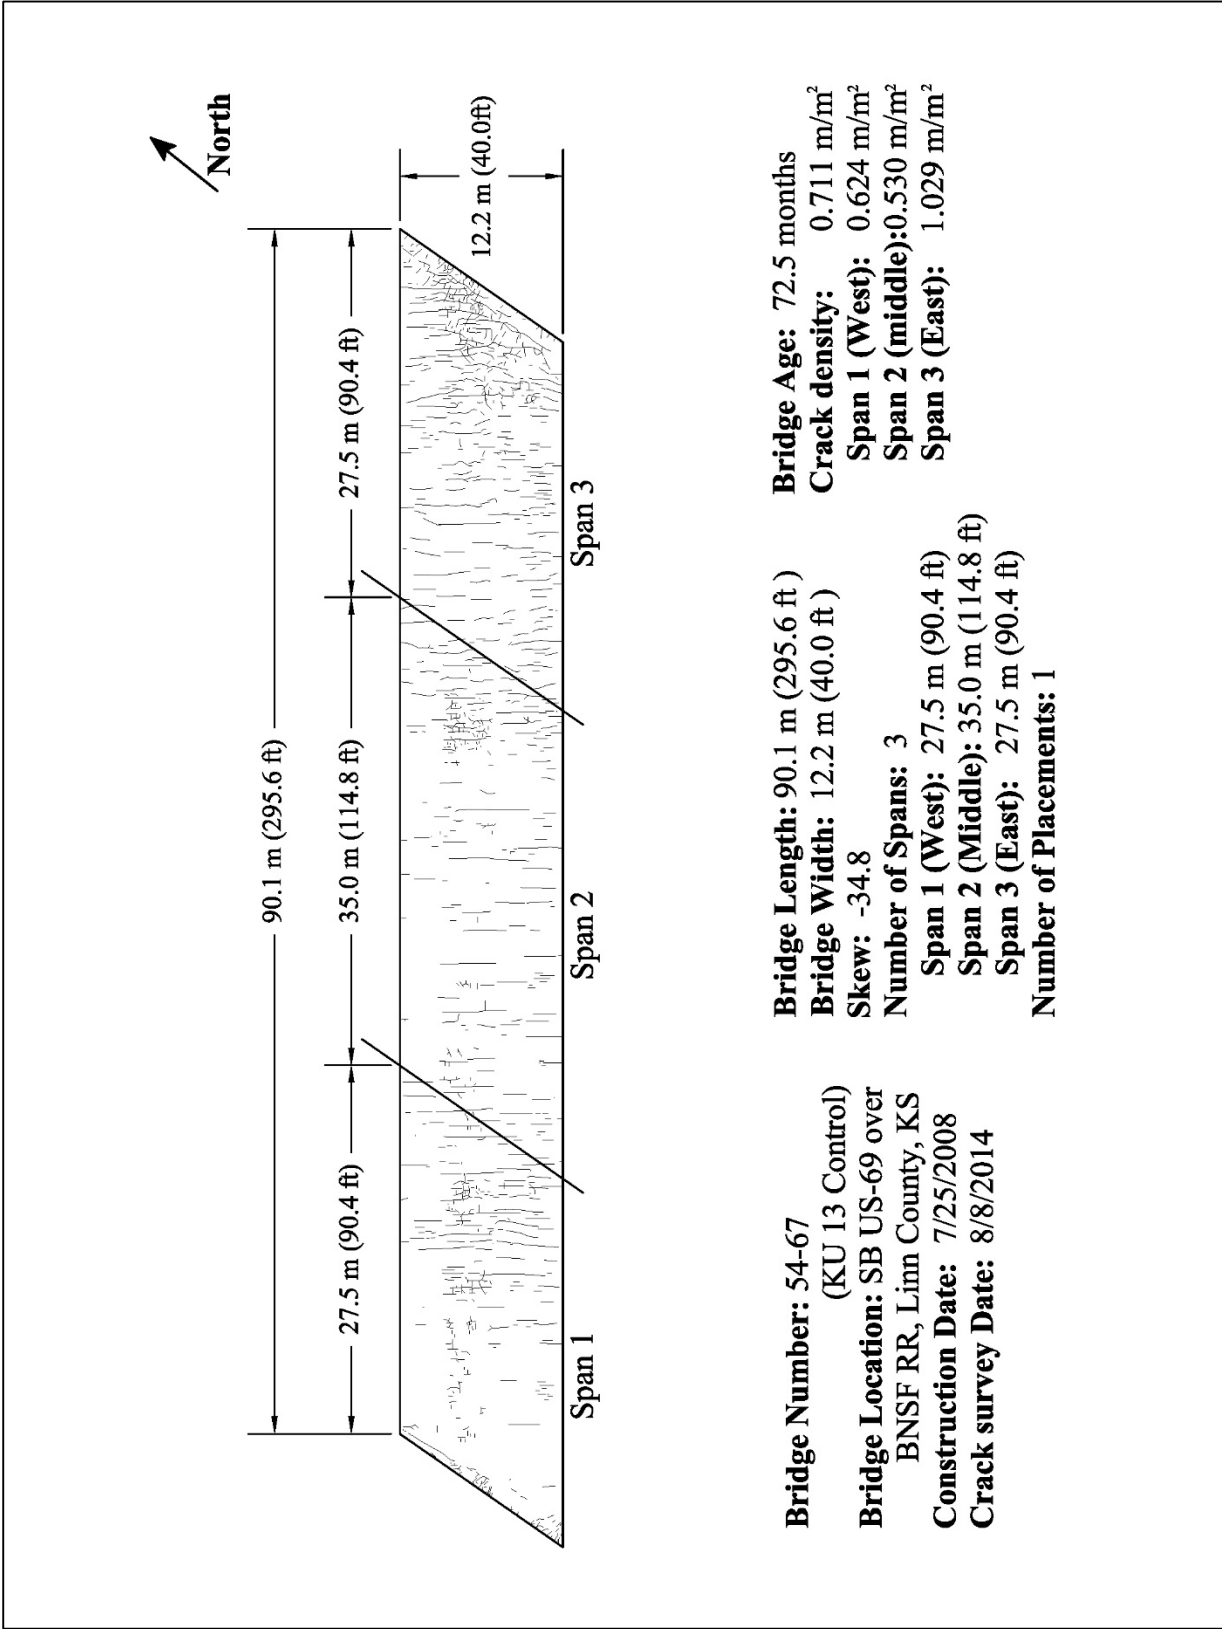
Figure 55: Control-13 (Survey 6)

Bridge deck Control-13 was placed on 7/25/2008 and has been surveyed seven times. The results of Surveys 6 and 7 are included in this report. Survey 6 was completed at a deck age of 72.5 months; the crack map is shown in Figure 55. Survey 7 was completed at a deck age of 84.1 months; the crack map is shown in Figure 56. In Survey 6, a crack density of 0.711 m/m^2 was observed (Figure 55). Survey 6 has a lower crack density than Survey 5, 0.807 m/m^2 (Bohaty et al. 2013). In Survey 7, a crack density of 0.718 m/m^2 was observed (Figure 56), which is slightly higher than Survey 6. Similar to LC-HPC-13, Survey 5 can be considered as an outlier. As shown in Figures 55 and 56, it can be seen that there are moderate-length transverse cracks distributed over the whole area of the bridge. Map cracking is present at some locations on the deck. Short cracks have propagated perpendicular to both abutments.

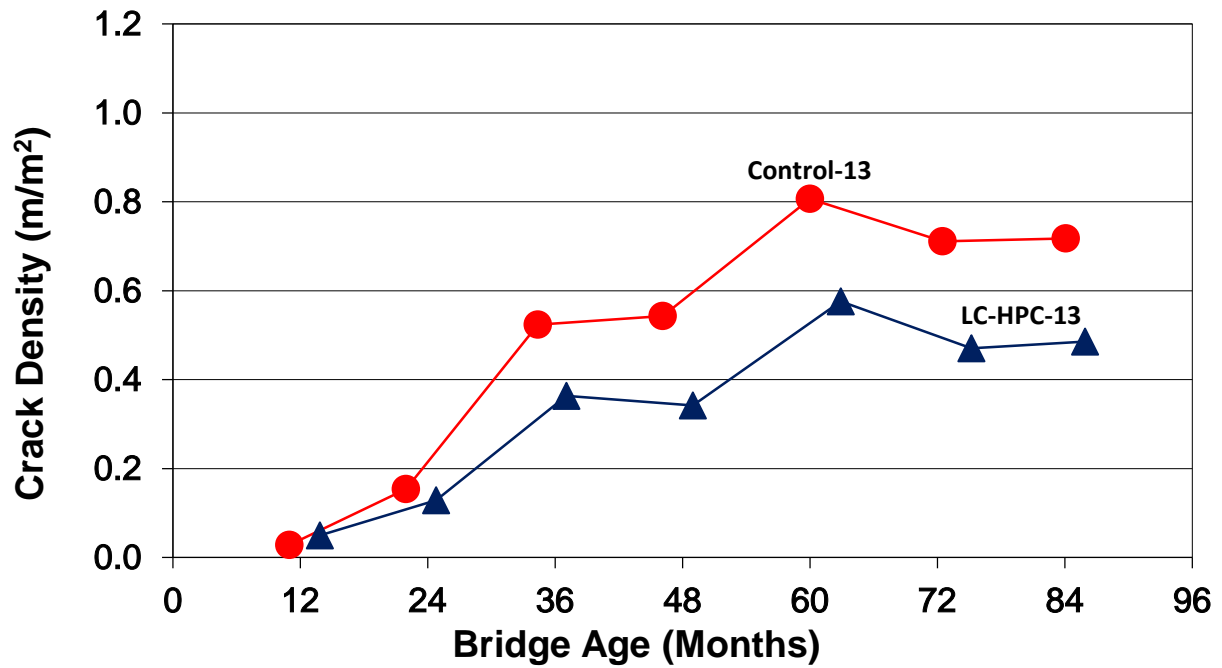
Figure 57: LC-HPC-13 and Control-13 Crack Densities Versus Deck Age

Figure 57 compares the crack densities for LC-HPC-13 and Control-13 over time. LC-HPC-13 has consistently exhibited less cracking density than Control-13 over the life of the decks.

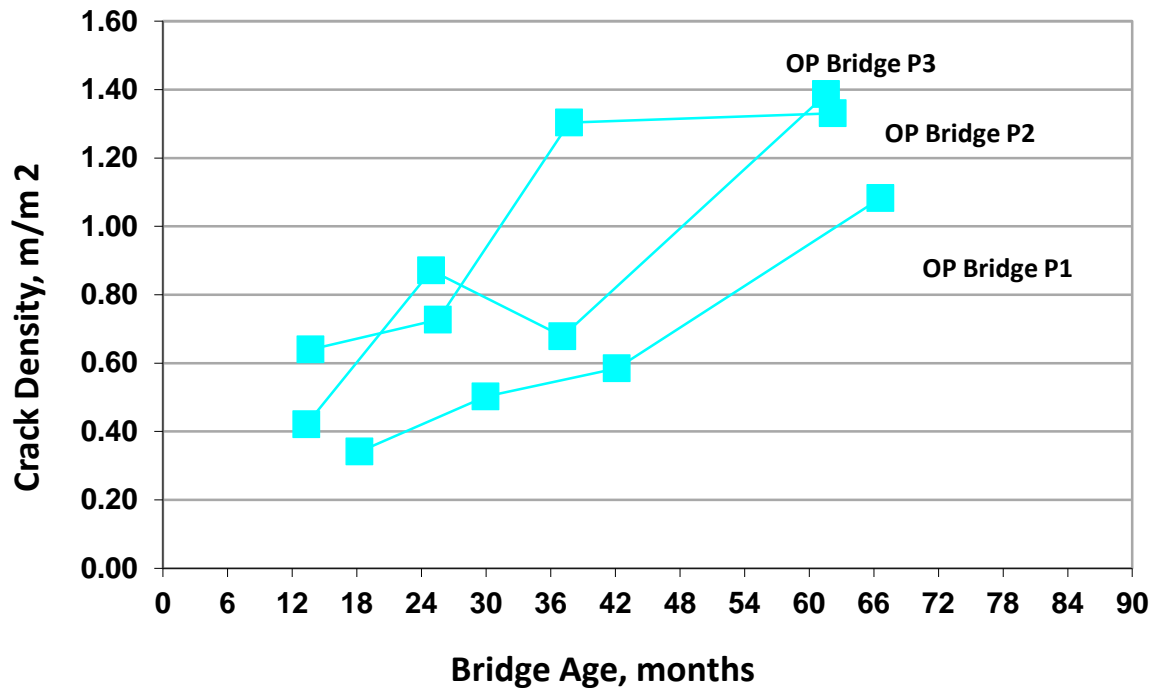
Figure 58: OP-14 Crack Densities Versus Deck Age (Bohaty et al. 2013)

Bridge deck OP-14 was constructed in three separate placements; Placements 1, 2, and 3 were cast on 12/19/2007, 5/2/2008, and 5/21/2008, respectively. OP-14 has been surveyed four times. Survey 4 is considered to be the last for OP-14 due to excessive deck cracking. Survey 4 recorded a crack density of 1.083, 1.331, and 1.387 m/m² for Placements 1, 2, and 3, respectively (Bohaty et al. 2013). Placements 2 and 3 of this deck recorded the highest crack densities among any of the decks included in this study (LC-HPC and control decks). Figure 58 compares the crack densities for OP-14 over time (Bohaty et al. 2013). OP-14 was bid as an LC-HPC bridge deck. However, the contractor did not follow important aspects of the LC-HPC specifications, and the owner, the City of Overland Park, did not enforce the specifications (McLeod et al. 2009).

Placement 1 of OP-14 was constructed on two separate dates because the concrete pump clogged after placing the first 30 ft (9 m) of the deck. This portion of the deck was demolished before the second construction attempt. For some concrete batches during the second attempt, the measured slump was much higher than the maximum slump specified for LC-HPC decks. Inadequate consolidation was observed during the construction: the gang vibrators were removed too quickly leaving visible holes at the deck surface. Excessive bullfloating was used on the deck surface, which resulted in excessive cement paste to the surface. The specified ten-minute time between finishing and placing burlap was exceeded throughout the deck construction. Also, water was used as finishing aid. Placements 2 and 3 of OP-14 had the same construction issues as Placement 1, resulting in high deck cracking. During the construction of Placement 2, concrete trucks were delayed and the contractor removed concrete from a previously placed wingwall and used it to complete a portion of the deck. During the construction of Placement 3, the deck reinforcement was not fully supported, resulting in reinforcement vibration. This issue may have

increased the potential for settlement cracking (Lindquist et al. 2008, Gruman et al. 2009, and McLeod et al. 2009).

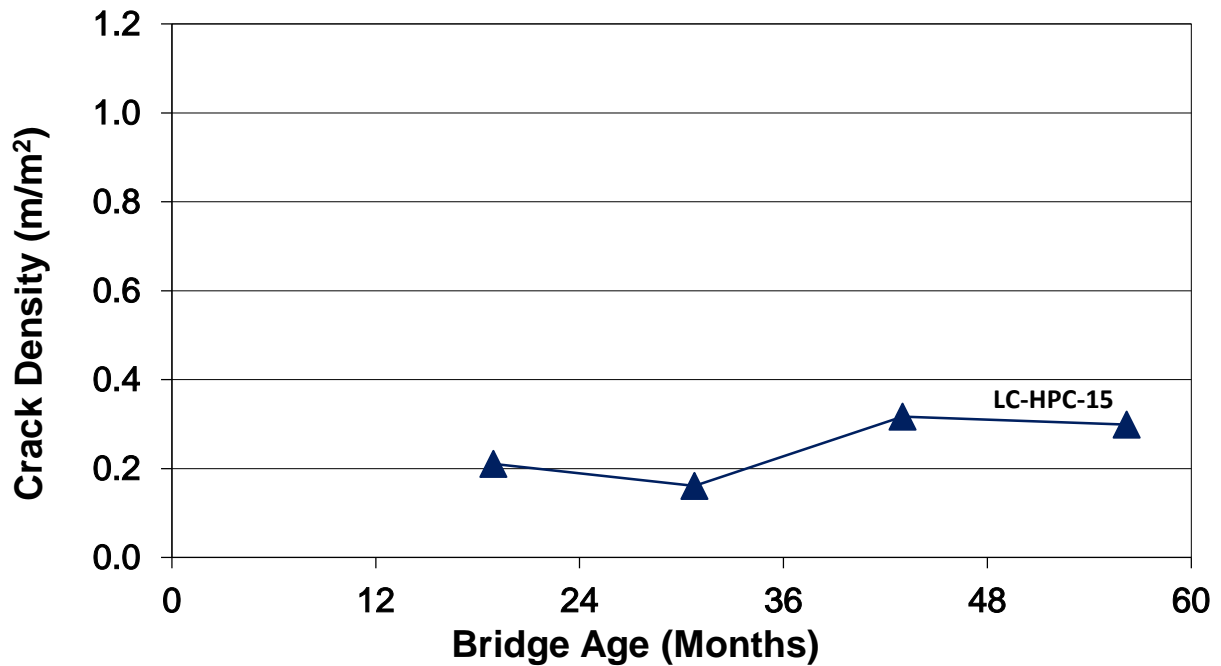
Figure 61: LC-HPC-15 Crack Densities Versus Deck Age

Bridge deck LC-HPC-15 was constructed on 11/10/2010. This deck does not have a control deck for comparison. LC-HPC-15 has been surveyed four times and this report includes the results of Surveys 3 and 4. Survey 3 was performed at a deck age of 43.0 months; the crack map is shown in Figure 59. Survey 4 was performed at a deck age of 56.2 months; the crack map is shown in Figure 60. A crack density of 0.316 m/m^2 was observed in Survey 3 (Figure 58), a significant increase in crack density from Survey 2, 0.161 m/m^2 (Bohaty et al. 2013). In Survey 4, a crack density of 0.299 m/m^2 was observed (Figure 59), slightly lower than in Survey 3. As shown in Figures 59 and 60, the majority of the cracks in LC-HPC-15 are transverse, and appear to run parallel to the top reinforcement layer. A few short cracks appear near the abutments. Figure 61 displays the crack density versus deck age for LC-HPC-15.

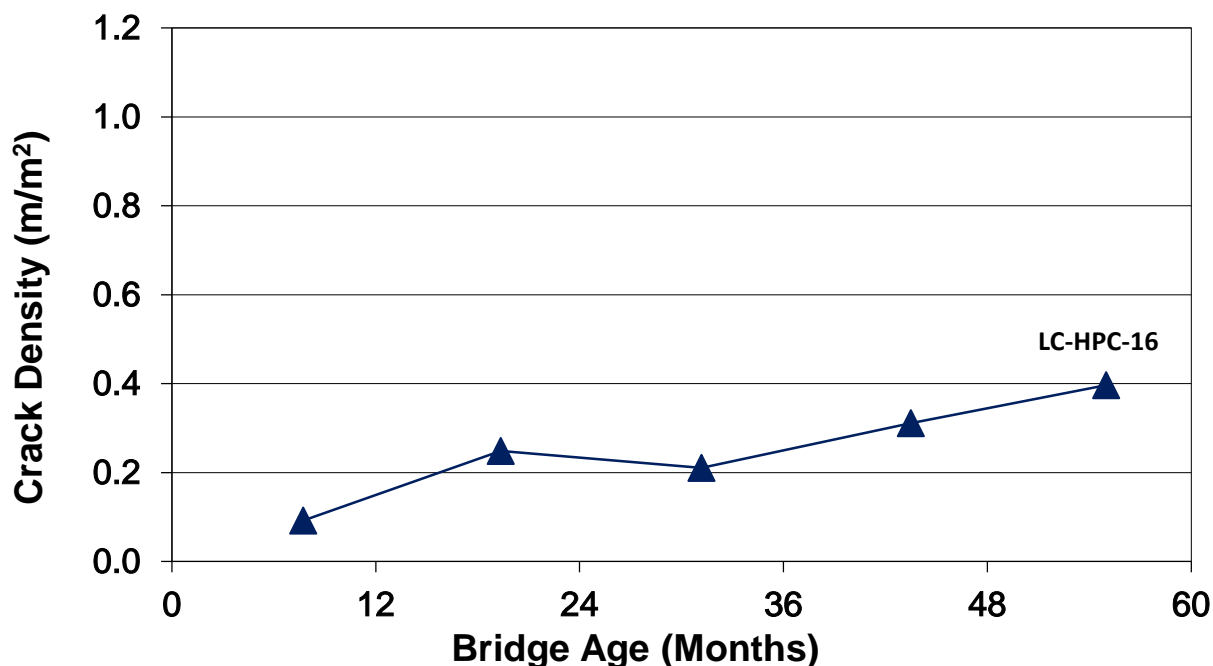
Figure 64: LC-HPC-16 Crack Densities Versus Deck Age

Bridge deck LC-HPC-16 was constructed on 6/11/2014. This bridge does not have a control deck for comparison. This deck has been surveyed five times. The results of Surveys 4 and 5 of LC-HPC-16 are discussed in this report. Survey 4 was completed at a deck age of 43.5 months; the crack map is displayed in Figure 62. Survey 5 was completed at a deck age of 55.0 months; the crack map is displayed in Figure 63. A crack density of 0.311 m/m² was observed in Survey 4 (Figure 62) compared to a crack density of Survey 3, 0.211 m/m² (Bohaty et al. 2013). In Survey 5, a crack density of 0.397 m/m² was observed (Figure 63). Most of the cracks are transverse (Figures 62 and 63). Map cracking is also present on some portions of the deck. Near the abutments, some cracks have propagated longitudinally. Figure 64 shows the crack density as a function of age for LC-HPC-16.

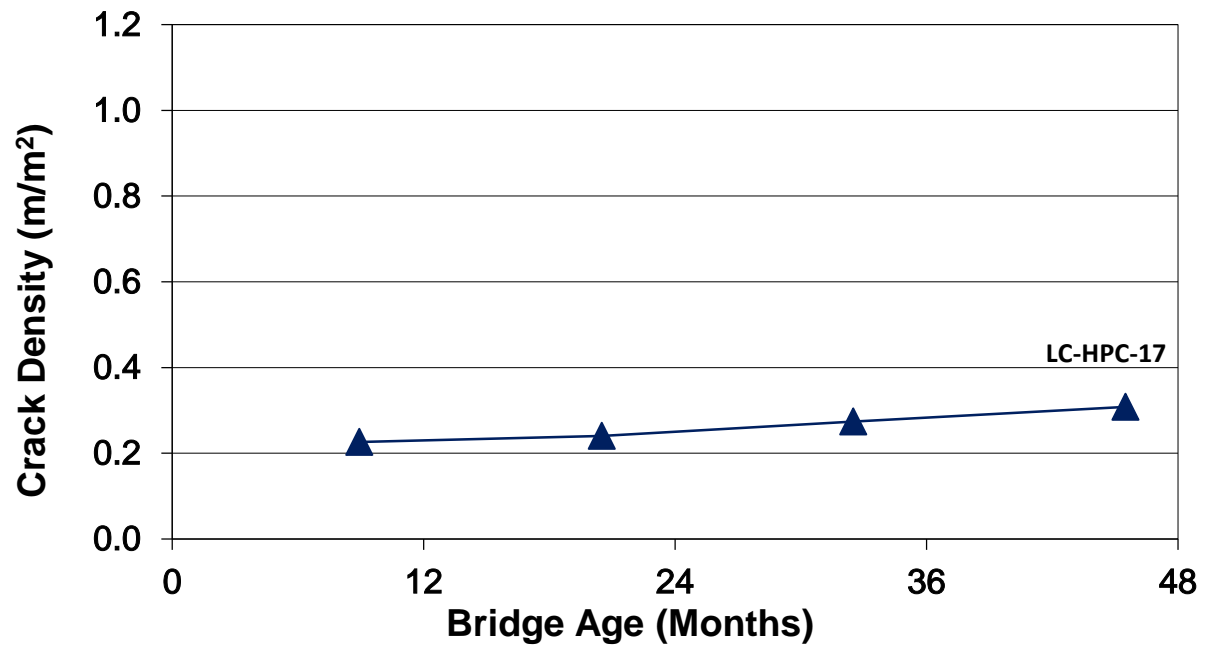
Figure 67: LC-HPC-17 Crack Densities Versus Deck Age

Bridge deck LC-HPC-17 was placed on 9/28/2011. There is no control deck for this bridge. This deck has been surveyed four times, and the results of Surveys 3 and 4 are included in this report. Survey 3 was performed at a deck age of 32.5 months; the crack map is shown in Figure 65. Survey 4 was performed at a deck age of 45.5 months; the crack map is shown in Figure 66. In Survey 3, an overall crack density of 0.274 m/m² was observed (Figure 65), slightly higher than the value reported by Bohaty et al. (2013) for Survey 2, 0.240 m/m². An overall crack density of 0.308 m/m² was observed in Survey 4 (Figure 66). The surveys do not include the sidewalks. As shown in Figures 65 and 66, the majority of the cracks are transverse and located near the mid-span. There are, also, some transverse cracks above the pier. Survey 4 recorded some small areas of map cracking near the east abutment. Cracks also propagate longitudinally near the west abutment. Figure 67 shows the crack density for LC-HPC-17 over time.

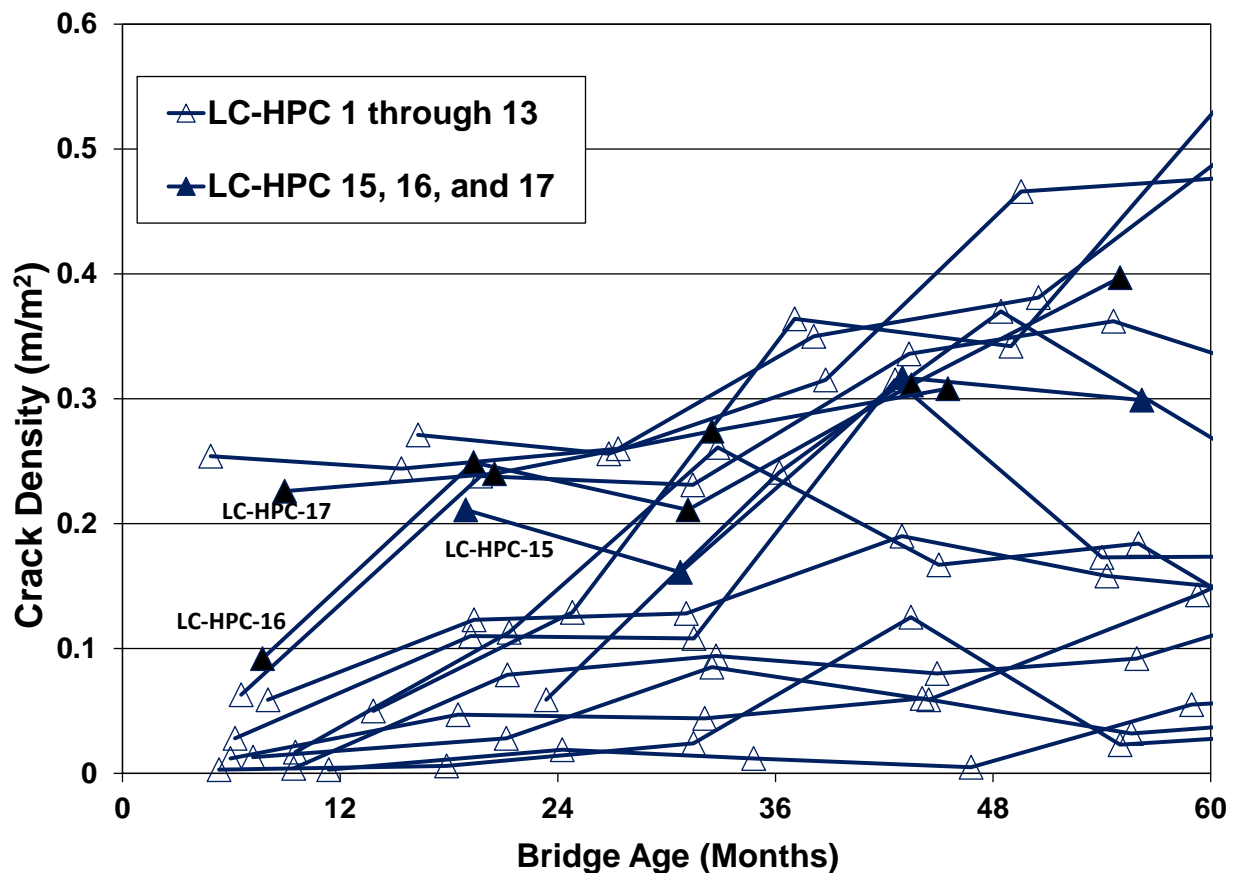
Figure 68: LC-HPC 1 through 13 and LC-HPC 15, 16, and 17 Crack Densities Versus Deck Age

Figure 68 compares paired LC-HPC decks (LC-HPC 1 through 13) to the unpaired LC-HPC decks (LC-HPC 15, 16, and 17) over time. The crack densities for the three unpaired LC-HPC decks fall just under the upper boundary of paired 13 LC-HPC decks. LC-HPC-16 started with a crack density similar to most of the unpaired LC-HPC-decks. However, the crack density jumped in the second and subsequent surveys. The majority of paired LC-HPC decks have exhibited lower crack densities during the first 60 months since construction.
