**APPLICATION OF ANGLES-WITH-PLATE RETROFIT IN REPAIRING
DISTORTION-INDUCED FATIGUE DAMAGES IN STRINGER TO FLOORBEAM
CONNECTIONS AND SKEWED GIRDER TO CROSS-FRAME CONNECTIONS**

Danqing Yu

Submitted to the graduate degree program in Civil, Architectural, and Environmental Engineering and the Graduate Faculty of the University of Kansas in partial fulfillment of the requirements for the degree of Master of Science.

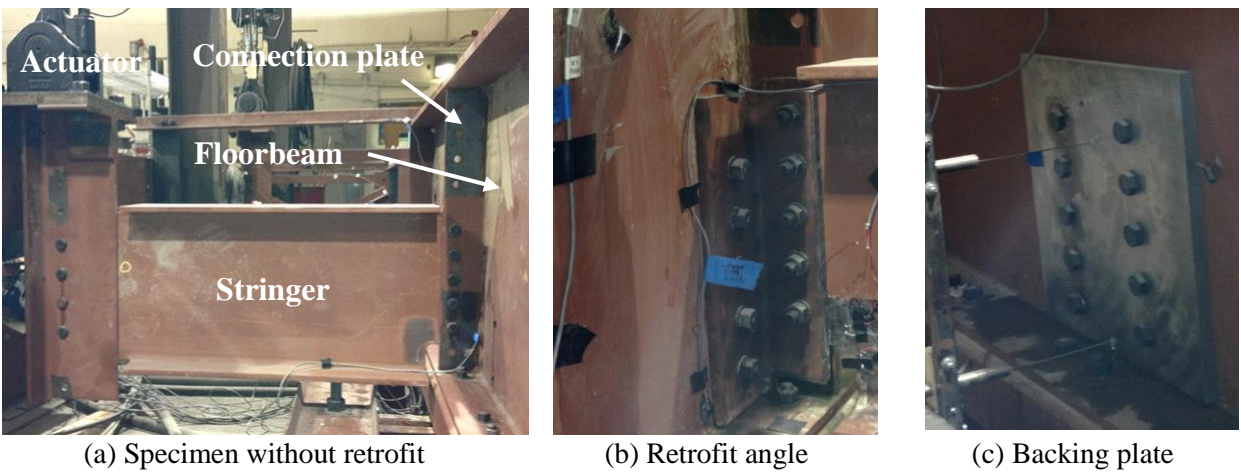
Figure 3-3: Photos of single-plate connection specimen (FS1)

Figure 3-2 presents the dimensions of the angles-with-plate retrofit. The retrofit was applied to the specimen when cracks grew to $\frac{3}{4}$ in. Photographs of the specimen and retrofit are shown in Figure 3-3.

At the beginning of the test, the specimen was loaded under fatigue to initiate cracks. The angles-with-plate retrofit was installed once the cracks had grown to $\frac{3}{4}$ in. along the floorbeam web to connection plate weld.

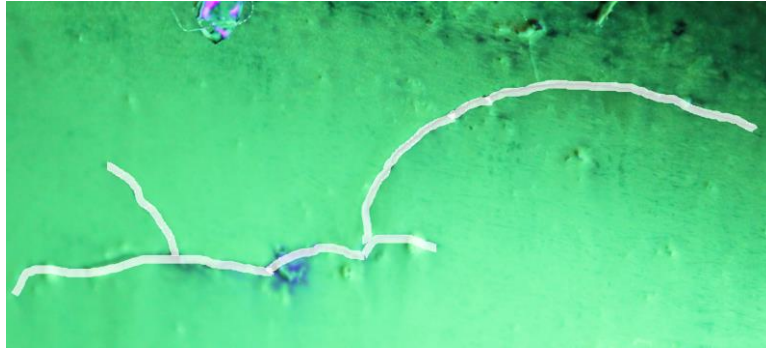
Figure 4-4: Photograph of cracks on the floorbeam web fascia side 1,200,000 cycles into Trial 3

Cracks first initiated at the connection plate side in Trial 1, and then propagated through the thickness of the girder web, appearing on the web fascia side in Trial 3. At the centerline of the fascia side, a 1 in. horizontal crack was observed 2¼ in. above the bottom flange 525,000 cycles into Trial 3. More crack branches appeared as additional cycles were applied. They joined the existing cracks, and formed spider-shaped cracks. Table 4-3 and Figure 4-3 present crack initiation

and propagation behavior for the floorbeam web fascia side in this trial. A photograph of cracks located on the web fascia side 1,200,000 cycles into Trial 3 is provided in Figure 4-4.

*Cracks are shown with white lines

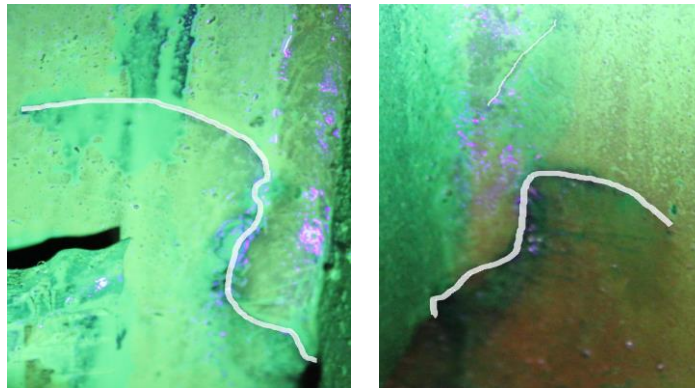
The cracks initiated in Trial 1 propagated vertically along the weld connecting the floorbeam web and the connection plate, then grew horizontally after propagating into the web. Crack initiation and propagation behavior on the connection plate side are presented in Table 4-4 and Figure 4-5. Figure 4-6 provides photographs of the cracks on the connection plate side 1,200,000 cycles into Trial 3.

(a) East side of stiffener

(b) West side of stiffener

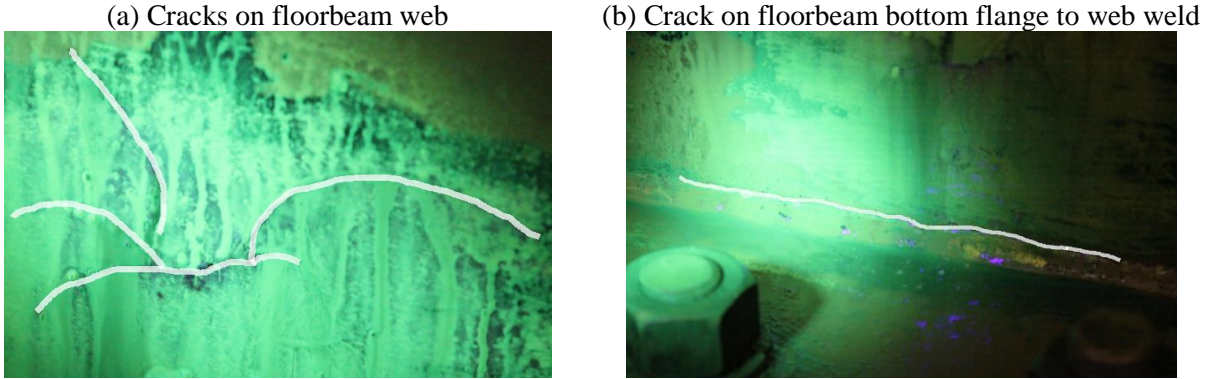
Figure 4-10: Photographs of cracks on floorbeam web fascia side 85,000 cycles into Trial 8

A new branch crack (Crack 8) was observed 25,000 cycles into Trial 8 on the floorbeam web, as presented in Table 4-7 and Figure 4-9. It grew faster than previous existing cracks. The crack on the floorbeam web-to-bottom flange weld (Crack 9) propagated much faster than the others: the length of the crack increased approximately 3 in. in 85,000 cycles. The test was halted 85,000 cycles into Trial 8, because the specimen had reached a critical state.

Photographs of the cracks 85,000 cycles into Trial 8 are presented in Figure 4-10.

* Cracks are shown with white lines

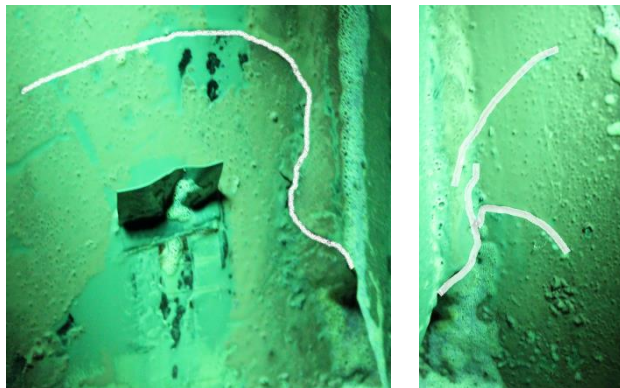
Figure 4-12: Photographs of cracks on connection plate side 85,000 cycles into Trial 8

Cracks continued growing on the connection plate side of the specimen throughout Trial 8, as shown in Figure 4-11 and Figure 4-12.

* Cracks are shown with white lines

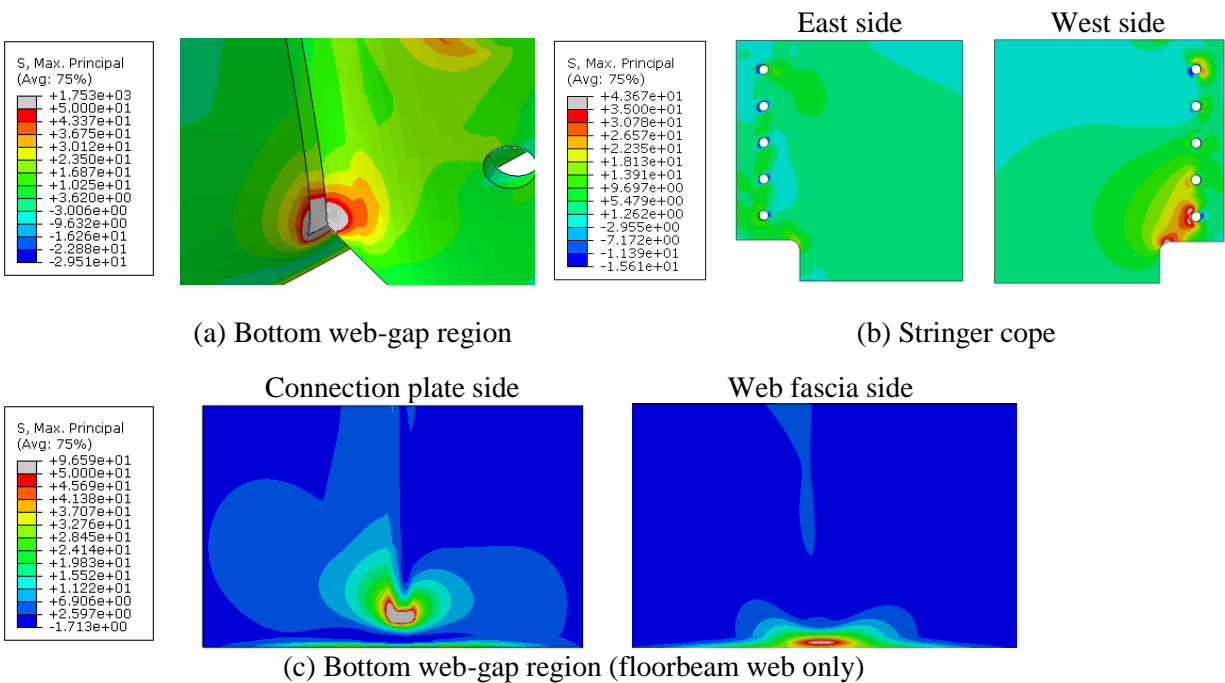
Figure 5-4: Simulation results for single-plate connection specimen FS1, Model 1

As expected, stresses were concentrated in the bottom web-gap region. On the connection plate side, large-magnitude stresses occurred at the bottom of the floorbeam web to connection plate junction. On the fascia side of the web, stresses were concentrated near the bottom flange.

For the stringer, the cope was the location where relatively larger stresses occurred, but the magnitude of the stresses was much lower than those observed in the web-gap region. The distribution of stresses on the two sides of the stringer cope were different. The stresses on the west side were larger than on the east.

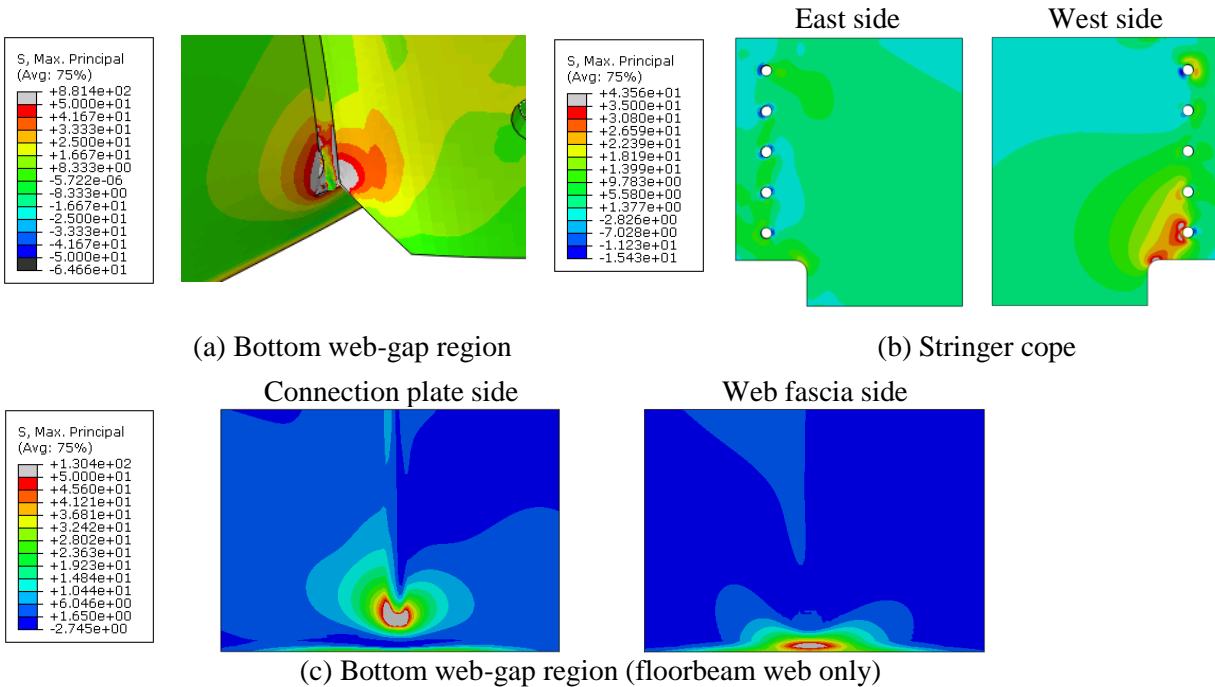
Figure 5-5: Simulation results for single-plate connection specimen FS1 Model 2

Model 2 was created to simulate the physical test specimen FS1 at the end of Trial 1. As shown in Table 5-1, two 3/4 in. cracks were created explicitly to simulate the actual crack geometries. The computed stress results are presented in Figure 5-5.

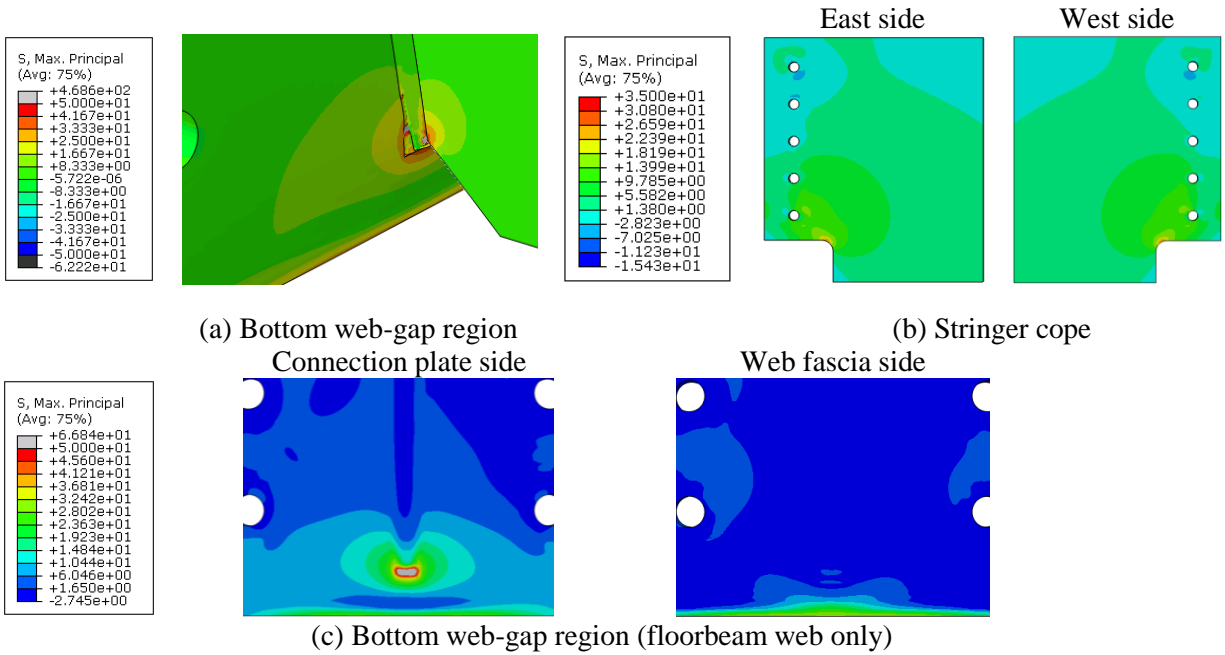
Figure 5-6: Simulation results for single-plate specimen FS1 Model 3

Compared with Model 2, in Model 3, stresses in the bottom web-gap region significantly decreased. For the stringer cope, stresses on the west side were clearly reduced. The stress distributions on the east and the west sides became more similar.

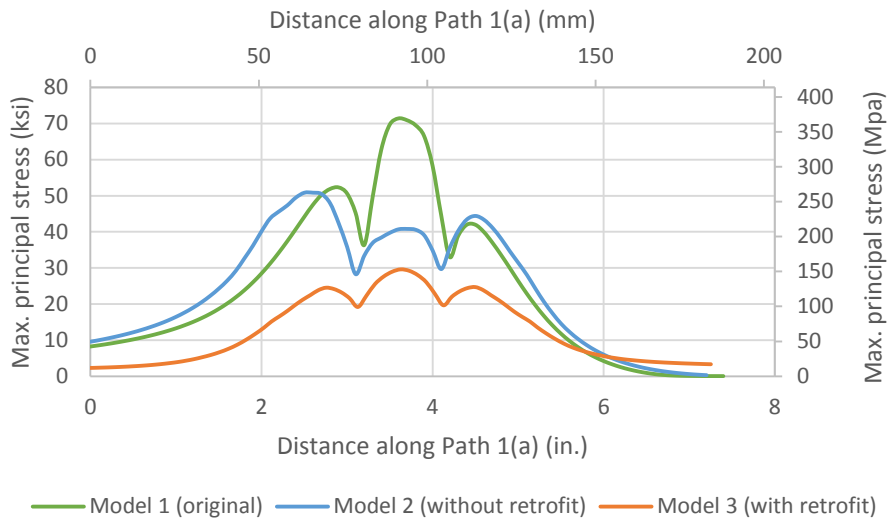
Figure 5-7: Stresses along Path 1(a) for single-plate connection FS1: Model 1, Model 2, and Model 3

For the early-stage fatigue damage, in which cracks had not yet propagated into the floorbeam web, the angles-with-plate retrofit was found to reduce stresses significantly. Stresses in the retrofitted condition were approximately 40% of the peak stress along Path 1(a) and 67% of the peak stress along Path 2.

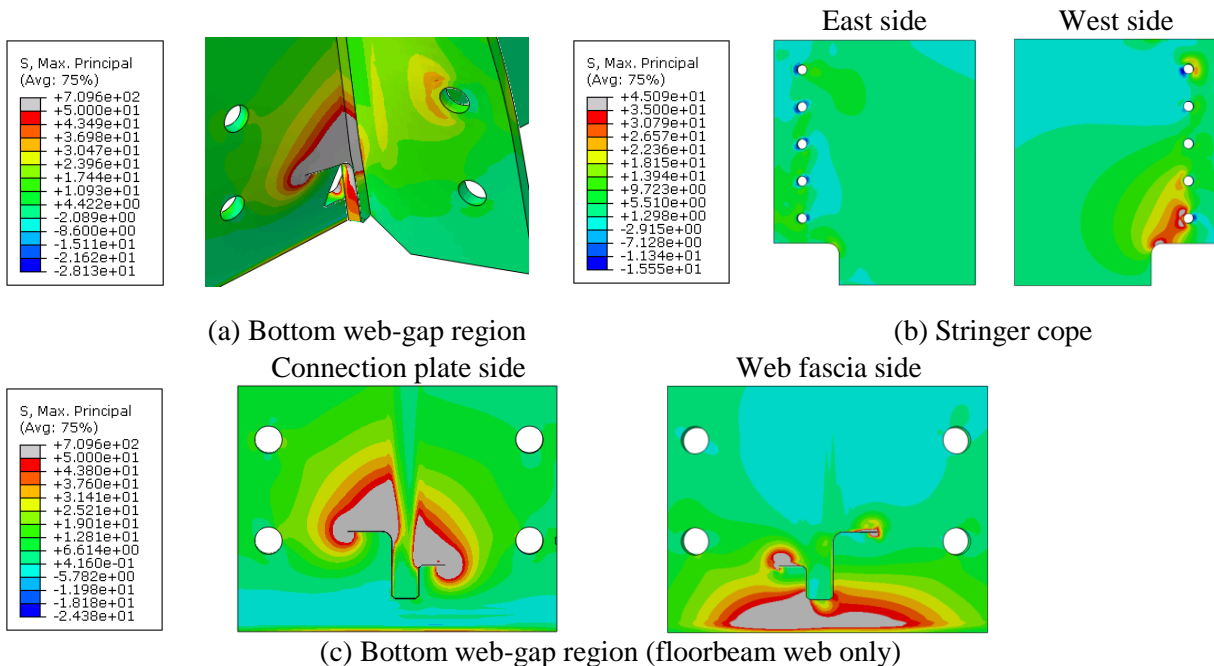
Figure 5-9: Simulation results for single-plate connection Specimen FS1: Model 4

Stresses on the connection plate side were concentrated at the crack tips and the regions above the horizontal cracks. On the web fascia side, stresses in the region near the bottom flange markedly increased compared to Model 1 and Model 2, in which the fatigue cracks had not propagated into the floorbeam web. Stresses in the stringer cope region were similar to those observed in Model 1

and Model 2. The development of cracks on the floorbeam web did not have a significant effect on stresses in the stringer cope regions.

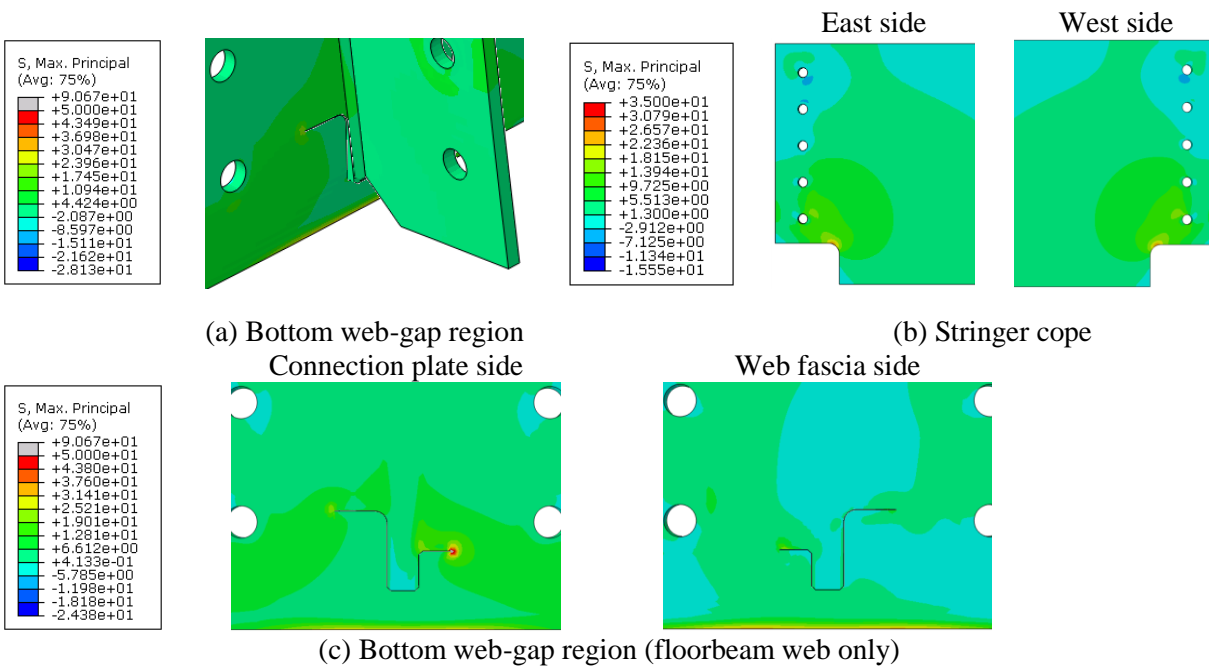
Figure 5-10: Simulation results for single-plate connection specimen FS1: Model 5

Comparing the results for Model 5 with Model 4, the angles-with-plate retrofit significantly reduced stresses on both sides of the floorbeam web. Stresses on the west side of the stringer cope decreased, and the stress distributions on the east and the west sides became more similar to each other.

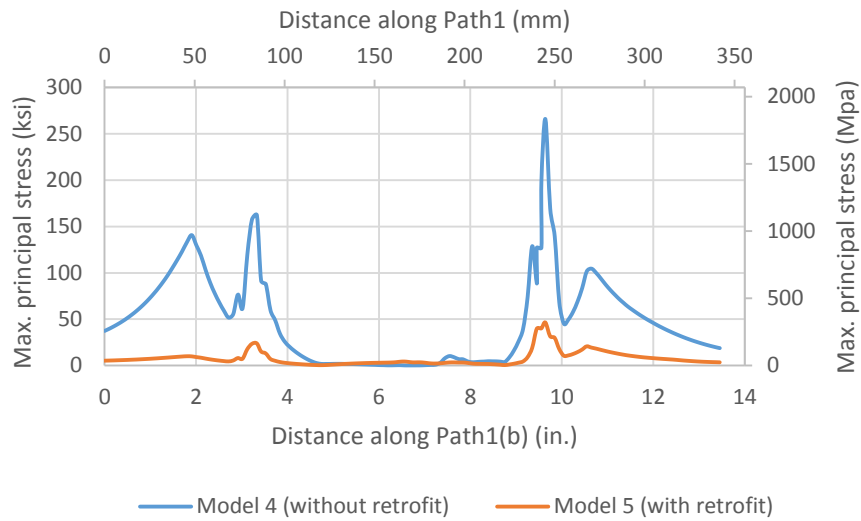
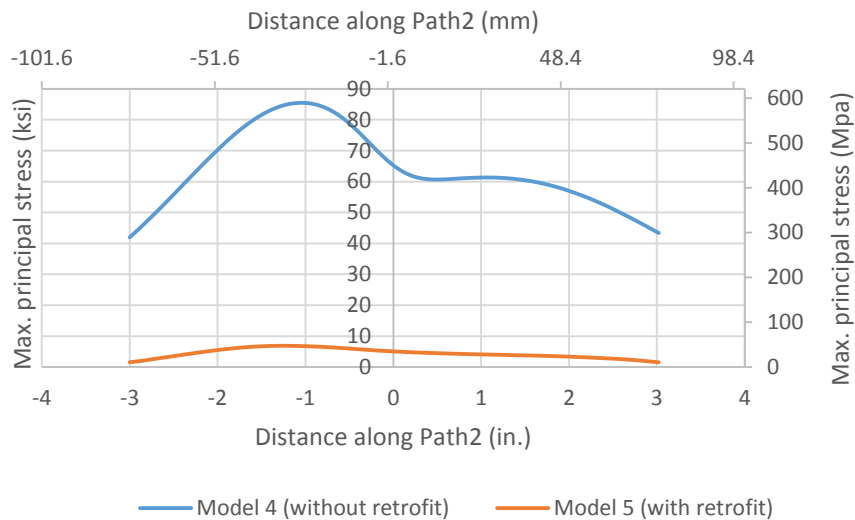
Peak stresses along Path 1(b) and Path 2 reduced 85% and 92%, respectively, after retrofitting.

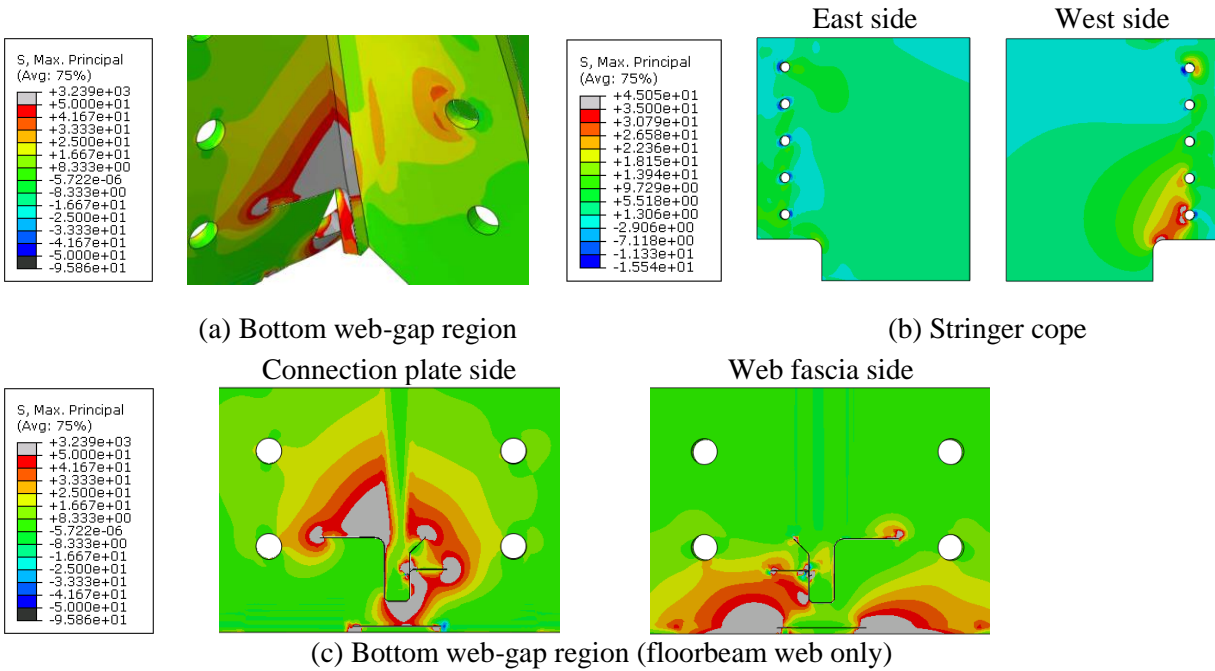
Figure 5-13: Simulation results for single-plate connection specimen FS1: Model 6

The cracks created within Model 6 simulated the actual cracks in the physical specimen at the end of Trial 5, as shown in Table 5-1. Compared with the previous models, an important difference in Model 6 is that a 2.7 in. crack was simulated as a through-thickness crack at the toe of the weld connecting the floorbeam web and the bottom flange.

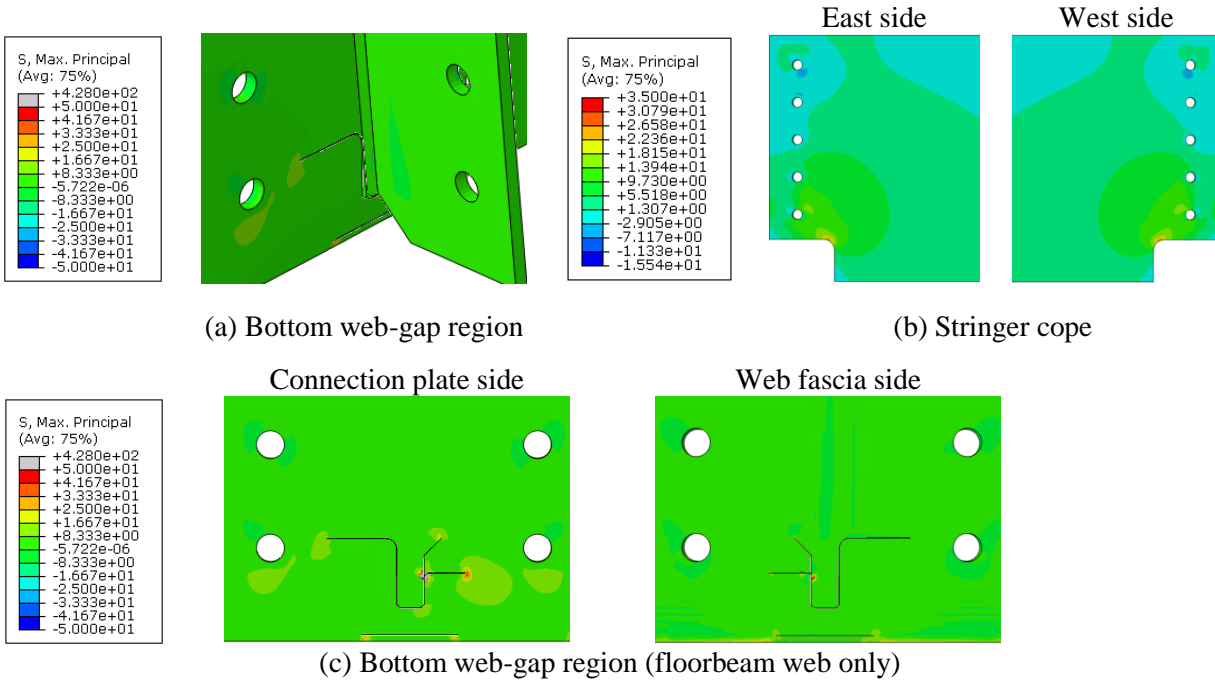
* The limits of the color bar in Model 7 were the same as in the Model 6
Figure 5-14: Simulation results for single-plate connection specimen FS1: Model 7

The angles-with-plate retrofit was simulated in Model 7, in which the crack geometries were the same as in Model 6. As shown in Figure 5-14, the stresses that were concentrated in the damaged regions in Model 6 were significantly less in Model 7.

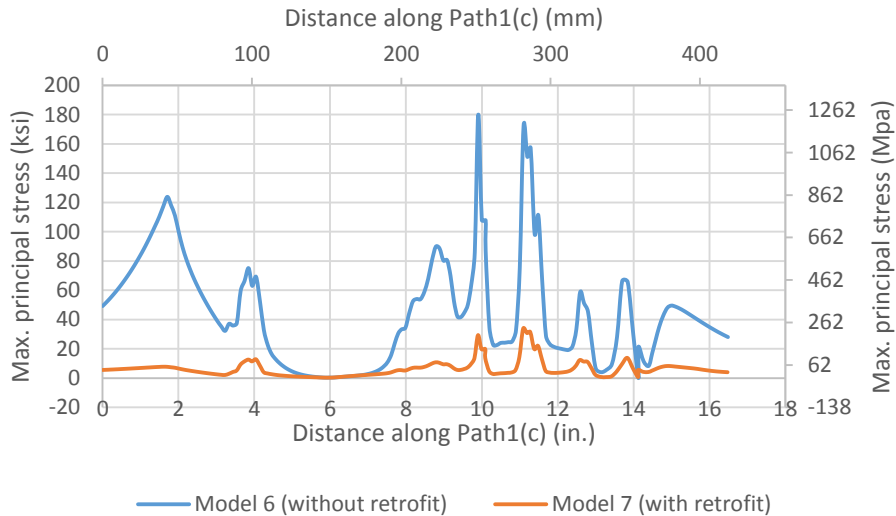
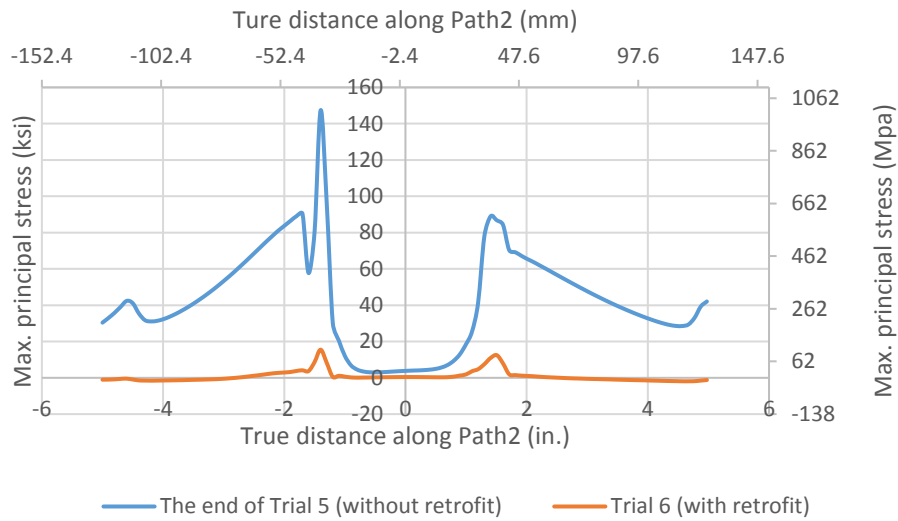
Figure 5-15 and 5-16 present the stresses along Path 1(c) and Path 2 for Model 6 and Model 7. The peak stresses along the two paths were reduced 81% and 90%, respectively, by the retrofit.

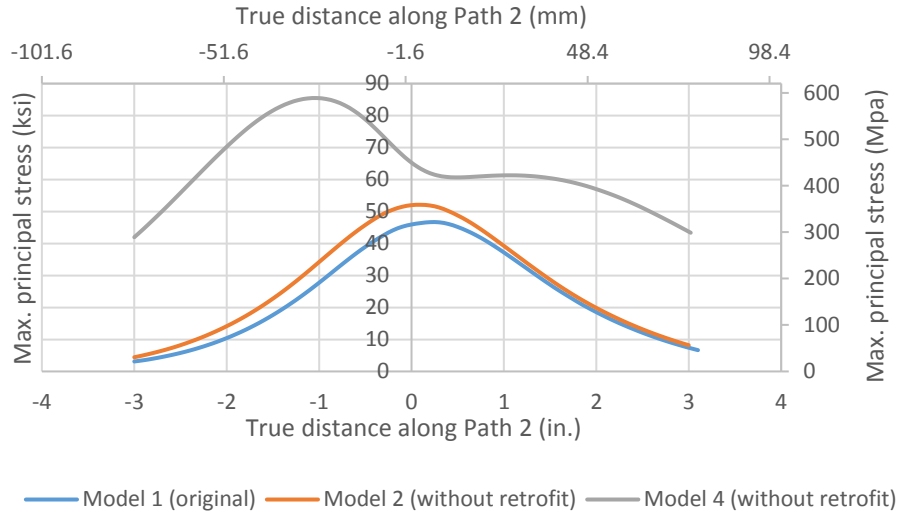
Figure 5-17: Comparison of stresses along Path 2 in Model 1, Model 2, and Model 4

It is worth mentioning that before the crack initiated at the weld connecting the floorbeam web and the bottom flange, the stresses along Path 2 increased as the cracks on the floorbeam web propagated, as shown in Figure 5-17. This may lead to, or at least speed up the cracking of the floorbeam web to bottom flange weld. As presented in Table 5-3, the angles-with-plate retrofit was found to reduce 67% of the peak stress along Path 2 in Model 2 and 92% in Model 4, indicating

that the retrofit is also useful for preventing initiation of the crack on the weld connecting the floorbeam web and the bottom flange.

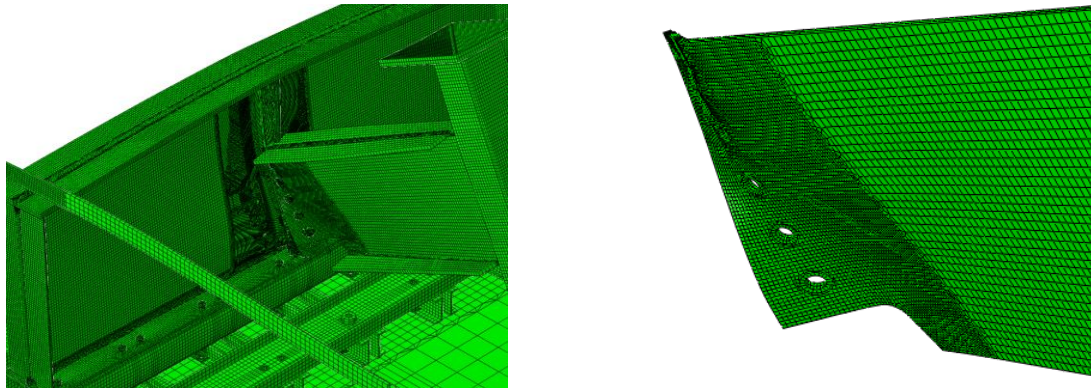
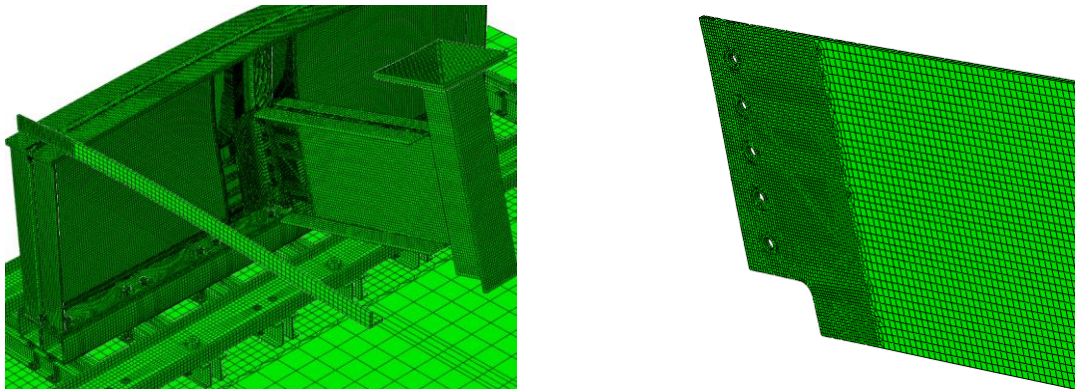
Figure 5-18: Deformation of the stringer web in single-plate connection models

As shown in Figure 5-18(a), the stringer web is subject to a twisting mode under the actuator load, due to the single-plate connection scheme. After retrofitting, the twisting was significantly reduced. This explained the change of the stresses around the stringer cope.

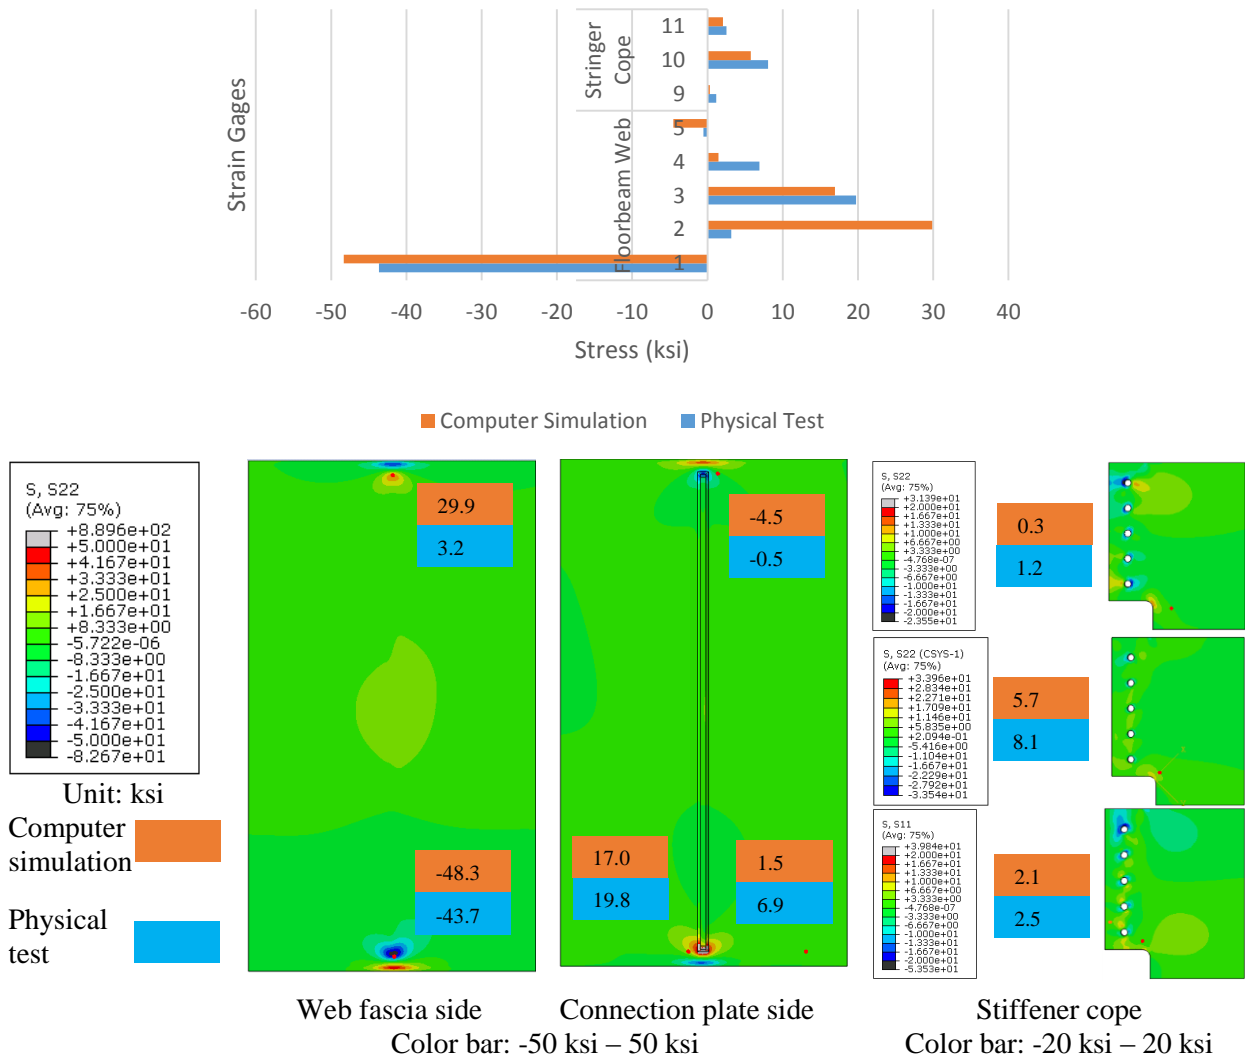
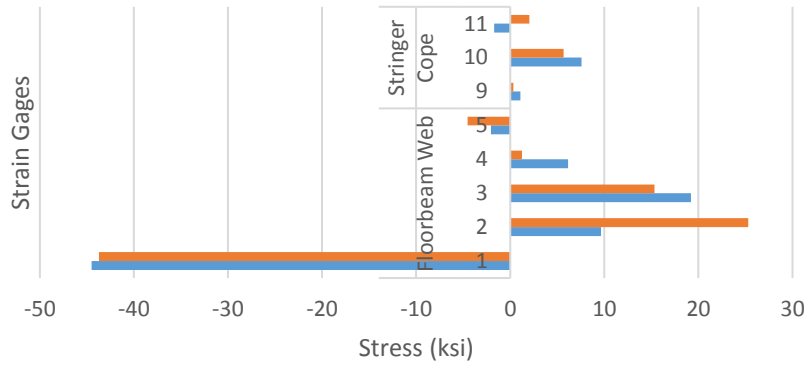
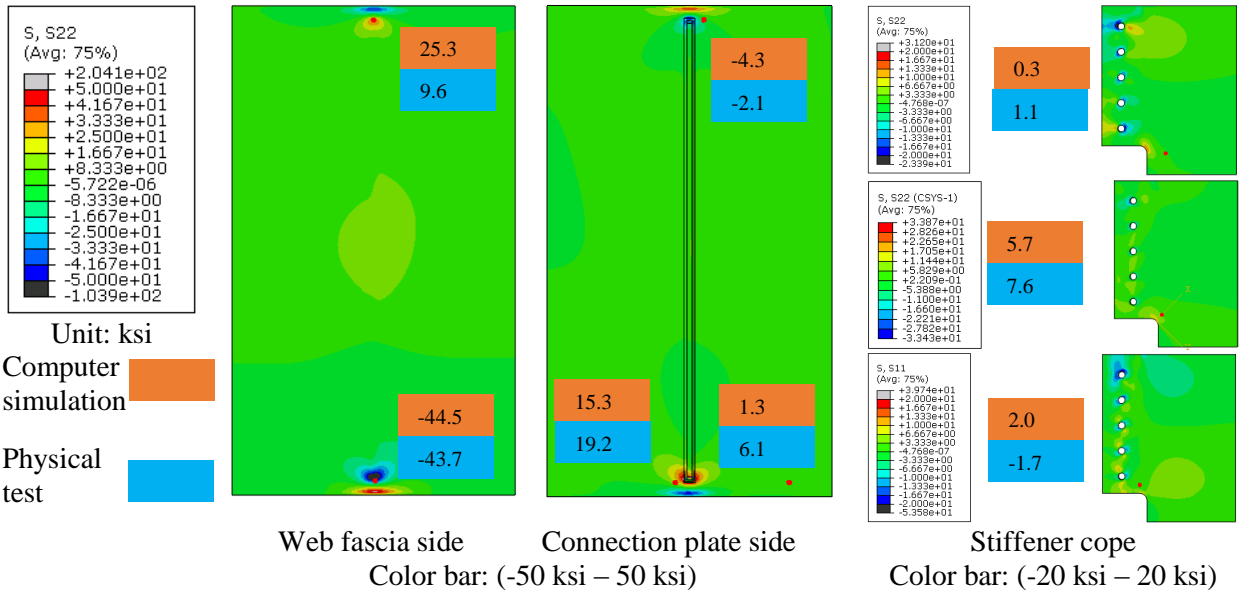
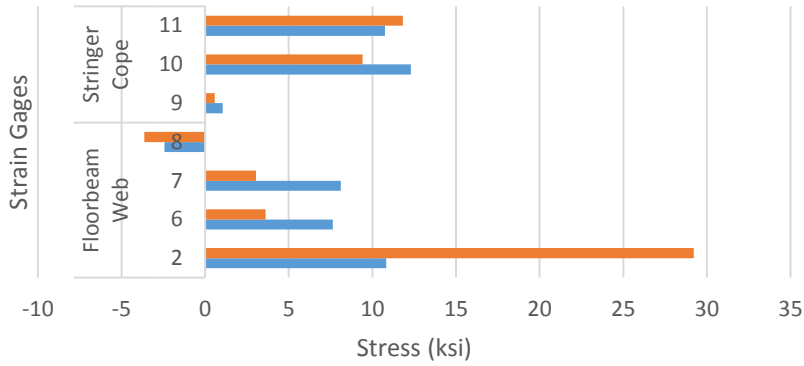
As presented in Figure 6-1 and Figure 6-2, the stresses at the bottom web-gap on the fascia side obtained from the computer simulations and the physical tests agreed well. However, the stresses in the upper web-gap region obtained from the computer simulations were much larger than those measured in the physical tests.

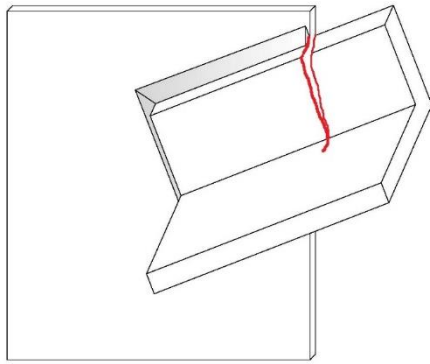
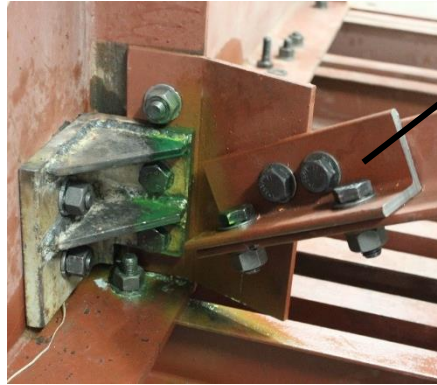
697,000 cycles into Trial 20-2, the actuator displacement interlock was triggered. After inspecting, a crack was observed at the junction of the cross-frame angle and the bottom gusset plate. As presented in Figure 3-2, when it was observed, the crack had already cut through the vertical leg of the angle. The exact time of the crack initiation was unknown. However, initiation occurred near this cycle count since the girder had been inspected just 22,000 cycles earlier and the crack was not observed. After the crack was detected, a steel angle was bolted as a retrofit on the damaged cross-frame, as shown in Figure 3-2. However, it was not able to provide enough stiffness and was not able to stop the crack growth. The crack cut through the remaining cross-frame angle in less than 100,000 cycles.

The angle bolted to repair the crack on the cross-frame

Figure 3-2: Crack on 20-degree skewed cross-frame 697,000 cycles into Trial 20-2 and the steel angle bolted to repair it

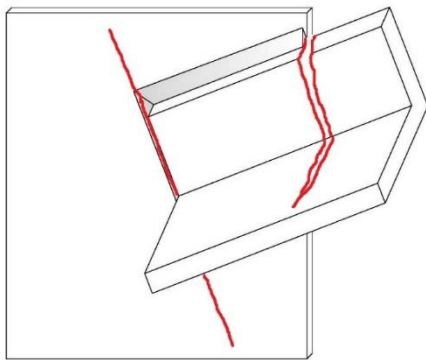
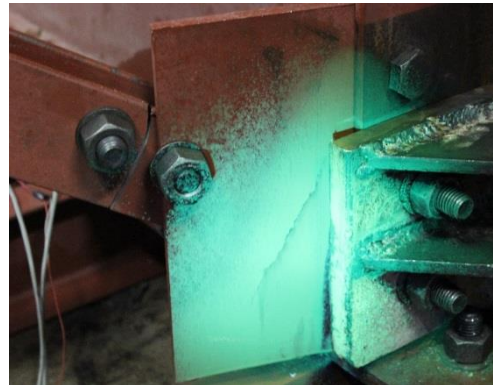
775,000 cycles into Trial 20-2, a large crack was observed on the bottom gusset plate of the cross-frame (Figure 3-3). It grew along the cross-frame angle-to-gusset plate weld.

Figure 3-3: Cracks on 20-degree skewed cross-frame 775,000 cycles into Trial 2

A plate was then attached to the cracked gusset plate so that test could continue. At 875,000 cycles into Trial 20-2, a bolt on the steel angle used to repair the crack on the cross-frame failed in shear, as shown in Figure 3-4. When it was noticed, the bolt had already failed entirely. The crack on the gusset plate continued growing and extended beyond the attached plate. The test continued after replacing the bolt and plate. However, after 22,000 cycles (897,000 cycles into Trial 2), the bolt failed at the same location.

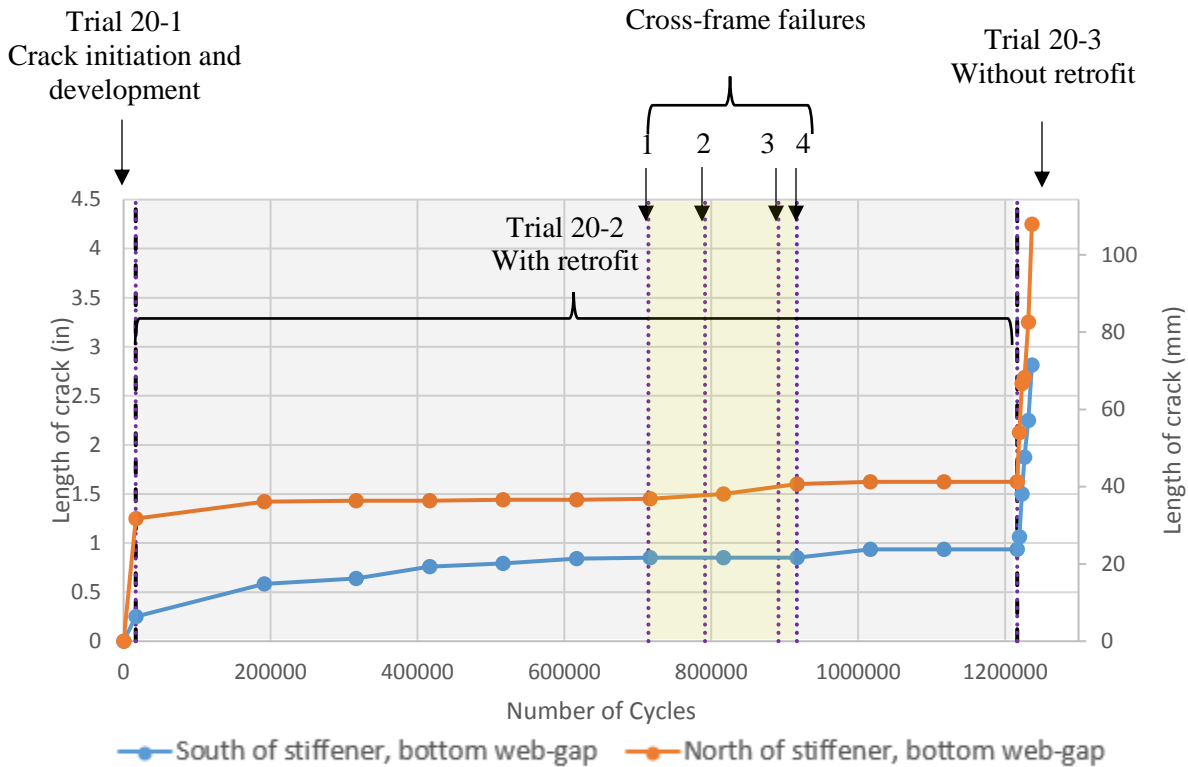
Figure 3-6 depicts the propagation of the bottom web-gap crack versus the number of applied cycles. In the retrofitted trial, the growth rates were extremely small compared with the rates in the unretrofitted trials. In the unretrofitted trials, the crack growth rates in the south bottom and north bottom web-gap regions were 58.2 and 106.2 in. per million cycles, respectively, while in the retrofitted trials, the crack growth rates were only 0.6 and 0.3 in. per one million cycles.

Figure 3-6: Crack propagation vs. number of applied cycles for 20-degree skewed specimen

Explained below, the notations 1, 2, 3, and 4 in Figure 3-6 correspond to the four failures of the cross-frame.

- 1: A crack was observed at the junction of the cross-frame angle and the bottom gusset plate. A steel angle was bolted on the cross-frame in attempting to repair the damage.
- 2: A large crack was observed on the gusset plate of the cross-frame along the weld connecting the cross-frame angle to the gusset plate. A plate was then bolted to the gusset plate to strengthen it.
- 3: The bolt used to repair the damaged cross-frame angle cracked by shear. The broken bolt was replaced with a new one.

4: The bolt used to repair the damaged cross-frame failed again. A decision was made to weld the cracks on the cross-frame as well as to bolt the angle and the plate. More bolts were added to strengthen the connection.

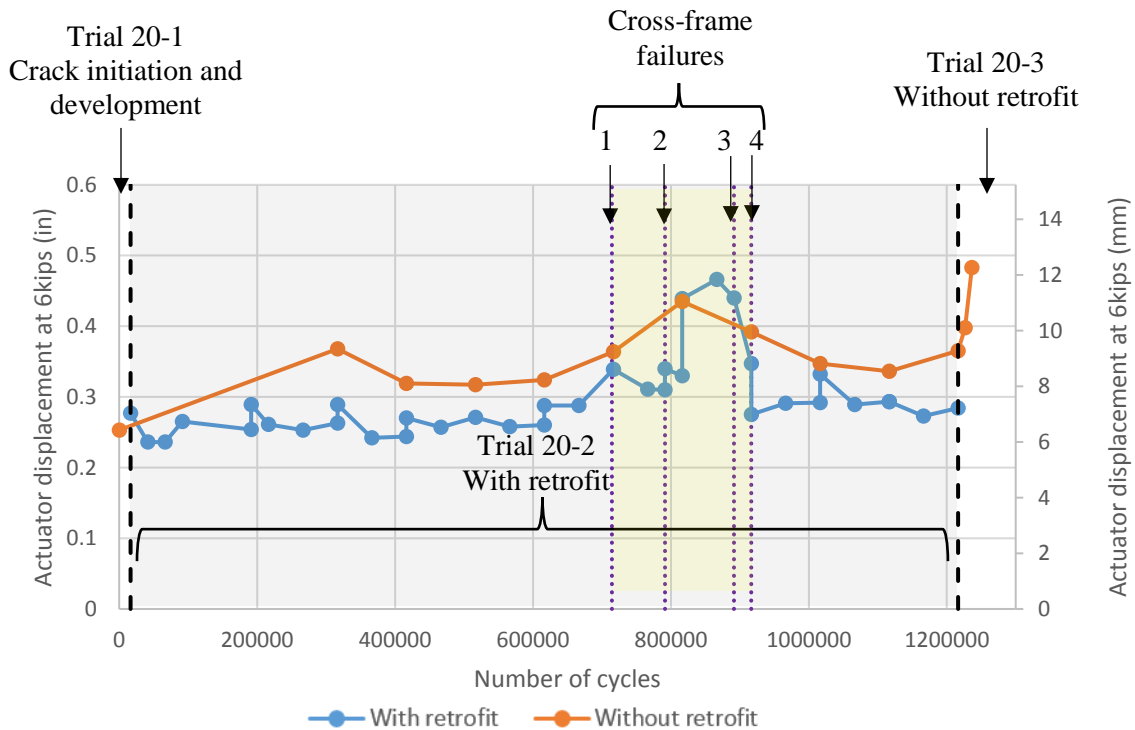
Figure 3-7: Actuator displacement at 6 kip of actuator force for the 20-degree skewed specimen

Ignoring the period in which the cross-frame was broken, the retrofit increased the connection stiffness approximately 26.4%, on average.

The actuator displacement increased and become abnormal during the period in which the cross-frame was broken. The angle and the plate bolted on the cross-frame was not able to provide enough stiffness, thus the behavior of the damaged cross-frame governed the actuator displacement. This phenomenon ended after the cracks on the cross-frame were welded.

In Trial 20-3, the growth of cracks in the web-gap region led to an increase in the actuator displacement. The connection stiffness decreased 24.8% over 20,000 cycles. Compared to the beginning of the test, the connection stiffness decreased approximately 47.6%.

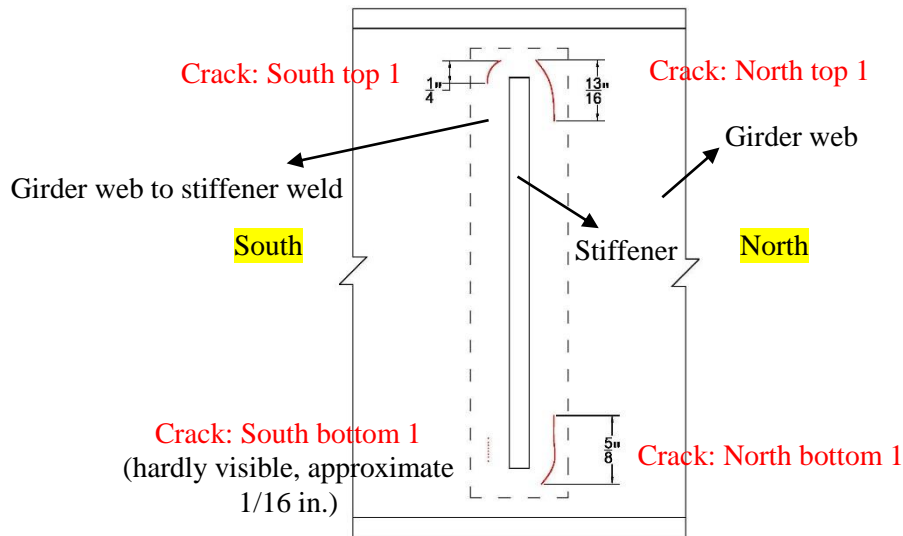
The angles-with-plate retrofits were installed in both the top and the bottom web-gap regions 313,000 cycles into Trial 40-1. Figure 5-1 presents a schematic drawing showing the crack lengths when the retrofits were installed.

Figure 5-1: Cracks present in 40-degree skewed specimen 313,000 cycles into Trial 40-1 (schematic)

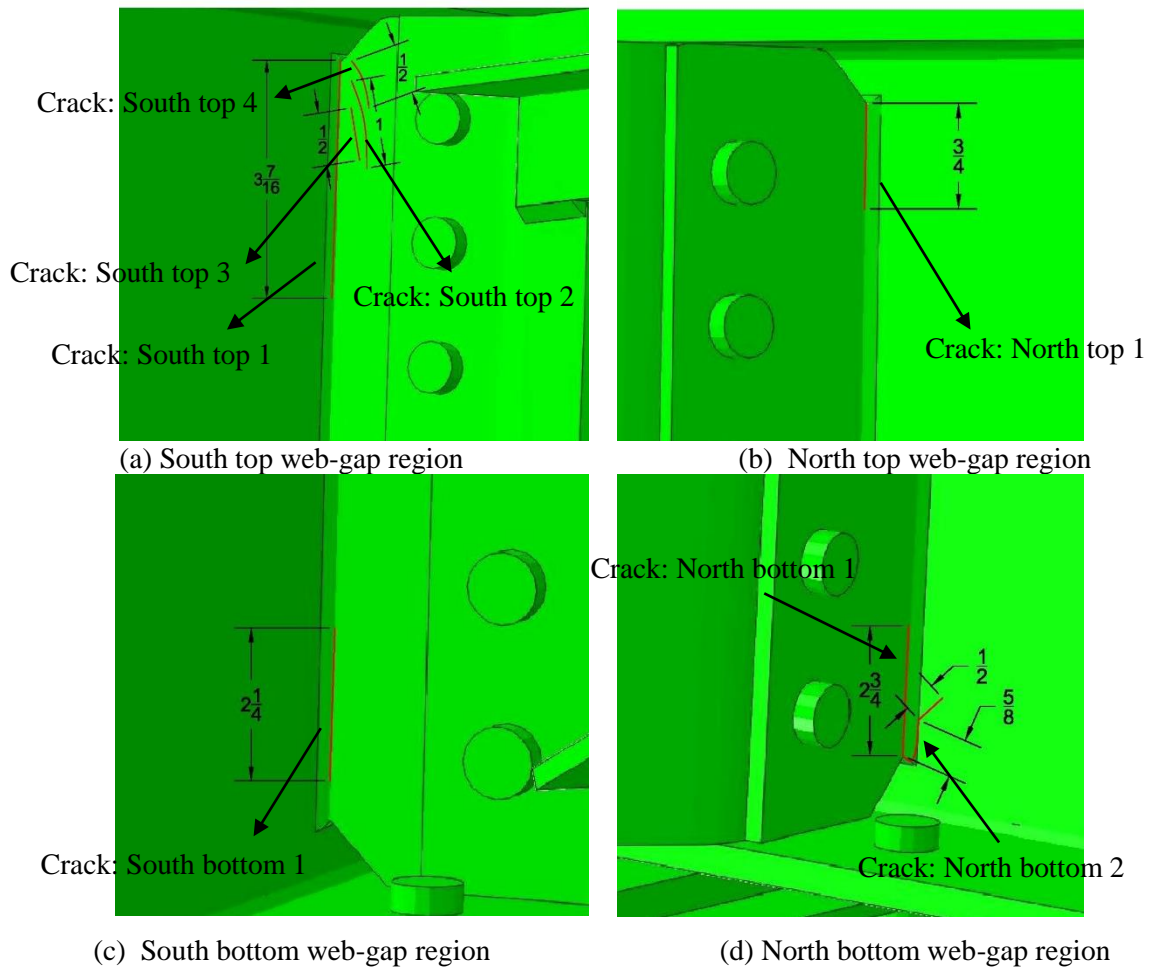
A $\frac{1}{4}$ in. crack (South top 2) was observed on the south side of the top portion of the stiffener 435,000 cycles into Trial 40-3. Most of the fatigue cracks reported in web-gap regions initiated at the end of the weld connecting the girder web and the stiffener, growing along the weld and then propagating into the girder web and growing horizontally. Cracking of the stiffener was an unexpected occurrence.

786,000 cycles into Trial 40-3, another $\frac{1}{16}$ in. crack (South top 3) was observed on the south side of the top part of the stiffener. After another 145,000 cycles, a new $\frac{3}{4}$ in. crack (South top 4) was observed in the same region.

931,000 cycles into Trial 40-3, a $\frac{1}{2}$ in. crack (North bottom 2) was detected at the north bottom end of the girder web to stiffener weld. The cracks propagated into the girder web 1,050,000 cycles into Trial 40-3. A schematic drawing showing the distribution of the cracks 1,150,000 cycles into Trial 40-3 is presented in Figure 5-2.

Figure 5-2: Cracks of 40-degree skewed specimen 1,150,000 cycles into Trial 40-3 (schematic drawing)

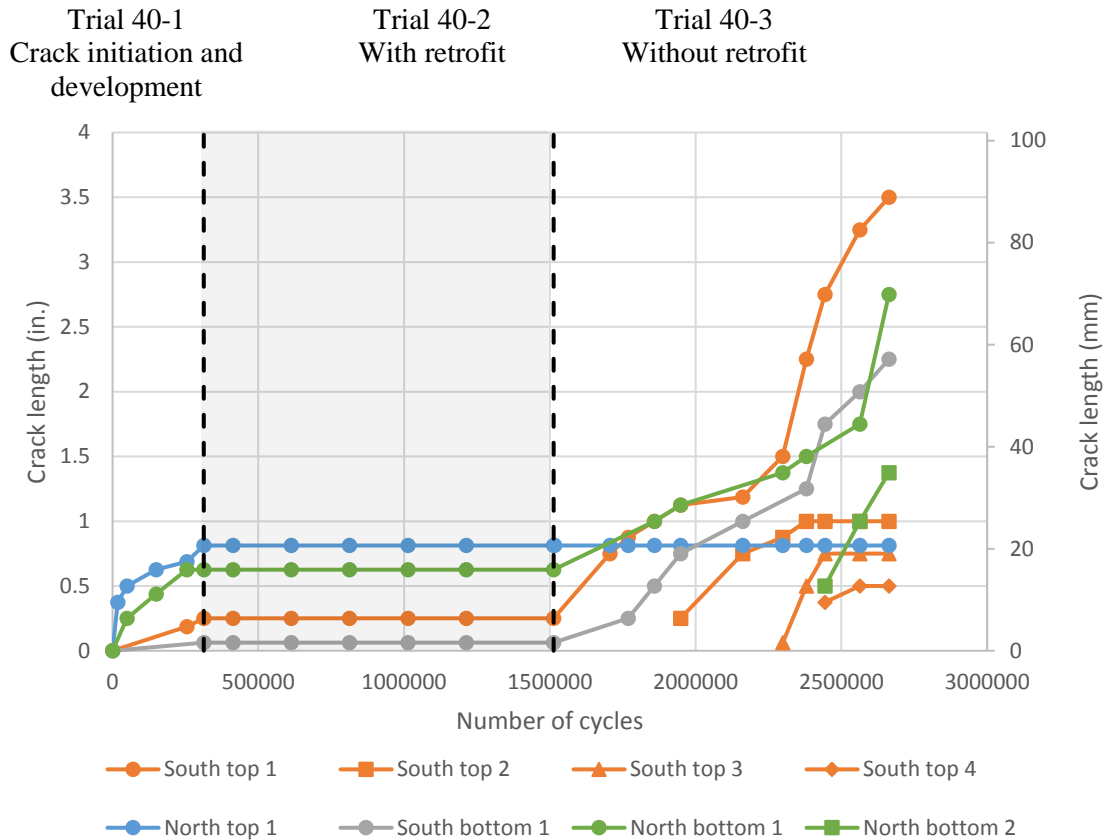
The cracks on the stiffener (Crack: South Top 2, 3, 4, as notated in Figure 5-2) were surface cracks and were very thin. As shown in Figure 5-4, which presents the crack initiation and propagation with respect to the number of applied cycles, propagation of the cracks on the stiffener (Crack: South Top 2, 3, 4, as notated in Figure 5-2) tended to pause after their initiation.

Figure 5-4: Crack propagation vs. number of applied cycles for 40-degree skewed specimen
