**APPLICATION OF ANGLES-WITH-PLATE RETROFIT IN REPAIRING
DISTORTION-INDUCED FATIGUE DAMAGES IN STRINGER TO FLOORBEAM
CONNECTIONS AND SKEWED GIRDER TO CROSS-FRAME CONNECTIONS**

Danqing Yu

Submitted to the graduate degree program in Civil, Architectural, and Environmental Engineering and the Graduate Faculty of the University of Kansas in partial fulfillment of the requirements for the degree of Master of Science.

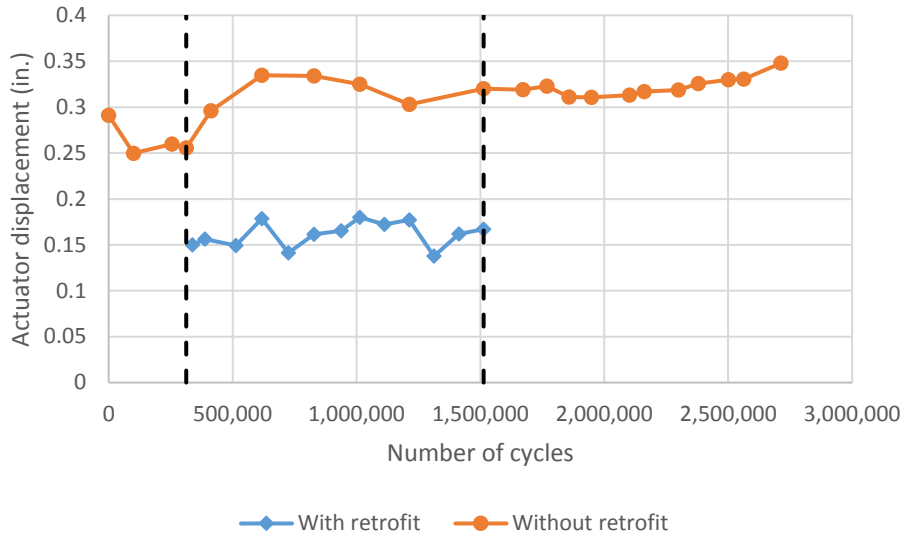
Figure 5-5 presents actuator displacement at 2.5 kip of actuator force with respect to the number of applied cycles. The angles-with-plate retrofits were installed on both the top and the bottom web-gap at the beginning of Trial 40-2. After installing the retrofit, the actuator displacement decreased about 50%. In Trial 40-3, the retrofits were removed, and cracks were allowed to propagate freely. At the end of the test, the connection stiffness had decreased approximately 20% as compared with the beginning of the test.

Figure 5-5: Actuator displacement vs. number of applied cycles at 2.5 kip of actuator force for the 40-degree skewed specimen
