The Collapse of the Alto Río Building during the 27 February 2010 Maule, Chile, Earthquake

Cheng Song,^{a)} Santiago Pujol,^{a)} M.EERI, and Andrés Lepage,^{b)} M.EERI

The Alto Río Building, a 15-story building located in Concepción, Chile, collapsed during the 2010 Maule earthquake. Construction of the building was completed in 2009 following the Chilean building code of 1996. The building was provided with reinforced concrete structural walls (occupying nearly 7% of the floor area) to resist lateral and vertical loads. The walls failed in the first story, causing the overturning of the entire building. This paper provides detailed field observations and discusses plausible causes of the collapse. [DOI: 10.1193/1.4000036]

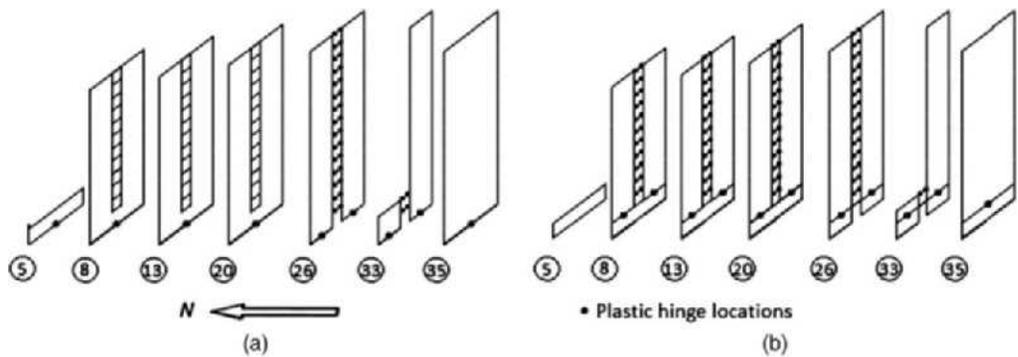
Figure 14. Limiting mechanisms (flanges not shown for clarity) used in analyses A through D (Table 4): (a) First-story failure mechanism; (b) second-story failure mechanism. Photo credit: E. Fierro and A. Iruretagoyena.

direction of load (Table 4). Limit analyses of the mechanisms with wall hinges in the second story produced base-shear coefficients ranging from 0.29 to 0.44 (Table 4). For all analysis groups and loading directions, independent from the assumptions made, analyses assuming the first story to be the critical story produced results that were consistently larger than the results from analyses assuming that the second story was the critical story. The ratio of the estimated strength of first-story collapse mechanisms to the estimated strength of second-story collapse mechanisms ranges from 1.12 to 1.39.

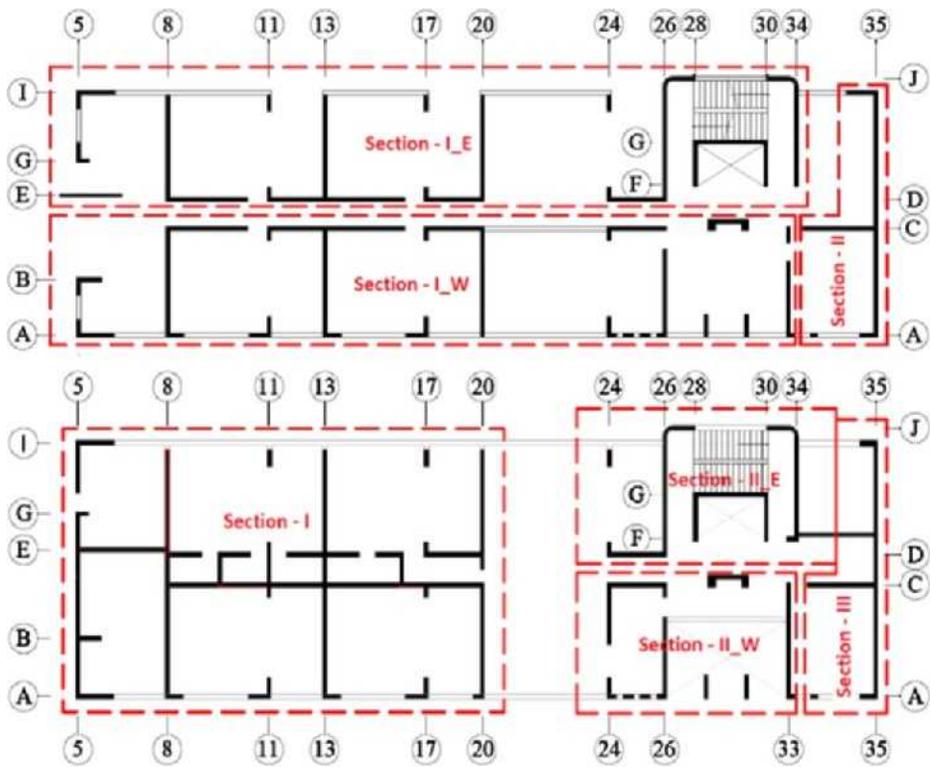
Figure 15. Sections used in analyses A through D (Table 4). Second story is shown above and first story is shown below. Photo credit: E. Fierro and A. Iruretagoyena.

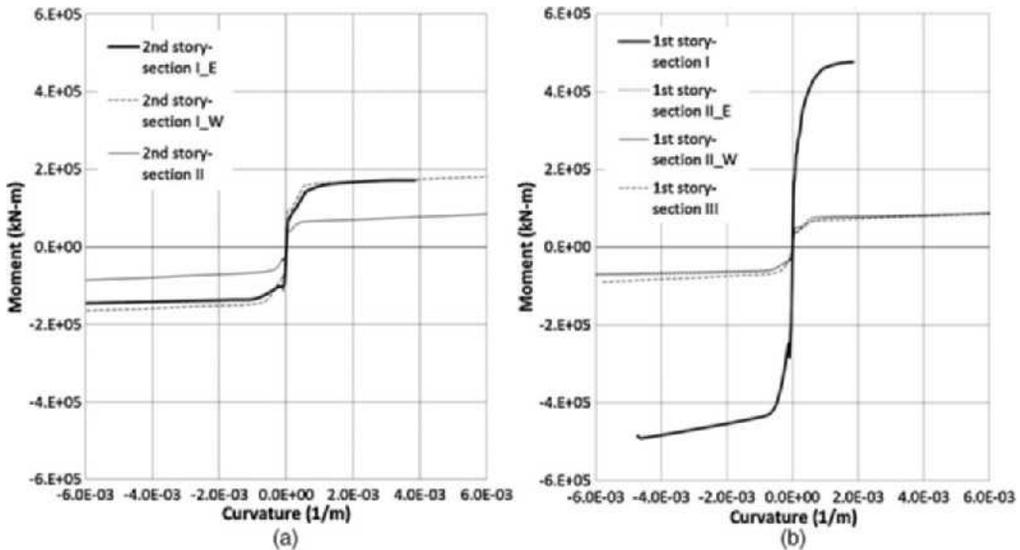
Representative moment-curvature relationships computed for analysis group A are shown in Figure 16. These relationships suggest that the sections considered could reach yielding before limiting concrete strains would develop.

Figure 16. Moment-curvature diagrams for cross sections in Figure 15 (positive moment corresponds to eastward forces): (a) Second-story walls; (b) first-story walls.

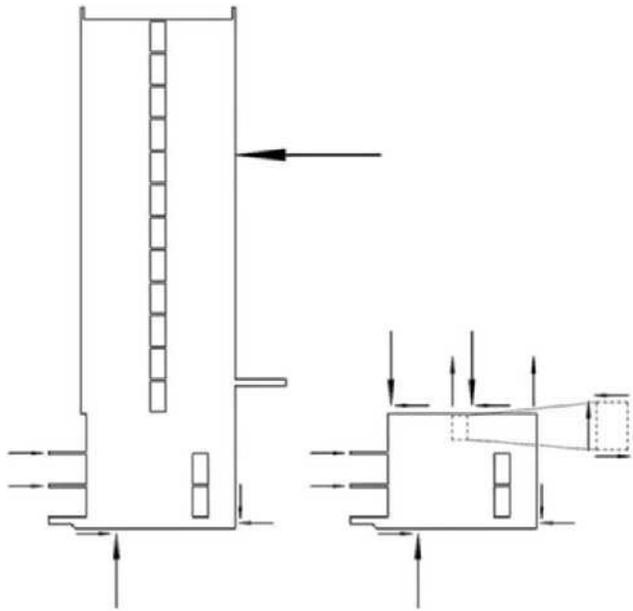
Moehle et al. (2011) have stated that very large shear forces can develop in “solid walls below or above a row of openings.” This statement points directly at the boxed region in Figure 17. This figure shows the forces applied by upper walls (separated by a stack of openings) to a continuous or solid wall at the base. The wall panel directly below the openings is expected to resist fractions of the vertical forces applied by wall boundaries working in tension and compression next to the openings above. These force fractions have opposite sense and result in shear distortion of the wall segment under the openings.

Figure 17. Idealized forces near the base of the wall along axis 13. (Note: the horizontal force at the top of the panel under high shear is assigned to the slab.)

evaluate the strength of a panel under the loading and boundary conditions described. If the wall panels below openings did fail in shear, the first story would cease to be stronger than the second story (as suggested by the simplified analyses presented in the previous section), and the critical section (for flexure) would move to the base of the first story.

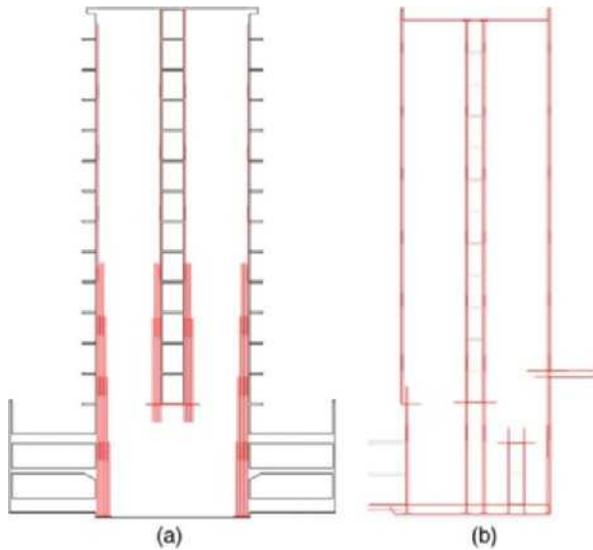
Damage in wall segments located under a “row” or stack of openings was observed in at least two other buildings surveyed after the 2010 Maule Earthquake: Centro Mayor, in Concepción (see Figure 18); and Torre Mayor, in Chillán. In both of these buildings, the boundary reinforcement next to the openings was anchored in the solid wall below the stories with openings (Figure 19). In Alto Río, all boundary reinforcement was anchored into the foundation (two stories below grade; Figure 19). Alto Río also had walls perpendicular to the panel presumed to have failed in shear (along axes C and D). The consequences of these differences deserve careful study. The task is not simple because we have found no experimental data to

Figure 19. Distribution of wall boundary reinforcement: (a) Centro Mayor Building; (b) Alto Río Building.

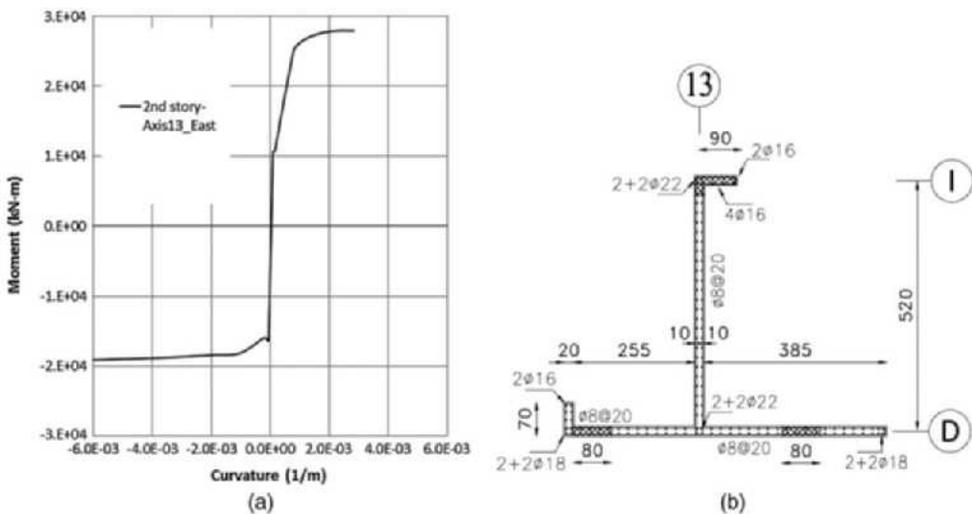
Figure 20 shows a moment-curvature relationship computed for a section at the base of the second floor. The computed yield ($\varphi_y = 0.001$ 1/m) and limit curvatures ($\varphi_u = 0.003$ 1/m) are sufficient to justify a rotational capacity of at least 1% on the basis of conventional assumptions (Wallace and Moehle 1992):

But the applicability of the method used to arrive at this estimate may be questioned given the limited information available on the capacity of the method to reproduce experimental results and given the presence of discontinuities along axis I. The following discontinuities have received much attention (IDIEM 2010):

Figure 20. Wall along Axis 13, base of second story: (a) Computed moment-curvature relationship; (b) cross section (dimensions in cm). Notes: Shaded areas were ignored because they were unsupported; positive values correspond to eastward forces; assumed axial load equal to approximately 5% of the product of concrete strength times gross area (all other required assumptions described in section on limiting flexural strength).

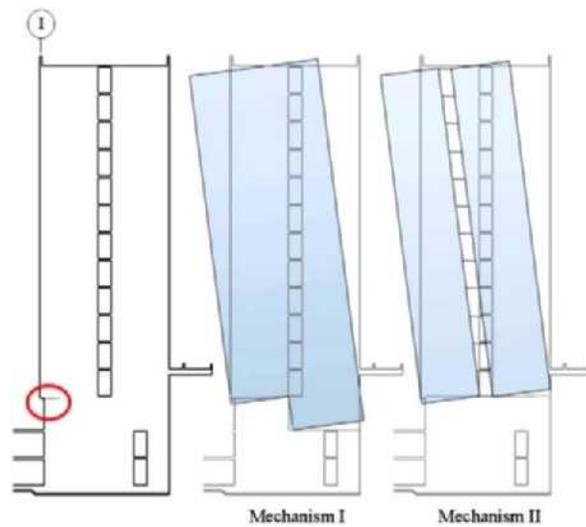
It has been suggested (IDIEM 2010) that the discontinuities along axis I and the re-entrant corners and flange cutoffs in walls along axes 8, 13, and 20 caused failure in compression of wall sections near the top of the first story on the east side of the building (Figure 22). This plausible failure is more likely to have led to collapse mechanism II than collapse mechanism I because mechanism II is weaker. But field evidence indicates that mechanism II did not occur. Mechanism I could have governed if the wall segments under hallways were damaged by shear and/or the bases of the first-story walls on the west side of the building were weakened in tension by splice failures at the bottom of the first story.

Figure 22. Idealized failure mechanisms associated with a presumed failure caused by geometric discontinuities along axis I.

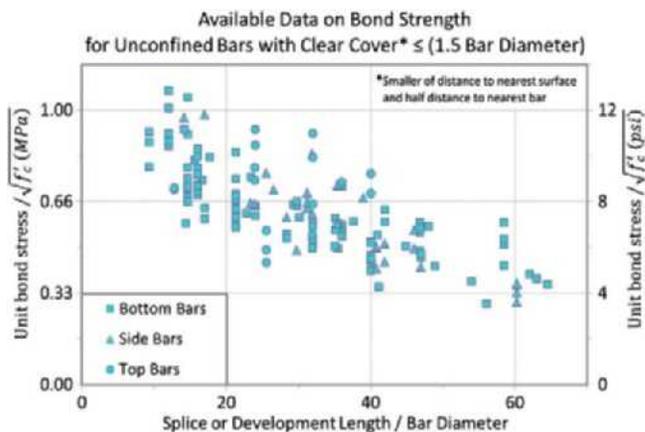
Figure 24 shows that, for splices with *more than* 40 bar diameters in length and no more than 1.5 bar diameters in clear cover (or 3 bar diameters in clear spacing), and considering the scatter in the data, it is possible to find cases in which the static bond strength—for monotonic loads—is *less than* $(^{1/3}) \sqrt{f'_c}$ in MPa ($4\sqrt{f'_c}$ in psi).

Figure 24. Monotonic, static bond strength of unconfined deformed bars with relatively small cover (data reported by ACI 408 2001 and [Seliem et al. 2009](#)).

This estimate and the data in Figure 24 suggest that the hypothesis that bond failure took place in lap splices is plausible. The measurements in Figure 24 were obtained in static and monotonic tests. In Alto Río, the bars resisted dynamic load reversals.

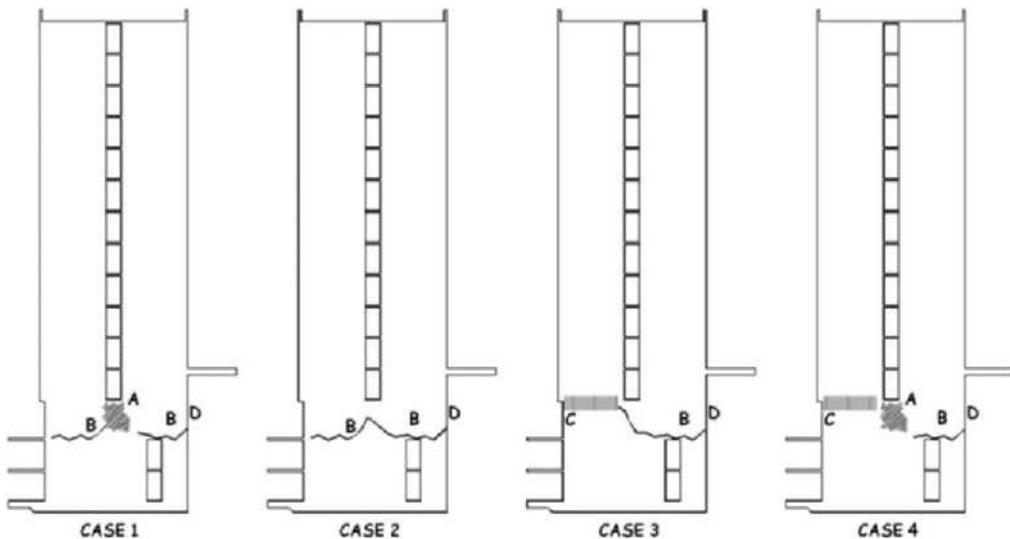
In the preceding sections four types of local failure that may have led to collapse described: (A) shear failure of the wall panels under stacks of wall openings (hatched area in Figure 25); (B) fracture of bars at sections with low reinforcement ratios (marked by zig-zag lines in Figure 25); (C) stress concentration at re-entrant corners and flange cutoffs in walls (dotted areas in Figure 25), and (D) failure of unconfined lap splices. None of these local failures explains by itself the collapse and the state of the structure after the collapse. Four combinations of failure types A through D are listed in Table 7. It is plausible that any of these combinations may have led to the collapse and the state of the structure after the collapse. At this point the evidence is not sufficient to pick one combination with confidence. But the field evidence does show two clear facts: on the west side of the building the failure surface was close to the base of first-story walls and all the vertical reinforcement on that side of the building failed in tension (failure cause B) or bond (failure cause D).

Figure 25. Combinations of local failures that may have led to collapse.

Case	Failure Cause				Comments
	A	B	C	D	
	Shear	Fracture	Compression	Splices	
1					Destruction of the hatched region A in Figure 25 could be followed by fracture of the reinforcement (B) and/or the failure of the splices (D) leading to collapse. This combination would require severe distortion of the slabs connecting the walls above the second story. The state of the north facade in Figure 4 does not indicate that such distortion occurred.
2					This combination (bar fracture and splice failure) would explain the overturning of the building and its state after collapse. An argument against it is that other buildings with similar amounts of vertical reinforcement and unconfined splices did not fail.
3					Compressive failure of the dotted region C in Figure 25 may have been followed by failures B and D as the building pivoted about NS walls (Figure 2). In buildings with similar structural layouts in Viña del Mar (Toledo building) and Santiago (Emerald building), compression failures in the stems of T-shaped walls and splice failures on stems of T-shaped walls on the opposite side the building were observed.

4					Destruction of the hatched region A in Figure 25 could be followed by compression failure C. Failures B and D could then lead to collapse. This combination would require severe distortion of the slabs connecting the walls above the second story. The state of the north facade in Figure 4 does not indicate that such distortion occurred.
