**POST RETROFIT ANALYSIS OF THE  
TUTTLE CREEK BRIDGE  
Br. No. 16-81-2.24**

**THE KANSAS DEPARTMENT OF TRANSPORTATION  
KDOT PROJECT NUMBER: KTRAN, KU-04-5**

**Structural Engineering and Engineering Materials  
SM Report No. 88  
January 2007**

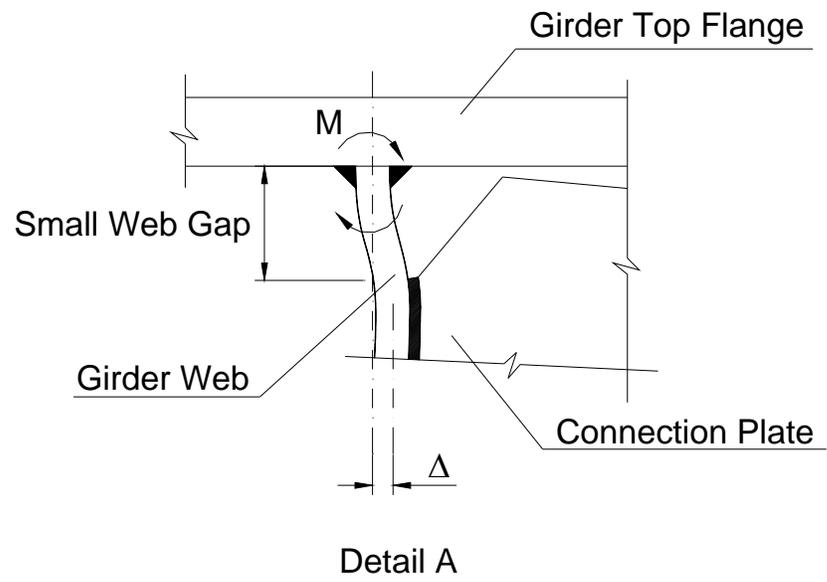
**Figure 2-1: Web-Gap Region**

The web gap region consisted of a 1"x 1" diagonal cut removed from the top and bottom of the stiffener as shown in Figures 2-1 and 2-2. This cut allowed the fillet weld between the web and flange to be continuous. This gap creates high stress concentrations in the web and creates the potential for fatigue cracks to propagate in this area. Two types of cracks that occurred in the upper web-gap region were designated as either weld tears or horizontal cracks. Figure 2-3 shows the two types of cracks, and Figure 2-4 presents a photograph of actual cracks.

The primary source of fatigue cracking in the Tuttle Creek Bridge was the lack of attachment between the top of the stiffener and the tension flange. The web-gap cracking was the result of differential deflection of the girders. Braces in the diaphragms created a tension force on the stiffener due to the difference in deflections between the two girders. This caused the web-gap to undergo double-curvature bending. Figure 2-5 shows the tension force created by the diaphragms. This type of detail is classified as a category C fatigue detail according to the 2004 AASHTO LFRD specifications.

A previous repair of the web-gap region was implemented in 1986. To repair the weld tears, the joint was “softened” by cutting the stiffeners 1 in. below the termination of the existing cracks. A 0.5-in. radius was placed at the end of the cut. Even though this was supposed to have repaired the problem, weld tears continued to

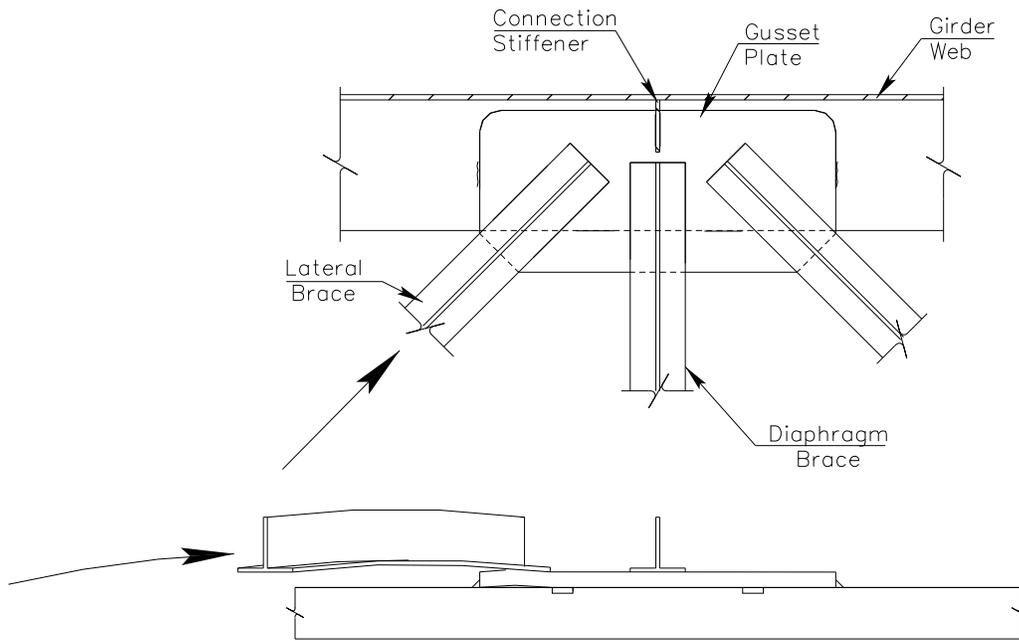
**Figure 2-9: Gusset Plate Cracking Source (Distortion of Lateral Brace)**

The source of the gusset plate cracks was not clearly defined. One theory was that cracks developed from the bending stress of the girder (Figure 2-8). Another possibility considered was that distortion of the girder caused high compressive stresses in the diagonal bracing. The lateral bracing could potentially buckle upward along its weak axis introducing a prying action on the gusset plate (Figure 2-9). Another theory considered racking of the gusset plate due to loads from the diagonal bracing. Twisting of the gusset plate would cause cracking to develop at the ends of the fillet weld (Figure 2-10). To help clarify this issue, strain gages were placed on the top and the bottom of the plate as shown in Figure 2-11.

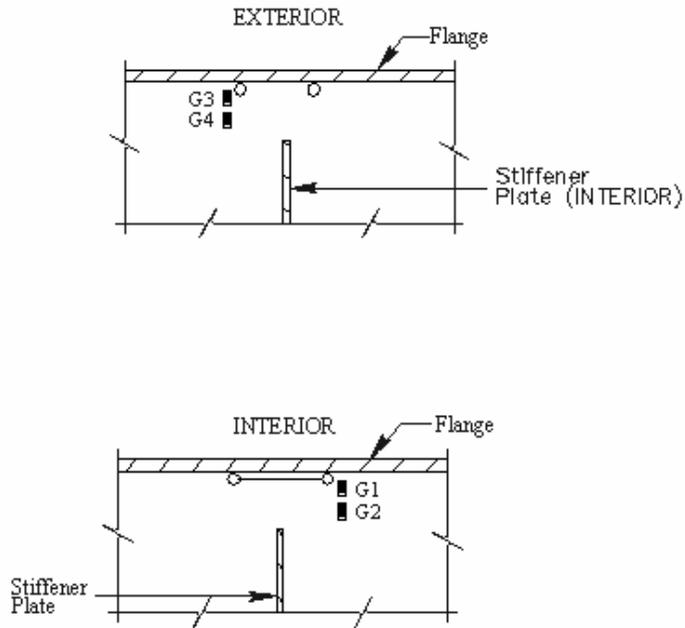
**Figure 5-1: Upper Web Gap Gages**

For the upper web-gap extrapolated values with the truck moving westbound, the average maximum stress was reduced from 35.4 ksi to 9.3 ksi. For the truck moving eastbound, the maximum average stress value changed from 12.6 ksi to 6.7 ksi. These values show a significant decrease in stress at the critical point where a crack might form in the upper web gap region. In the lower web gap region, the absolute value of the stress was reduced, but the margin was not as pronounced as in the upper web-gap region.

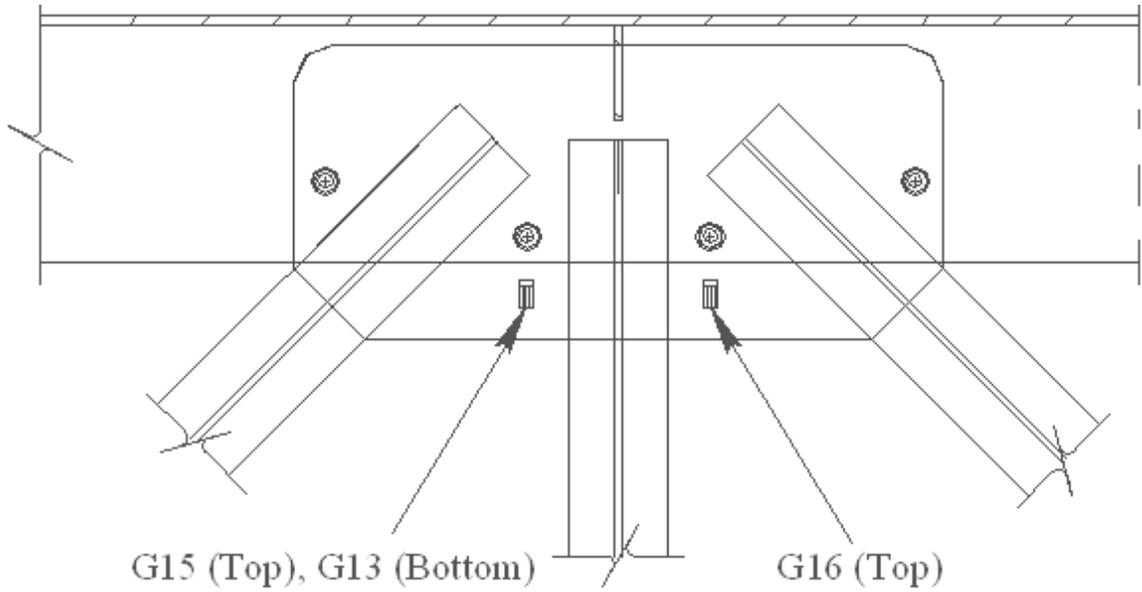
**Figure 6-4: Location of Relocated Gages**

The exact cause of cracking in the gusset plate was unknown after the first field investigation. In order to help determine why the cracking was occurring, three gages were moved to new locations on the gusset plate. Gage 13 was placed on the bottom side of the gusset plate with gage 15 placed directly above it on the top side. Gage 16 was placed in a similar location as gage 15 on the opposite side of the center brace. The locations are shown in Figure 6-4.

The stress over time for these gages is shown in Figures D-1 through D-11. The majority of the data supports the theory that there is bending force acting on the gusset plate during loading. This is illustrated when gage 13 experiences a stress that is opposite of the stress in gage 15. Gage 16 is also provided as a reference but is not directly related to the position of gage 13. Due to the majority of the tests exhibiting this relationship, prying action is occurring in the plate and is contributing to the formation of cracks.

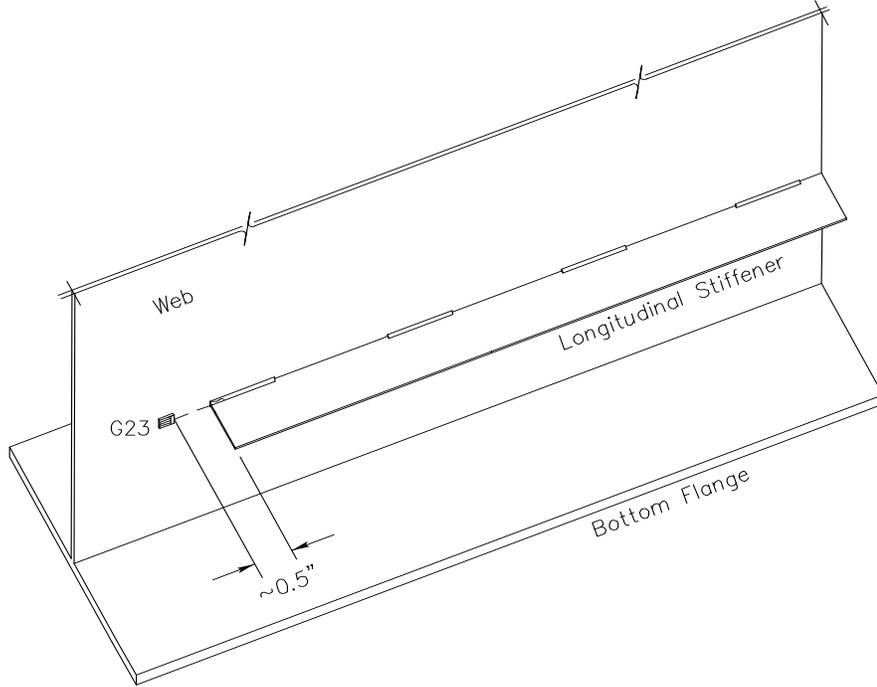
**Figure 7-2: Longitudinal Stiffener Gage Location**

As in the pre-retrofit test, only the effect of the tapering repair was investigated. A single gage was placed at the same location as in the pre-retrofit test. The gage was located closest to Span 29. The placement is shown in Figure 7-2.

Two repairs were performed on the longitudinal stiffener. First, cracks in the butt welds of the stiffener were repaired. This was accomplished by grinding off the butt welds and re-welding them. Second, the end of the longitudinal stiffener was tapered to reduce the stress concentration because the termination point of the stiffener is classified as a category E detail according to the 2004 AASHTO LRFD specifications. This repair was used as a preventative measure, and the second repair is shown in Figure 7-1.

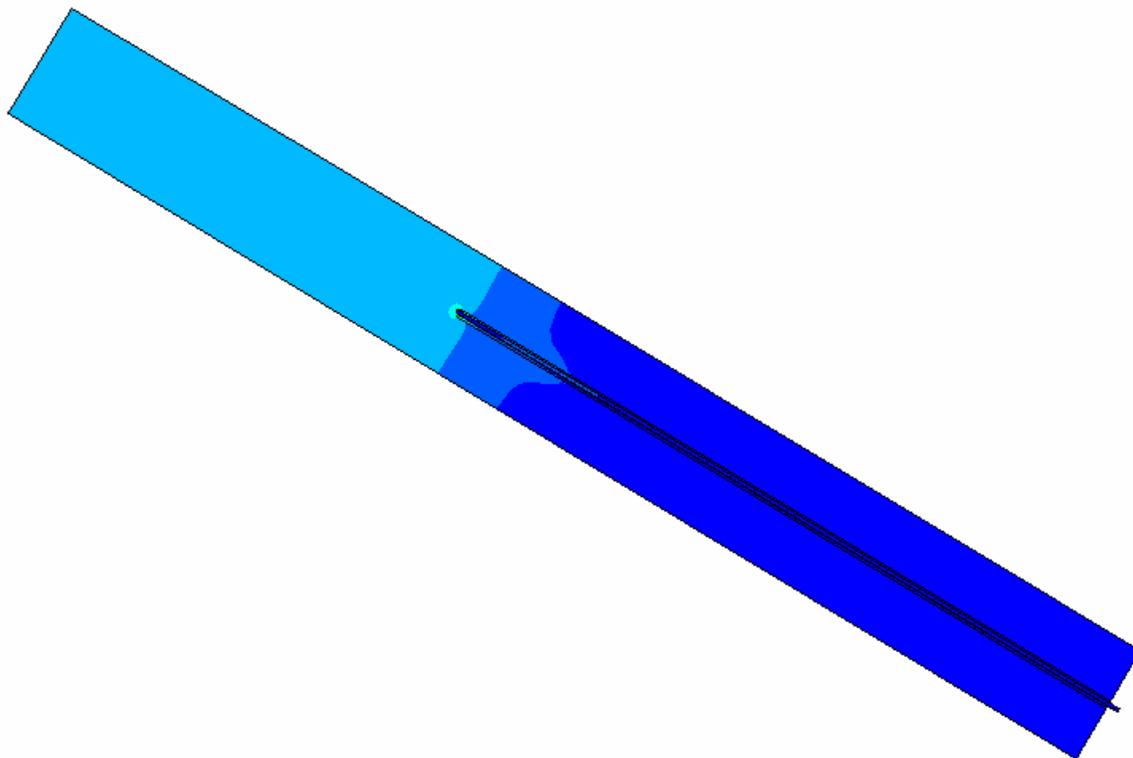
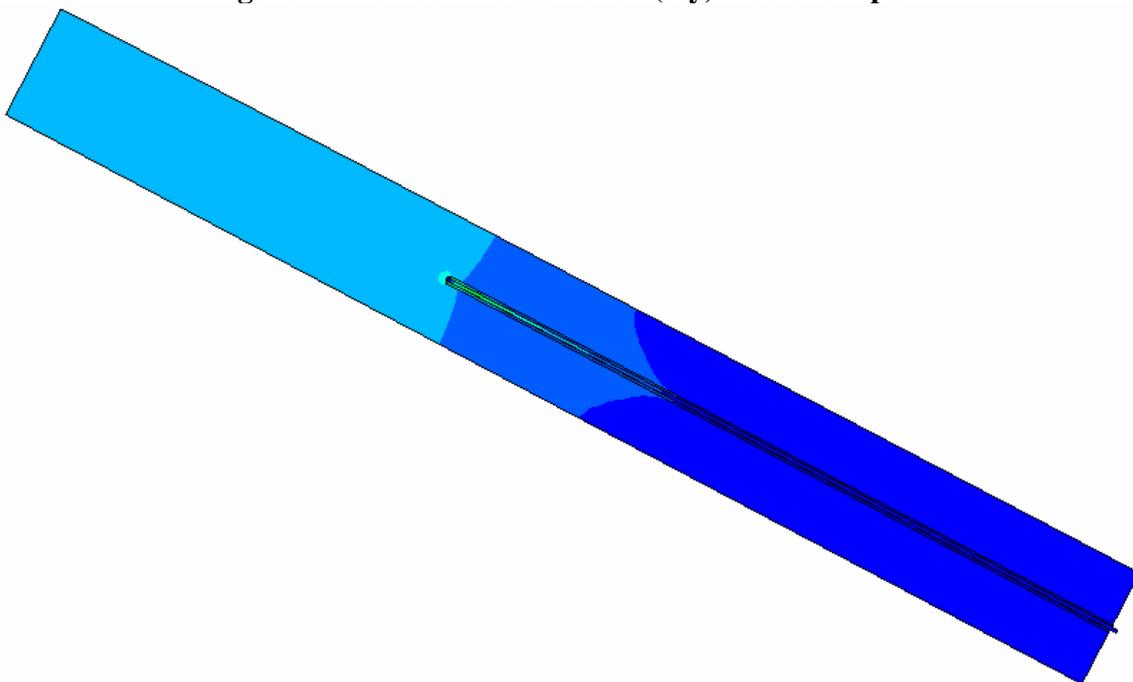
**Figure 12 - Girder web/stiffener (x-y) – before repair.**

**Figure 13 - Girder web/stiffener (x-y) – after repair.**

Figures 12 and 13 show that reduction in the stresses along the girder web caused by the repair was not significant. Although stress concentrations were localized at the tip of the stiffener in both cases, the maximum stress decreased after the repair.

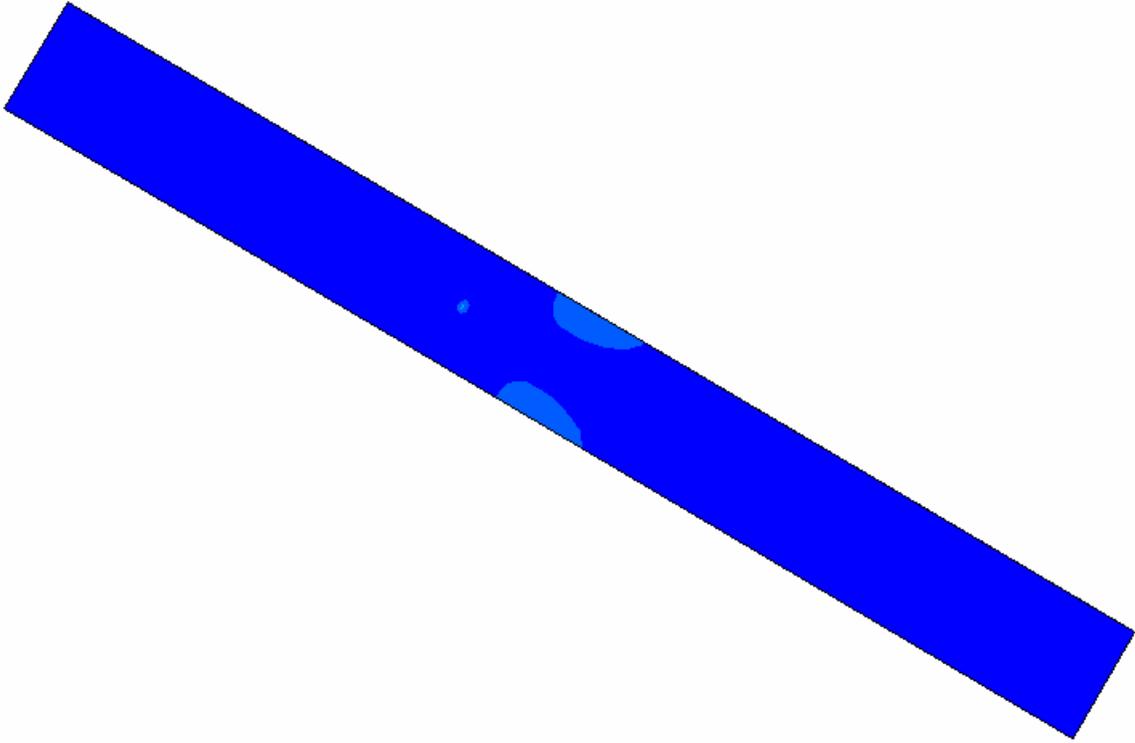
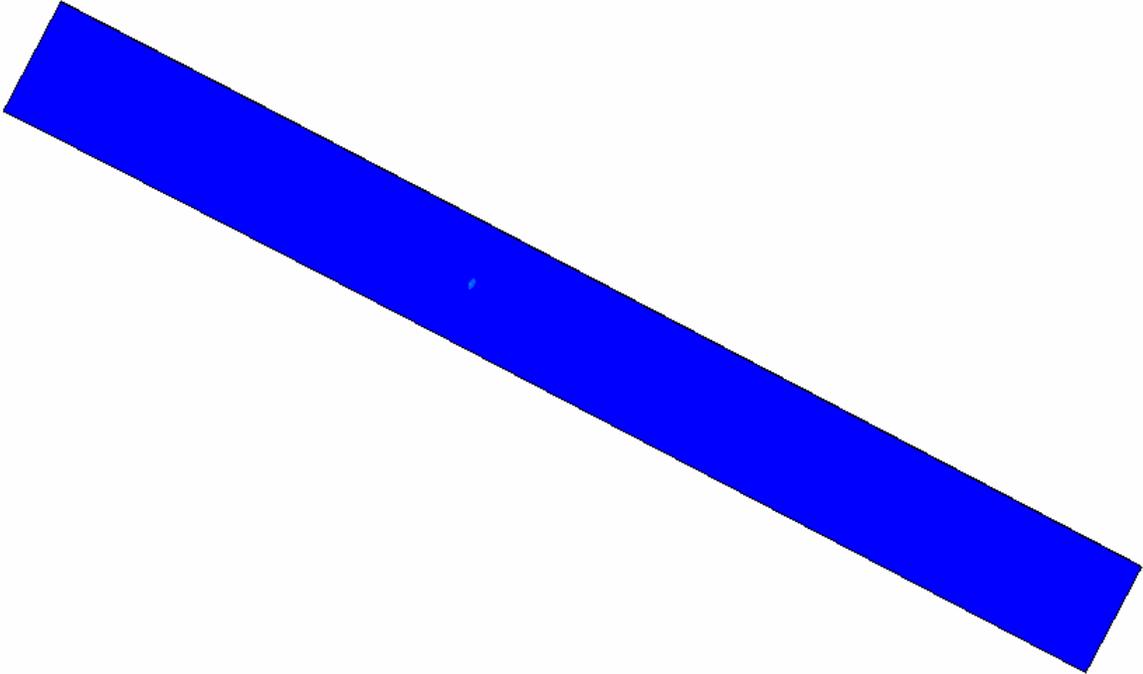
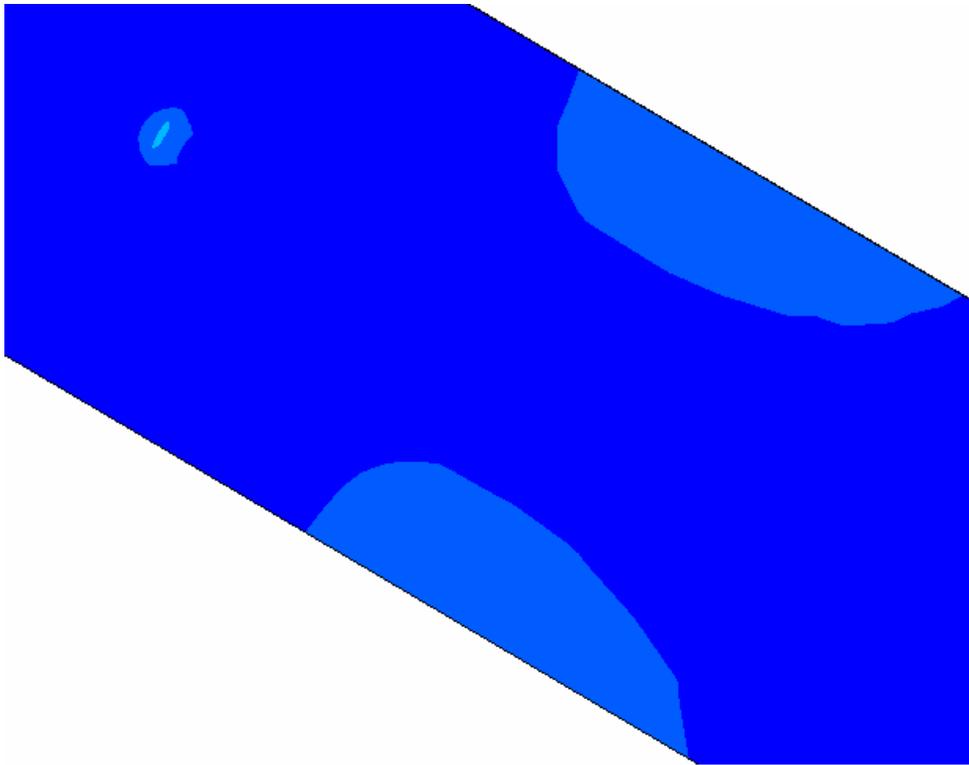
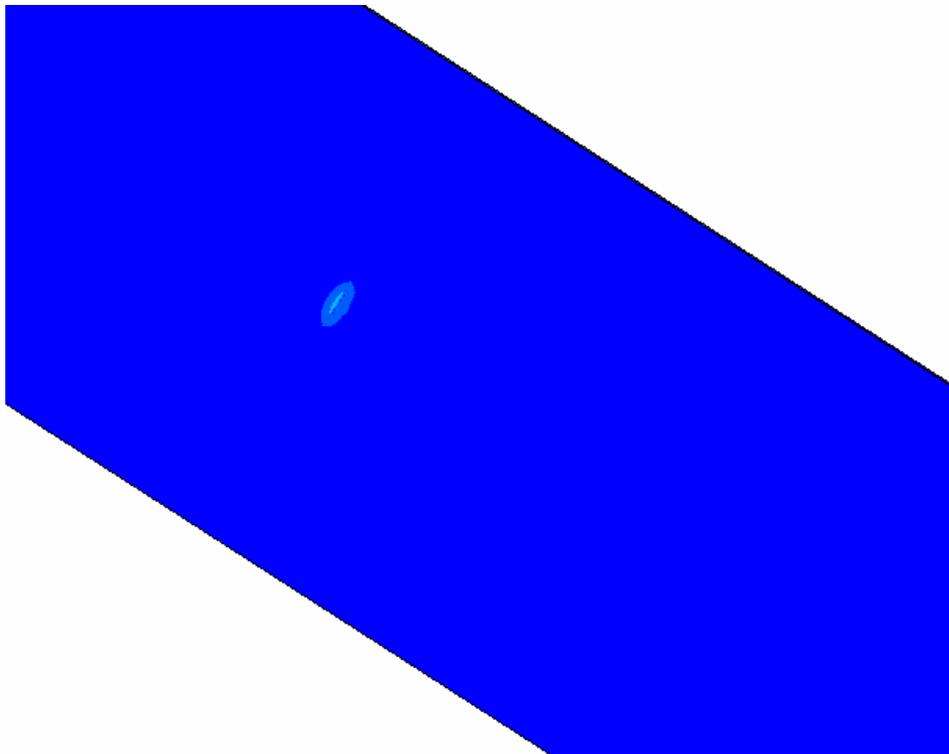
**Figure 14 - Girder web (x-y) - before repair.**

**Figure 15 - Girder web (x-y) - after repair.**

**Figure 16 - Girder web (x-y) - detail 1 - before repair.**

**Figure 17 - Girder web (x-y) - detail 1- after repair.**

Figures 14 thru 17 show that on the side of the girder web opposite to the stiffener, stress concentrations were found right at the tip of the stiffener. However, the area over which these stress concentrations were present was very small. The implementation of the proposed repair did reduce the size of the region affected by stress concentrations. The FEM indicate that stress gradients at the sides of the model, near the tip of the stiffener, were eliminated by the repair (Figures 14 through 17).

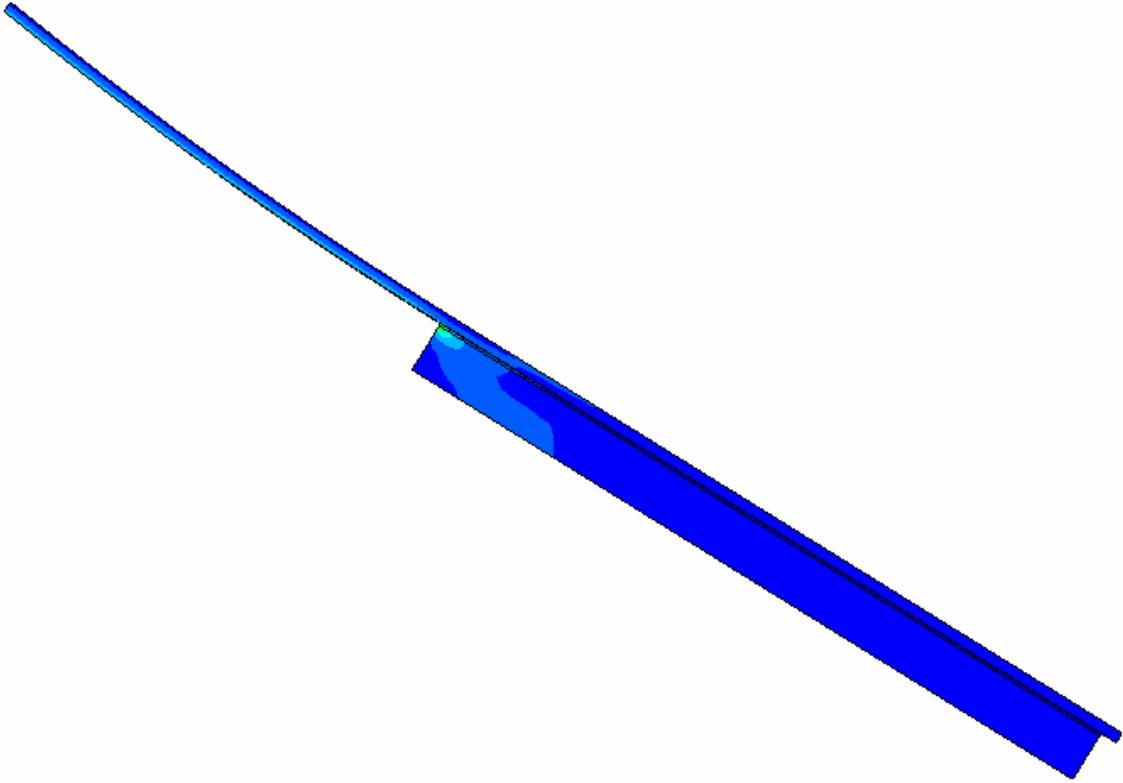
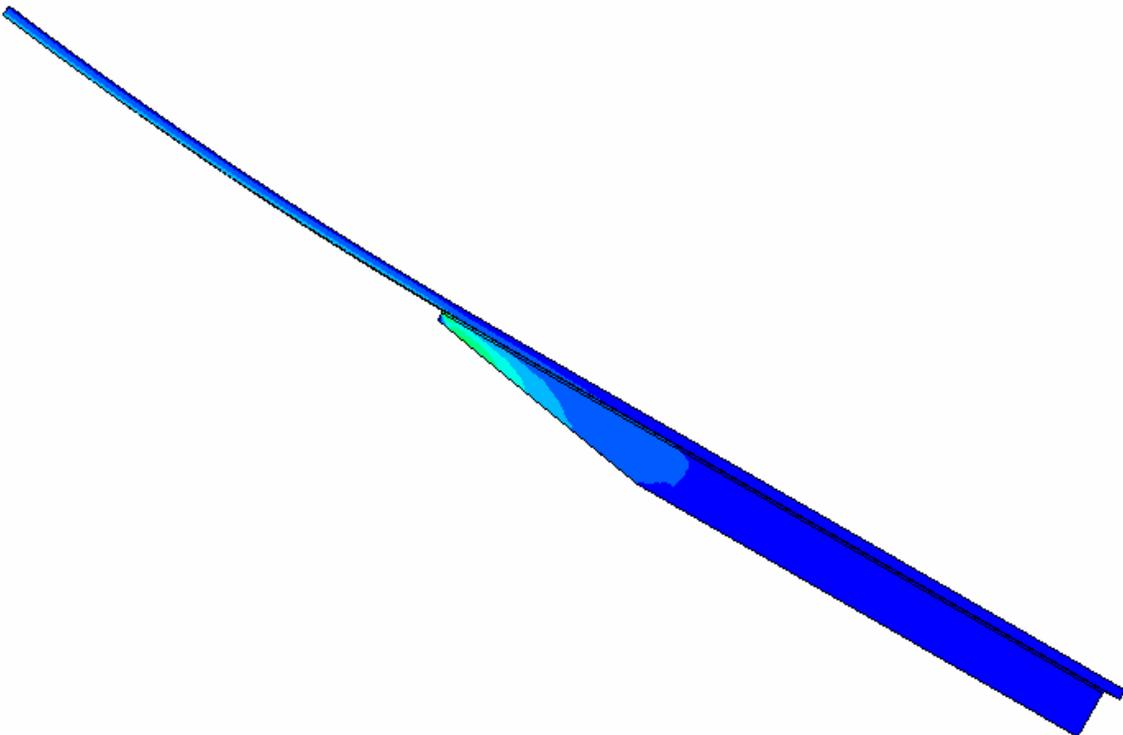
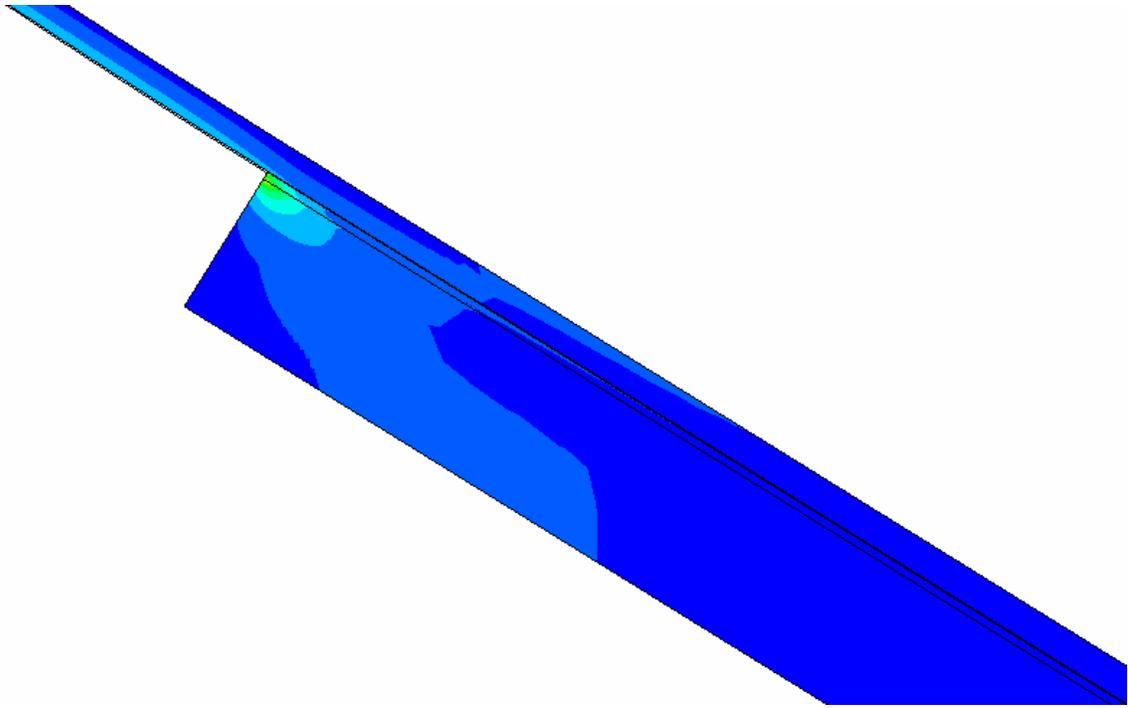
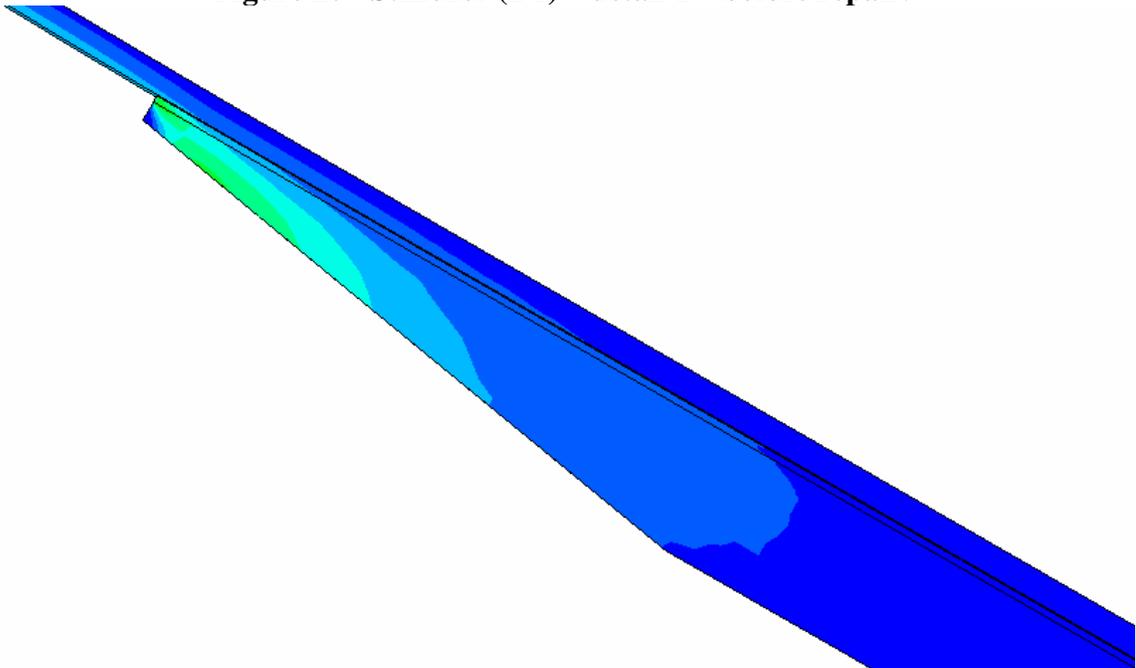
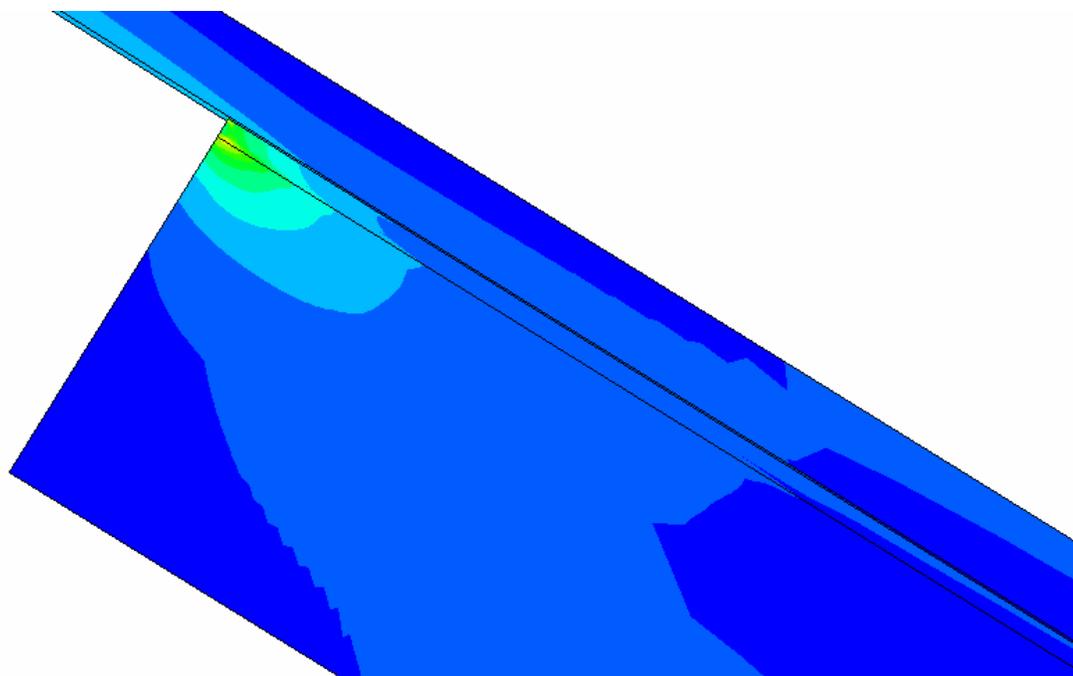
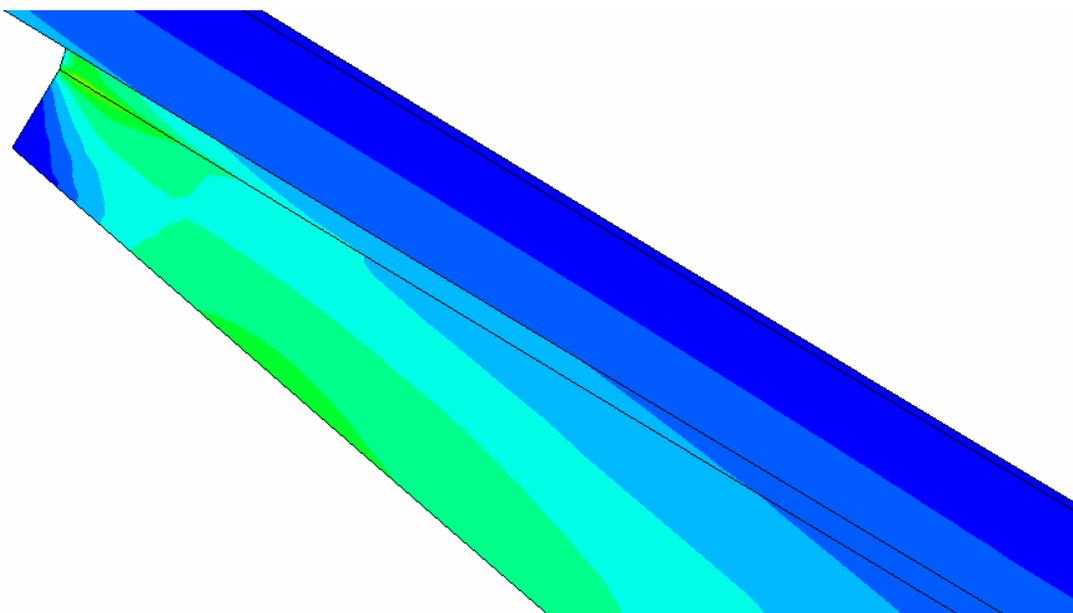
**Figure 18 - Stiffener (x-z) – before repair.**

**Figure 19 - Stiffener (x-z) – after repair.**

**Figure 20 - Stiffener (x-z) – detail 1 – before repair.**

**Figure 21 - Stiffener (x-z) – detail 1 – after repair.**

**Figure 22- Stiffener (x-z) – detail 2 – before repair.**

**Figure 23 - Stiffener (x-z) – detail 2 – after repair.**

Figures 18 through 25 show that the longitudinal stresses along the stiffener were similar in magnitude. After the repair, stresses propagated from the tip of the stiffener over a larger area along the stiffener. Also the stress distribution after the repair shows a much more gradual gradient. This can be observed in Figures 24 and 25 (detail 3), where areas with higher stresses are shown in yellow.

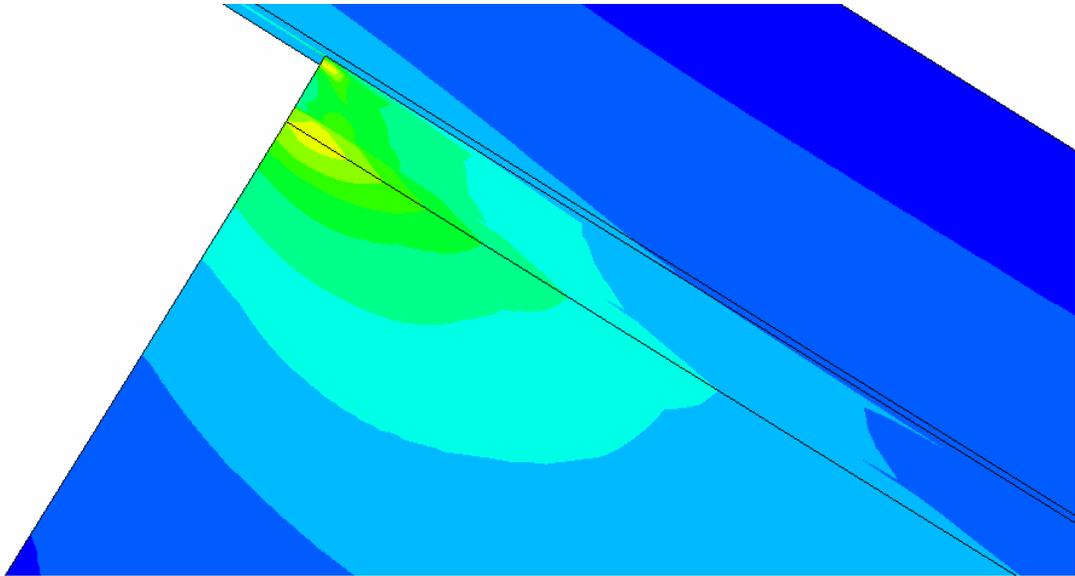
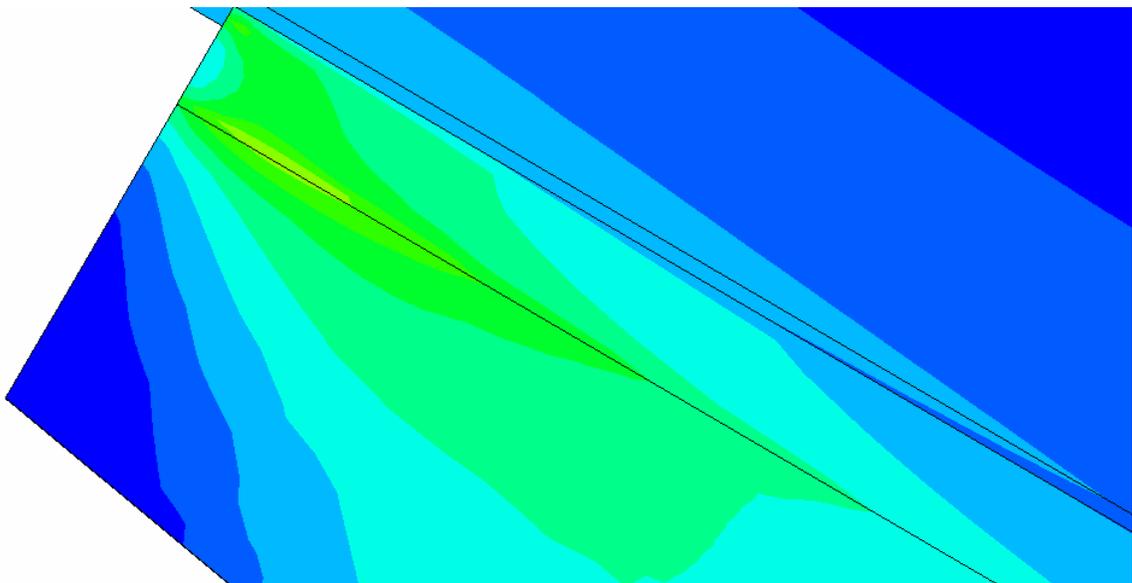
**Figure 24 - Stiffener (x-z) – detail 3 – before repair.**

**Figure 25 - Stiffener (x-z) – detail 3 – after repair.**

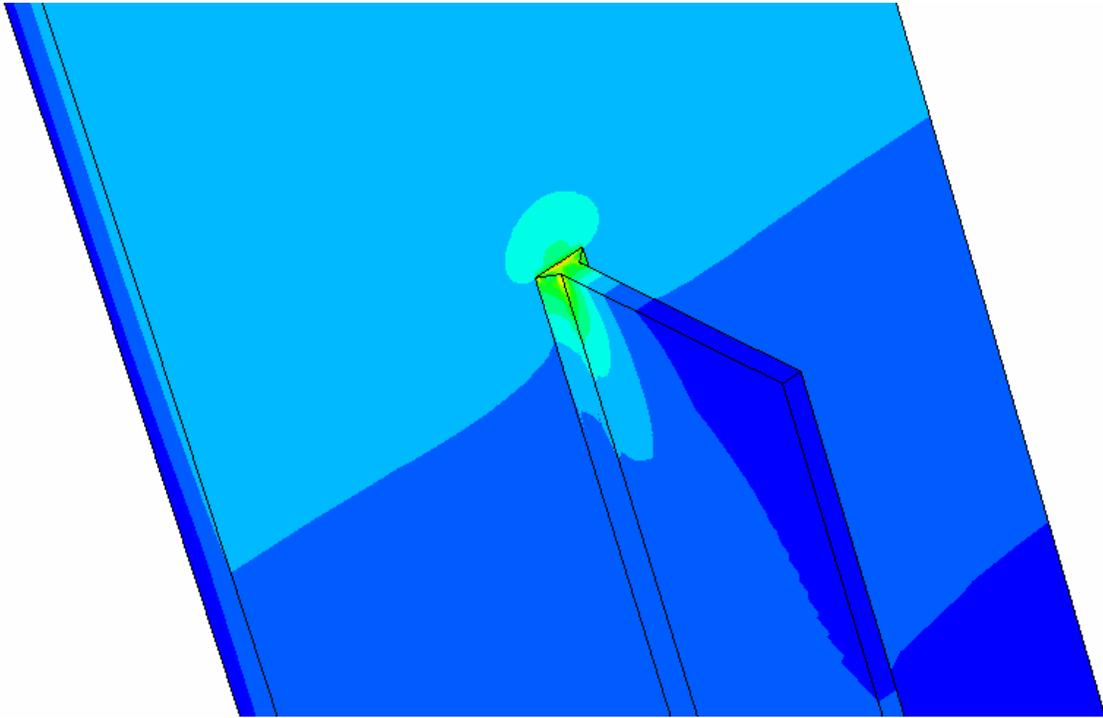
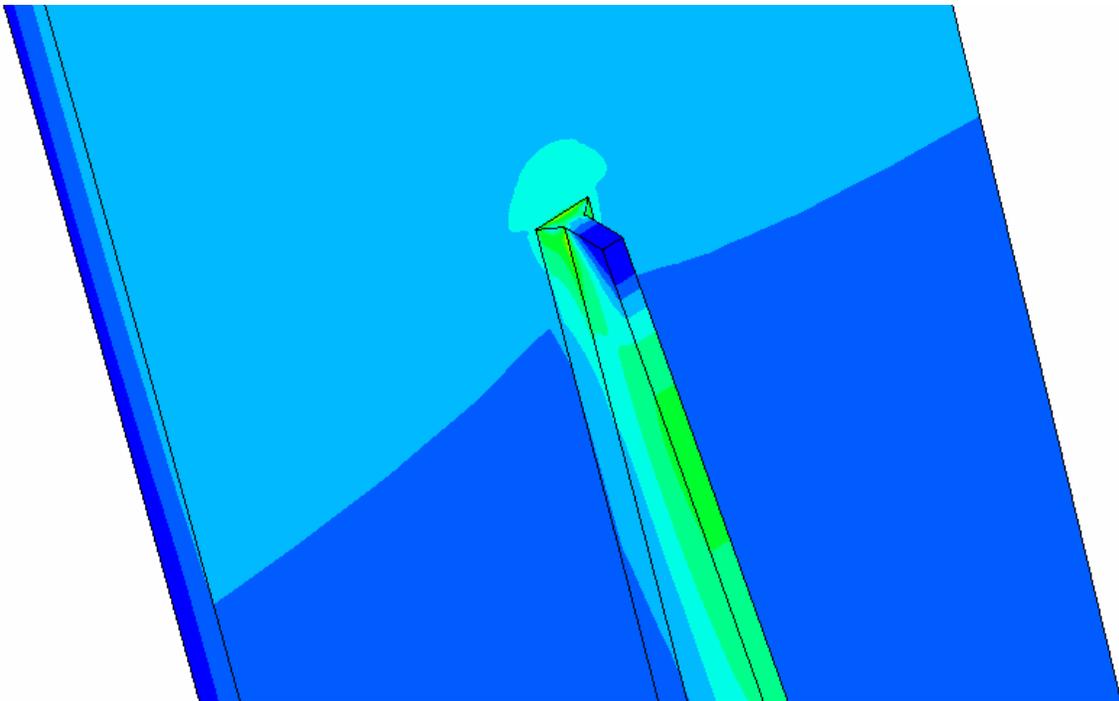
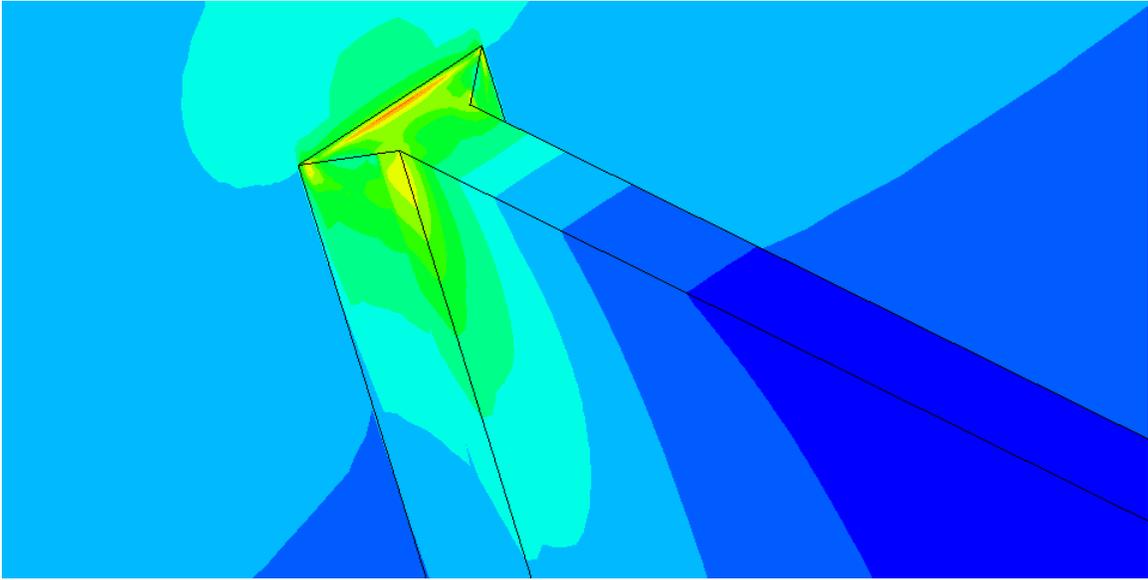
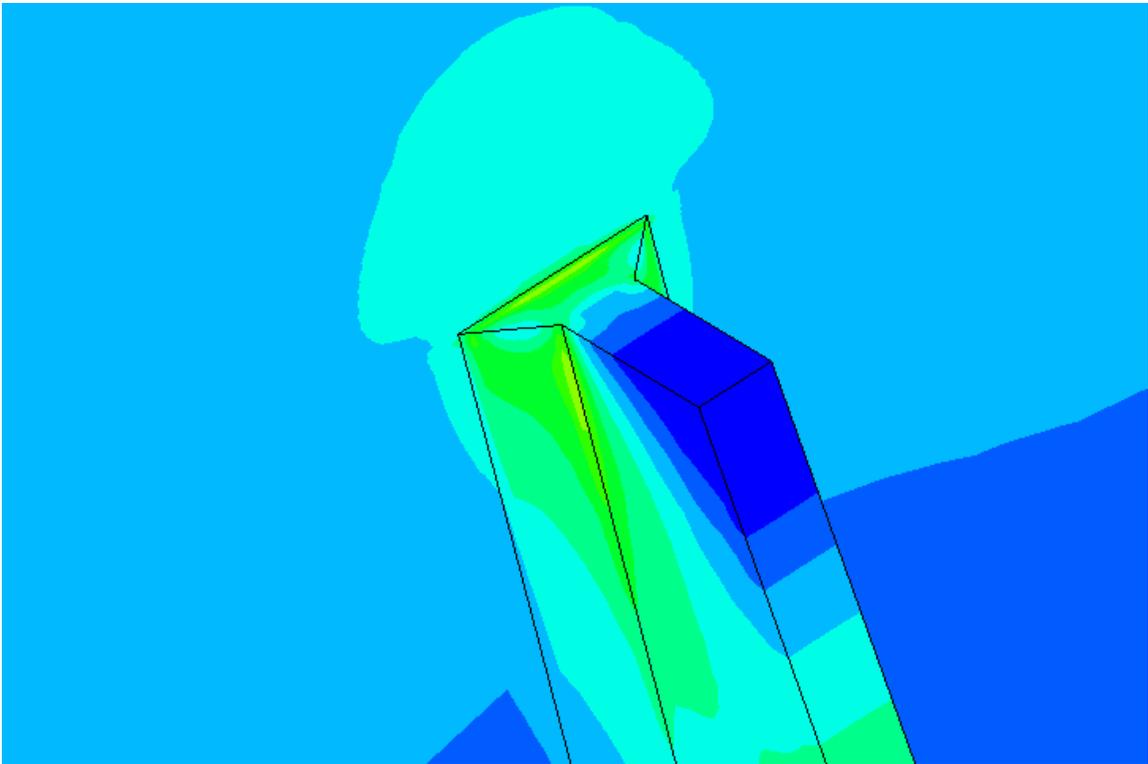
**Figure 26 – Tip of stiffener - detail 1- before repair.**

**Figure 27 – Tip of stiffener - detail 1- after repair.**

**Figure 28 – Tip of stiffener - detail 2- before repair.**

**Figure 29 – Tip of stiffener - detail 2- after repair.**

Figures 26 thru 31 show that the magnitude of the stresses (shown in increasing order of magnitude as yellow, orange and red) decreased with the repair. Figures 30 and 31 show that the front face of the stiffener within the fillet weld region was the area most affected by these stress concentrations. It was found by direct comparison of results from FEMs that after the repair the maximum stresses were reduced by approximately 25%, which would improve the fatigue life.

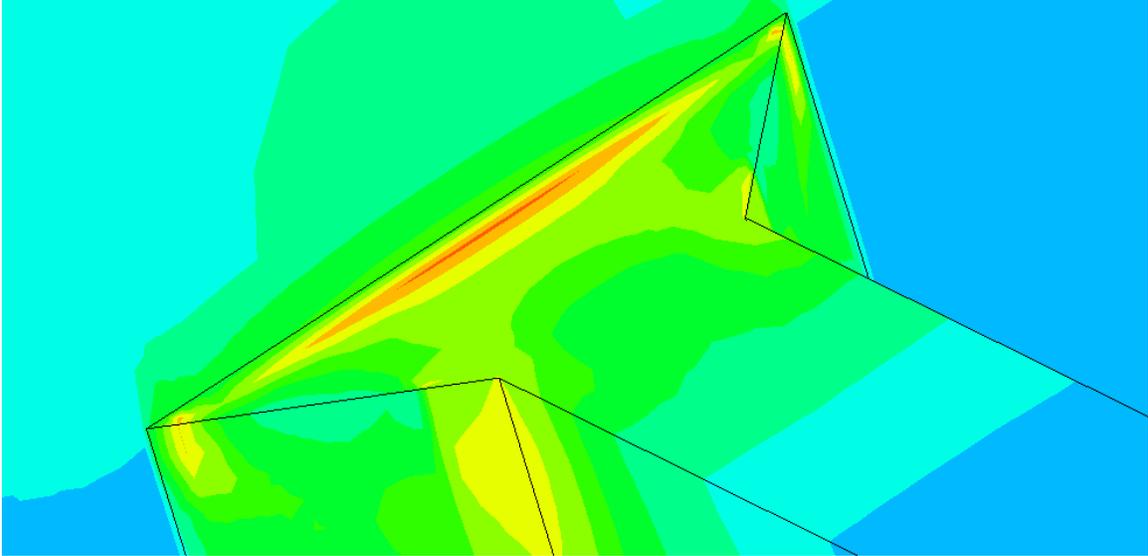
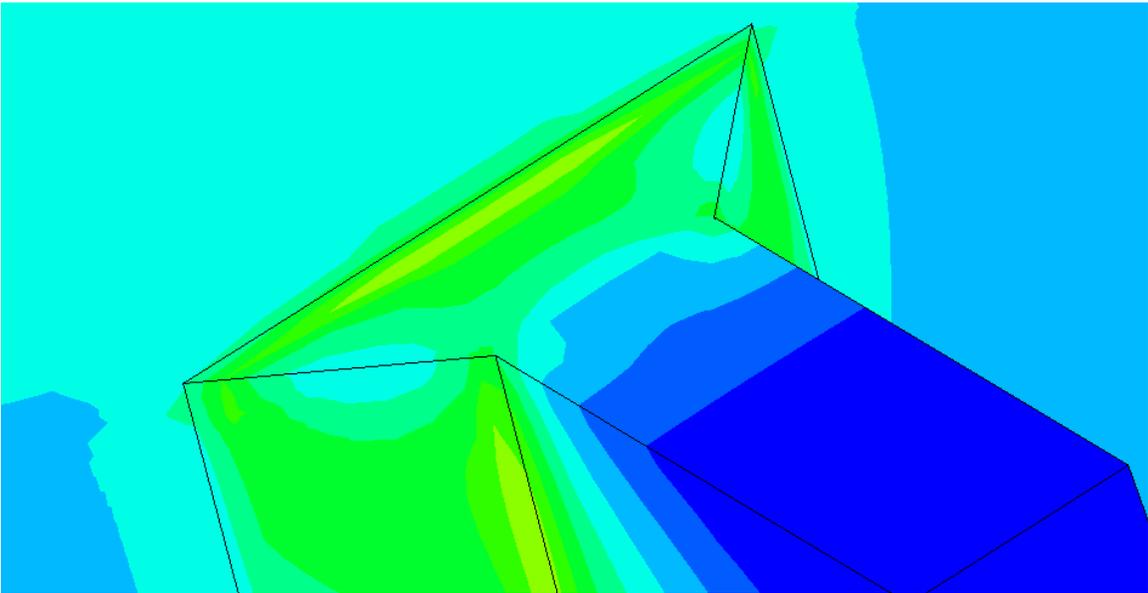
**Figure 30 – Tip of stiffener –detail 3- before repair.**

**Figure 31 – Tip of stiffener –detail 3- after repair.**
