# **FIELD INSTRUMENTATION AND ANALYSIS OF THE TUTTLE CREEK BRIDGE**

**Br. No. 16-81-2.24 (017)**

**KDOT PROJECT NUMBER: KTRAN, KU-04-5  
KUCR PROJECT NUMBER: KAN 35730  
Final Report**

**Department of Civil, Environmental,  
and Architectural Engineering  
The University of Kansas  
Lawrence, Kansas 66045**

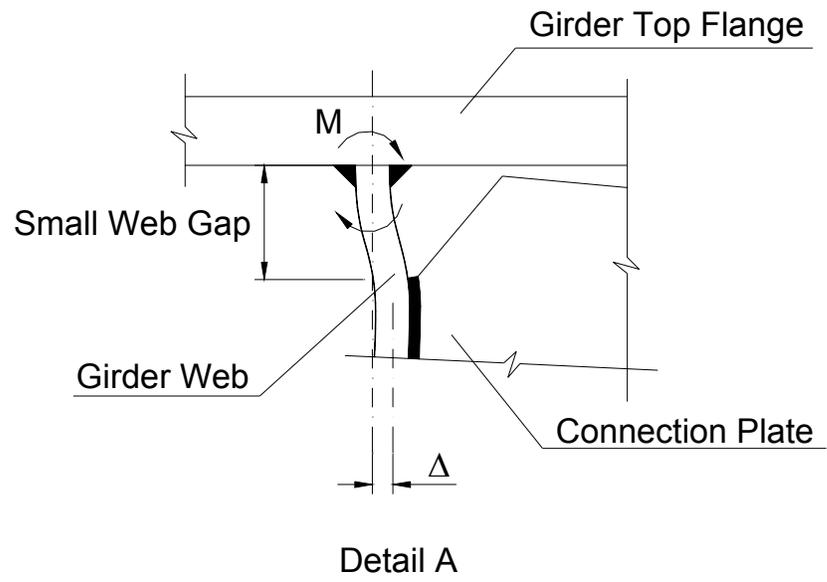
**Figure 2-1 Web-Gap Region**

The majority of cracking in the Tuttle Creek Bridge is within the web-gap region of the girders. The web-gap region is a 1 x 1 in. diagonal clip from the top and bottom of the connection stiffener to allow for the fillet weld of the primary member to be continuous, as seen in Figures 2-1 and 2-2. Unfortunately, this cope creates high stress concentrations in the web that can initiate fatigue cracking. Two types of cracks have been observed in the upper web-gap: weld tears and horizontal cracks.

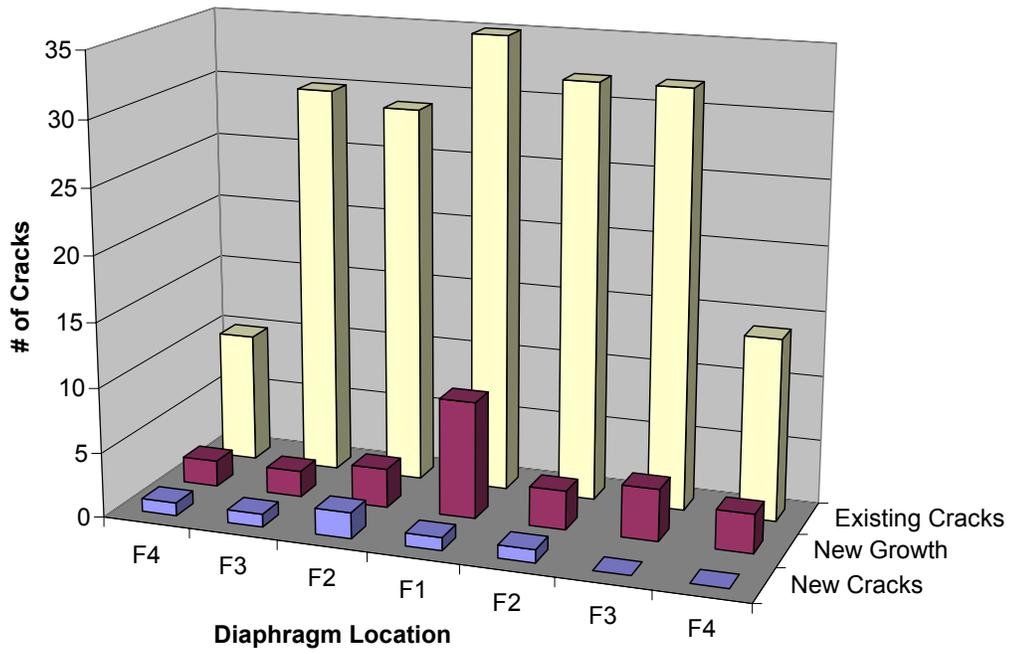
Figure 2-5 Horizontal Cracking Survey (Full Spans)

Another frequent cracking pattern is horizontal cracking. The horizontal cracks are found at the bottom of the fillet weld connecting the upper flange to the web of the girder. The cracks are located on both the interior and exterior sides of the girders. Exterior horizontal cracks are found less frequently than the similar interior horizontal cracks. Only 13 exterior, horizontal cracks have been found, as opposed to 291 interior, horizontal cracks.

The inspection reports revealed helpful information concerning the web-gap cracking problem. Surveys of each span indicated that web-gap cracks were not more or less abundant for any particular span. Full spans compared to hinged spans did not show any recognizable patterns. However, the comparison of diaphragm locations did indicate patterns for the cracking. Interior horizontal cracks showed a bell-shaped curve distribution, with larger number of cracks appearing in the middle diaphragms, as shown in Figures 2-5 and 2-7. Weld tears displayed a rather constant development regardless of diaphragm location, as shown in Figures 2-6 and 2-8.

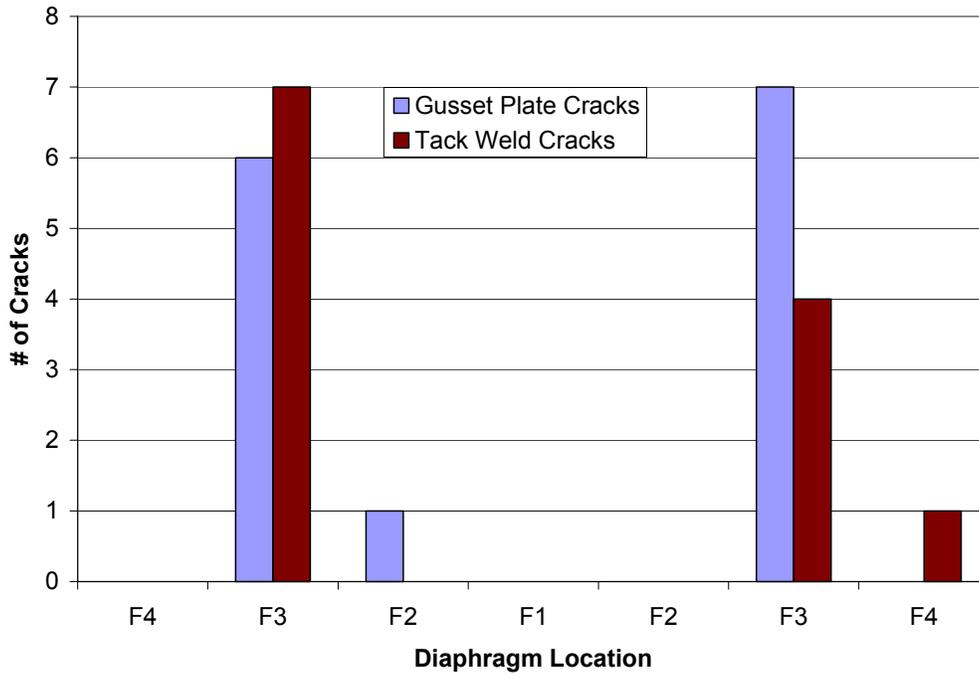
**Figure 2-13 Gusset Plate Cracking (Full Spans)**

The gusset plate cracks are found throughout the bridge, without any concentration on any particular spans. A survey of the diaphragm locations revealed that most of the gusset plate cracking was confined to the second diaphragm, labeled F3 in Figure 1-4. The distribution of the cracks between the diaphragms is displayed in Figure 2-13. The first diaphragm from the pier, labeled F4, displayed no evidence of fillet weld cracking, since these locations had been retrofitted in 1986. The cracks are equally dispersed on each side of the gusset plates. In other words, the sides closer to the pier were not more or less likely to crack than the opposite side.

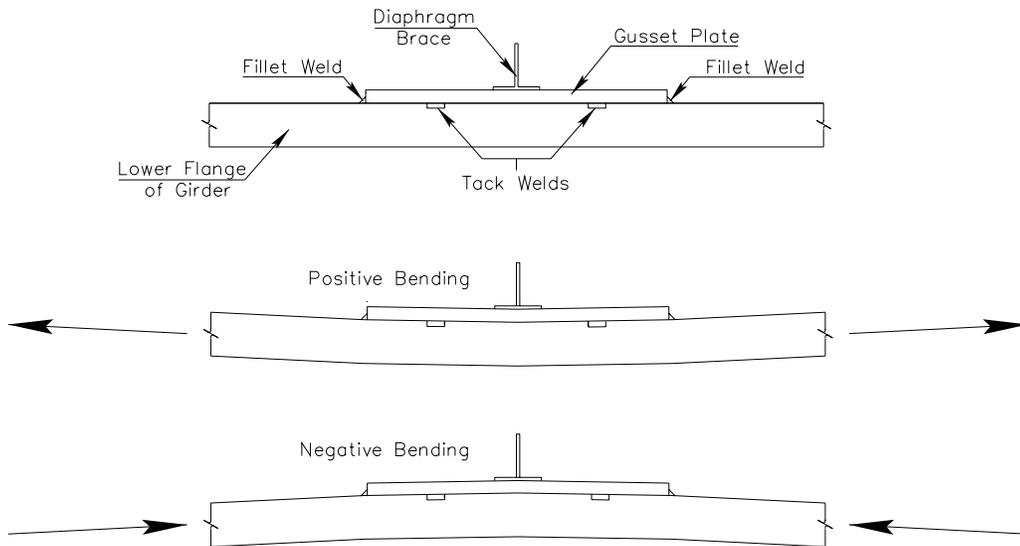
**Figure 2-14 Gusset Plate Cracking Source (Bending Stresses)**

As opposed to the web-gap cracking, the source of the gusset plate cracks is in debate. One theory is the cracks have developed from the bending stress of the girder, a solely load-based fatigue. Figure 2-14 shows a diagram of this type of fatigue source. Another possibility is due to distortion of the girder causing high compressive stresses in the diagonal bracing. The lateral bracing buckles upward along its weak axis causing a prying action on the gusset plate. A drawing of this theory is presented in Figure 2-15. Another theory is racking of the gusset plate due to loads from the diagonal bracing. The twisting of the gusset plate would cause cracking to develop at the ends of the fillet weld. Figure 2-16 shows this theory of plate distortion.

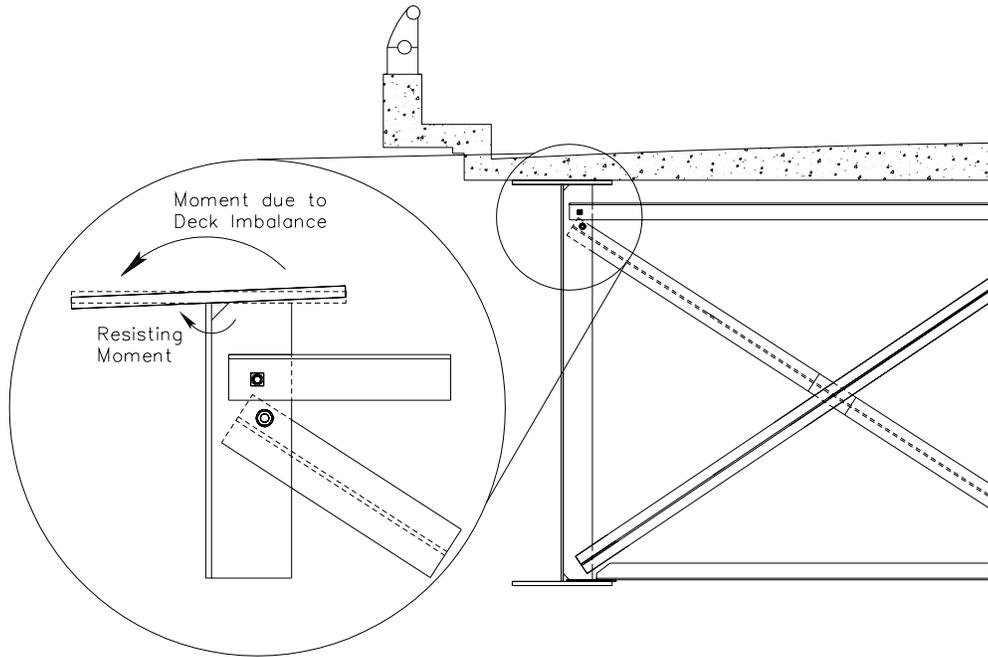
**Figure 5-11 Cracking Theory (Cantilevering of the Deck)**

Perhaps unforeseen loads from the dead weight of the structure caused the crack patterns. An imbalance of the deck load on the upper flange could cause tensile forces within the interior, web-gap region. If the weight of the deck cantilevered over the girder flange were high compared to the deck weight, the flange would rotate outwardly, as shown in Figure 5-11. This rotation would create tensile forces within the web-gap region. This would explain the abundance of cracks on the interior side of the girder.

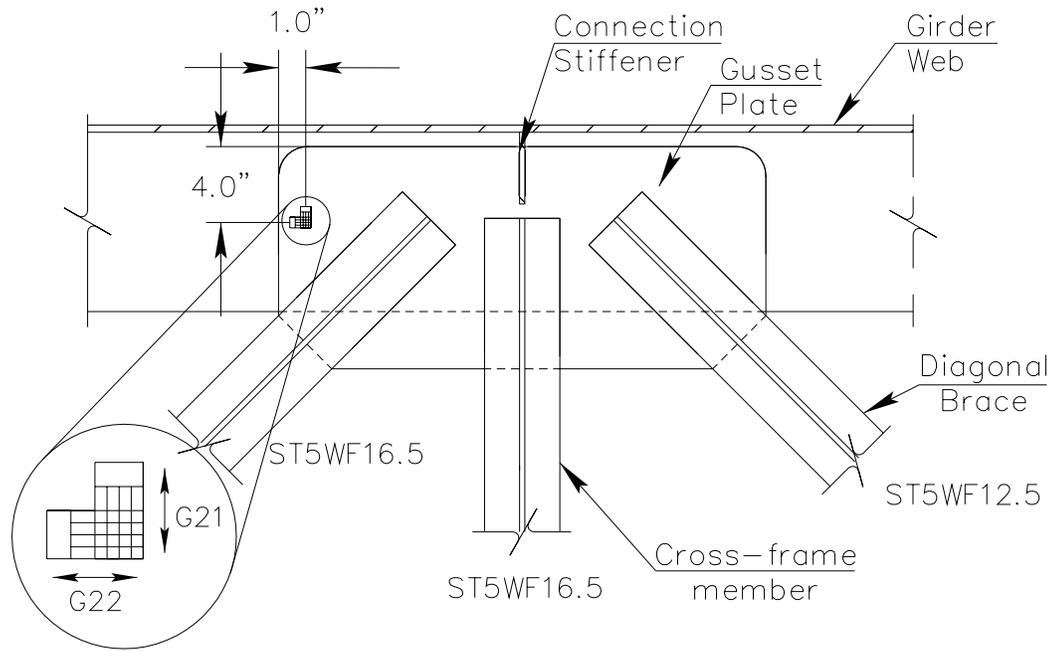
**Figure 6-3 Gusset Plate Rosette (Diaphragm F3)**

A rosette placed on the gusset plate, as shown in Figure 6-3, was used to measure the magnitude and direction of the forces within the plate. If the measured stresses were primarily parallel with the girder, bending of the girder would be the logical culprit for the cracking. However, if the forces were parallel with the diagonal brace attached to the plate, distortion caused by this brace would be the source of the problem.

Gages placed on the gusset plate assisted in explaining the source of the weld cracking. For a vehicle traveling westbound on span 29, the gage readings indicate that the plate is being stretched to 0.5 ksi parallel and perpendicular with the girder. When the truck was eastbound on span 29, the average perpendicular stress was equal magnitude, but opposite direction, than the westbound vehicle. Maximum and minimum values for the different load cases, located in Tables 6-1 through 6-4, summarize these findings.

These measurements indicate that the stresses within the gusset plate are not solely from bending forces of the girder. As the truck passes over the bridge, the lateral bracing is shown to apply stress to the gusset. This data supports the theory that the gusset plate cracking is caused partly by distortion of the lateral brace. If the lateral brace were pushing against the plate, then it would be deforming. This distortion would create a prying action on the gusset plate. This prying would be a logical cause of the cracking. The data refutes the theory that only bending forces of the girder are solely causing the cracking, but it does not disprove that the girder stresses are not contributing.

3. The field measurements taken in the gusset plate region suggest a source of the fatigue cracking. Although the cyclic loadings of the girders may create additional fatigue loading on the weld, the primary source of the gusset plate cracks is believed to be from cyclic loading of the lateral braces. Stresses measured on the gusset plate indicate perpendicular load cycling. The inspection reports indicate that the majority of the cracks are located in lower stress regions within the girder, which would indicate that the bending stresses are not creating the cracks. Cyclic loading of the lateral braces is believed to be the source of the gusset plate cracks.

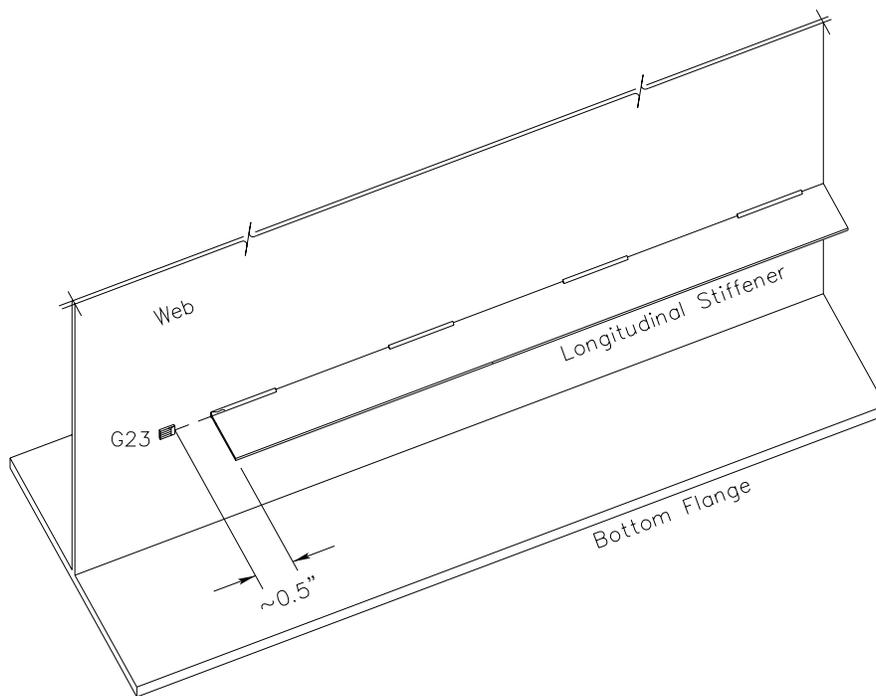
**Figure 7-2 Longitudinal Stiffener Gage (Span 29)**

One, single-element gage was used to provide a prior-to-retrofit measurement. Only the tapering repair was investigated, since the butt weld repair was not a new structural configuration. The gage was placed close to the end of the lower longitudinal stiffener, as shown in Figure 7-2. The very tip of the stiffener, in theory, should have the highest stress. The gage, however, could not be placed directly on the tip, therefore the stresses may be higher than those measured. Nevertheless, its

Results from the various loadings can be found in Tables 7-1 through 7-4. For the eastbound truck, the average stress cycle was 4.6 ksi, while the westbound truck created a 3.4 ksi cycle. Since the cycle entered into the tensile region, this detail is particularly vulnerable to fatigue. Residual stresses could make this tensile cycle even more damaging. This stress value will be good to compare with the post-retrofit stresses to see the effectiveness of the repair.

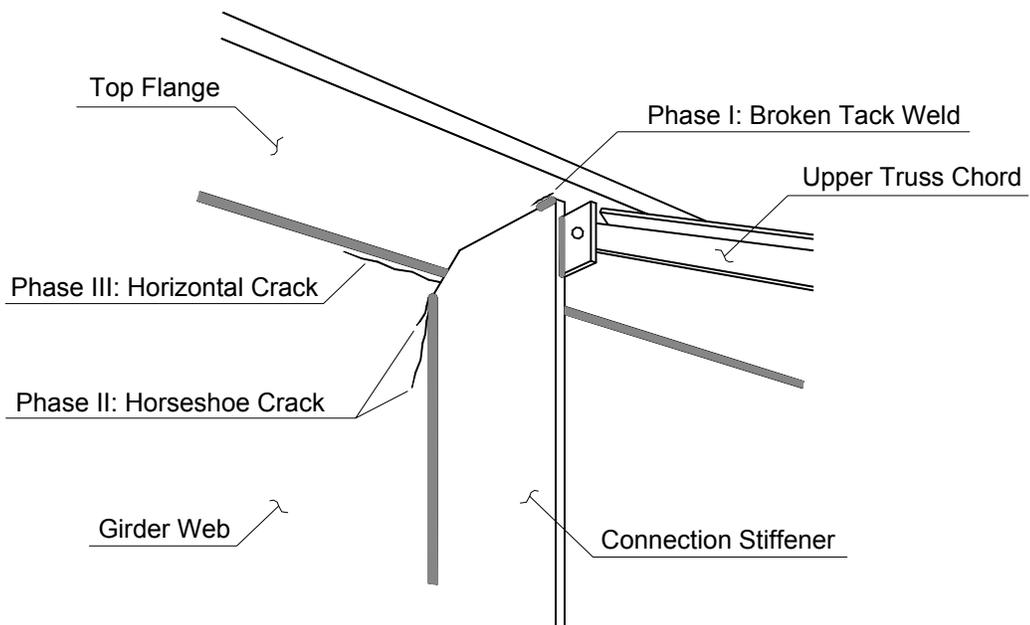
**Figure B-6 Crack Growth in the Westgate Bridge**
