**Fabrication error  
Indexed eXamples and Solutions:  
FIXS**

**A Report on Research Sponsored by  
Kansas Department of Transportation  
KTRAN Project No. KU-98-8  
Mid America Transportation Center  
MATC/KU 98-2  
National Steel Bridge Alliance**

**UNIVERSITY OF KANSAS CENTER FOR RESEARCH, INC.  
LAWRENCE, KANSAS  
JUNE 1999**

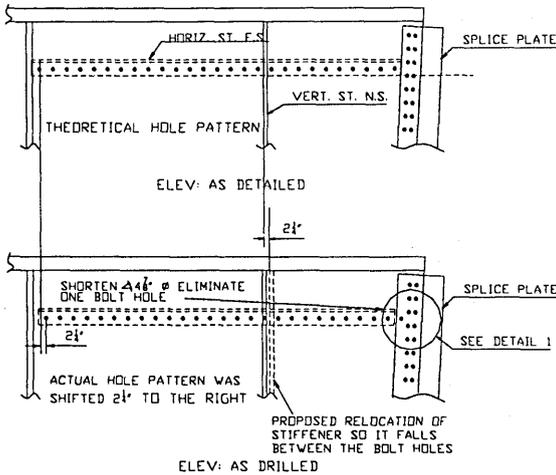
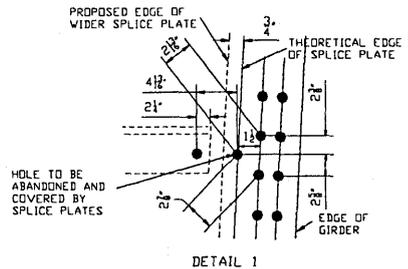
### Case #TF204:

**Description of Error:** Holes for fastening the horizontal stiffener have been misdrilled. The actual hole pattern was shifted 2 1/4" to the right (see "as drilled" sketch). The hole pattern interferes with a splice plate and a vertical stiffener. The vertical stiffener is an angle bolted to the girder web with bolt locations above and below horizontal stiffener. In sketches, only outstanding leg of vertical stiffener angle is shown.

The splice plate will be widened to cover the abandoned hole.

The vertical stiffener will be relocated so it falls between the bolt holes.

**Solution Recommended:** To shorten the angle by 4 7/8 inch and eliminate one bolt hole. The bolt hole to be abandoned will be covered by splice plate wider than called out originally by design. The vertical stiffener will be relocated so it falls between bolt holes.

In this case, not only the solution recommended is provided, but also "Other Possible Solutions: the stiffener could have been moved far enough to miss the splice plate. This would have been the best solution had the error been noticed before the stiffener was in place. In actual case, shop did not realize there was a problem until they tried to clamp the splice plates in place for drilling." was added to provide guidance for different situations.

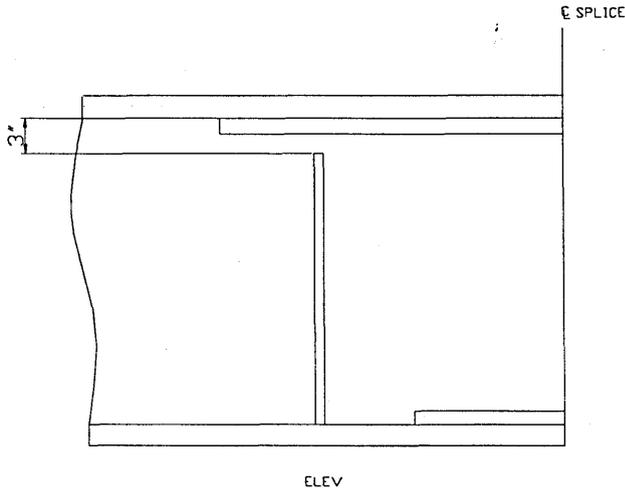
### Case #DL169:

*The stiffener had already been welded into place.*

**Description of Error:** A stiffener was shown to fit tight against both flanges. One inside splice plate extended beyond the location of the stiffener.

*Cut the stiffener off 3 in. from the flange to allow the splice plate to be placed in the proper location.*

**Solution Recommended:** Cut the stiffener off 3" from the flange. This was acceptable since this was a plain stiffener rather than a diaphragm connection plate.

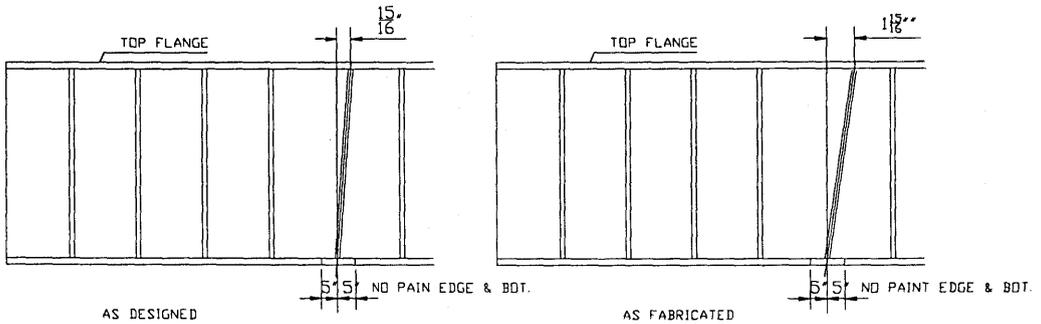
### Case #NC501:

Kick equals  $1 \frac{15}{16}$  in. in lieu of  $15/16$  in.

**Description of Error:** Bearing stiffeners welded in place out of plumb--kick =  $1 \frac{15}{16}$ " in lieu of  $15/16$ ".

The stiffener was left in place and a shim used to bolt cross frame to stiffener.

**Solution Recommended:** Since bottom location of stiffener above the sole plate is correct and out of plumbness was less than 5%, stiffener was left in place and a shim used to bolt cross frame to stiffener.

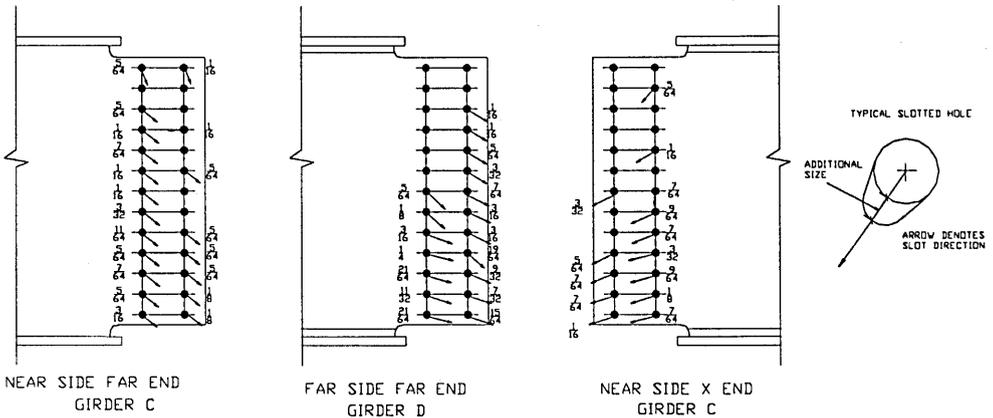
### Case #TF195:

Several holes in the web were elongated at the splice connection.

**Description of Error:** Several holes in the web were elongated at the splice connection.

Drill  $1 \frac{3}{16}$  in diameter holes for  $1 \frac{1}{8}$  in. bolts and use hardened washers on both sides.

**Solution Recommended:** Drill  $1 \frac{3}{16}$  inch diameter holes for  $1 \frac{1}{8}$  inch bolts and use hardened washers on both sides.

**Other Possible Solutions:** Instead of using the uncommon bolt size of  $1 \frac{1}{8}$  inch as done in actual repair, consider use of 1 inch bolts in oversize holes and use hardened washers on both sides.

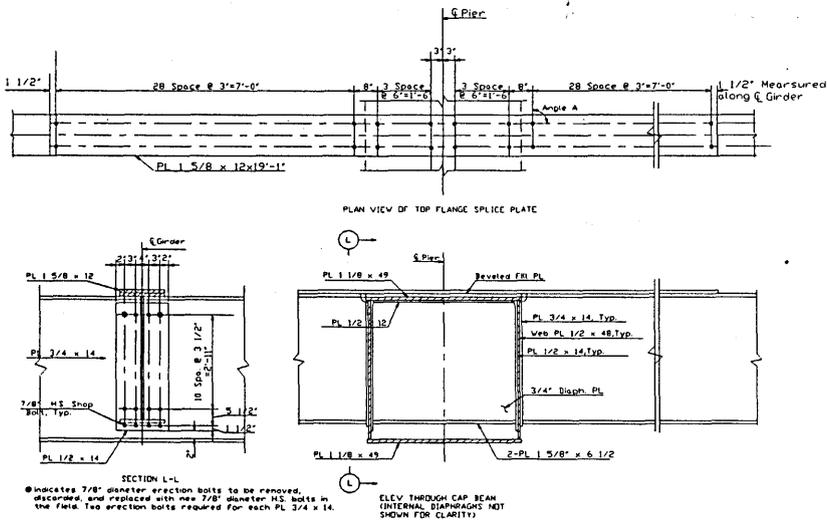
### Case #JJ142:

**Description of Error:** In order to assure that a full contact friction/moment connection is made between the girders and steel cap beam, without introducing residual stresses into the joint, the girder to steel cap beam connection must be completed prior to placing and bolting the top flange splice plate. The erection procedure was followed at the two locations mentioned. When the top flange splice plates were placed, misfit occurred between the bolt holes of the top flange splice plates, steel cap beam, and girders.

1) A shim plate between the girder and cap beam may be used, or 2) the top flange splice plate holes may be reamed.

If the holes were reamed then install hardened washers over the oversized holes in the outer ply and tighten the bolts.

**Solution Recommended:** These misfits may be resolved by one of the following methods:

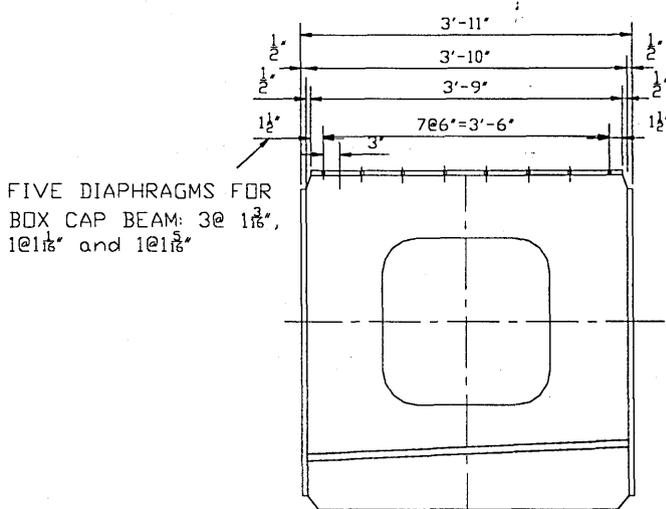
### Case #MG119:

In the box cap beam the internal bracing diaphragms located where the girder connection plate bolt to the top flange of the girder and the top flange of the box have insufficient edge distance.

**Description of Error:** In the box cap beam five internal bracing diaphragms located where the girder connection plate bolt to the top flange of the girder and the top flange of the box have insufficient edge distance. Three diaphragms have two bolts with 1 3/16" edge distance; 1 has two bolts with 1 1/16" edge distance; and 1 diaphragm has two bolts with 1 5/16" edge distance.

Drill an extra set of bolt holes at 3 in. from the last two bolt holes that have insufficient end distance.

**Solution Recommended:** Drill an extra set of bolt holes at 3" from the last two bolt holes that have insufficient end distance.

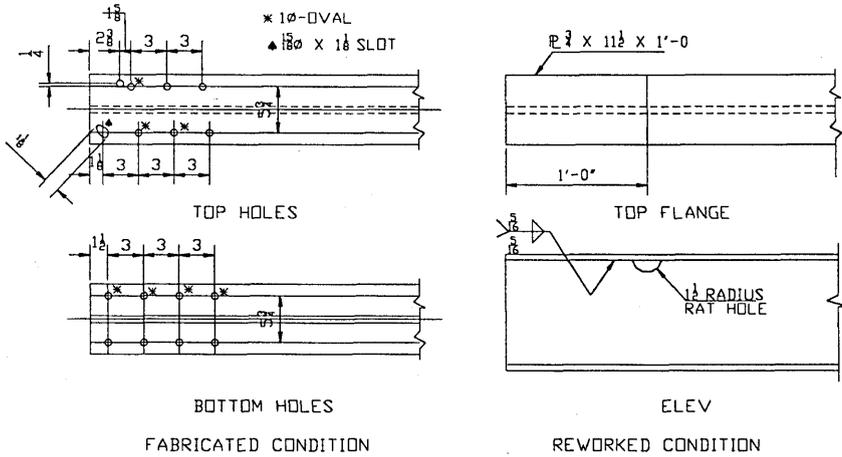
**Case #FB150:**

**Description of Error:** There is an egg shaped hole in the girder flange. The hole is approximately a 15/16 φ by 1 1/8 slot. (Also see misshapedHole, 'MSPH-C008').

Add new plate using full penetration weld at flange and 5/16 in. weld at web.

100% RT at flange and 100% MT at web.

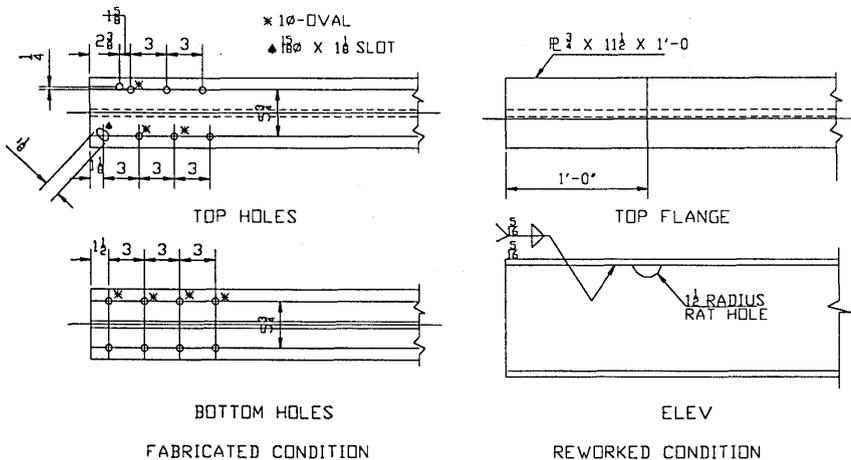
### Case #TF214:

**Description of Error:** Egg-shaped holes occur on the flanges at a splice location. The holes are approximately 1"  $\phi$  ovals. (Also see misshapedHole, 'MSPH-C001')

100 percent RT a flange and 100 percent MT at web.

Drill holes correctly.

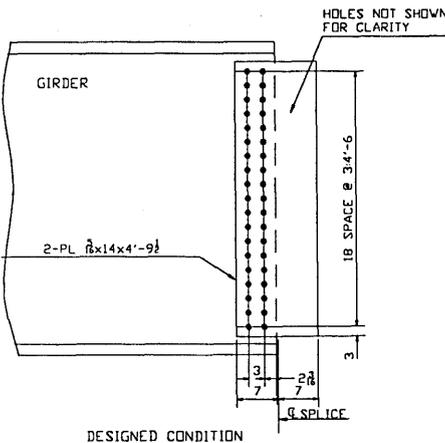
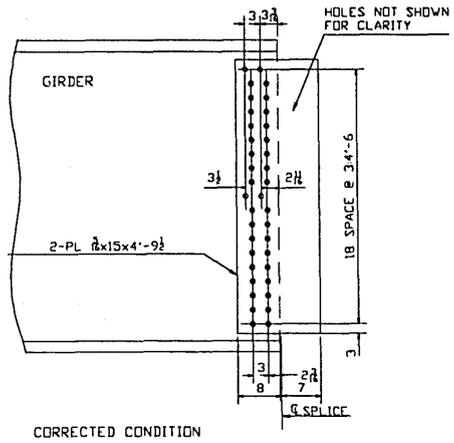
Case # JJ148:

Description of Error: The 11/16 dia. web lay down holes on a girder have been laid out and drilled. Four holes are mislocated.  
 Solution Recommended: To leave the holes in this location and custom fabricate new splice plates to match existing girder web holes.

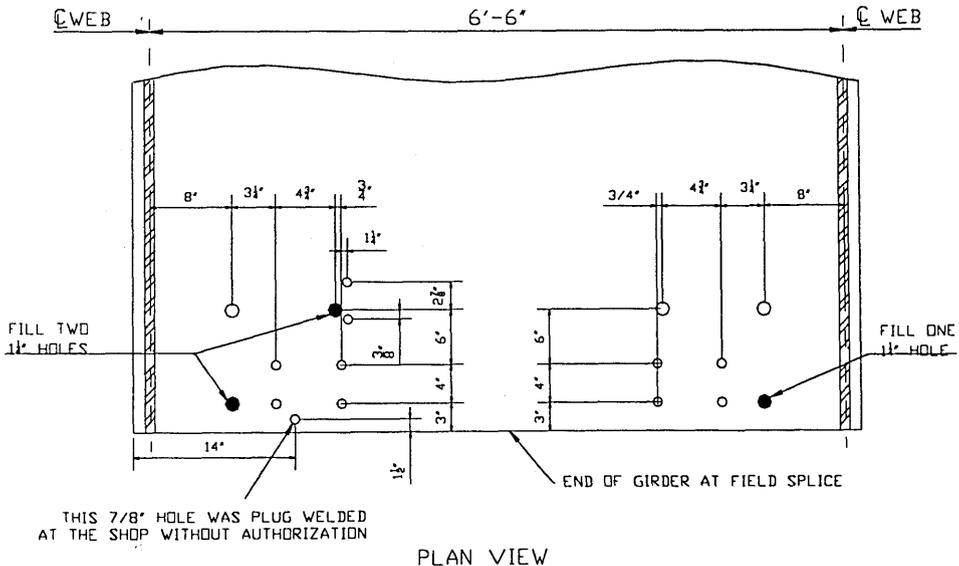
Description of Error: The 7/8" diameter hole shown on the diagram was drilled and plug welded without any permission at the shop and was discovered by chance during field radiography. The six 1 1/4" holes were also drilled wrong but were evaluated, repaired and NDT tested before acceptance of the girder. (see case 'MLCH-C013' for following error on same member)  
 Solution Recommended: This is a two-part problem.

- 1) Since conditions allowed filling and NDT testing of the 1 1/4" φ holes, the same technical fix should be possible on the 7/8" hole.
- 2) Since the fabricator did not bring the 7/8" hole to the attention of the owner, the fabricator's QC is called into question. For this reason, repair of this defect will be decided on by design department and the consulting engineers handing the project.

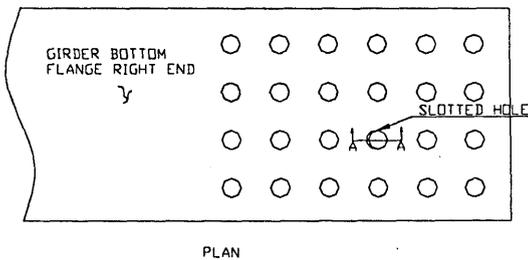
Description of Error: Girder bottom flange right end has a partially drilled hole mislocated by 5/32 of an inch. The splice and fill plates at this splice will have round holes.

Solution Recommended: To use this girder as fabricated.

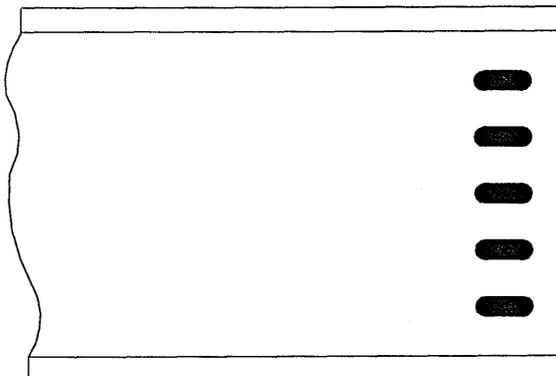
Description of Error: Holes drilled near the end of the girder were drilled 1/2" off. These holes are for reinforcing steel to pass through at an end abutment.

Solution Recommended: Extend holes toward end of girder, making it a slot.

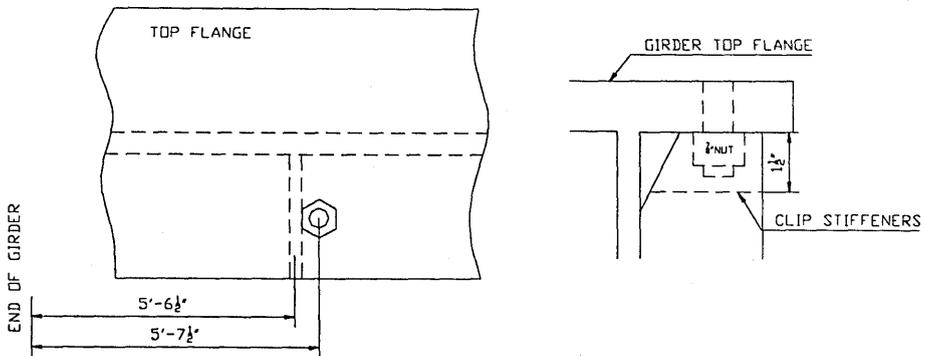
Description of Error: Due to a detailing error, three girders have top flange splice plate holes drilled too close to the stiffener bar at extension dimension 5'-6 1/2" to allow bolt access. The stiffener is located at 5'-7 1/2" and the hole for the splice plate is at 5'-7 1/2" which results in a 1/4" interference.

Solution Recommended: To clip the stiffener bars.

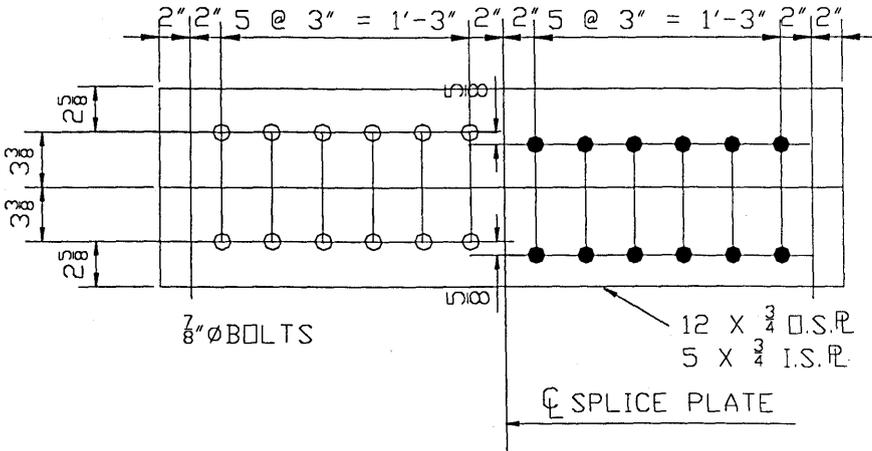
(Repair procedure was never implemented, as the beam was inadvertently cut 3/4" to short and was rejected for out of tolerance specification on center of holes to edge of beam. Repair would have required DOT final visual inspection.)

Solution Recommended: Make new splice plates with mismatched hole pattern.

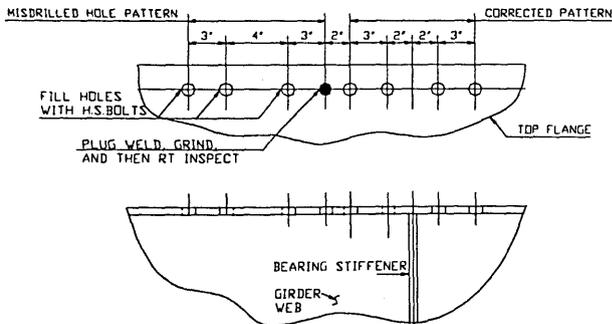
- 2) The actual repair is not recommended due to the adverse effect of plug welds on fatigue performance as discussed in tutorial topic on avoiding plug welds. Filling abandoned holes with high strength torqued bolts is not cosmetic but rather provides the structural benefit of pre compressing the edge of the extraneous hole so that fatigue cracking is discouraged. The fact that there is adequate edge distance at the corrected hole closest to the abandoned holes means that no additional bolts need to be added to the corrected pattern.

- 3) The alternative solution recommended is to abandon the misplaced holes, filling with high strength bolts and tightening so that area around extraneous holes is pre compressed decreasing likelihood of fatigue cracking. If 2' distance prevents tightening of hex bolt, use button head bolt for abandoned hole closest to corrected pattern. See tutorial topic on avoiding plug welds for further discussion.

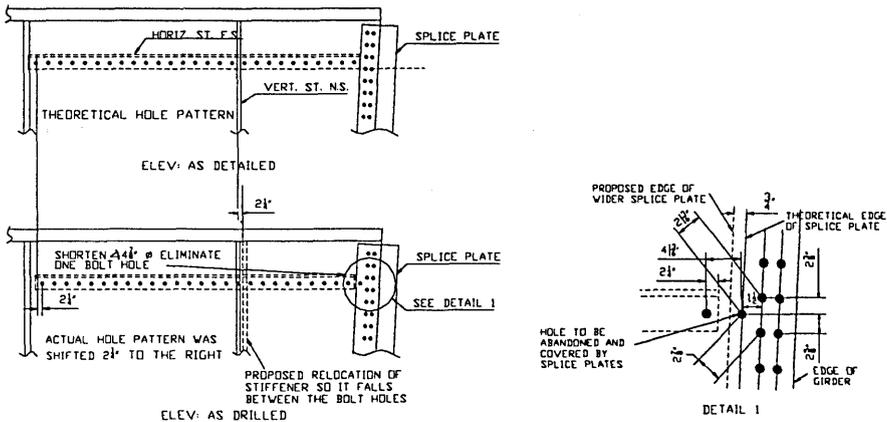
Description of Error: Holes for fastening the horizontal stiffener have been misdrilled. The actual hole pattern was shifted 2 1/4" to the right (see "as drilled" sketch). The hole pattern interferes with a splice plate and a vertical stiffener. The vertical stiffener is an angle bolted to the girder web with bolt locations above and below horizontal stiffener. In sketches, only outstanding leg of vertical stiffener angle is shown.

Solution Recommended: To shorten the angle by 4 7/8 inch and eliminate one bolt hole. The bolt hole to be abandoned will be covered by splice plate wider than called out originally by design. The vertical stiffener will be relocated so it falls between bolt holes.

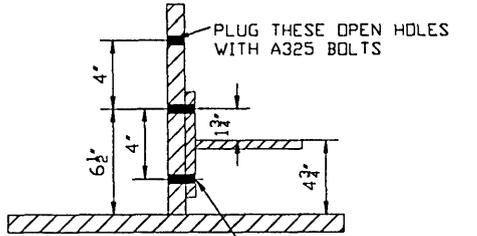
Description of Error: The holes for two gusset plates were drilled 4" too high. There are 16 bolts which attach each gusset plate to the girder.  
 Solution Recommended: Fill the top row of holes with bolts. Use the bottom set of holes as the new top row, then drill the bottom row in the correct location.

SOLUTION

DRILL THESE HOLES IN  
 FIELD: LAY-OUT PROPER  
 MEASUREMENTS + DRILL  
 WITH MAGNETIC CORE  
 DRILL.

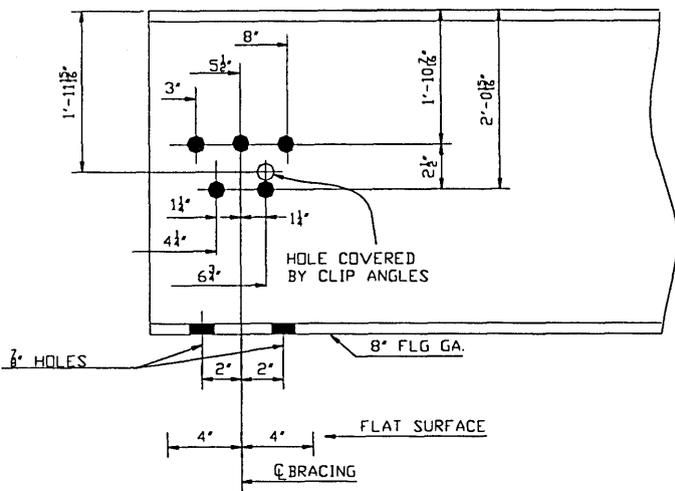
Description of Error: An additional hole was inadvertently punched in the web of this beam.

Solution Recommended: Since this is an interior beam, it would seem prudent to leave the extra hole in place and cover it with the two clip angles already present as part of the connection. If the clip angles did not already cover the hole, could fill the hole with a bolt, nut, & double washer.

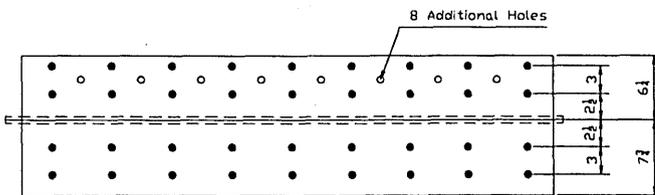
Description of Error: Diaphragm located at extension dimension 28'-7 11/16 in cap beam has its top connection plate misfit by 3/4 inch. This misalignment results in lack of edge distance.

Solution Recommended: To add 8 additional holes to the connection to make up for shy edge distance as shown on sketch. The bolt holes were placed at centerline location between existing bolt lines both laterally and tangentially.

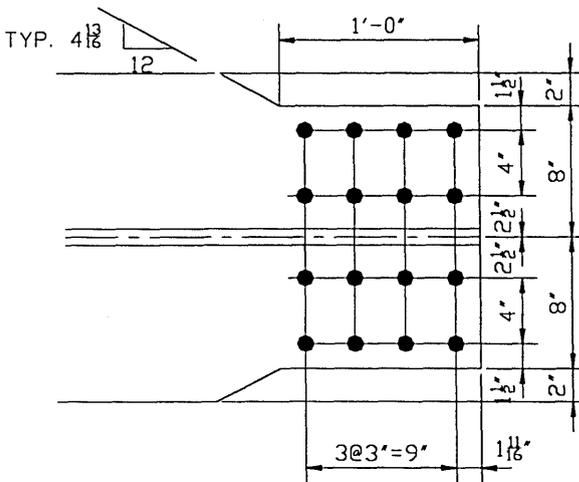
Description of Error: Specified flange width was 16" (see sketch). Actual flange width is 15 3/4". Edge distance member does not meet specifications. The type of edge on member is flame cut.

Solution Recommended: Check dimensions of member to see if removal of 1/16" would allow planed edge. Planed edge will allow smaller edge distance requirement. Check edge distance specifications with planed edge and reduction of 1/16". If edge distance with planed edge will not meet specifications then cut and replace member at acceptable location or replace entire member.

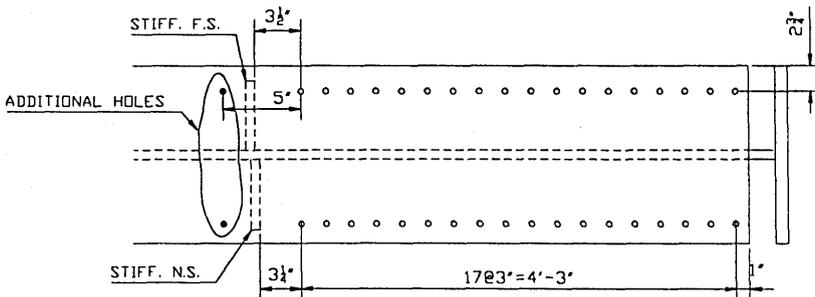
Description of Error: Girder top flange far end has the hole pattern drilled for the splice plate shifted by 1/2 inch which results in 1" end distance.

Solution Recommended: Lengthen the splice by 5" and add an extra set of bolts. Due to the location of the stiffener bars the gage on this extra set of holes will be 5 inches.

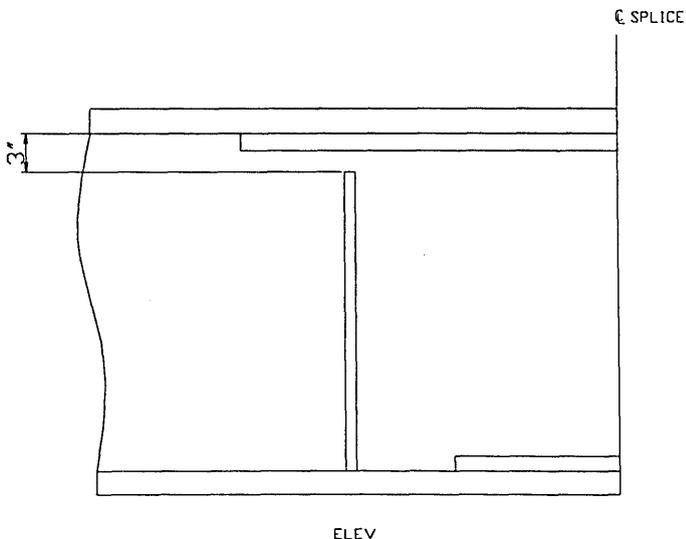
Description of Error: A stiffener was shown to fit tight against both flanges. One inside splice plate extended beyond the location of the stiffener.

Solution Recommended: Cut the stiffener off 3" from the flange. This was acceptable since this was a plain stiffener rather than a diaphragm connection plate. Other possible solutions: the stiffener could have been moved far enough to miss the splice plate. This would have been the best solution had the error been noticed before the stiffener was in place. In actual case, shop did not realize there was a problem until they tried to clamp the splice plates in place for drilling.

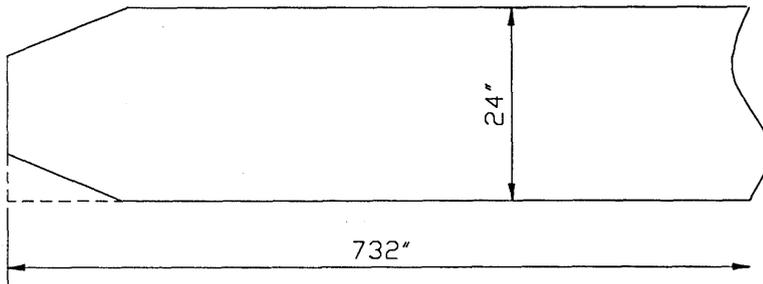
Description of Error: Top flange was to be clipped on the far side to miss abutment wall. It was clipped on both sides.

Solution Recommended: OK to leave as is.

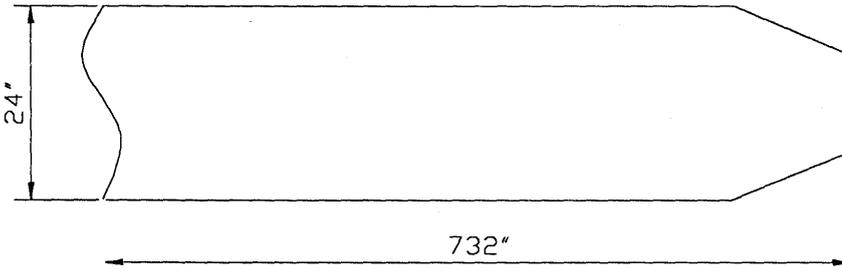
Description of Error: Top flange was to be clipped. The shop clipped both the top and bottom flanges.

Solution Recommended: Cut off plate 6" beyond last splice hole. Weld a new flange plate on. Get the splice X-rayed.

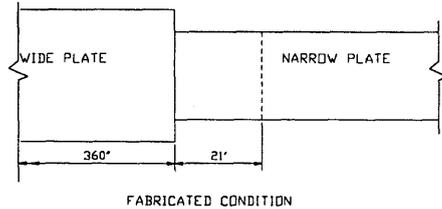
Description of Error: Bottom flange was made up of 2 plates spliced together in the shop. The narrow piece ended up 21" too long, the wide piece 21" too short. The flange had been spliced together and tacked to the web.

Solution Recommended: Remove flange from web. Cut 21" off narrow end. Splice a 21" piece on to the wide end. Send revised drawings. Have the splice x-rayed.

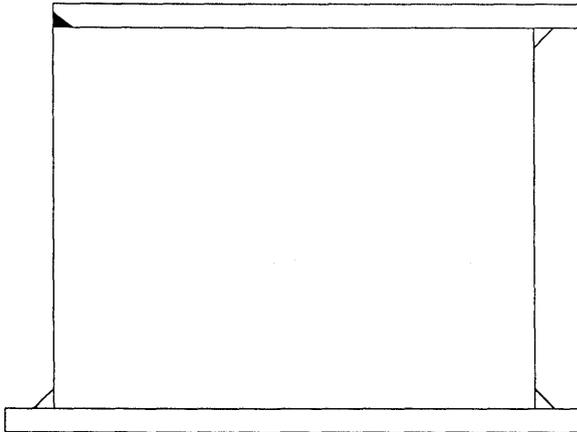
Description of Error: When flame cutting one top flange plate for a steel cap beam, the cutting machine was incorrectly set causing the plate to be cut 3/8" narrow. The flange is supposed to overhang the web by 3/8".

Solution Recommended: Align the edge of the flange plate with the web on one side of the box which will give a 3/8" overhang on the other side. The edge that aligns will have a single bevel full penetration weld with a backing bar.

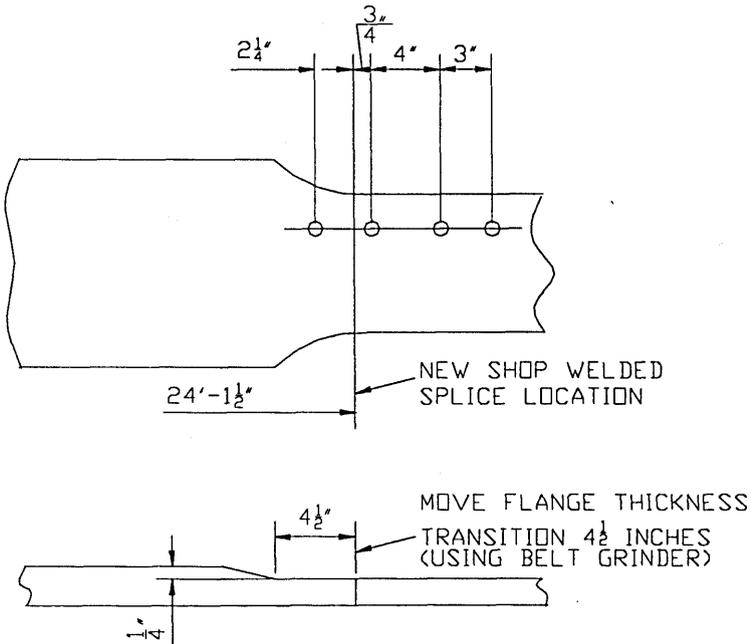
Description of Error: A girder has been fabricated with the shop welded splice shifted away from X-end. (The thicker of the two flanges being spliced is longer than called out by design). The resulting shop welded splice subsequently falls in the bolt hole pattern for floor beam at extension dimension 24'-3 3/4".

Solution Recommended: Corrective action calls for grinding the thicker flange to match the thinner flange thickness for approximately 4 1/2 inches thus allowing the floor beam to fit properly.

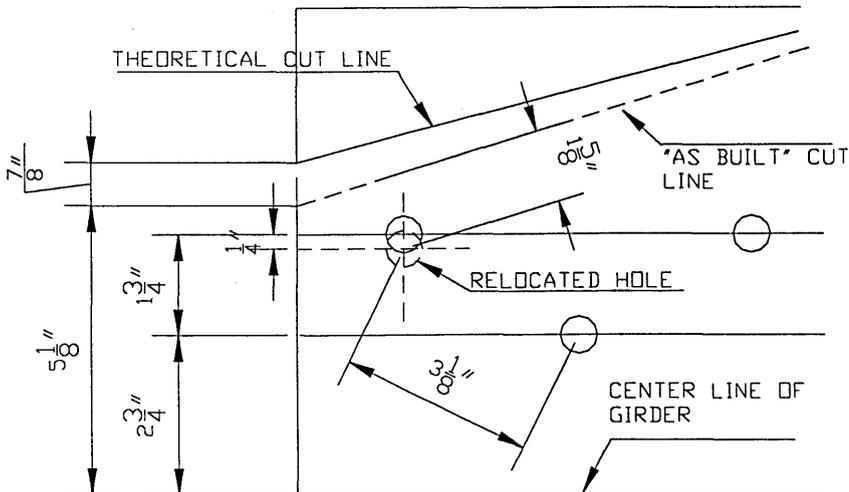
Description of Error: One girder has the corners clipped incorrectly. The centerline of girder to edge of clip is called out by design to be 6 inches. As fabricated, this dimension has been cut to 5 1/8 inch (1'-0 3/8 inch along length of taper cut). Review of "As Built" indicates by relocating hole 1/4 inch (neither splice plate nor flange are drilled at this writing); an 1 1/2 inch edge distance and 3 inch optimum between holes can be maintained. In any event, the edge distance will be maintained knowing 2 5/8 inch minimum center to center of hole can still be maintained.

Solution Recommended: Relocate hole 1/4 - 3/8 inch allowing the clip (taper cut) to remain as fabricated. Drawing revised to reflect "as built" condition.

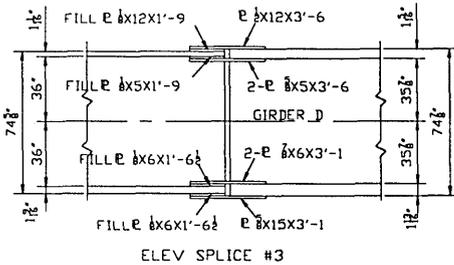
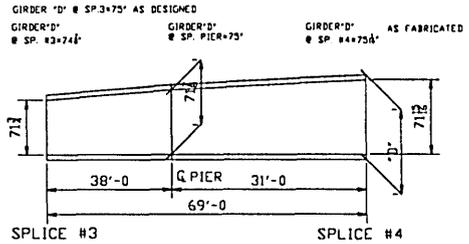
Description of Error: The web plate for one girder (marked girder D in sketches) has been cut narrow. The as fabricated web depth is 1/4" narrow at field splice #3, 1/8" narrow at pier #2, and 1/16" narrow at field splice #4. The girder is fabricated and is in the laydown area for the drilling of the field splices.

Solution Recommended: Provide 1/8" fill plates at field splice to accommodate the web depth under run.

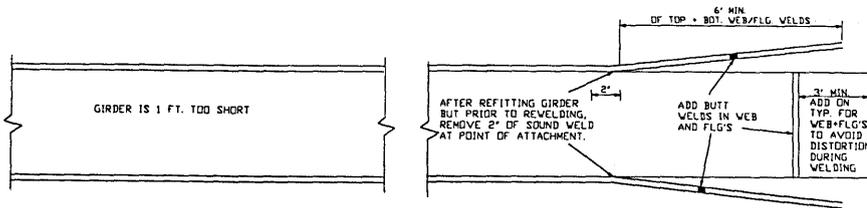
Description of Error: During burn-off for length, girder was cut 1' too short.

Solution Recommended: Cut top and bottom web/flange welds back 6' min. pry open to allow new web butt weld and RT. Note: new web section shall be min.3' long. While girder remains pryed open, make flange butt welds and R.T., then reweld both top and bottom web/flange welds. Engineer shall locate butt joints and stagger location so flange and web welds are at different cross section. 100 % R.T. is required, followed by 100% M.T. of web and flanges prior to refit, 100% M.T. after final weld.

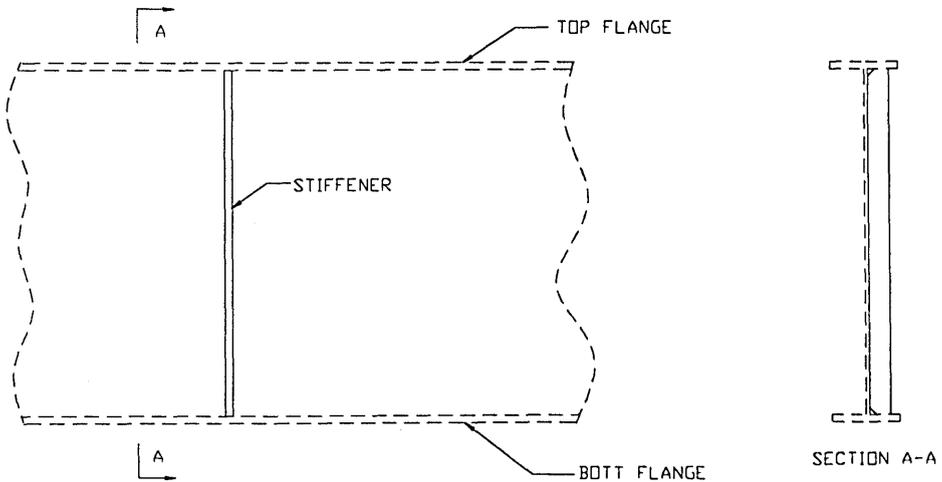
Description of Error: The bearing stiffener was cut too short and was welded in place before they discovered the gap between the bottom flange and the bottom of the stiffener.

Solution Recommended: Cut stiffener out, grind weld area on the web, then magnetic particle test the web for cracking and replace with a correct length stiffener.

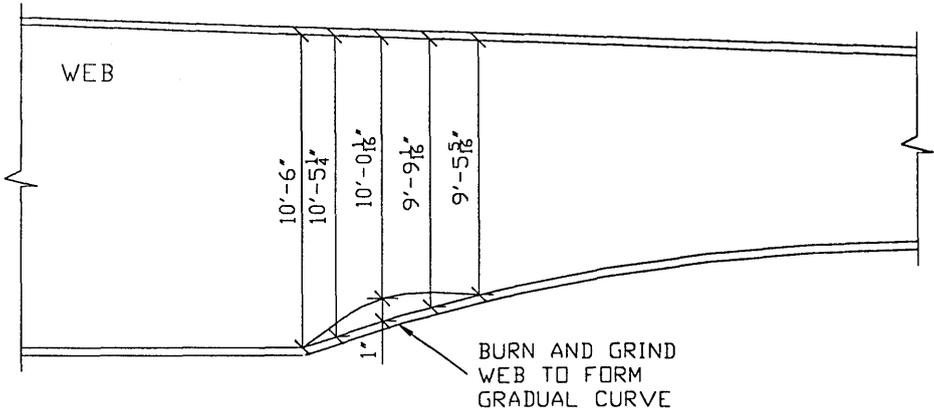
Description of Error: The web plate near the center of the girder in the haunched area was cut 1" too narrow along the parabolic curve, which caused an indentation approximately 5'-0 long.

Solution Recommended: Grind web to form a gradual curve where the indentation was cut so as to create a smooth transition to weld the bottom flange to. Provide radial transitions at the 10'-5 1/4" and 9'-5 5/16" web depth locations. Adjust stiffener depth as needed in affected area.

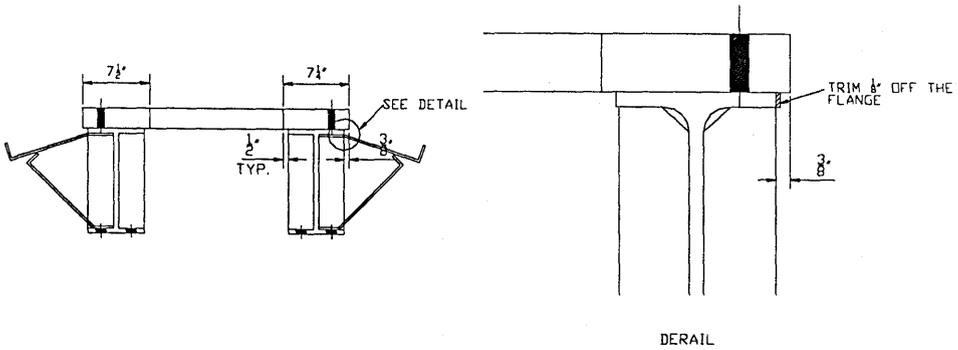
Description of Error: The finger plate from one end towards the middle 19'-4" was cut too narrow which did not allow for enough overhang for the 3/8" fillet weld to attach the W12 x 35 top flange to the underneath side of the finger plate.

Solution Recommended: To trim 1/8" off vertically, of the top flange of the W 12' x 35 in the affected area of the finger plate on the side where there was not enough overhang, to allow for a 3/8' weld.

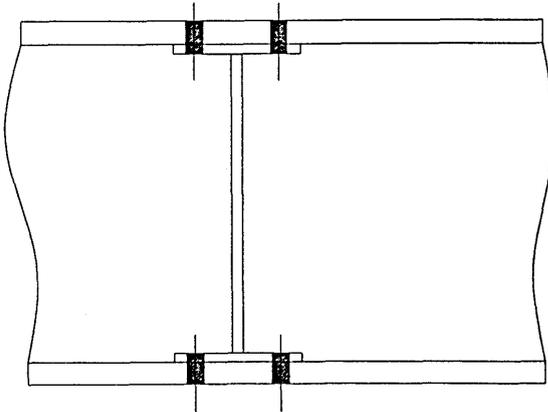
Description of Error: The top flange is the tension flange in this area. Its connection was made properly. The stiffener was to be welded to the bottom flange but was not welded when it was noticed the driller had drilled holes in the top and bottom flange. The stiffener was not yet welded into the girder.

Solution Recommended: Shorten the stiffener by 3/8" (the thickness of the auxiliary plate). Put an auxiliary plate at the bottom, similar to the one at the top.

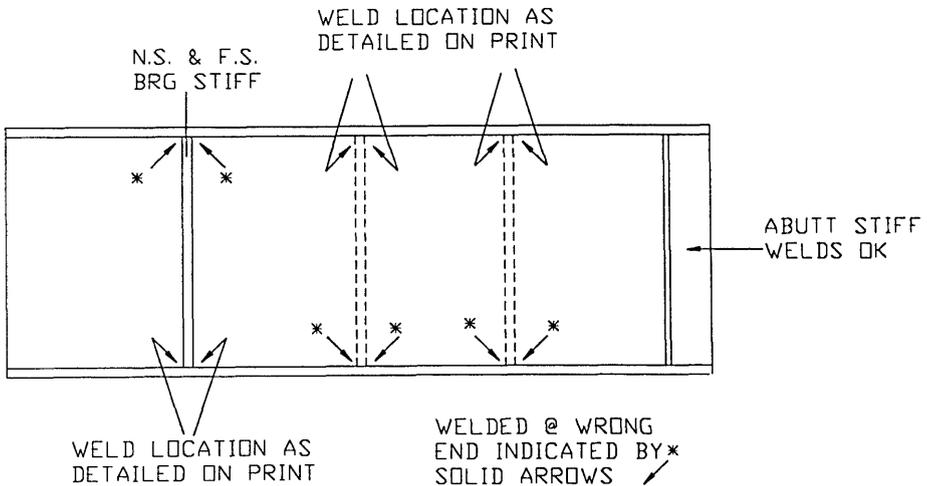
Fatigue category of incorrect welds was checked by DOT and found acceptable for this case so leave incorrect welds in place.

Solution Recommended: Leave incorrect stiffener welds as is and N.D. test (MT). Weld the stiffeners to correct flanges.

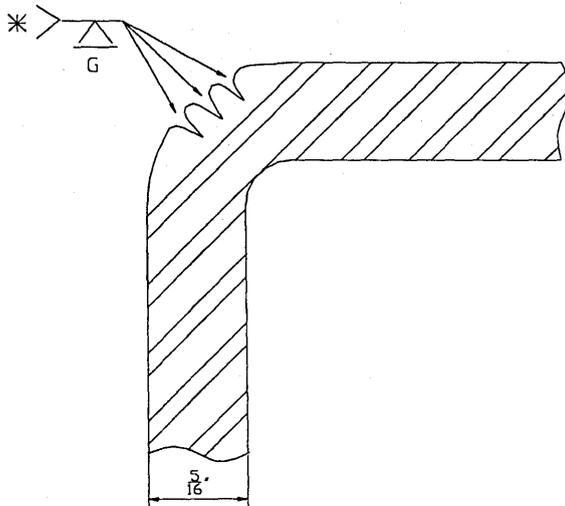
Description of Error: Stress fractures occur at the corners of bent diaphragm plates.

Solution Recommended: All diaphragms with stress fractures will be subject to a dye penetrant examination on the entire of length of the bend. The dye penetrant examination will be in accordance with ASTM E165 and a written dye penetrant examination procedure. All diaphragms with excess 1/4" gap will not be used on this project. All diaphragms less than 1/4" gap will be repaired by welding with FCAW approved welding procedure and ground smooth.

\* REMOVE TO SOUND METAL 1" PAST DEFECT, WELD  
AND GRIND SMOOTH AT THE APPLICABLE LOCATION

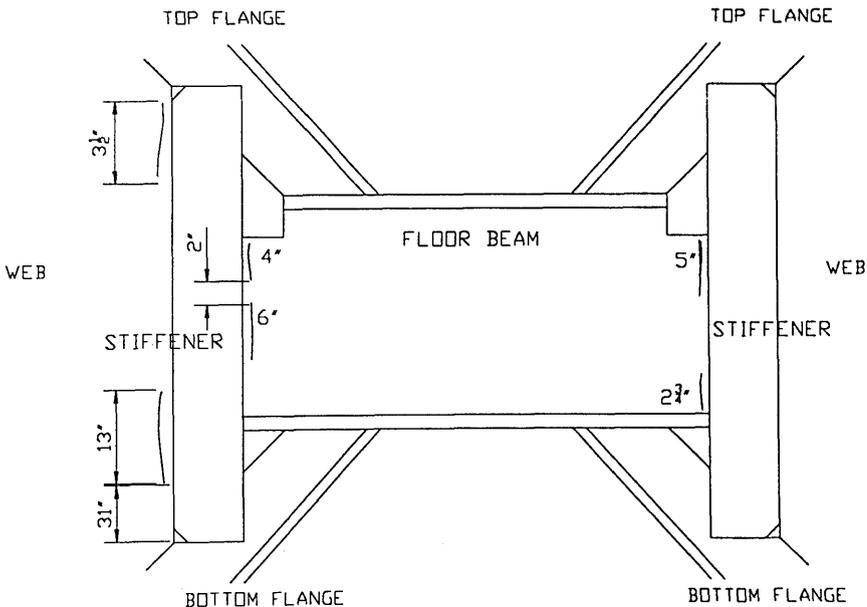
Description of Error: Cracks occur in the vertical weld attaching the stiffeners to the web or else in the vertical weld connecting the floorbeam to the stiffener.

Additional Comments: This is not a fabrication error. This case arose during the retrofit of an existing bridge. The case is included here to provide an example of cracking. If a similar case is encountered, refer to NCHRP Report (National Cooperative Highway Research Program Report 336: DISTORTION-INDUCED FATIGUE CRACKING IN STEEL BRIDGES ).

Solution Recommended: Preheat. Remove the cracked weld using air-arc carbon gouging.

Grind the gouged areas. Inspect the gouged areas using magnetic particle testing. Replace the removed weld metals by rewelding, air cool to ambient temperature and then reinspect the crack area using magnetic particle testing not before 24 hours after welding is complete.

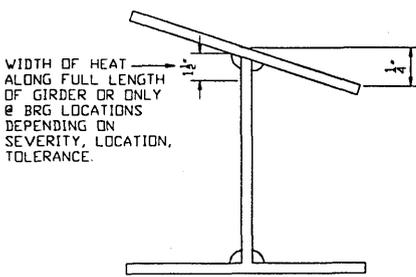
FLANGE TILT

Remarks: Very common problem. Heating method is always required at bearing locations where 0 degree flange tilt is allowed.

Solution Recommended: For flange tilt: apply heat aiding entire girder length at the web/flange. 900° -1000° F max. heat on obtuse side. For "cupping": apply heat along entire flange on the face opposite the web/flange weld keeping width of heat approx. 1 1/2" (Jacking force is optional). Final checks are required to verify flange tilt and cupping.

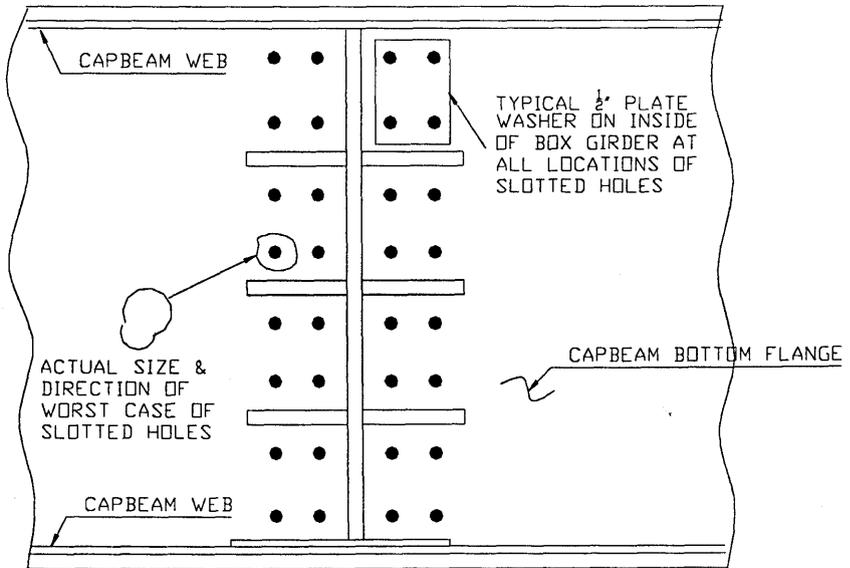
PLAN

Description of Error: Capbeam bottom flange where girder bottom flange bolts to capbeam has 32 holes that are elongated up to 3/8 inch. The corresponding bottom flange holes in the girder are not elongated.

Solution Recommended: Furnish plate washers which shall be 1/2 inch.

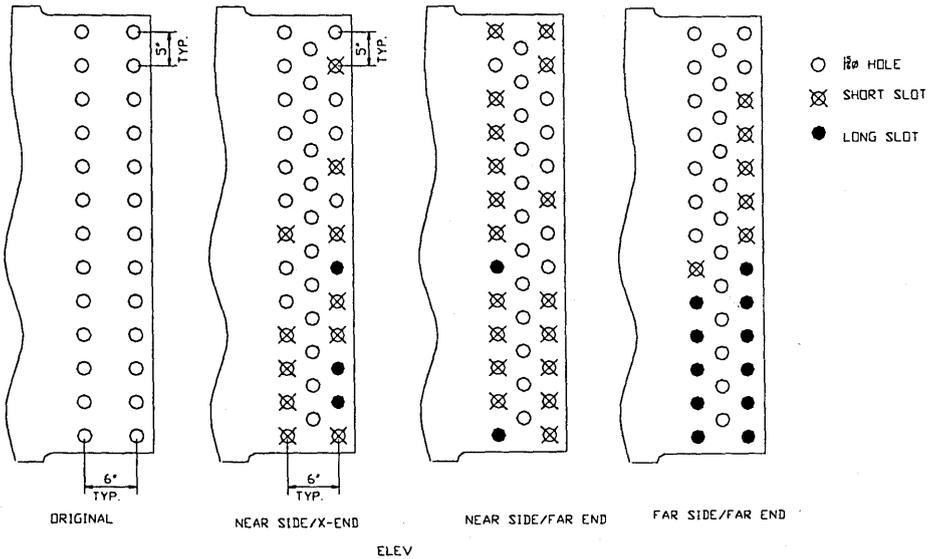
Description of Error: Several holes in the web were misshaped to become short or long slotted.

Solution Recommended: Add a center row of holes to the bolt hole pattern. In doing such, all bolts will be 7/8" diameter, this is a center ply only for slots, thus no special provisions are required for washers. The calculations indicate this approach allows the bolts to jointly develop a greater shear capacity than the original design. Calculations used allowable shear stress values of 15.5 ksi for standard hole, 13.5ksi short slot, and 9.0 ksi for long slot.

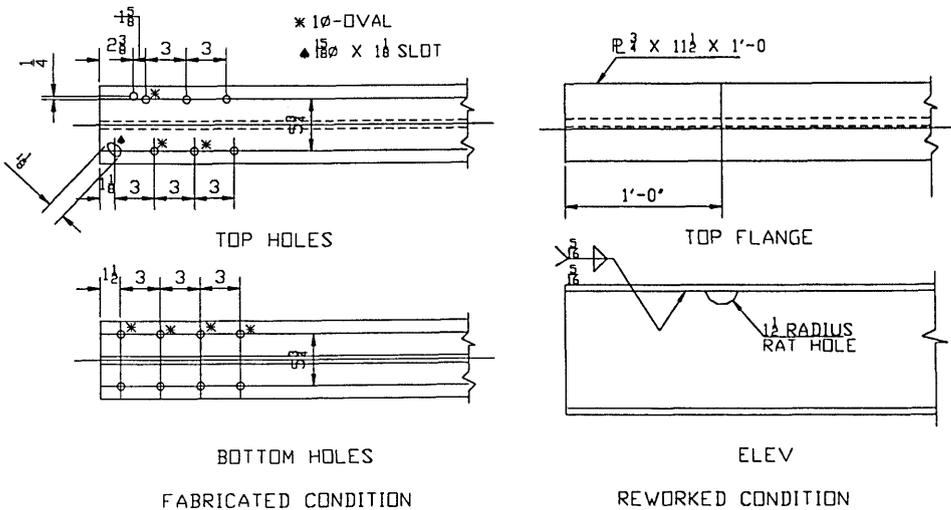
Case #TF214:

Description of Error: Egg-shaped holes occur on the flanges at a splice location. The holes are approximately 1 dia. ovals. (Also see misshapedHole, 'MSPH-C001')  
 Solution Recommended: Cut off the existing flange. Add new plate using full penetration weld at flange and fillet weld at web. 100 percent RT a flange and 100 percent MT at web. Drill holes correctly.  
 Other Possible Solutions: Drill all holes from the solid to 1 1/16" diameter holes for 1" diameter A325 bolts if edge distance (AASHTO 1 3/4" edge distance for 1" bolts) had been present.

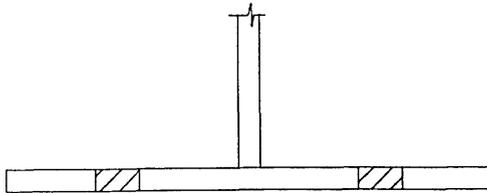
Description of Error: Bearings should have been drilled and tapped for  $\frac{3}{4}$ "  $\phi$  bolts. Were made for  $\frac{7}{8}$ "  $\phi$  bolts instead.

Solution Recommended: OK to leave as is. Make revised drawings showing larger holes. Make shop sheet to return  $\frac{3}{4}$ " bolts to stock and to order  $\frac{7}{8}$ " bolts.

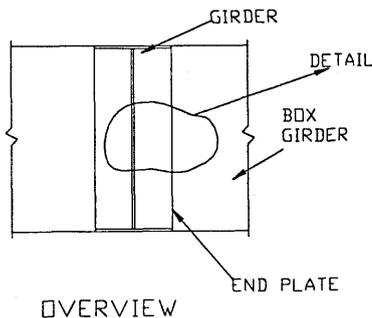
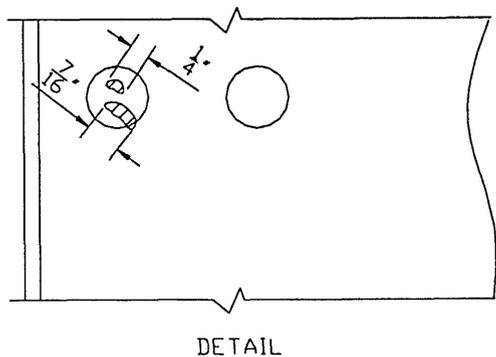
Description of Error: A flange gouge at a bolt hole on the outside row 6<sup>th</sup> from the bottom on the end plate of a girder. The inside of the hole was gouged in two places approximately 1/8" deep. The girder end plate connects to a box girder web.

Solution Recommended: The gouges in the 6<sup>th</sup> bolt hole in the girder may be removed by drilling out the hole to 1 1/16" as well as the corresponding box web hole. A 1" bolt will be used to fill it.

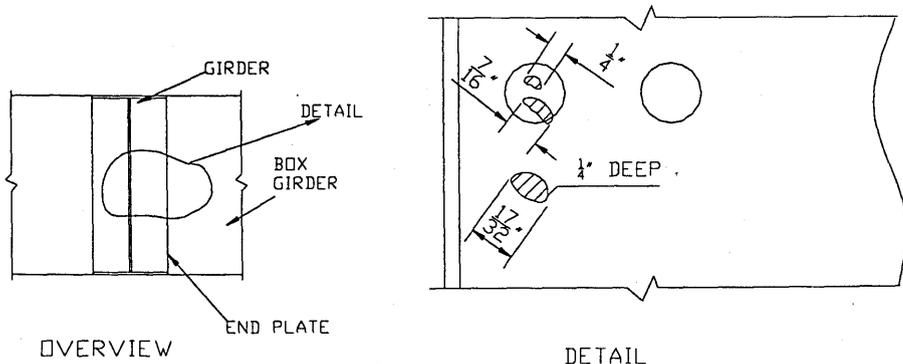
Description of Error: A flange gouge at a bolt hole on the outside row 6<sup>th</sup> from the bottom on the end plate of a girder. The inside of the hole was gouged in two places approximately 1/8" deep. The girder end plate connects to a box girder web.

Solution Recommended: The 1/4" deep gouge near the 6<sup>th</sup> bolt hole may be removed by grinding, welding, grinding the weld and UTing the area.

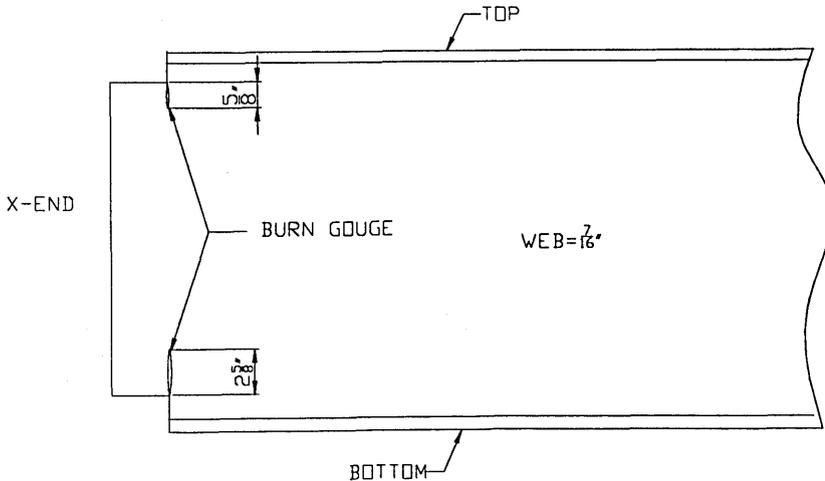
**Case #FB157:**

Description of Error: Burn gouges in top and bottom web from cutting copes.  
 Solution Recommended: 1) Grind 60° bevel, 1/4" deep on web repair area's. 2) Attach run off bars by tacking in weld groove (do not tack to parent material). 3) Preheat and weld 1<sup>st</sup> side per approved weld procedure. 4) Back gouge 2<sup>nd</sup> side to sound weld metal. 5) Weld 2<sup>nd</sup> side per approved weld procedure. 6) Remove run off bars by air-arc gouge and grind 1" radius per shop drawings. 7) RT weld repair area's per contract spec.

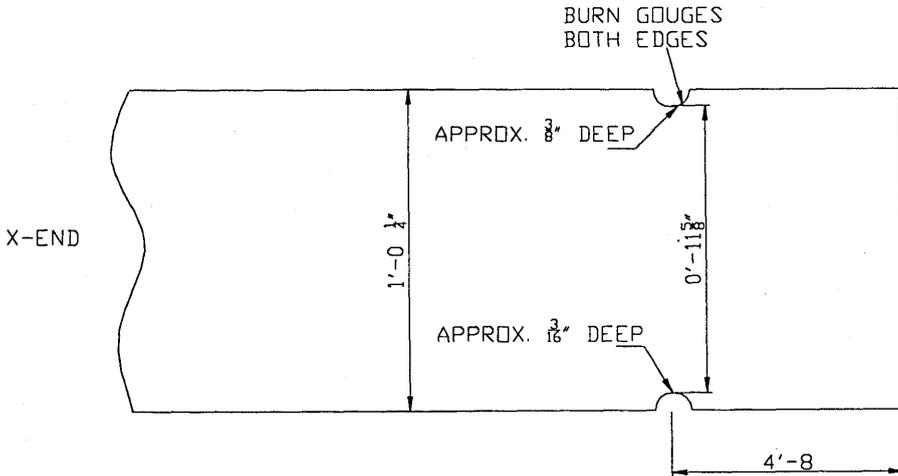
Description of Error: The bottom flange for a girder has burn gouges on the edges 4'-8" from the right end. The gouges are on both edges and across from each other.

Solution Recommended: 1) Grind defect area to remove any slag or dross remaining from the cutting operation. 2) Preheat gouged area to applicable temperature. 3) Weld gouged area with approved weld procedure with electrodes no greater than 5/32" diameter. 4) Grind weld flush with base metal. 5) Finished and ground repair shall be UT inspected.

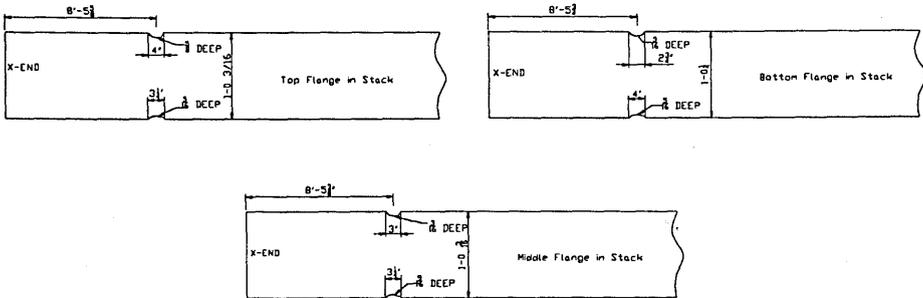
Description of Error: Top flanges for 3 girders K, L and M have gouges on their edges at extension dimension 8'-5". The gouges are on both edges of the flanges and across from each other.

Solution Recommended: Allow a cut, reverse the ends, butt pieces together and reweld, then 100% radio graph butt weld. There is sufficient material fit. Trim off gouge material at end of piece when final welding is complete.

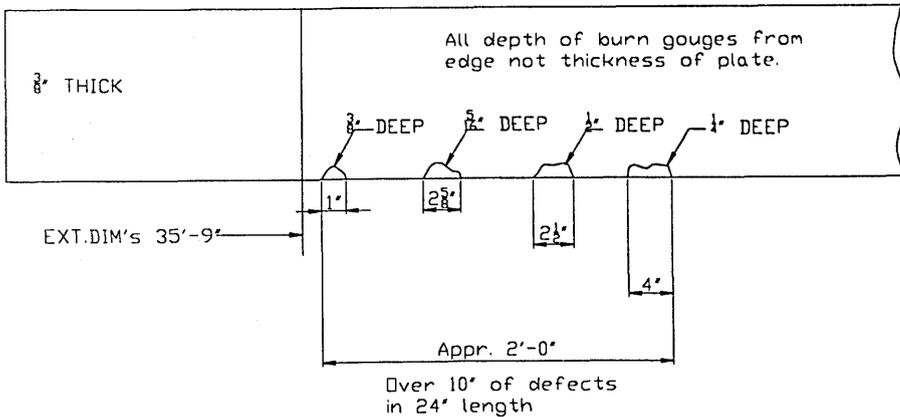
Description of Error: Girder web plate has 4 burn gouges on the bottom edge. These gouges range from 1/4" to 1/2" deep.

Solution Recommended: Since this is a web, there is no extra width. Make two cuts and add new material. Radiograph butt welds 100%.

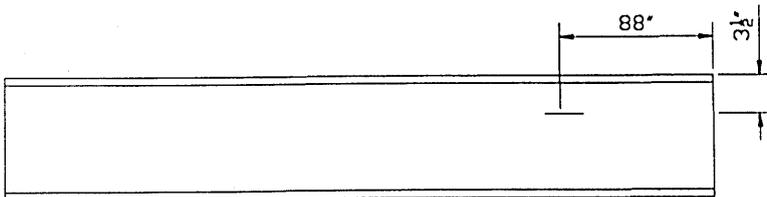
Description of Error: Girder web plate was damaged in handling while at fabricating plant. Cavity (gouge) area is located approximately 88 inches from girder end and 3 1/2 inches down from top flange.

Solution Recommended: 1) Grind cavity (gouge) suitable for MT. 2) MT repair cavity to assure no defect exists. 3) Preheat without interruption until the repair is complete. (Preheat / interpass 250 degrees F- 450 degrees F). 4) Using electrode purchased for Fracture Critical Members, repair using approved weld procedure (SMAW flat). 5) Postheat for 15 minutes (400 degrees F - 500 degrees F). 6) Grind repair area and visually inspect.
