**Fabrication error  
Indexed eXamples and Solutions:  
FIXS**

**A Report on Research Sponsored by  
Kansas Department of Transportation  
KTRAN Project No. KU-98-8  
Mid America Transportation Center  
MATC/KU 98-2  
National Steel Bridge Alliance**

**UNIVERSITY OF KANSAS CENTER FOR RESEARCH, INC.  
LAWRENCE, KANSAS  
JUNE 1999**

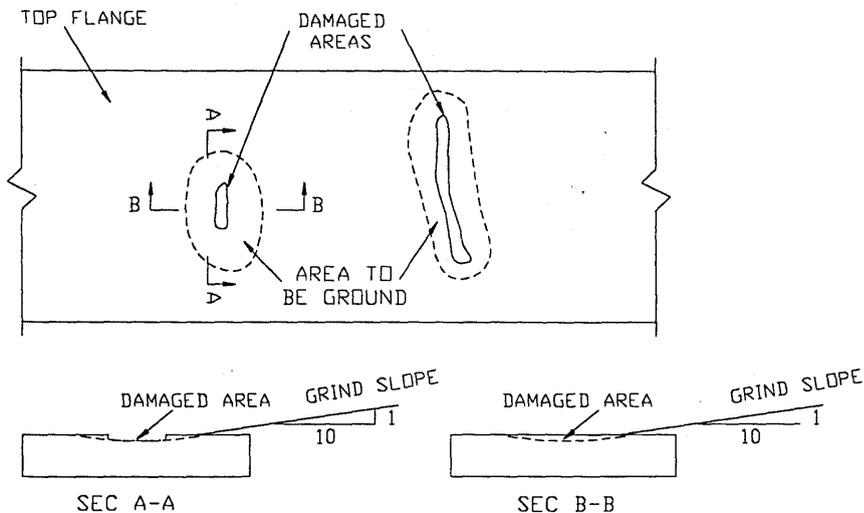
Description of Error: The flanges were damaged by the Contractor while he was removing an unacceptable section of deck that had been poured.

Solution Recommended: 1) The damaged areas on the flanges must be ground out smoothly. The maximum slope for the grinding is to be 1" vertical to 10" horizontal. The grinding is to be done in the direction of the major stress (i.e.- longitudinally along the girder). A circular grinder may be used if the repair is finished with a belt grinder in the direction of the major stress. Notches deeper than 1/4" may not be repaired with this procedure without further approval. 2) When the repair is complete the areas that have been ground shall be inspected by a DOT materials inspector. After the repair has been approved the ground areas shall be painted with organic zinc-vinyl paint.

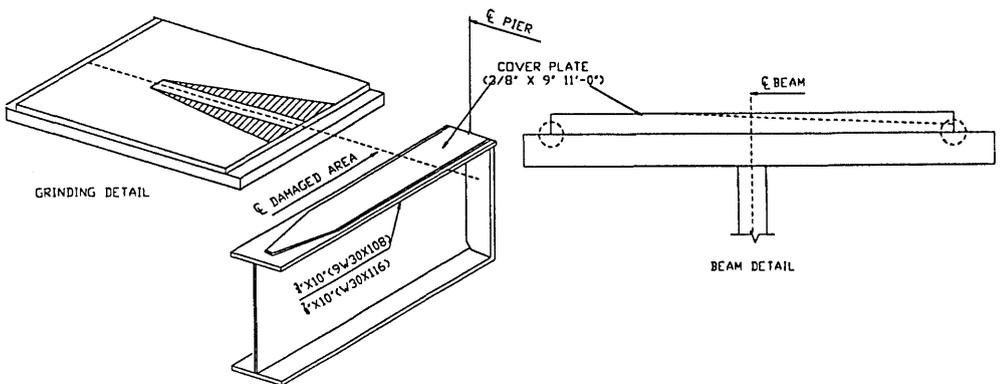
Case #NC506:

Description of Error: A cover plate had been cut with a saw during the removal of the concrete slab. Another cut was discovered at a second location during inspection of the cover plates for weld cracking. The saw cuts were measured in the field.  
 Solution Recommended: Grind a 16:1 transition at both locations. Do not grind below saw cut depth. It is also recommended that future routine bridge inspection include observation of each saw cut location.

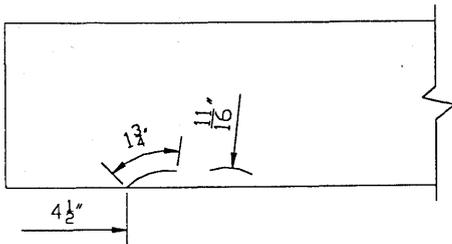
WEB B2 1/2 X 42 47'-1

Description of Error: A fabrication error occurred when web burning machine jumped its track and burned into the webs. The webs affected are for girders A2 and B2.

Solution Recommended: Weld and grind the gouges and ultrasonic test the areas for soundness.

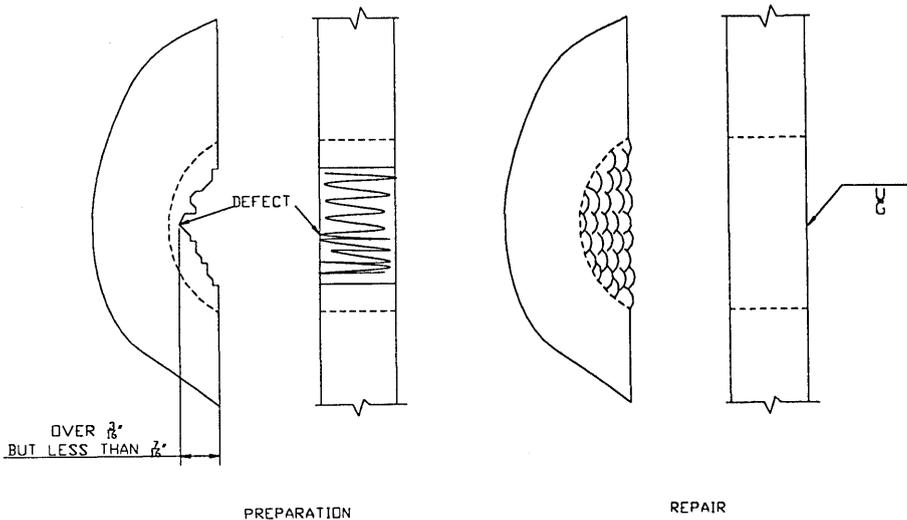
Case #MB-F001:

Description of Error: Gouges in cut base metal edges that are 7/16" deep or less, where the surface should be flat.  
 Solution Recommended: If the gouge meets the tolerance of greater than 3/16" and less than 7/16" from the cut edge, welding with single arc shield metal arc welding (S.M.A.W) is required, If gouge is less than 3/16" deep from the cut edge see below for other solution. Preparation is required for welding. (preparation of gouged area includes air-arc gouging or grinding to the bottom of the burn. Preheat is required. These are only if welding is involved) If welding is required then magnetic particle testing (M.T.) and/or ultrasonic testing (U.T.) is required.  
 Other Possible solutions: If the gouge is less than 3/16" deep from the cut edge, grinding to a slope of 1 inch to remove the gouge is acceptable. No welding required.

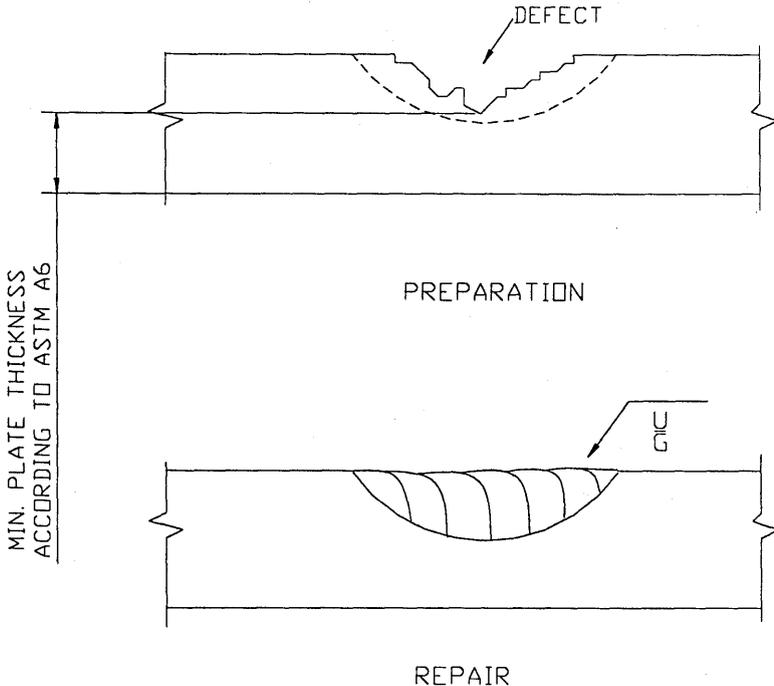
Description of Error: Defect in base metal where base metal should be flat with little or no discontinuities on the base metal surface.

Solution Recommended: Single pass semi-automatic submerged arc weld (SAW) in place of the defect after preparation of base metal. Preparation of the defect area by air-arc gouging or grinding to the bottom of defect is required. Preheat is also required. Minimum plate thickness is according to ASTM A6.

Other Possible solutions: Removal of the defect by grinding without welding is permitted, providing the thickness of the plate is not reduced by more than the permissible minimum thickness of the plate.

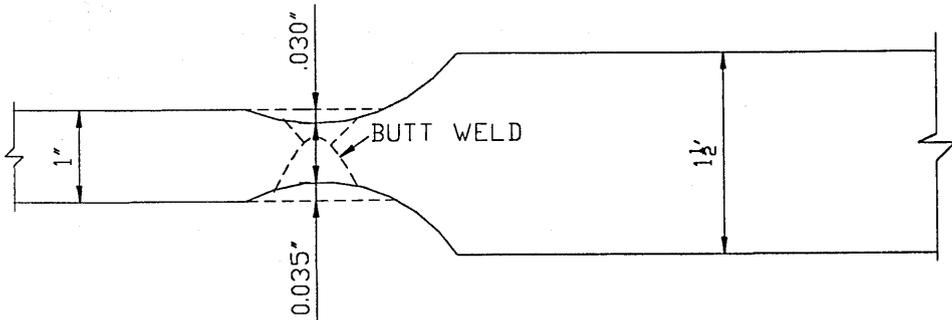
Description of Error: There was a transition of thickness on the web. In the process of removing the weld reinforcement the weld was over ground in excess of 0.010". (in violation of 5.04.15c of the 1990 MDOT Standard Specification.) Over grinding occurred on both sides of the web.

Remarks: The over grinding was discovered which reviewing the original radiographs.

Solution Recommended: Build up the defection area using the same weld procedure used to make the weld originally followed by grinding properly.

Other Possible solutions: Replace the web.

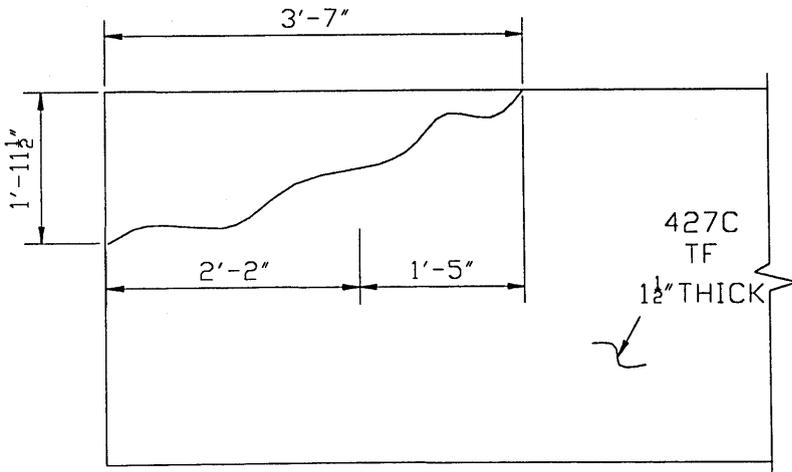
427-14E

Description of Error: A lamination appears in the top flange of the girder.  
 Solution Recommended: This repair shall be made by preparing a cavity by means of grinding or air arc gouging to a depth of 1/4 to 3/8 inch. The ends of the cavity shall taper smoothly up to the plate surface at a slope not to exceed 1 to 1. Where the cavity extends to the plate edge, an edge run-off tab shall be used.  
 Preheat 250-450° F shall be used and temperature shall be maintained until repair is complete. Welding electrode (FCM) purchased this contract shall be used. Shielded metal arc or submerged arc may be used. However at least the first four layers of any repair shall be shielded metal arc welding using electrodes of 1/8 or 5/32 diameter. The maximum pass thickness shall be 1/8 for SMAW or 1/4 SAW. Welding parameter shall be as specified in the applicable WPS in the following table.  
 SMAW - WPS 90-15

SAW - WPS 90-890-990-1090-11.  
 Following welding, postheat shall be employed and shall continue without interruption from the completion of repair welding to the end of the minimum postheat period. Postheat of the repair area shall be between 400° and 500° F for one hour per inch of repair weld thickness or for two hours whichever is less.  
 The repair weld shall be ground flush and base metal suspect area shall again be inspected by means of UT to determine if any applicable change has occurred as a result of the sealing process.

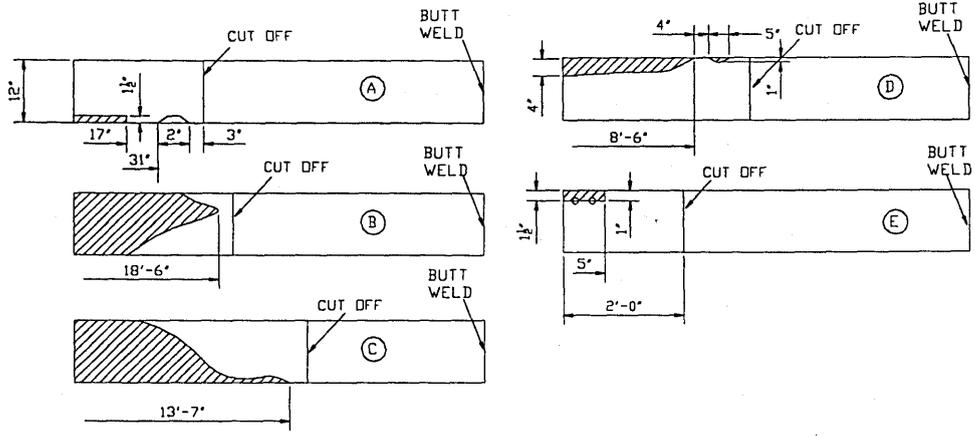
Case #: NC510:

Description of Error: Laminations occur in the girder flanges.  
 Solution Recommended: Cut off the defective area. UT test after cutting to assure all laminations are removed. Butt-weld new flange material to the plate. Butt welds shall be at the good end, if the end far thist from the laminations. All butt welds to be radiographed. All repaired material to be used in top flange compression regions. Plates marked B, C, D, and E constitutes top flange of the drop-in piece of span 2. Plate A constitutes top flange of an end span. Laminated area of Plate A should be placed at the free end (abutment) and not the field splice end of the girder piece.

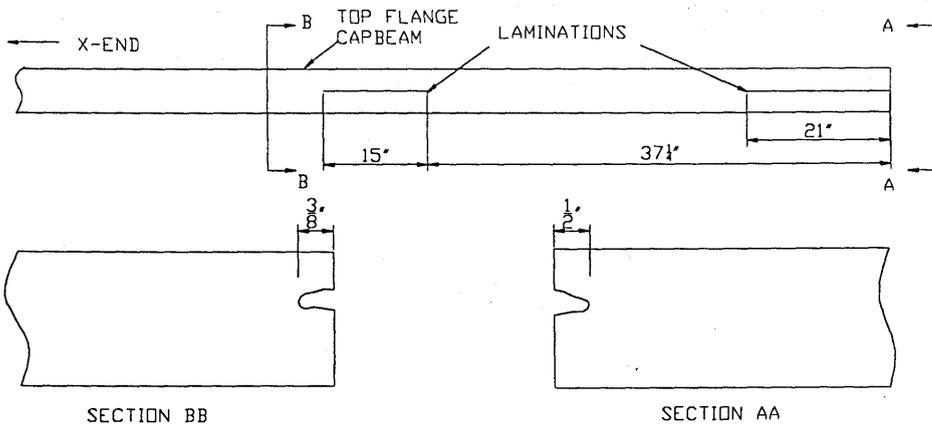
Description of Error: Cap beam top flange has two laminations along its edge. Fabricators have ground 3/8 inch deep in the edge of the flange and the 15" lamination was removed but the 21" lamination still shows indications.

Solution Recommended: Grind the 21" lamination the additional 1/8" to remove the indications and repair these areas per approved fabrication correction procedure.

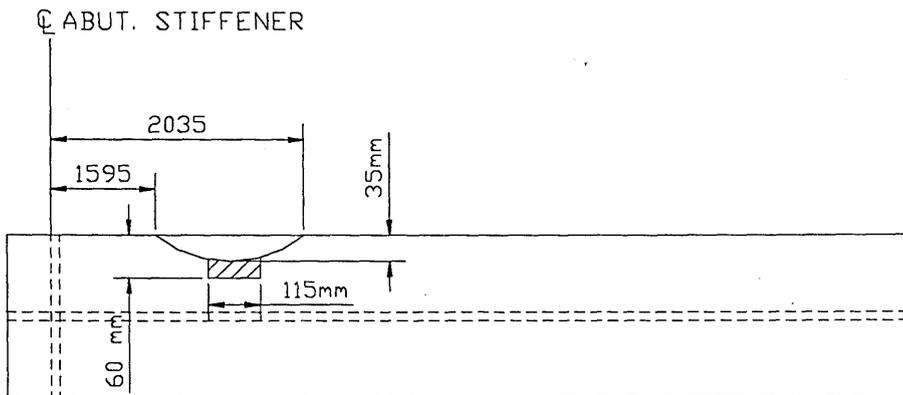
GIRDER TOP FLANGE NEAR SIDE

Description of Error: A lamination was discovered at mid-thickness in the edge of a top flange plate after cutting. Its apparent max depth was 35 mm, so it was repaired in accord with Section 3 of the Bridge Welding Code. After shafting (welding web to flange and installing stiffeners), the lamination reappeared on the opposite flange edge, indicating a full width separation. Although this is a compression flange, stud shear connectors will be attached for composite action, so horizontal shear in the flange will be substantial. Solution Recommended: Possible solutions could include: partial or complete flange replacement; designing an array of high strength fasteners to clamp flange together, (and/or provide composite connection to slab); or a combination of edge and slot welds to "connect" flange. Fabricator opted to remove and replace a 3500 mm long portion of the flange, starting from the abutment end. This required removing flange-to-web and stiffener-to-flange fillet welds approx. 600 mm beyond flange replacement to allow flange-web separation for butt welding and X-raying joint. To facilitate replacing flange-to-web weld, size of corner clips (snips) of stiffeners and connection plate at web-flange juncture were increased by 10 mm (horiz. and vert.) to 35 mm horiz. and 75 mm vert. during weld removal. RT of butt weld and MT of replaced fillets are required for final checks.

Remarks: This is a large radius curved structure, so cross frame connection plates' welds to flange carry live load stresses. Decreasing their lengths by 10 mm was not judged critical due to the large radius involved, and larger clips allowed better access for semi-auto SAW of flange to web. Requiring fully automatic SAW for the replacement flange-to-web weld would mandate complete removal and replacement of existing sound welds attaching connecting plates and bearing stiffeners to the web and bottom (tension) flange. This would produce higher residual stresses in the girder and require extensive hand labor to accomplish.

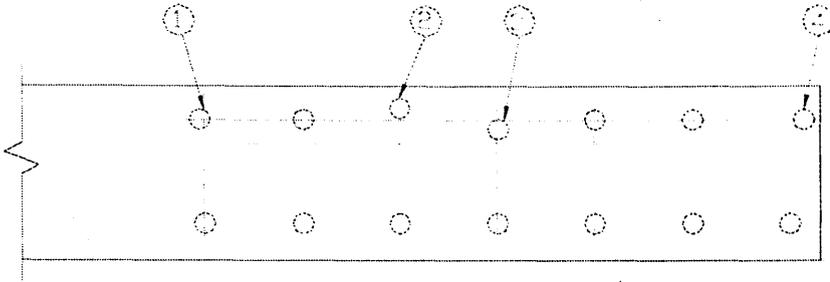
## Mislocated Holes in Flanges and/or Flange Splice Plates

Too close to end of flange (AASHTO Div 1, 10.24.7.1). Remember that there is minimal stress in flange at this point. Consider planing end of flange for small error, or if too close, do not consider in capacity, so additional bolts required to compensate, lengthening splice plate if necessary. May place bolt in errant hole to maintain sealing pitch, exclude debris, and avoid confusion on future inspections. Too close to edge of flange. This is worst situation and must be considered on a case-by-case basis. If only slightly deficient, may satisfy AASHTO by planing edge to remove burn gouges, hardened material, minor defects. If less than 1 bolt diameter between edge of hole and edge of flange, install bolts but lengthen splice to add commensurate number of extra bolts. If hole breaks edge (or edge is under contact area of washer), may need to add enough bolts to fully develop the splice before it reaches that location, and may need to use wider splice plates to allow bolts in errant holes while satisfying criteria for high strength installation (distribution of clamping force).

Too close to edge of flange and splice plate. This is worst situation and must be considered on a case-by-case basis. If only slightly deficient, may satisfy AASHTO by “planing” edge to remove burn gouges, hardened material, minor defects. If less than 1 bolt diameter between edge of hole and edge of flange, install bolts but lengthen splice to add commensurate number of extra bolts. If hole breaks edge (or edge is under contact area of washer), may need to add enough bolts to fully develop the splice before it reaches that location, and may need to use wider splice plates to allow bolts in errant holes while satisfying criteria for high strength installation (distribution of clamping force).

Bolt too close to end of flange. Remember that minimal stress in flange at this point. Consider planing end of flange for small error, or if too close, lengthen splice and add bolts. If outside splice plates only, may be able to change from straight line to staggered pattern to add bolt within same splice length.

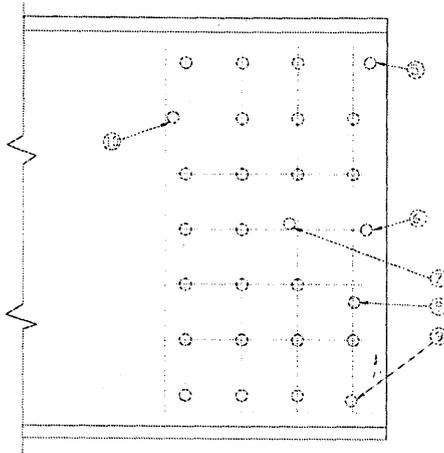
## Mislocated Holes in Webs and/or Web Splice Plates

Hole too close to free edge. Based on hole position, consider effect on splice capacity of ignoring that bolt. (Min at neutral axis), and how close hole is to edge. May be able to justify using "as is". If not sure, evaluate pattern and any holes not yet drilled to see if spacing and edge distance on other holes permit. As a last resort, increase web splice plate size and add a row of bolts.

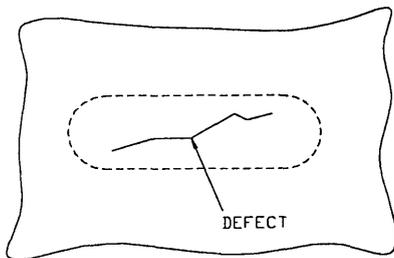
PREPARATION

- 1) for any discontinuity 1 inch in length or less, no plate repair is required, and need not be explored.
- 2) For any discontinuity over 1 inch in length and 1/8 inches maximum depth, no plate repair required, but the depth should be explored.
- 3) For any discontinuity over 1 inch in length with depth over 1/8 inches but not greater than 1/4 inches, removal is required, but not need weld.
- 4) For any discontinuity over 1 inch in length with depth over 1/4 inches but not grater than 1 inch, completely remove and weld are required. Aggregate length of the welding shall not exceed 20% of the length of the plate edge being repaired.
- 5) For any discontinuity over 1 inch in length with depth greater than 1 inch, see AWS 3.2.3.7.

**Required Final Checks / Verification:** If welding is required, use a single arc semi-automatic submerged arc weld(S.A.W.) after preparation. Magnetic particle inspection (M.T.) and/or ultrasonic inspection (U.T.) are require for the final checks.
